Test Report For:
SPIG Industries, LLC
SGET End Terminal

TESTED TO:
Manual for Assessing Safety Hardware (MASH 2016)
Test 3-33

TEST REPORT NUMBER:
TR-P38109-02-A

REPORT DATE:
August 20, 2018

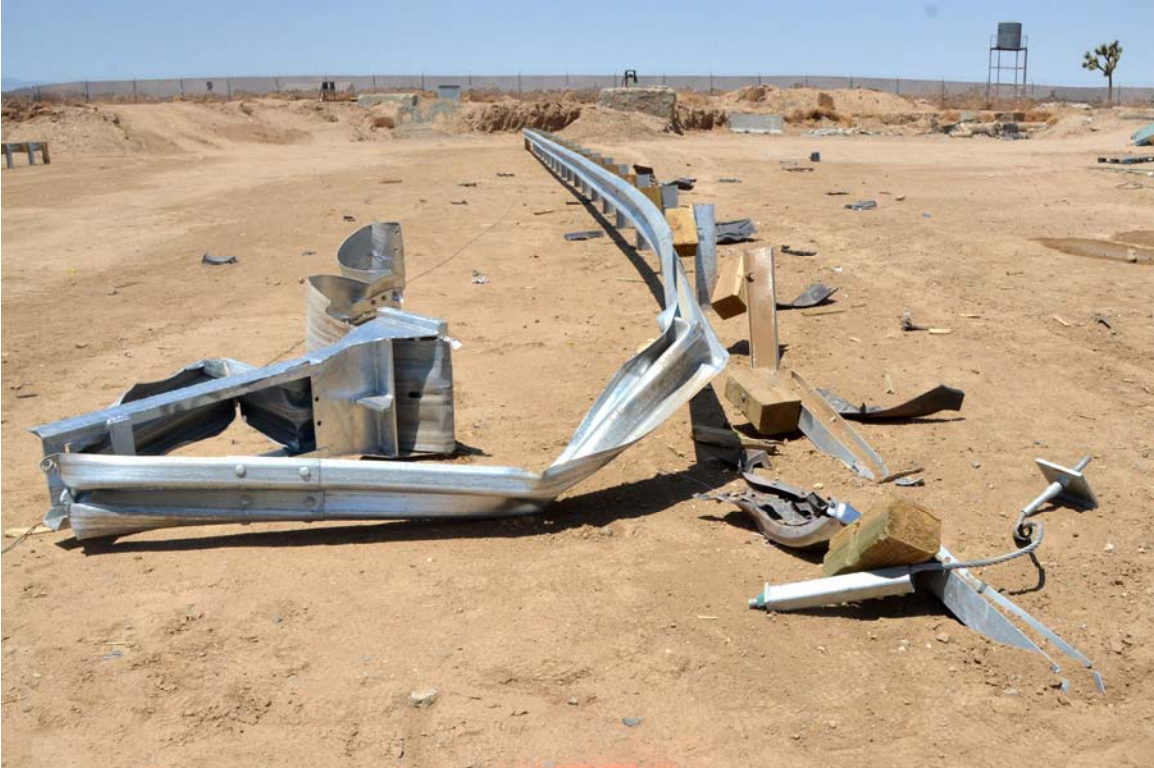
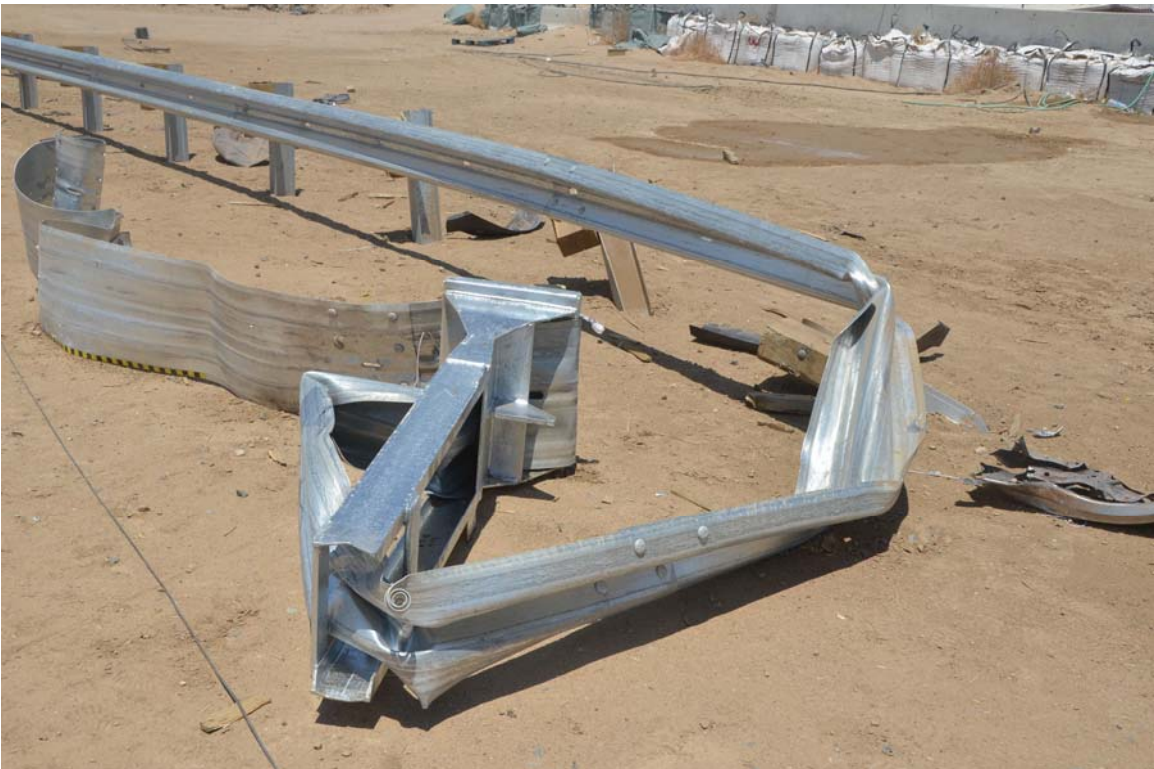
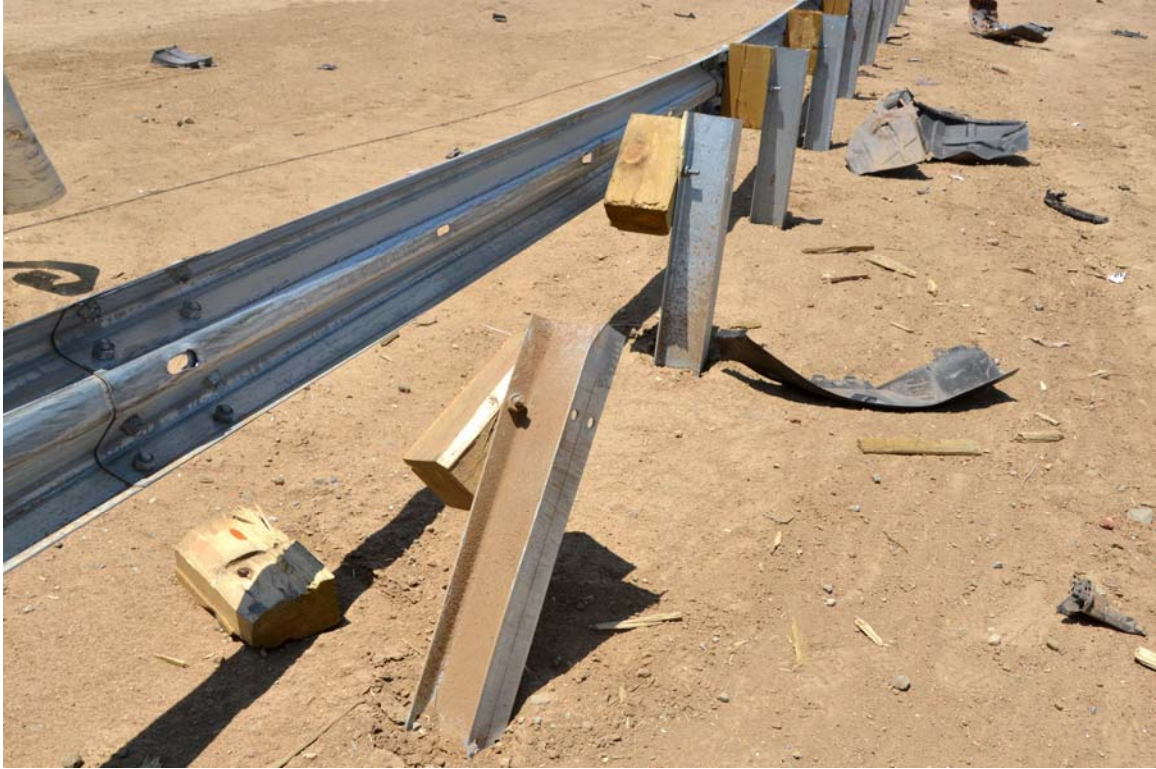
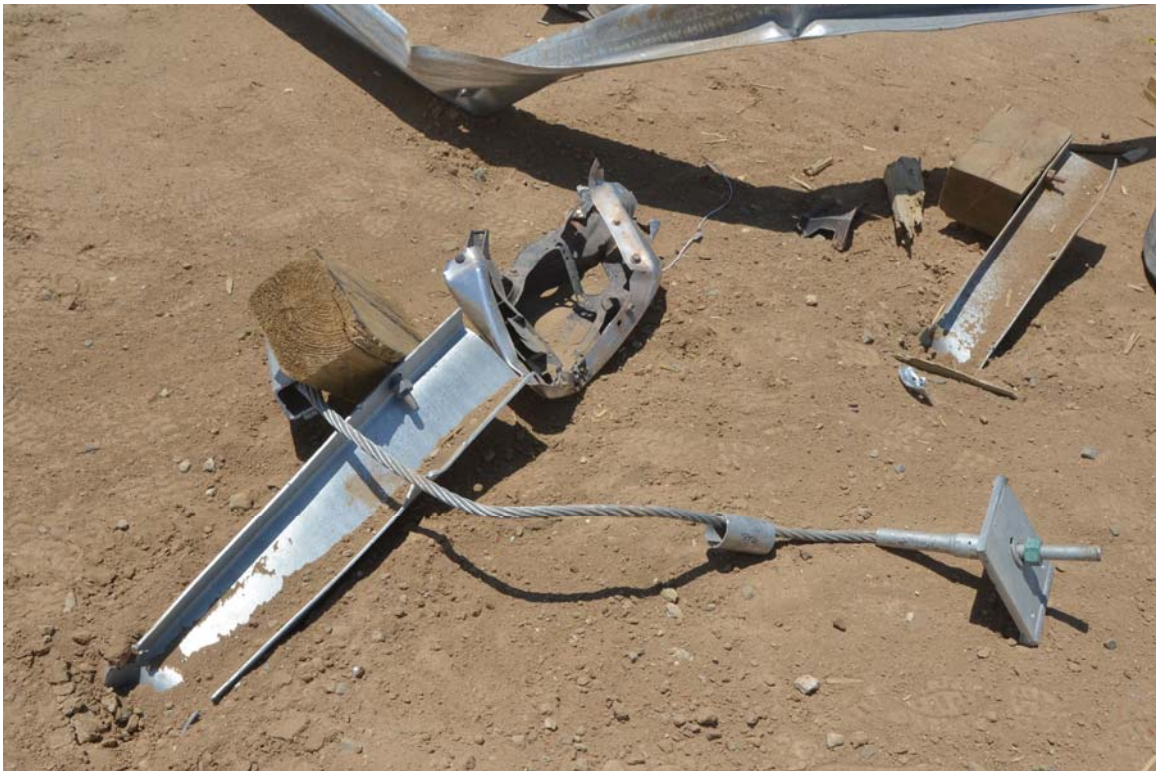
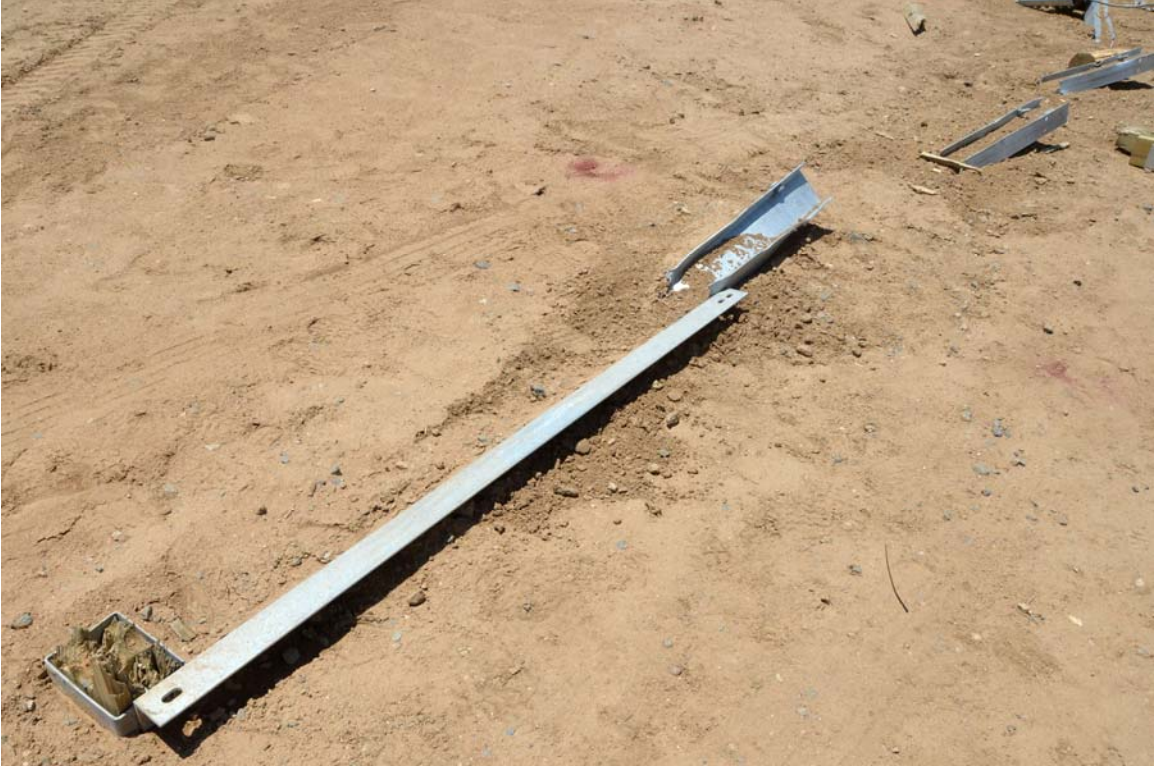
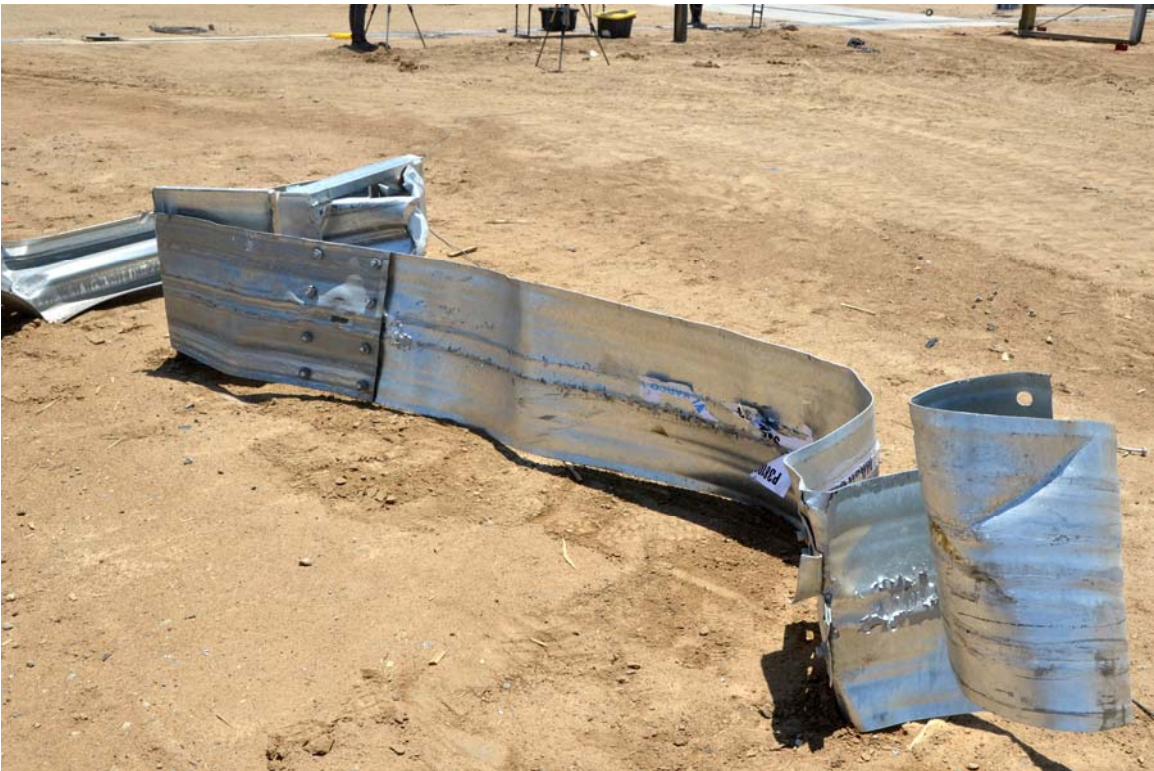
The system was damaged from post 1 through post 7 and the first four (4) W-beam guardrail panels were damaged. The chute of the impact head was deformed and the top mounting tab was broken. Post 1 broke away at the ground line but the strike plate and block remained intact. Post 2 through 7 were bent at the ground line. Post 8 was pulled from the rail and had minor deformation.

FIGURE 31. Test Article Damage

FIGURE 32. Test Article Damage

FIGURE 33. Test Article Damage

FIGURE 34. Test Article Damage

FIGURE 35. Test Article Damage

FIGURE 36. Test Article Damage

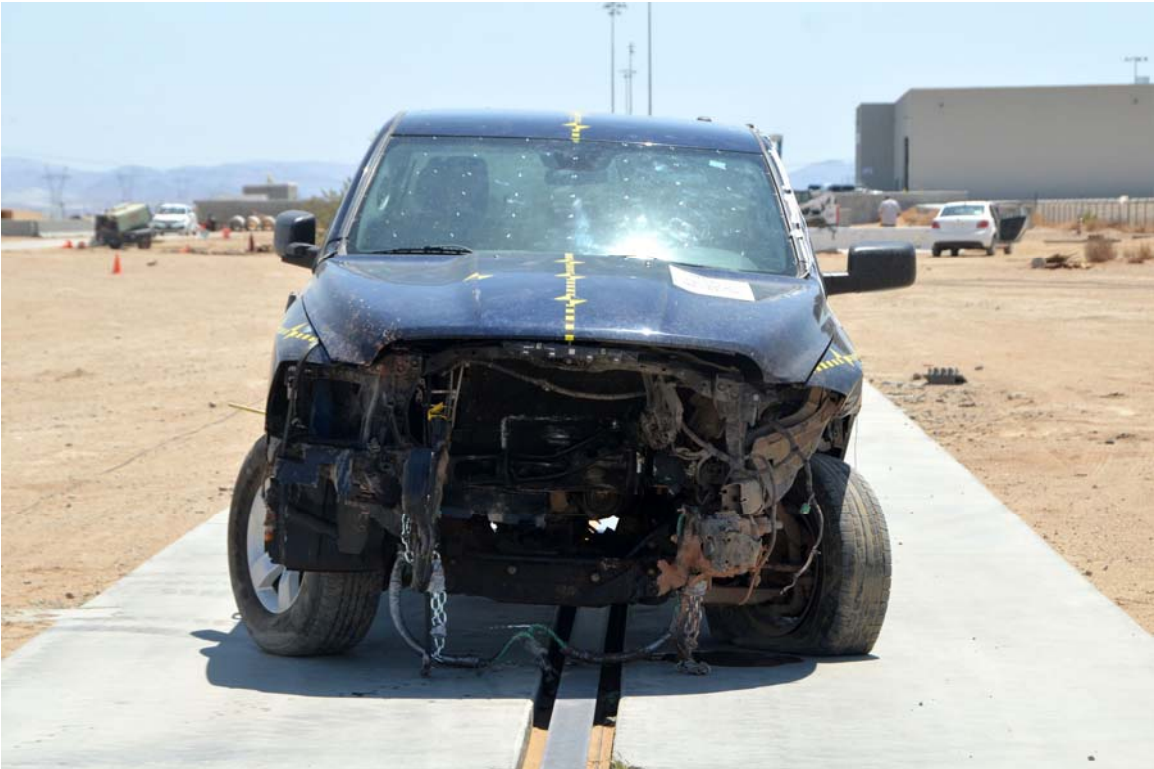
The vehicle's damage was concentrated at its front end. The front bumper detached from the vehicle and both frame rails were bent. The radiator and its support were crushed. The subframe behind both front quarter panels were deformed. The engine was shifted and pushed rearward. Both front headlights detached from the vehicle and the front left tire was punctured. The occupant compartment was not penetrated and the deformation limits were not exceeded.

FIGURE 42. Post-Test Front View of Test Vehicle
