Test Report For:  
**SPIG Industries, LLC**  
**SGET End Terminal**

TESTED TO:  
**Manual for Assessing Safety Hardware (MASH 2016)**  
**Test 3-34**

TEST REPORT NUMBER:  
**TR-P38106-01-A**

REPORT DATE:  
**August 20, 2018**

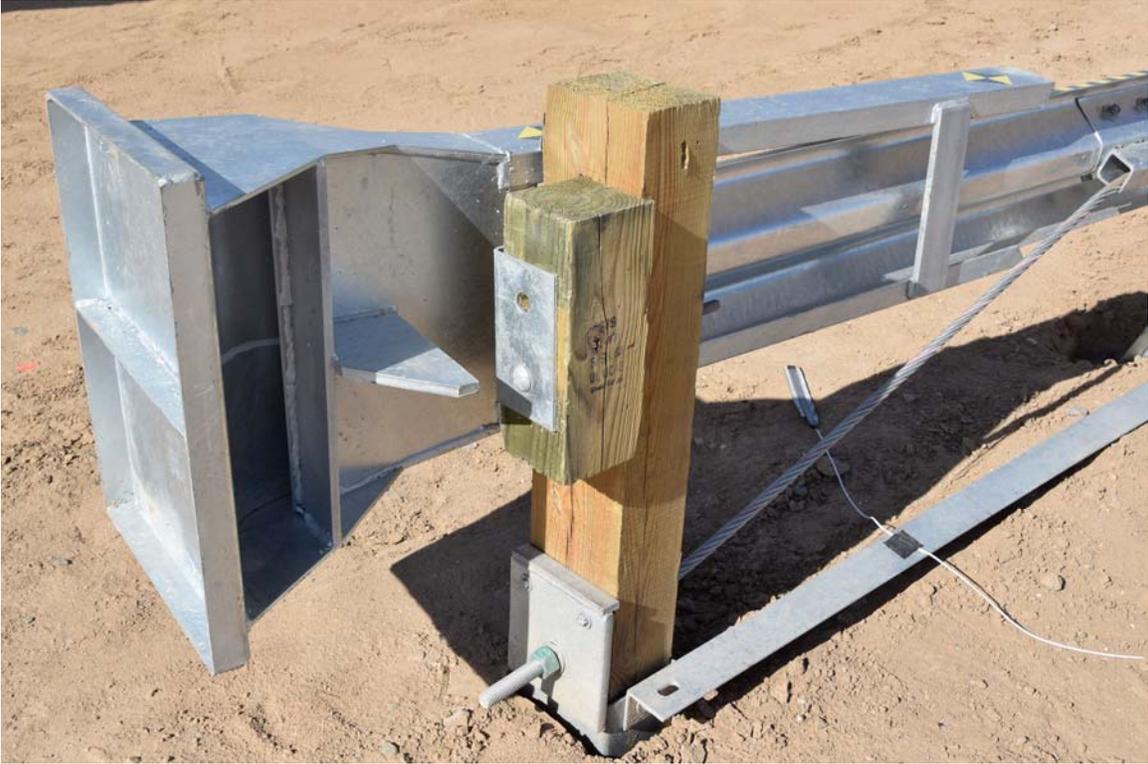
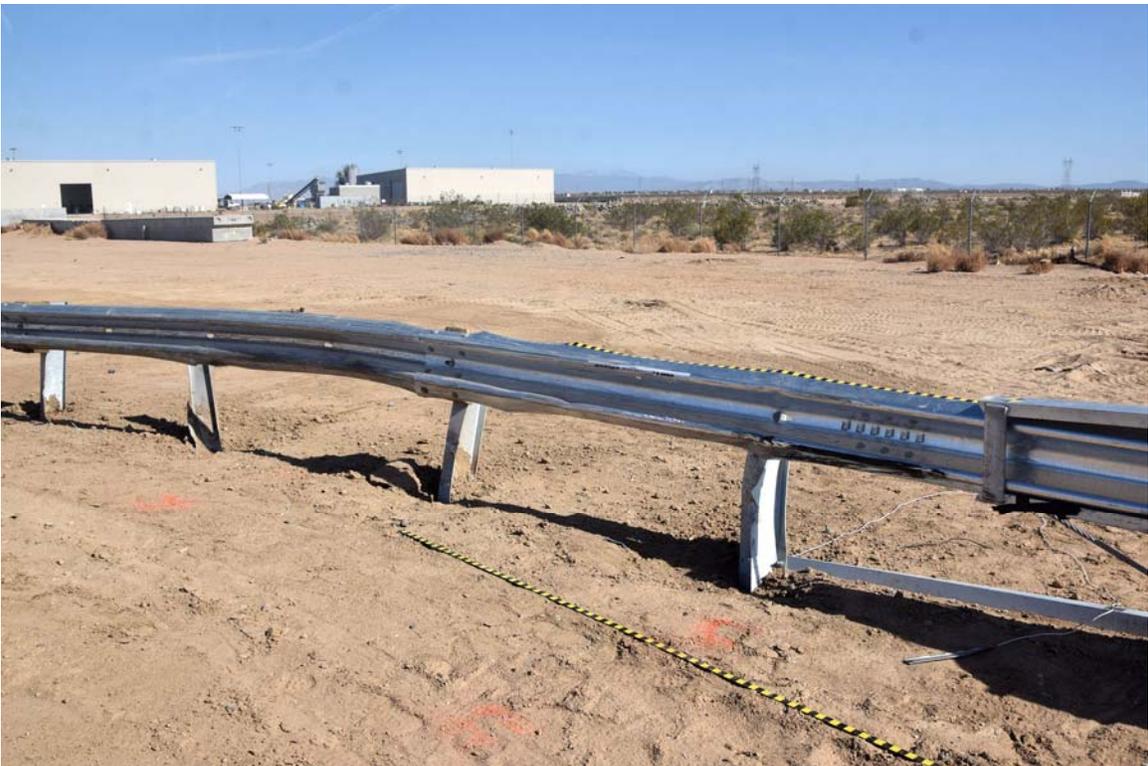
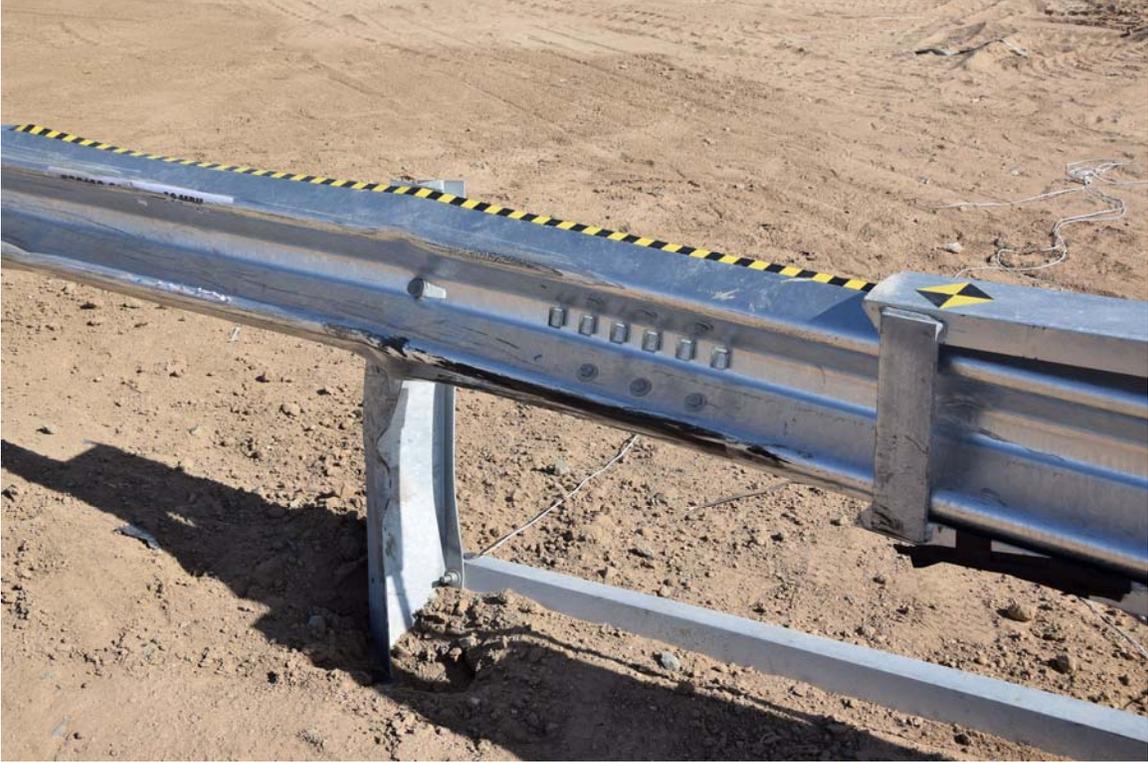
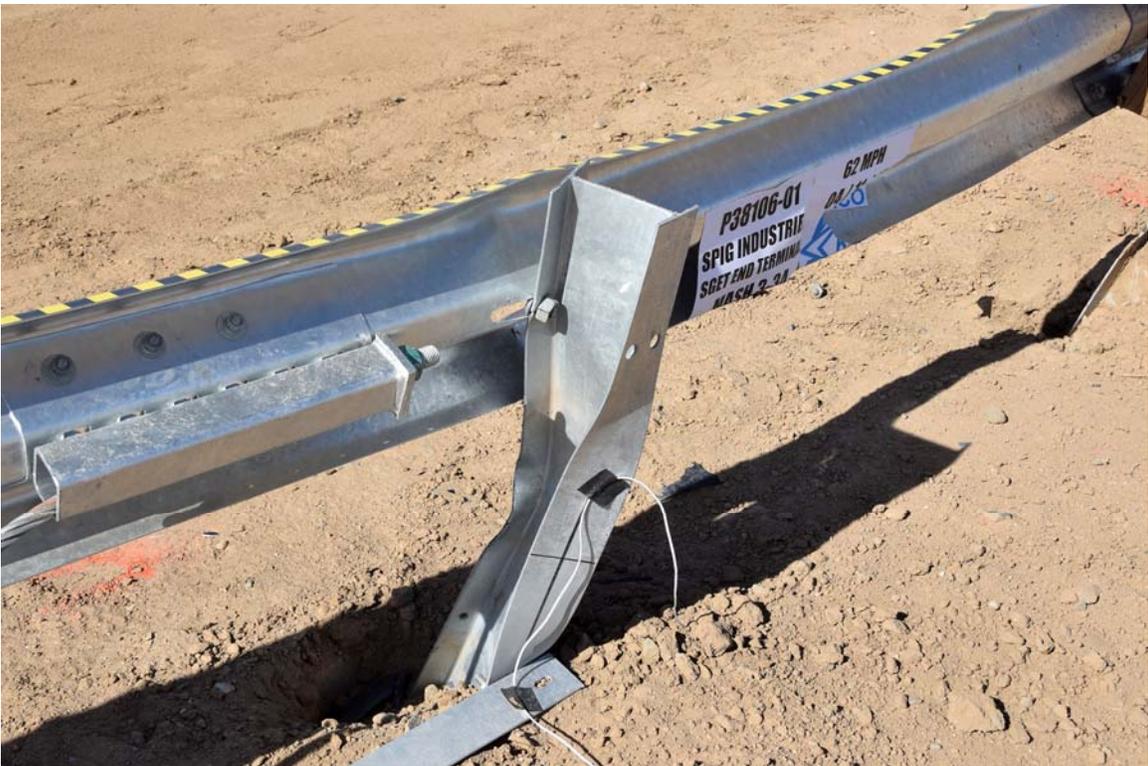
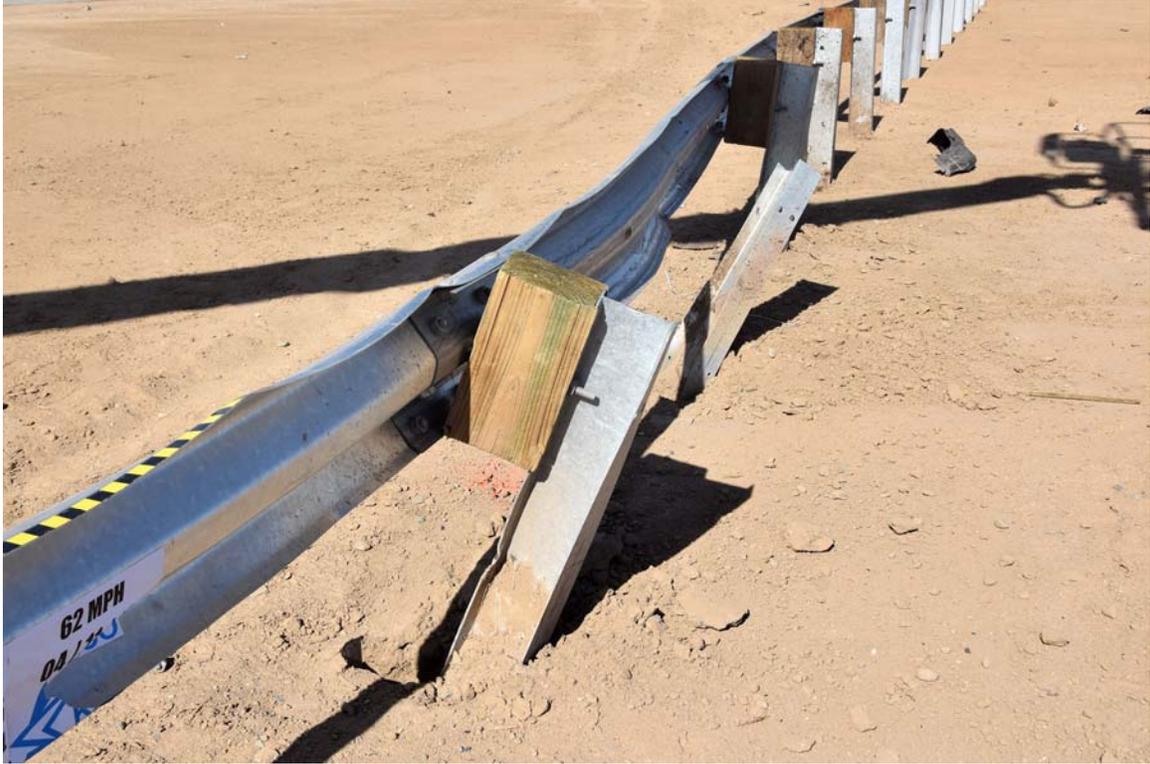
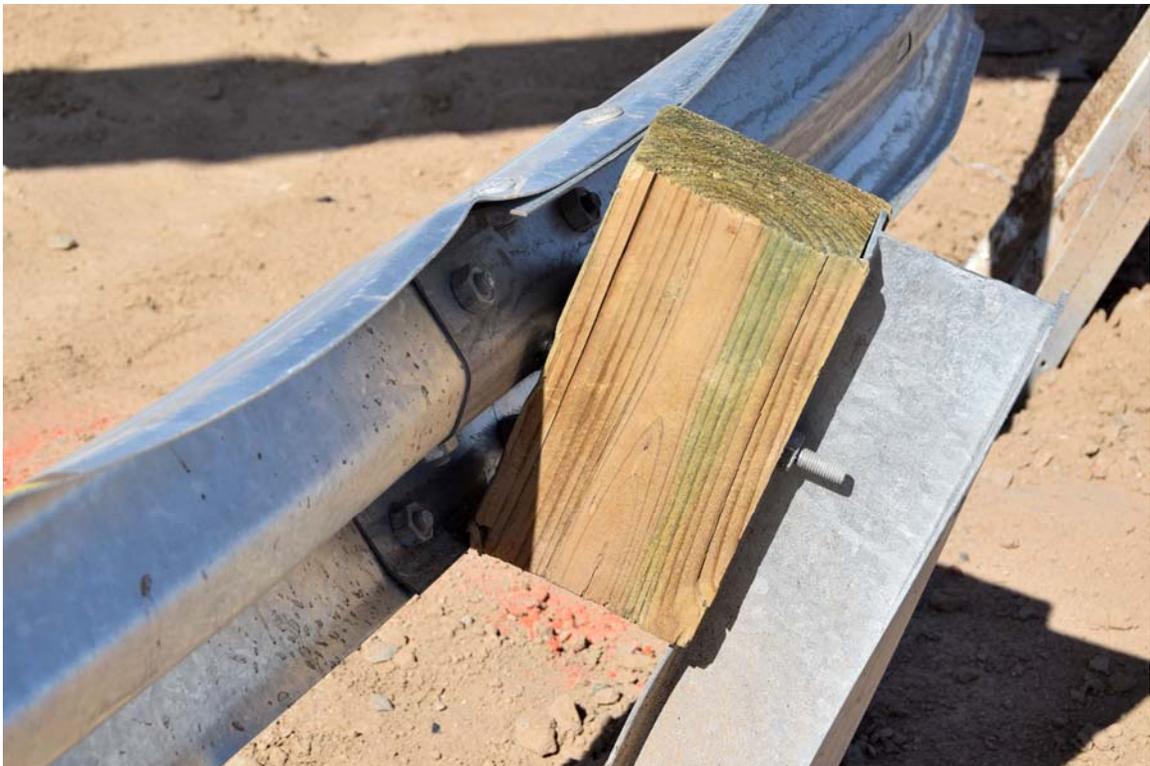
The system was damaged from post 2 through post 5 and rails 1 through 3 were damaged. The impact head had cosmetic damage and no visible structural damage. The ground strut and cable assembly remained intact with no visible damage.

- Post 1 – slight shift in soil
- Post 2 – twisted in the soil, deformation of the flange and web. The bolt hole was torn but the bolt remained intact
- Post 3 – deformed to the field side of the system and damage to the flanges
- Post 4 – deformed to the field side, traffic side flanges were deformed and the bolt head sheared off
- Post 5 – deformed just above the breakaway holes and remained attached to rail
- Post 6 – slight shift in soil and leaning towards the field side

FIGURE 31. Test Article Damage

FIGURE 32. Test Article Damage

FIGURE 33. Test Article Damage

FIGURE 34. Test Article Damage

FIGURE 35. Test Article Damage

FIGURE 36. Test Article Damage

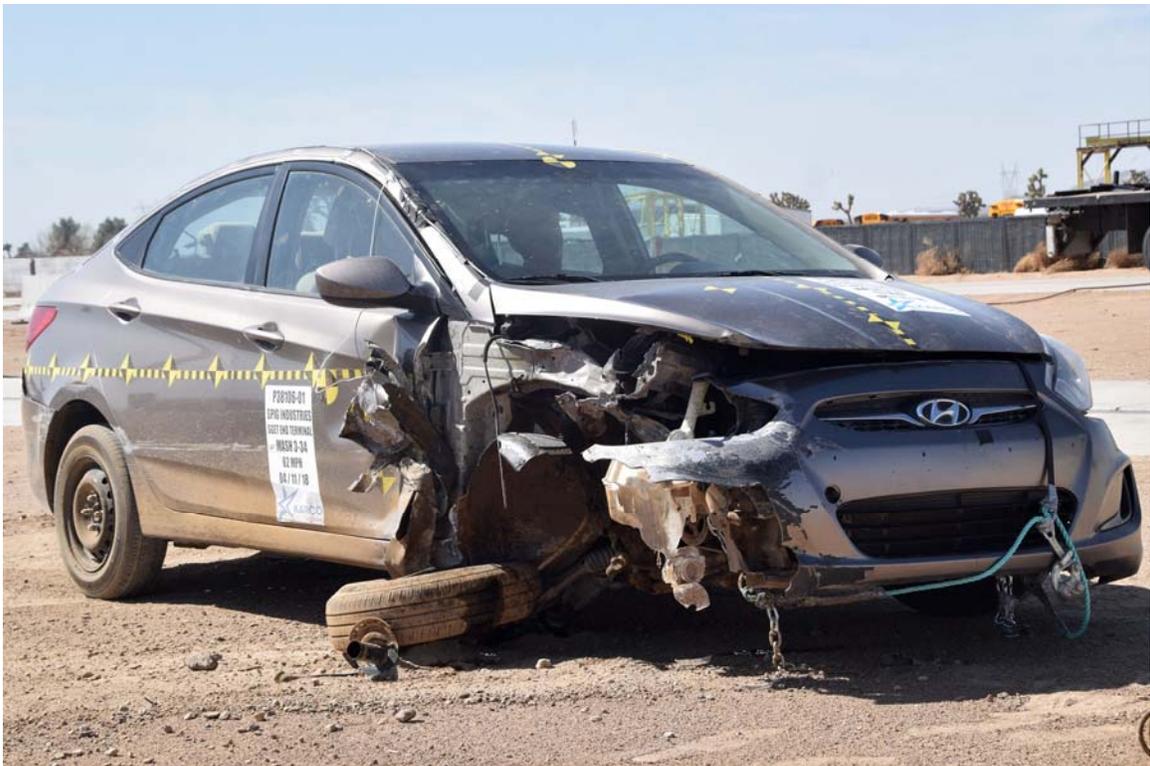
The vehicle's damage was concentrated at its front-right side. The front wheel assembly was only held on by the steering rod. The front shock assembly, sway bar and lower control arm was damaged. The front-right quarter panel was torn from the front of the vehicle. the front passenger door was damaged. The body structure behind the quarter panel was deformed and torn at its leading edge. The bumper fascia, hood and headlights were also damaged. The occupant compartment was not penetrated and the deformation limits were not exceeded.

FIGURE 44. Post-Test Right Front  $\frac{3}{4}$  View of Test Vehicle
