Test Report For:  
**SPIG Industries, LLC**  
**SGET End Terminal**

TESTED TO:  
**Manual for Assessing Safety Hardware (MASH 2016)**  
**Test 3-35**

TEST REPORT NUMBER:  
**TR-P38032-01-A**

REPORT DATE:  
**August 20, 2018**

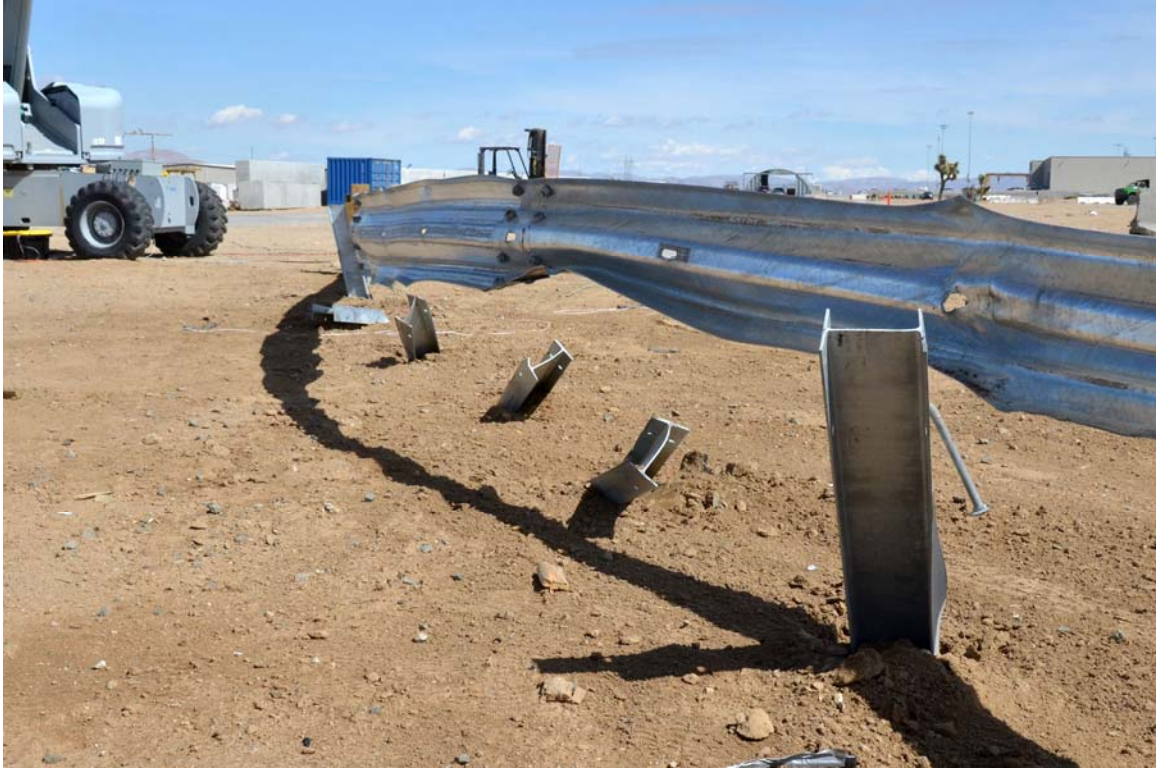
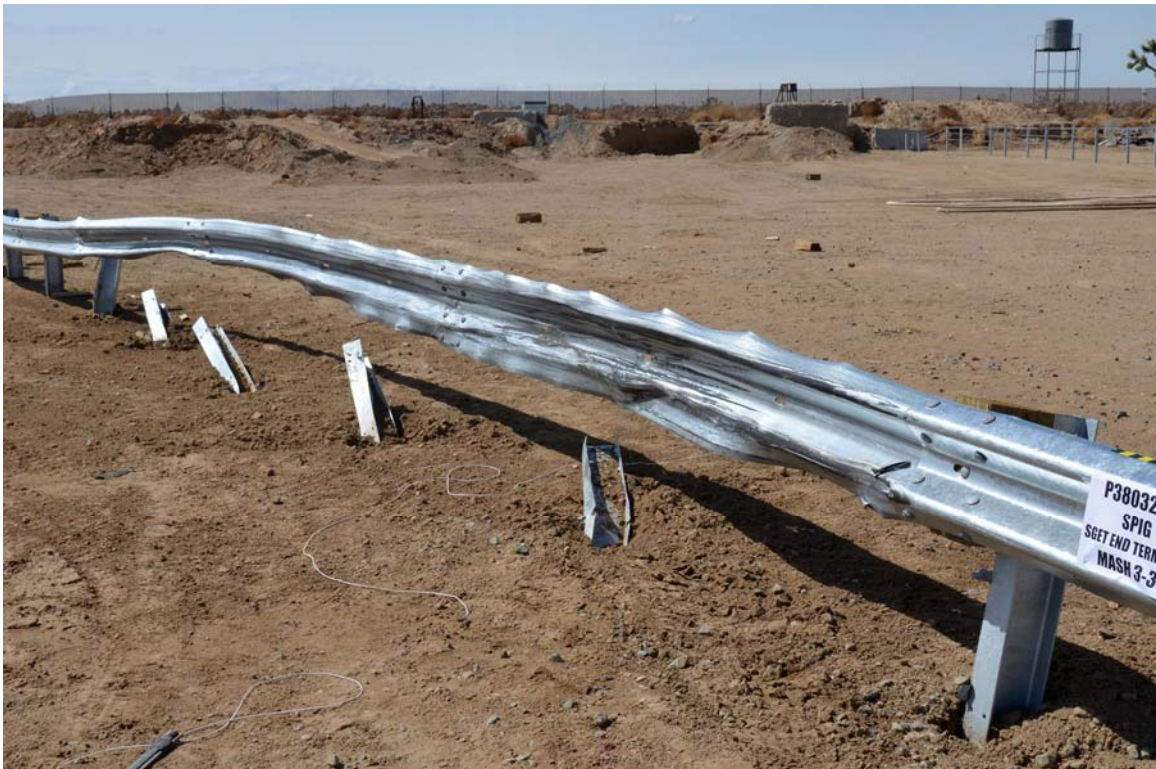
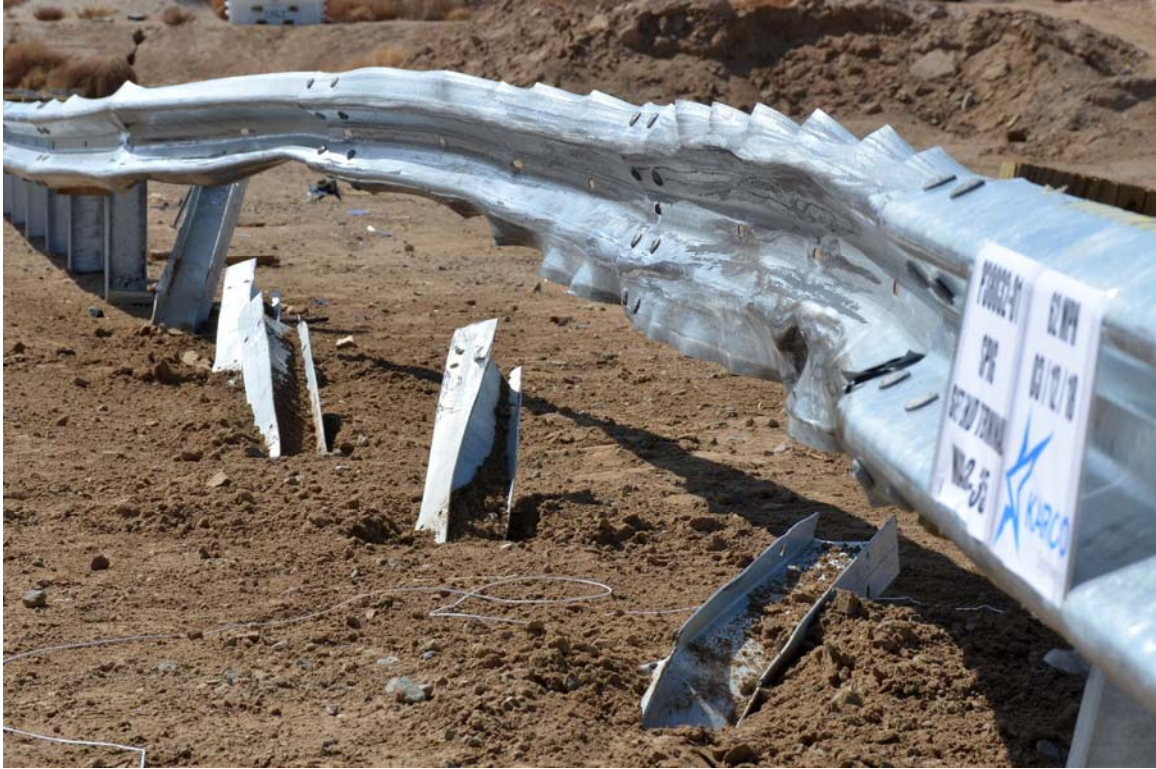
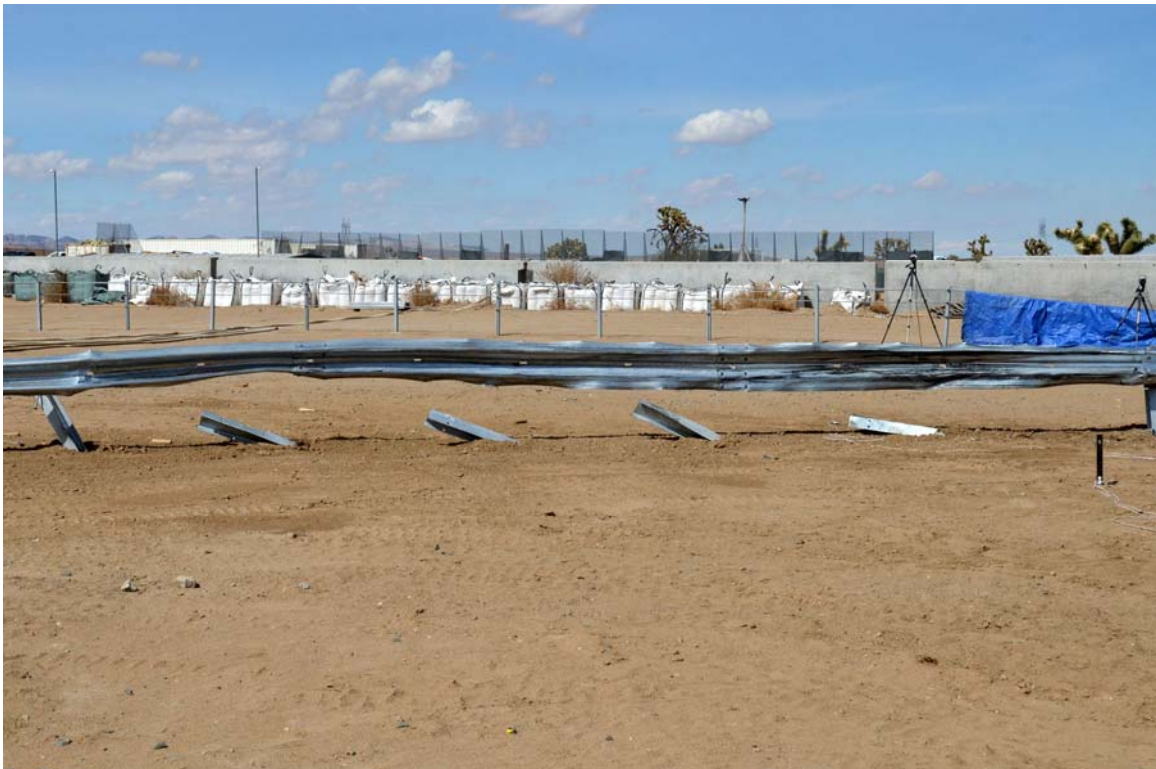
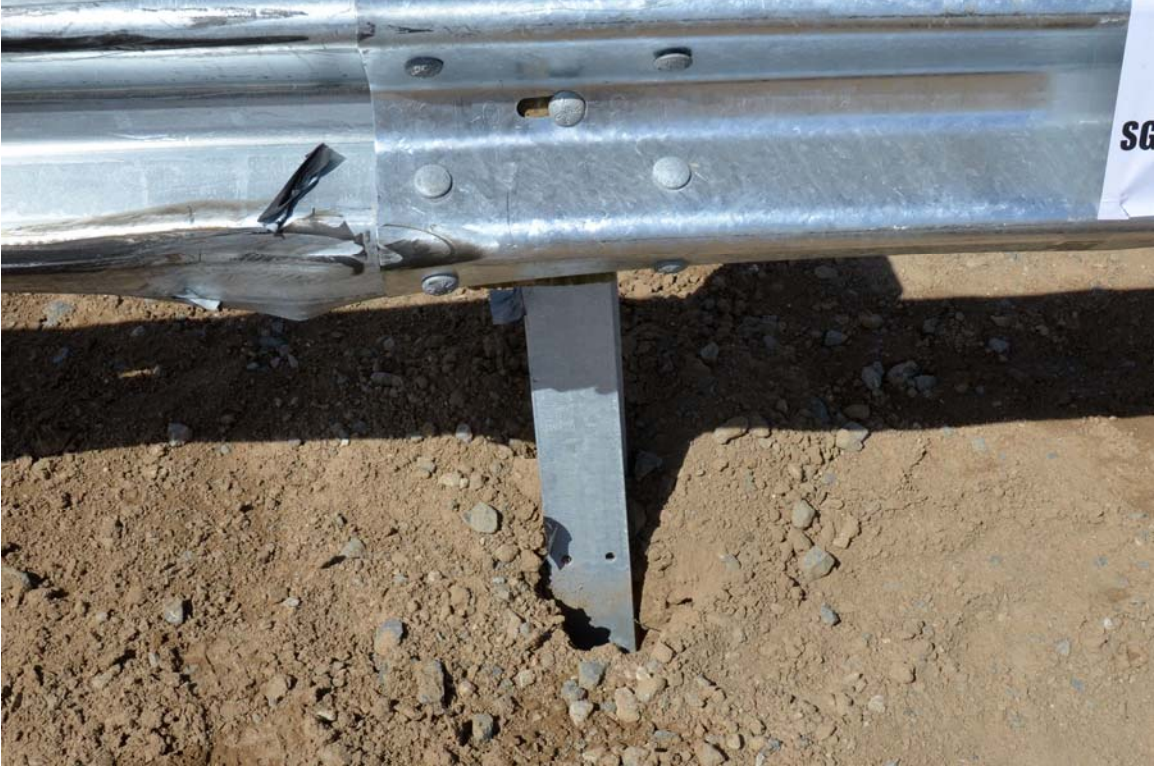
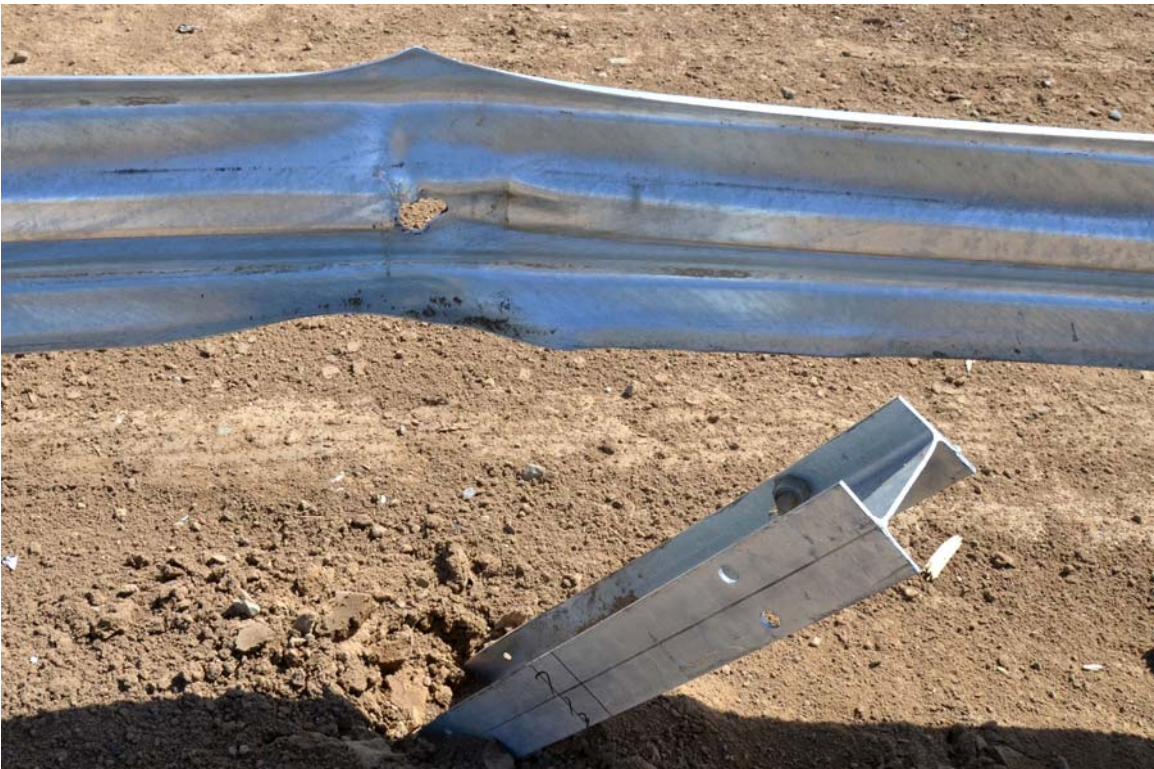
The system was damaged from post 1 through post 8 and the first four (4) W-beam guardrail panels were damaged. The lag bolts that mount the impact head to post 1 were torn from the post. There was no visible damage to the cable anchor assembly. Post 1 through 3 shifted in the soil and post 2 and 3 remained attached to the rail. Post 4 through 8 were bent at the ground line and detached from the rail. The downstream end of the installation was also damaged from the second impact with the test vehicle. Posts 15 to 17 leaned in the soil and there was a slight bend in rails 8 and 9.

FIGURE 31. Test Article Damage

FIGURE 32. Test Article Damage

FIGURE 33. Test Article Damage

FIGURE 34. Test Article Damage

FIGURE 35. Test Article Damage

FIGURE 36. Test Article Damage

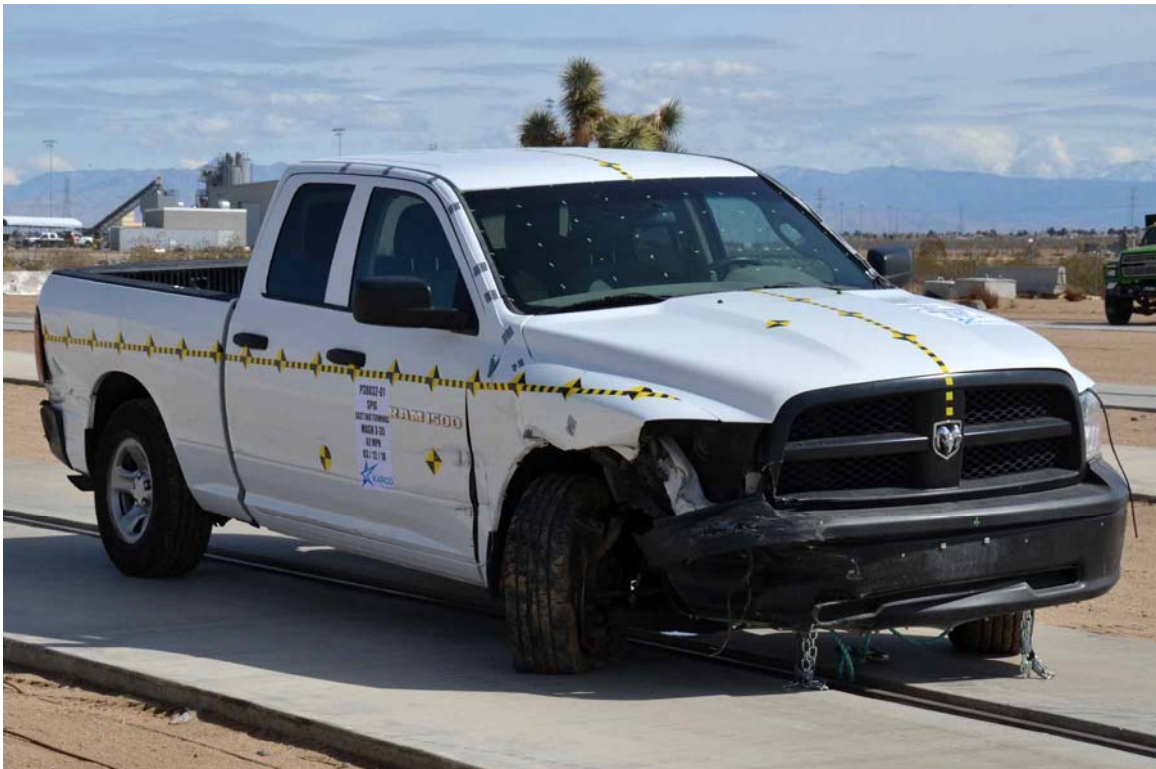
The vehicle's damage was concentrated at its front-right side. The subframe assembly behind the quarter panel was deformed. The lower control arm was bent and the tire was punctured. The side of the front bumper was deformed inward and was lodged behind the front wheel. The front quarter panel, both doors and bedside were damaged. The front head light was detached and the grill was damaged. The occupant compartment was not penetrated and the deformation limits were not exceeded.

FIGURE 44. Post-Test Right Front ¾ View of Test Vehicle
