Test Report For:
SPIG Industries, LLC
SGET End Terminal

TESTED TO:
Manual for Assessing Safety Hardware (MASH 2016)
Test 3-37b

TEST REPORT NUMBER:
TR-P38033-01-NC

REPORT DATE:
August 17, 2018

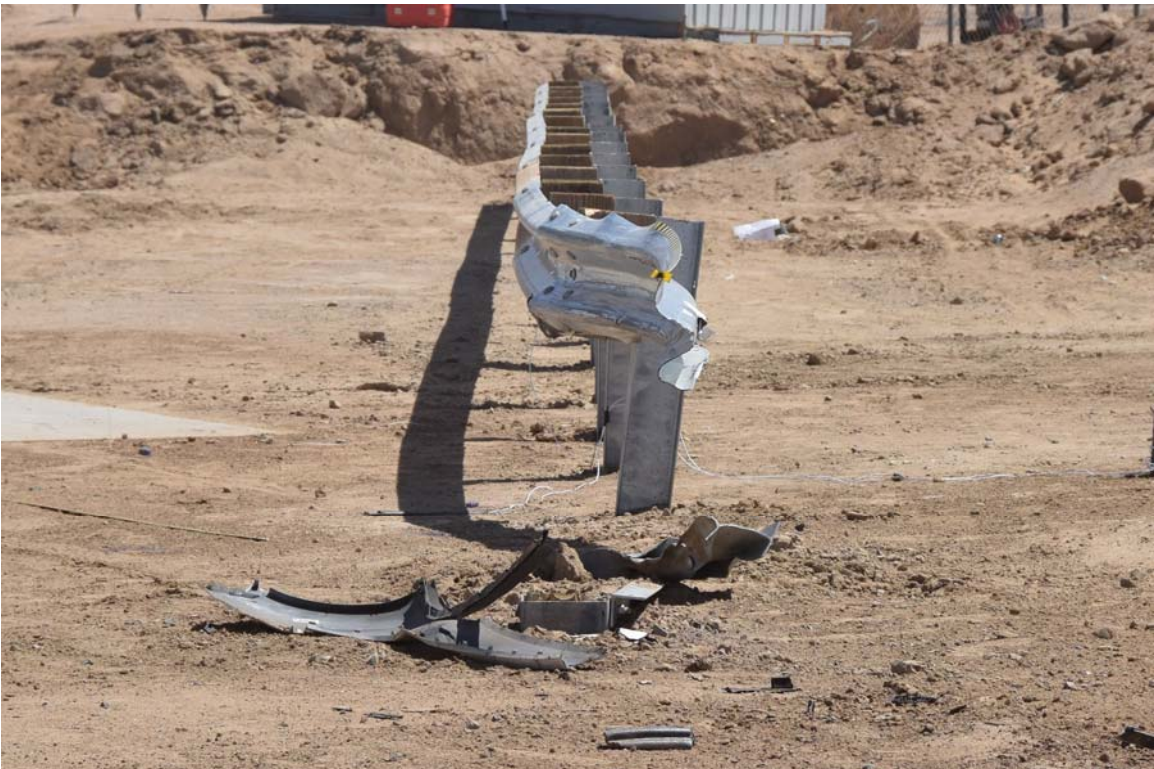
FIGURE 16. Post-Test Front View of Test Article

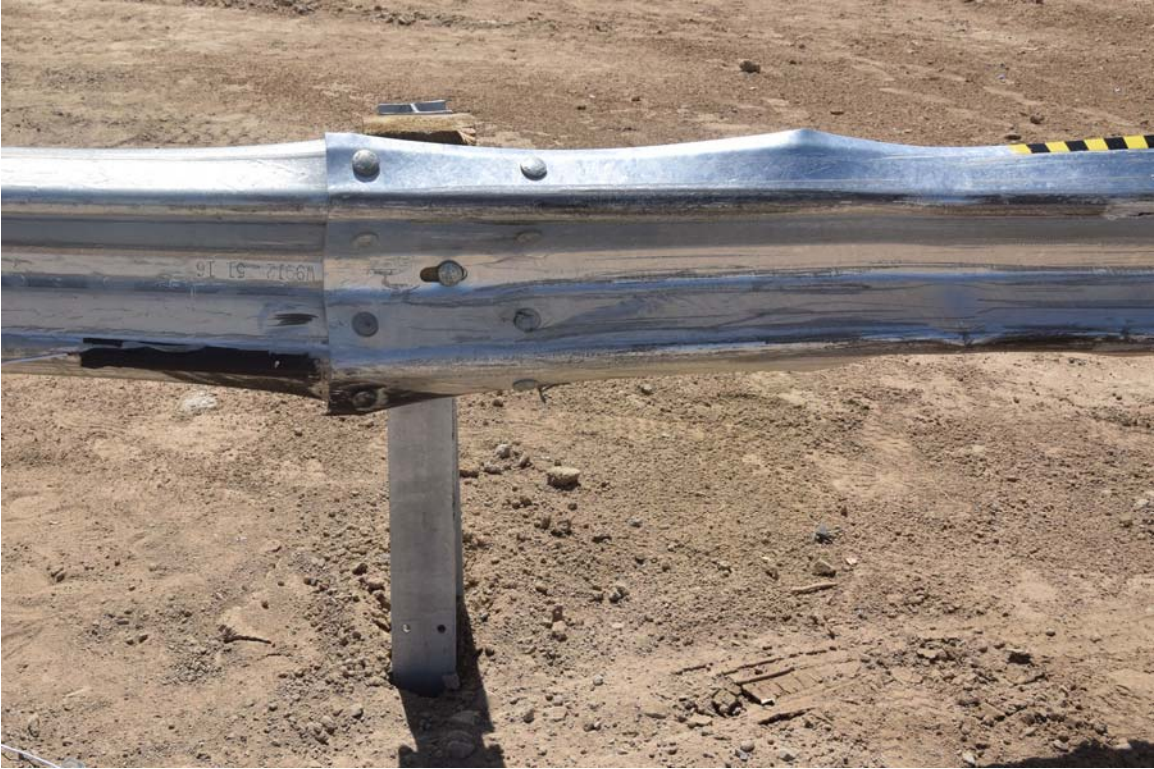
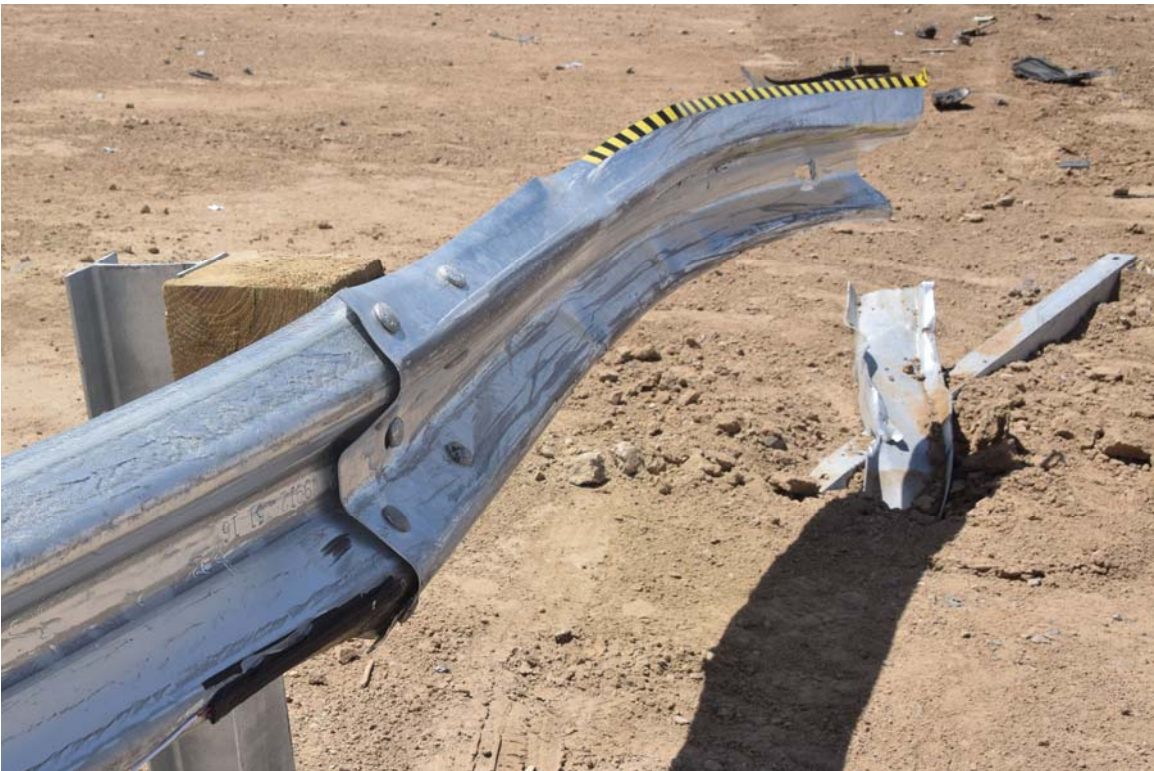
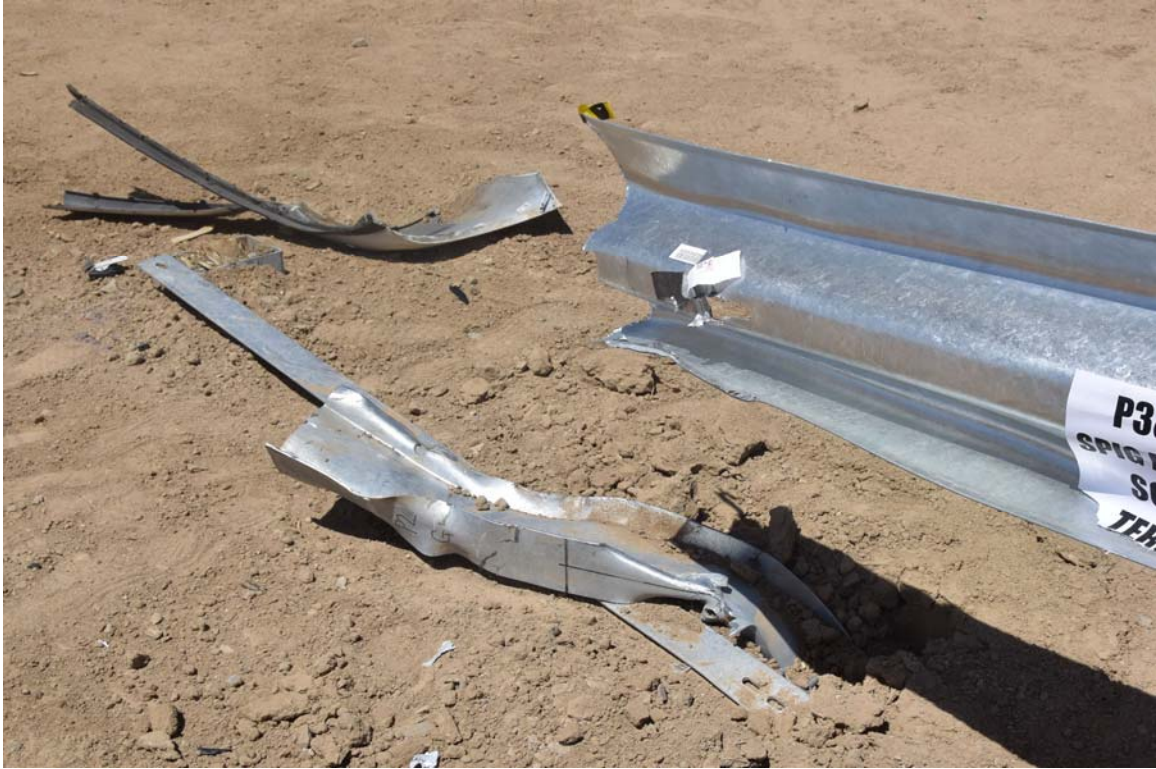
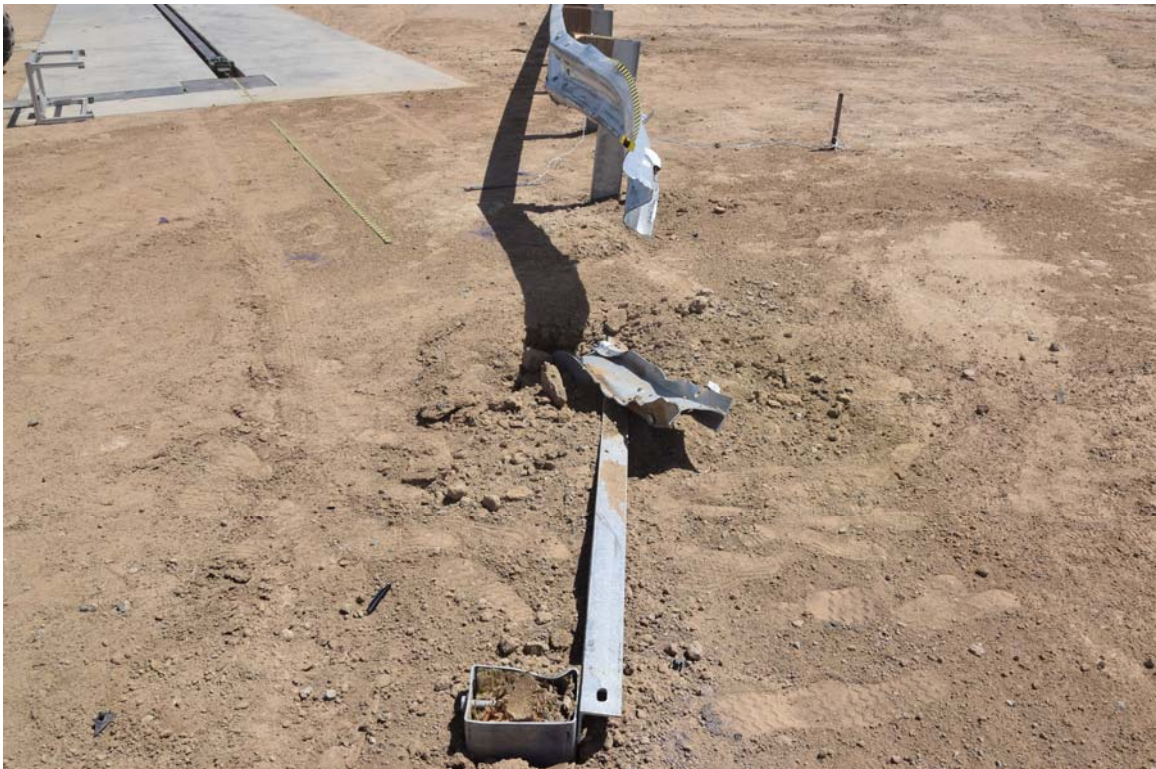
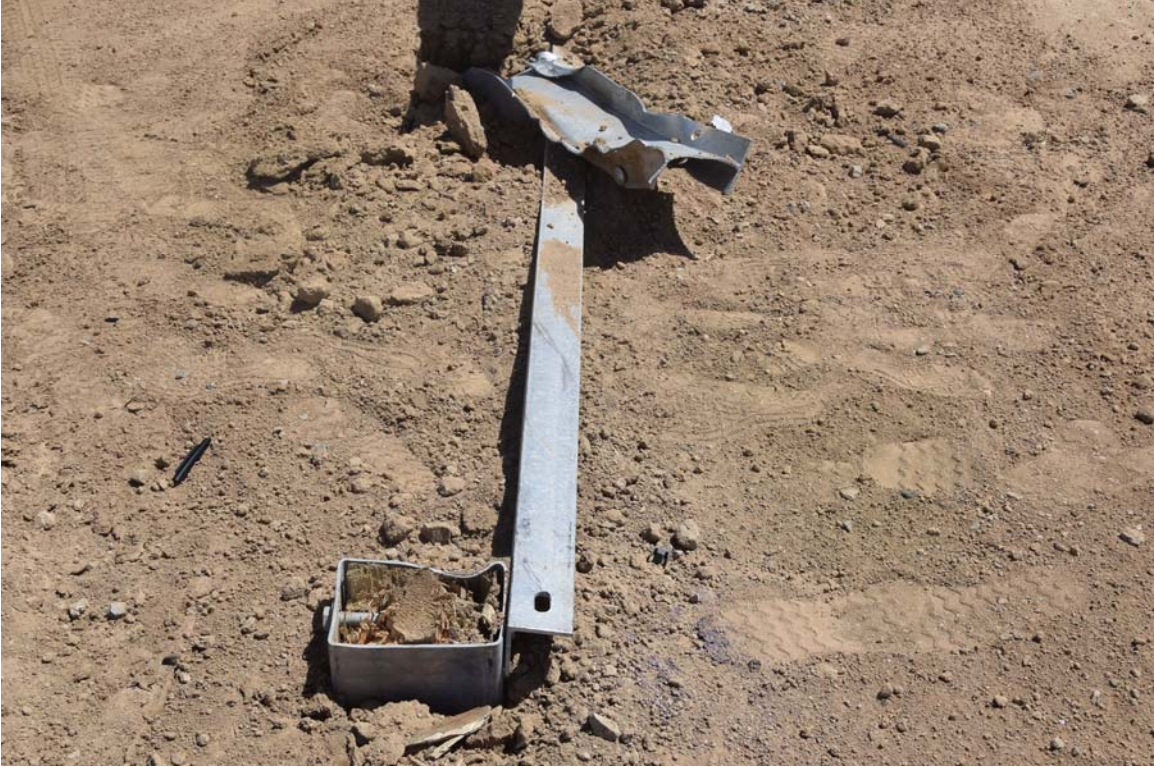
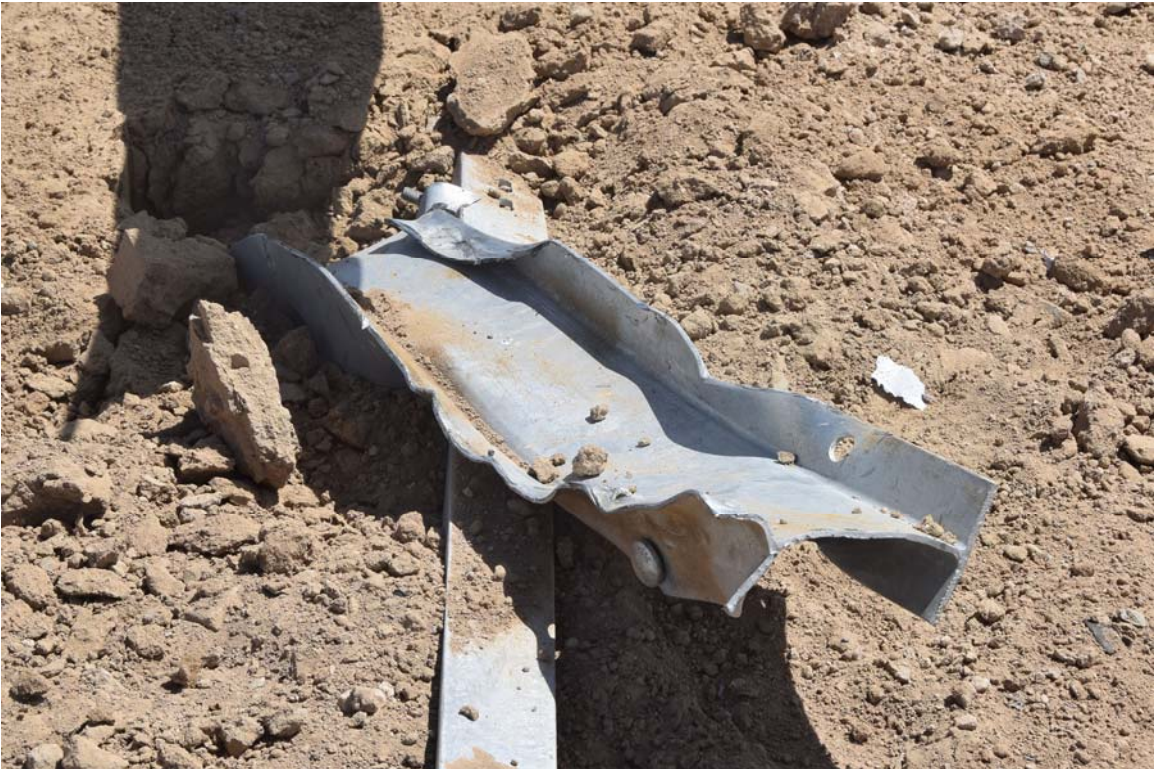
The system was damaged for the first 12.5 ft. (3.8 m), post 1 through post 3. The first W-beam tore at the end of the reinforcement plate. The piece of W-beam that remained attached to the rest of the terminal was deformed. The remaining damage to the system consisted of post damage. Even though the impact head and cable anchor assembly separated from the terminal, it was not subject to any damage.

- Post 1 – Wooden post was broken at soil tube connection point
- Post 2 – Folded down at base
- Post 3 – Slight shift downstream
- Post 4 – Slight shift downstream

FIGURE 31. Test Article Damage

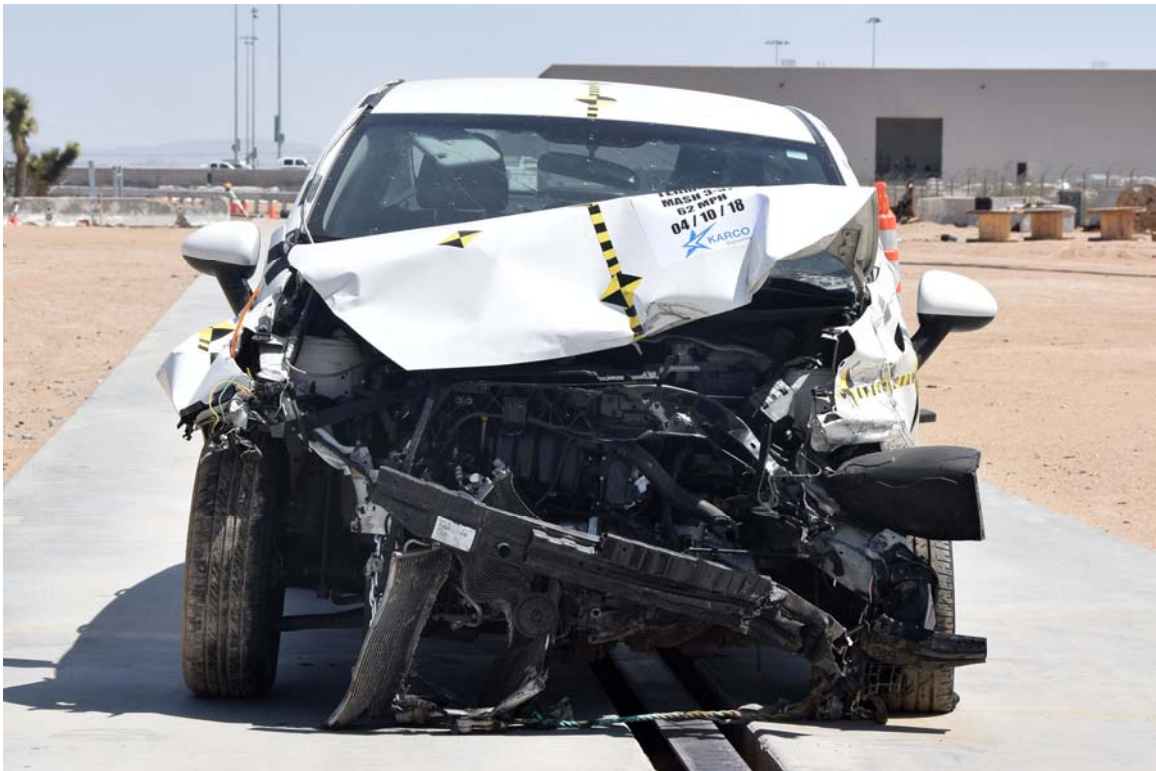
The majority of the vehicle damage occurred at the front end. The bumper fascia, bumper beam, quarter panels, and hood were all damaged due to the impact. The bumper fascia separated from the vehicle and the bumper beam deformed and detached from the driver side crush can. The quarter panels and hood were also subject to deformation. Both headlights were broken and separated from the vehicle.

Within the engine compartment the radiator, radiator support, and driver side crush rail were damaged. The engine shifted slightly rearward. The front driver side tire was flattened as a result of the impact. The occupant compartment was not penetrated and the deformation limits were not exceeded.

FIGURE 42. Post-Test Front View of Test Vehicle
