Test Report For:
SPIG Industries, LLC
SGET End Terminal

TESTED TO:
Manual for Assessing Safety Hardware (MASH 2016)
Test 3-31

TEST REPORT NUMBER:
TR-P38108-01-B

REPORT DATE:
September 22, 2022

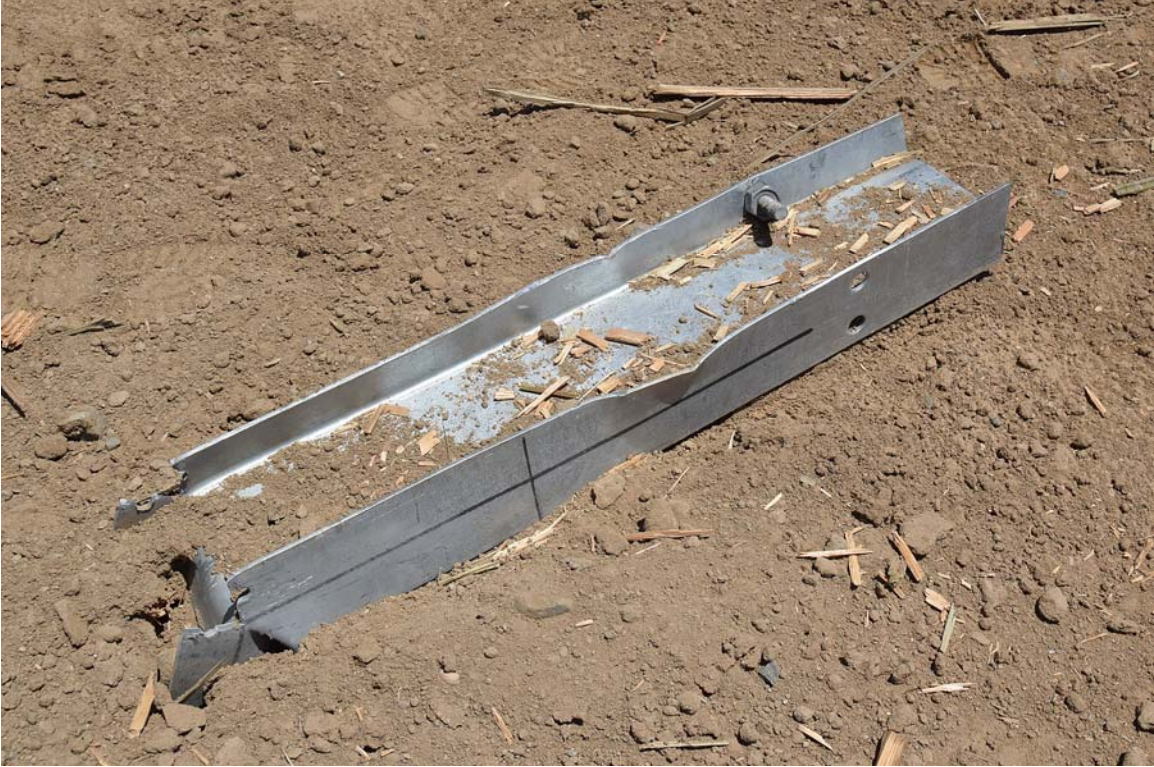
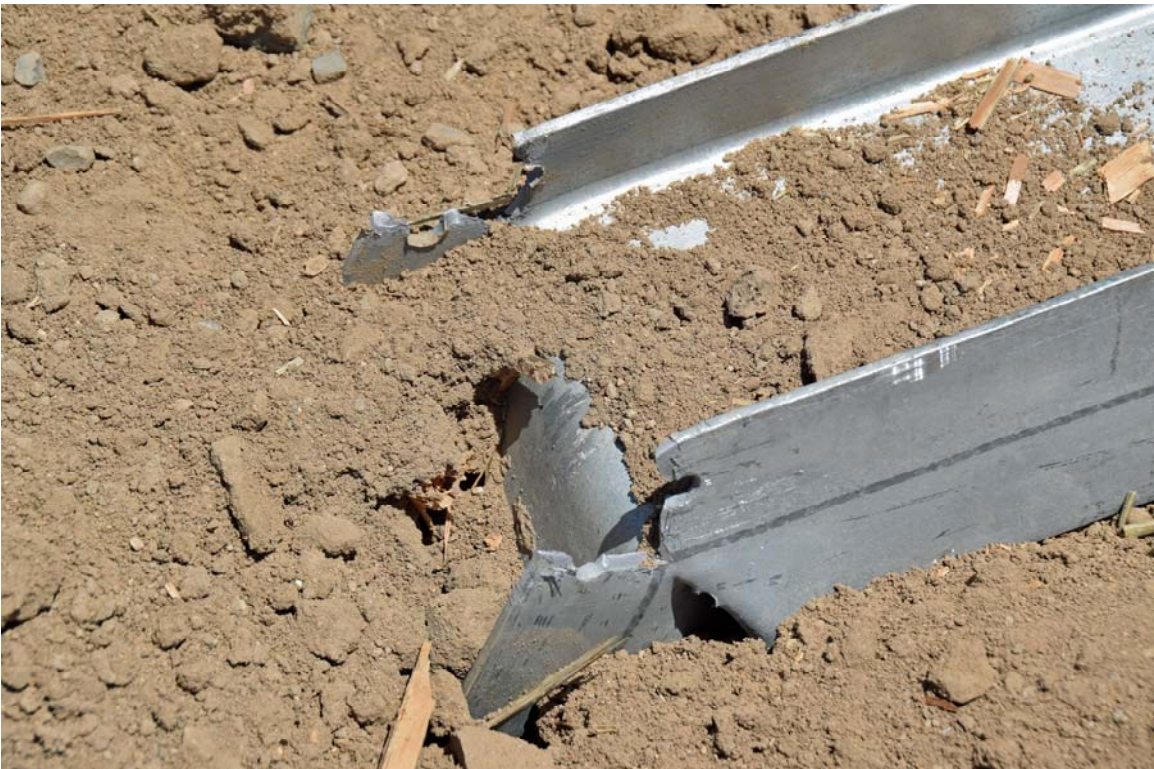
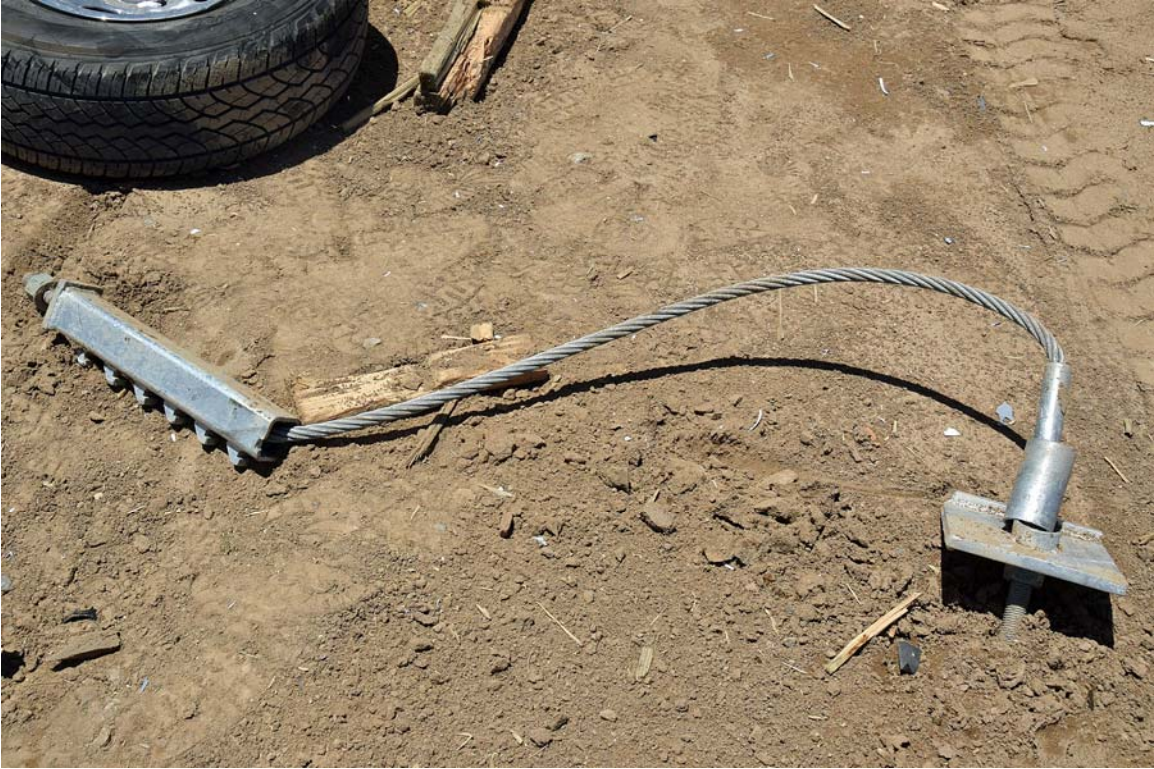
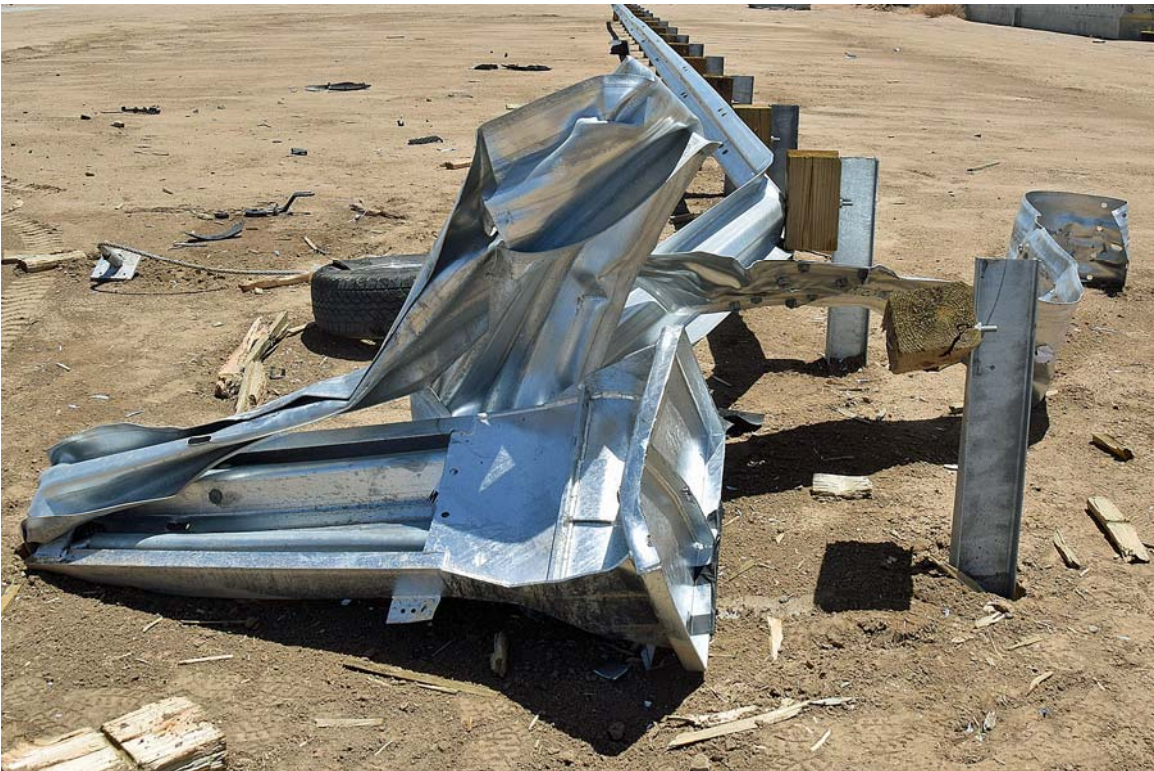
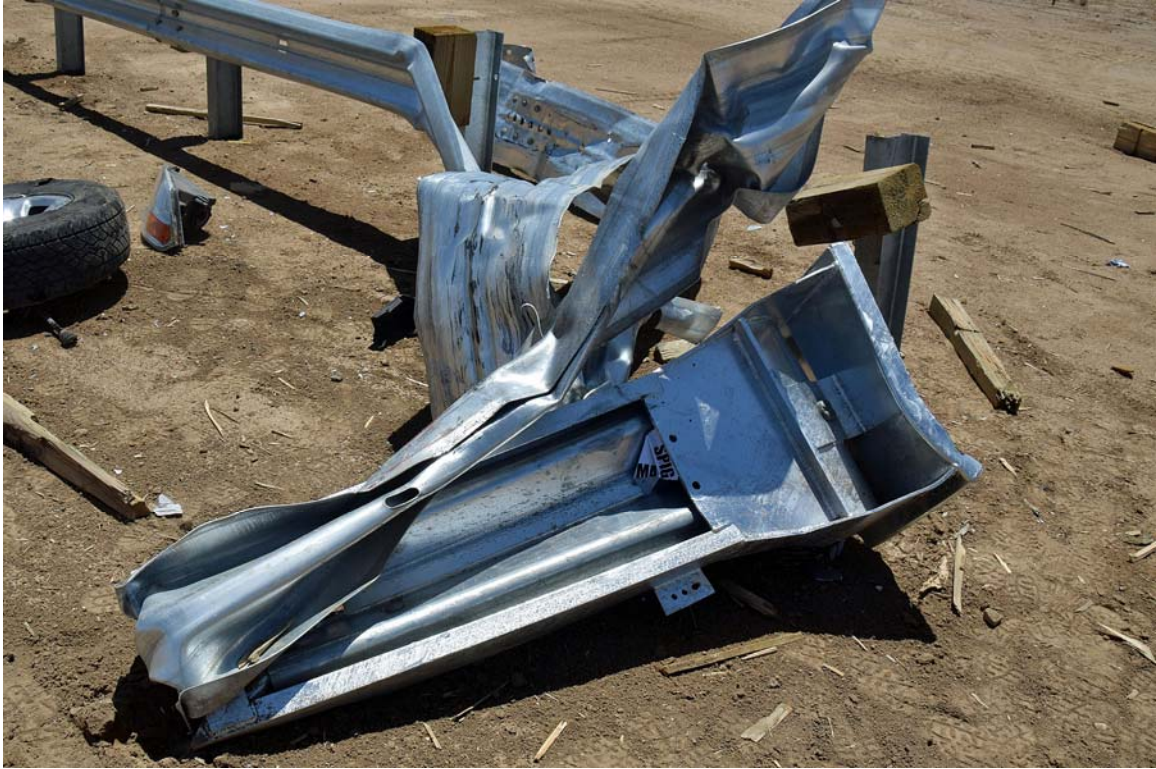
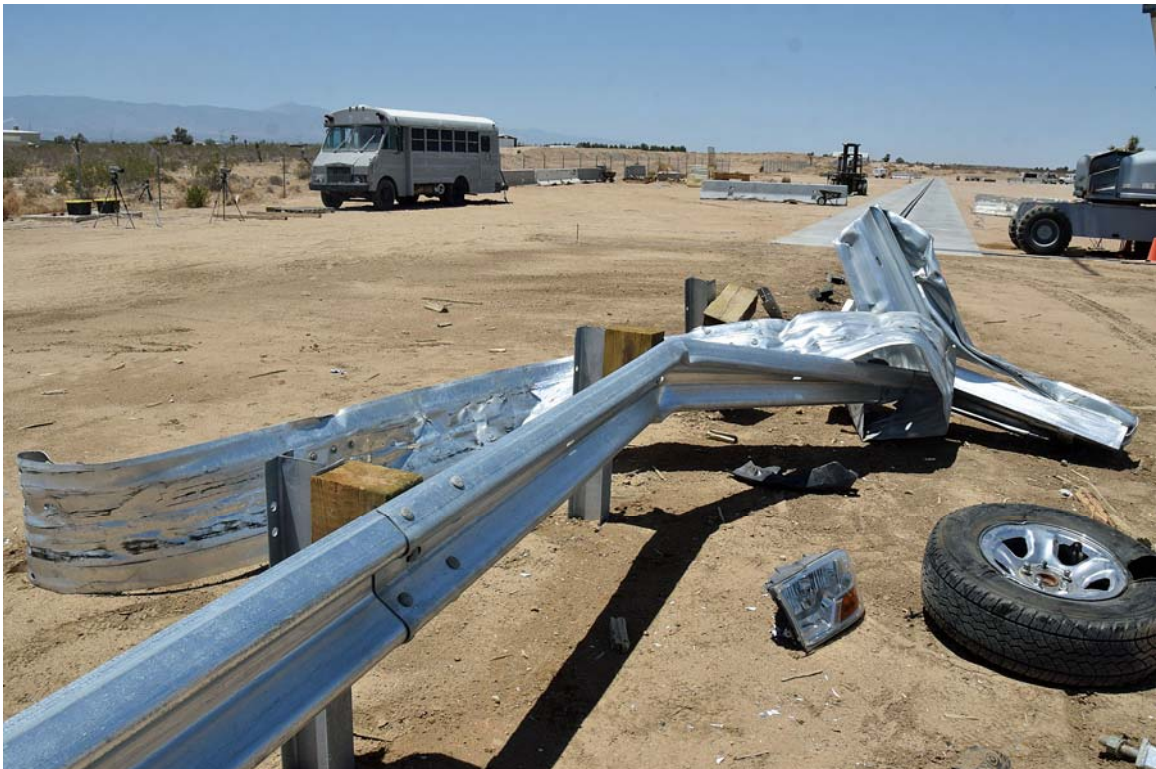
The system was damaged from post 1 through post 8. The first rail and the majority of rail 2 were fed through the impact head. The wooden portion of post 1 was broken at its base. Post 2 through 6 were bent at the ground line and activated the breakaway holes. Post 7 disengaged from the rail and post 8 remained attached to the rail. The front face of the impact head was deformed. The reinforcement panel remained attached to the first rail and was flatted with the rail. The guardrail grabber had a slight tear at its upstream end.

FIGURE 31. Test Article Damage

FIGURE 32. Test Article Damage

FIGURE 33. Test Article Damage

FIGURE 34. Test Article Damage

FIGURE 35. Test Article Damage

FIGURE 36. Test Article Damage

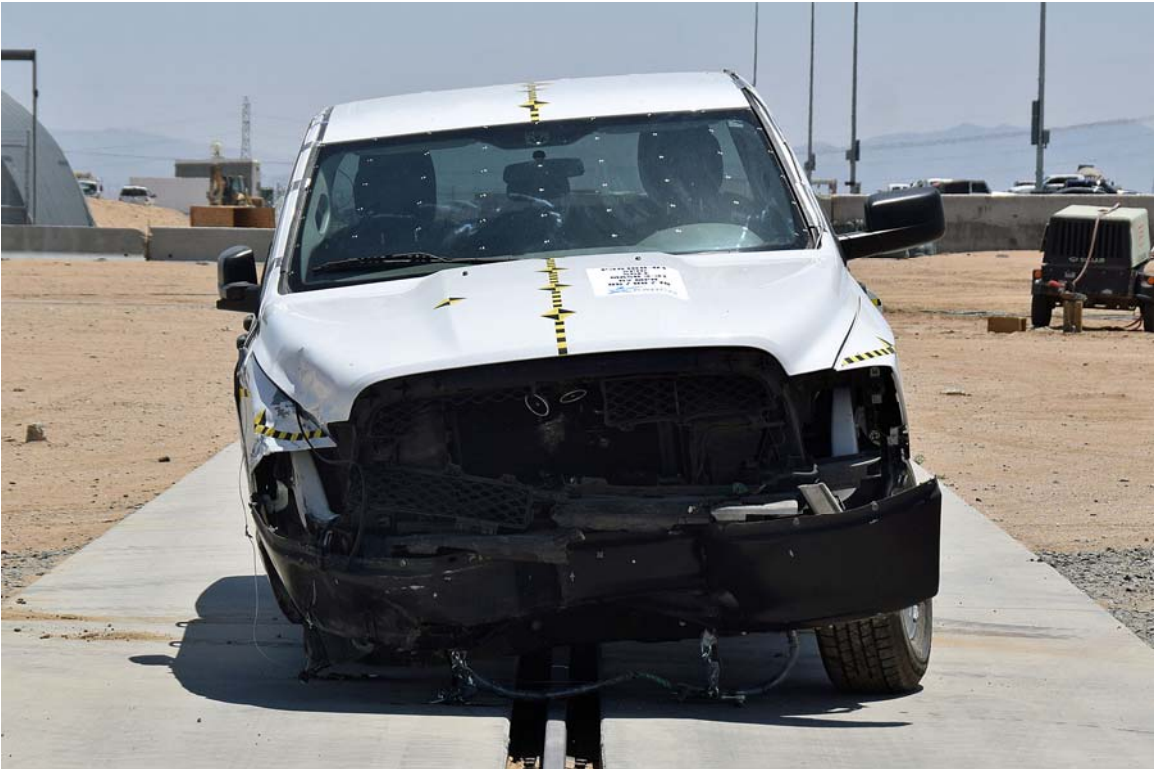
FIGURE 42. Post-Test Front View of Test Vehicle

The vehicle's damage was concentrated at its front end and passenger side. The front bumper was deformed at its center and the frame rails were bent inward. The radiator was crushed and pushed rearward into the engine. The front passenger side spindle was broken and caused the wheel to detach from the vehicle. The passenger side quarter panel and its support were deformed. Both passenger side doors and the bed side were deformed. The occupant compartment was not penetrated and the deformation limits were not exceeded.
