# Property Inspection Report

Report Prepared By: Clarence Livingstone, License 4457

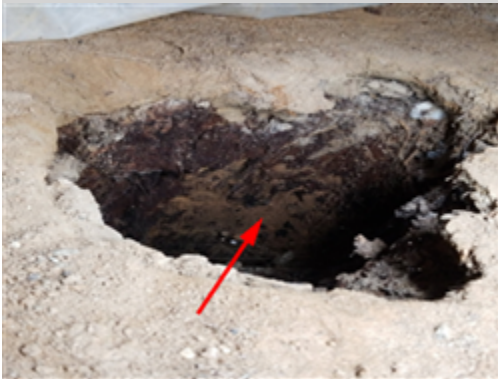
##### (A1 - 2.1 ) Main House

Two large holes or low areas are noted in the crawl space area. The openings appears to be sink holes or a depression that has occurred over time. One hole was approximately 1 foot wide and about 4 feet deep. The hole needs to be investigated to determine the cause, outline a repair, and to ensure that the movement has not disturbed the supporting soil of the piers and or foundation perimeter. A licensed general contractor should be consulted to investigate the holes to ensure the stability of the home, if the hole is found to extend below the depth of the footings the contractor should consult an engineer for a complete evaluation and to develop a repair plan. Please note the stability of the soil or the depth of the hole could not be determined, this condition could pose a safety concern, the foundation area and surrounding areas adjacent to the hole should be entered with caution.

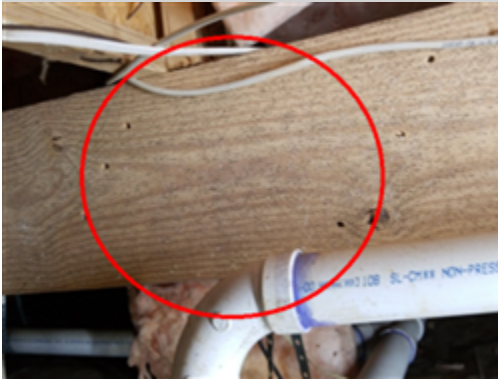
##### **(A1 - 3.1 ) Main House**

The wood framing in the crawl space area was noted to have random spots of fungal growths typical of mold.

If the buyer has additional concerns related to the presence of the fungal growths such as mold, an industrial hygienist should be consulted.

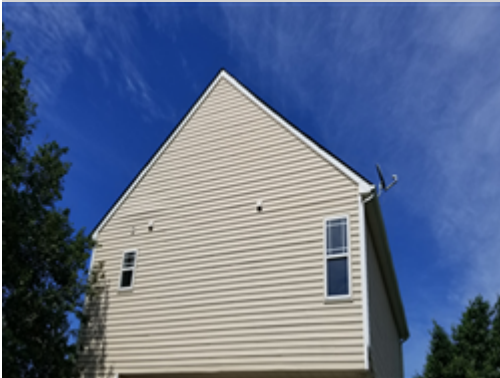
#### (B1 - 1.1 ) Main House

This siding must be installed to allow for expansion/contraction or buckling/gaps will result creating points of entry for water penetration. The siding on this home was noted to have several open gaps and buckled sections at panel intersections. A licensed general contracting company and a certified vinyl siding installer should be consulted to inspect the condition of the wood framing and sheathing and verify the siding/flashing installation.

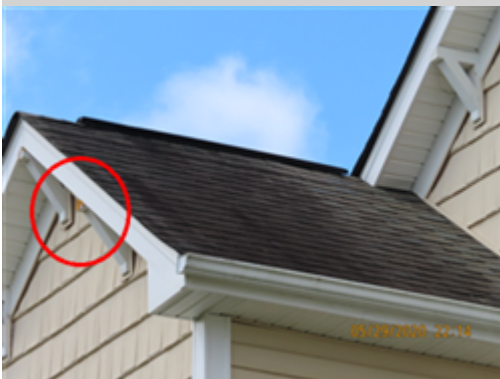
#### (B1 - 2.1 ) Main House Front

Exposed molding. Unpainted molding can cause additional decay. A licensed general contractor should be consulted to repair all visible damage and check the home for possible areas of hidden damage.

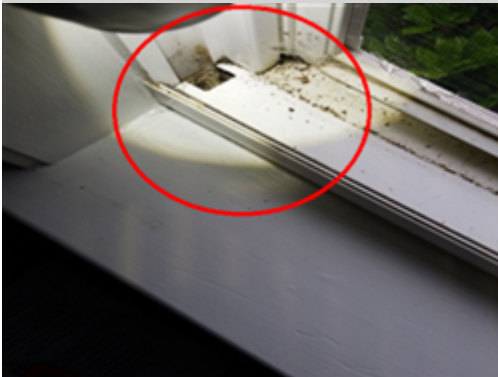
#### **(B2 - 1.1 ) All Windows**

All window sills fill with water after heavy rain. Sills will need to be cleaned out of debris and evaluated for sill damages. The weather-stripping for some windows is damaged. A licensed general contractor should be consulted for evaluation and repair.

All window sills fill with water after heavy rain. Sills will need to be cleaned out of debris and evaluated for sill damages. The weatherstripping for some windows is damaged. A licensed general contractor should be consulted for evaluation and repair.

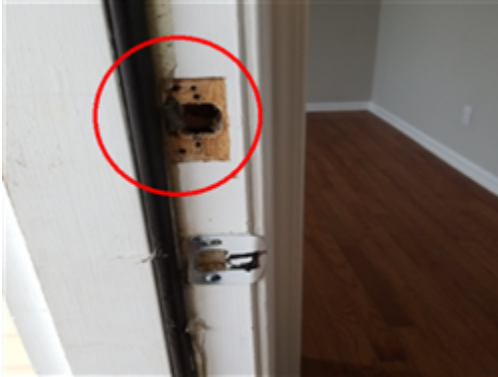
#### (B2 - 2.1 ) Door

The door jamb is missing a striker where the door lock is engaged to provide security. The plate needs to be replaced to ensure that the door closes securely. A general repair specialist or licensed general contractor should be consulted for evaluation and repair.

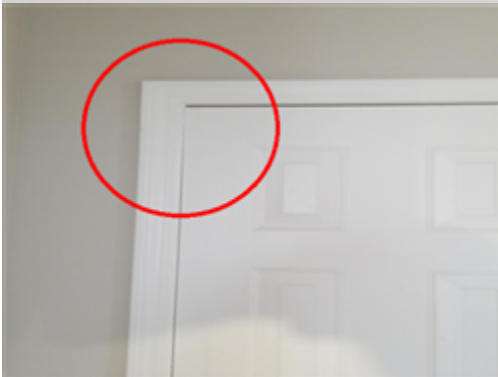
#### (B2 - 3.1 ) Door

The door rubs at the top corner and is difficult to open or close. This condition could cause framing movement. The door needs repair to ensure that the door closes easily. A general repair specialist or licensed general contractor should be consulted for evaluation and repair.

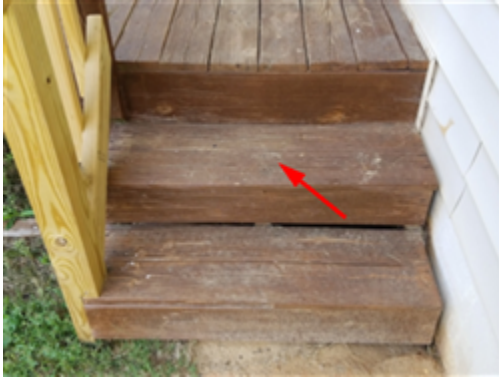
##### **(B3 - 1.1 ) Deck**

The deck steps are loose and in need of repair or replacement to ensure safe and functional use of the deck/porch. A licensed general contractor should be consulted for a complete evaluation and to make necessary repairs.

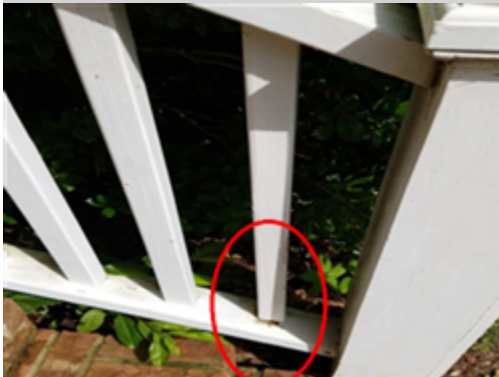
##### **(B3 - 2.1 ) Porch**

The hand railing baluster is loose and in need of repair or replacement to ensure safe and functional use of the porch. A licensed general contractor should be consulted for a complete evaluation and to make necessary repairs.

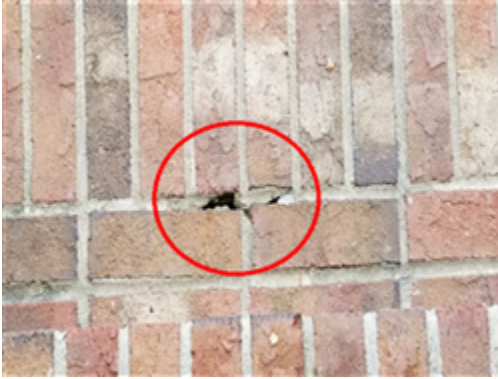
##### **(B3 - 3.1 ) Steps**

The brick step is missing mortar joint and is in need of repair. Deterioration of the mortar has created conditions that could result in additional damage to the steps due to water damage. A licensed general contractor should be consulted for a complete evaluation and to make necessary repairs.

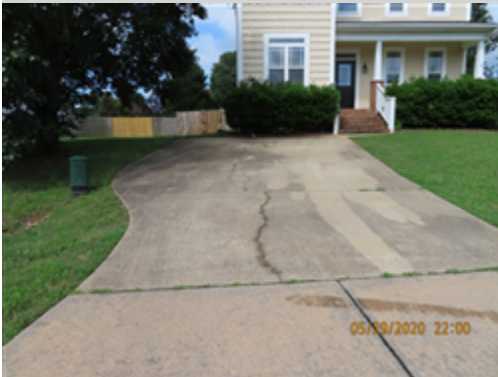
##### **(B4 - 1.1 ) Driveway**

The driveway is cracked and displaced. The raised section of the driveway has created a path for water penetration under the slab and a trip or fall hazard. A licensed general contractor should be consulted for further evaluation and repair.

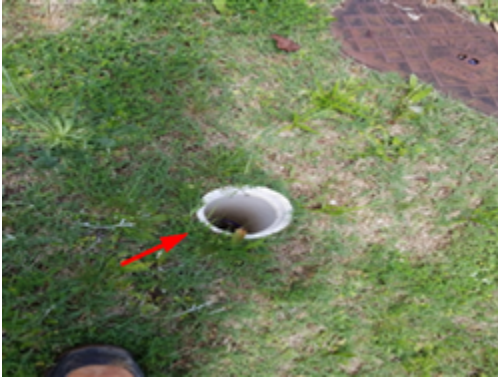
**(B4 - 2.1 ) Walk**

Plumbing cleanout pipe at front of house is missing a cap. Debris can clog up drain. A licensed plumbing contractor should be consulted to make necessary repairs.

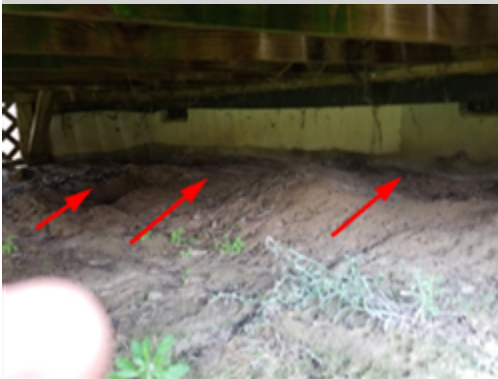
**(B5 - 1.1 ) Grading**

Under the deck, the rear yard slopes toward the home and there is evidence of erosion of soil against the perimeter of the home. Corrections are needed to control drainage and prevent water penetration, a licensed general contractor should be consulted for a complete evaluation and to make necessary repairs.

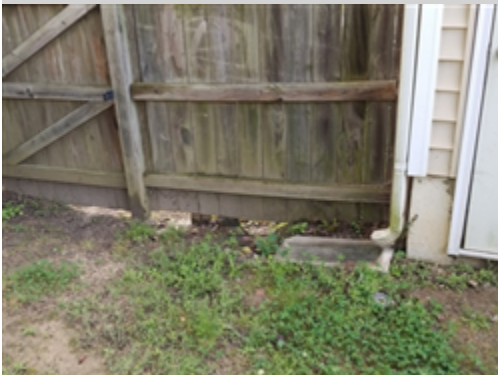
**(B5 - 2.1 ) Grading**

On both sides of the house, the house roof gutter downspout exits are too close to the foundation perimeter. This can result in erosion of the supporting soil and cause water penetration. Corrections are needed to control drainage and prevent water penetration, a licensed general contractor should be consulted for a complete evaluation and to make necessary repairs.

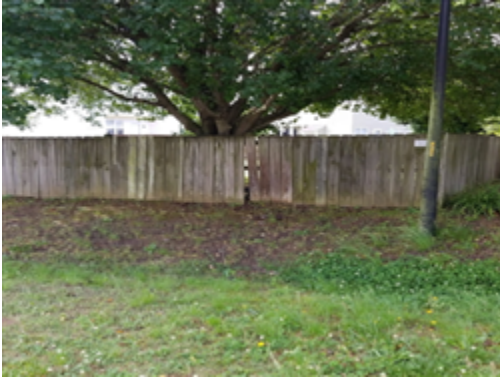
**(B5 - 3.1 ) Fence**

Backyard fence needs repair at several locations.

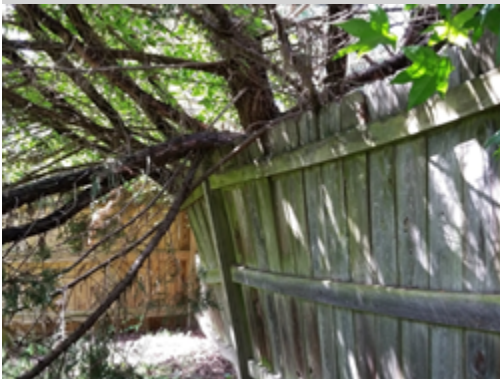
**(B5 - 4.1 ) Fence**

Damage to fence.

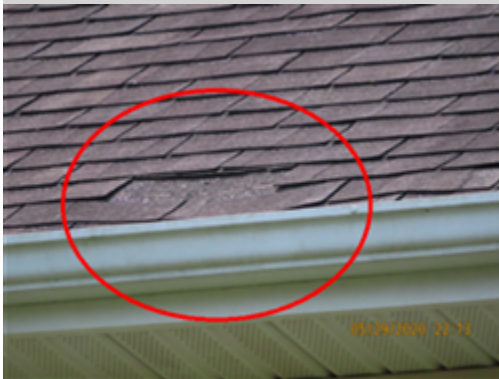
#### (C1 - 1.1 ) Main House

The roof shingles were noted to be lifting or curling at the corners of the tabs. Since shingles are designed to lay flat to shed water and debris, the curling can result in trapped moisture and leaks. Shingles curl for several reasons including: end of the service life, improper installation and or limited ventilation. A licensed roofing contractor should be consulted for a complete evaluation of the roof covering and flashings system to make necessary repairs to ensure the weathertightness of the roof covering system. At the time of the repair, the roofer may be able to answer questions related to the life expectancy of the roof covering system.

A shingle is missing on the right area of the roof surface and in need of replacement. The missing shingle could indicate an underlying problem with the shingle installation or sheathing. A licensed general contractor should be consulted for a complete evaluation of the roof covering system to verify that shingles are installed correctly and to make necessary repairs to ensure the weathertightness of the roof covering system.

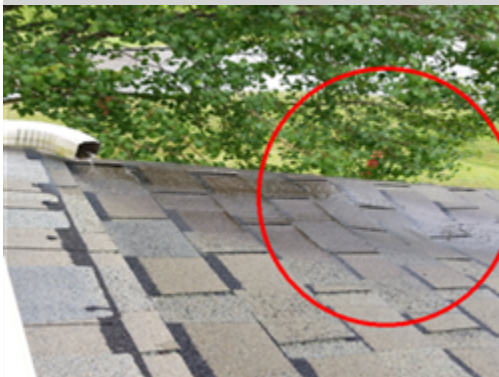
#### (C1 - 2.1 ) Porch-1

There are several visible repairs to the roof covering. Repairs typically indicate physical damage or history of leaks and can indicate that a roof covering is approaching the end of the service life. The owners should be asked for disclosure related to the history of repairs. A licensed roofing contractor should be consulted to evaluate the repairs and determine the life expectancy of the roof covering.

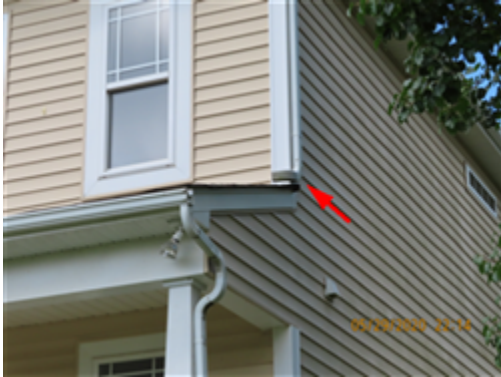
#### (C1 - 3.1 ) Porch-2

Roof gutter down spout exits onto porch roof. This is contributing to the porch roof damages.

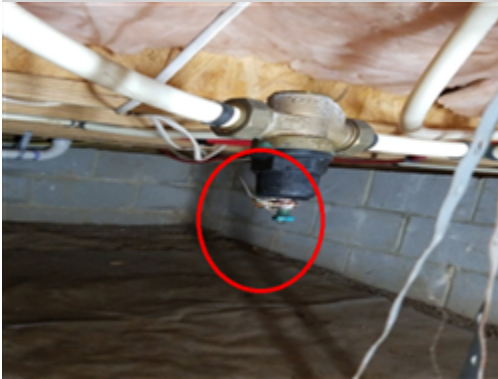
##### (D1 - 1.1 ) Crawl Space

The plumbing system is in need of further evaluation and repair; the following concerns were noted at the time of the inspection:

1. Pressure Reducing valve is leaking and corroded
2. Standing water is visible

Plumbing issues should be corrected prior to purchasing the home to prevent leaking or future problems and ensure sanitary conditions. A plumbing contractor should be consulted for a complete evaluation of the system and to make necessary repairs.

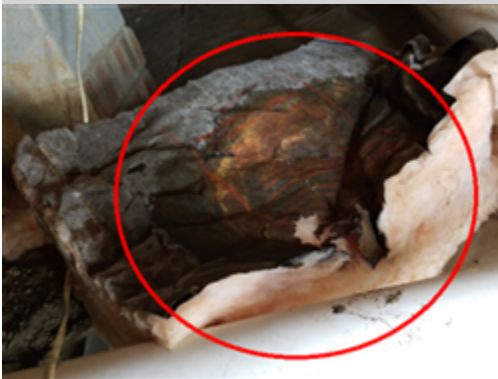
##### (D1 - 2.1 ) Crawl Space

The plumbing system is in need of further evaluation and repair; the following concerns were noted at the time of the inspection:

1. Evidence of water leak - Wet insulation

Plumbing issues should be corrected prior to purchasing the home to prevent leaking or future problems and ensure sanitary conditions. A plumbing contractor should be consulted for a complete evaluation of the system and to make necessary repairs.

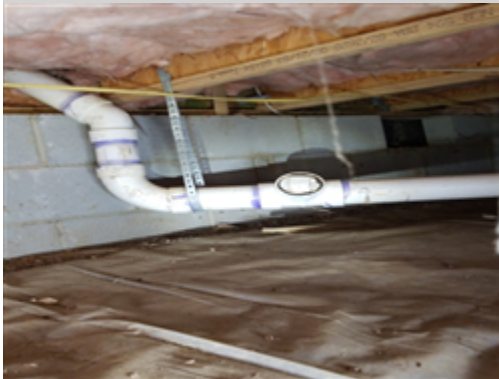
### (D2 - 1.1 ) Crawl Space

Possible leak. liquid on vapor barrier. A licensed plumbing contractor should be consulted for complete evaluation and of the waste line systems to determine the general condition of the system and to make necessary repairs.

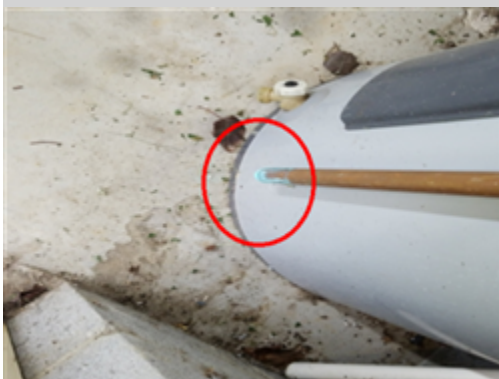
### (D3 - 1.1 ) Unit #1

The overflow pipe was noted to be corroded A licensed plumbing contractor should be consulted to evaluate the system and repair/replace as needed to ensure safe, reliable and proper operation of the water heating system.

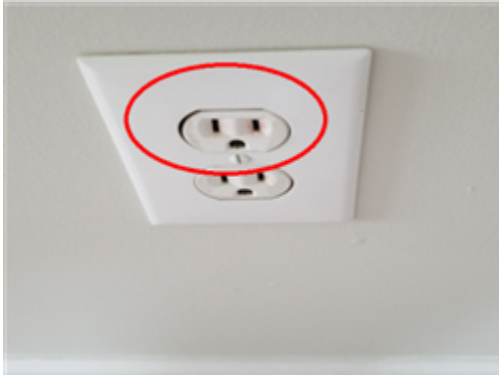
**(E5 - 1.1 ) Living Room**

The receptacle has visible damage that could indicate a short or history of arcing. A licensed electrical contractor should be consulted for a complete evaluation to determine the significance of this concern and make necessary repairs to correct defects and prevent safety hazards. (near Patio door)

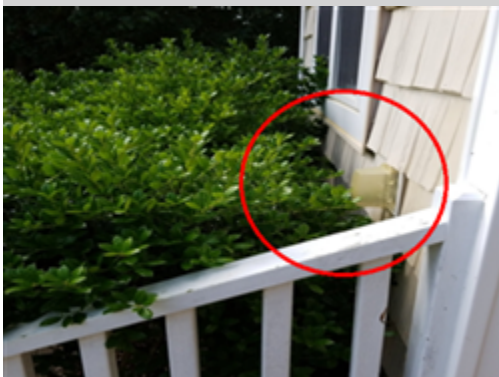
**(E5 - 2.1 ) Exterior**

The receptacle had no power or tested as not hot. This could indicate a damaged receptacle or branch wiring circuit. A licensed electrical contractor should be consulted for a complete evaluation to determine the significance of this concern and make necessary repairs to correct defects and prevent safety hazards.

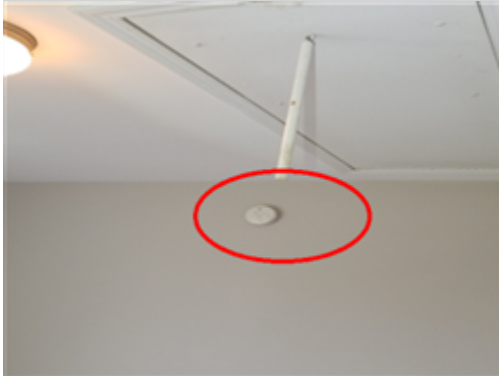
##### **(E5 - 3.1 ) Stairway**

The smoke detector did not respond to the test button. A properly functioning smoke detector is vital to the safety of a home. Smoke detectors should be replaced or updated every 5 to 7 years and batteries changed annually. The unit should be repaired or replaced to ensure a safe environment. (Upstairs Bedroom)

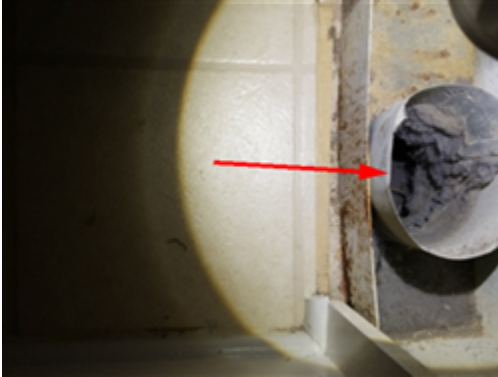
##### (H1 - 3.1 ) Laundry

The dryer duct system is in need of repair to ensure proper air flow and the following concern was noted at the time of the inspection:

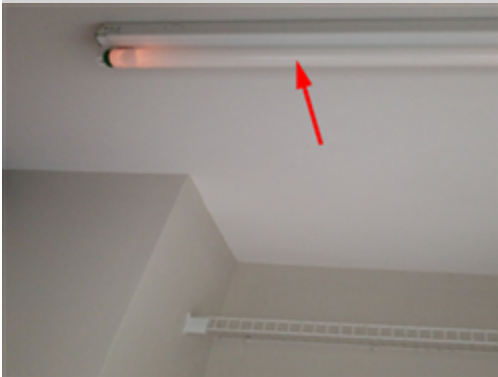
##### (H1 - 4.1 ) Laundry

Light fixture did not come on when switch was turned on. Light fixture needs further evaluation and repair.

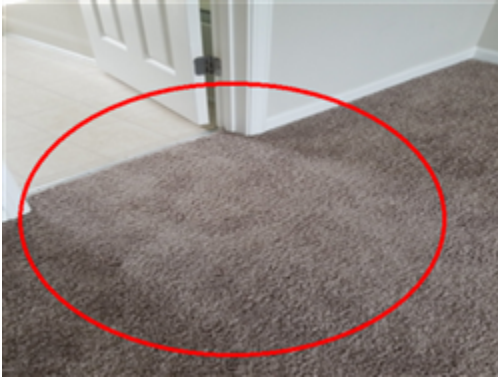
**(H1 - 5.1 ) Bedroom: Master**

The flooring squeaks in this area more than typical. A flooring installation/ repair company should be consulted for further evaluation to determine the significance and source of the concern.

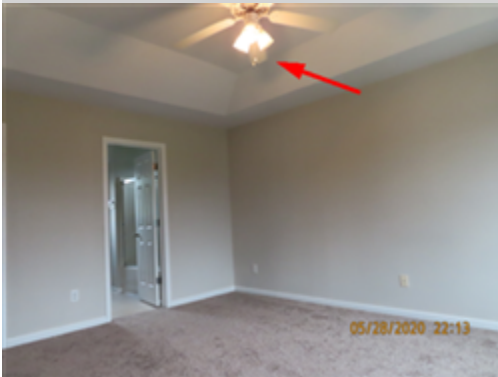
The ceiling fan is off balance, fans need to be balanced and secure to operate safely. The light receptacle box needs to be verified to be rated for fan installation. A licensed electrical contractor should be consulted for further evaluation and repair.

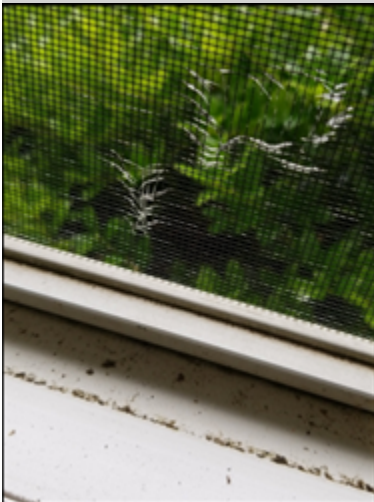
Damage window screen in second floor hall window.

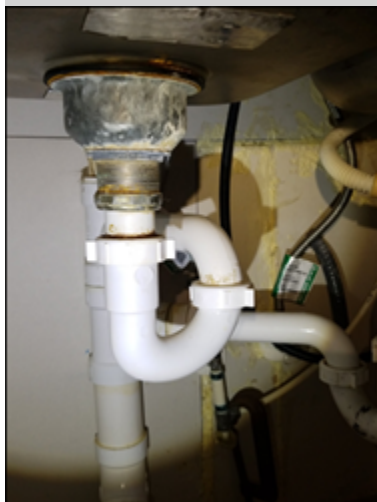
Although no leaks were detected at the time of inspection, the inspector has some concern about the plumbing configuration in this area. A plumbing contractor should be consulted for a complete evaluation of the system and to make necessary repairs.

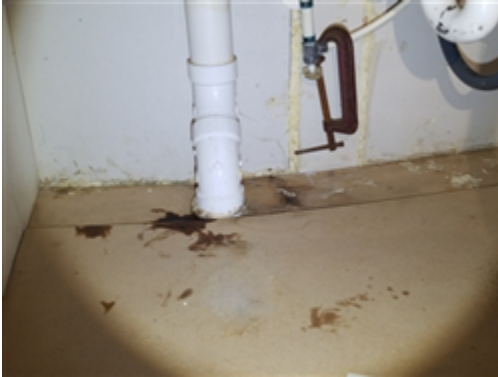
Although no leaks were detect at the time of inspection, the inspector has some concern about the plumbing configuration in this area. A plumbing contractor should be consulted for a complete evaluation of the system and to make necessary repairs.

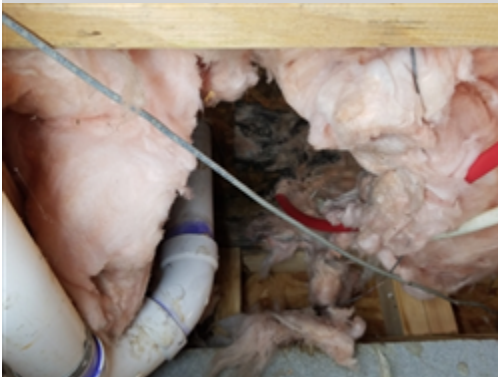
Although no leaks were detect at the time of inspection, the inspector has some concerns about the plumbing configuration in this area. A plumbing contractor should be consulted for a complete evaluation of the system and to make necessary repairs.

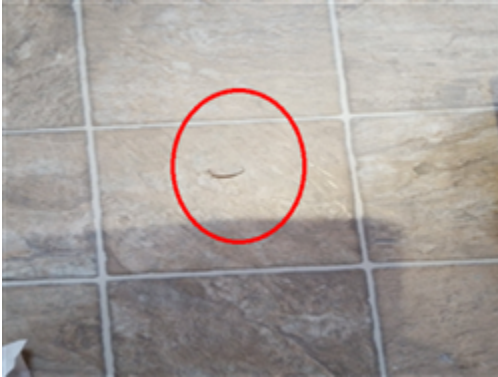
Damaged vinyl flooring.

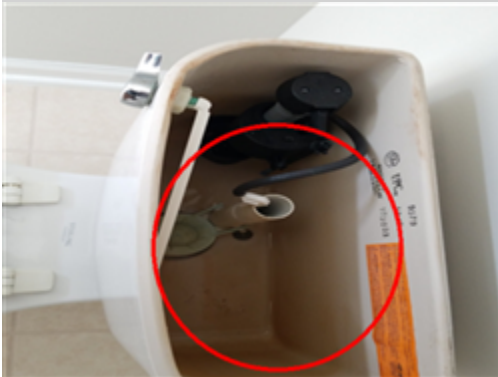
Toilet tank floater is missing from this toilet. A licensed plumbing contractor should be consulted for a complete evaluation and to make necessary repairs.

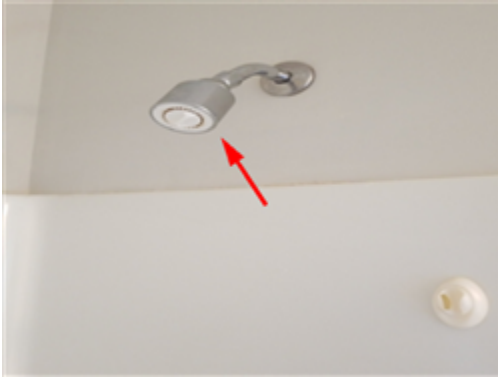
Shower head is noisy. This condition should be looked at by a licensed plumbing contractor for a complete evaluation and to make necessary repairs.

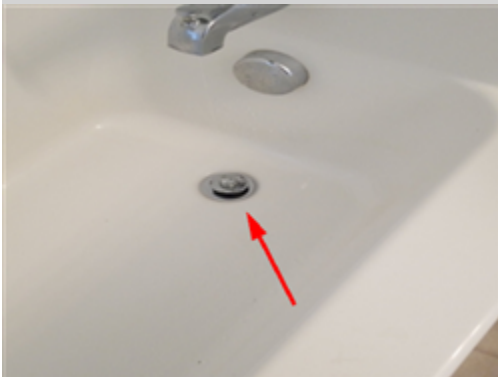
Tub stopper does not close properly. A licensed plumbing contractor should be consulted for a complete evaluation and to make necessary repairs.

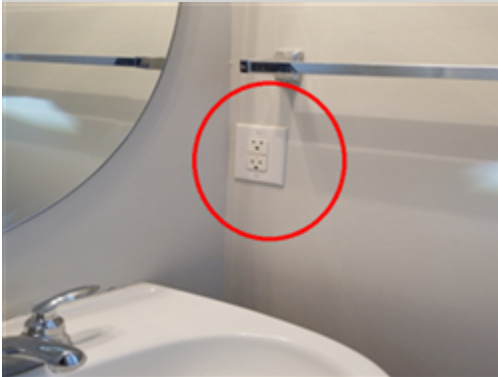
At least one GFCI receptacle was not functional in second floor hall bathroom. A licensed electrical contractor should be consulted for a complete evaluation to determine the significance of this concern and make necessary repairs to correct defects and prevent safety hazards.

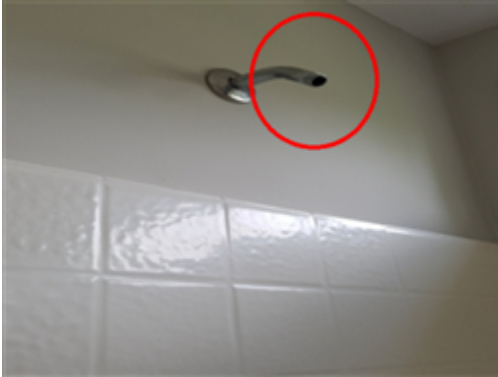
Missing master bathroom shower head. A licensed plumbing contractor should be consulted for a complete evaluation and to make necessary repairs.

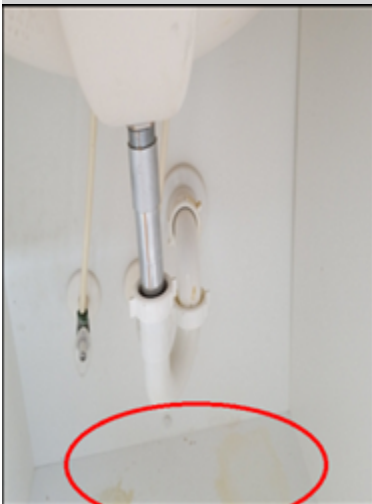
Evidence of previous water stain. A licensed plumbing contractor should be consulted for a complete evaluation and to make necessary repairs.

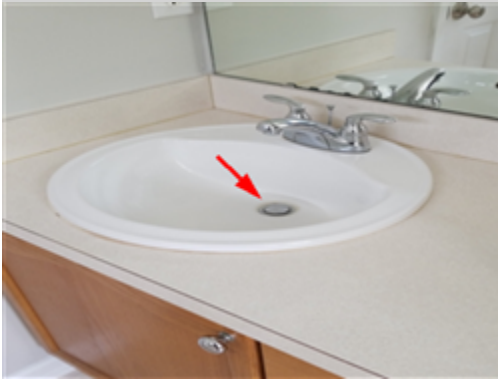
Sink stopper does not close properly. A licensed plumbing contractor should be consulted for a complete evaluation and to make necessary repairs.

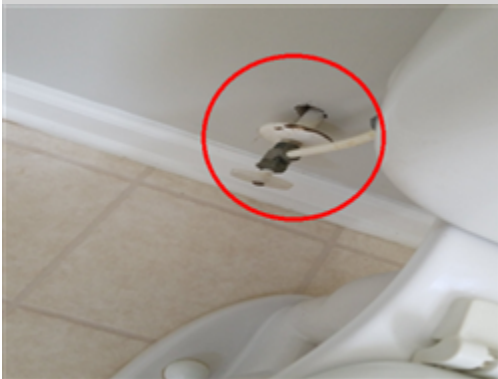
Water supply lines are loose. This condition can result in water leaking into the wall areas. A licensed plumbing contractor should be consulted for a complete evaluation and to make necessary repairs.

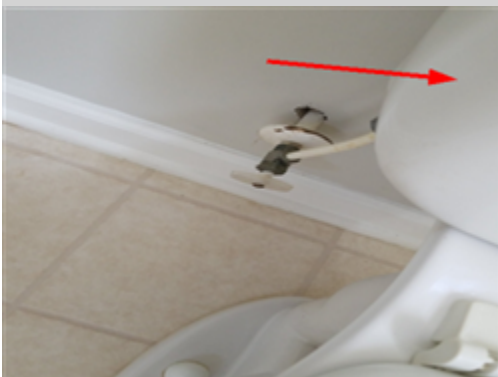
Toilet tank does not retain water. A licensed plumbing contractor should be consulted for a complete evaluation and to make necessary repairs.

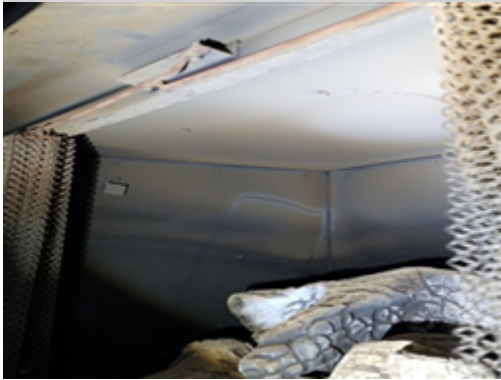
Fire place does not have exterior venting. Exterior venting prevents hazardous operation of the gas log unit. This is a hazardous condition that needs correction. A licensed general contractor should be consulted for a complete evaluation and repair.

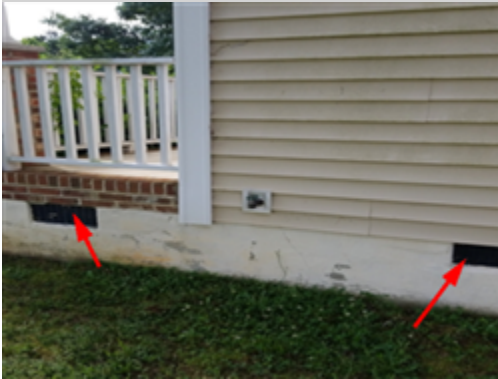
80% of the foundation vents for the home are closed. However, no moisture control system has been installed to replace the natural ventilation. The configuration does not meet industry standards and needs a complete review by a licensed general contractor.

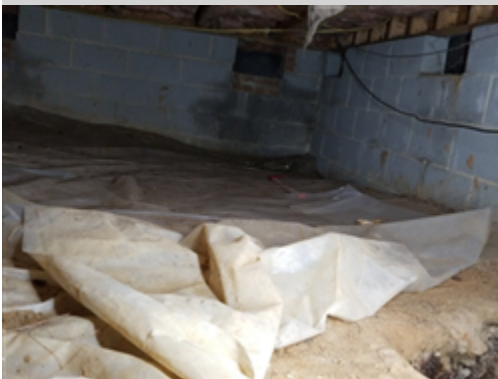
The crawl space presented evidence of elevated humidity and current/or past evidence of condensation. At the time of the inspection the following concerns were noted:
