Property Visit

Prepared on behalf of Example Lettings Ltd

123 Preview Street
Sample City
London
AB1 2CD

January
18th 2025
10:30

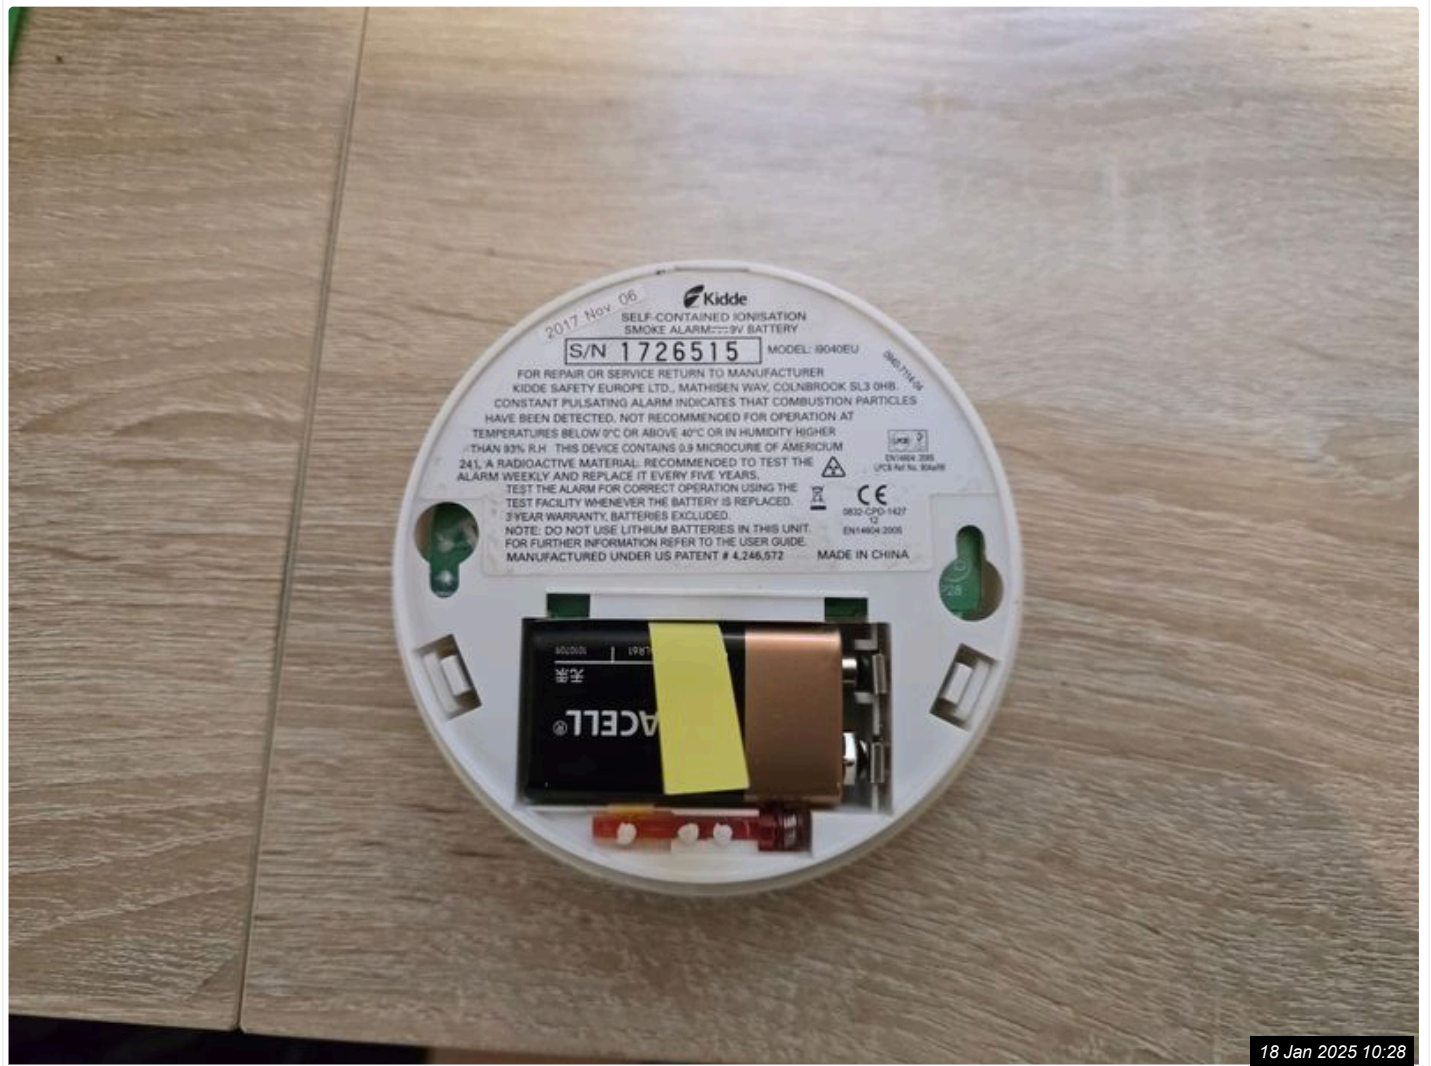
Ref # 2.3

Smoke Alarm (removed)	Entrance Hall Ceiling ground floor	Alarm tested for power only, audible alarm noted Out of date	Replacement date 06-11-2022

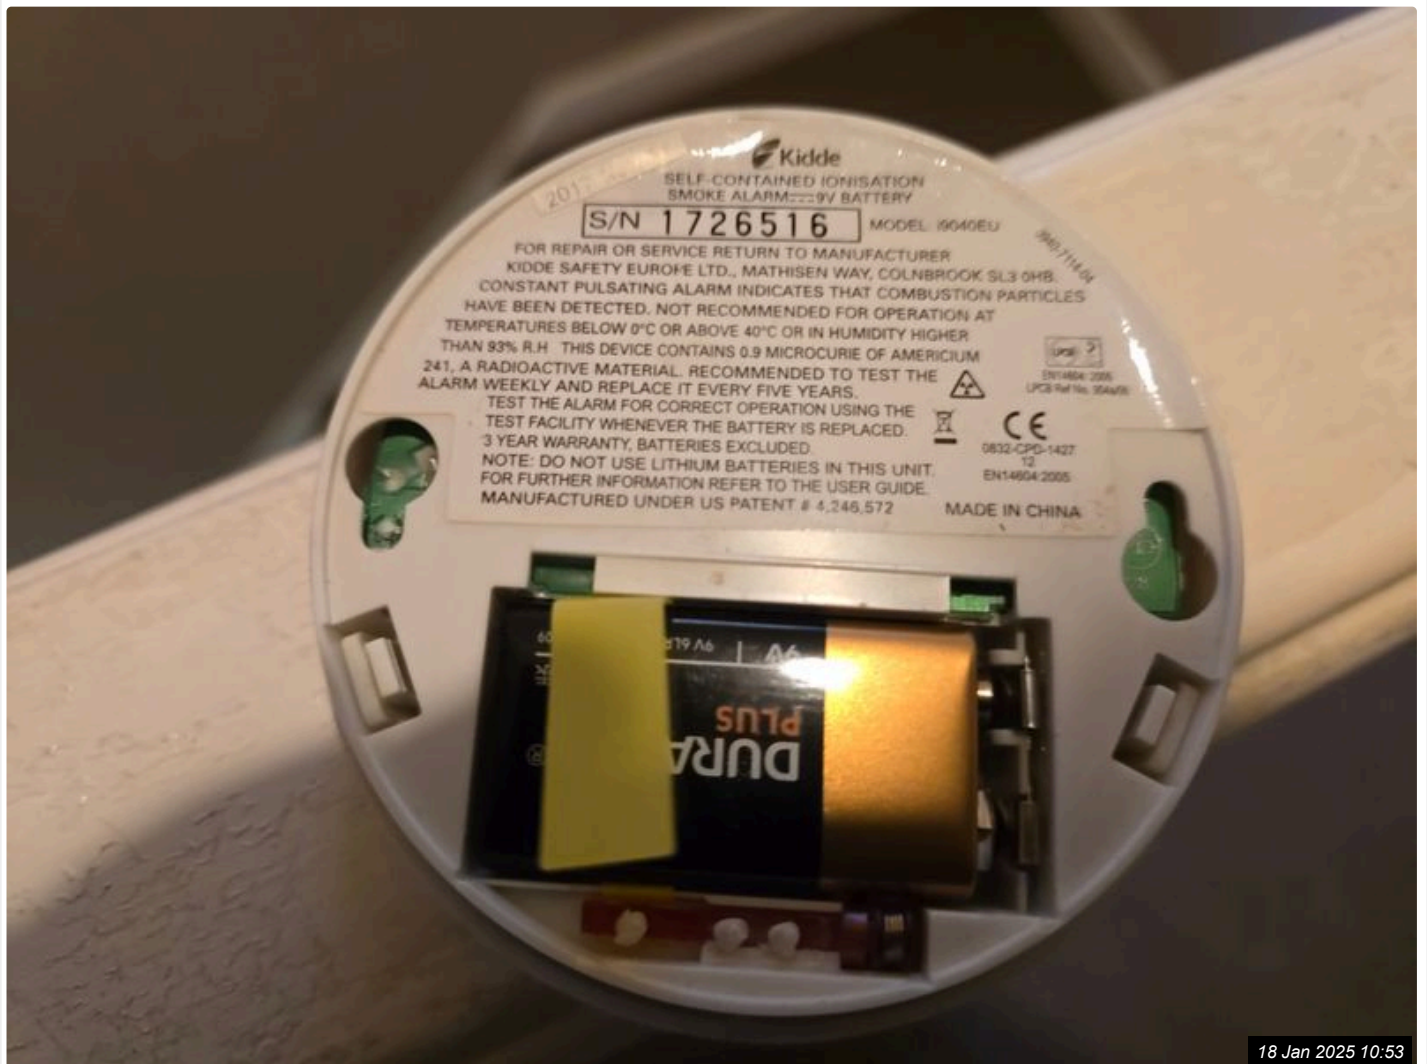
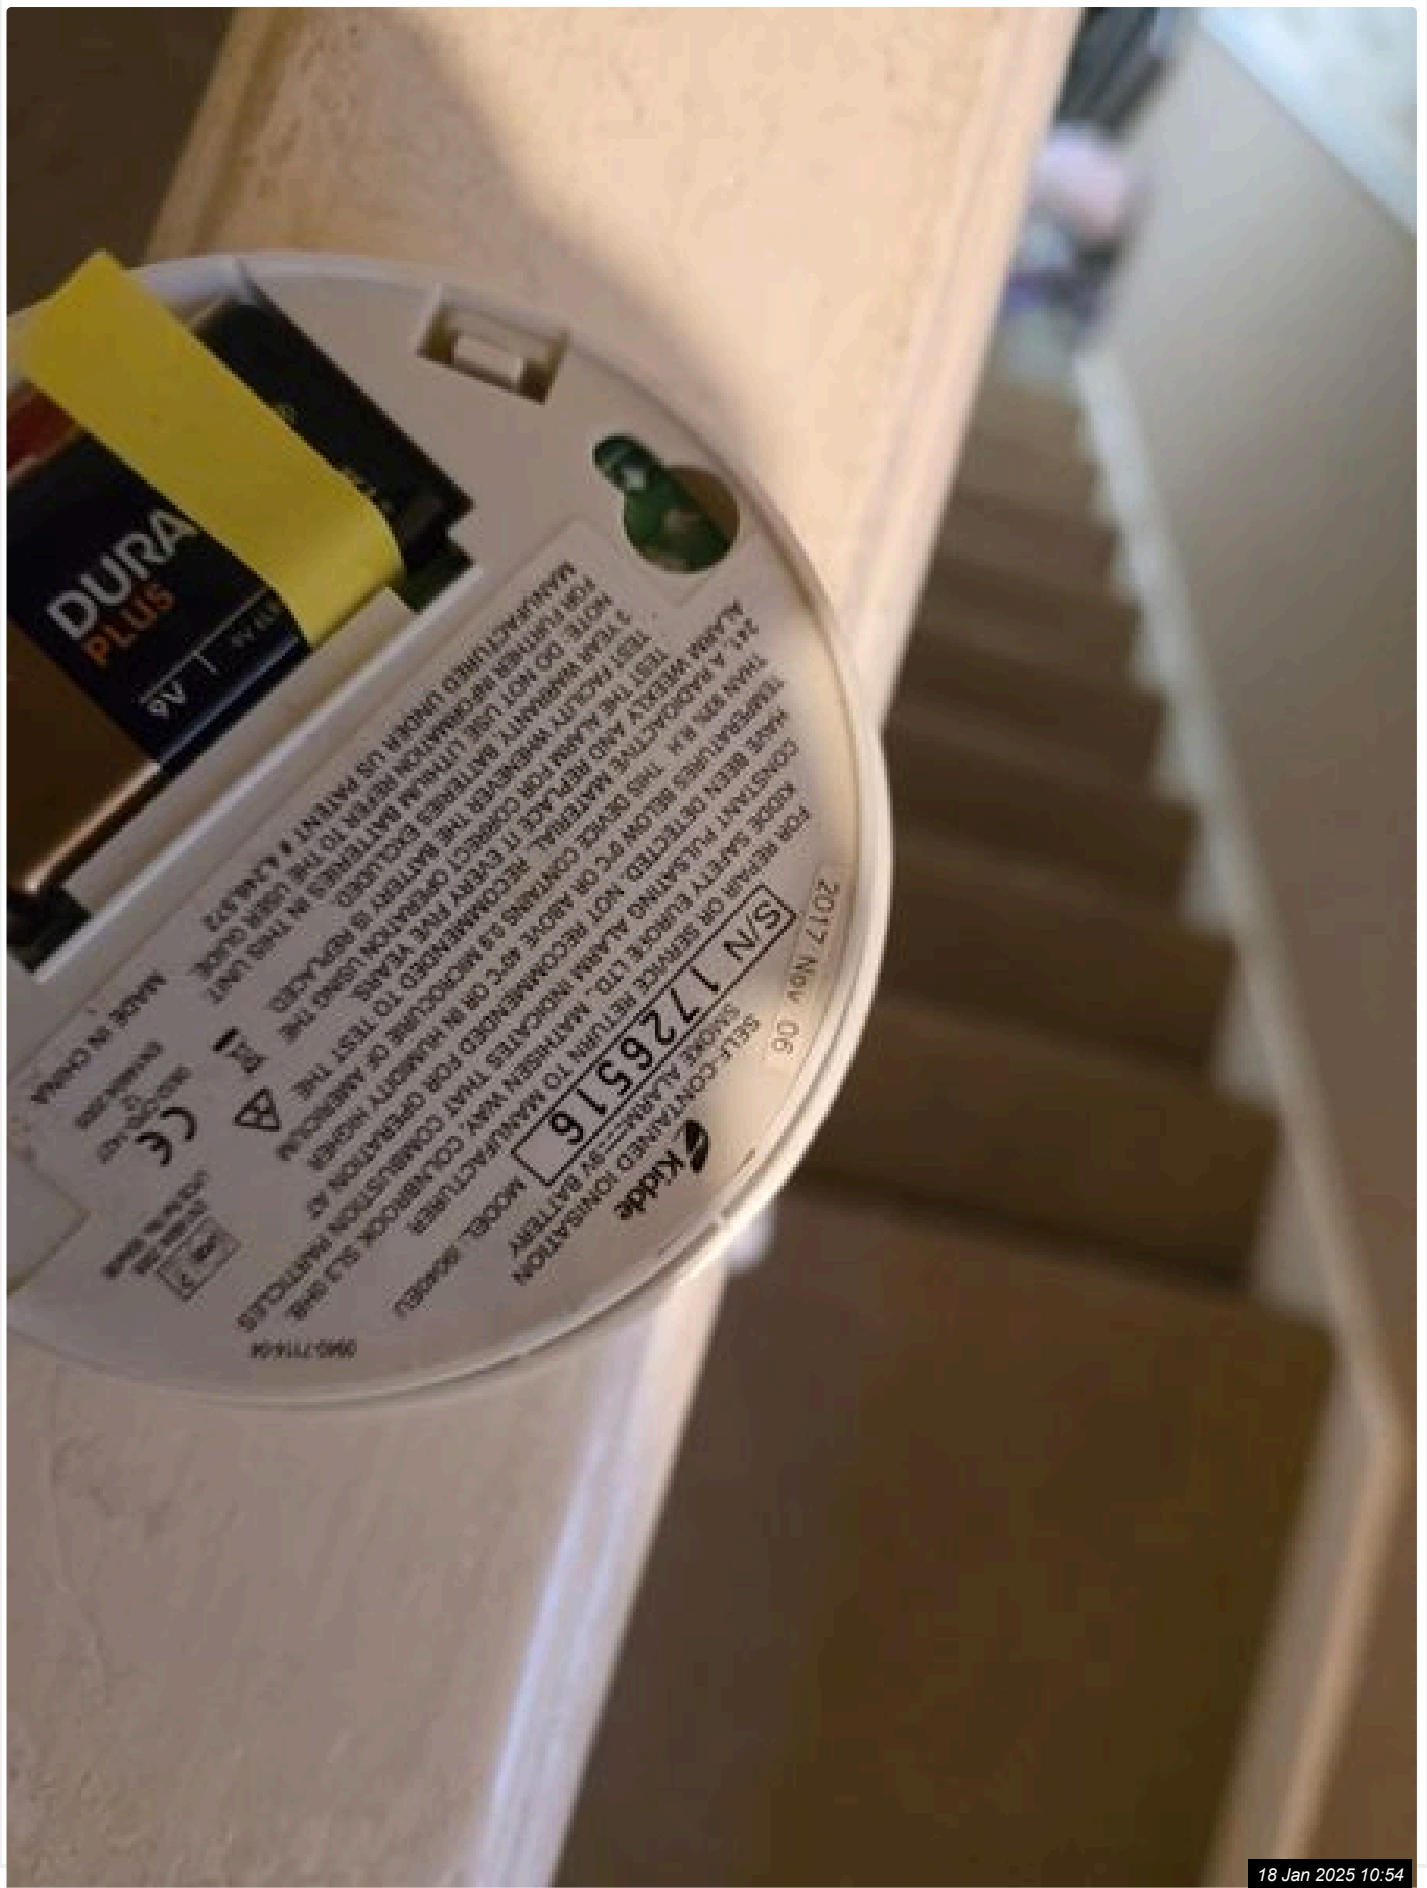
Ref # 2.4

Smoke Alarm (removed)	Landing Ceiling 1st floor	Alarm tested for power only, audible alarm noted Out of date	Replacement date 06-11-2022
---	-----------------------	---------------------------	--	--------------------------------

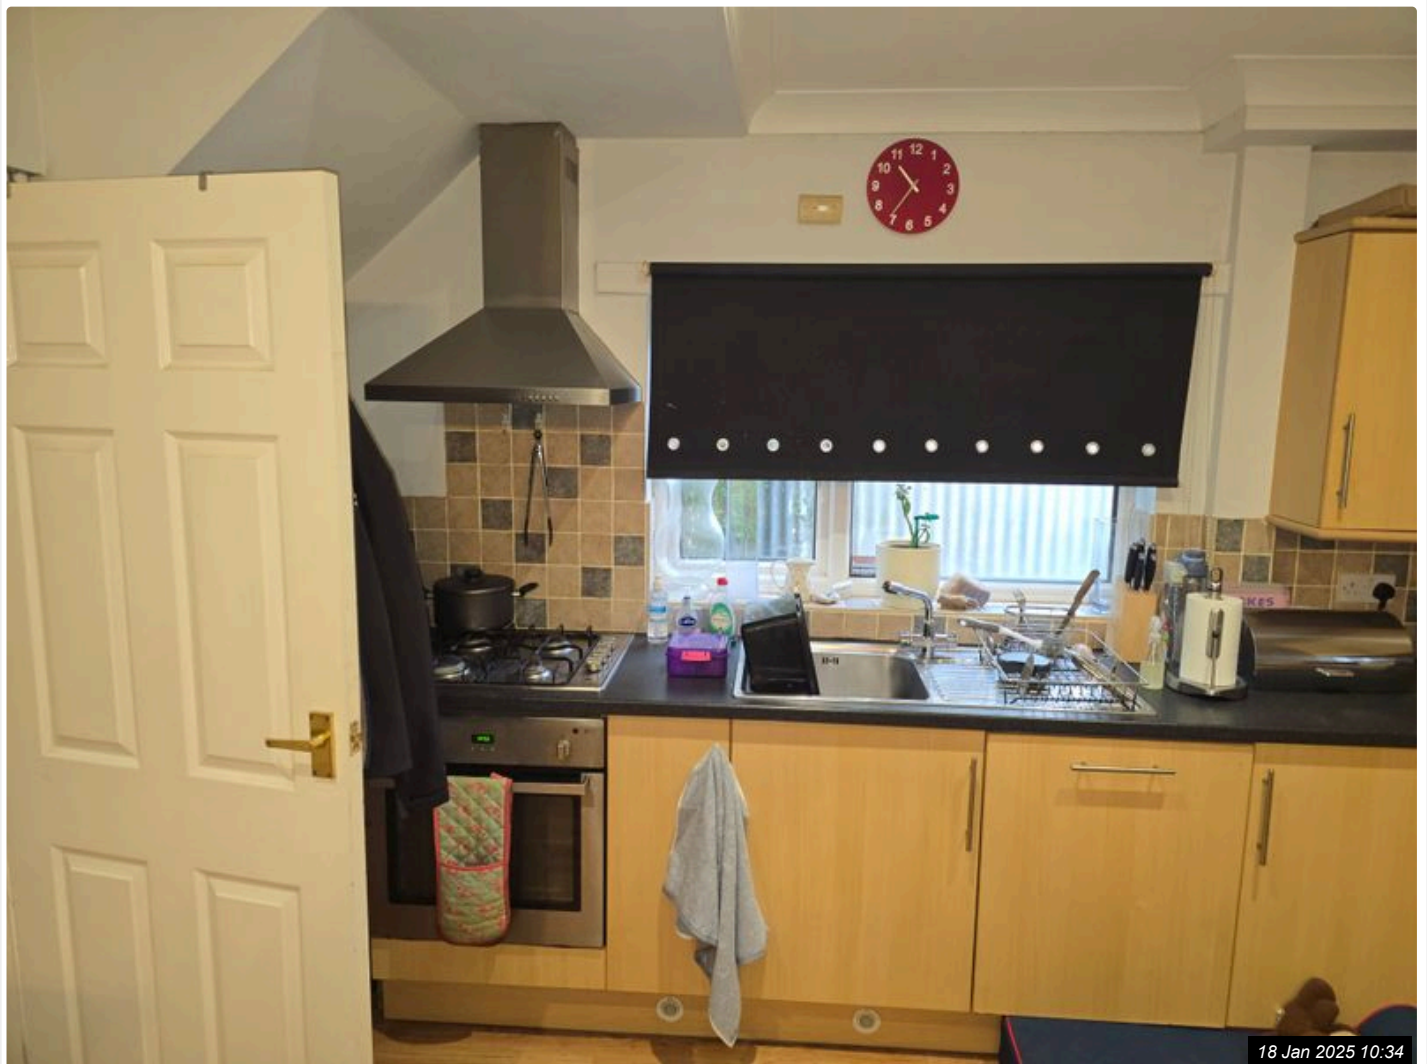
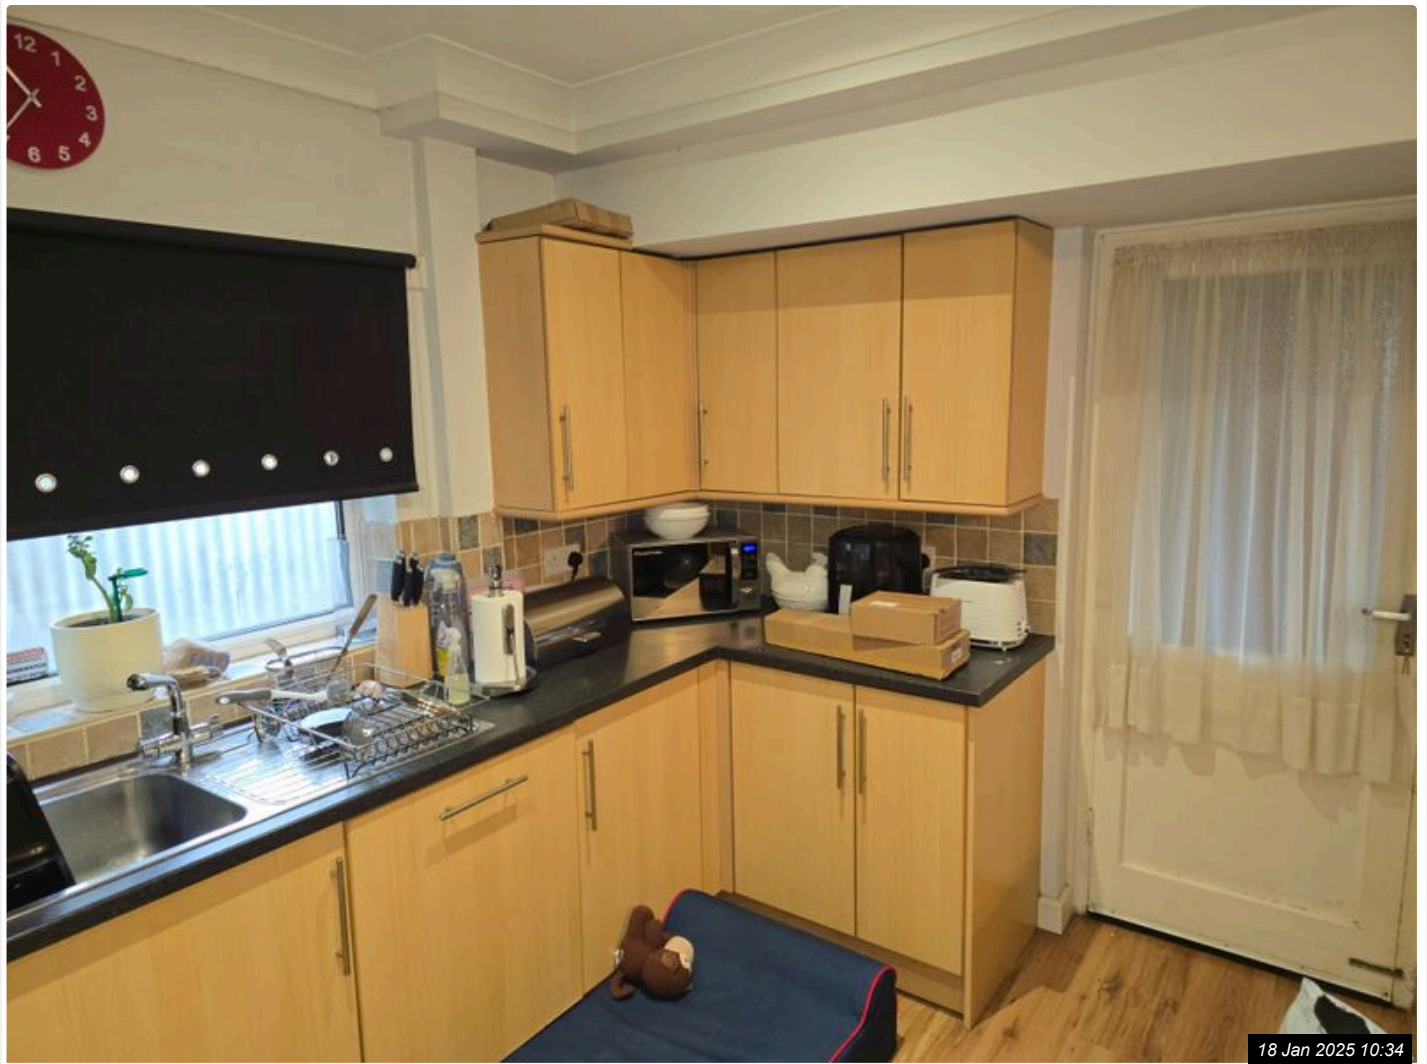
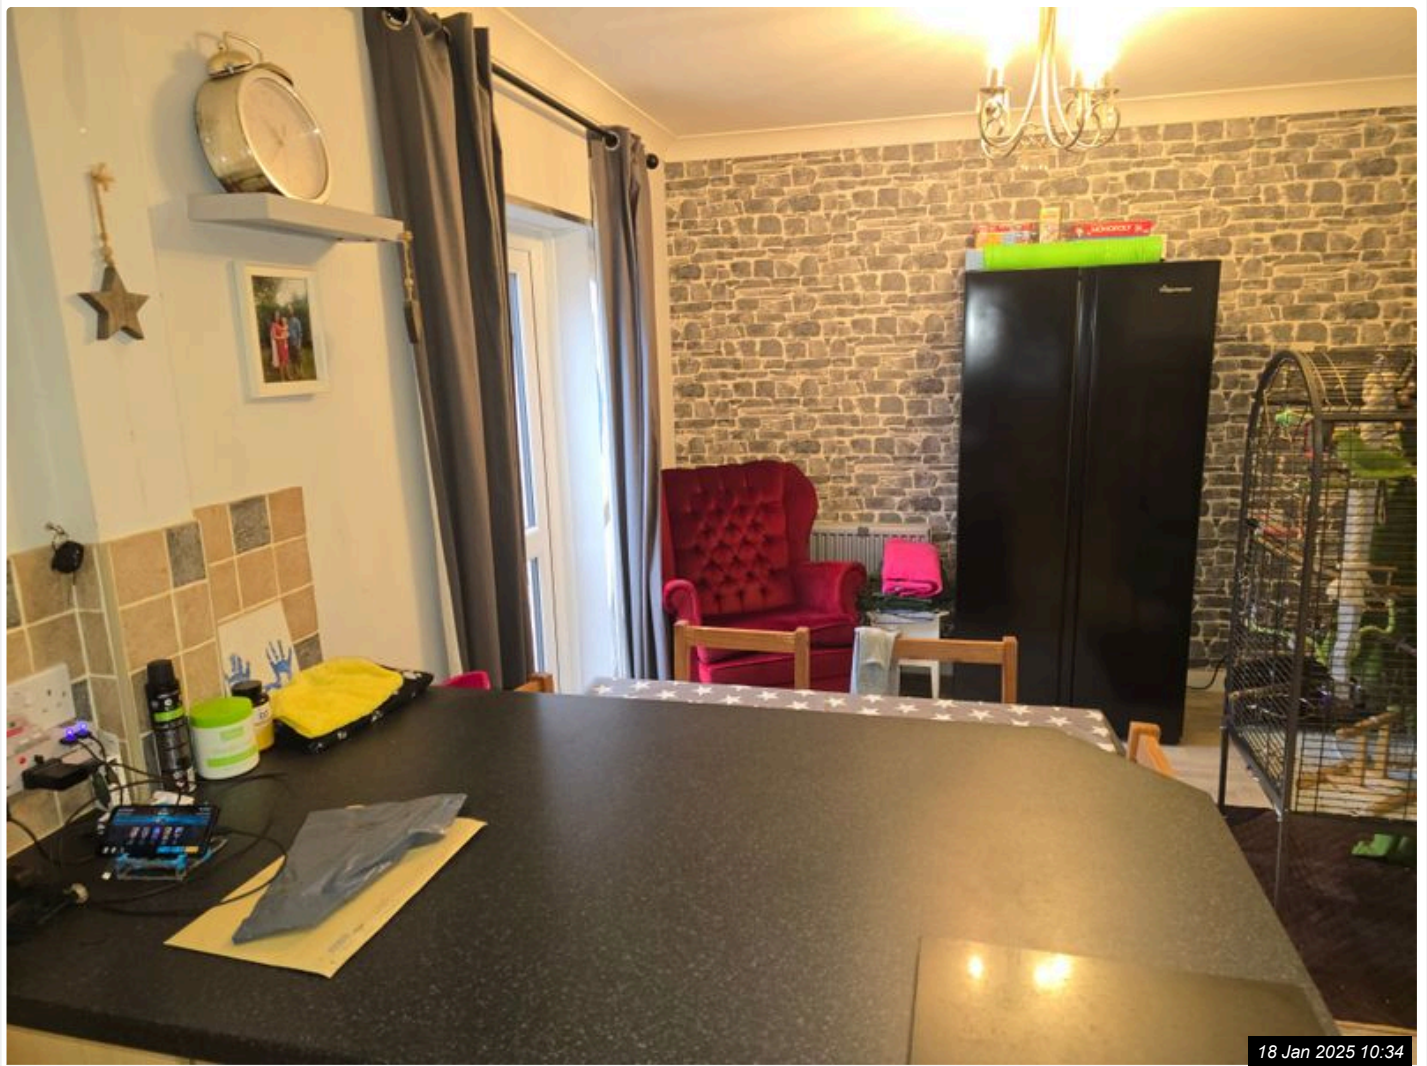
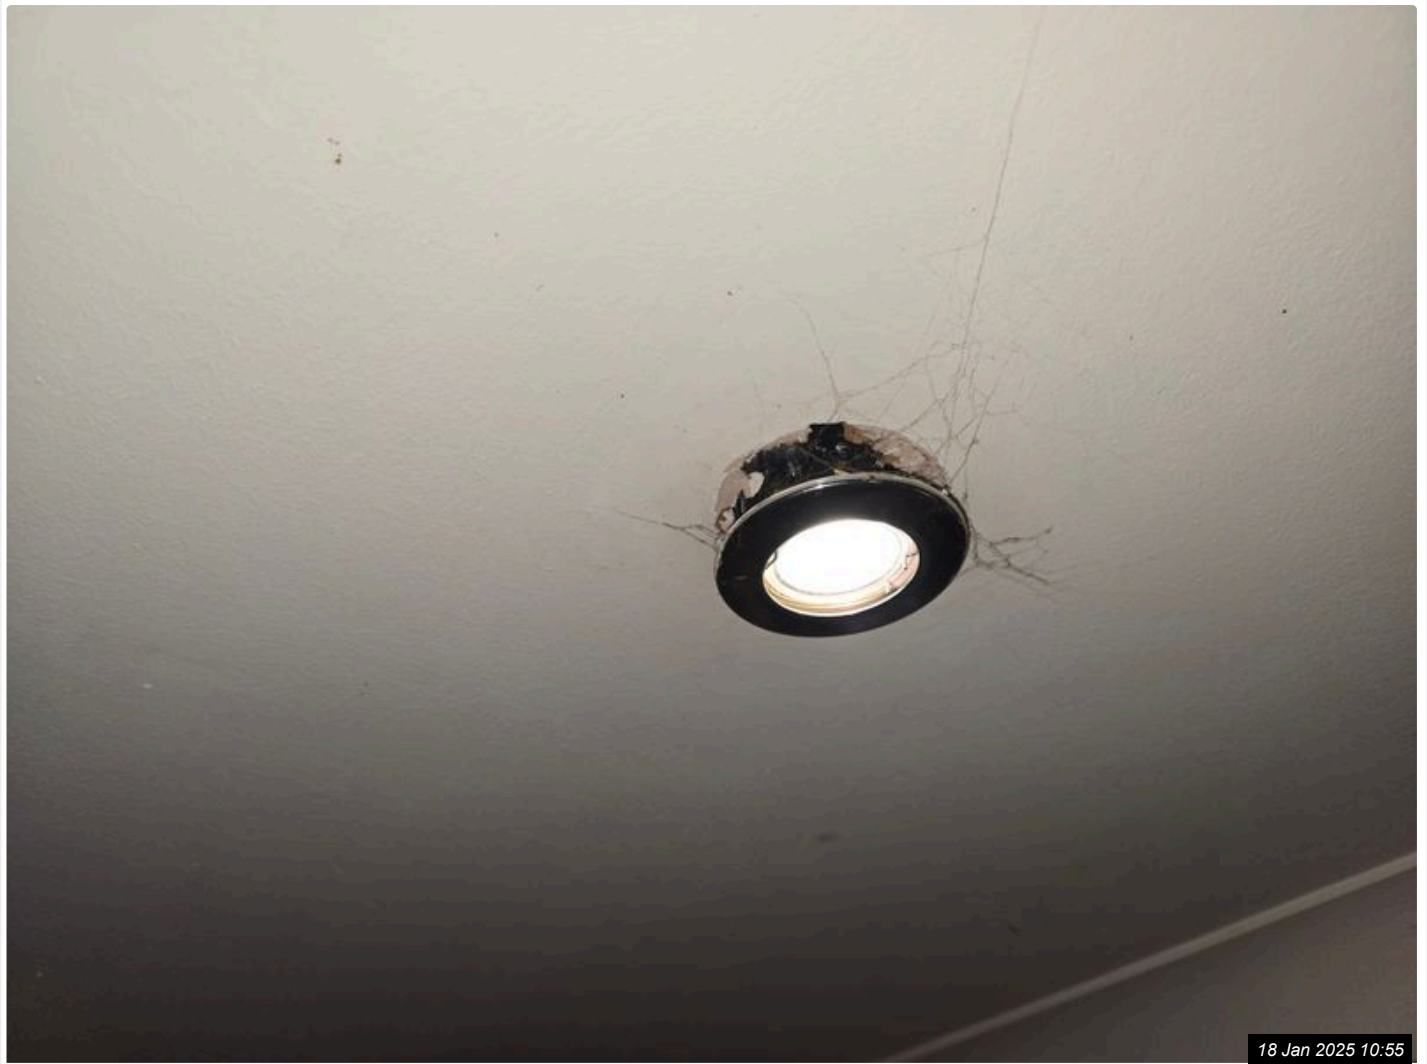
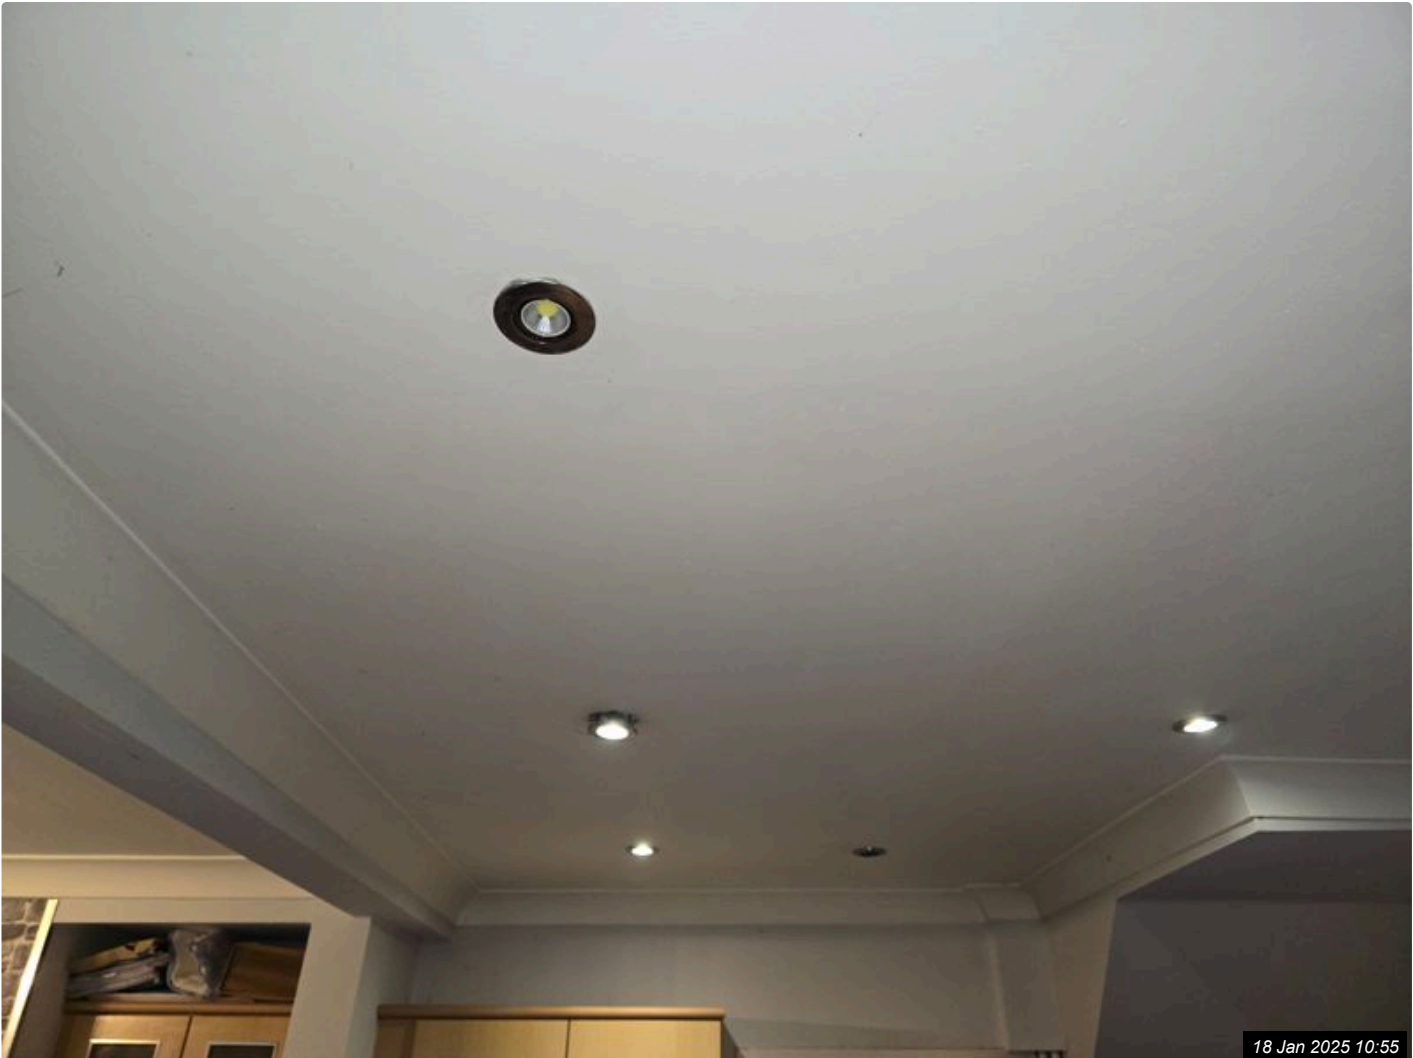
Ref # 3.3

Kitchen	Good	Spotlight fitting is loose One is not working, tenant Unable to reach Needs Maintenance - Investigate

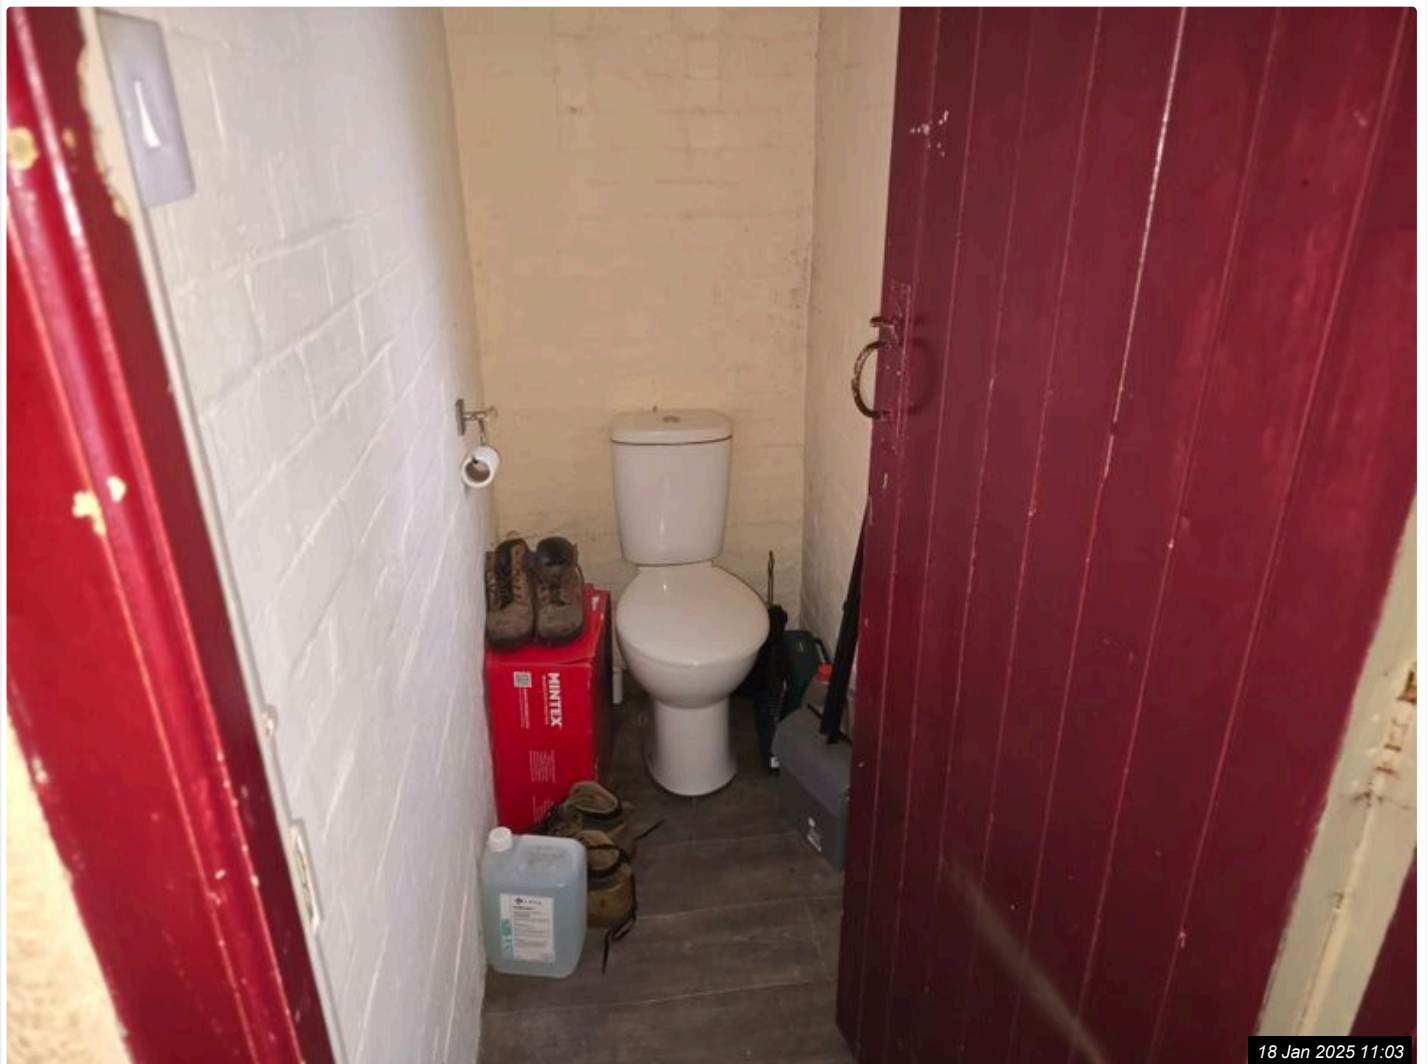
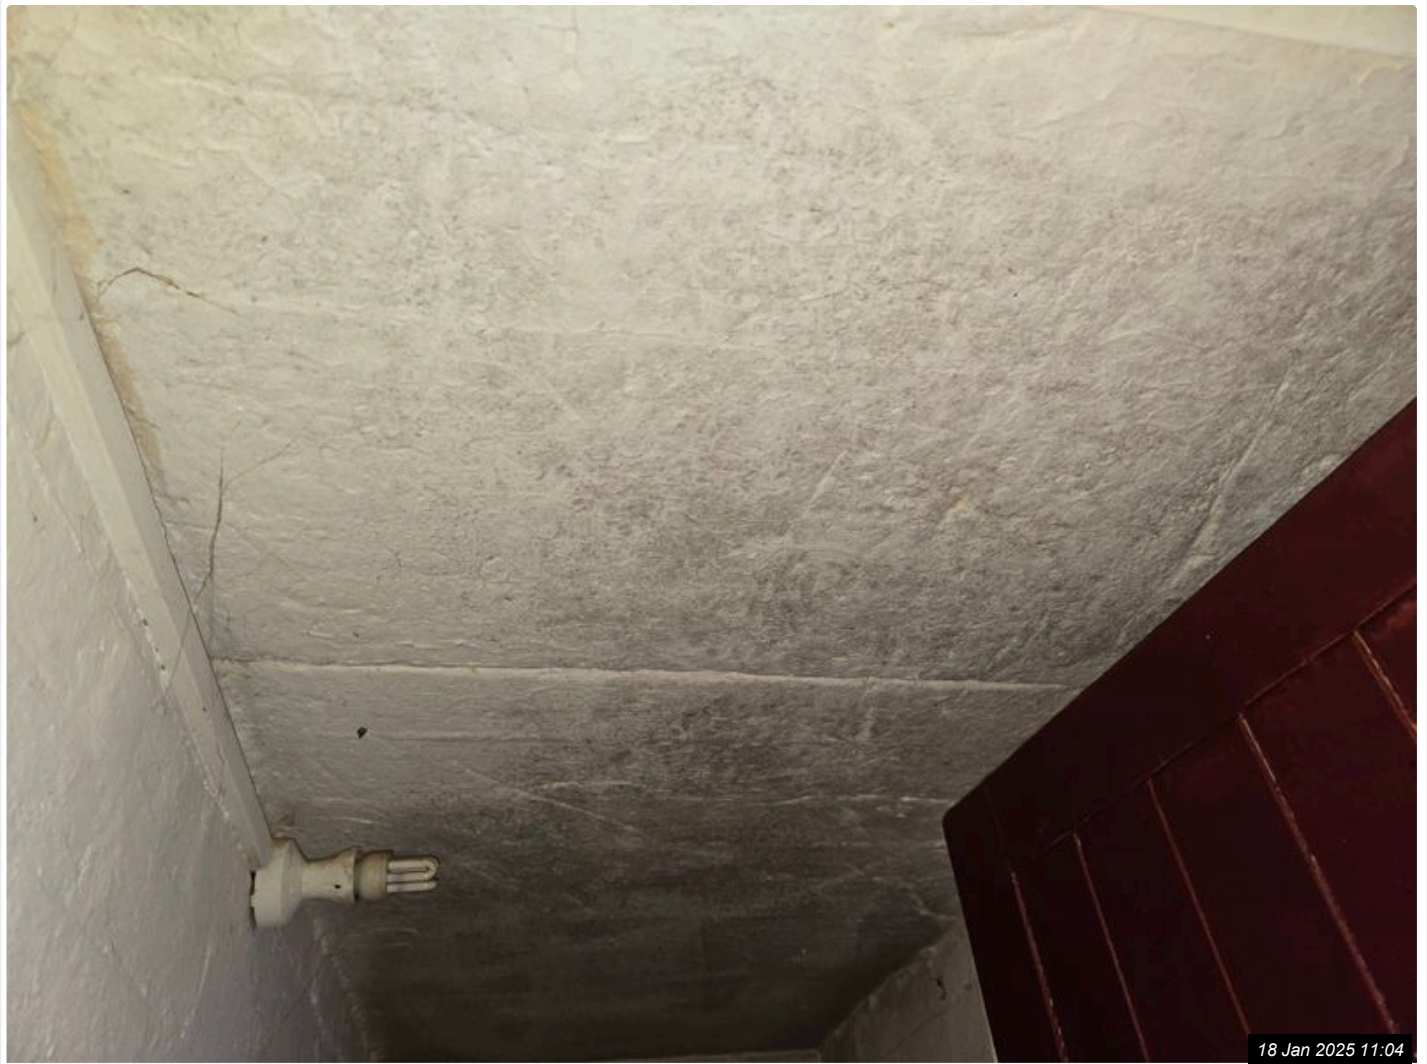
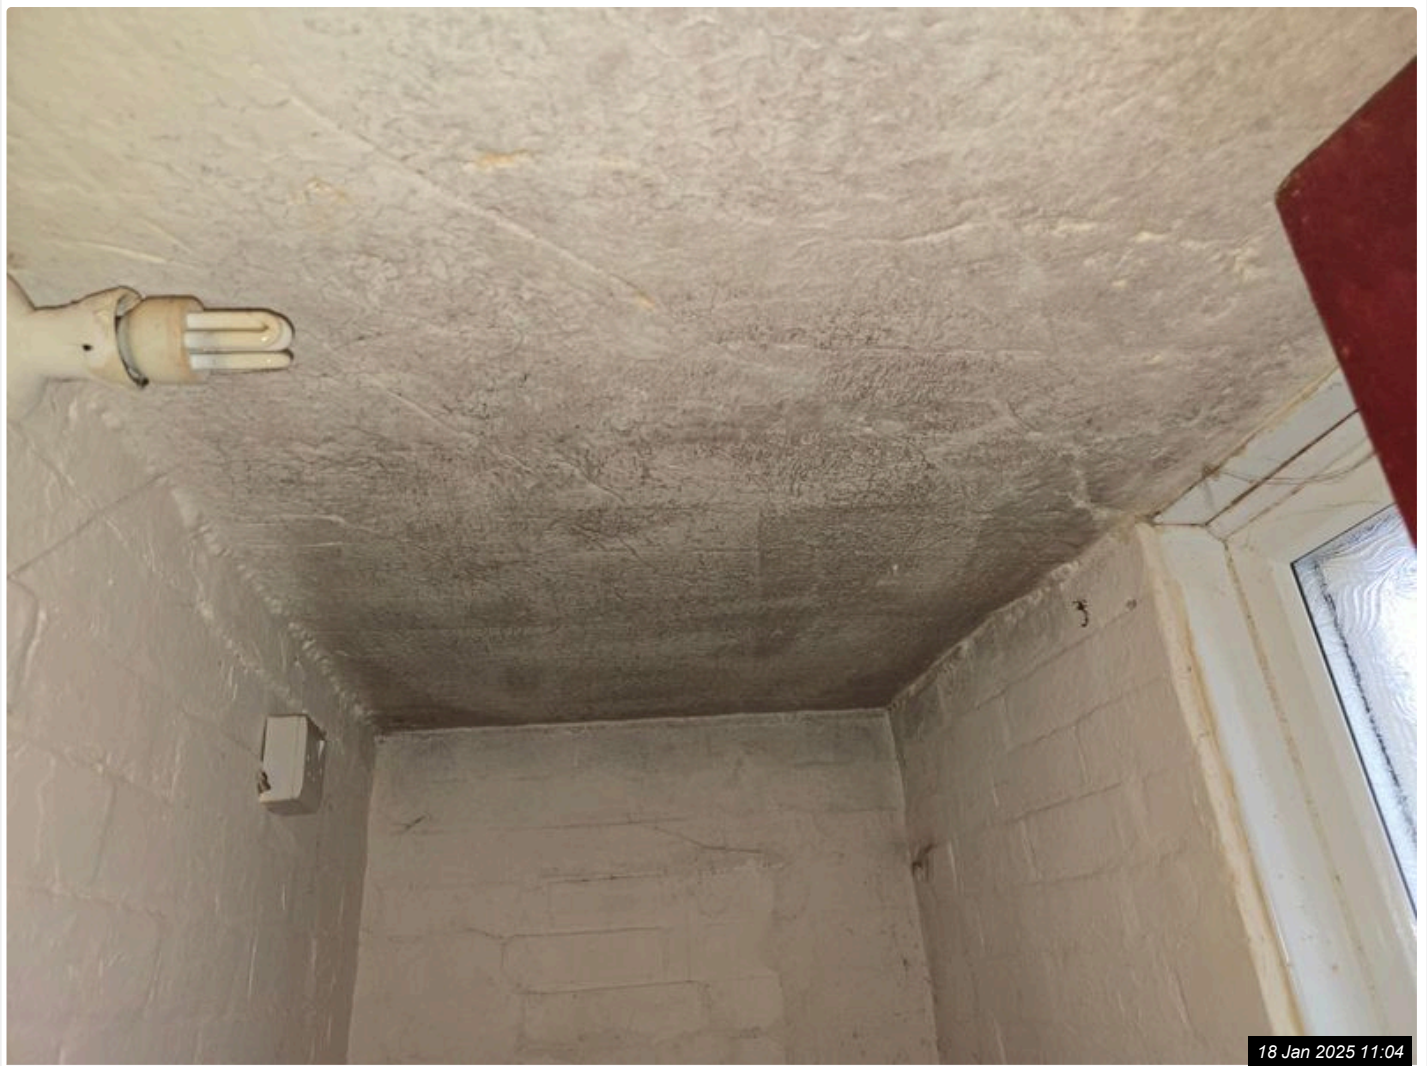
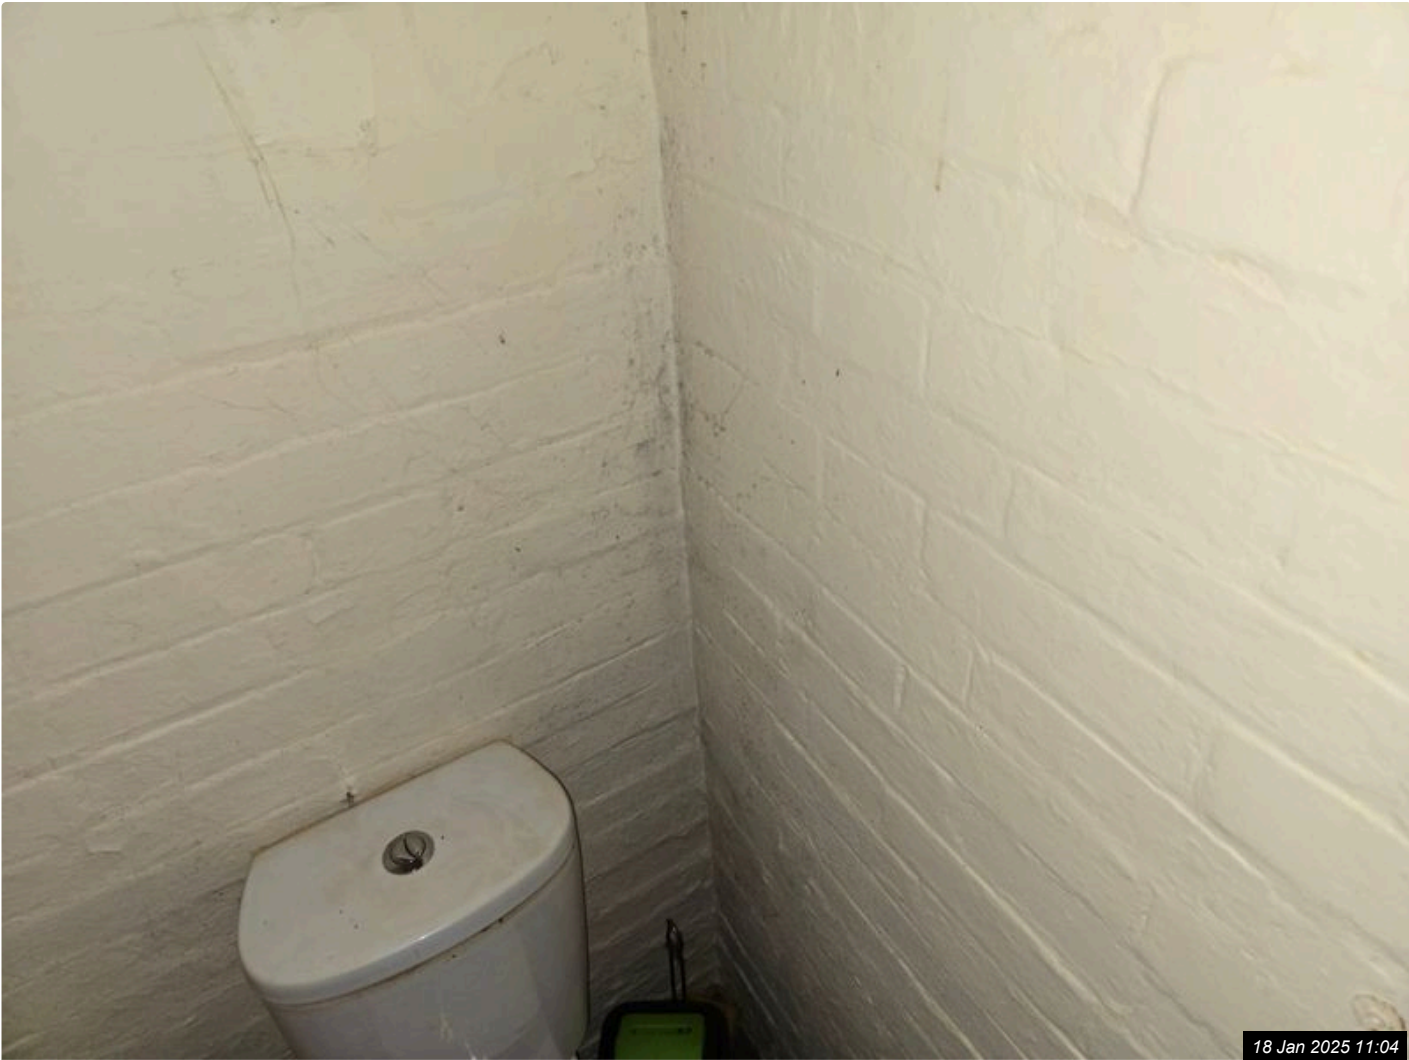
Ref # 3.6

toilet	Good	Heavy mould growth, not used by tenant Needs Maintenance - Landlord
