Property Visit

Prepared on behalf of Example Lettings Ltd

123 Preview Street
Sample City
London
AB1 2CD

January
18th 2025
10:30

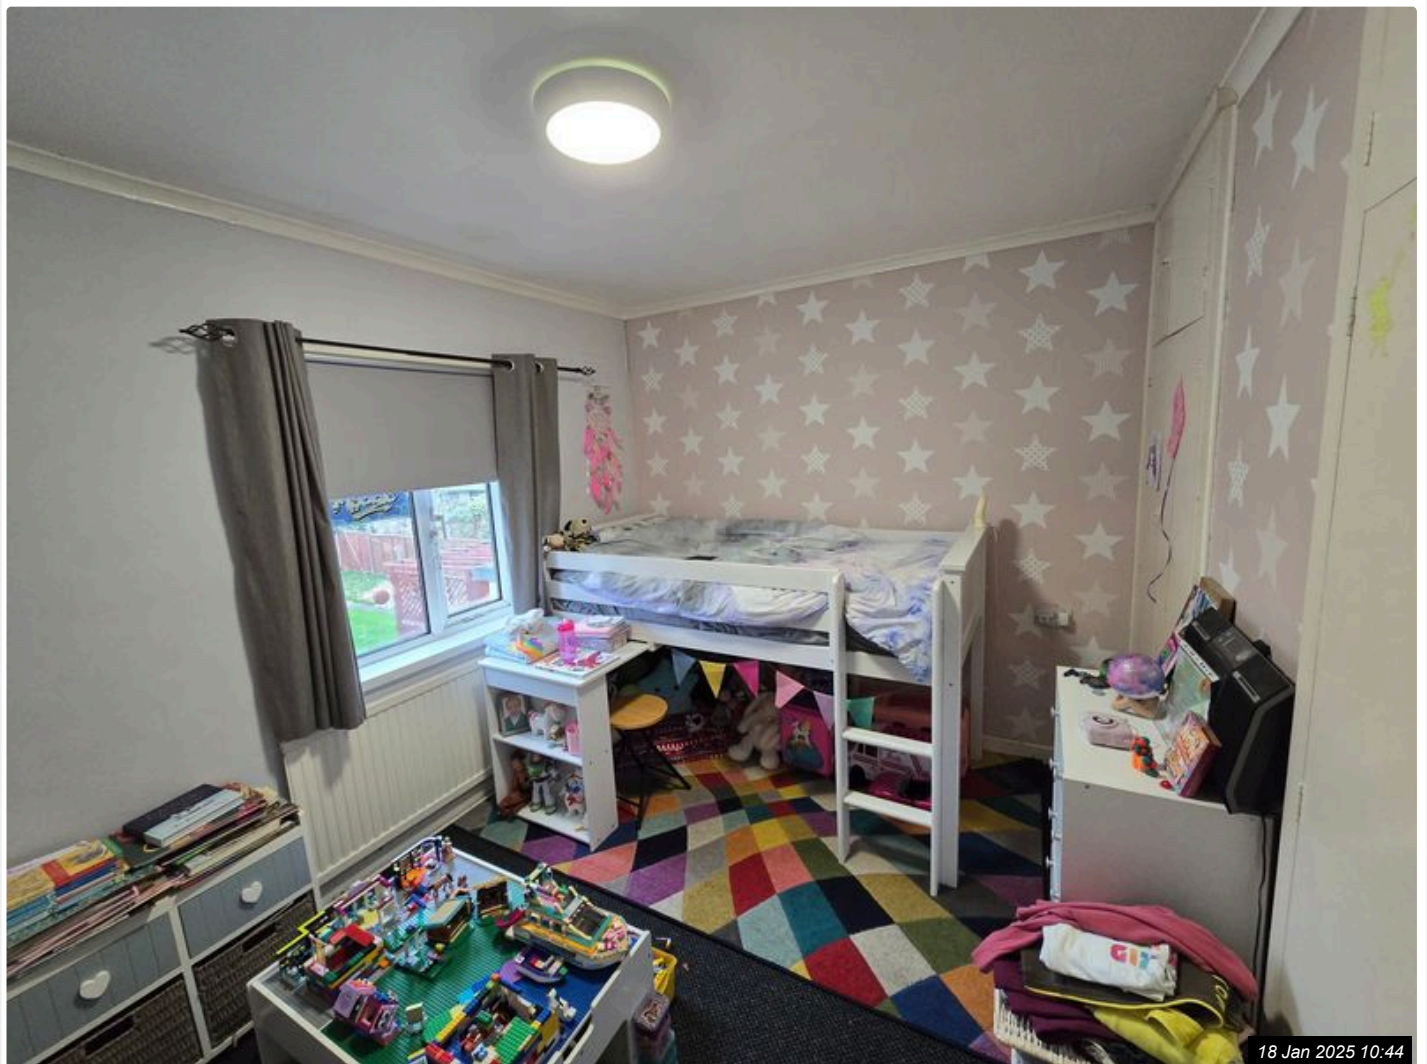
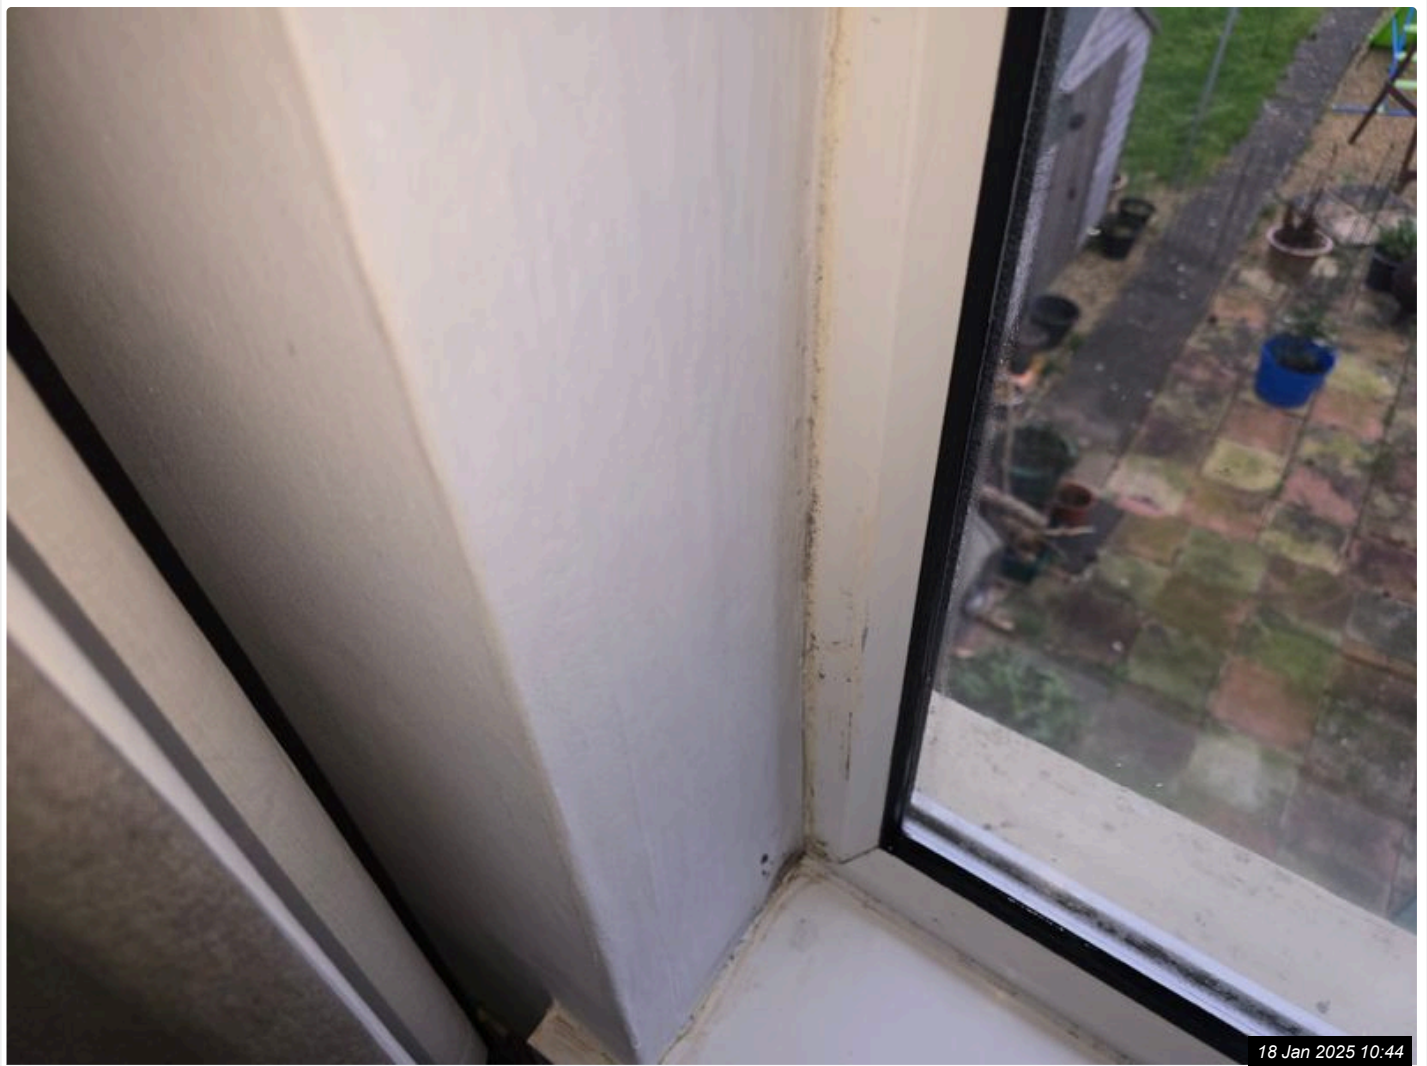
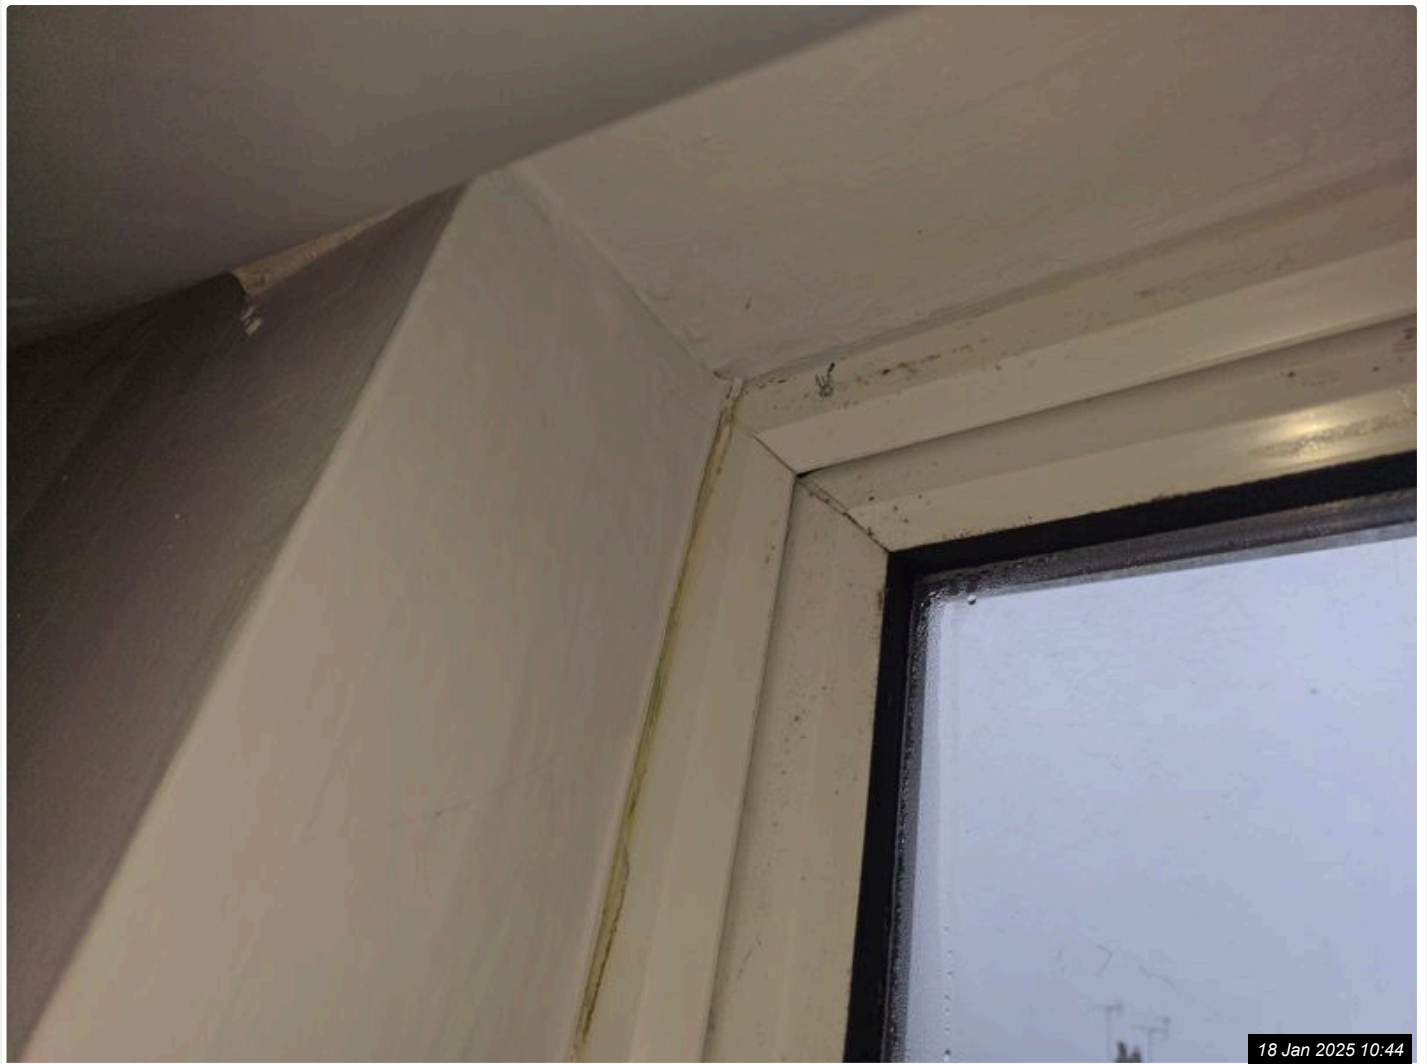
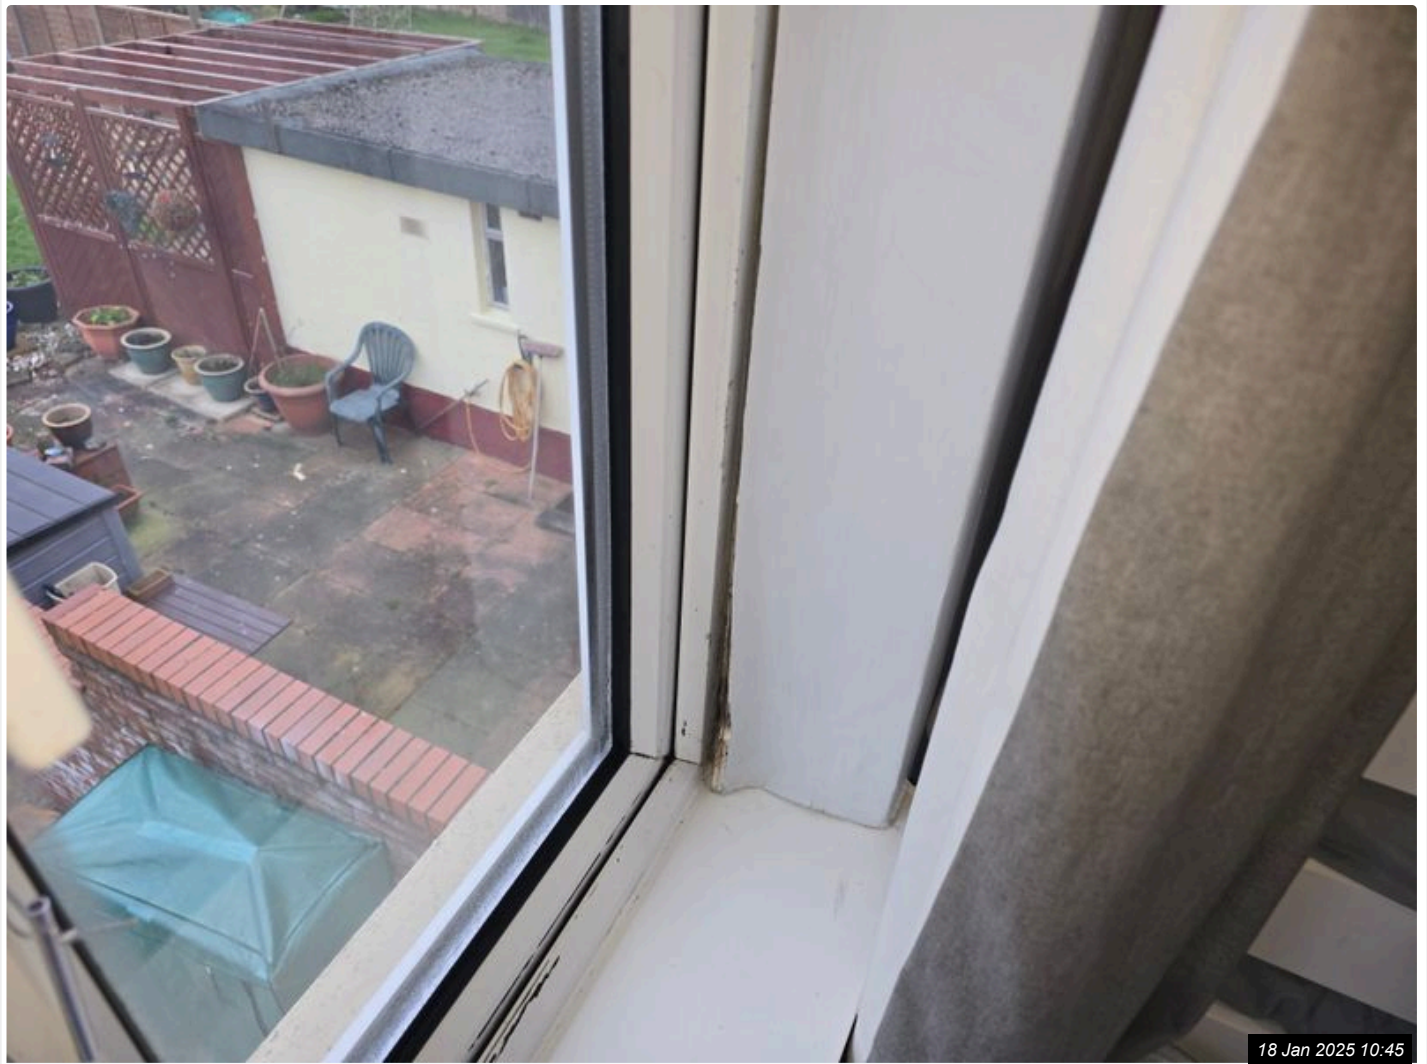
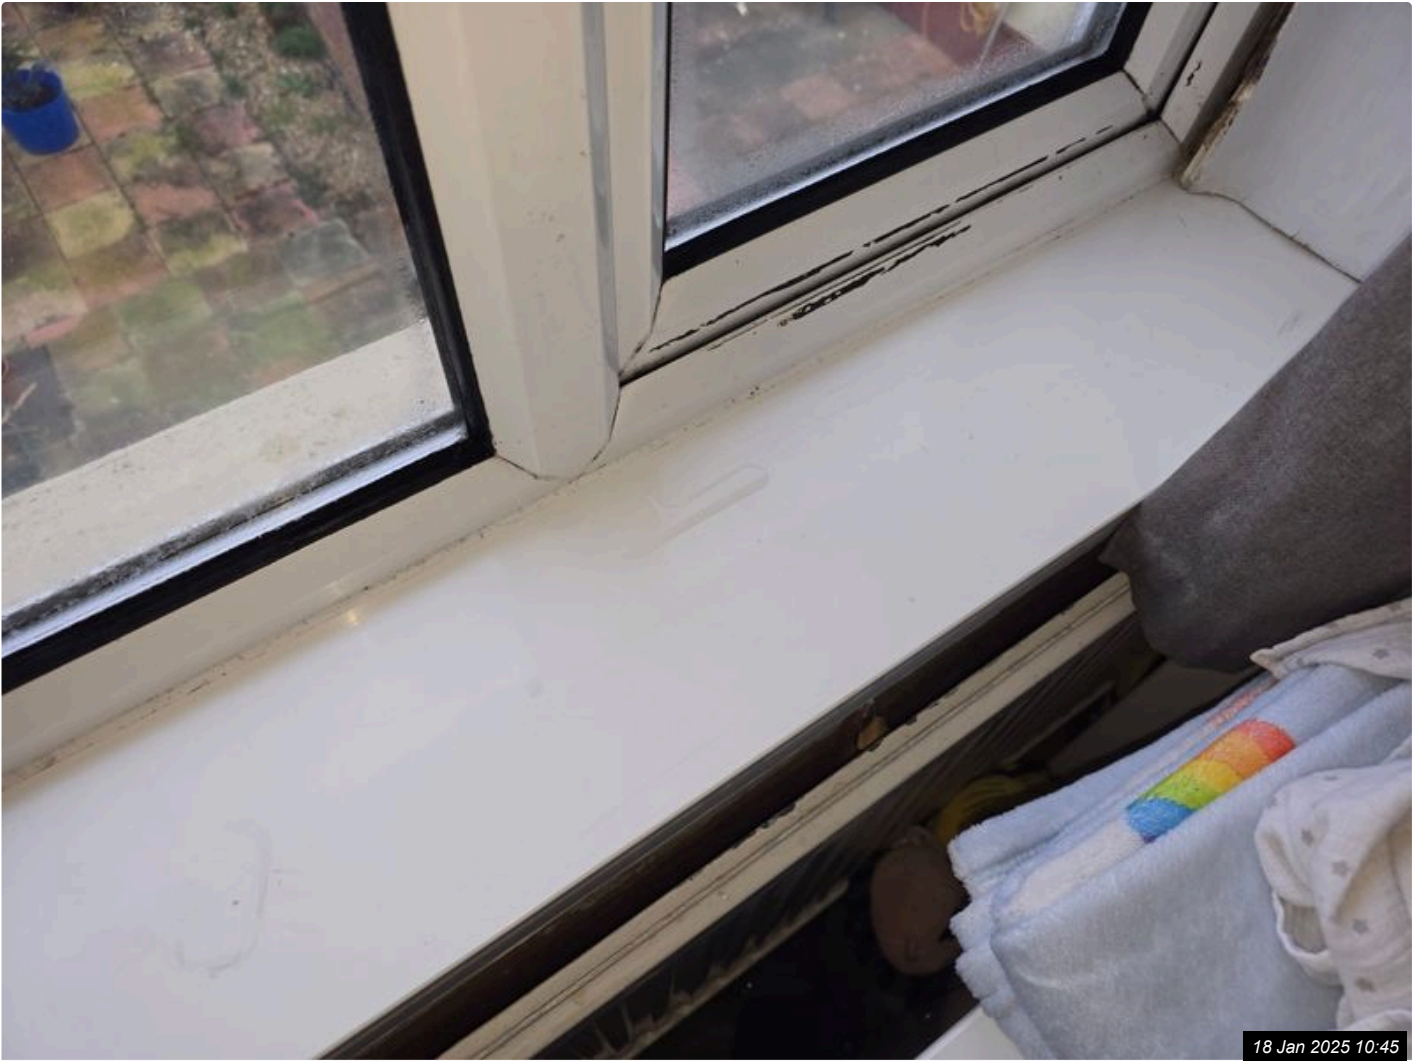
Ref # 3.10

3.10 📷	bedroom 1	Good	Water on sill from window condensation Information for landlord - Landlord
-----------	-----------	------	---

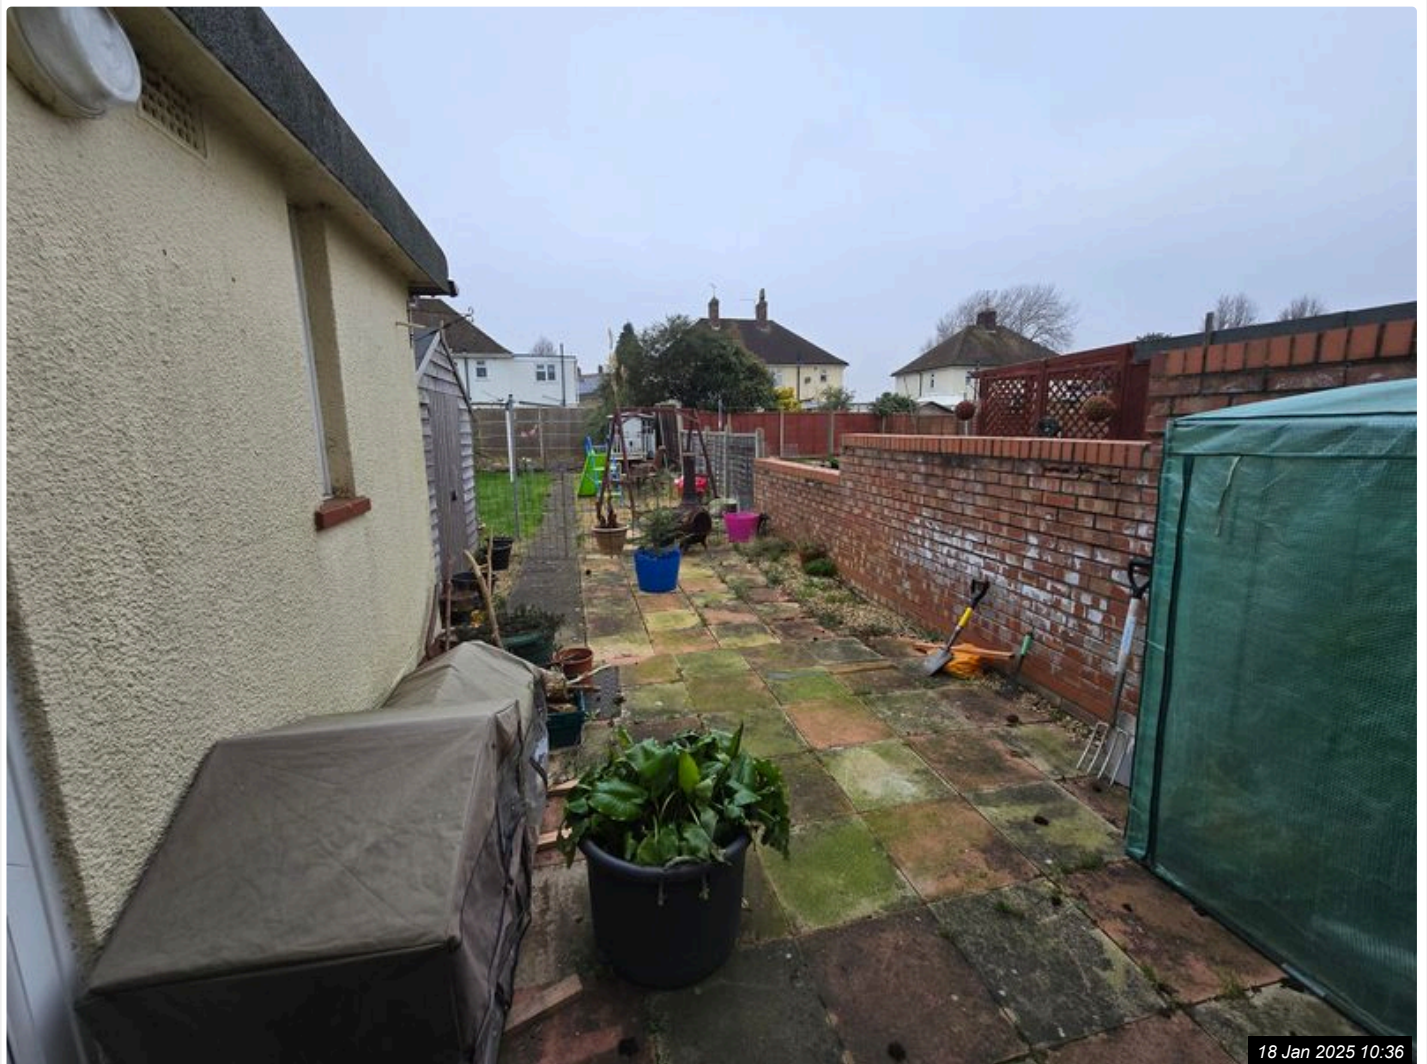
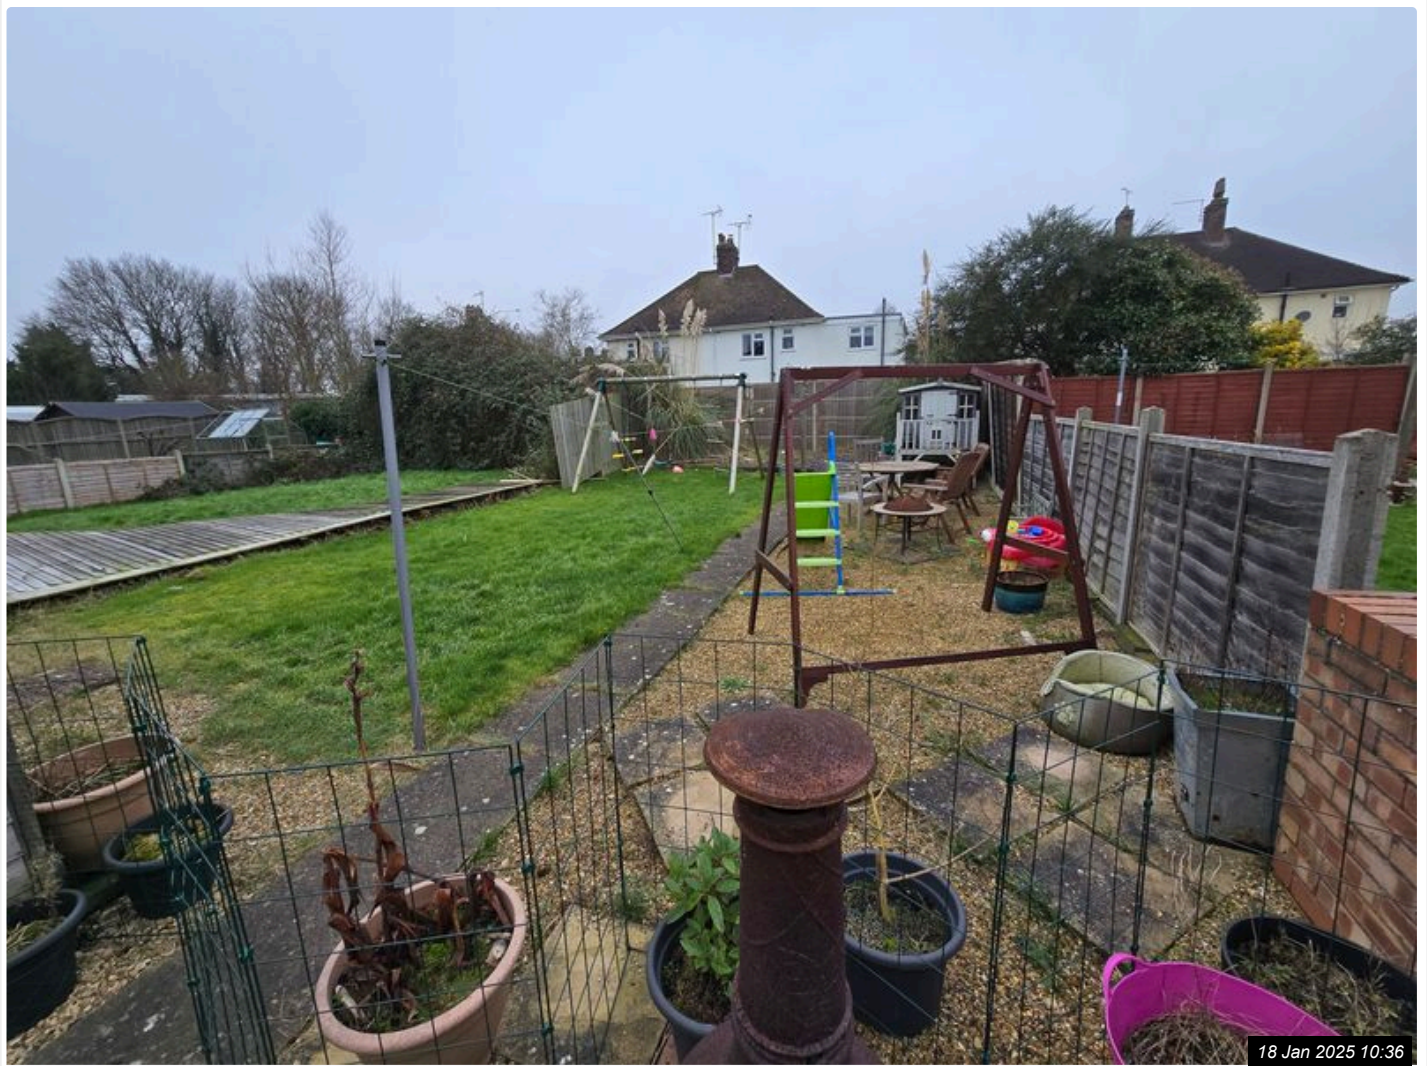
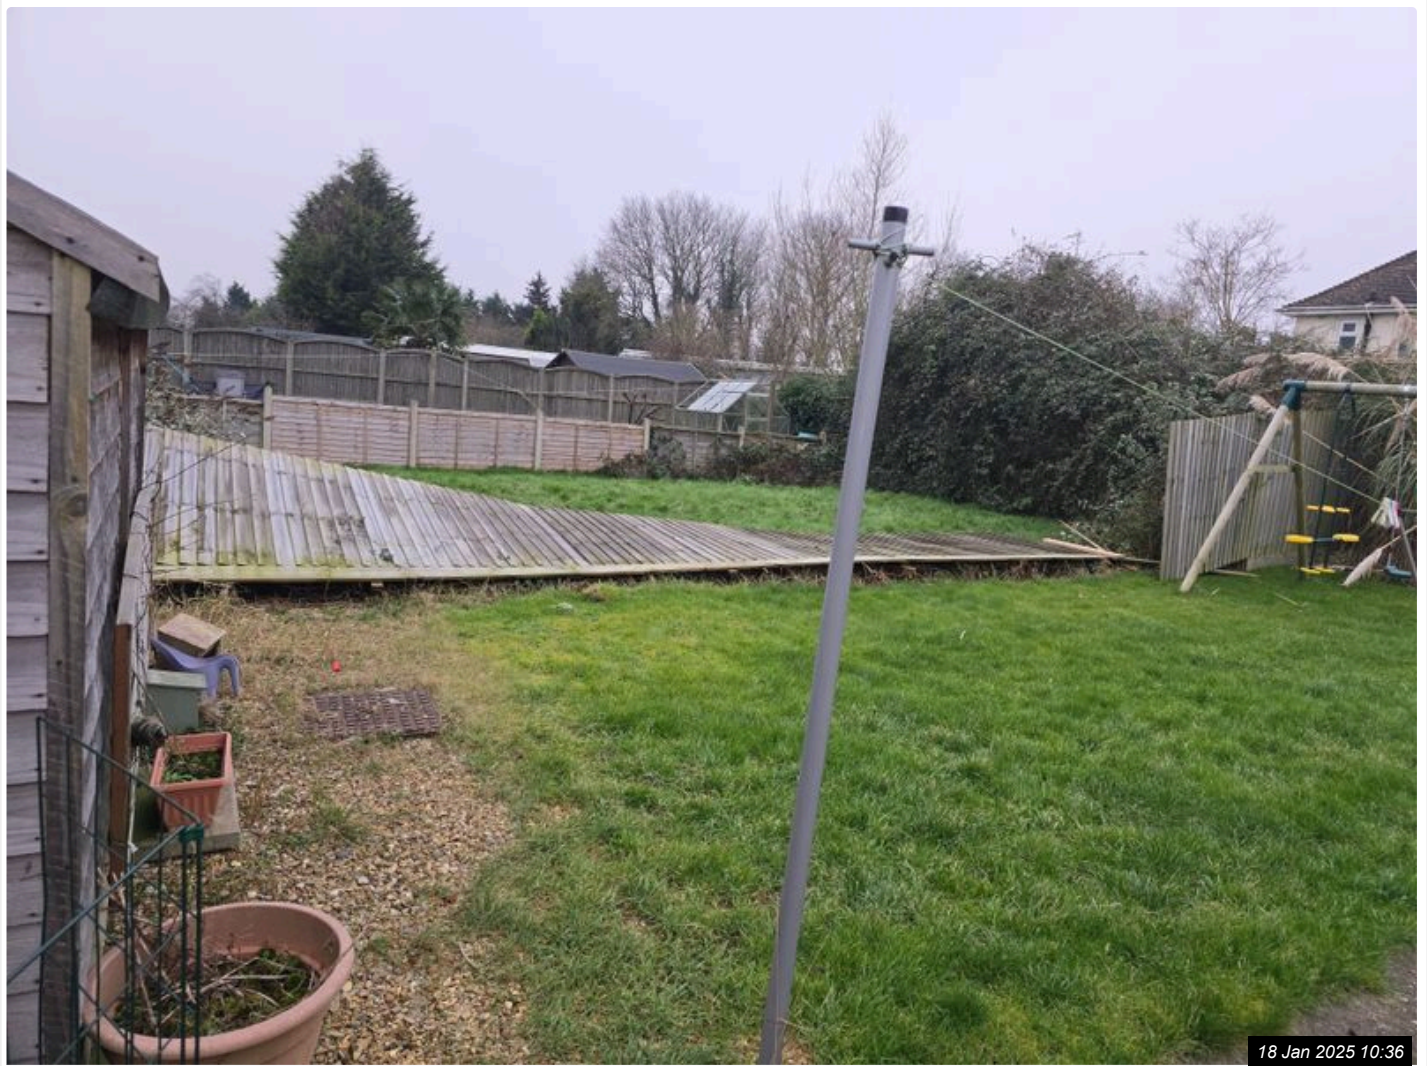
Ref # 3.14

rear garden		Fencing down to LHS of garden, landlord aware, fix in process

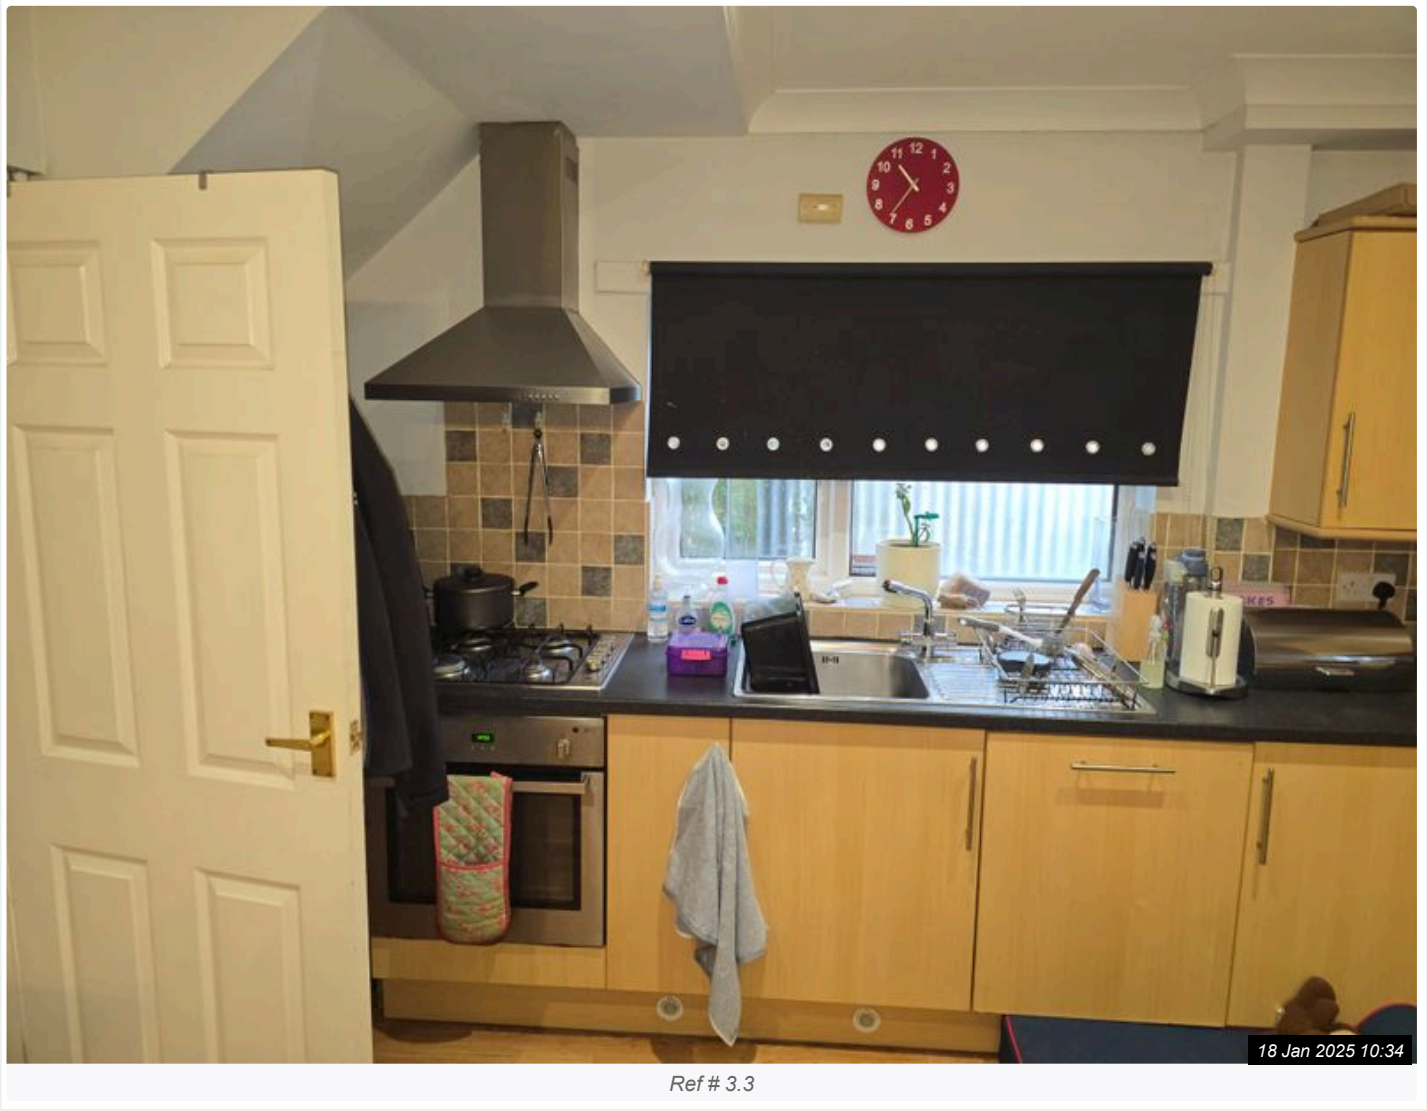
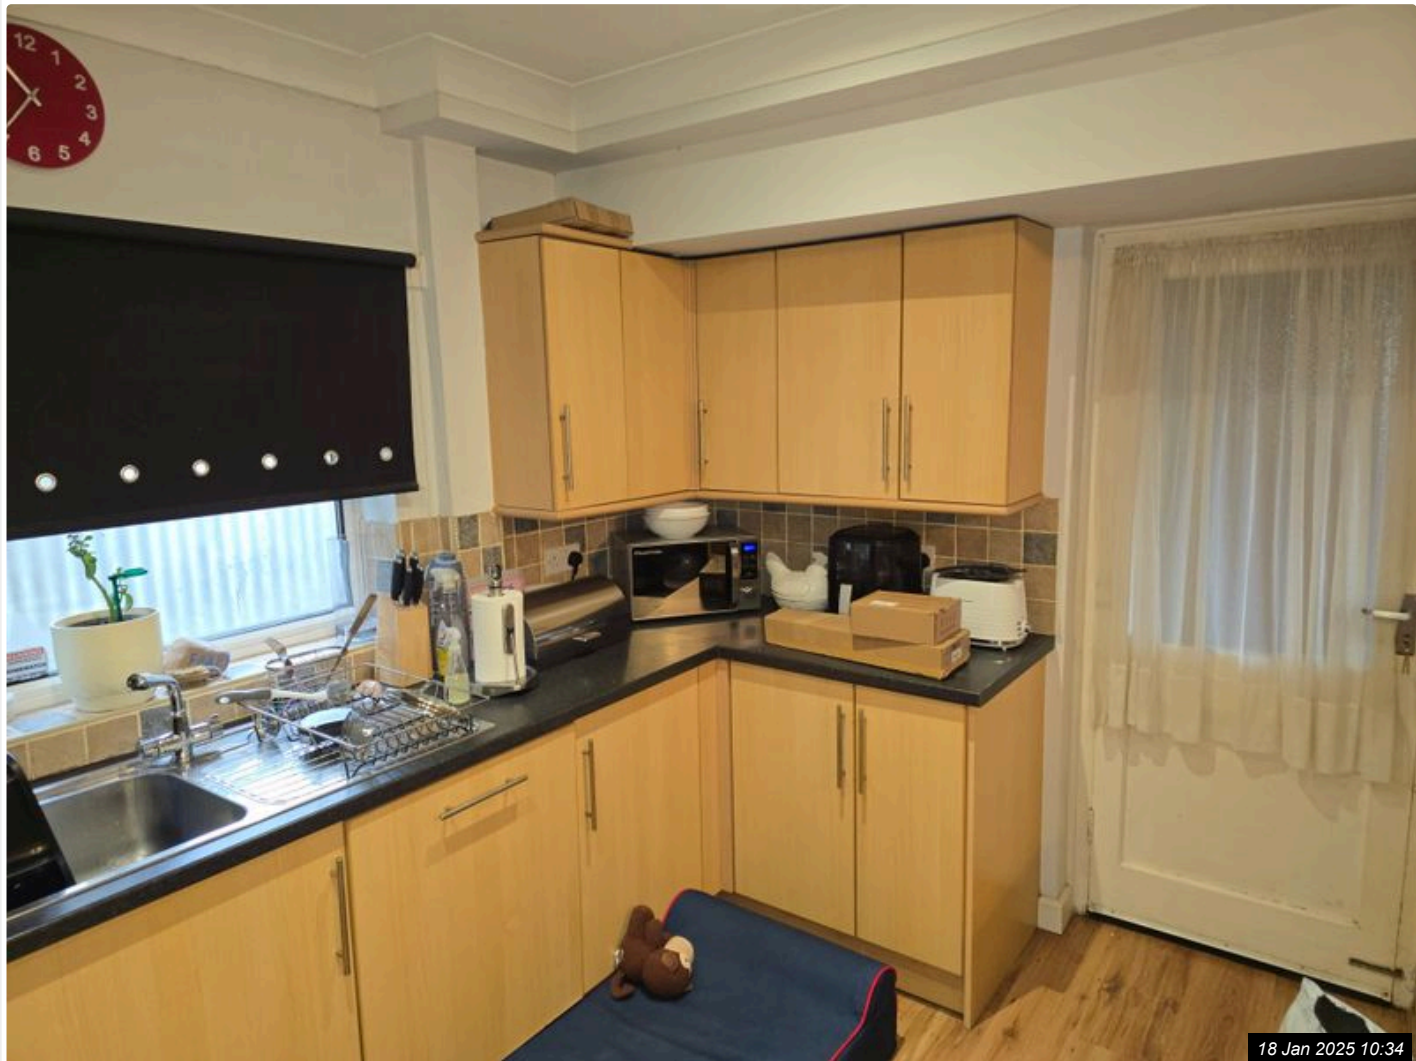
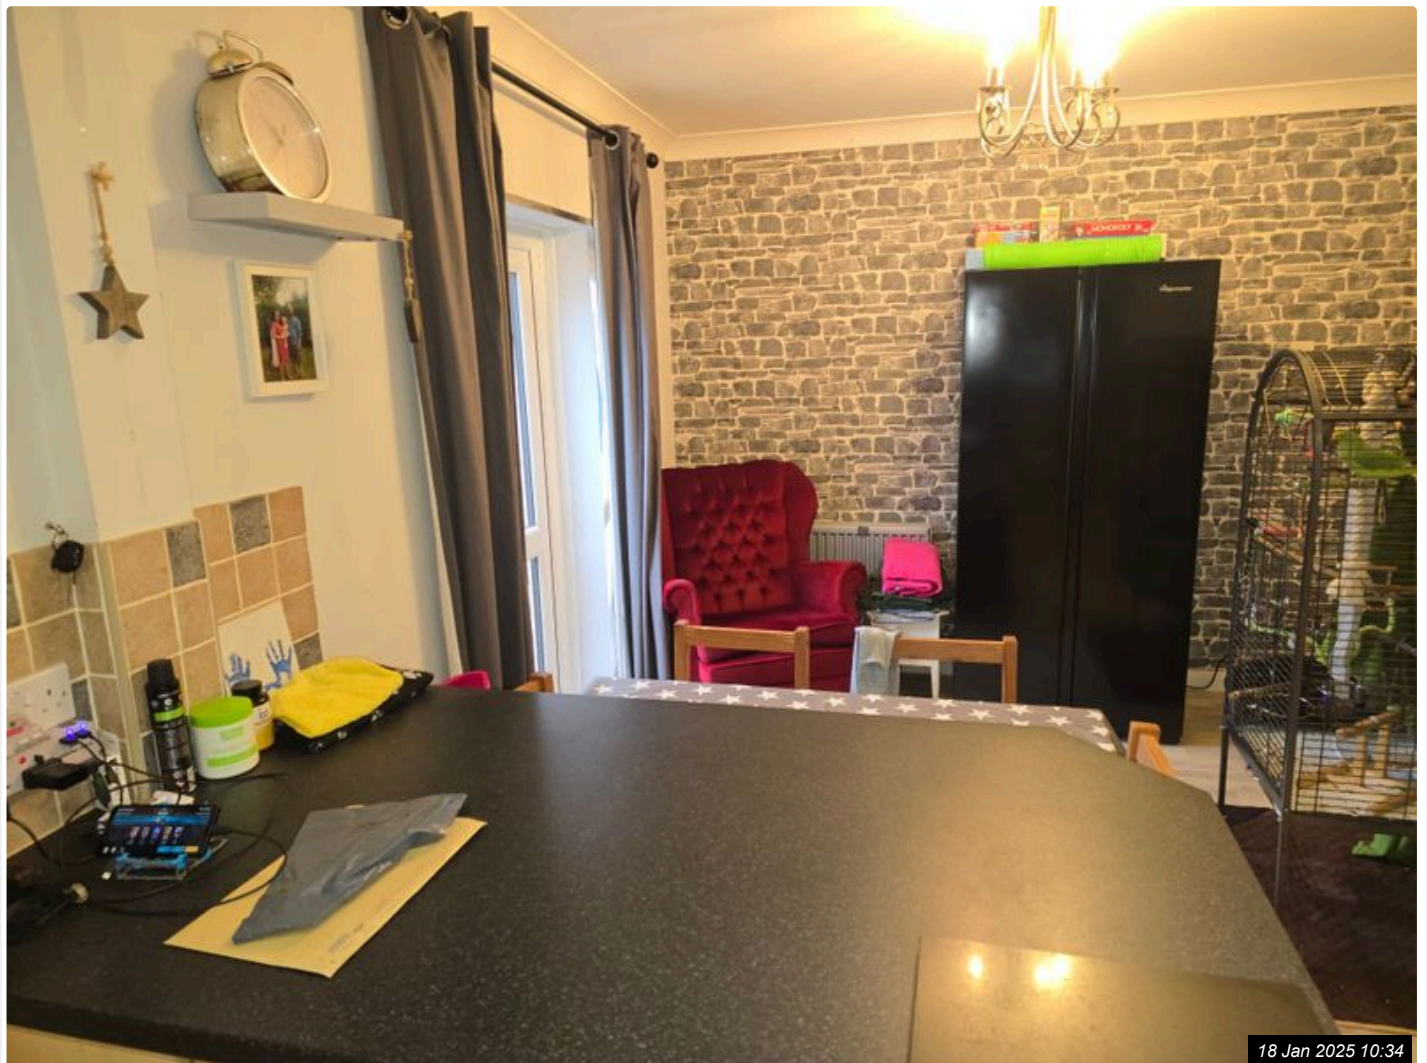
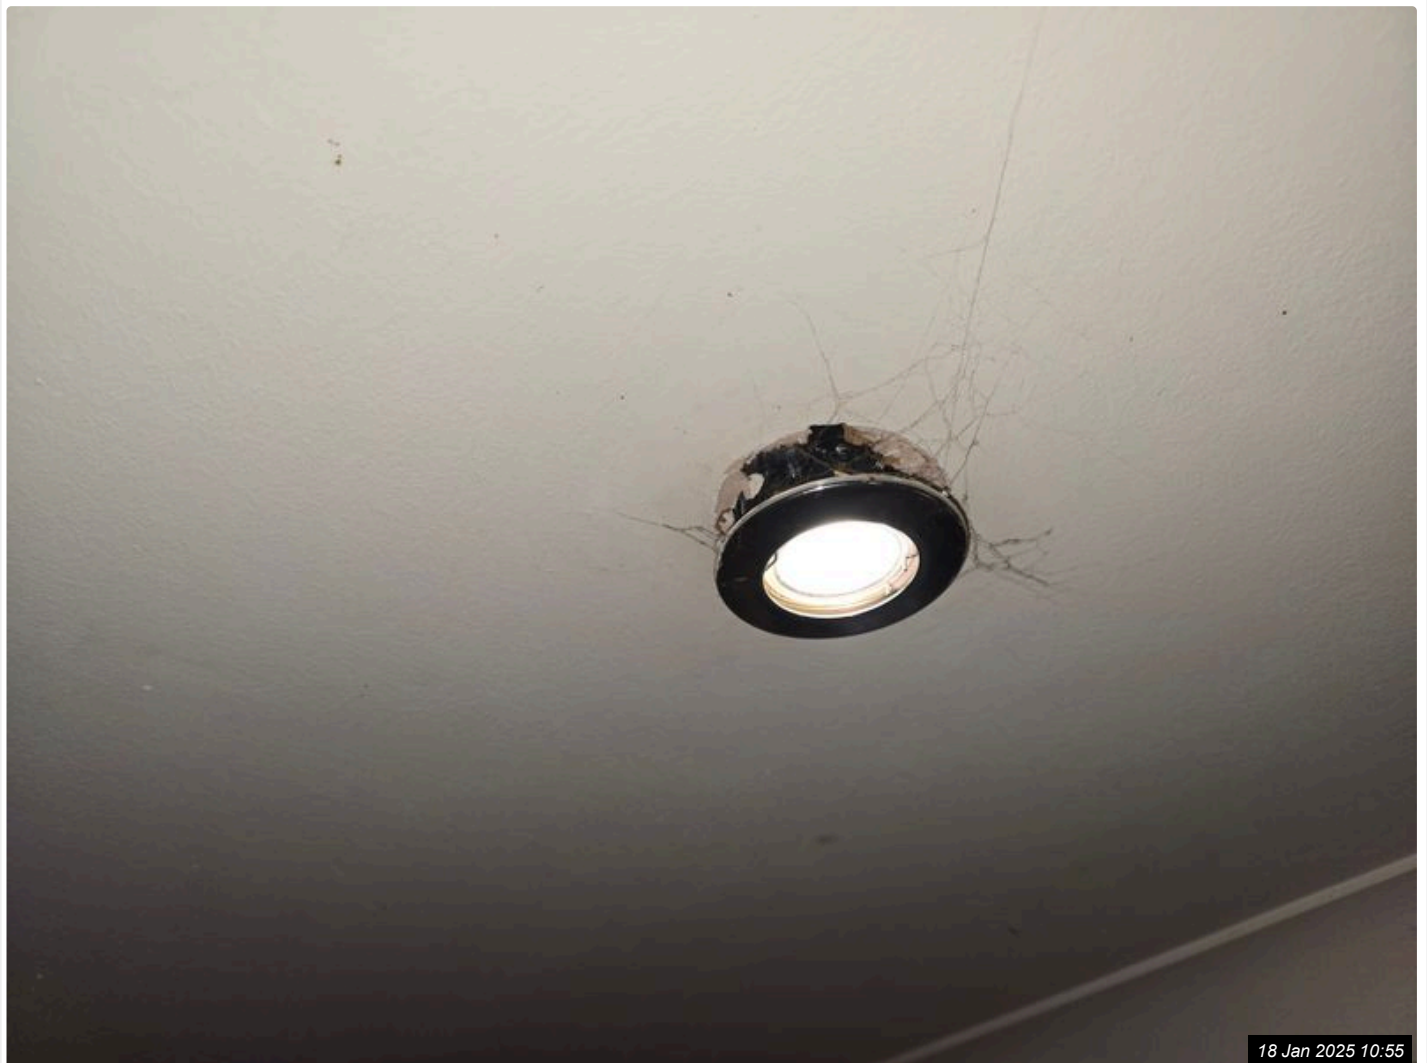
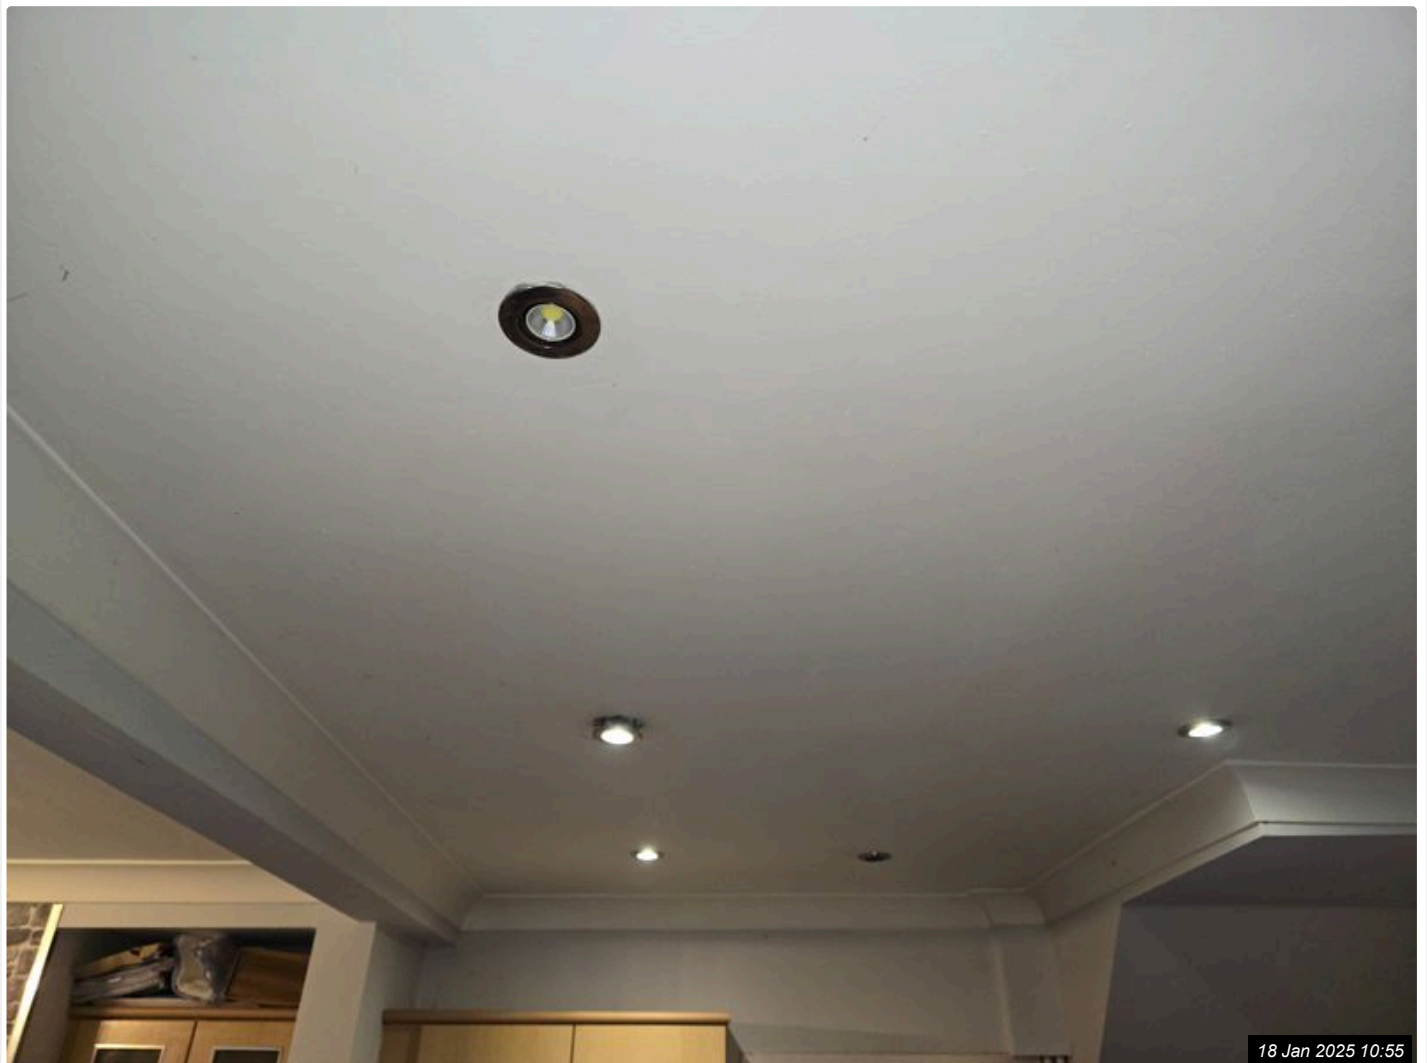
Ref # 3.3

Investigate Responsibilities		
Ref	Action Required	Comments
3.3 Overview photographs » Kitchen	Needs Maintenance	Spotlight fitting is loose One is not working, tenant Unable to reach
