Property Visit

Prepared on behalf of Example Lettings Ltd

123 Preview Street
Sample City
London
AB1 2CD

January
18th 2025
10:30

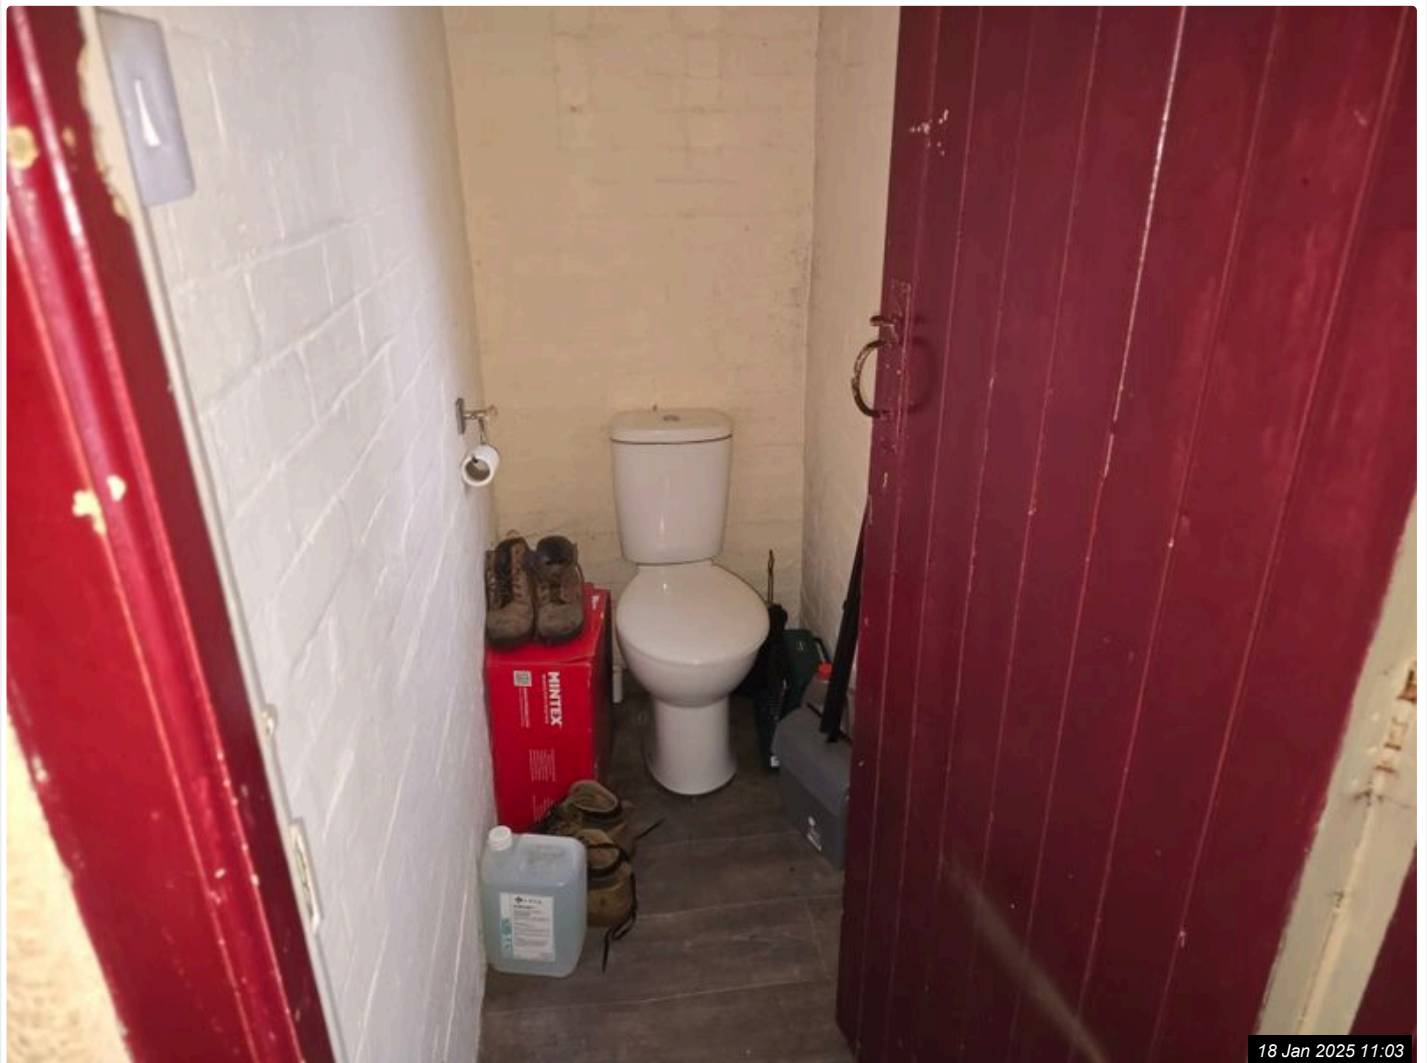
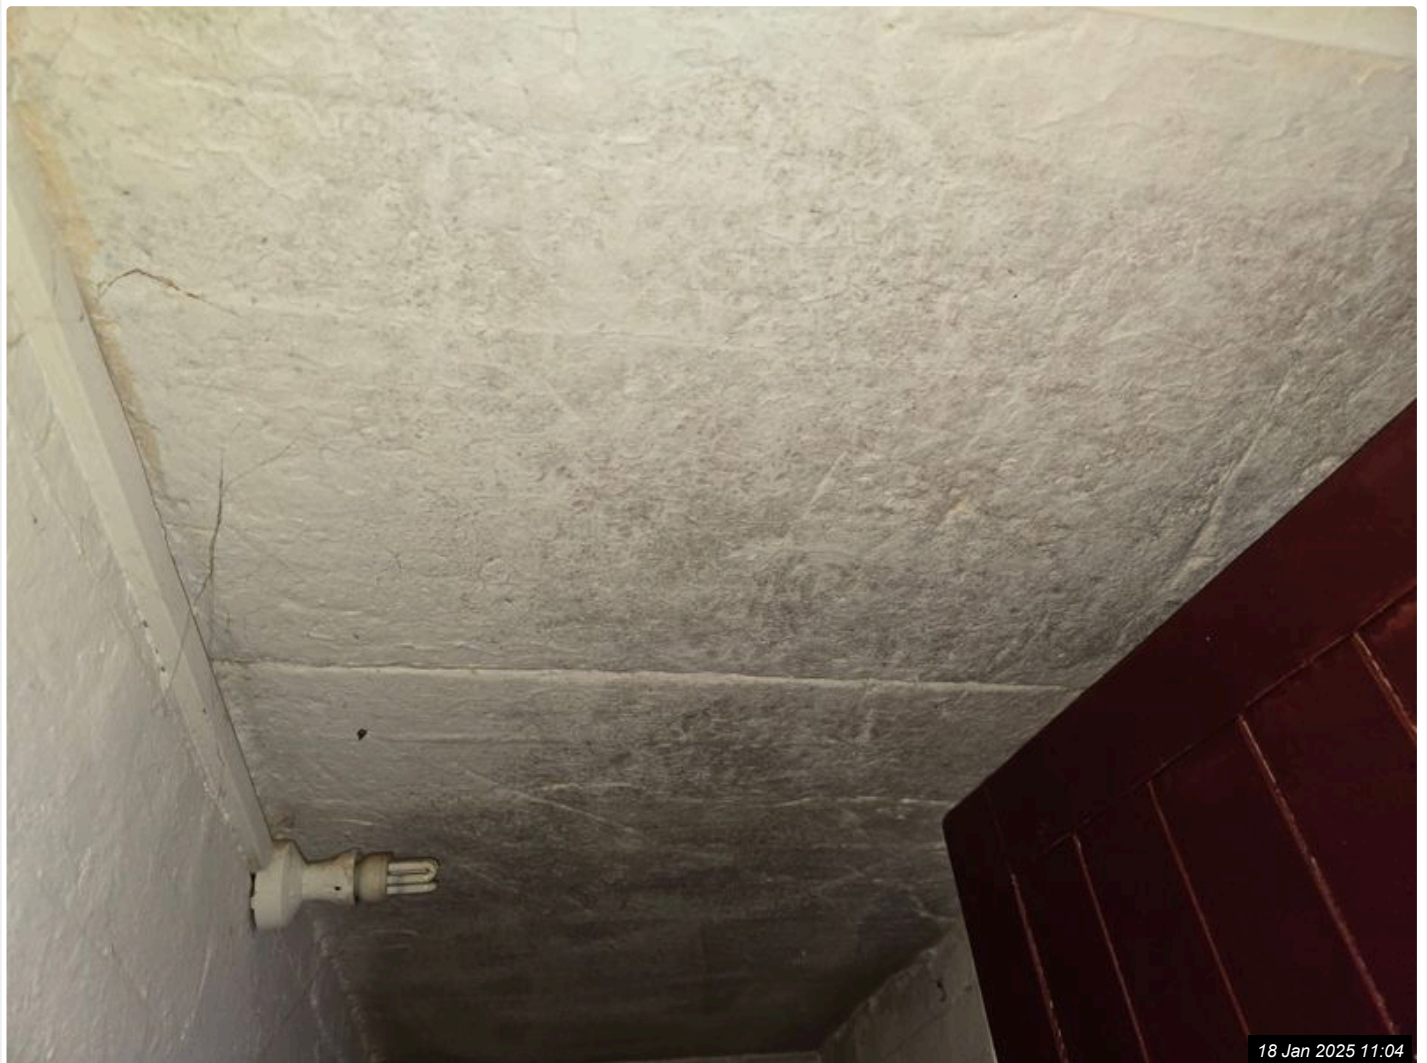
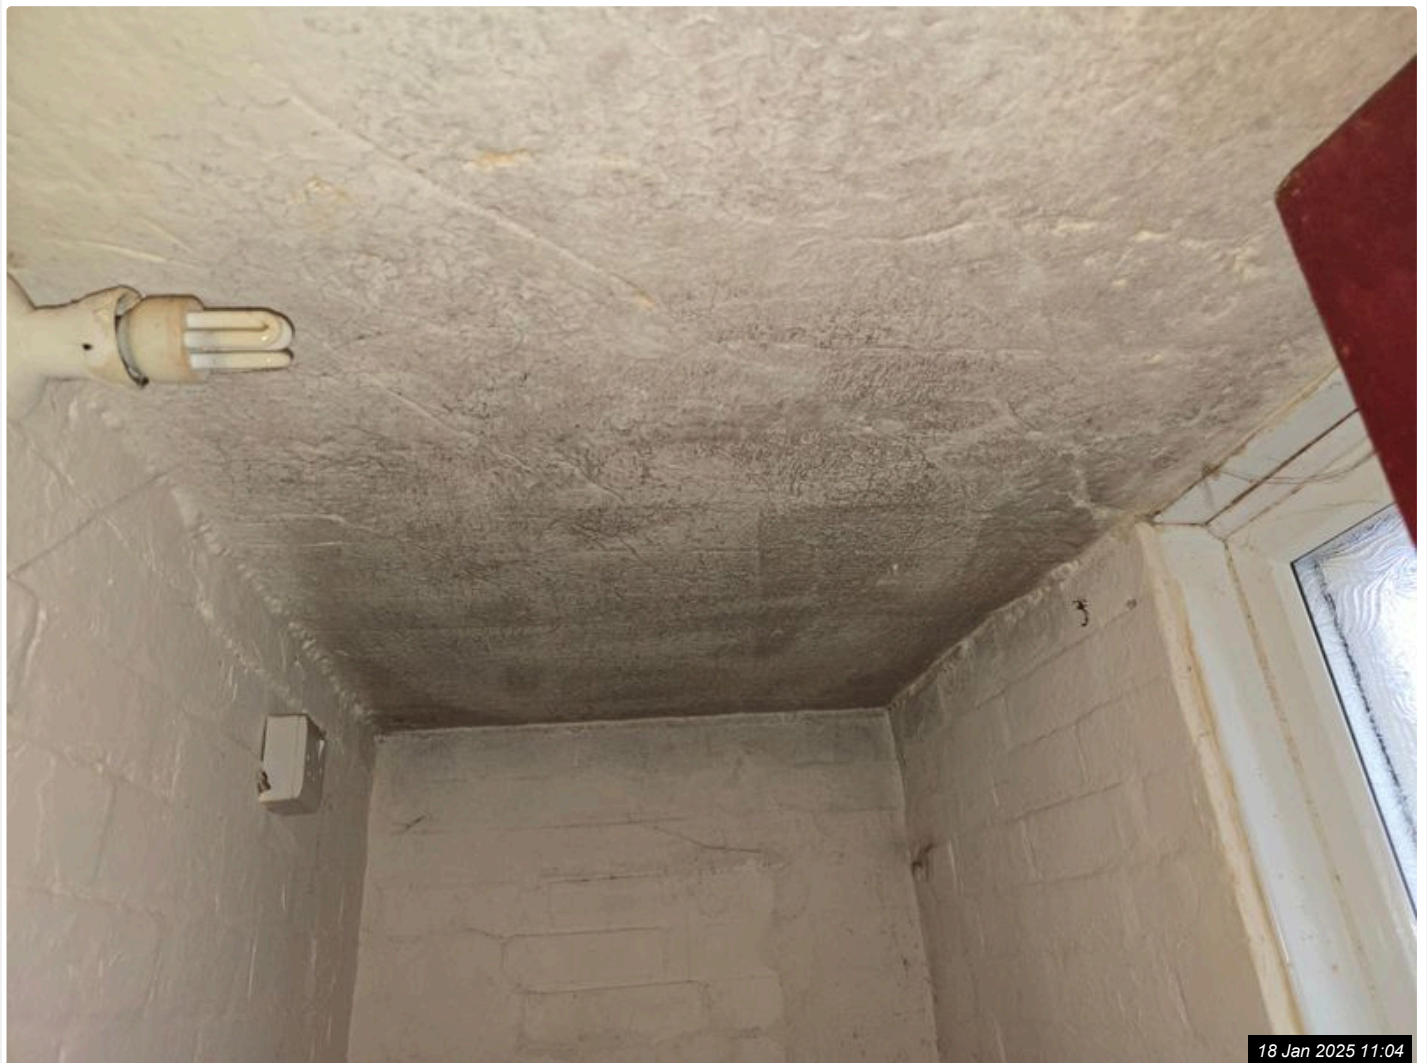
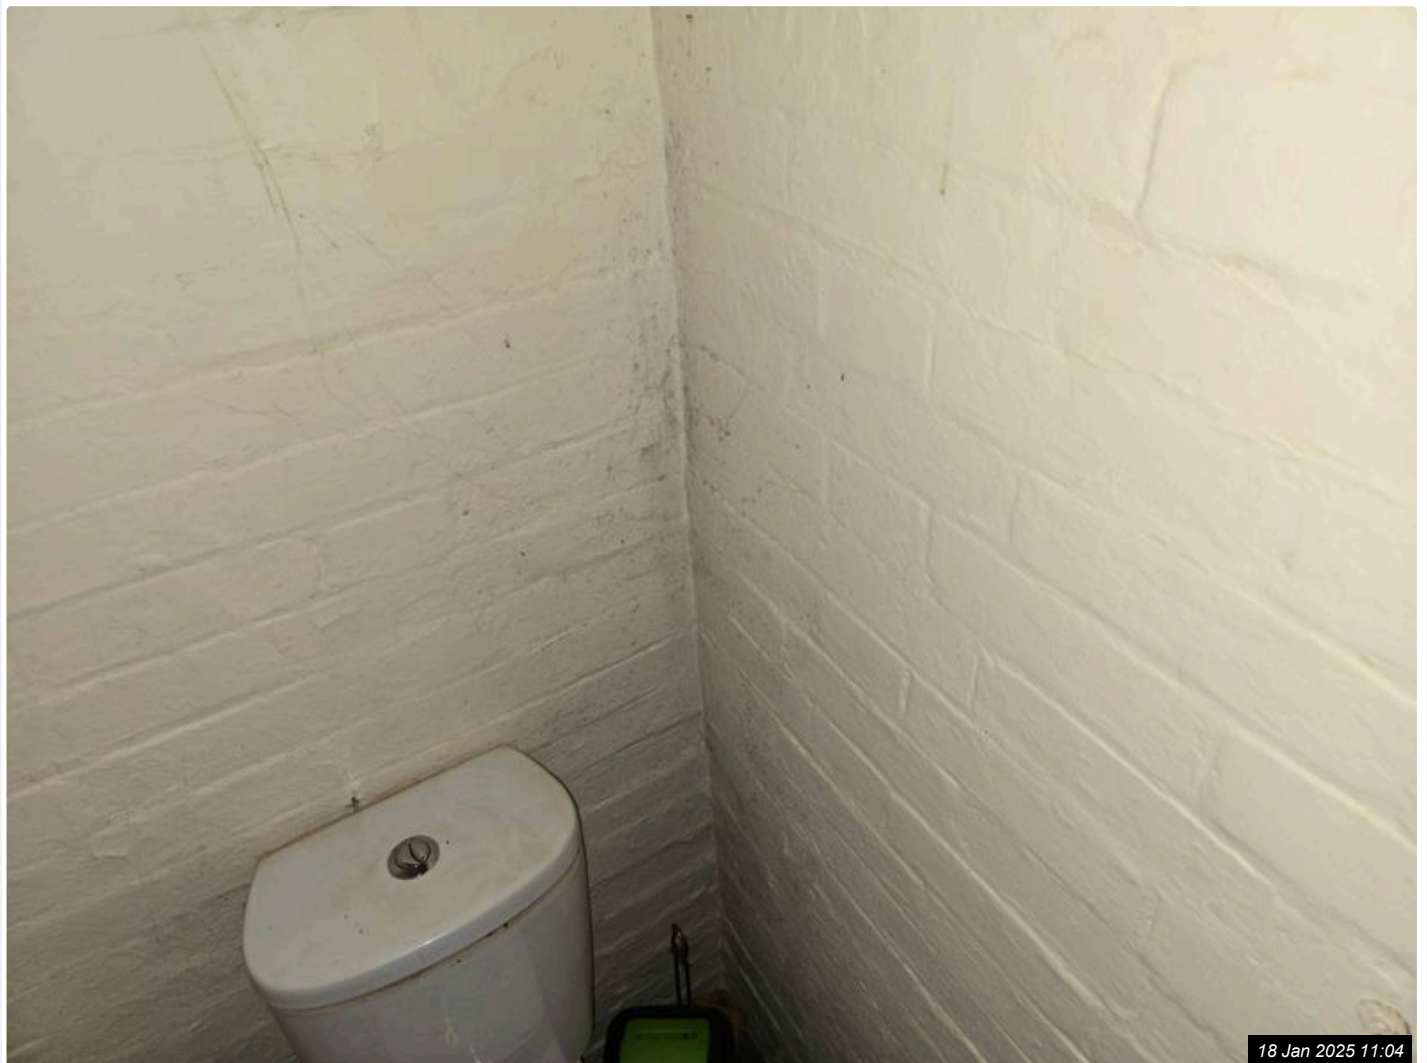
Ref # 3.6

Landlord Responsibilities		
Ref	Action Required	Comments
3.6 Overview photographs » Toilet	Needs Maintenance	Heavy mould growth, not used by tenant

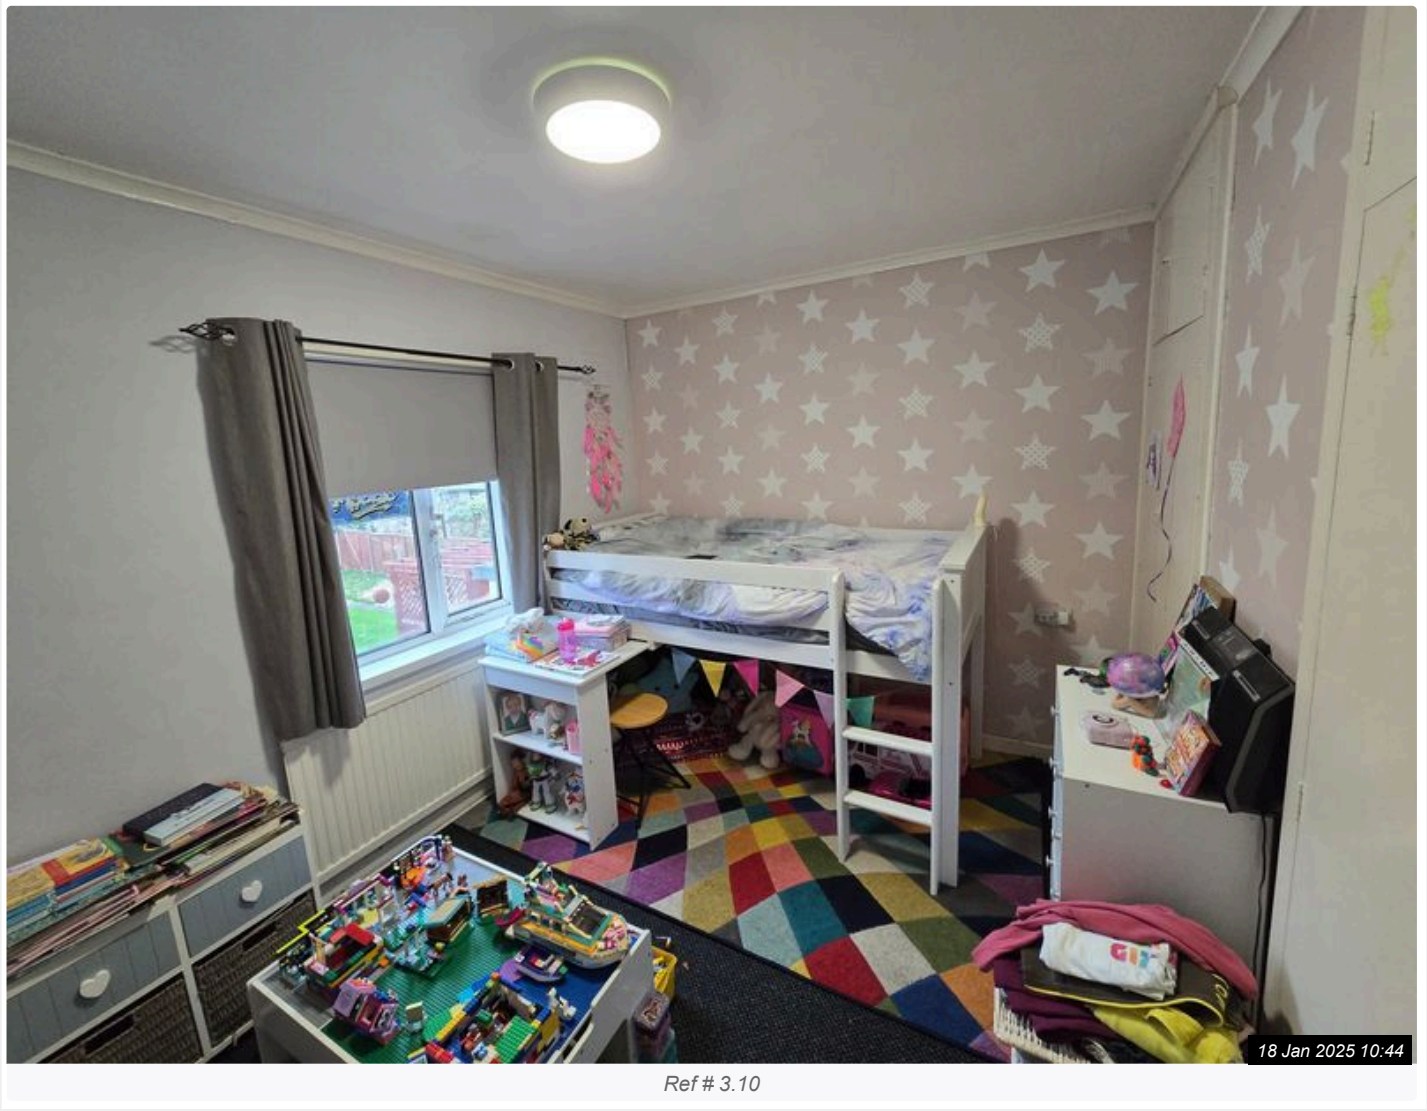
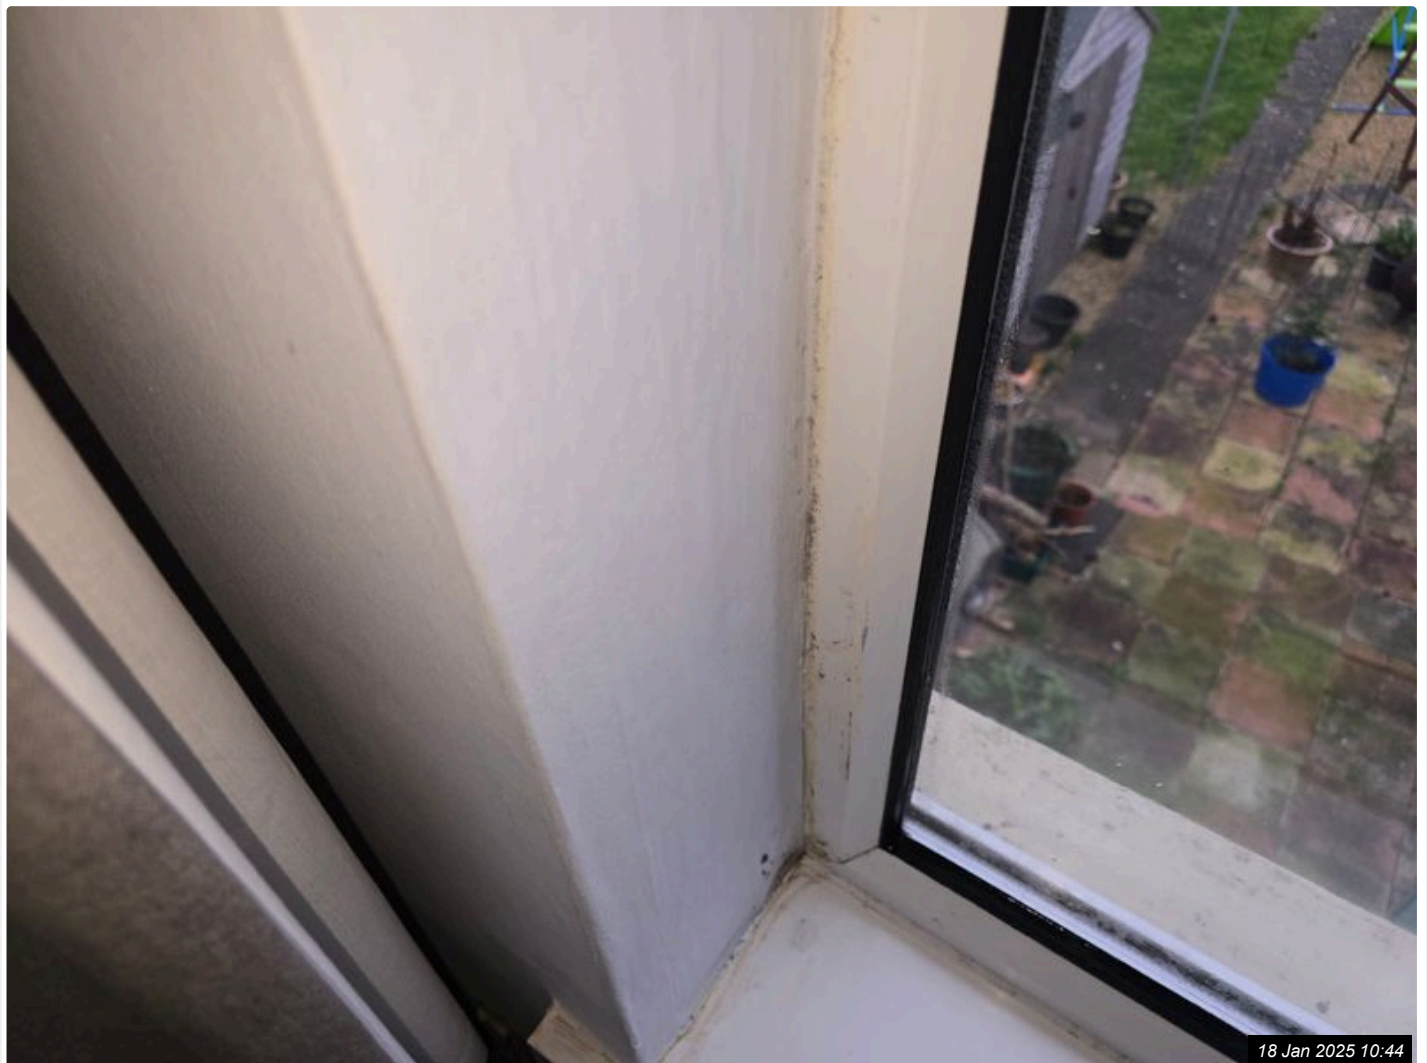
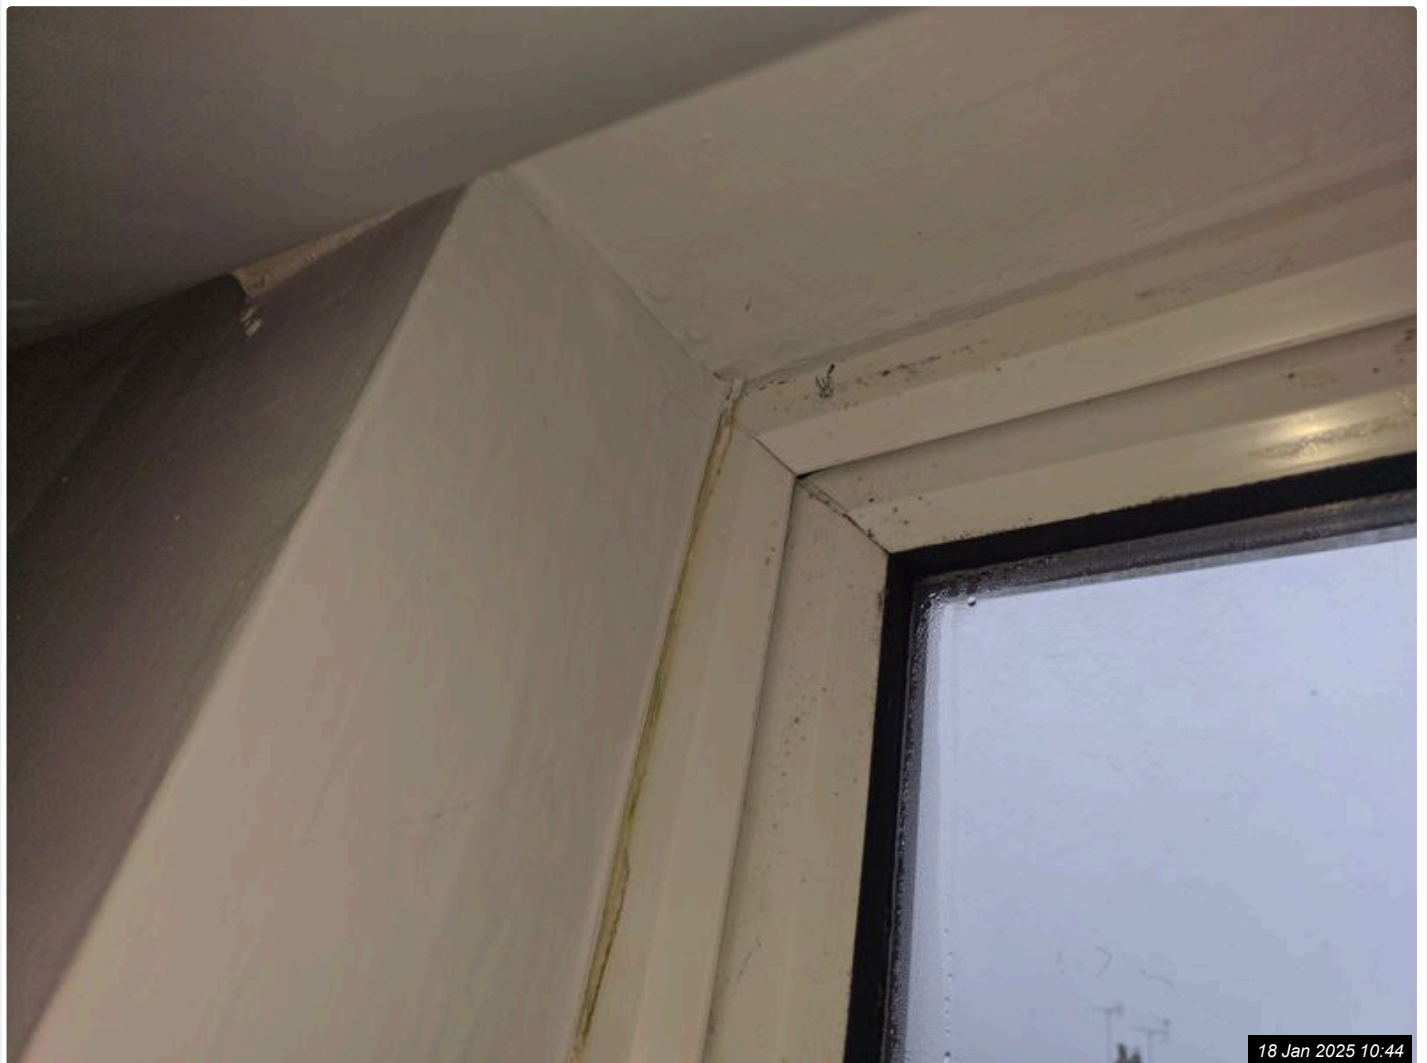
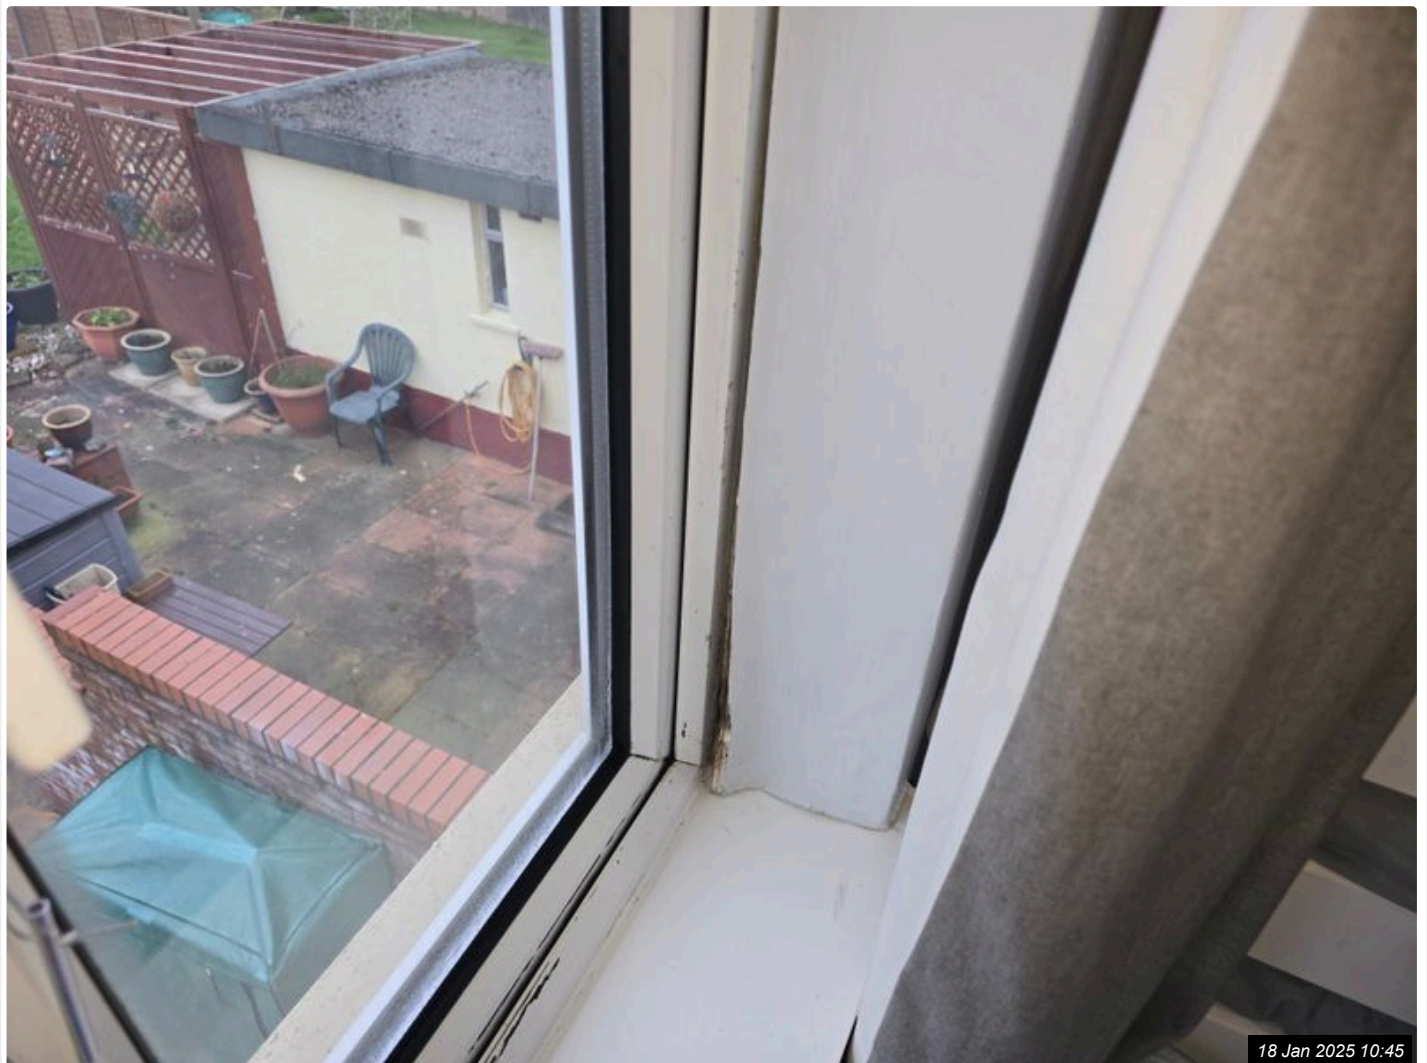
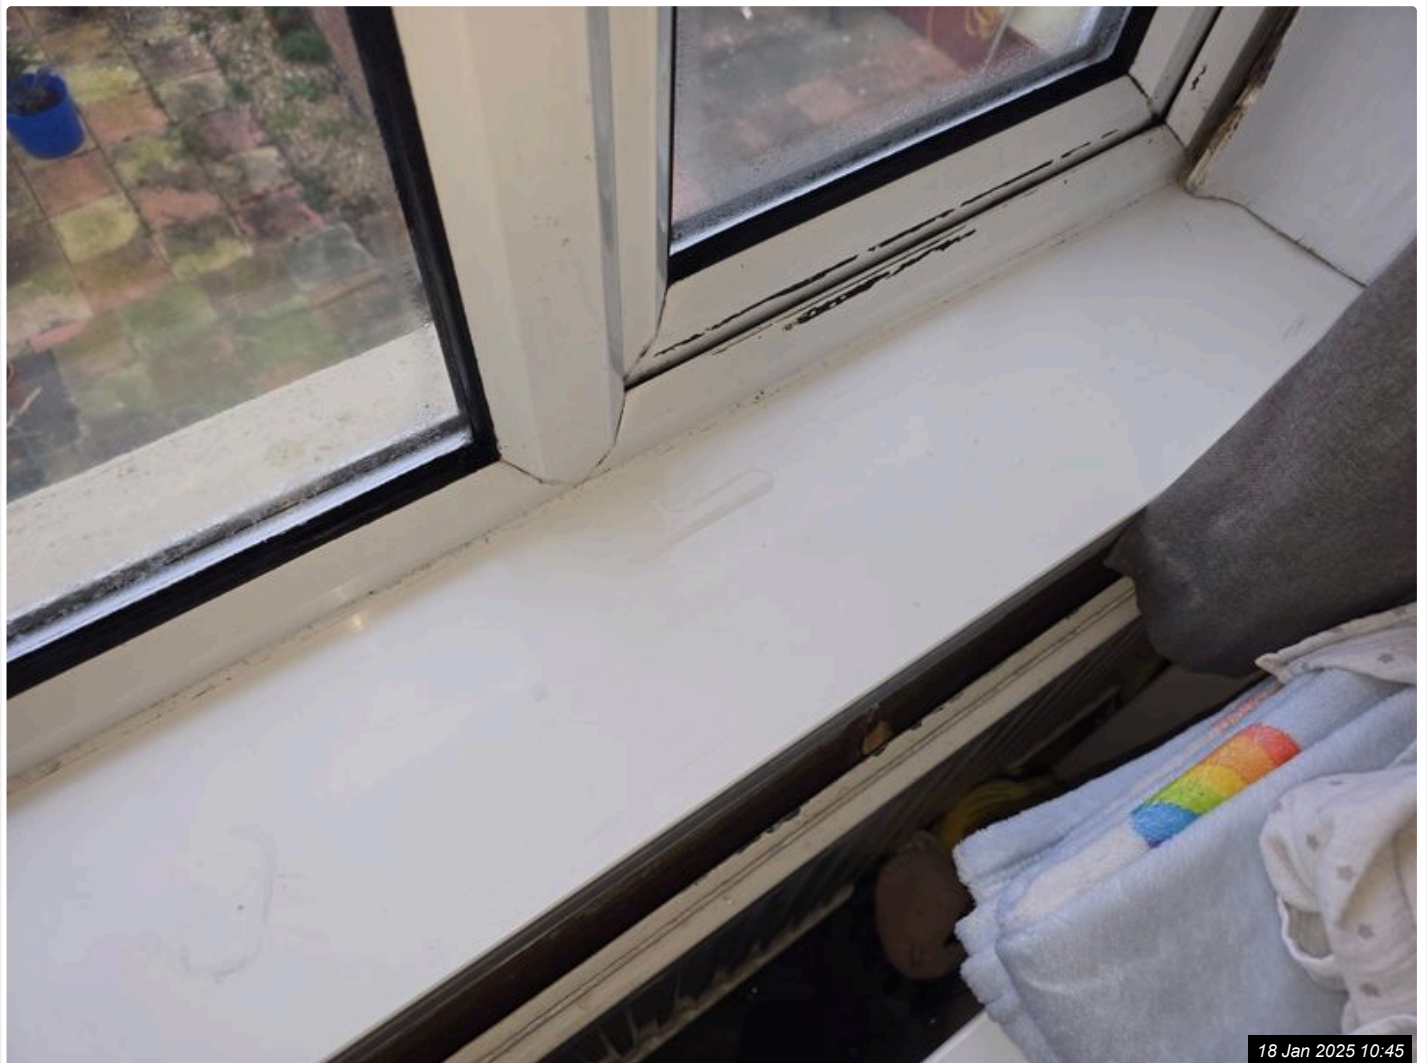
Ref # 3.10

3.10 Overview photographs » Bedroom 1	Information for landlord	Water on sill from window condensation
--	-----------------------------	--
