# Inventory & Schedule of Condition

Prepared on behalf of Example Lettings Ltd

123 Preview Street  
Sample City  
London  
AB1 2CD

**September**  
**13th 2024**

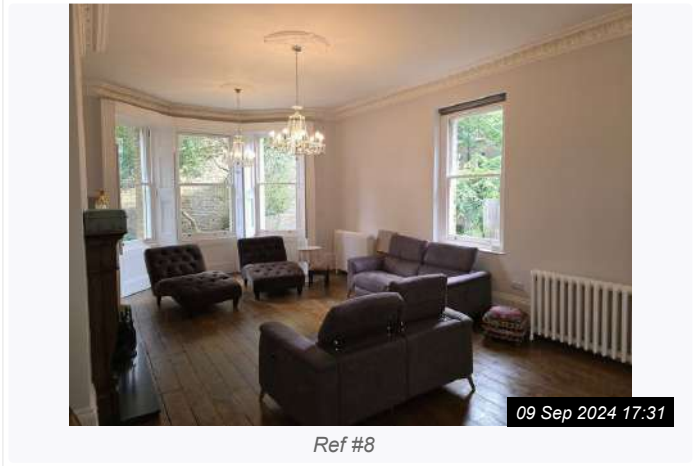
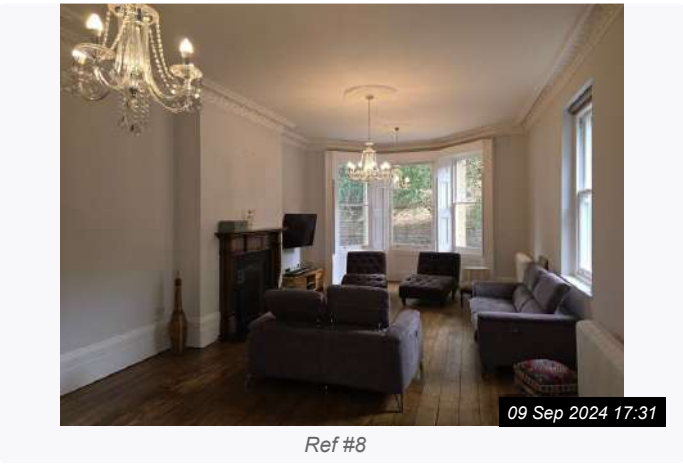
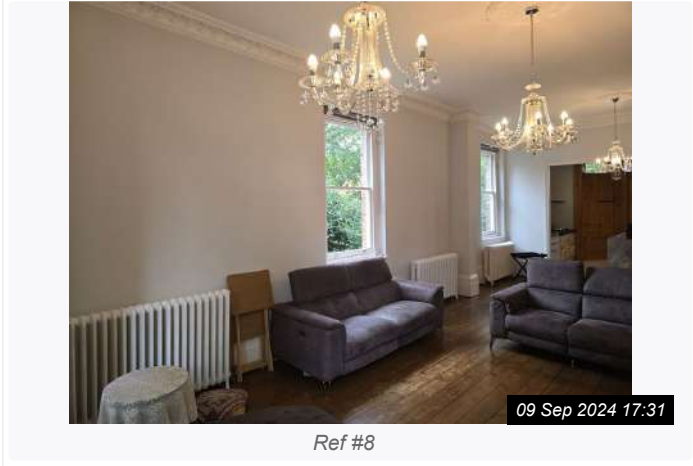
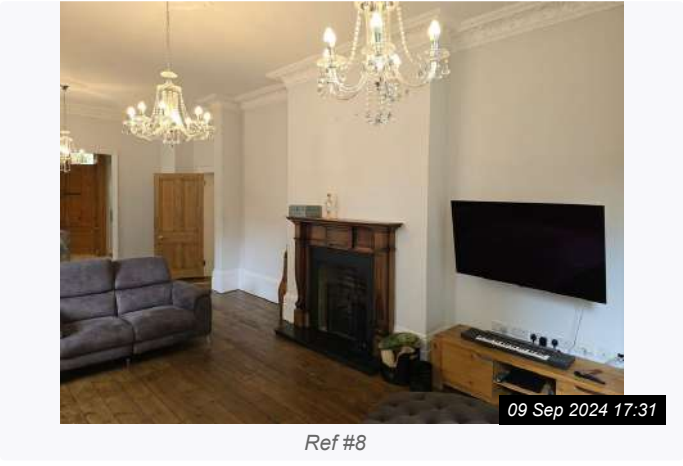
| Ref | Name | Description | Condition |
|---|---|---|---|
| 8.1<br>📷 | Door/ Frame/<br>Threshold | <p>Door: Brown wooden four panel door with Gray metal furniture including: two handles and two mortice lock covers</p> <p>Reverse: to match; brass double hook to top</p> <p>Frame: White painted wooden frame</p> <p>Threshold: grey metal transverse strip</p> | <p>Door: Signs of age and use; repaired Square to left hand side; pinholes to mid-level Centre; discoloration to mid-level left-hand side; door handle and lock cover in good condition; all in working order</p> <p>Reverse: filled holes to top; and surface damage to upper hand side; small area of damage to Middle; line scratch to left hand side middle; minor marking and discoloration throughout</p> <p>Frame: exterior is in generally good clean condition with chip to lower right hand side and minor chipping to lower left hand side; painted over defects</p> <p>Interior: chip to Upper right-hand side; chip near bottom of strike plate fitting area; strike plate not present</p> |

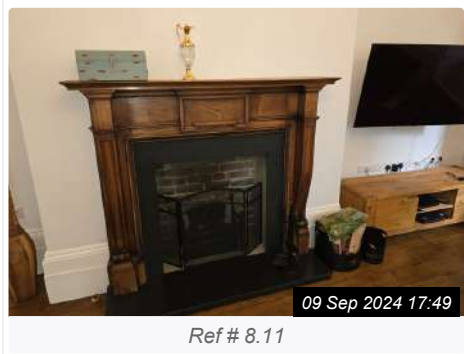
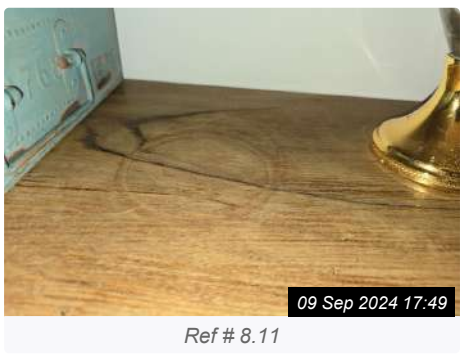
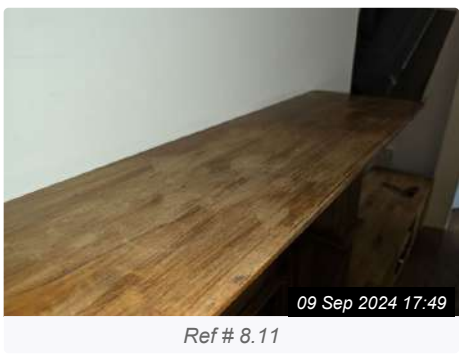
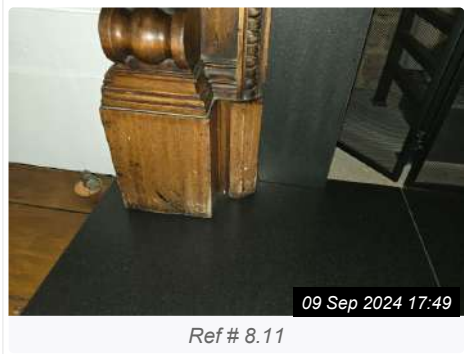
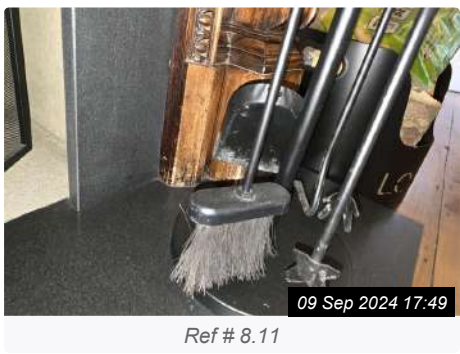
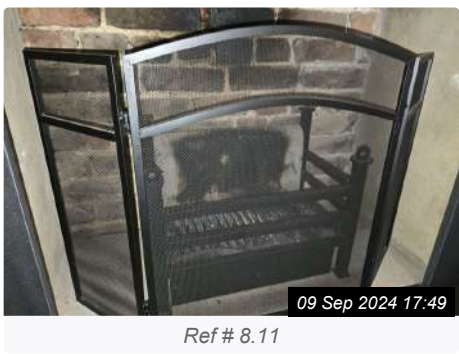
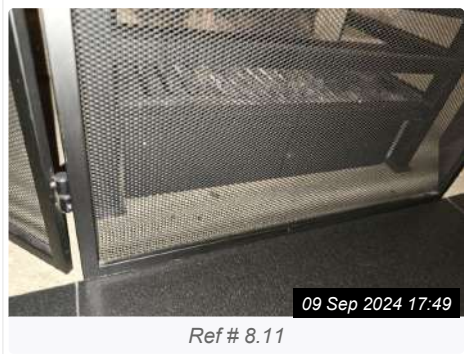
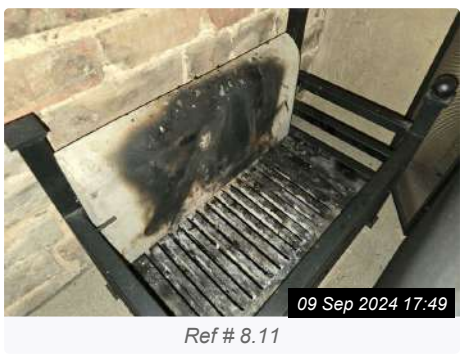
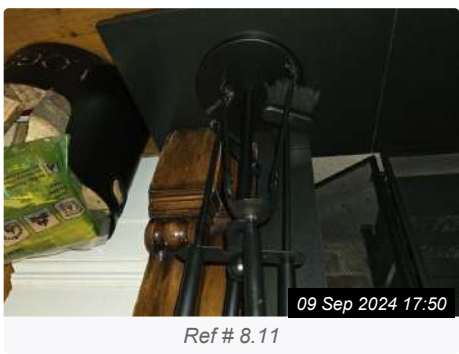
| Ref | Name | Description | Condition |
|---|---|---|---|
| | | <div>09 Sep 2024 17:50</div> <div>Ref # 8.11</div> | |

| 8. RECEPTION ROOM 2 (CONT.) | | | |
|---|---|---|---|
| 8.11<br>📷 | Fireplace | <p>Brown wooden mantle and surround; black stone inner surround and hearth with clear glass pane to top; cement and exposed brick interior; black metal fire basket with draw to bottom</p> <p>Black metal framed with matching mesh fireguard</p> <p>Black metal four part fire utensil set and stand oh</p> | <p>Generally in a good condition</p> <p>Mantal As signs of age; wear to tops: heavy wear/ chipping / light damage to bottom left and right hand sides</p> <p>Interior condition is consistent with use; some debris to base</p> <p>Residue to rear of fibre basket</p> <p>Fireguard is intact; small scratch to right hand side of Center panel; minus signs of use</p> <p>All present and in working order; some white residue to tool ends</p> |

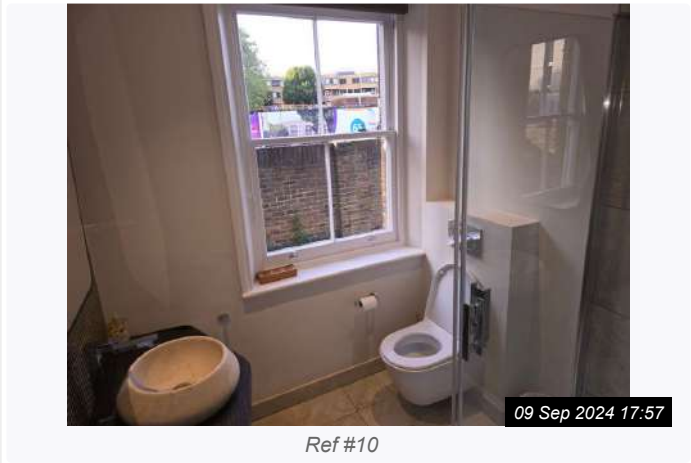
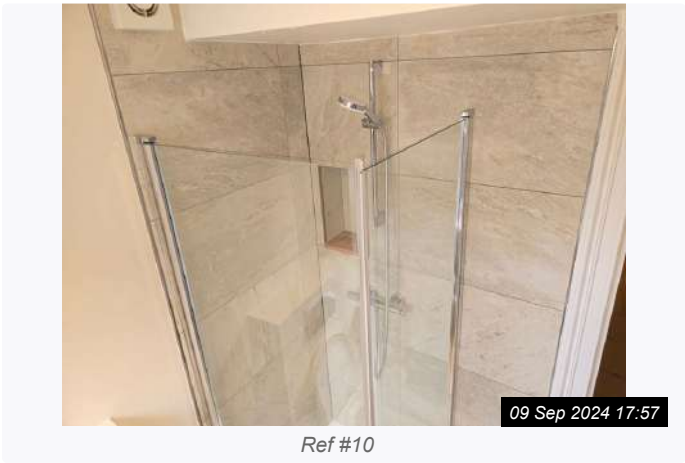
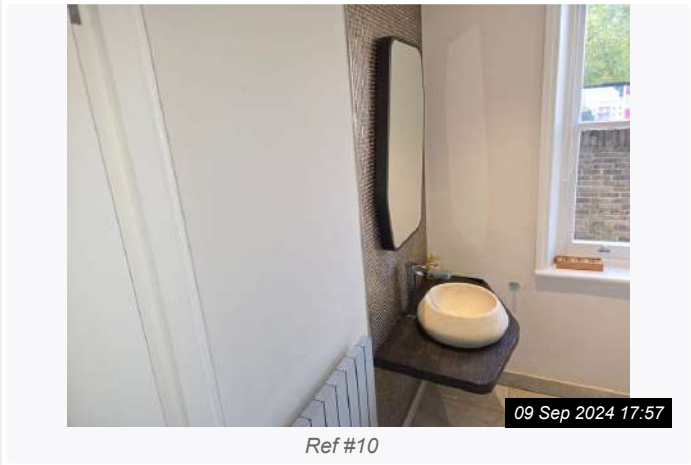
| Ref | Name | Description | Condition |
|---|---|---|---|
| 10.1<br>📷 | Door/ Frame/<br>Threshold | <p>Door: White wooden four panel door with grey metal furniture including: two handles and thumbtwist lock</p> <p>Frame: White painted wooden frame; two grey metal strike plate</p> <p>Threshold: grey metal transverse strip</p> | <p>Good condition with minor surface damage to closing hedge upper level<br/>Some marking to interior left-hand side</p> <p>Minor Mark mid-level right hand side; otherwise in good condition; some cracking to bottom of lower strike plate</p> <p>Condition consistent with use</p> |

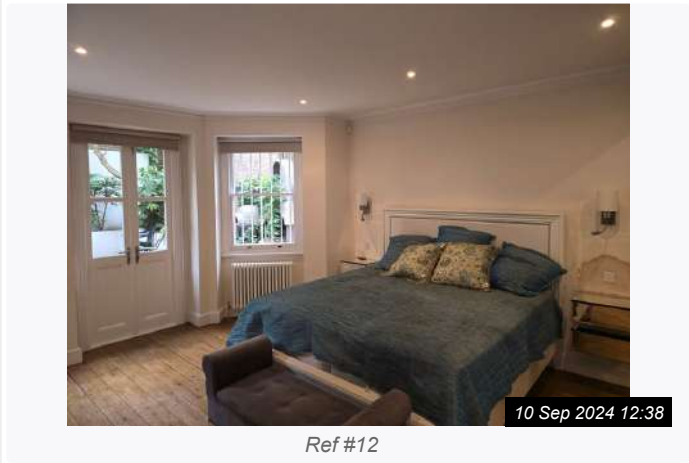
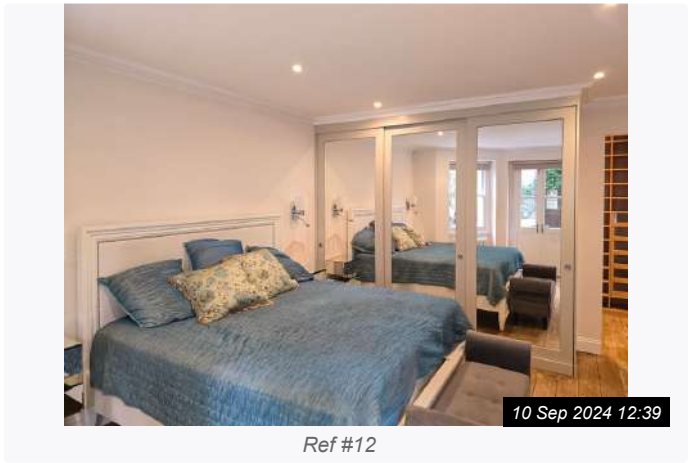
| Ref | Name | Description | Condition |
|---|---|---|---|
| 12.1 | Door/ Frame/ Threshold | Wooden panel door with brushed metal furnishings.<br><br>X2 chrome hinges<br><br>White painted wooden frame<br><br>Wooden floor board threshold | Damage to Top outer edge of exterior door<br><br>Some cracks in the woodwork<br><br>Frame in good condition |

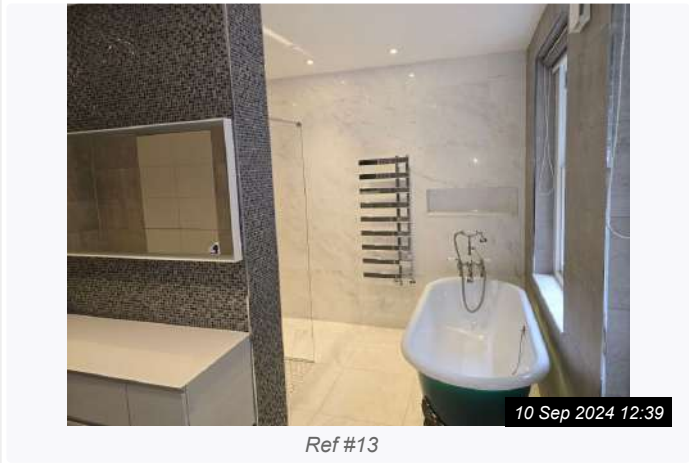
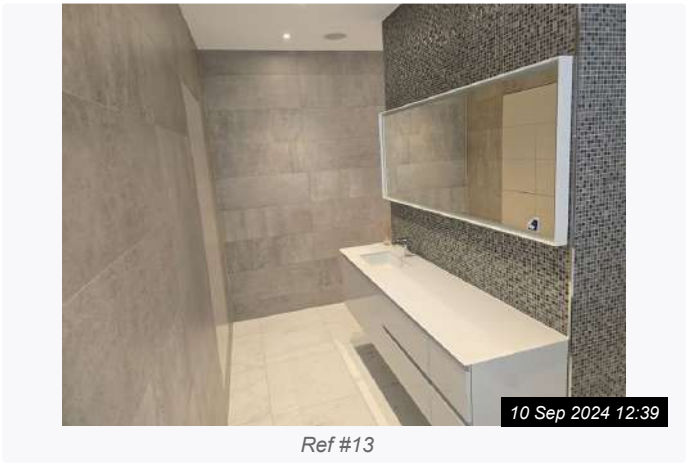
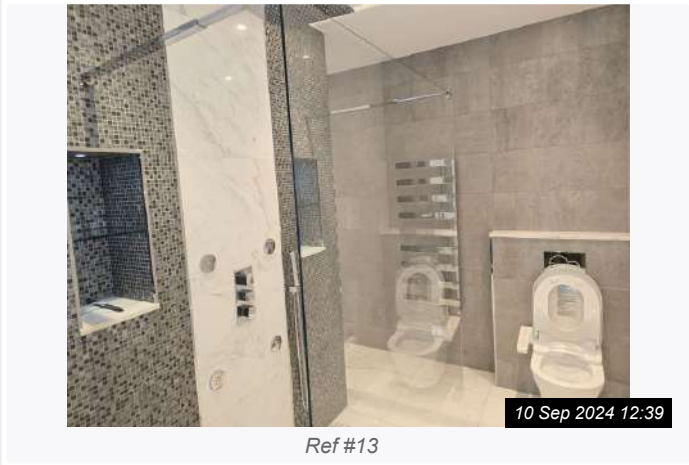
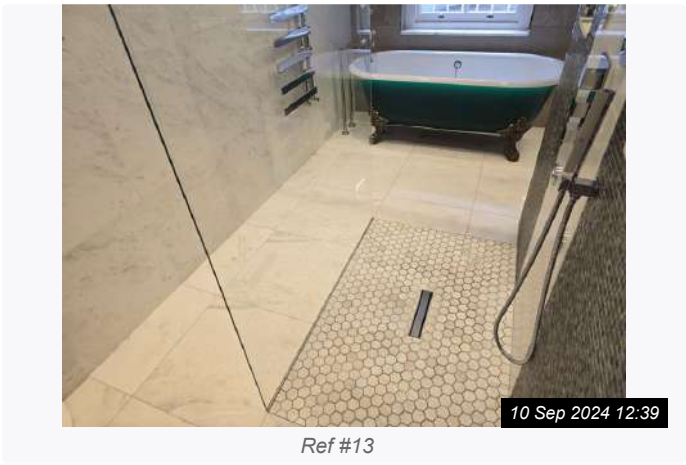
| Ref | Name | Description | Condition |
|---|---|---|---|
| 13.1<br>📷 | Door/ Frame/<br>Threshold | White painted wood panel door with chrome knobs and twist lock mechanism<br><br>White painted frame to match | Some small scuffs and marks to edges of door, left hand side, inner door. |

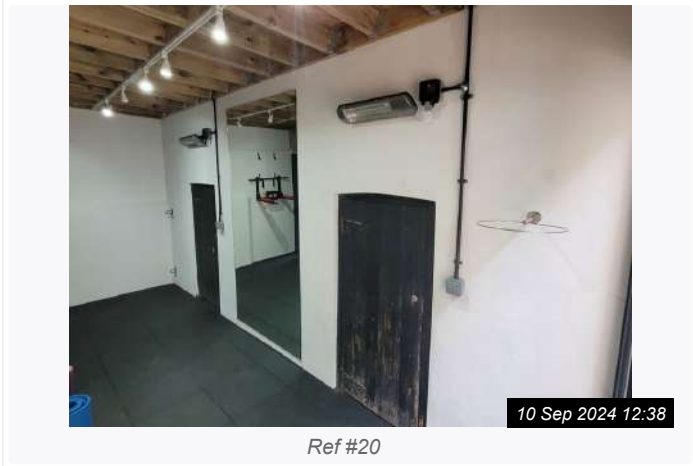
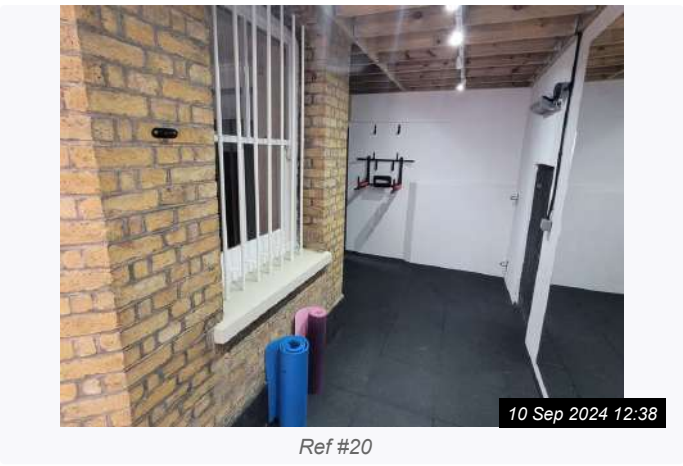
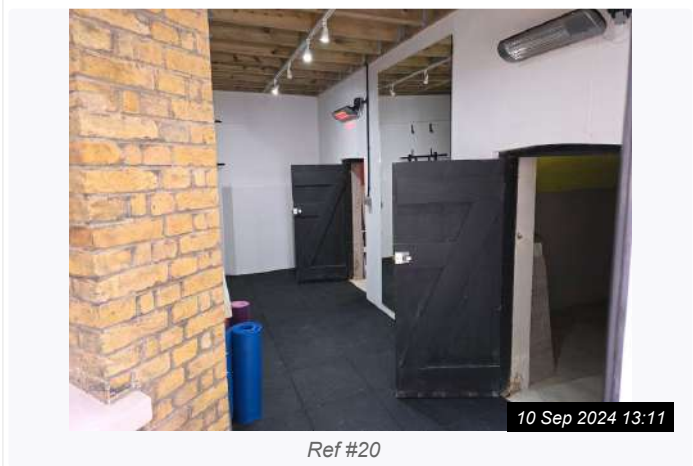
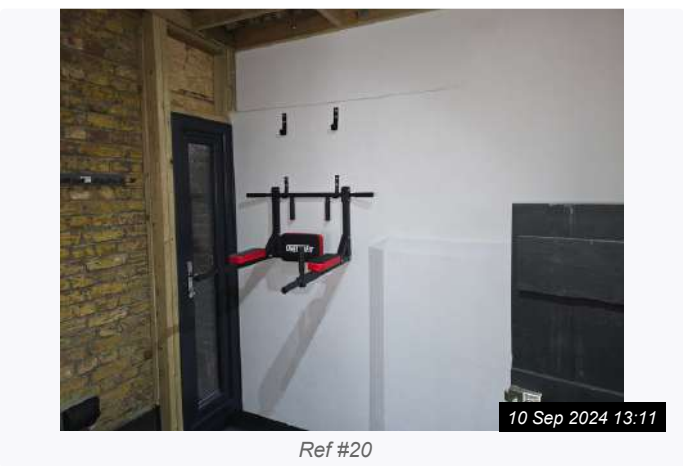
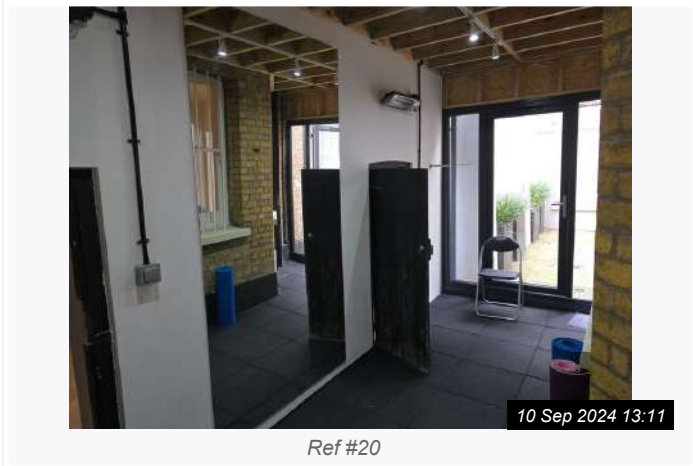
| Ref | Name | Description | Condition |
|---|---|---|---|
| 20.1<br>📷 | Door/ Frame/<br>Threshold | Grey wood effect upvc double doors with windows to either side and chrome handles and hinges<br><br>Matching single door to rear. | All in good clean working order |
