Property Inspection Report

A nice street, Visalia, CA 93291
Inspection prepared for: Home Buyer
Real Estate Agent: Starla Harlow - The Equity Group

Date of Inspection: 12/21/2018 Time: 9:00 AM
Age of Home: 1980 Size: 1150
Weather: Foggy

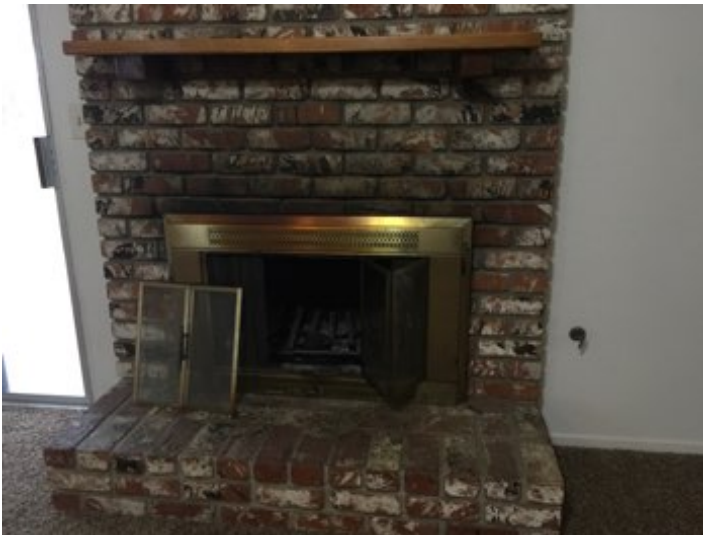
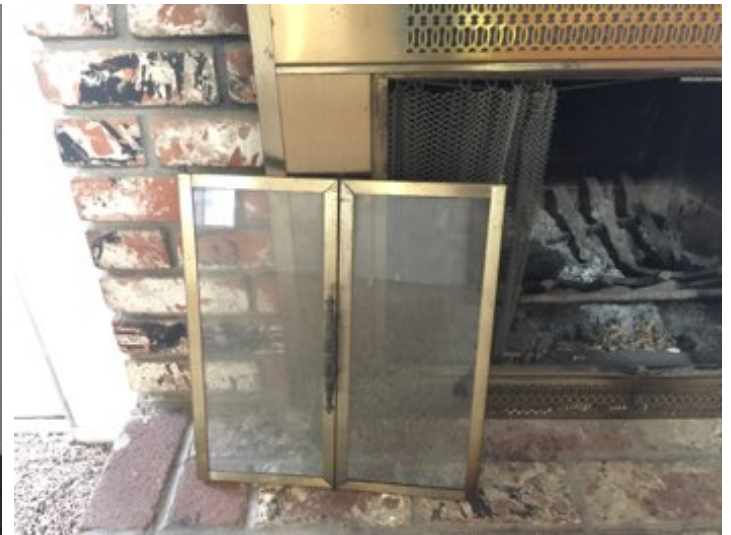
2. Fireplace Condition

Page 4 Item: 2	Fireplace Condition	<ul style="list-style-type: none"> The wood-burning fireplace lacked an operating ember barrier. This condition is a potential fire hazard as it may allow hot embers to be deposited on the combustible floor-covering material.
Kitchen

- The wood-burning fireplace lacked an operating ember barrier. This condition is a potential fire hazard as it may allow hot embers to be deposited on the combustible floor-covering material.

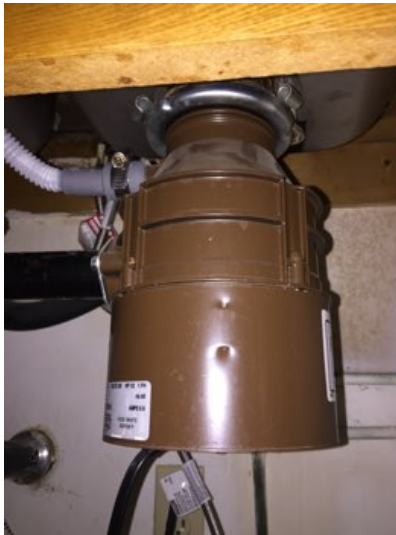
4. Garbage Disposal

Page 6 Item: 4	Garbage Disposal	<ul style="list-style-type: none"> The garbage disposal was excessively noisy, may have loose items within, worn components and may need to be replaced soon.
Master Bedroom

- The garbage disposal was excessively noisy, may have loose items within, worn components and may need to be replaced soon.

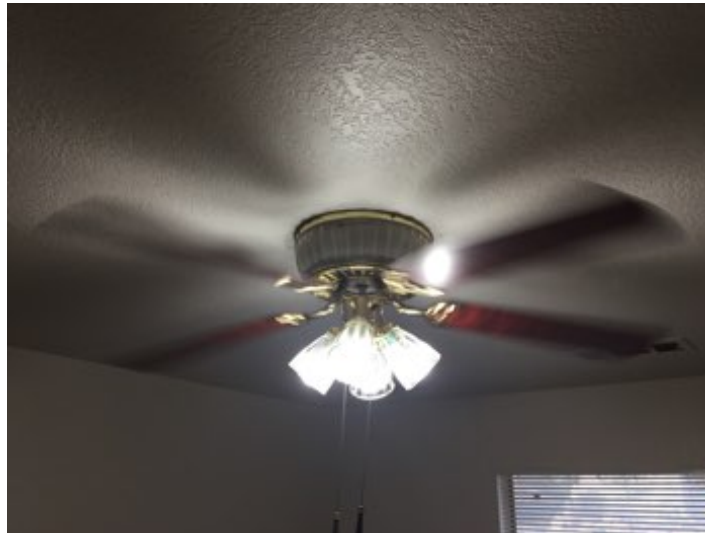
3. Ceiling Fan Condition

Page 9 Item: 3	Ceiling Fan Condition	<ul style="list-style-type: none"> A ceiling fan in this area wobbled during operation and appeared to be out of balance. This condition may eventually cause the fan to come loose from its mounting device and fall. The inspector recommends correction.
Master Bathroom

- A ceiling fan in this area wobbled during operation and appeared to be out of balance. This condition may eventually cause the fan to come loose from its mounting device and fall. The inspector recommends correction.

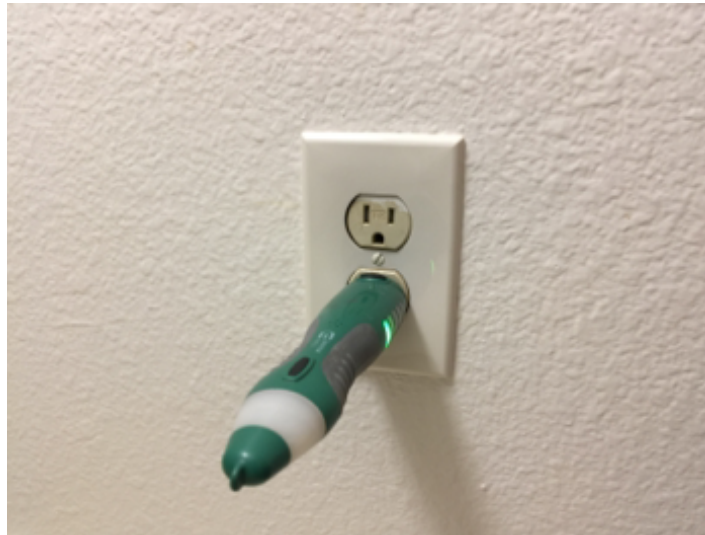
3. GFI Outlet Condition

- No Ground Fault Circuit Interrupter (GFI) protection was provided for this rooms electrical outlets located within 6 feet of a plumbing fixture. Although this may not have been required at the time the home was built, The Inspector recommends installation of ground fault circuit GFI protection as a safety precaution. All electrical work should be performed by a qualified electrician.

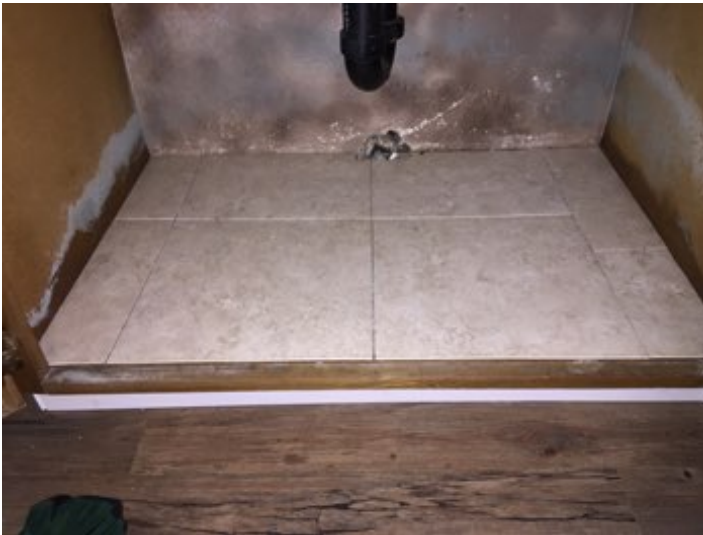
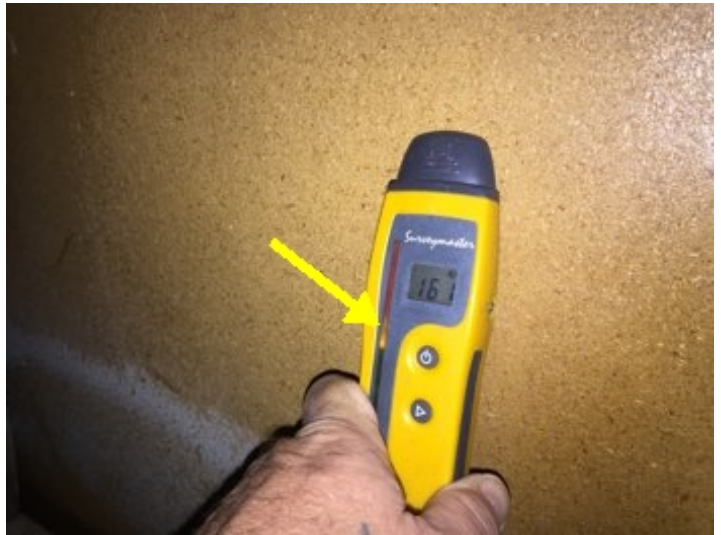
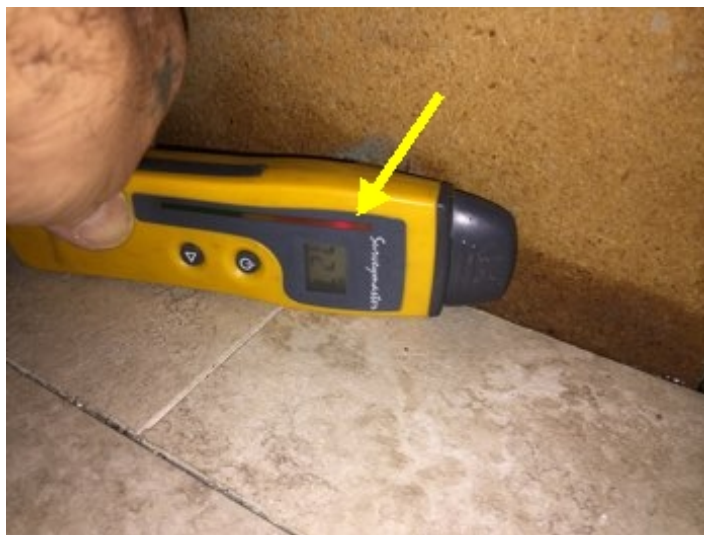
4. Cabinets

Page 11 Item: 4	Cabinets	<ul style="list-style-type: none"> The base of the bathroom sink cabinet showed damage from past moisture intrusion. The moisture meter showed elevated levels of moisture present in the floor indicating recent leakage as shown on moisture meter. The source of the leak should be located. This condition investigated further to avoid further damage to the cabinets and wall/floor structure.

- The base of the bathroom sink cabinet showed damage from past moisture intrusion. The moisture meter showed elevated levels of moisture present in the floor indicating recent leakage as shown on moisture meter. The source of the leak should be located. This condition investigated further to avoid further damage to the cabinets and wall/floor structure.

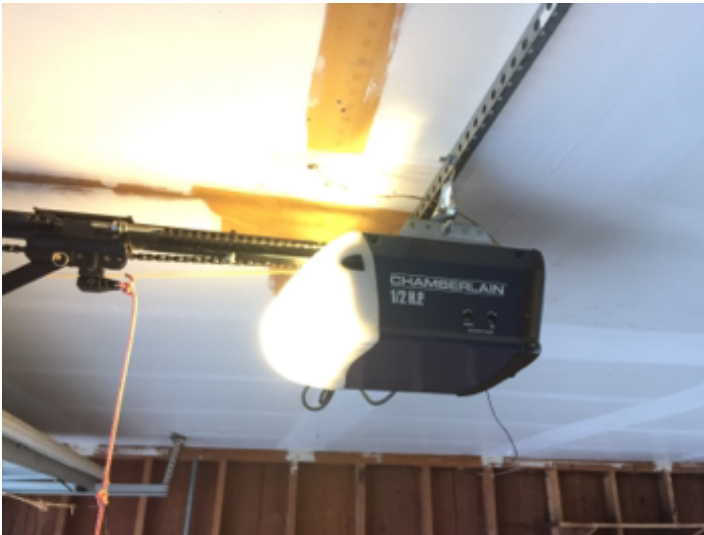
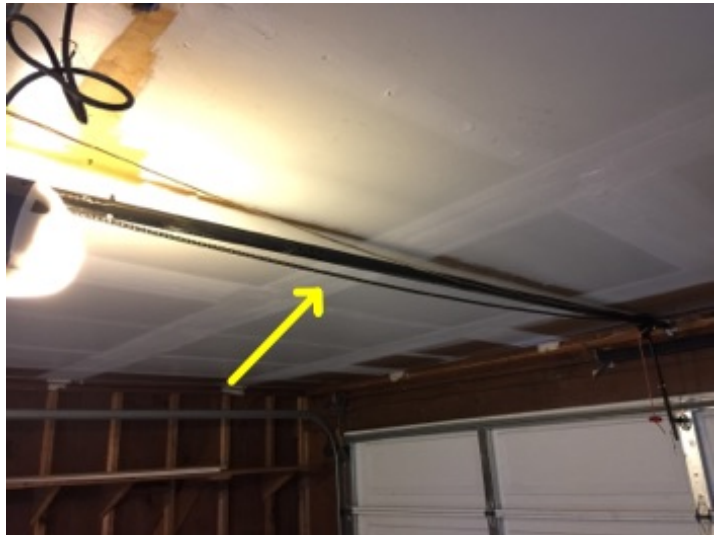
3. Garage Opener Status

Page 15 Item: 3	Garage Opener Status	<ul style="list-style-type: none"> The drive chain it appears need adjustment at the time of inspection. We suggest consulting a qualified professional.

- 🔍 • Operated unit. The unit raised and lowered the door in a satisfactory manor.
- The drive chain it appears need adjustment at the time of inspection. We suggest consulting a qualified professional.

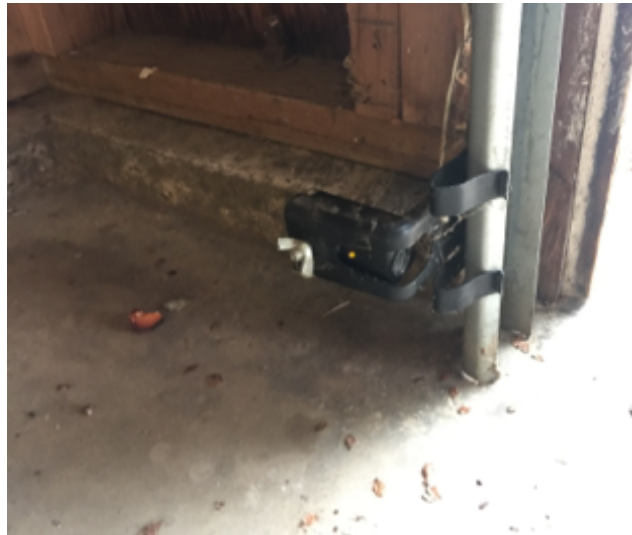
4. Garage Door Reverse Status

- OK • Eye beam system present and operated well on South door at time of inspection. The North door has alignment issues and did not operate correctly at the time of the inspection.

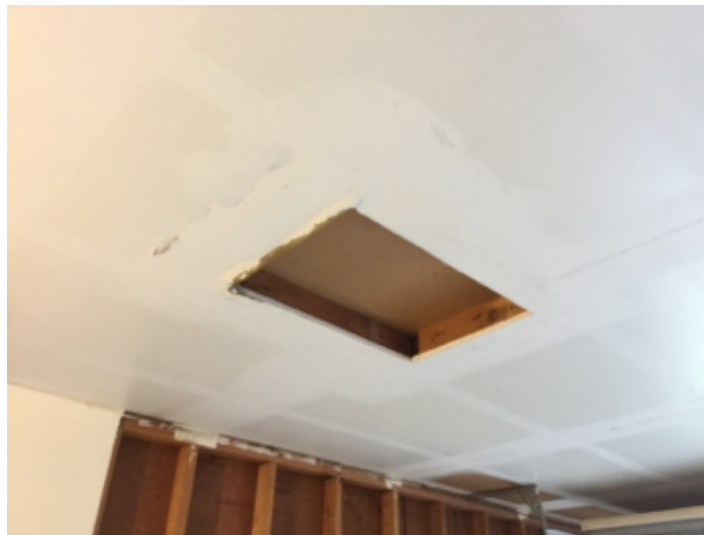
5. Firewall

Page 16 Item: 5	Firewall	<ul style="list-style-type: none"> Large hole cut into firewall for what appears to be access to the attic. This lowers the amount of time that the structure would delay the fire entrance into the house. We suggest consulting a qualified professional.
Water Heater

- Large hole cut into firewall for what appears to be access to the attic. This lowers the amount of time that the structure would delay the fire entrance into the house. We suggest consulting a qualified professional.

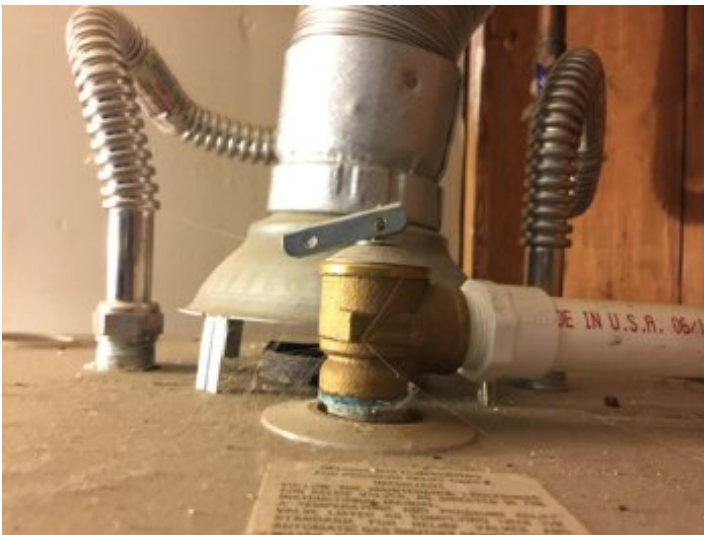
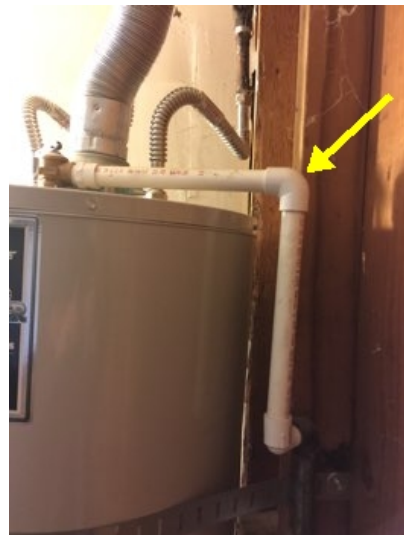
3. TPRV

Page 17 Item: 3	TPRV	<ul style="list-style-type: none"> The discharge line installed may be a type not commonly used in this situation and may be a dangerous condition if <u>TPRV</u> opens. We suggest consulting a qualified professional.
Roof

- 🚫 • The water heater is equipped with a Temperature Pressure Relief Valve (**TPRV**).
- The discharge line installed may be a type not commonly used in this situation and may be a dangerous condition if **TPRV** opens. We suggest consulting a qualified professional.

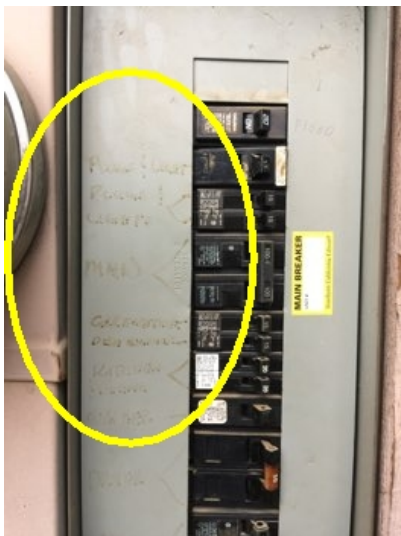
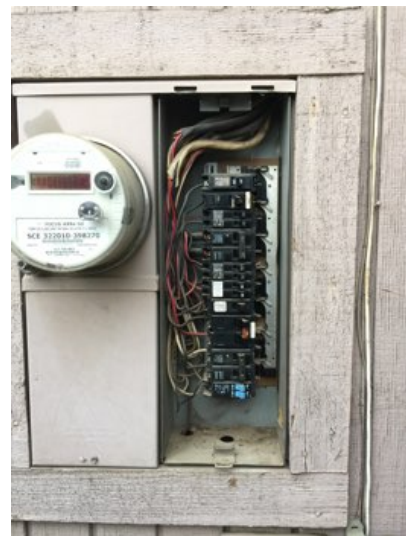
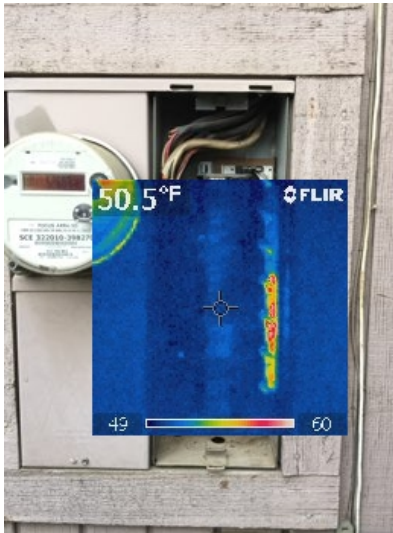
2. Breakers

- The Circuit label for the main electrical service panel is shown in the photo. We suggest remarking labels as original labels are non-existent or fading.

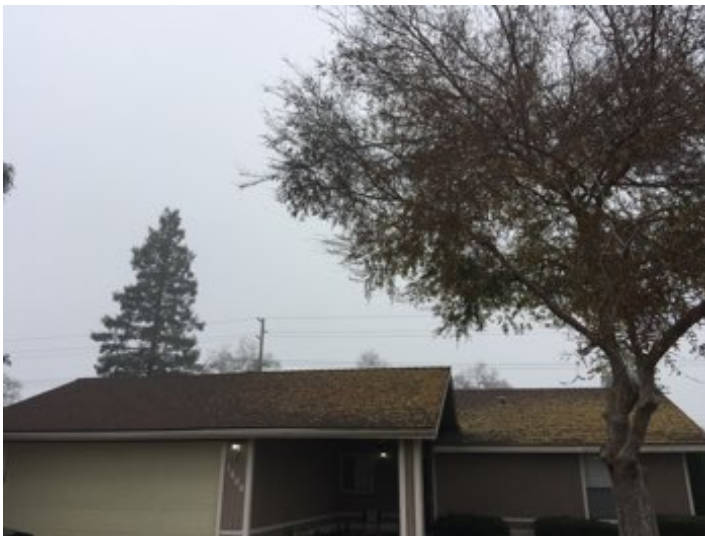
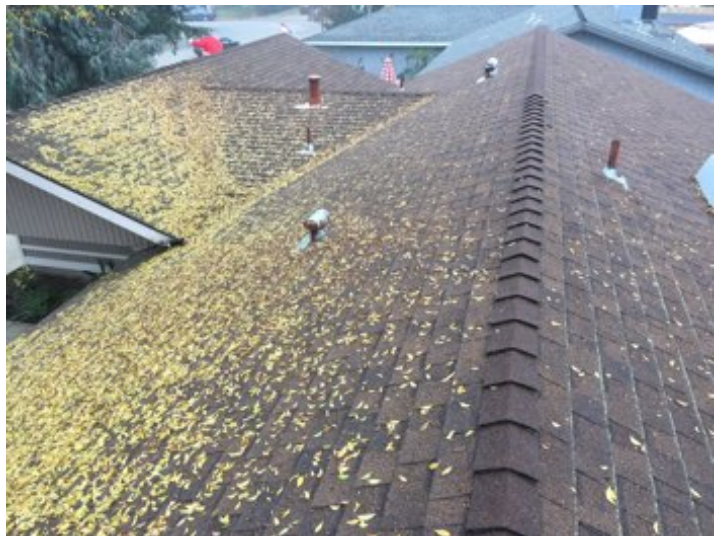
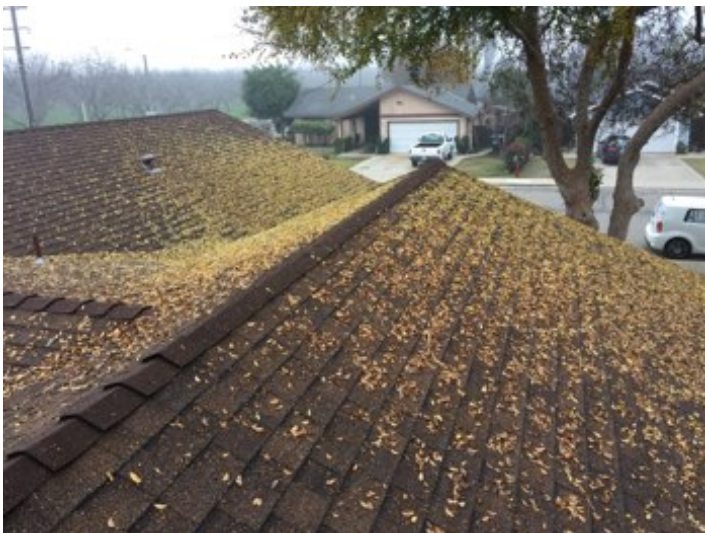
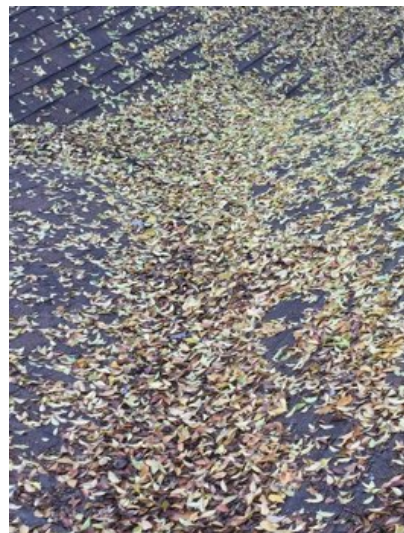
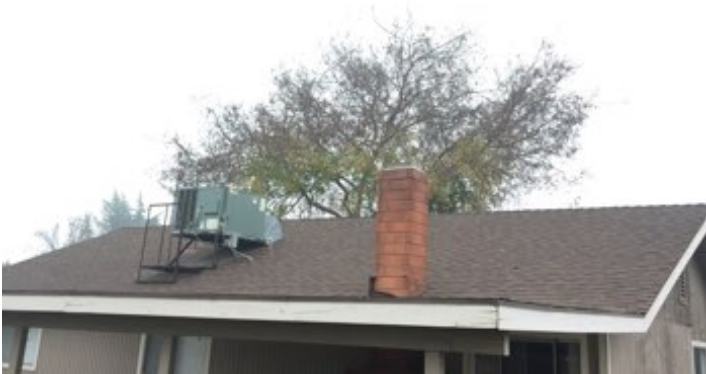
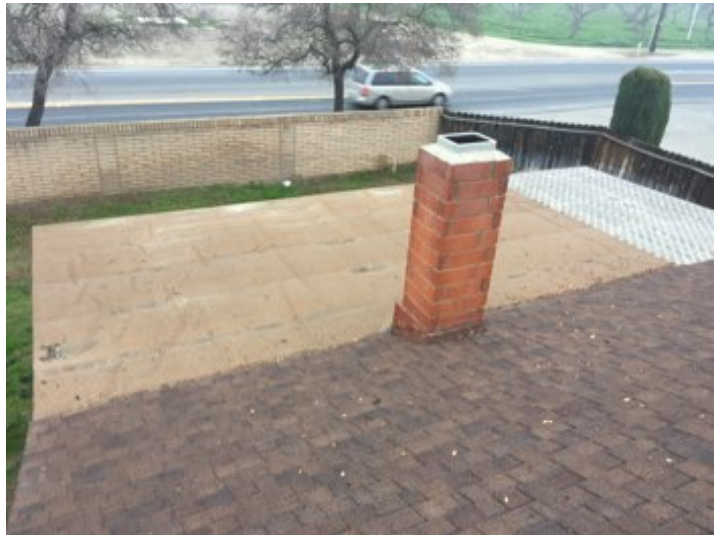
1. Roof Condition

Page 23 Item: 1	Roof Condition	<ul style="list-style-type: none"> Debris accumulated on the South East roof at the time of the inspection may damage roof covering materials by retaining moisture. Clearing the roof of debris should be included in annual maintenance.

- Asphalt composition shingles covering the roof of this home appeared to be in serviceable condition at the time of the inspection.
- Debris accumulated on the South East roof at the time of the inspection may damage roof covering materials by retaining moisture. Clearing the roof of debris should be included in annual maintenance.

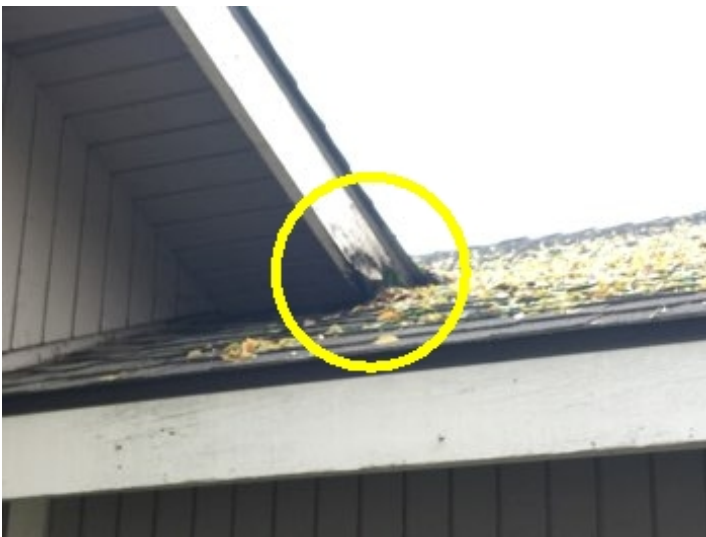
South roof

Page 24 Item: 2	Facia and Trim Condition	<ul style="list-style-type: none"> • Fascia at the following locations around the home had moisture damage visible. <ul style="list-style-type: none"> -South roof. -South West corner. -Above garage man door. <p>See Clark's report for details and exact locations.</p>

- Fascia at the following locations around the home had moisture damage visible.

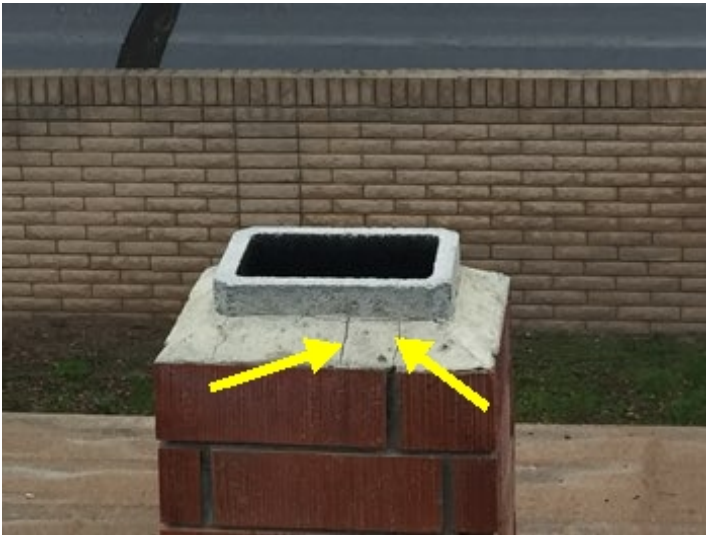
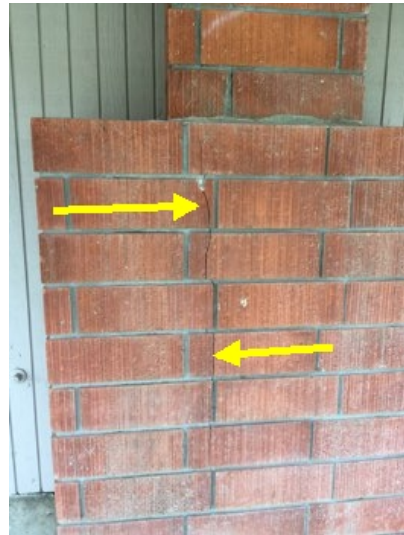
4. Chimney

Page 26 Item: 4	Chimney	<ul style="list-style-type: none"> • No rain cap was installed. A protective cover installed at the top of chimney flue to prevent rain from entering is referred to as a rain cap. Some rain caps are screened to keep out birds and rodents as well. Rain that mixes with soot form a chemical action which breaks the flue and chimney mortar down quicker. • Damaged chimney crown observed. It is important for the crown to be in good condition as it provides a first line of defense against outdoor elements. When the crown is cracked, water gets in and freezes and thaws, causing larger cracks. A damaged chimney crown allows moisture to seep between the chimney and the liner as well as into the chimney, which can cause shaling and <u>spalling</u>. We suggest repair. A great preventative measure against this type of damage after repair is to weatherproof the chimney crown and, while you're at it, the chimney itself. • Large crack observed on chimney at the patio area. The unit appears secure however we suggest further investigation and repairs if needed.

- No rain cap was installed. A protective cover installed at the top of chimney flue to prevent rain from entering is referred to as a rain cap. Some rain caps are screened to keep out birds and rodents as well. Rain that mixes with soot form a chemical action which breaks the flue and chimney mortar down quicker.

- Damaged chimney crown observed. It is important for the crown to be in good condition as it provides a first line of defense against outdoor elements. When the crown is cracked, water gets in and freezes and thaws, causing larger cracks. A damaged chimney crown allows moisture to seep between the chimney and the liner as well as into the chimney, which can cause shaling and **spalling**. We suggest repair. A great preventative measure against this type of damage after repair is to weatherproof the chimney crown and, while you're at it, the chimney itself.

- Large crack observed on chimney at the patio area. The unit appears secure however we suggest further investigation and repairs if needed.

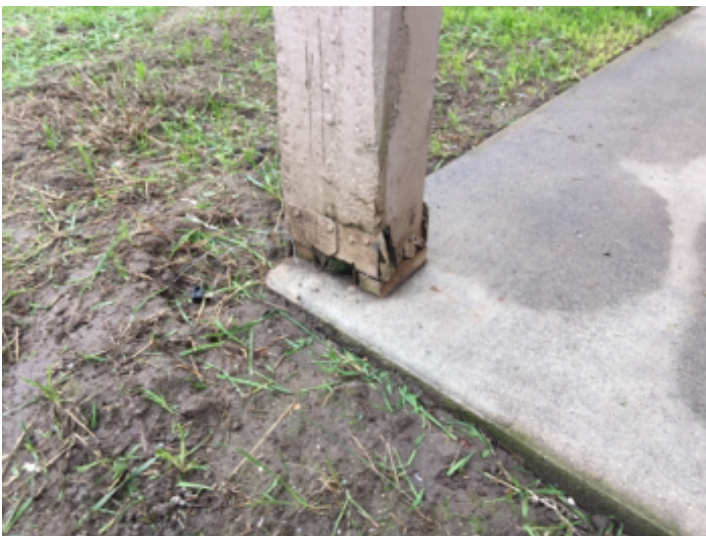
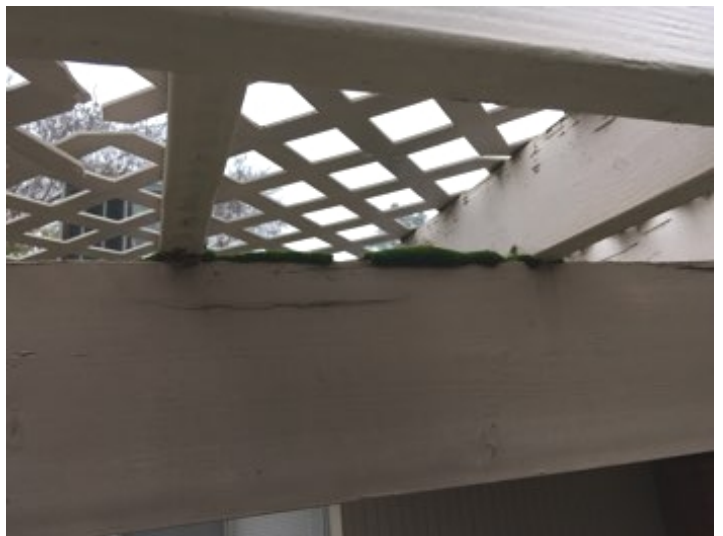
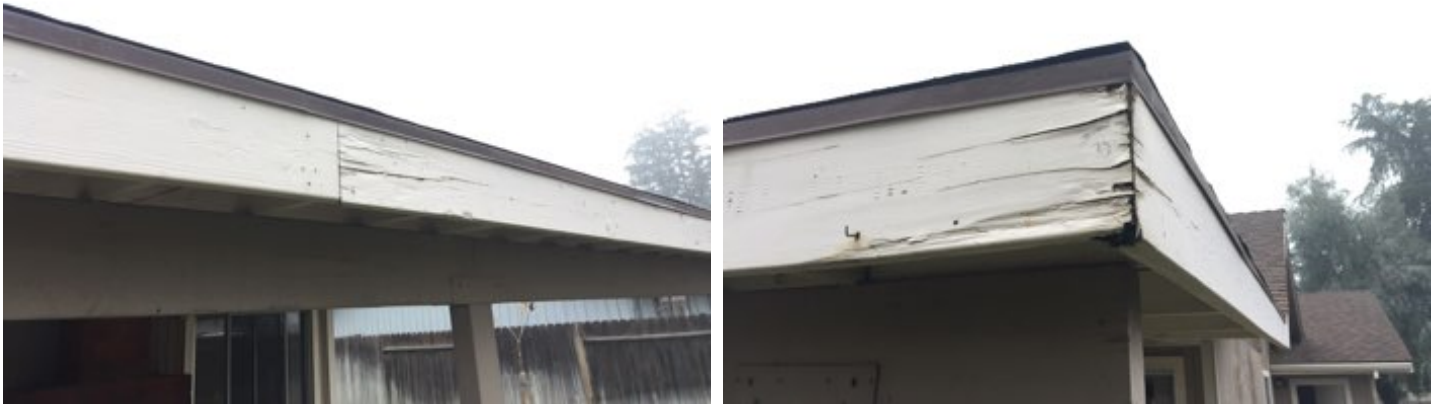
1. Patio Damage

Page 27 Item: 1	Patio Damage	<ul style="list-style-type: none"> • Patio has several areas of damage noted. Please see Clark's pest report for further details and specific locations.

- Patio has several areas of damage noted. Please see Clark's pest report for further details and specific locations.

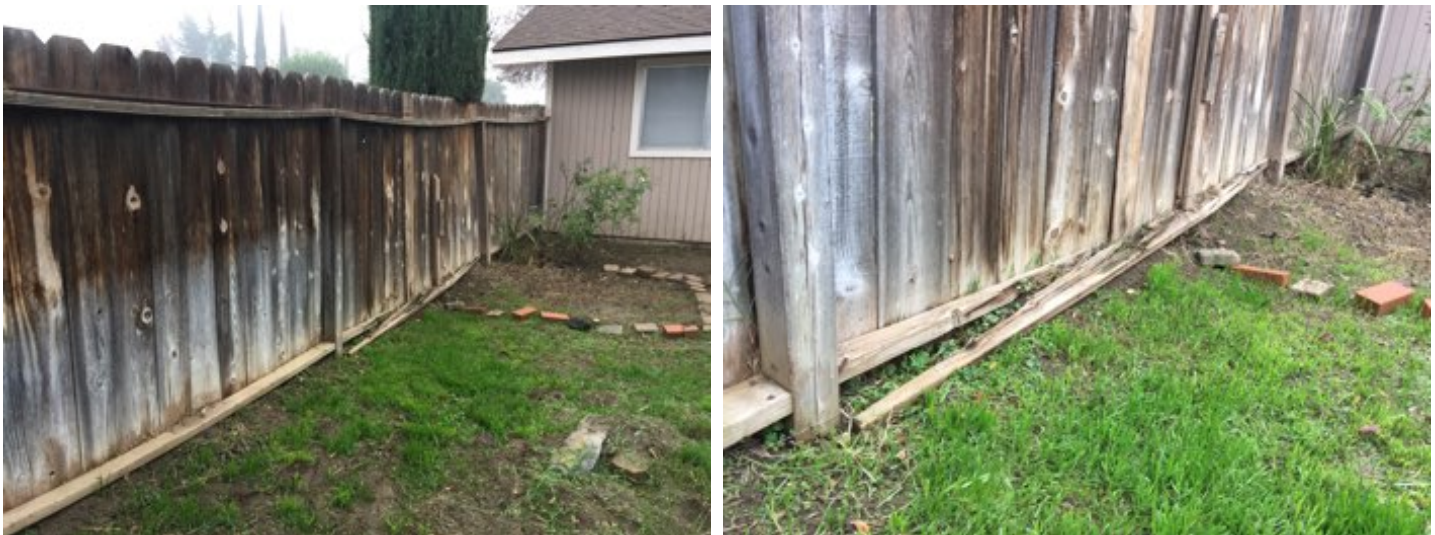
2. Fence Condition

Page 28 Item: 2	Fence Condition	<ul style="list-style-type: none">• Some wood posts on the East fence line examined during the inspection were loose and needed maintenance or replacement.• Wood boards forming the fence barrier on West side were damaged and in need of repair.
Cooling

- Some wood posts on the East fence line examined during the inspection were loose and needed maintenance or replacement.
- Wood boards forming the fence barrier on West side were damaged and in need of repair.

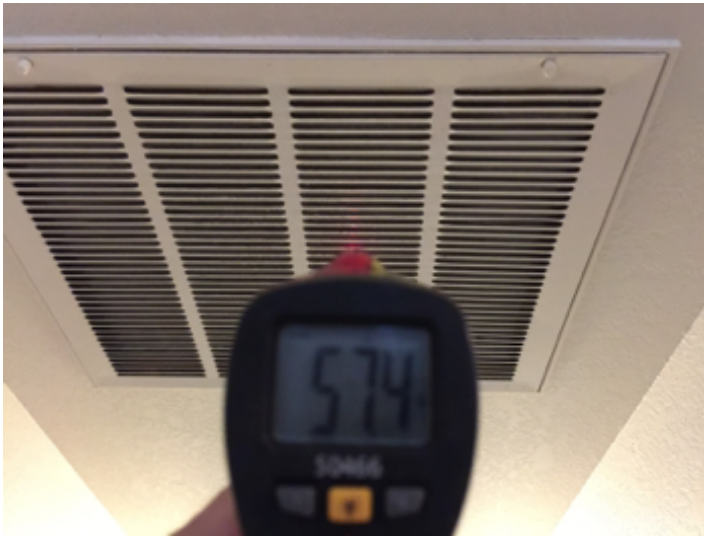
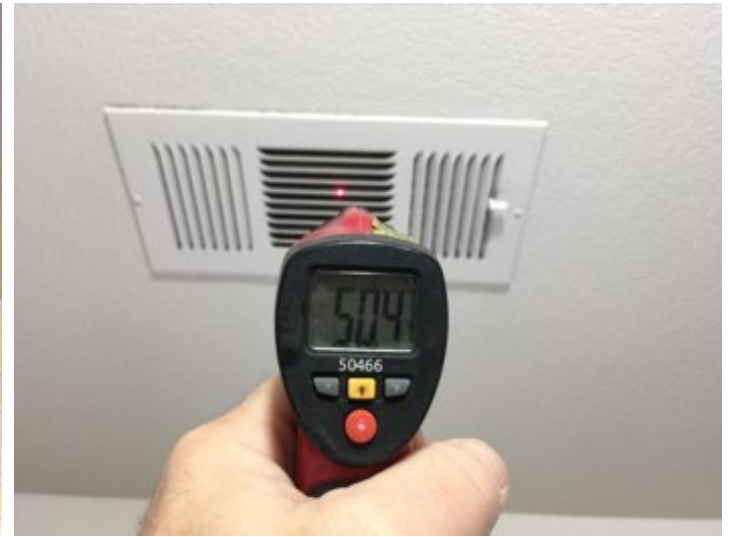
3. Air Temperatures and Gradient

Page 29 Item: 3	Air Temperatures and Gradient	<ul style="list-style-type: none">• Air temperature measured at supply and return registers had a difference of less than the minimum of 10 degrees Fahrenheit. <p>We suggest washing the condenser coils outside. If the temperature does not return to normal conditions, we recommend service by a qualified HVAC technician.</p>

- The General Home Inspection does not include confirming even temperature distribution by the cooling system.
 - Air temperature measured at supply and return registers had a difference of less than the minimum of 10 degrees Fahrenheit.
- We suggest washing the condenser coils outside. If the temperature does not return to normal conditions, we recommend service by a qualified HVAC technician.
