OnPoint Property Inspections, LLC

Home Inspection Report

117 Callee Dr

Inspected on Wed, Jun 2 2021 at 9:49 PM

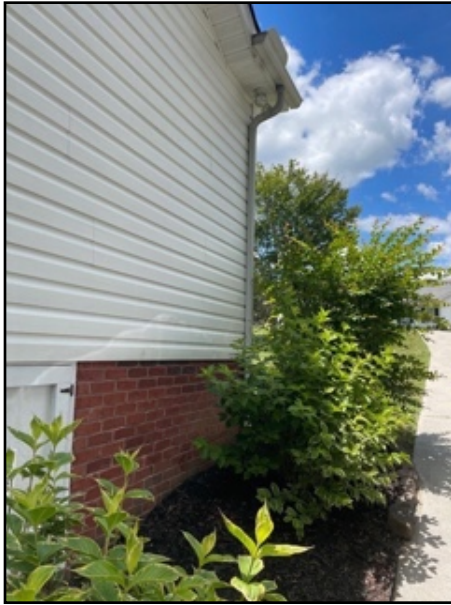
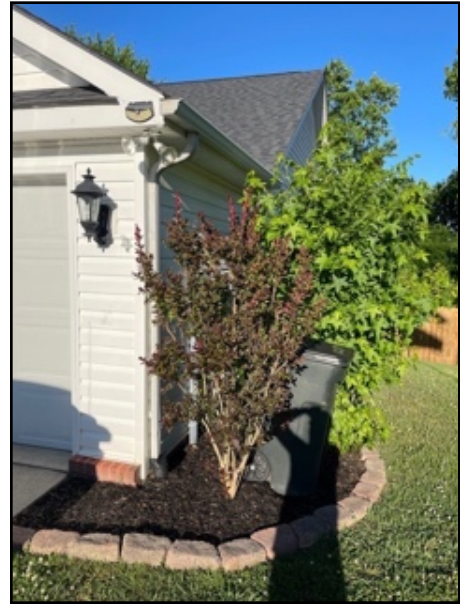
The vegetation (shrubs and/or trees) was in contact with the exterior walls. All vegetation should be trimmed away from structure to prevent potential moisture intrusion and damage to the house.

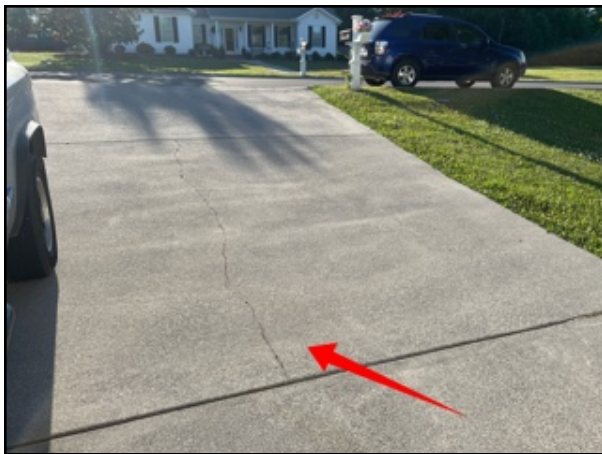
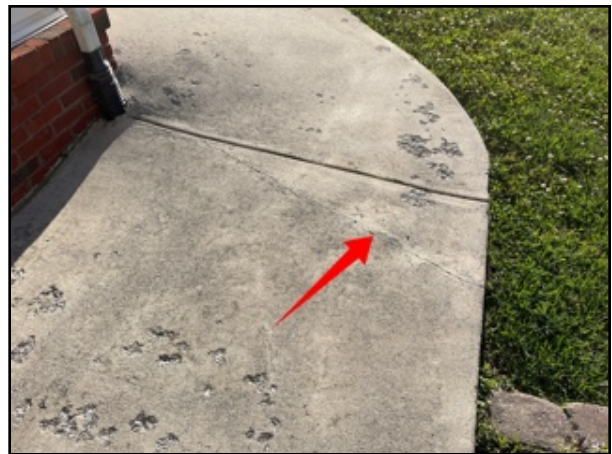
Settlement cracks observed in driveway & walkway on front side of home. These cracks should be monitored and addressed if they widen and/or become displaced.

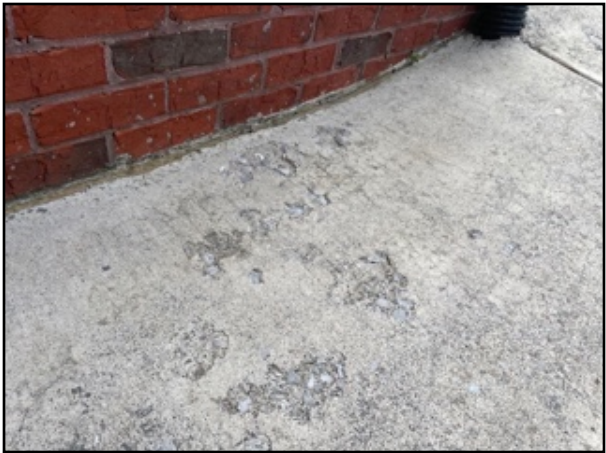
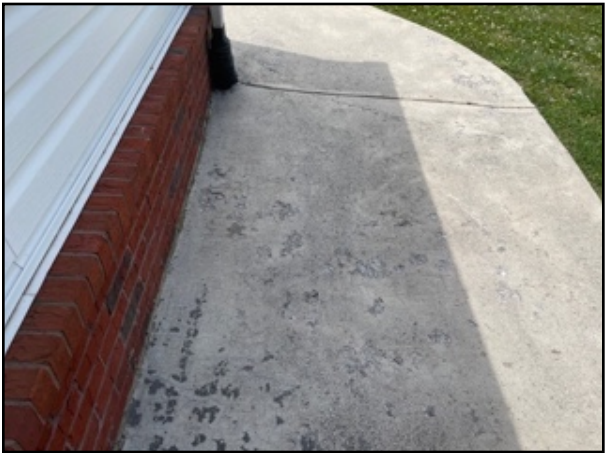
Comment 3:
Spalling (corrosion) observed on concrete walkway. Spalling is surface deterioration that causes large flakes of concrete to detach from the surface. It can be caused by poor concrete mix at the time of original construction made worse by freeze damage. Recommend patching with an appropriate material to help prevent continued deterioration.

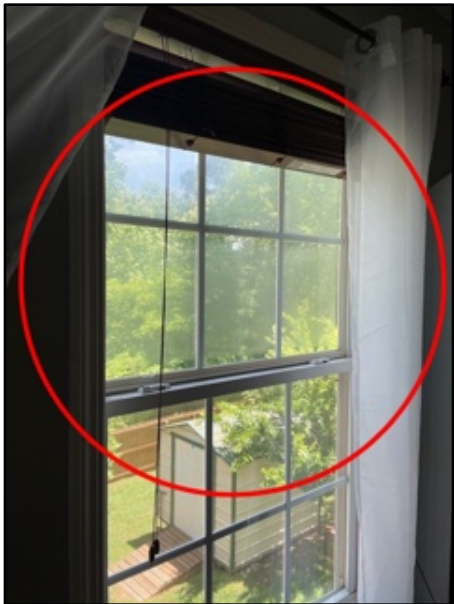
Figure 4-1

Comment 4:
Observed fogged window located in the family room. The hermetic seal has failed and will require replacement. These rubber-like seals are prone to failure with age and heat. Recommend further evaluation and replacement by a qualified contractor.

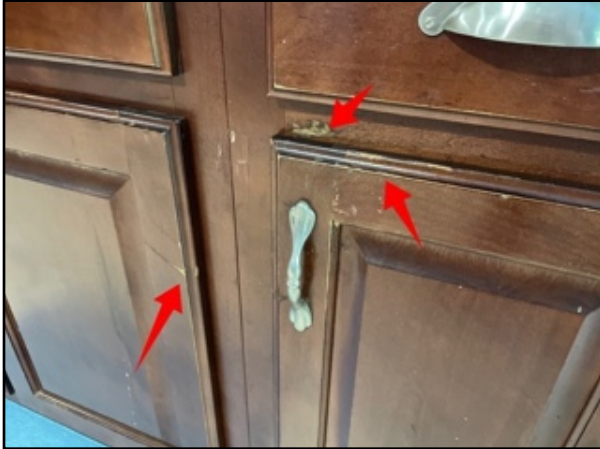
Figure 5-1

Observed worn cabinets & loose hardware throughout kitchen. Recommend securing hardware where needed.

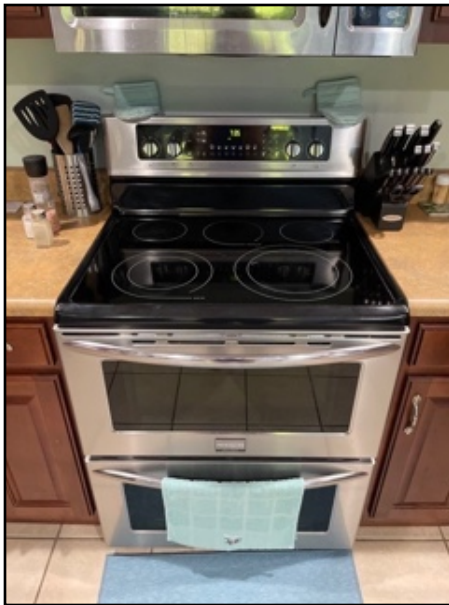
Figure 6-1

Anti-tip was not installed. Recommend having the anti-tip device installed for child safety.

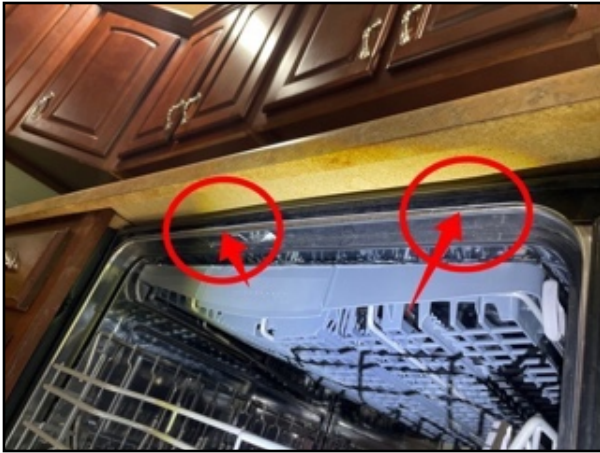
Figure 8-1

Dishwasher was not properly secured to the countertop. Recommend having a qualified contractor secure the dishwasher to the counter with the proper mounts.

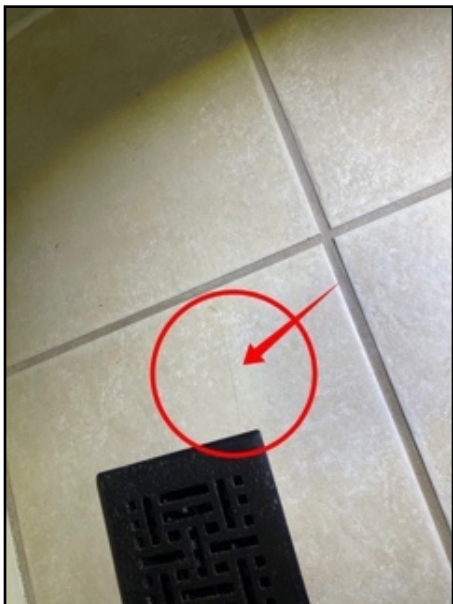
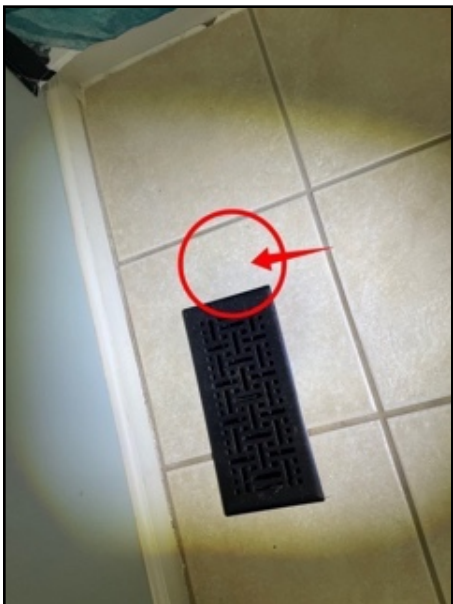
Cracked tile in master bathroom. Recommend further evaluation and repair by a qualified contractor.

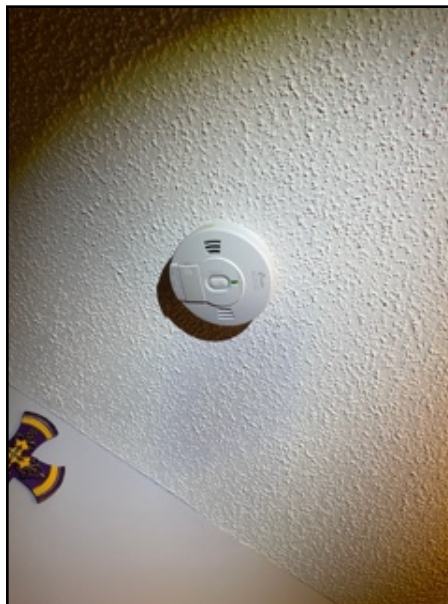
Recommend replacing smoke detectors that are older than 7 years for safety.

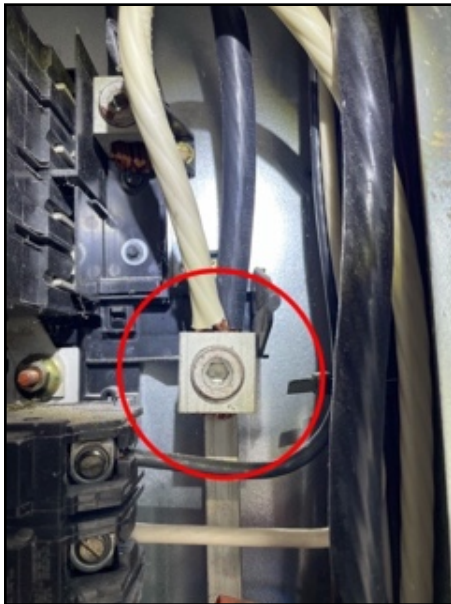
Figure 13-1

Double tapped neutral lugs were observed in the main panel. Recommend further evaluation and repair by a qualified electrician

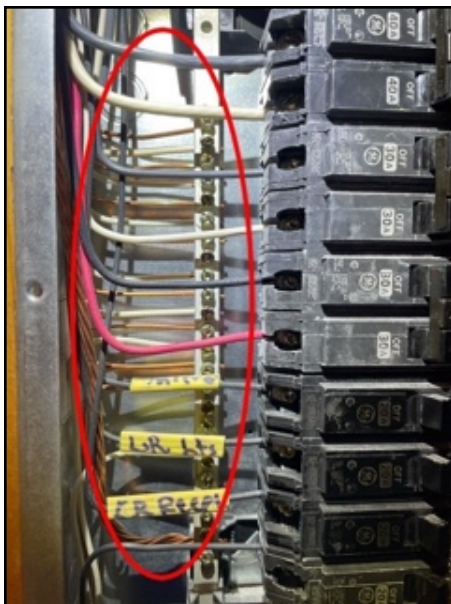
Figure 14-1

In most cases in a sub panel, the neutral and grounding conductors are separated. The sub panel is fed with separate ground and neutrals but the ground and neutral branch circuit wires are not separated. Recommend further evaluation and repair by a qualified electrician.

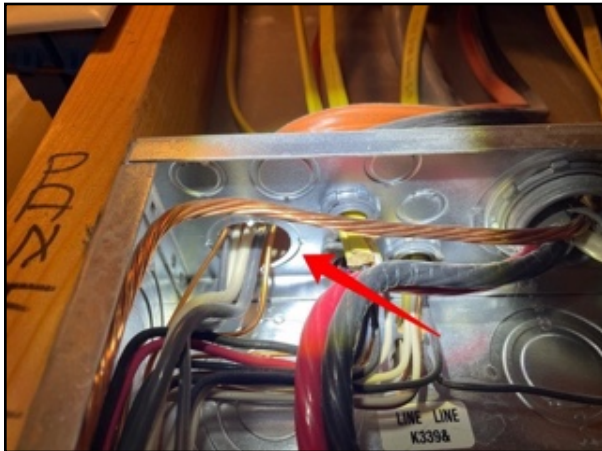
Figure 15-1

Recommend having a qualified electrician install the proper connector bushings on the wiring entering/exiting the sub panel for safety.

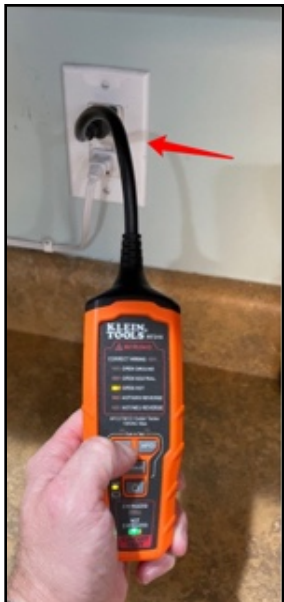
Figure 16-1

The GFCI in kitchen next to coffee maker did not trip properly when tested. Recommend further evaluation and replacement by a qualified electrician.

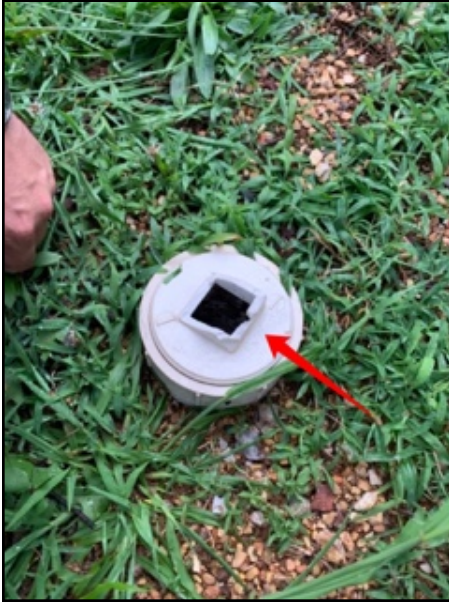
Figure 18-1

Observed damaged sewer clean out cap located in backyard. Recommend having it replaced with a proper cap.

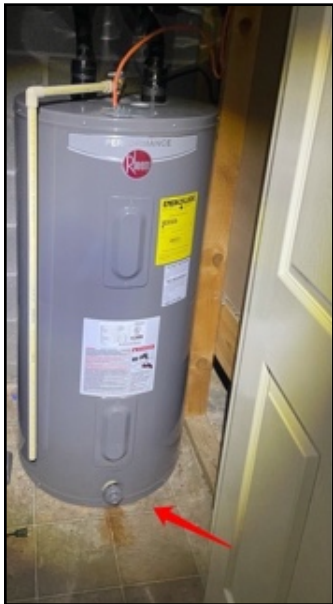
Figure 20-1

Recommend having a drip pan installed to catch potential leaks.

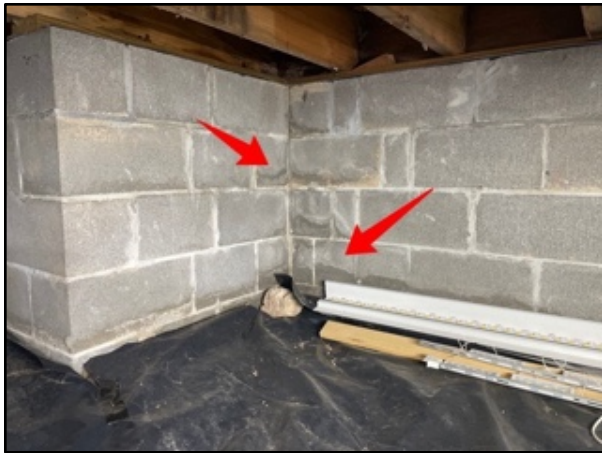
Figure 24-1

Observed efflorescence and moisture intrusion on block wall. Recommend further evaluation by a qualified specialist.

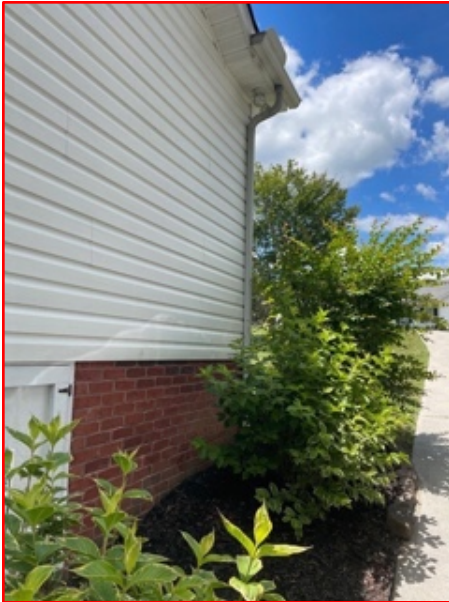
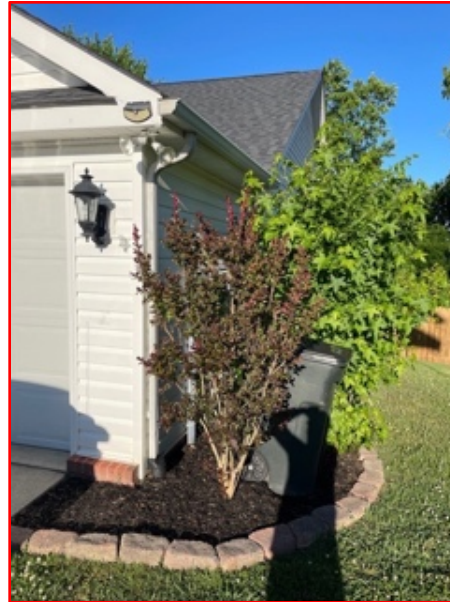
1) The vegetation (shrubs and/or trees) was in contact with the exterior walls. All vegetation should be trimmed away from structure to prevent potential moisture intrusion and damage to the house.

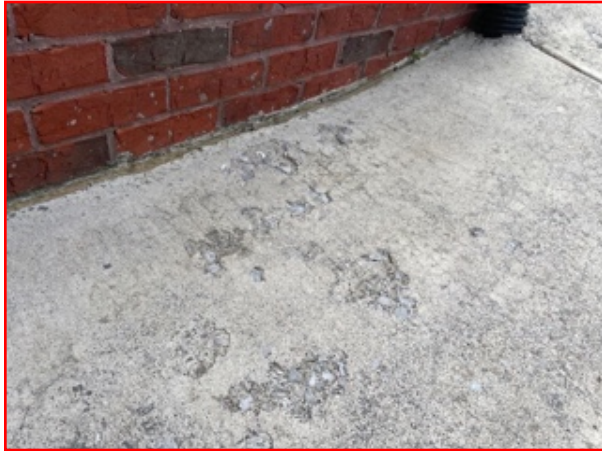
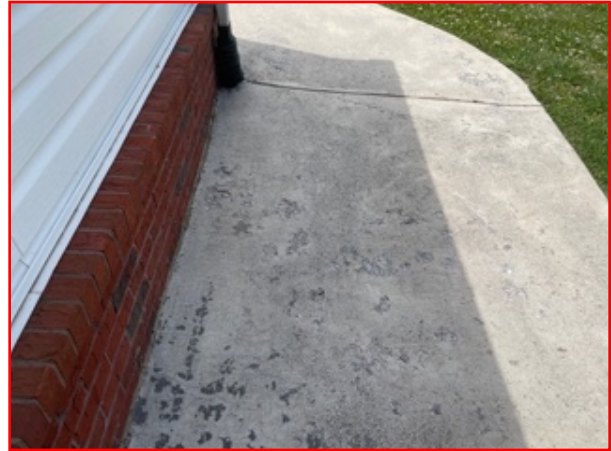
2) Spalling (corrosion) observed on concrete walkway. Spalling is surface deterioration that causes large flakes of concrete to detach from the surface. It can be caused by poor concrete mix at the time of original construction made worse by freeze damage. Recommend patching with an appropriate material to help prevent continued deterioration.

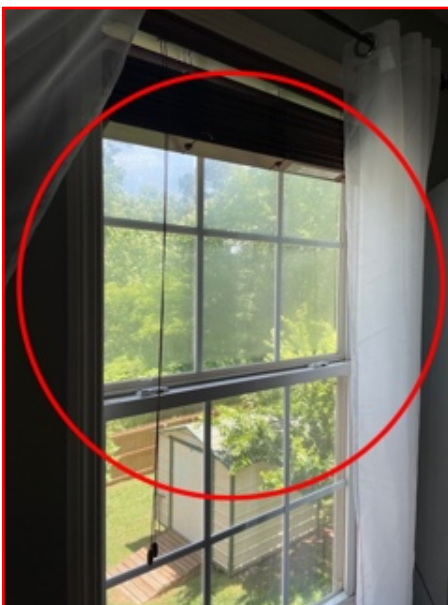
Figure 4-1

3) Observed fogged window located in the family room. The hermetic seal has failed and will require replacement. These rubber-like seals are prone to failure with age and heat. Recommend further evaluation and replacement by a qualified contractor.

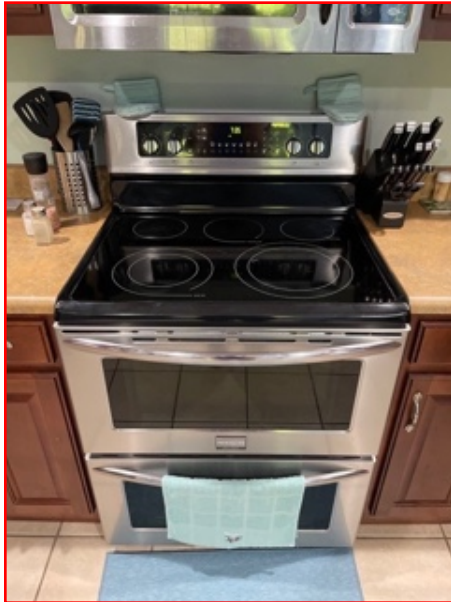
Figure 6-1

4) Anti-tip was not installed. Recommend having the anti-tip device installed for child safety.

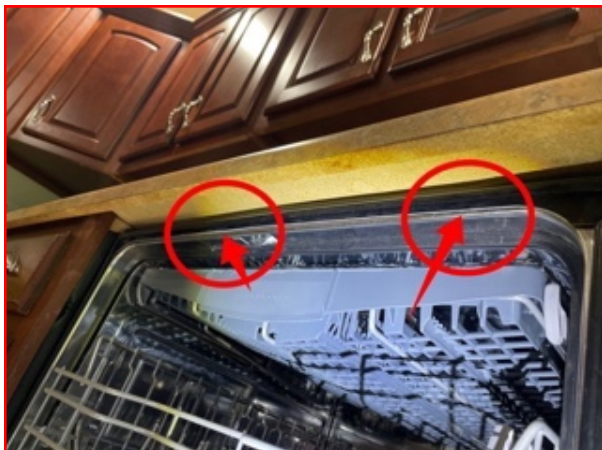
Figure 8-1

5) Dishwasher was not properly secured to the countertop. Recommend having a qualified contractor secure the dishwasher to the counter with the proper mounts.

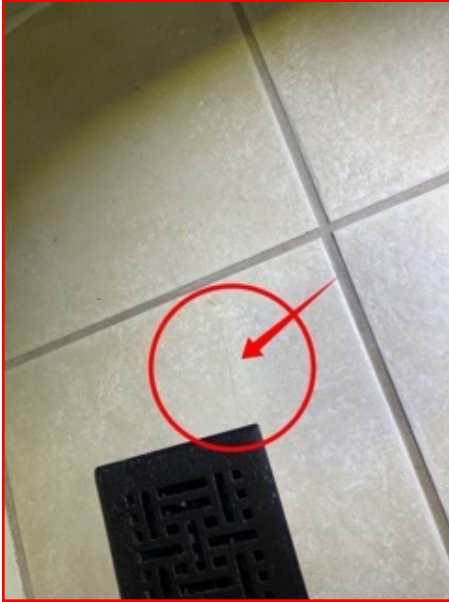
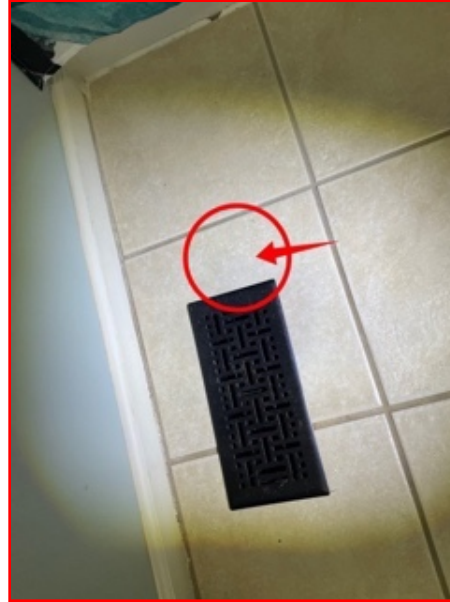
6) Cracked tile in master bathroom. Recommend further evaluation and repair by a qualified contractor.

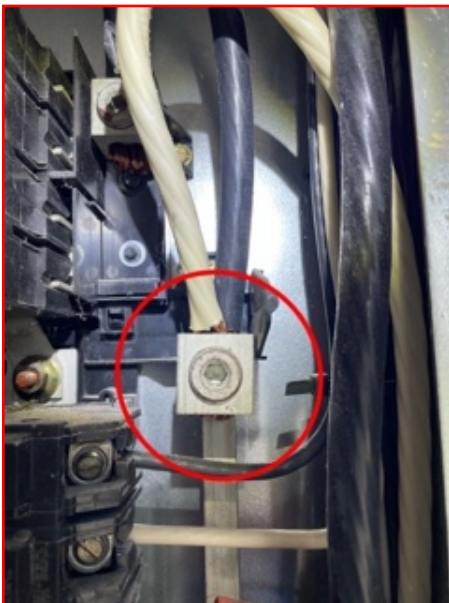
Figure 13-1

7) Double tapped neutral lugs were observed in the main panel. Recommend further evaluation and repair by a qualified electrician

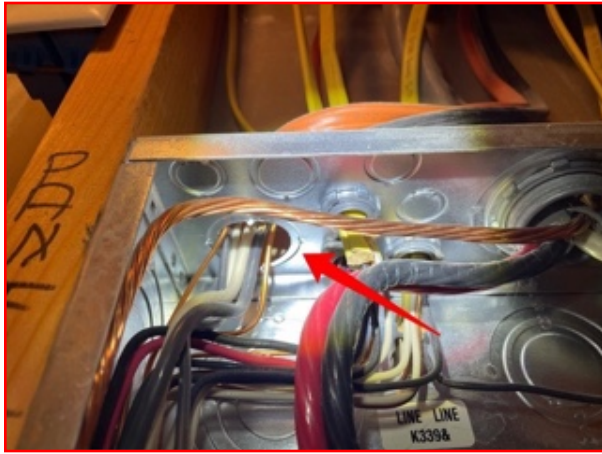
Figure 15-1

8) Recommend having a qualified electrician install the proper connector bushings on the wiring entering/exiting the sub panel for safety.

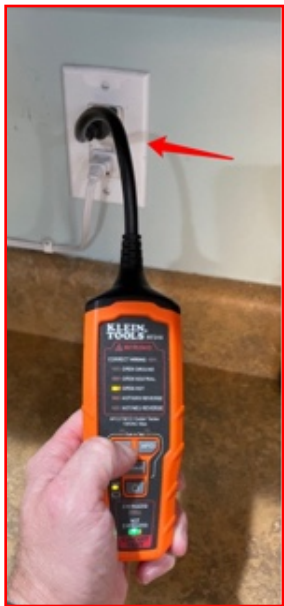
Figure 16-1

9) The GFCI in kitchen next to coffee maker did not trip properly when tested. Recommend further evaluation and replacement by a qualified electrician.

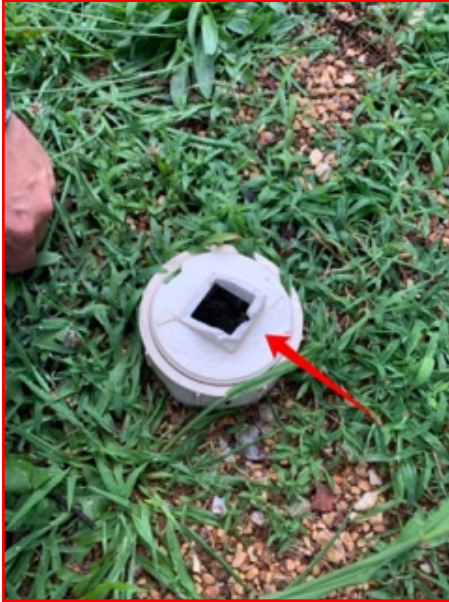
Figure 18-1

10) Observed damaged sewer clean out cap located in backyard. Recommend having it replaced with a proper cap.

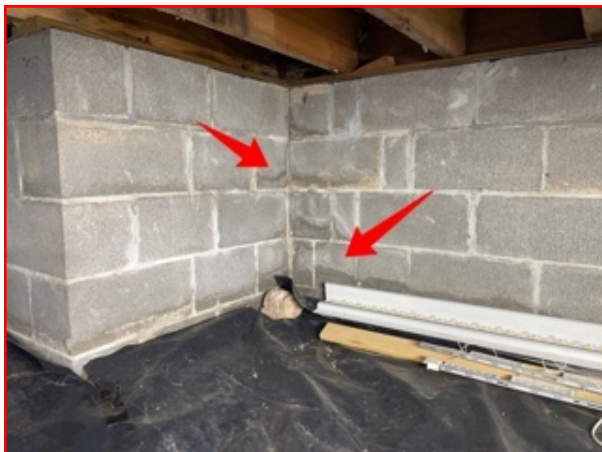
Figure 24-1

11) Observed efflorescence and moisture intrusion on block wall. Recommend further evaluation by a qualified specialist.
