OnPoint Property Inspections, LLC

Home Inspection Report

2252 Know Your Home Dr
Chattanooga, TN 37343

Inspected on Tue, Jun 8 2021 at 2:00 PM

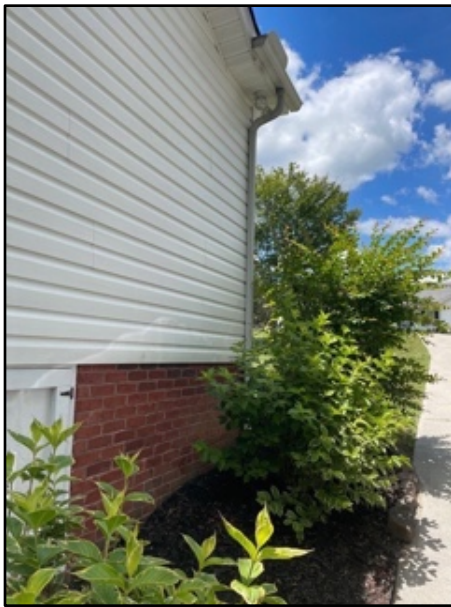
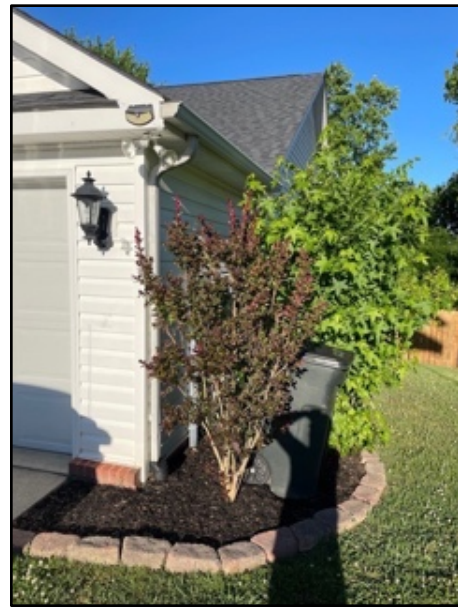
The vegetation (shrubs and/or trees) was in contact with the exterior walls. All vegetation should be trimmed away from structure to prevent potential moisture intrusion and damage to the house.

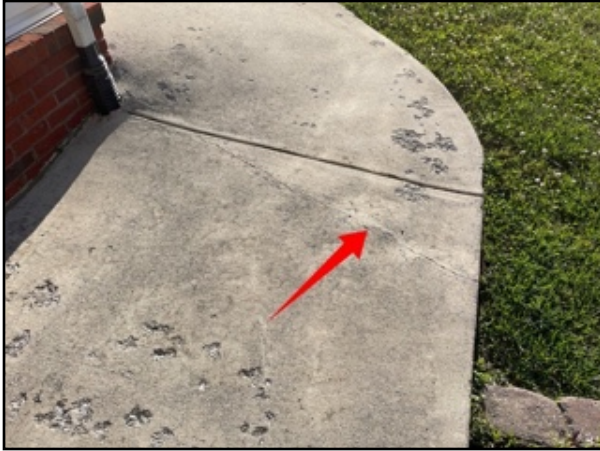
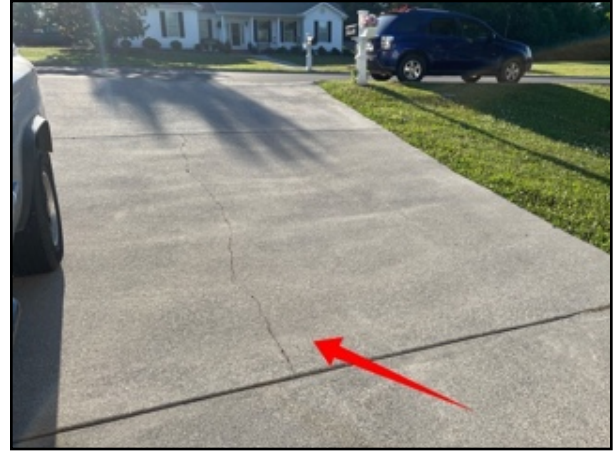
Settlement cracks were observed in the driveway & walkway on the front side of home. These cracks should be monitored and addressed if they widen and/or become displaced.

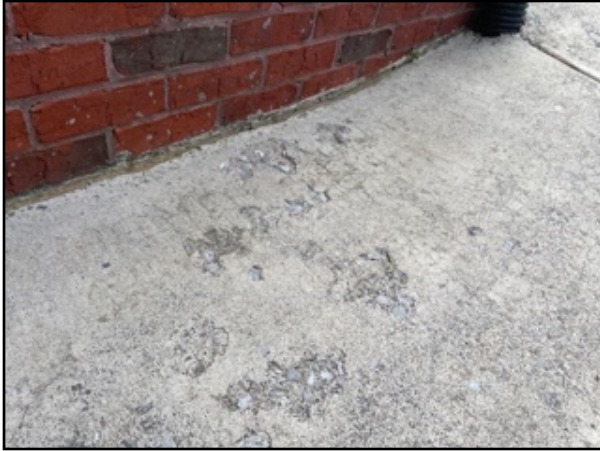
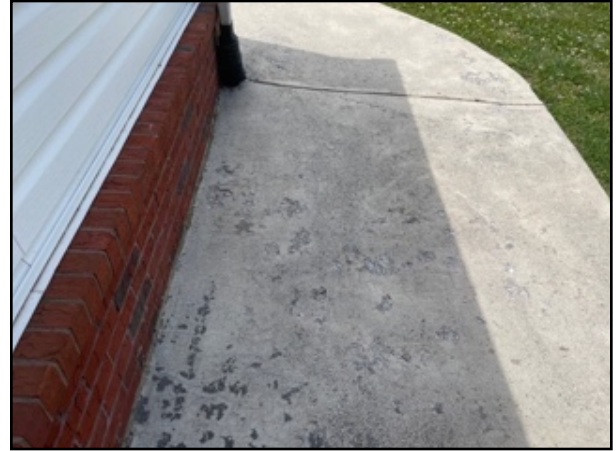
Spalling (corrosion) was observed on the concrete walkway. Spalling is surface deterioration that causes large flakes of concrete to detach from the surface. It can be caused by poor concrete mix at the time of original construction made worse by freeze damage. Recommend patching with an appropriate material to help prevent continued deterioration.

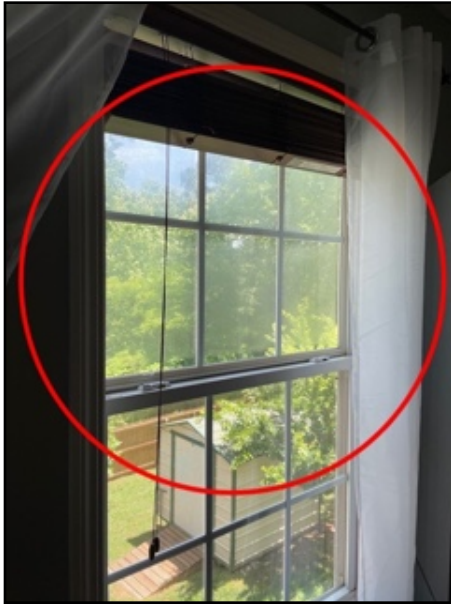
Figure 4-1

Observed a fogged window located in the family room. The hermetic seal has failed and will require replacement. These rubber-like seals are prone to failure with age and heat. Recommend further evaluation and replacement by a qualified contractor.

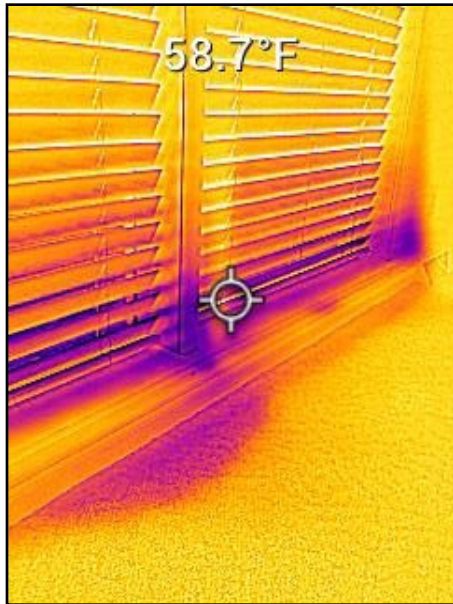
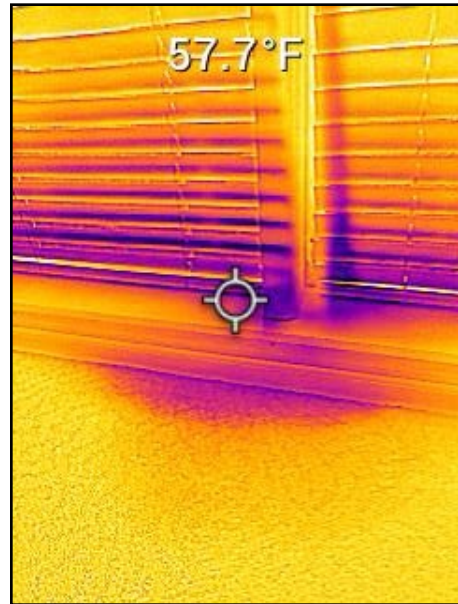
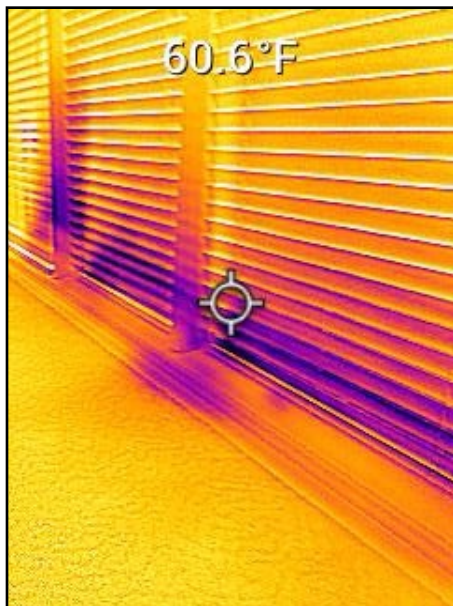
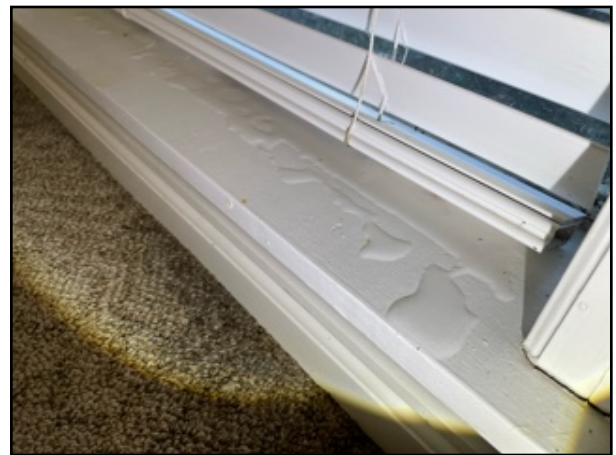
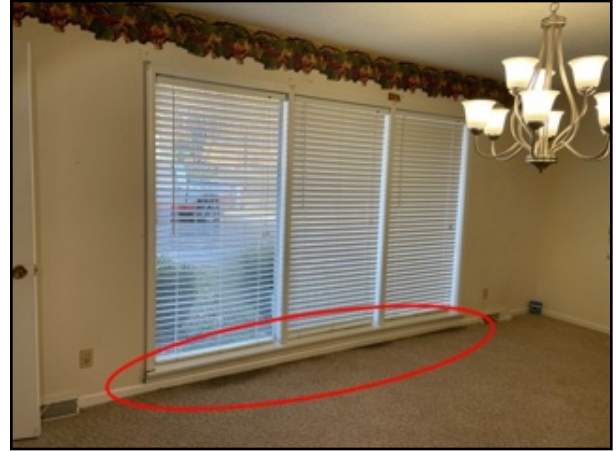
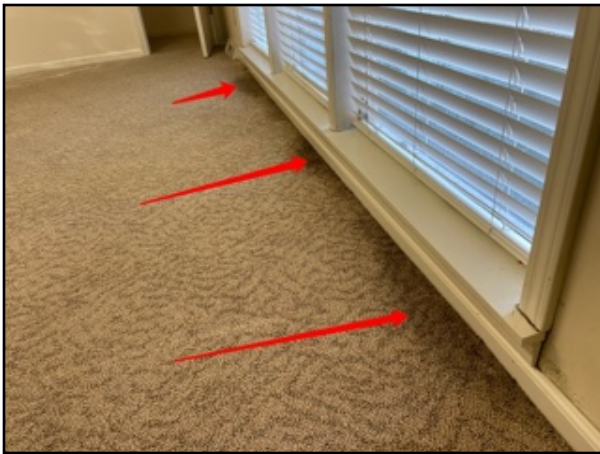
Observed water on the window sill located in the lower level back dining room. The large glass windows appeared to have excessive amount of condensation on the glass. This condensation looks to be building up on the window sill and running down into the carpet. This moisture is causing damage around the lower window sill. Recommend further evaluation and repair by a qualified contractor.

Attached: Thermal images to show the areas with moisture.

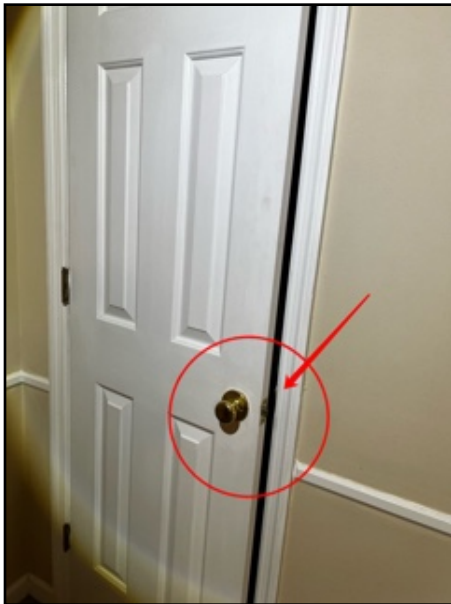
Figure 6-1

The front bedroom closet door did not latch properly. Recommend repair.

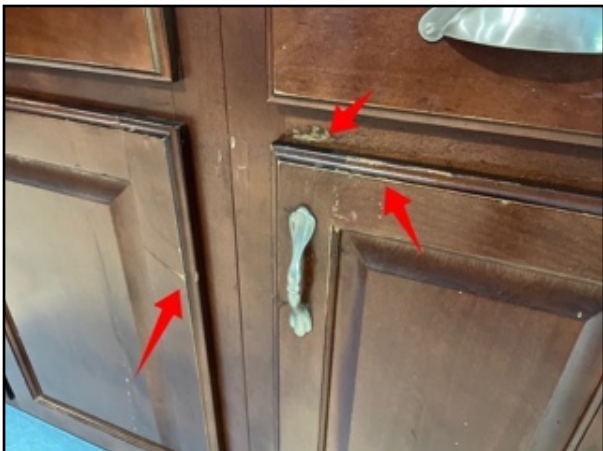
Figure 7-1

Observed worn cabinets & loose hardware throughout kitchen. Recommend securing hardware where needed.

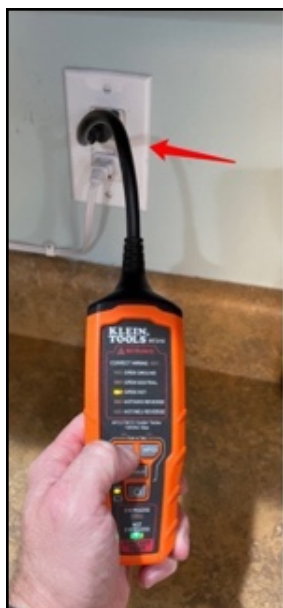
Figure 8-1

Comment 8:
The GFCI in the kitchen next to the coffee maker did not function properly when tested. Recommend further evaluation and replacement by a qualified electrician.

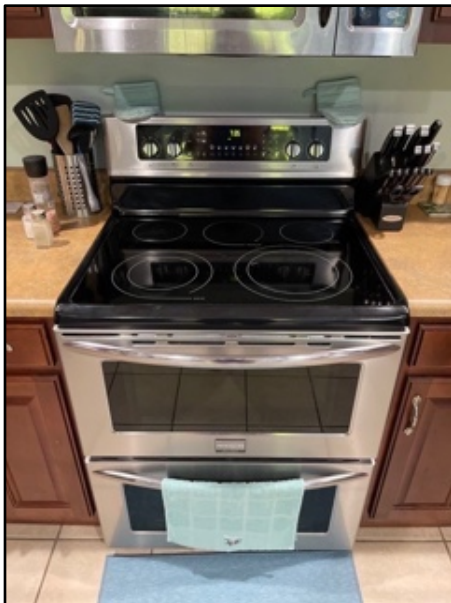
Figure 9-1

The anti-tip was not installed on the appliance. Recommend having the anti-tip device installed for child safety.

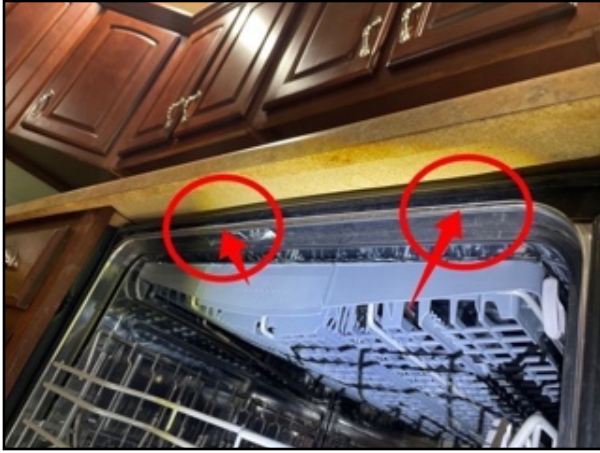
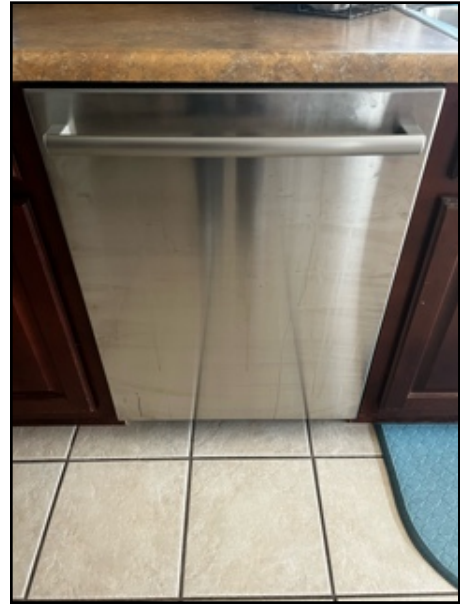
The dishwasher was not properly secured to the countertop. Recommend having a qualified contractor secure the dishwasher to the counter with the proper mounting hardware.

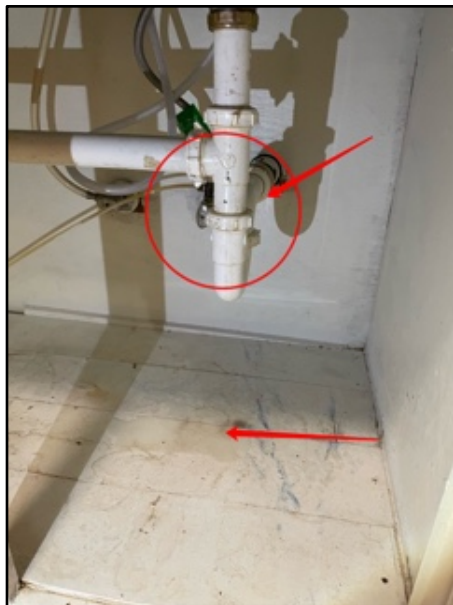
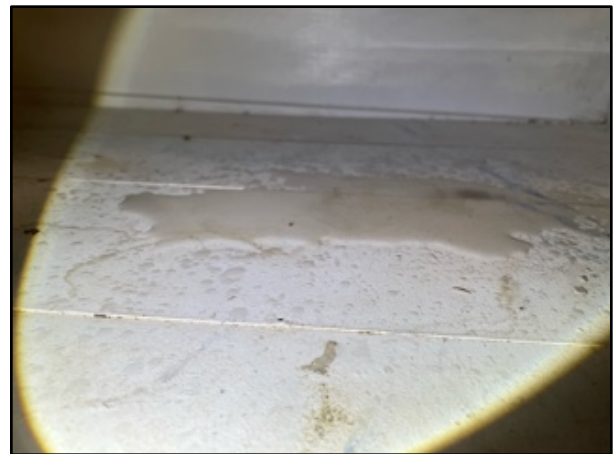
Observed a leak beneath the hallway bathroom sink. Recommend further evaluation and repair by a qualified plumber.

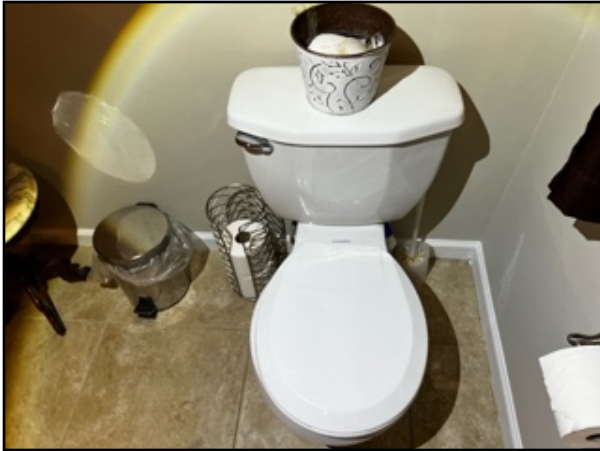
Figure 13-1

The toilet in the main bathroom was loose at floor. Recommend further evaluation and repair by a qualified plumber.

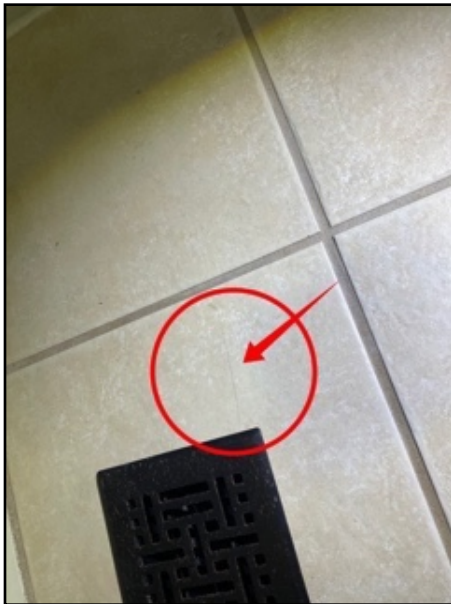
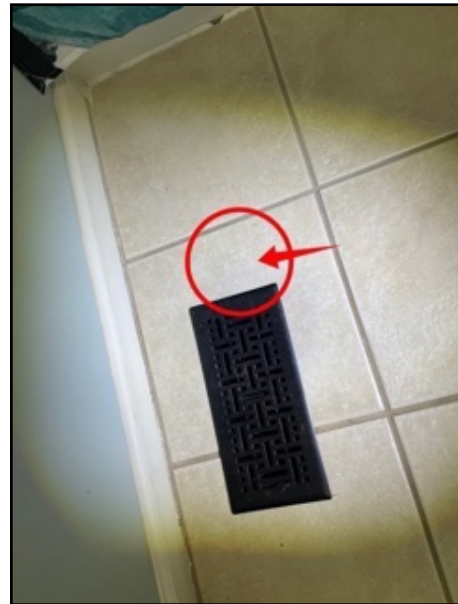
Comment 14:
Observed a cracked tile in master bathroom. Recommend repair.

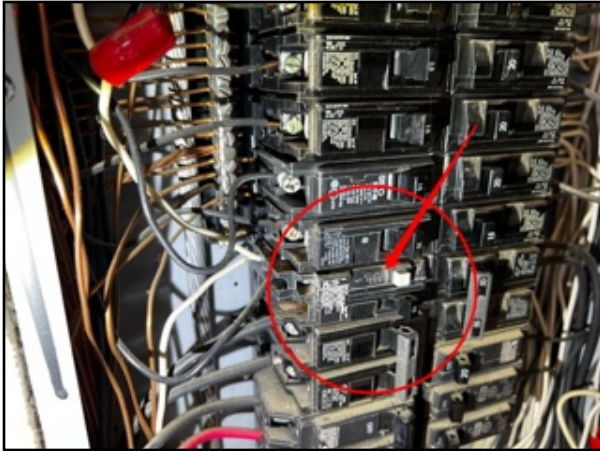
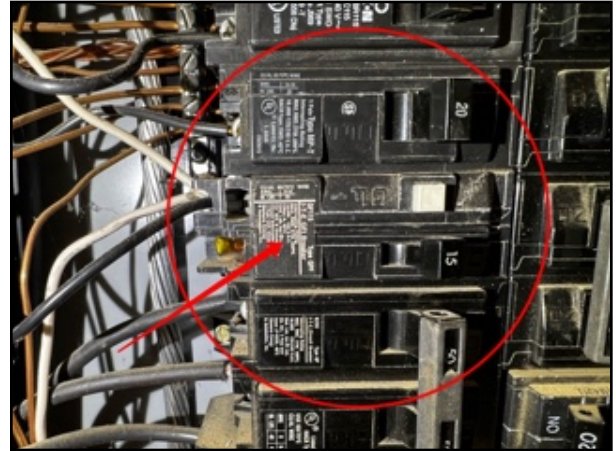
The GFCI breaker in the panel did not operate when tested. Recommend having it replaced by a qualified electrician.

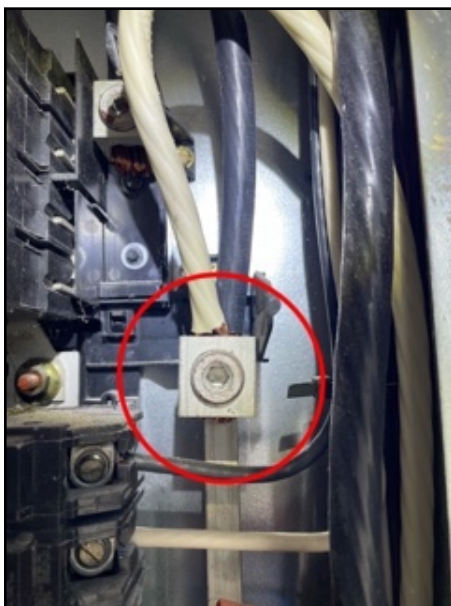
Figure 19-1

Observed double tapped wires on the neutral lugs in the main panel. Recommend further evaluation and repair by a qualified electrician.

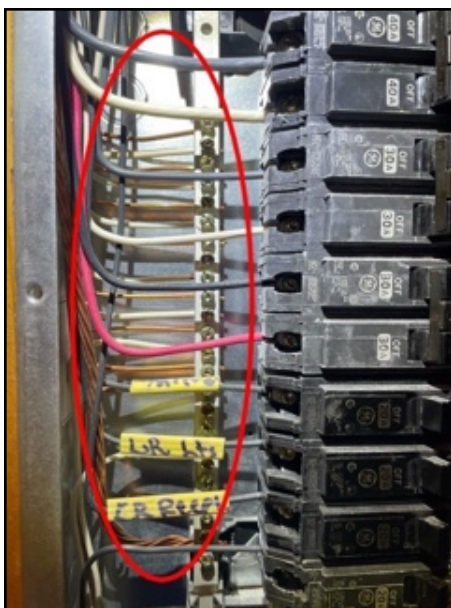
Figure 20-1

The grounds & neutral wires should be separated on their own bus bar within the panel. Recommend further evaluation and repair/correction by a qualified electrician.

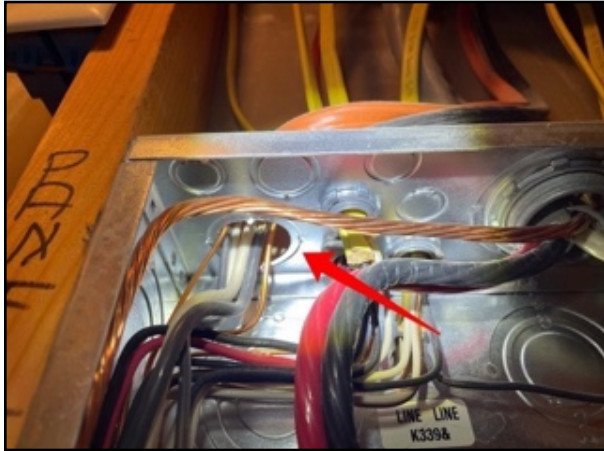
Figure 21-1

Recommend having a qualified electrician install the proper connector bushings on the wiring entering/exiting the sub panel for safety.

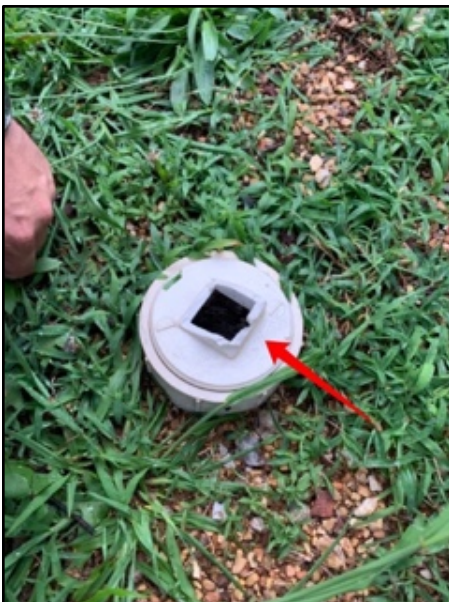
Figure 23-1

Observed a damaged sewer clean out cap located in backyard. Recommend having it replaced.

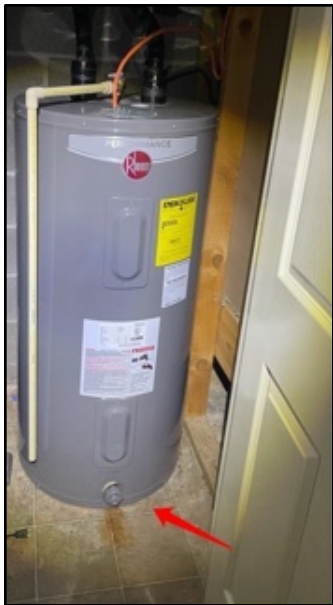
Figure 25-1

Recommend having a drip pan installed to catch potential leaks.

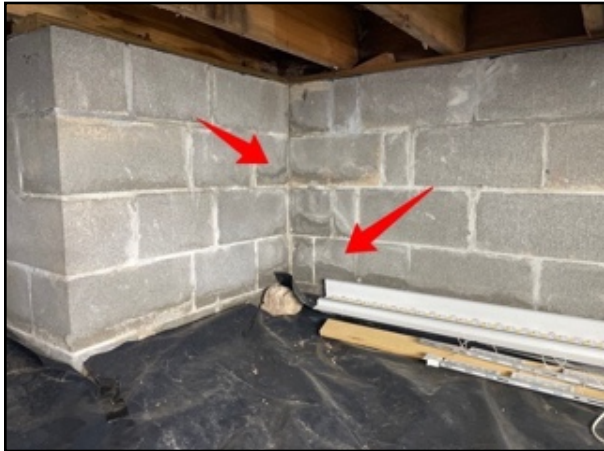
Figure 30-1

Observed efflorescence and moisture intrusion on the block wall in the crawlspace.

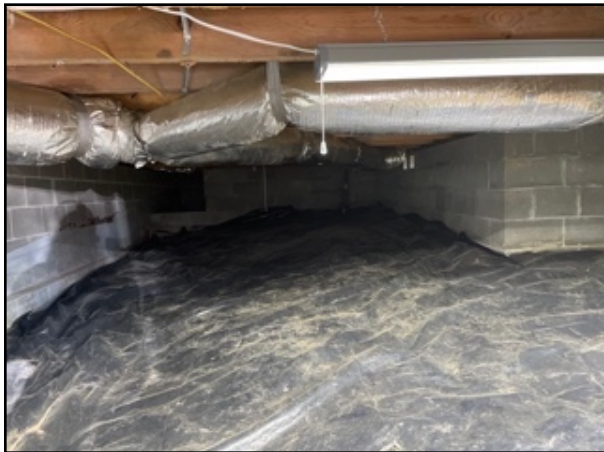
Figure 31-1

The crawlspace was properly vented and the vapor barrier was in satisfactory condition. Observed a sump pump perimeter drain system. The sump pump functioned properly when tested.

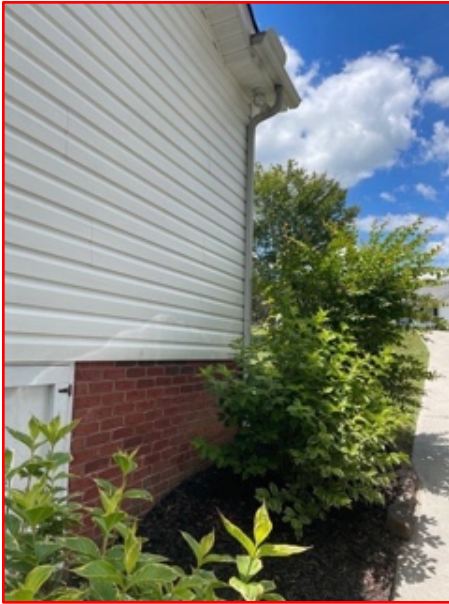
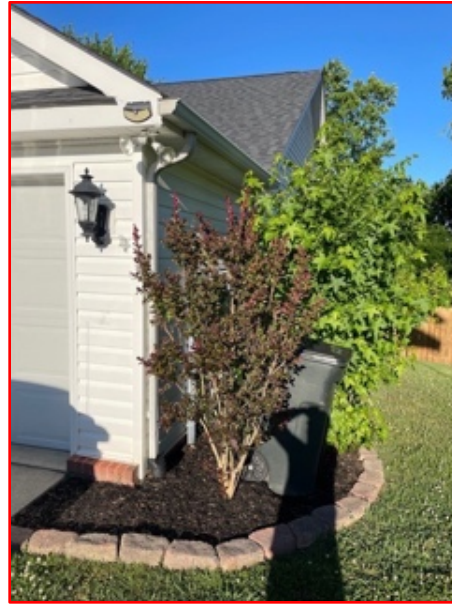
1) The vegetation (shrubs and/or trees) was in contact with the exterior walls. All vegetation should be trimmed away from structure to prevent potential moisture intrusion and damage to the house.

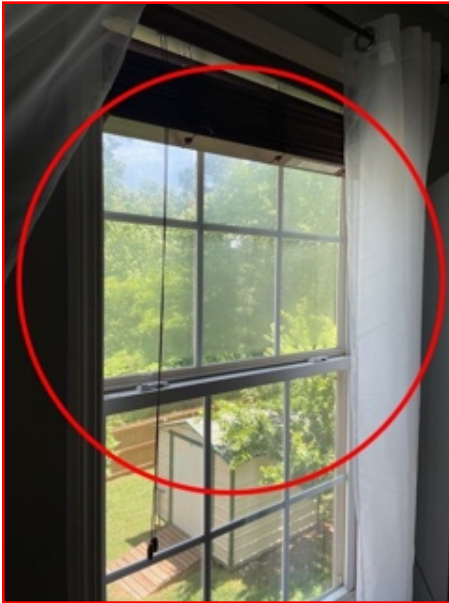
Figure 4-1

2) Observed a fogged window located in the family room. The hermetic seal has failed and will require replacement. These rubber-like seals are prone to failure with age and heat. Recommend further evaluation and replacement by a qualified contractor.

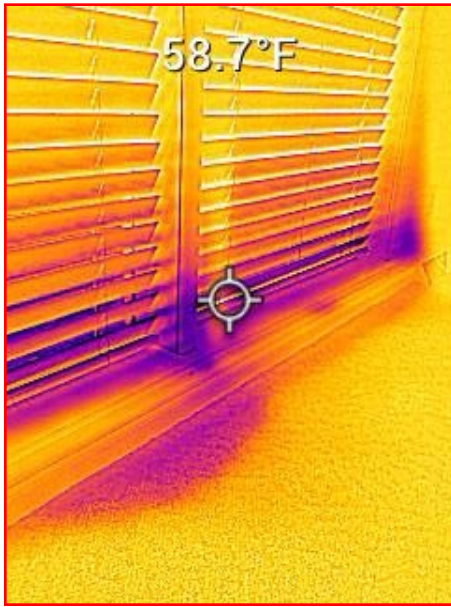
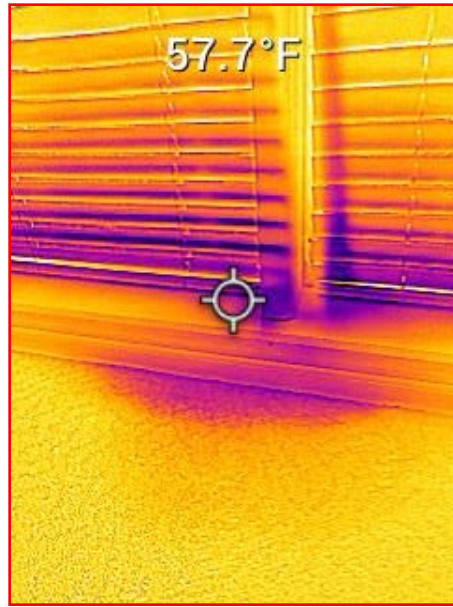
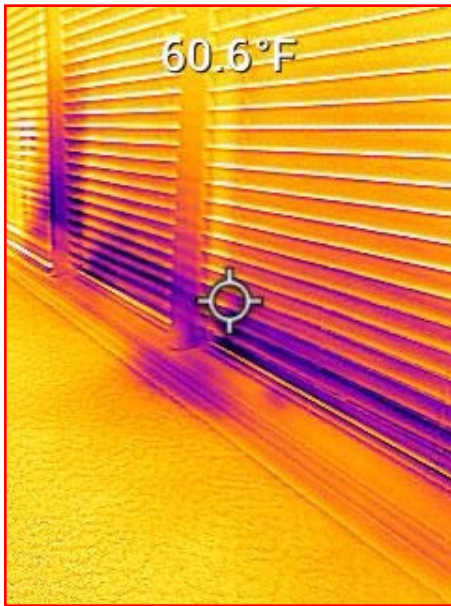
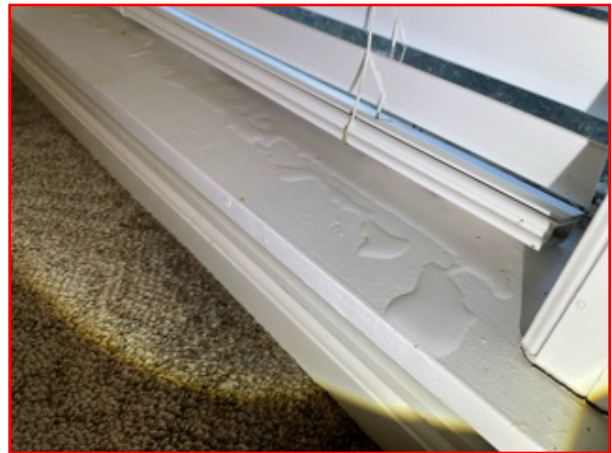
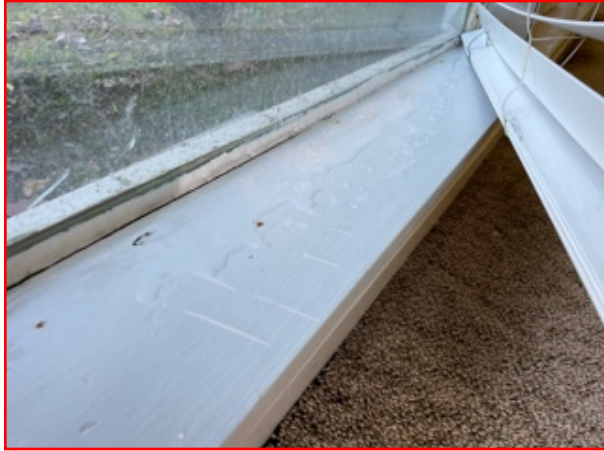
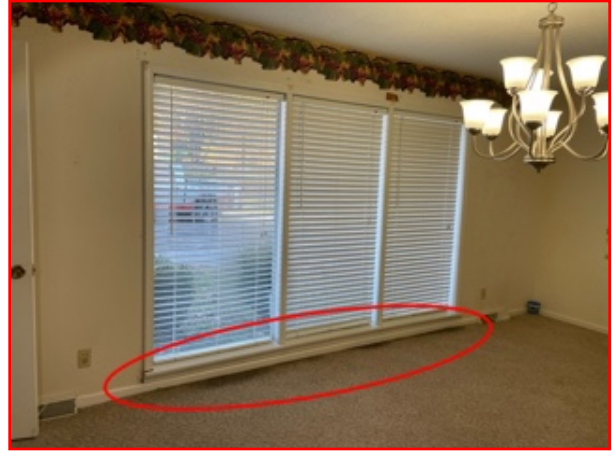
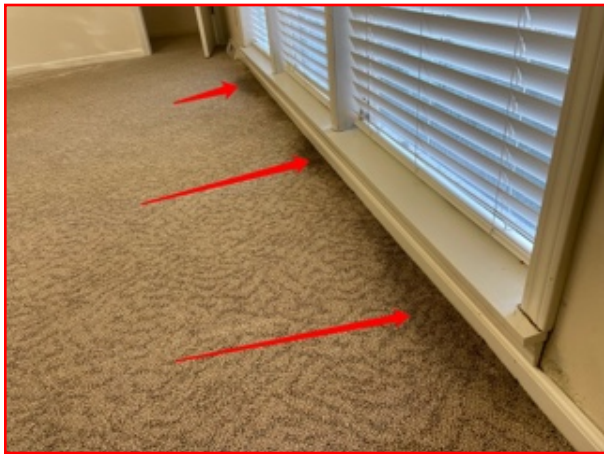
3) Observed water on the window sill located in the lower level back dining room. The large glass windows appeared to have excessive amount of condensation on the glass. This condensation looks to be building up on the window sill and running down into the carpet. This moisture is causing damage around the lower window sill. Recommend further evaluation and repair by a qualified contractor.

Attached: Thermal images to show the areas with moisture.

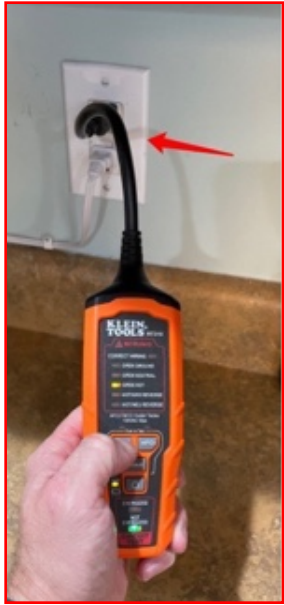
Figure 8-1

4) The GFCI in the kitchen next to the coffee maker did not function properly when tested. Recommend further evaluation and replacement by a qualified electrician.

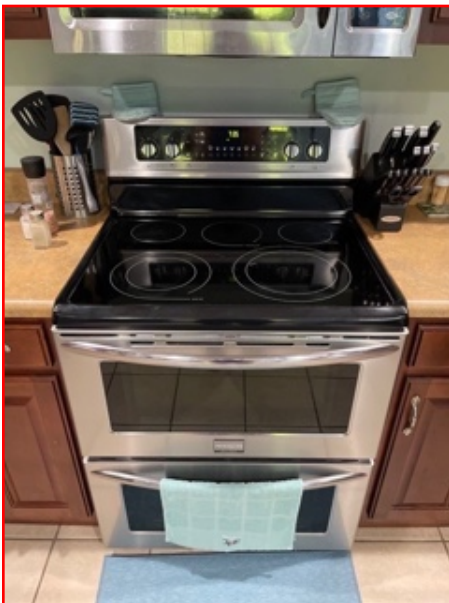
Figure 9-1

5) The anti-tip was not installed on the appliance. Recommend having the anti-tip device installed for child safety.

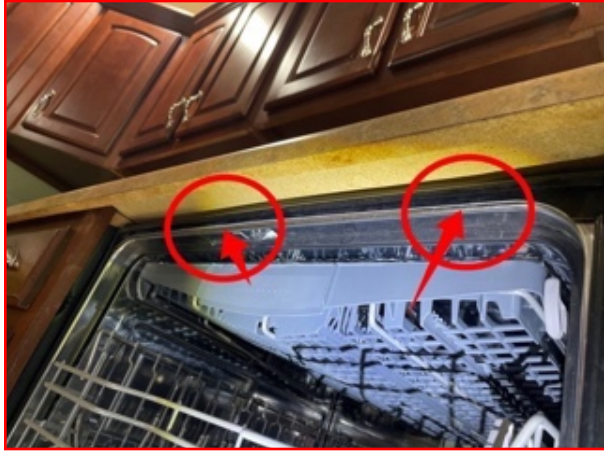
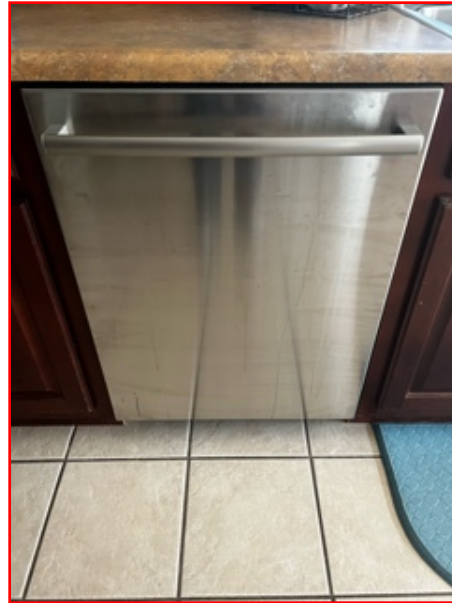
6) The dishwasher was not properly secured to the countertop. Recommend having a qualified contractor secure the dishwasher to the counter with the proper mounting hardware.

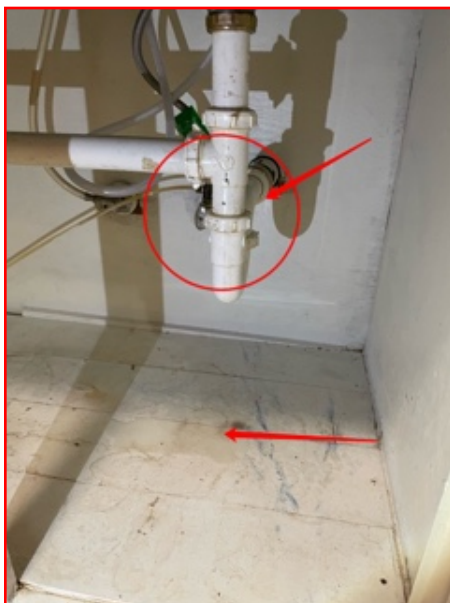
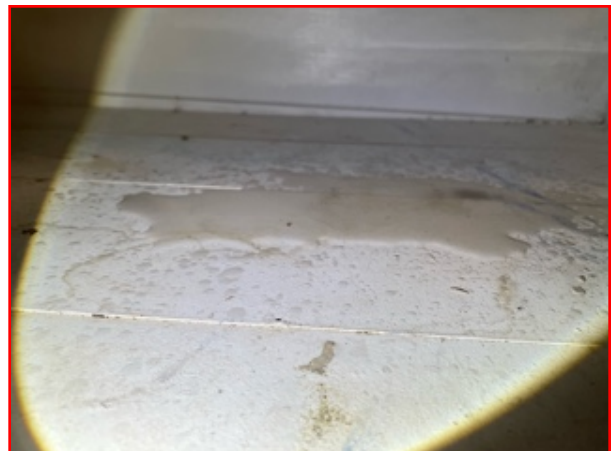
7) Observed a leak beneath the hallway bathroom sink. Recommend further evaluation and repair by a qualified plumber.

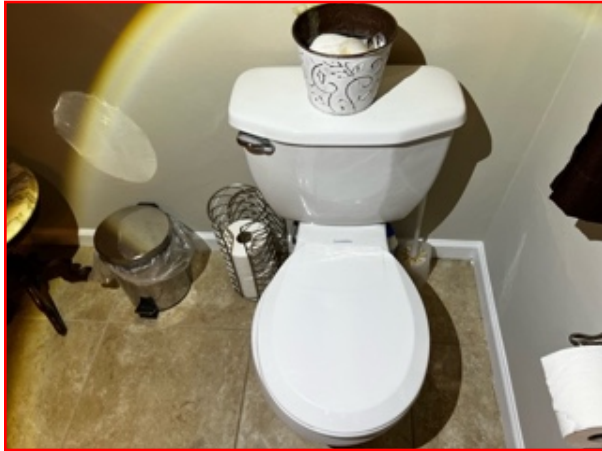
Figure 13-1

8) The toilet in the main bathroom was loose at floor. Recommend further evaluation and repair by a qualified plumber.

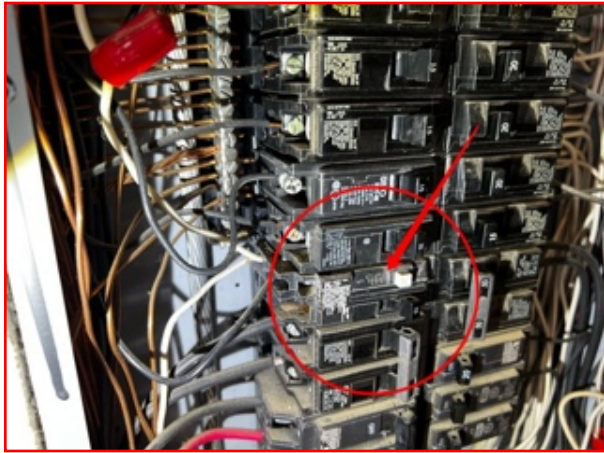
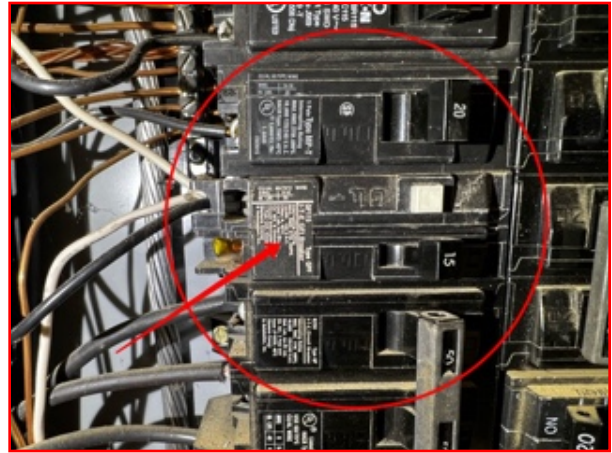
10) The GFCI breaker in the panel did not operate when tested. Recommend having it replaced by a qualified electrician.

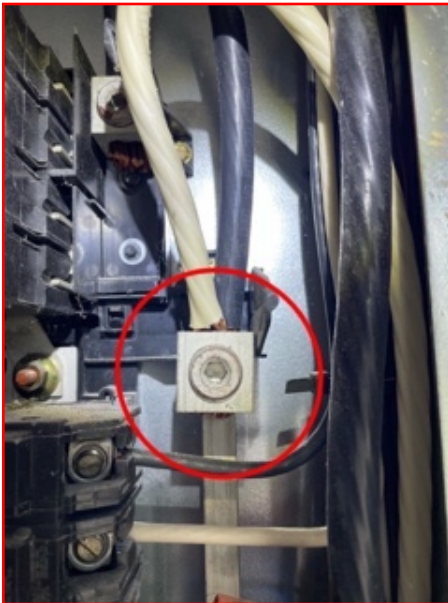
Figure 19-1

11) Observed double tapped wires on the neutral lugs in the main panel. Recommend further evaluation and repair by a qualified electrician.

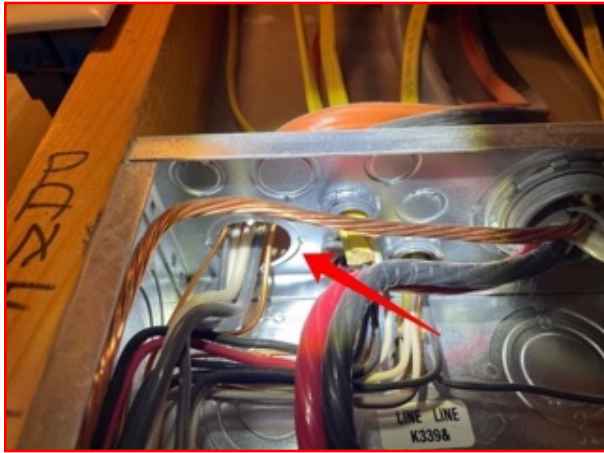
Figure 21-1

12) Recommend having a qualified electrician install the proper connector bushings on the wiring entering/exiting the sub panel for safety.

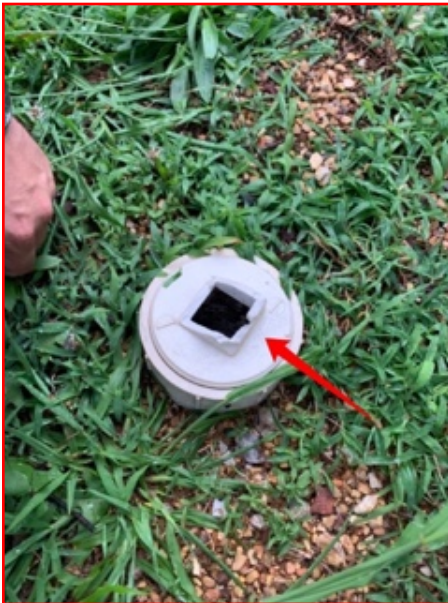
Figure 23-1

13) Observed a damaged sewer clean out cap located in backyard. Recommend having it replaced.
