BORESCOPE INSPECTION REPORT

GAS TURBINE ENGINE
TAURUS 65
COLD END DRIVE

Engine Serial Number
OHI21-D0140

Inspection Date
Tuesday, January 16, 2024

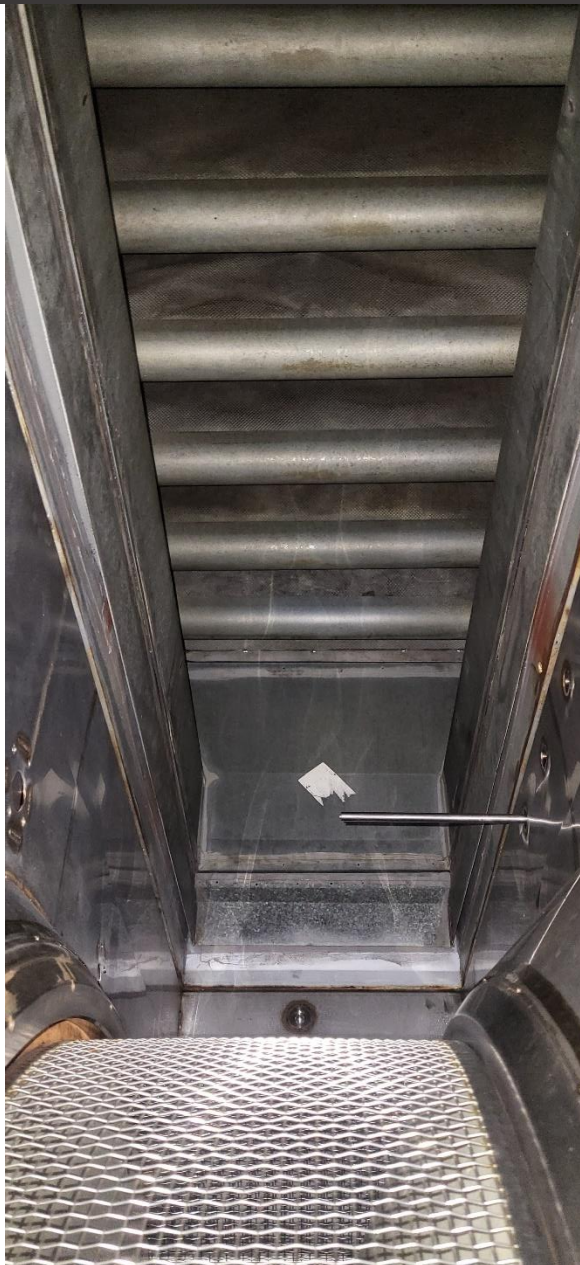
Air Inlet Duct

- a)Potential FOD
- b)Corrosive Pitting
- c)Cracks
- d)Excessive fouling

Normal Condition

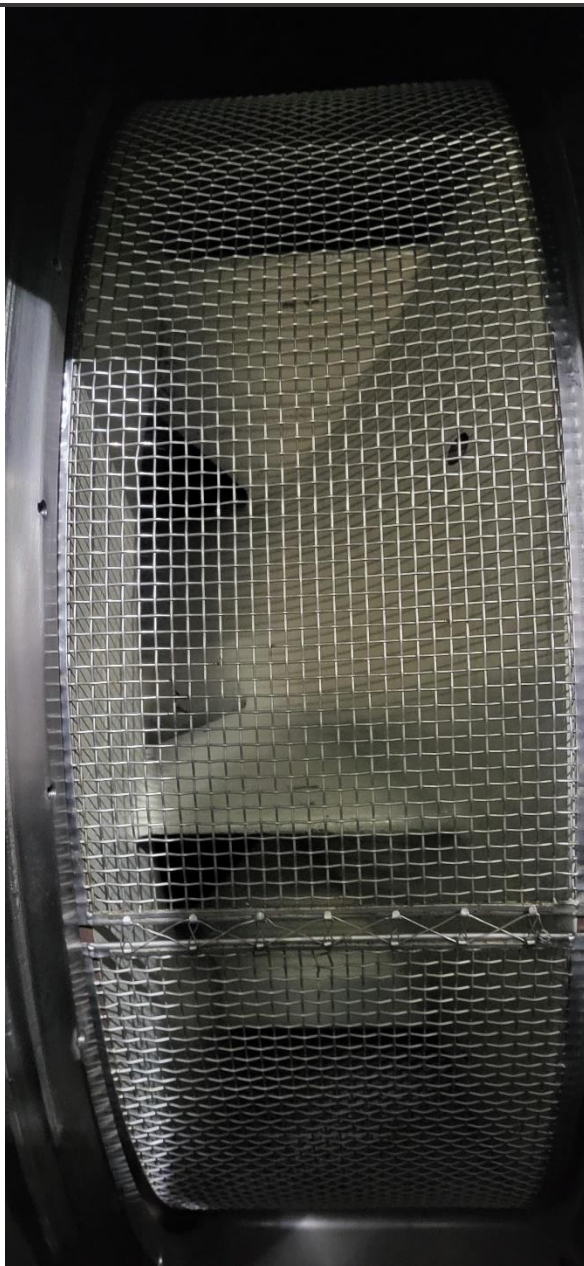
Air Inlet Screen

a)Potential FOD
b)Cracks, damaged mesh

Normal Condition

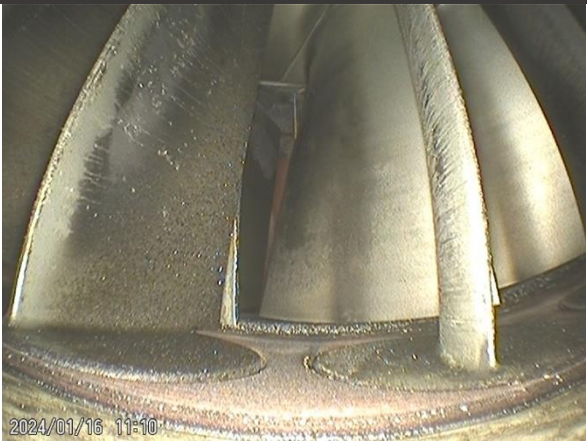
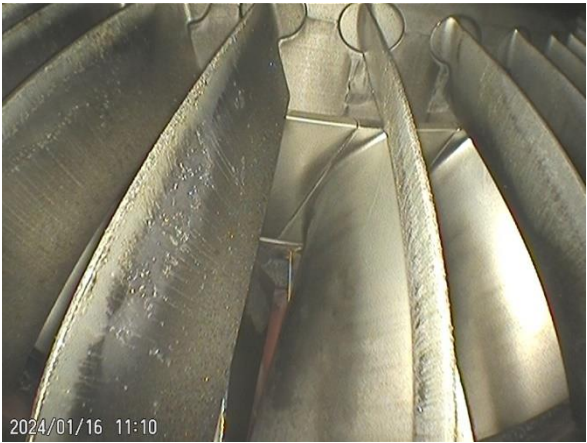
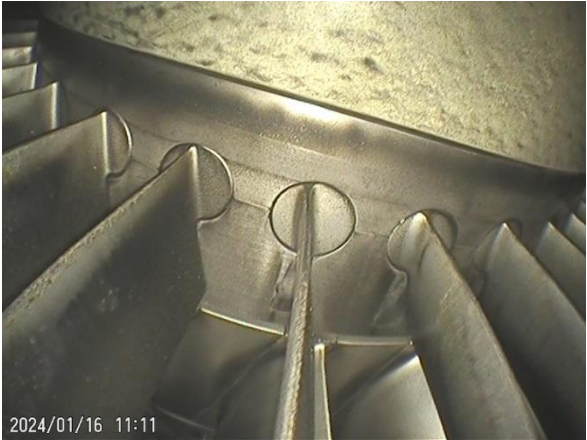
IGV

- a)Nicks and dents, Qty and size
- b)Excessive fouling
- c)Corrosive pitting. Affected Area

Normal Condition

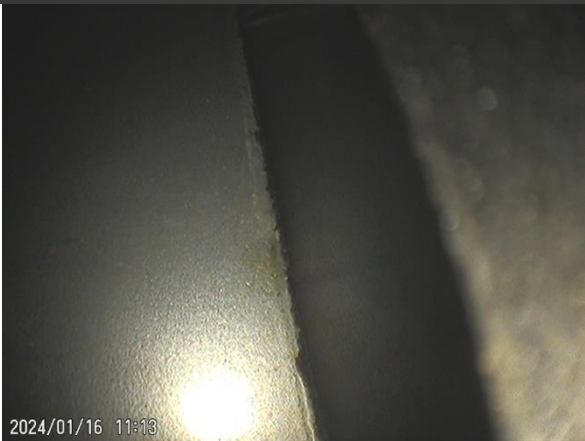
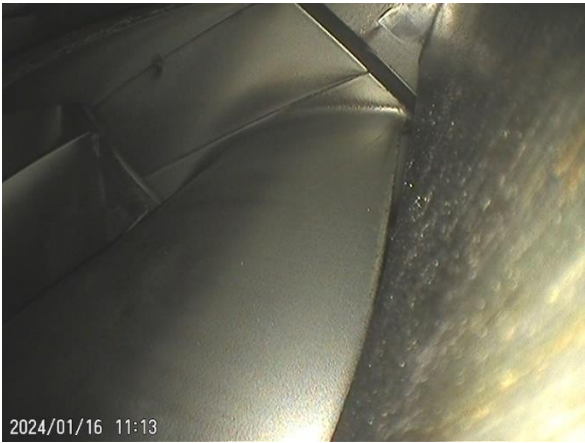
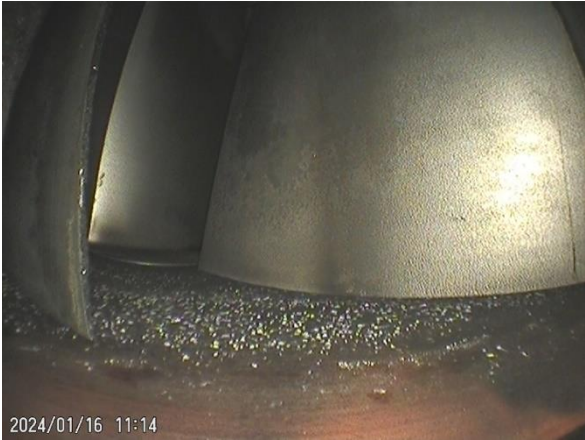
1st Stg
Compressor
Blades

- a)Nicks and dents, Qty and size
- b)Excessive fouling
- c)Corrosive pitting. Affected Area
- d)Tip rub, Gap & curling

Normal Condition

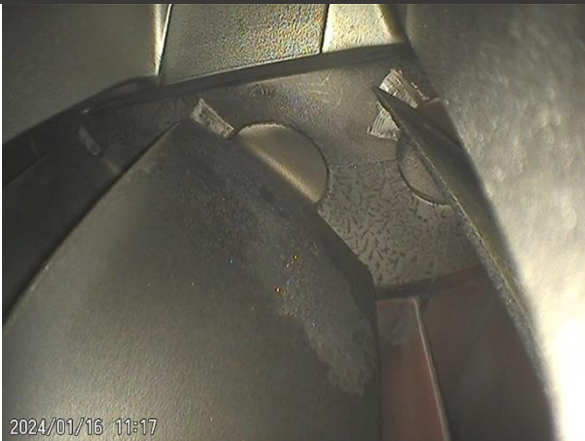
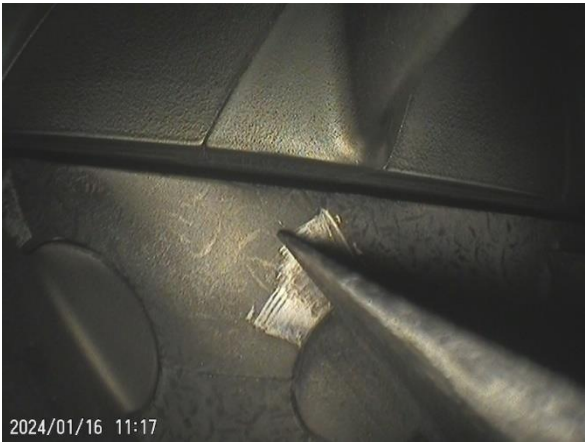
1st Stg
Compressor
VGV

Minor

Blade tip rub, gap
width

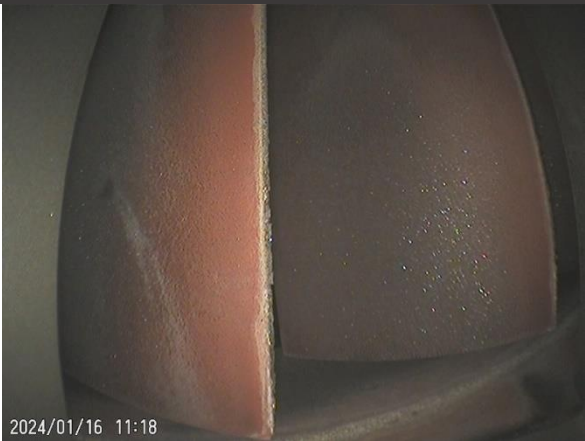
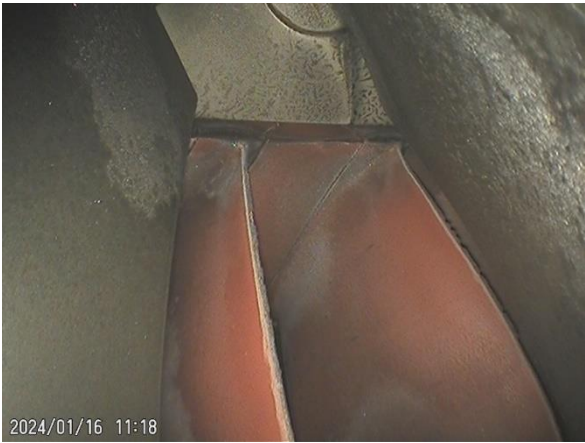
2nd Stg
Compressor
Blades

- a)Nicks and dents, Qty and size
- b)Excessive fouling
- c)Corrosive pitting. Affected Area
- d)Tip rub, Gap & curling

Normal Condition

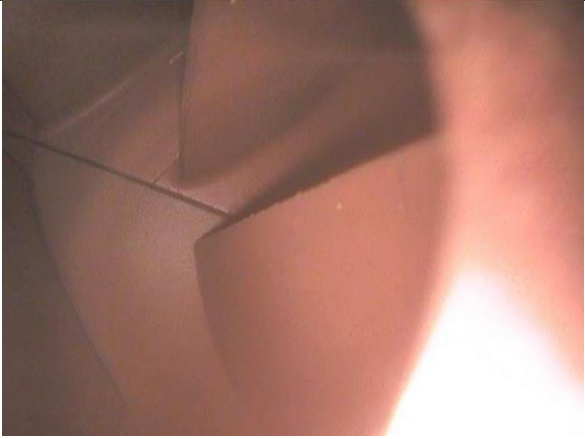
B 2nd Stg Compressor VGV

a)Nicks and dents, Qty and size b)Excessive fouling c)Corrosive pitting. Affected Area	Normal Condition Not applicable

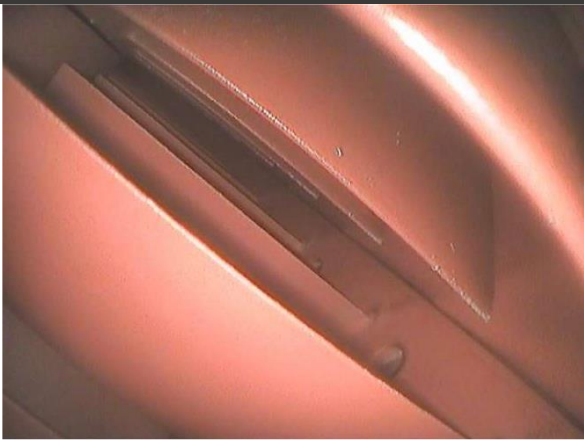
Access location Description	Picture	Inspection for	Severity / Comments
B 3rd Stg Compressor Blades

a)Nicks and dents, Qty and size b)Excessive fouling c)Corrosive pitting. Affected Area d)Tip rub, Gap & curling	Normal Condition Not applicable
C 4th Stg Compressor Blades

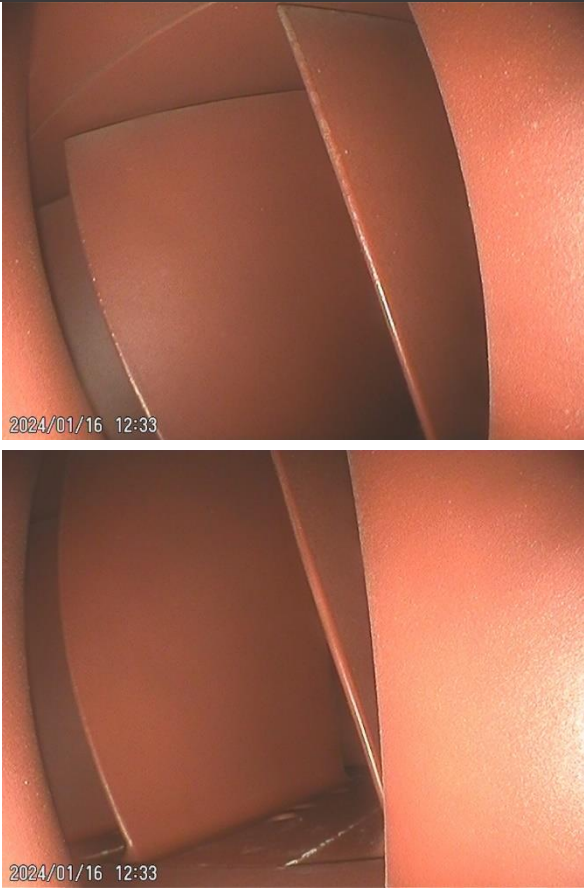
a)Nicks and dents, Qty and size b)Excessive fouling c)Corrosive pitting. Affected Area d)Tip rub, Gap & curling	Normal Condition Not applicable

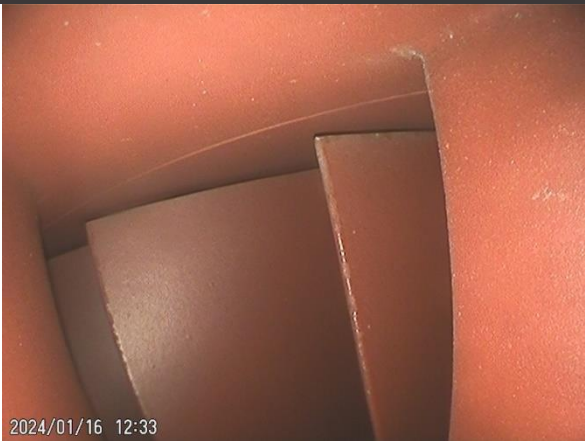
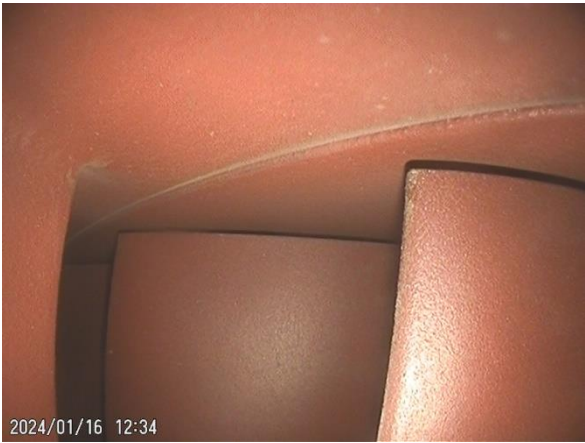
5th Stg
Compressor
Blades

- a)Nicks and dents, Qty and size
- b)Excessive fouling
- c)Corrosive pitting. Affected Area
- d)Tip rub, Gap & curling

Normal Condition

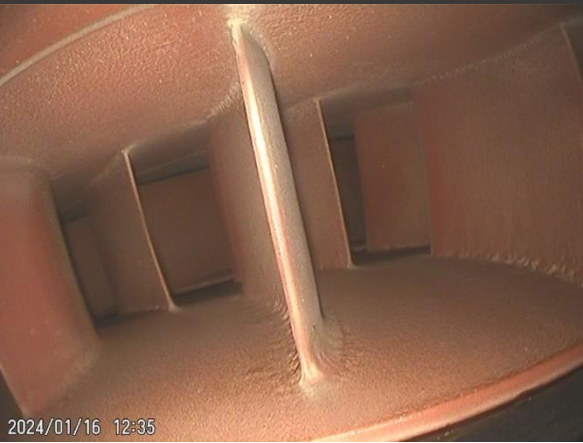
Access location Description	Picture	Inspection for	Severity / Comments
D Compressor Exit GV

Normal Condition Not applicable

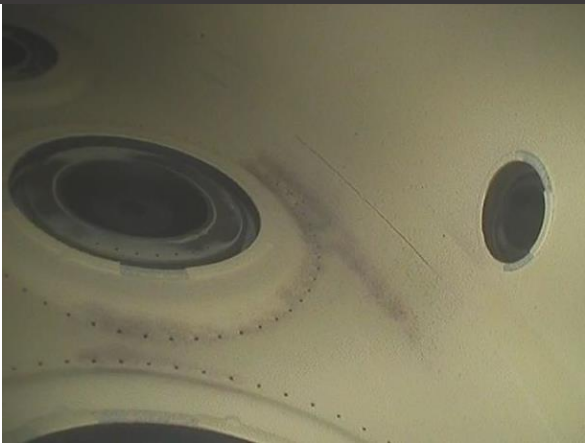
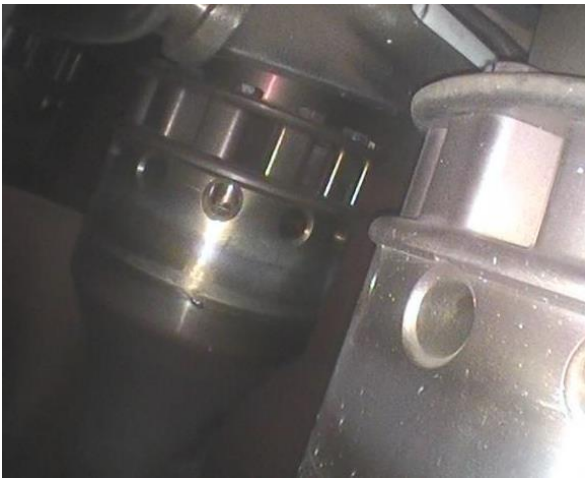
Access location Description	Picture	Inspection for	Severity / Comments
D Injectors

a)Pilot center erosion b)Fuel hole contaminated, blocked c)Liquid: broken fuel spoke	Normal Condition Not applicable

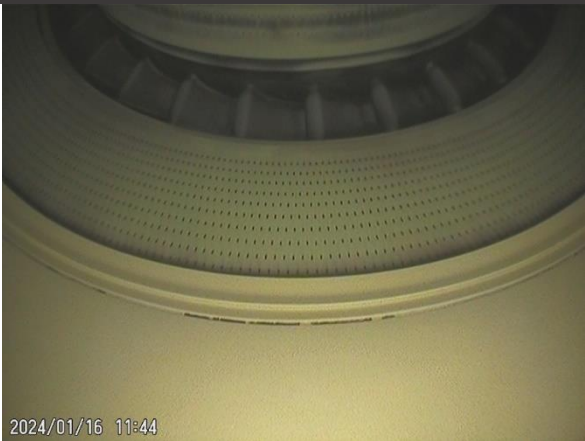
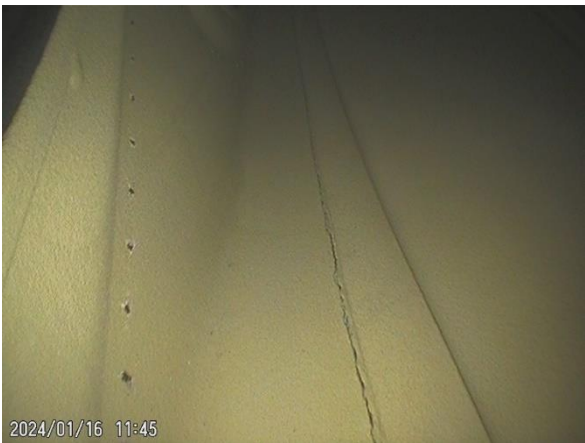
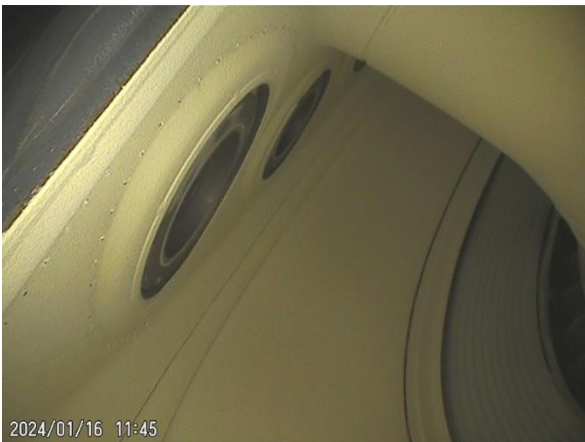
Combustor
Interior

a)Cracks, Qty, length, orientation	Normal Condition
b)Thermal erosion	Not applicable
c)Hot spots	
d)Buckling or warpage

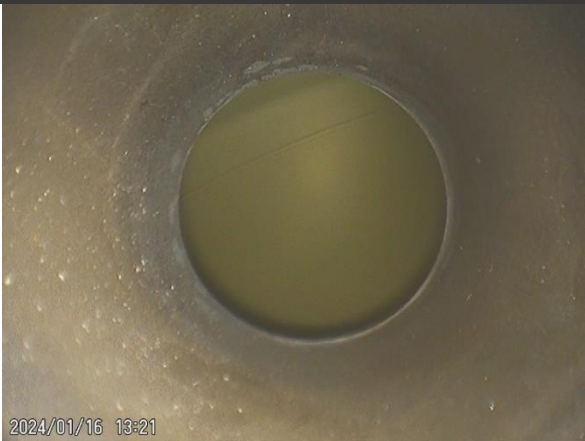
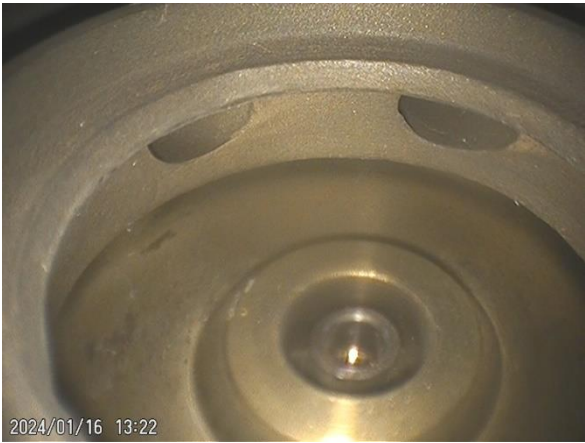
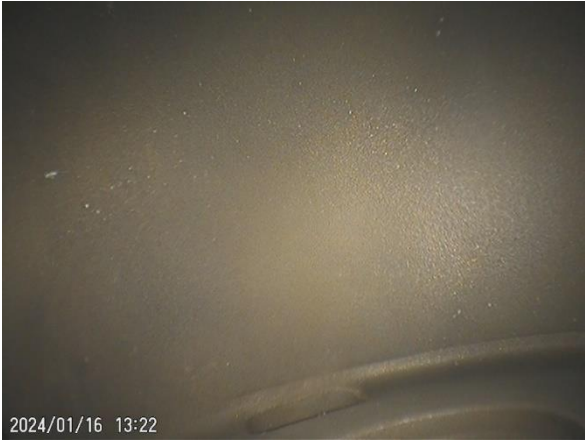
D
Torch Tube

Normal Condition
a)Thermal erosion
Not applicable

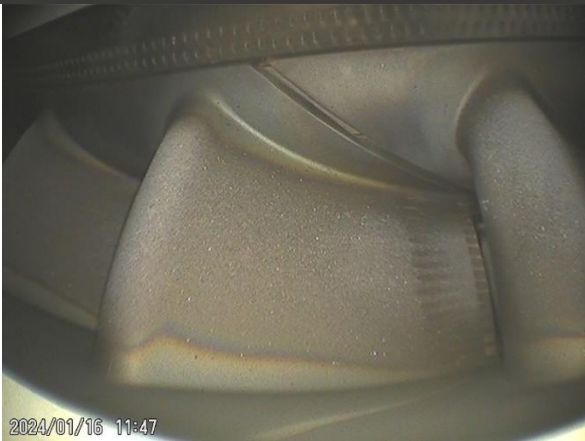
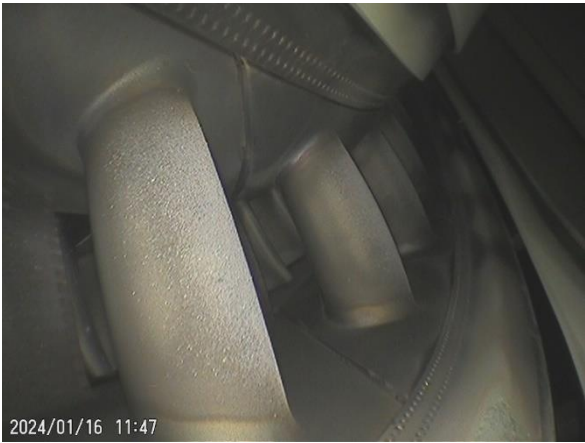
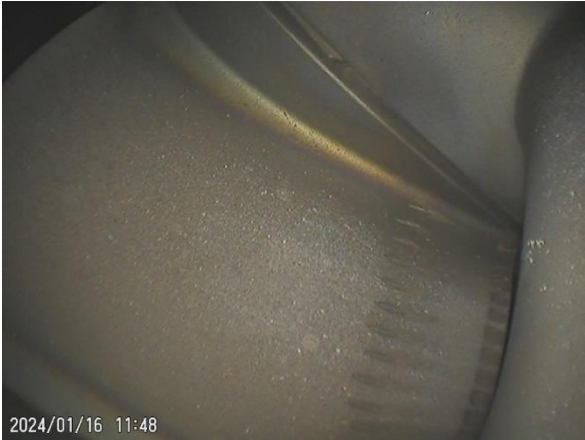
1st Stg Turbine
Nozzles

- a)Cracks, Qty, length, orientation
- b)Thermal erosion, Depth and area
- c)FOD Affected area

Normal Condition

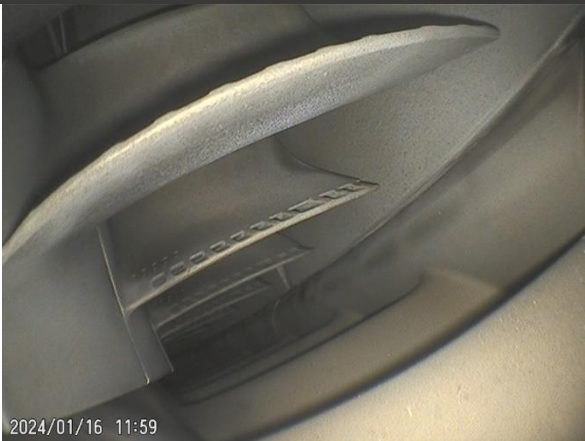
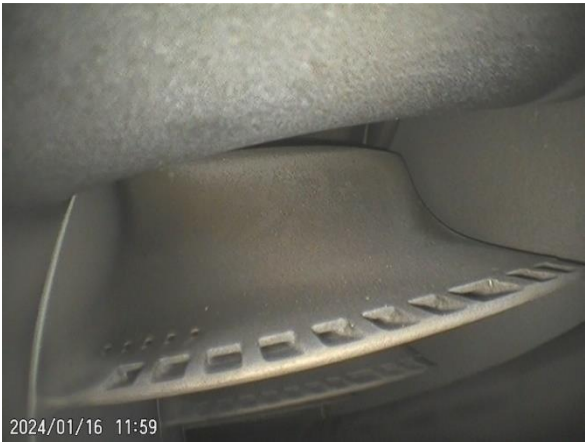
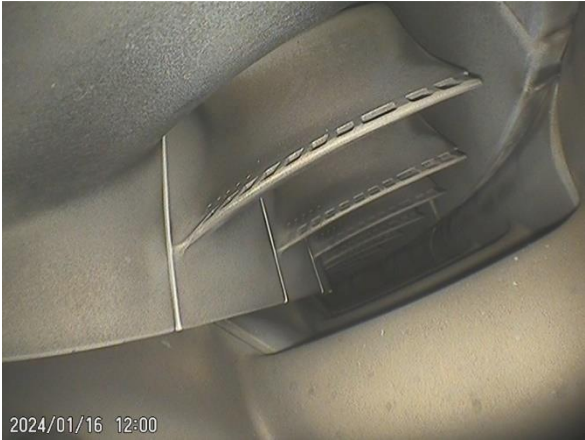
1st Stg Turbine
Blades

a)Cracks, Qty, length, orientation	Normal Condition
b)Thermal erosion, Depth and area	Not applicable
c)FOD Affected area	
d)Tip rub, gap width

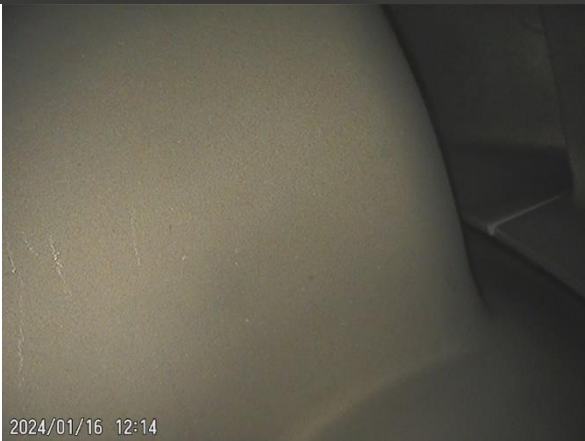
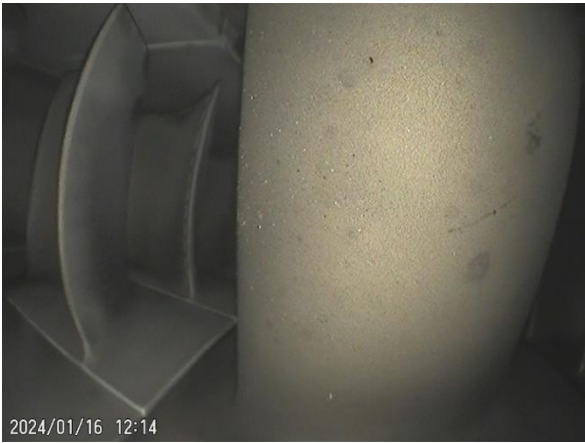
2nd Stg Turbine
Nozzles

- a)Cracks, Qty, length, orientation
- b)Thermal erosion, Depth and area
- c)FOD Affected area

Normal Condition

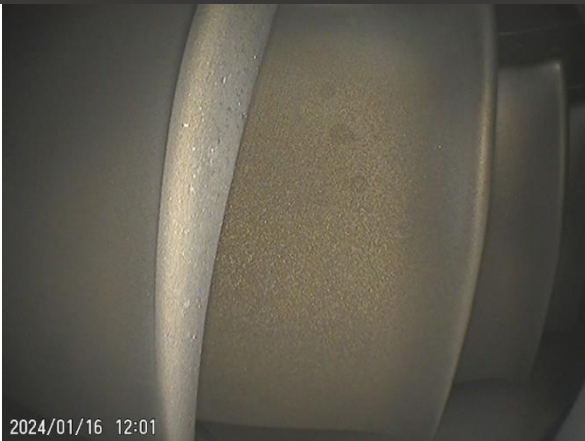
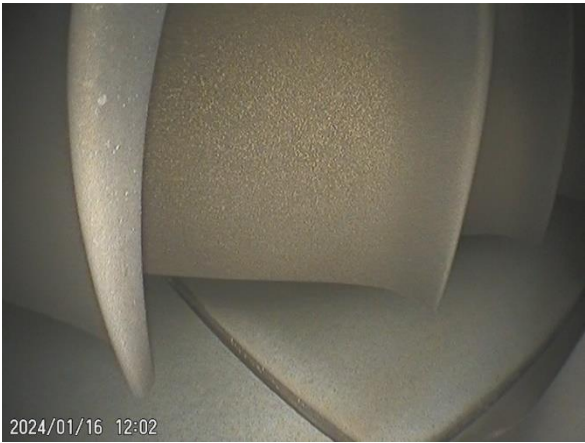
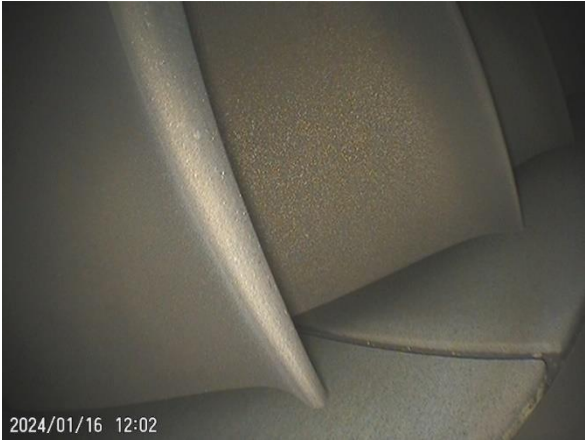
2nd Stg Turbine
Blades

a)Cracks, Qty, length, orientation	Normal Condition
b)Thermal erosion, Depth and area	Not applicable
c)FOD Affected area	
d)Tip rub, gap width

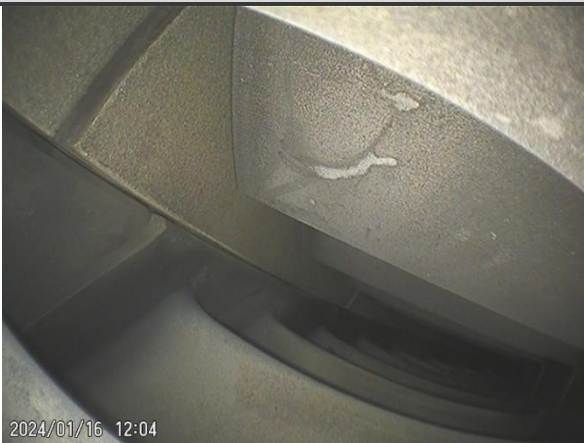
Access location Description	Picture	Inspection for	Severity / Comments
E 3rd Stg Turbine Nozzles

a)Cracks, Qty, length, orientation b)Thermal erosion, Depth and area c)FOD Affected area	Normal Condition Not applicable

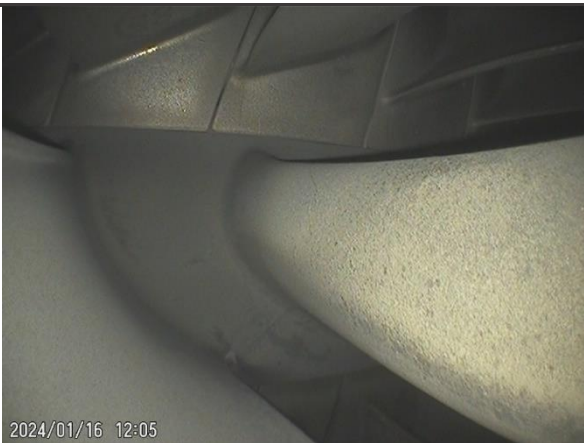
F 3rd Stg Turbine Nozzles

a)Cracks, Qty, length, orientation b)Thermal erosion, Depth and area c)FOD Affected area	Normal Condition Not applicable

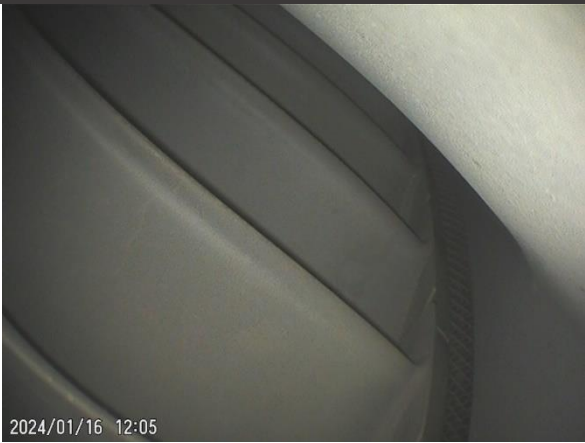
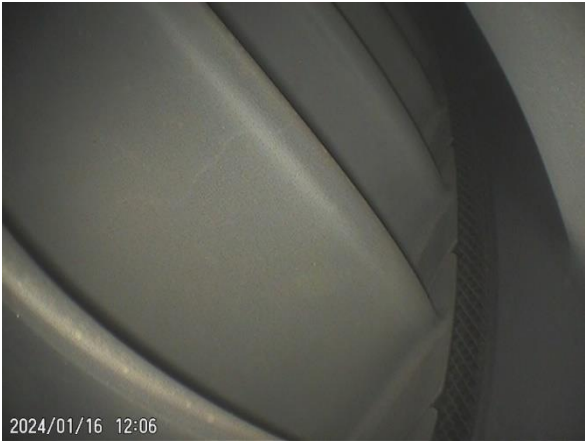
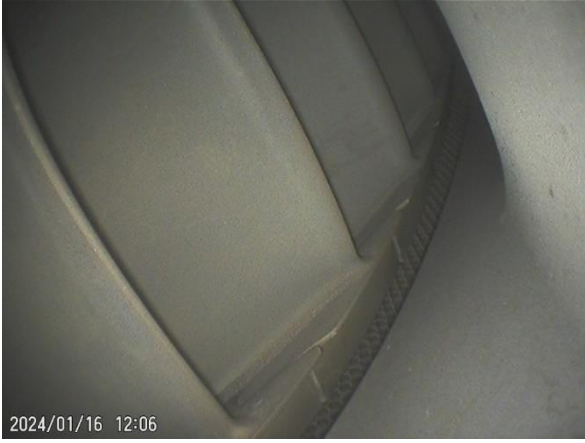
Access location Description	Picture	Inspection for	Severity / Comments
F 3rd Stg Turbine Blades

a)Cracks, Qty, length, orientation	Normal Condition
		b)Thermal erosion, Depth and area	Not applicable

c)FOD Affected area d)Tip rub, gap width

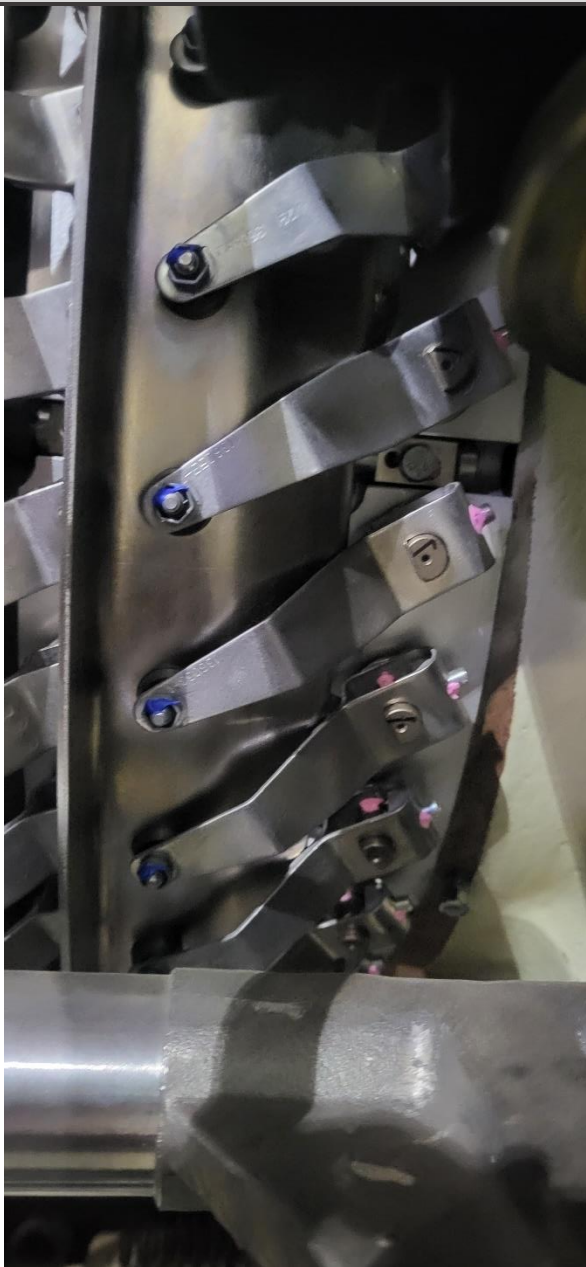
Access location Description	Picture	Inspection for	Severity / Comments
VGV IGV

a)Cracks b)Lever arms bent c)Grommet out of position on unison ring d)Corrosion	Normal Condition Not applicable

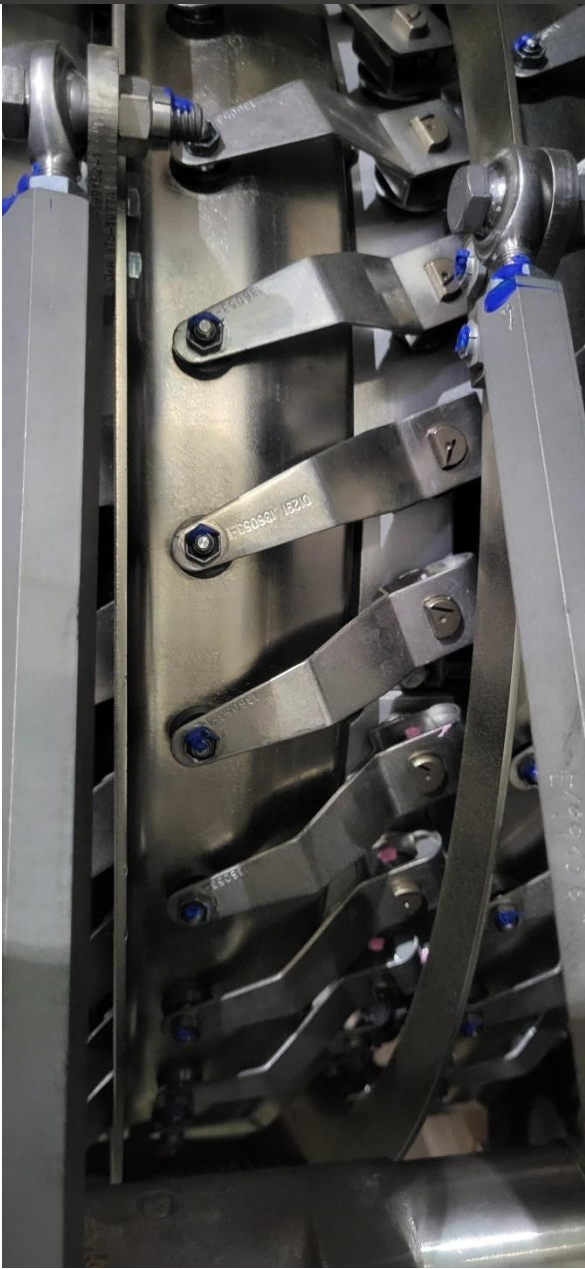
Access location Description	Picture	Inspection for	Severity / Comments
VG 1st Stg VG

a)Cracks b)Lever arms bent c)Grommet out of position on unison ring d)Corrosion	Normal Condition Not applicable

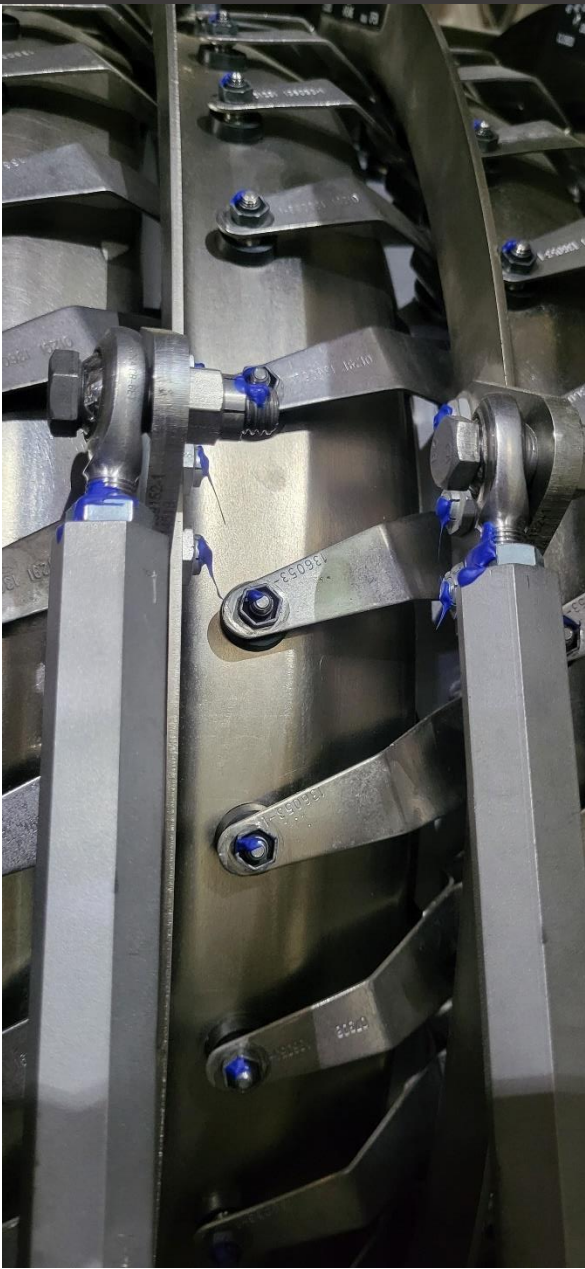
Access location Description	Picture	Inspection for	Severity / Comments
VGW 2nd Stg VGW

a)Cracks b)Lever arms bent c)Grommet out of position on unison ring d)Corrosion	Normal Condition Not applicable

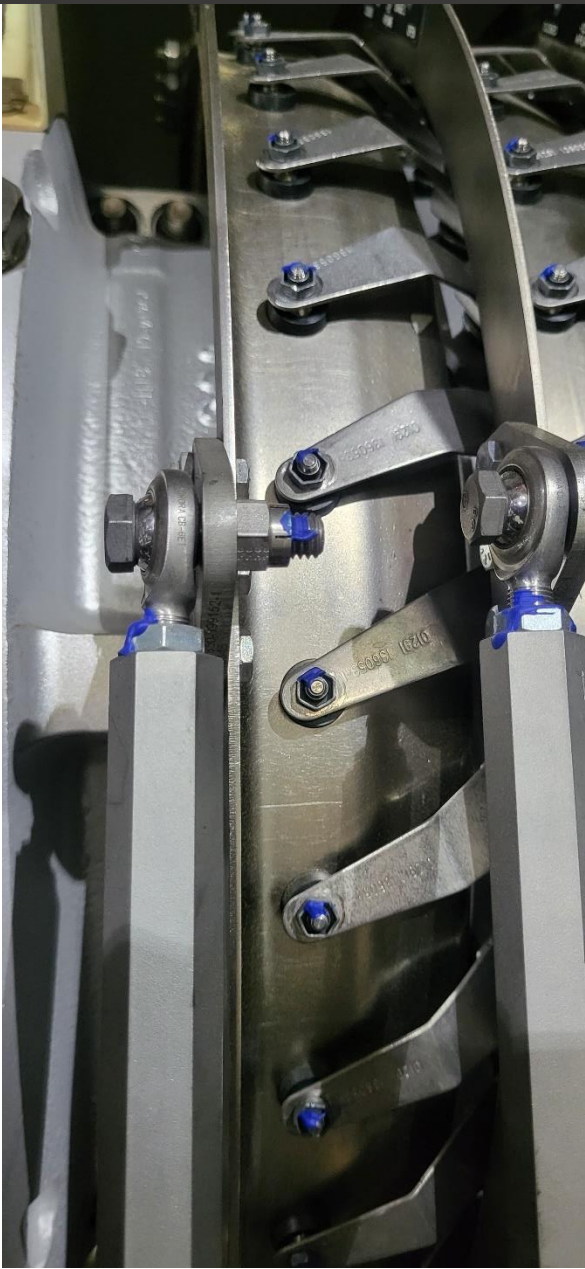
Access location Description	Picture	Inspection for	Severity / Comments
VGW 3rd Stg VGW

a)Cracks b)Lever arms bent c)Grommet out of position on unison ring d)Corrosion	Normal Condition Not applicable
