NOVEMBER 2021

# HANA + Walkable Arlington Walk Audit

**Arlington, Texas**

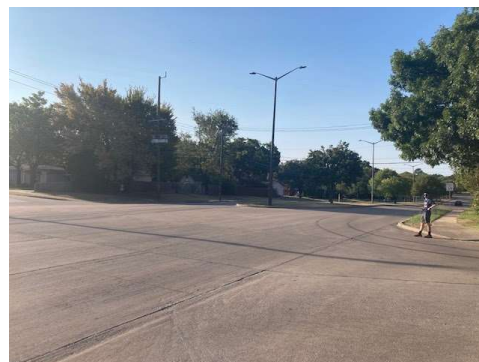
The greatest issue encountered in the S. Center Street route was the lack of intersection safety. During the course of the audit, pedestrians and cyclists were observed crossing six lanes of traffic to get to the strip mall on the

east side of S. Center Street (see Figure 2). Audit participant and long-time resident Jim Gayda observed that during weekday morning and evening traffic it would be very difficult if not impossible for pedestrians and cyclists to cross over S. Center street. Although a median can be found on S. Center Street, it does not serve as a pedestrian/bicycle walkway/island. The closest signalized crossing is approximately 700 feet away. The audit team observed unsafe driver behavior on S. Center Street. Drivers did not respect stop signs and did not look for pedestrians when leaving neighborhood streets and entering on S. Center street. Gayda reported concerns of speeding and reckless driver behavior along S. Center during weekday afternoons. With the exception of some cyclists riding on the street to make way for pedestrians present on sidewalks, cyclists of different ages (school age and adults) were observed riding on the sidewalks. Bicycle infrastructure was rated as very bad as there were no safe alternatives from sidewalks. Broken and cracked sidewalks, interrupted by poles and wires and low hanging trees were found on both sides of S. Center street (see Appendix, Figure 3). Some sidewalk gaps were up to two inches tall, making it a trip hazard and going against ADA sidewalk requirements (See Appendix, Figure 4). Litter was found scattered throughout the entire audit area along with overgrown grasses and dead plants, disrupting the textured markings on crossings (see Appendix, Figure 5). The audit team discussed safety concerns of wheelchair users and slower walkers including children and elderly (which were observed during the audit) using the sidewalks and crossings on S. Center Street.

*Figure 2. Crossing six lanes on S. Center Street (each lane is 12 ft wide)*

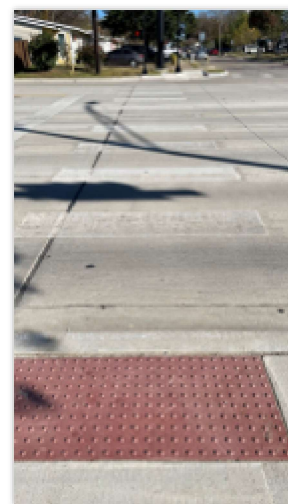
The route began at the front of the Blanton Elementary proceeding north to Biggs Terr, south along Meadow Lane to E Tucker, then east to Collins and north back to the point of beginning at the school. Collins St just underwent a complete street rebuild that was completed earlier this year so the street and sidewalks here are new. The street is seven lanes wide with a 40 mph speed limit; although, a school zone provides some additional safety before and after school. It was noted that the crosswalk from Lovers Ln to

the school sidewalk was barely visible on the street, even though it was just painted a few months ago. Crossing guards are typically present to assist students before and after school. Another issue at the school property is a pedestrian crossing light, just south of the traffic signal at Lovers and on the south side of the school's entrance driveway. The crossing signal is of little value to students at the school who never have to cross that driveway at Collins due to school sidewalks on either side of the driveway. For pedestrians on the west side of Collins, the signal was timed through two cycles. The signal was red for 6:35:00 then changed for 15 seconds to permit crossing. Biggs Terr and Meadow Ln also received recent street rebuilds so the street and sidewalks there were in excellent condition. There are few trees providing shade along Biggs Terr but overall, walking was comfortable. Meadow Ln had two major problems. First, when the street was rebuilt the existing sidewalks were replaced. Apparently there was never a sidewalk on either side of the street along the Meadow Lane Baptist Church property and no new sidewalk was installed during the street rebuild. There is a gentle S-curve in the street along church property (See figure 4) which makes it difficult to see down the street and for drivers traveling in both directions to see any bicycles or pedestrians on the street in that area. The church is directly behind Blanton Elementary property and there is a rear entrance to the school from the church parking lot and the second major problem in this area. A sidewalk from Meadow goes uphill to an opening in the fence and continues all the way to the school buildings; however, approximately 12 ft of sidewalk is missing before the entrance and the ground there has eroded considerably leaving only a narrow dirt path with steep drop off to the adjacent parking lot before the entrance to the

*Figure 8: Lovers Ln to Blanton sidewalk faded crosswalk*

- Blanton Elementary
  - Clearly defined crosswalk on Collins at Lovers Ln
  - Adjust timing of the pedestrian crossing signal at the Blanton entrance driveway (or remove it altogether as it offers no value to pedestrians in this area.)

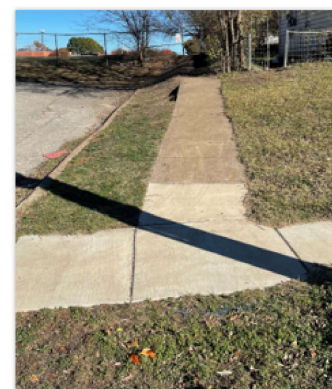
*Figure 9: Sidewalk abruptly ends on Meadow Ln*

- Blanton Elementary School
  - Rebuild sidewalks along E Tucker St
  - Install new sidewalks to improve safety in the vicinity of Meadow Lane Baptist Church where no sidewalks currently exist
- South Center Street
  - Re-visiting Arlington Hike and Bike plan: updates for safer pedestrian and bicycle infrastructure
  - Pedestrian islands across S. Center Street (crossing over to strip mall on the west side)
  - Safe bicycle infrastructure: change sharrows to protected bicycle lanes with barriers allowing movement up to downtown Arlington
- Julia Burgen Park
  - Increase sidewalk width and add sidewalks where there are none (especially in front of houses)
  - Narrowing/reducing car lanes
- Inwood:
  - Street rebuilding + community engagement to fix sidewalks and enlarge driveways if necessary
  - Narrow Cooper Street
  - Infill developments

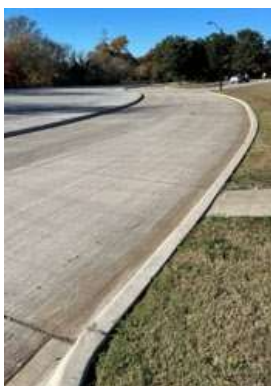
Figure 10: S Shape along Meadow Ln

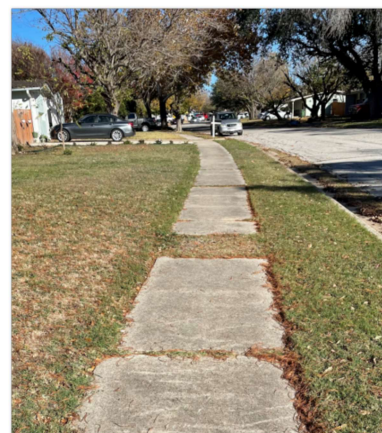
school property. The sidewalk resumes about 5 feet past the entryway but there is a piece of fence that completely blocks the sidewalk. Once past those obstacles, the sidewalk on the school property provides safe passage to the school as a shortcut. East Tucker is an older street with older sidewalks. There are missing sections and trip hazards about each four feet where settlement and tree roots have caused the sidewalk to separate at each joint and where

Figure 11: Sidewalk gaps on E. Tucker St.

they meet driveways all down the street. The sidewalks are in poor condition and could not be easily navigated by anyone using any type of mobility assistance device, such as canes, crutches, walkers, wheelchairs, or motorized mobility devices. There is ample shade on both sides of the street in this area. There are a significant number of cars parked along the street and often cars parked in driveways block the sidewalks. Most of the homes in this neighborhood have single car width driveways, a situation in common with the Inwood route. When these homes were built in the mid 1900s, most families had only one car so the driveways and parking were adequate but today most homes have at least two cars and often more so two cars parked in tandem on the driveway will block the sidewalk or the additional cars must be parked on the street. This situation is shared with many older neighborhoods in central and east Arlington, often in lower income neighborhoods. The City of Arlington should investigate sources of funding to provide grants to homeowners in these neighborhoods for expansion of their driveways. Additionally, the City could assist homeowners by making curb cuts for the expanded driveways and offering to pour concrete to expand driveways as part of a single project for multiple homeowners along the same street at one time and at an affordable rate. The Code Compliance Neighborhood Enhancement Team could coordinate with neighbors who wanted to participate. The combined efforts would result in safer streets for all users of the street.

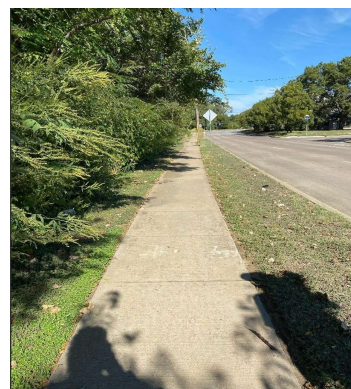
well-kept in terms of sidewalk safety, as the sidewalks were wide enough and freshly painted. The section of S. Center Street that the audit members took cut through a neighborhood that was missing sidewalks, causing the group to walk between driveways and front yards. A missing sidewalk poses a major problem for people in wheelchairs, people pushing strollers, and others with some form of mobility issue. Additionally, any sidewalks that did exist on S. Center Street were badly cracked, narrow, and had poles and power lines that cut through the middle. W. Park Row Drive was in noticeably better shape, but still had its fair share of problems. The sidewalks were too narrow, as the two members of our group could not comfortably walk side by side, and while cracks were fewer and farther between, they were still visible. One positive note about W. Park Row Street is that its tall trees allow for ample shading, which cools down the sidewalk and increases overall comfort. Overall comfort along the trail was inconsistent at best. S. Center Street offered very little shade. All three streets outside of the looping walking trail were missing water fountains and public bathrooms, two things that should be present in some form on two streets as important as S. Cooper and W. Park Row. Grass and landscaping maintenance is urgently needed in some locations, as some portions of the walking trail had bushes, shrubs, and trees poking out of their areas and causing walkers to move around them. Additionally, the grass of Julia Burgen Park was poorly maintained. When landscaping cuts into sidewalks, some people are required to move away from the sidewalk, which is a problem for people with mobility issues.

*Figure 21. Bushes and shrubs overlapping a sidewalk.*

- South Center street
  - Trash cans available on S. Center street
  - Greater upkeep in landscaping, removing overgrown vegetation/grasses interrupting sidewalks

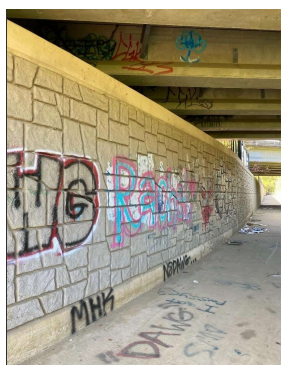
*Figure 22. Graffiti underneath the S. Center Street bridge.*

Vacant parking lots to nearby churches and schools were large, but sparsely populated. This is bad, because the portion of the parking lots that people are not using could be used for other buildings, houses, or nature. Another problem was trash and graffiti. Trash like soda cans, chip bags, balled-up paper, and more were littered about, and homeless camps had been left behind with no signs of the homeless still living there. Graffiti sat underneath the bridge on S. Center Street, some saying vulgar curse words, and other being general eye sores to look at. All in all, these issues made the walking experience generally uncomfortable.

- Closing sidewalk gaps, making sidewalks ADA friendly
- Julia Burgen Park
  - Clean up landscaping throughout route
  - Remove graffiti within Julia Burgen Park, under the bridge on S. Center Street

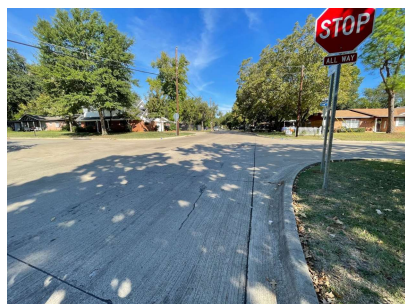
Figure 28. Lynda/Brookview intersection. This intersection can use traffic calming measures such as a roundabout.

the intersections of Inwood/Brookview and Lynda/Brookview, even though the stop signs were present, they were not highly visible so drivers sometimes skipped the stop sign and kept going. Even more concerning at Lynda/Brookview is that there are no sidewalk connections to the intersection and no other protective infrastructure despite the fact that the intersection is a bus stop for school children. The rest of the walk audit continued pleasantly on Lynda, but there were several lots at the intersection of Cooper Street that were empty which could benefit from infill developments/upzoning.

- Paint a crosswalk at Robin Ln., Park Row
- Inwood
  - Car ports: other methods of permeable paving (long term)
  - Interim strategies of bulb-outs and traffic circles to calm traffic

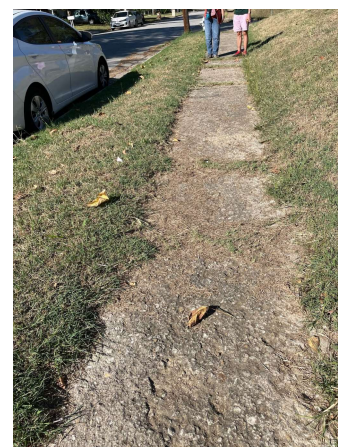
Figure 29. The general state of sidewalks in the area.

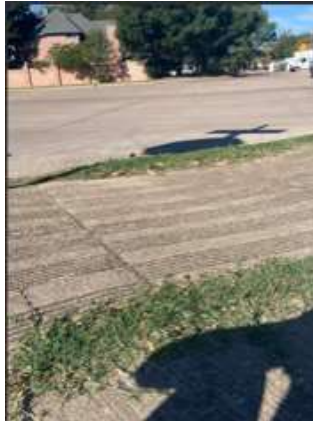
*Figure 3. Overgrown grass blocking textured markings*

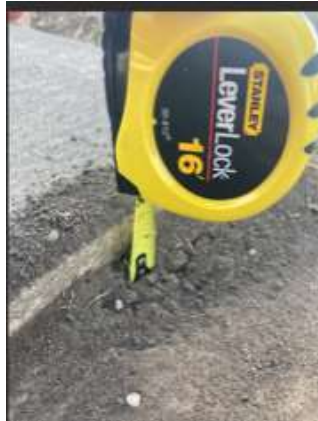
*Figure 4. Trip hazard: 2 inch sidewalk crack*

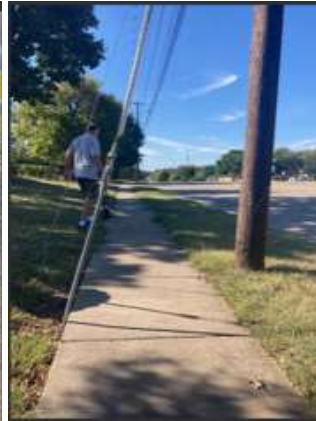
*Figure 5. Poles and cables blocking pedestrians and cyclists on sidewalks*

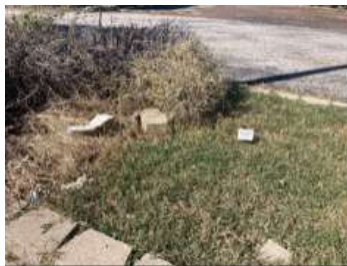
*Figure 6: Litter present: broken bricks and glass bottles, trash next to sidewalks*

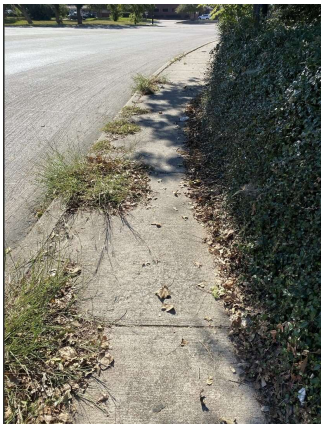
Figure 23: Grass growing from underneath the Sidewalk

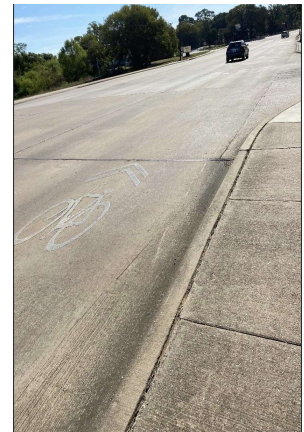
Figure 26: sharrow on S. Center Street, faded paint, unsafe infrastructure for cyclists

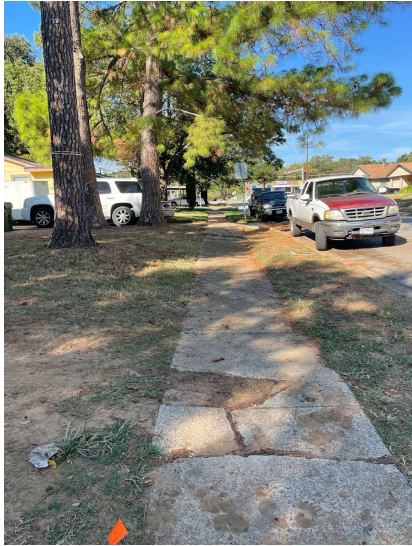
*Figure 30: A poorly maintained sidewalk on Inwood Street near Cooper Street intersection*

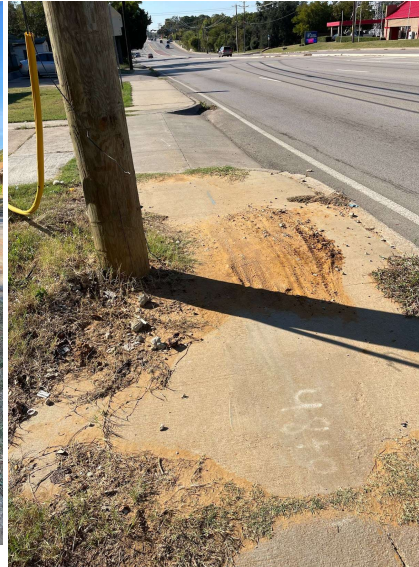
challenge: the team did not feel safe walking by vehicles despite the slightly wider sidewalks (6 ft as opposed to the usual 4 ft in the area) because the vehicles were driving at an uncomfortable speed for pedestrians to walk next to. The sidewalks on Lovers Lane were okay but midway through the street, the sidewalks stopped and we were forced to walk on the street. Despite the lack of sidewalks, the streets themselves (Lovers Lane and Brookview) are relatively wide so vehicles traversing the route would be driving relatively fast, which was the observation we took note of. At

*Figure 31: Cooper Street west sidewalk*

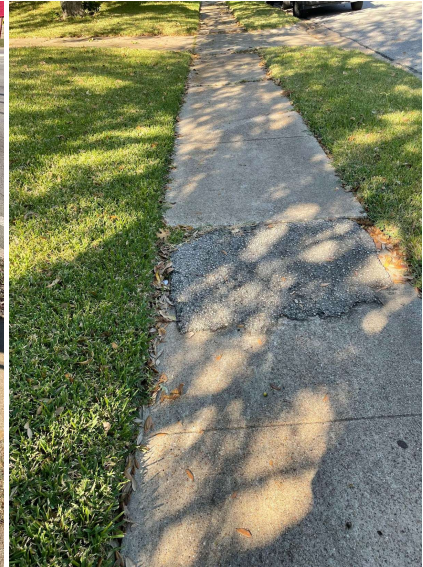
*Figure 32: The general state of sidewalks in the area*
