# PRE-PURCHASE INSPECTION REPORT

## 1973 Piper Arrow - Engine Cooling, Condition and Maintenance Findings

| Aircraft | 1973 Piper Arrow |
| Inspection date/location | August 19, 2026 / Lufkin, Texas (KLFK) |

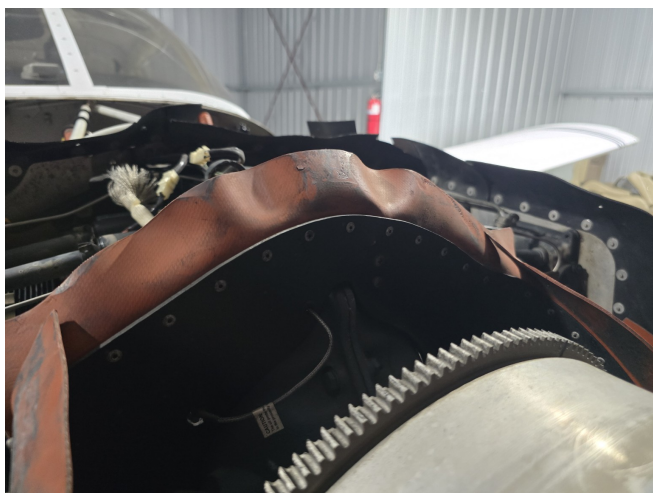
**Observed/Reported:** The engine baffling included small aft pieces that appeared ineffective in containing upper-plenum air. The forward baffle/seal area showed large wrinkles and visible paths where air could escape. Airflow appeared able to pass over or around the cylinders rather than being directed down through the fins.

**Why it matters:** Leakage reduces upper-deck pressure and the pressure differential across the cylinders. Because the fin passages are restrictive, even relatively small bypass paths can carry a disproportionate amount of air away from the cooling surfaces. This provides a direct, technically credible explanation for persistently high CHT.

**Classification:** Safety-of-flight / airworthiness evaluation required

Figure 1 - Wrinkled Front Baffle Seal The front flexible baffle seal is severely wrinkled, folded, and improperly positioned, preventing continuous contact with the upper cowling. The resulting gaps allow cooling air to bypass the cylinders rather than being forced through the cylinder cooling fins.

- Repair or replace distorted, undersized, deteriorated, or incorrectly oriented baffles/seals and the partially collapsed oil-cooler duct using approved data and eligible materials.

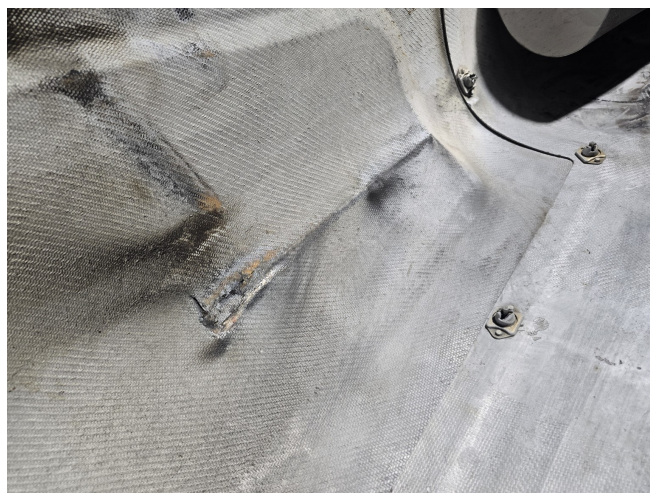
Figure 2 - Evidence of Cooling-Air Bypass Dark airflow and contact marks inside the upper cowling correspond with the baffle-seal location and document cooling air escaping past the baffling. This loss of upper-plenum pressure reduces cylinder-cooling efficiency.

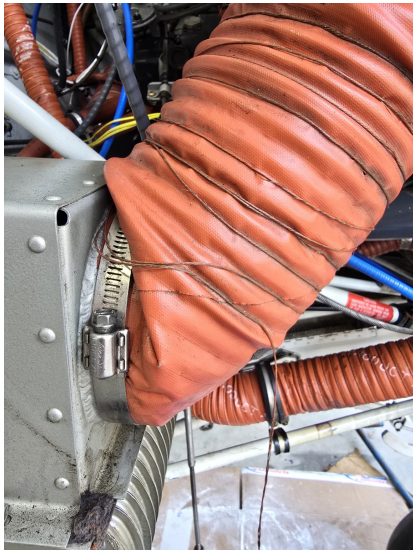
**Observed/Reported:** The oil-cooler SCAT duct was observed partially collapsed.

**Why it matters:** Reduced duct cross-section increases restriction and can lower cooler airflow. That can raise oil temperature even when the cooler itself is serviceable. Duct condition, routing, support, internal integrity, and conformity should be corrected and verified.

**Classification:** Airworthiness evaluation required

**Figure 3 - Exterior View of Collapsed Oil-Cooler SCAT Hose**  
The exterior view shows severe deformation and collapse of the oil-cooler air duct near its attachment to the cooler, substantially reducing the duct's effective cross-sectional area and restricting cooling airflow.

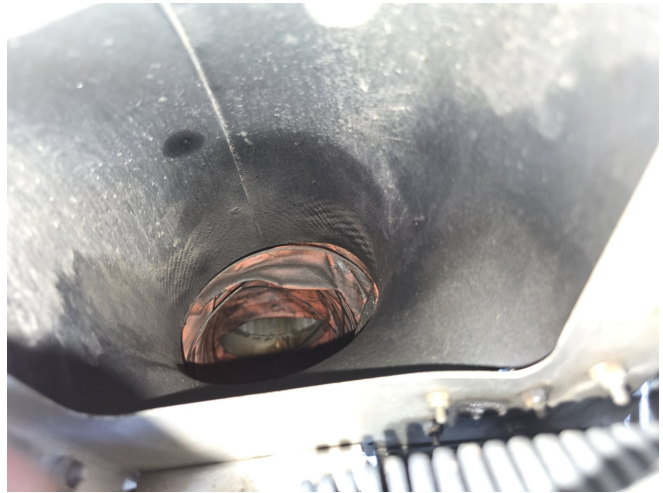
**Figure 4 - Collapsed Oil-Cooler SCAT Hose at Cowling Connection**  
The view through the cowling connection confirms that the oil-cooler cooling-air hose is collapsed and substantially restricted. This condition reduces airflow through the oil cooler and likely contributed to the reported high oil temperature.

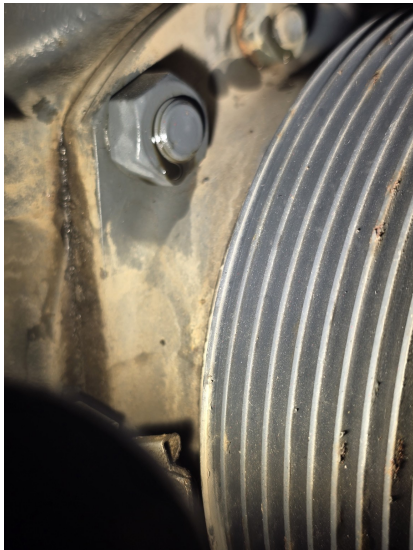
**Observed/Reported:** Oil was observed on the exterior of the engine following the prolonged ground run. Cylinders Nos. 1 and 2 had oil present along their lower sides, while Cylinder No. 3 had oil present on the top of the cylinder. Cylinder No. 2 also exhibited oil leaking upward through the threads of a cylinder hold-down nut.

Figure 7 - No. 2 Cylinder Hold-Down Nut Oil Leak Fresh oil is visible around the No. 2 cylinder hold-down nut. This leak contributes to the same longstanding oil saturation documented at the No. 2 cylinder base, adjacent engine area, and muffler shroud. The attachment hardware, stud, crankcase area, and sealing surfaces require further inspection.

- Clean the engine and belly, perform a controlled ground run, and reinspect for oil, fuel, exhaust, and induction leaks. Identify the sources of oil on Cylinders Nos. 1, 2, and 3 and the leakage through the threads of the No. 2 cylinder hold-down nut.

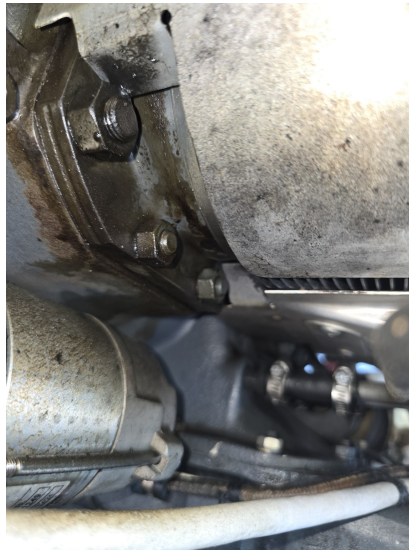
Figure 9 - No. 2 Cylinder Base and Hold-Down Nut Oil Leaks After the engine was cleaned, operated, and reinspected, oil leakage was confirmed at the base area of Cylinder No. 2. Oil leaking through the upper cylinder hold-down nut is also contributing to the extensive saturation of the cylinder, adjacent crankcase, and surrounding components. The amount of contamination is consistent with longstanding, unresolved leakage.

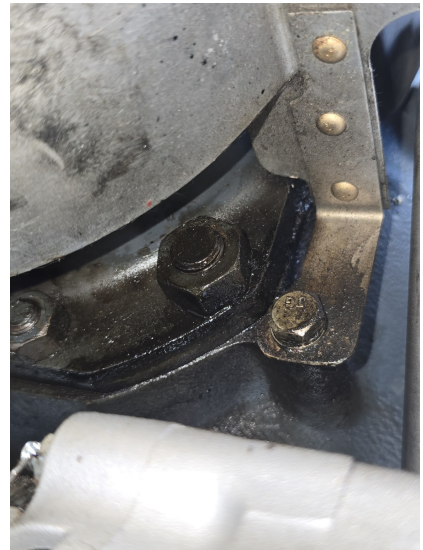
Figure 10 - No. 1 Cylinder Underside Oil Leak The underside of Cylinder No. 1 and the adjacent crankcase and attachment area exhibit heavy oil saturation and accumulated residue consistent with a longstanding, unresolved leak. Oil migrating downward from this area has contributed to the extensive contamination and heat-baked deposits observed on the muffler shroud below.

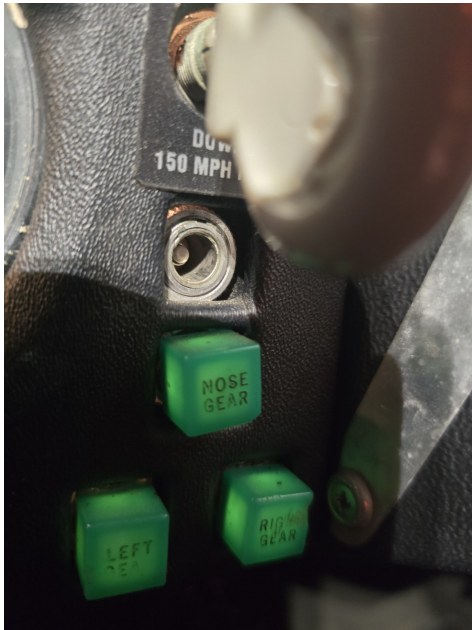
**Observed/Reported:** The landing-gear unsafe-warning-light receptacle remains installed; however, the light housing and bulb are missing. Consequently, the unsafe warning light cannot provide the pilot with its intended indication.

**Why it matters:** With the housing and bulb absent, the unsafe-warning circuit cannot provide its intended cockpit indication. The complete landing-gear extension, retraction, warning, and indication systems should be inspected and operationally tested, and the missing components restored, before further flight.

**Classification:** Safety-of-flight / airworthiness concern

Figure 6 - Missing Gear Unsafe Warning Light and Housing The landing-gear unsafe-warning-light lens and housing are absent, leaving the receptacle opening exposed. The three green individual gear-position indicators remain installed below it.

- Restore the missing landing-gear unsafe-warning-light bulb and housing, determine why they were removed, place the aircraft on jacks, and fully cycle and operationally test the landing gear, warning indications, microswitches, and emergency-extension system in accordance with applicable Piper service data.

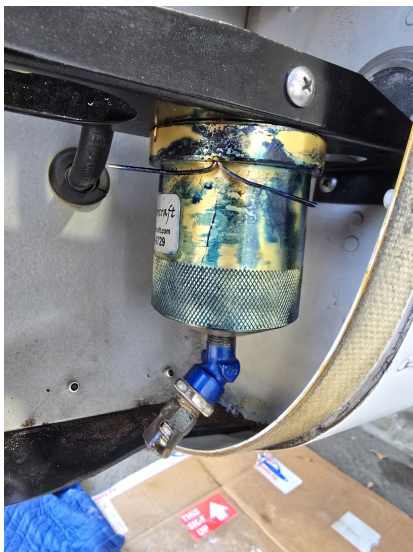
Figure 5 - Fuel Staining at Gascolator Significant blue fuel staining is present on the gascolator bowl and around its upper seam, indicating a current or previous fuel leak. The assembly requires inspection and leak testing.

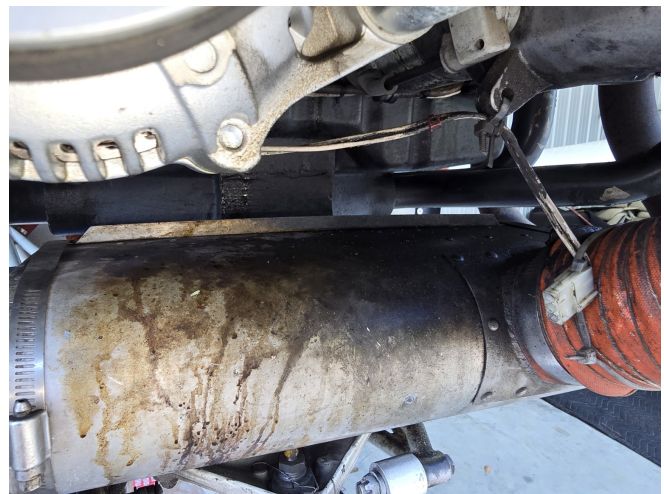
**Additional findings:** The muffler shroud was loose, and loose attachment screws had worn and damaged the shroud. Oil was present along the lower sides of Cylinders Nos. 1 and 2, and the lower front engine area exhibited extensive oil saturation. The oil-cooler SCAT hose was deteriorated and collapsed. The fuel gascolator showed substantial blue fuel staining. These conditions require inspection and corrective action using the applicable approved data.

Figure 8 - Oil Contamination and Heat-Baked Deposits on Muffler Shroud The muffler shroud exhibits extensive oil staining and heat-baked deposits directly below Cylinders Nos. 1 and 2. The accumulated and burned-on residue is consistent with prolonged exposure from the unresolved oil leaks at those cylinders rather than a recent isolated event. Oil contacting the hot exhaust and muffler assemblies presents a potential smoke and fire hazard.

- Remove and inspect the muffler/shroud assembly, pressure-test or otherwise inspect the exhaust as specified by applicable data, and correct loose or worn attachments.
