Property Condition Report

Inspection Address: La Quinta Inn
2585 Seaboard Avenue
San Jose, CA 95126

Inspection Date: 3/16/2012

Report Number: C-31612

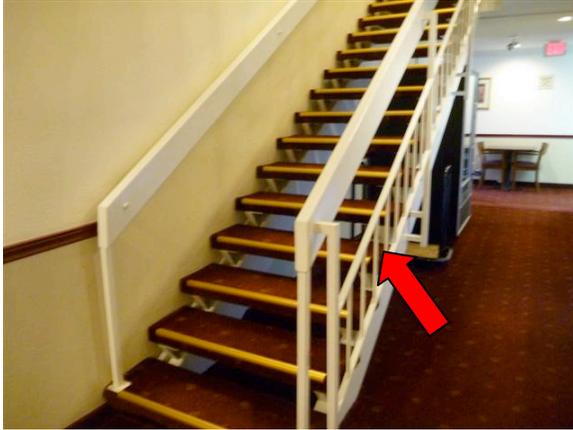
Photo #1: non-grippable, 4" openings

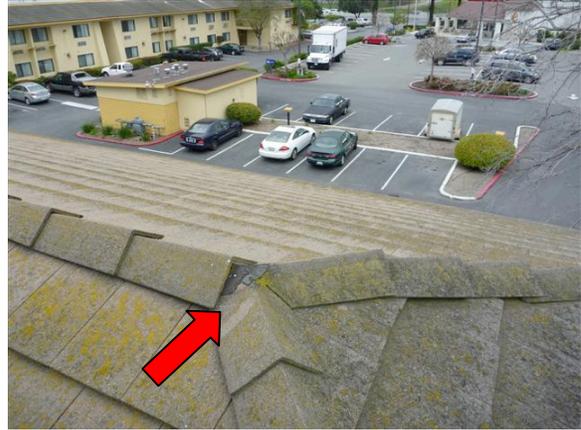
Photo #4: weather cap missing here

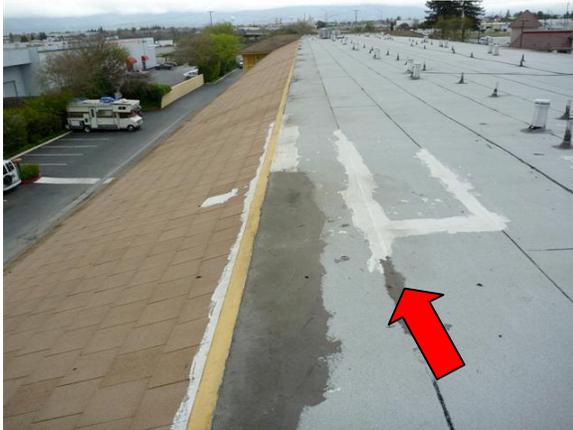
- 7.1.1 The building has a built-up roof covering along the center with sloped sides covered in concrete tile. Numerous patches of varying ages are present on the roof, showing that leaks and (poorly) attempted repairs have been ongoing.
- 7.1.2 The roof access is a ladder from the attic (3 places).

Photo #2: patches of varied age

- 7.2.1 The majority of the roof field is in good condition, but several problem areas exist. The roof has at least four active leaks and several areas of staining in the attic as well as two slumped roof surfaces (at the eave of the left building) and so is in need of immediate repair to the roof surface covering. The existing flat and sloped tile roof repairs are substandard, using improper materials. The repairs should include addressing the poor roof slope / water ponding. Water ponding can lead to settling of the roof surface, which leads to greater water ponding and further settling. Repairs should be performed by a reputable company (an example is Platinum Roofing - 408.280.5028).

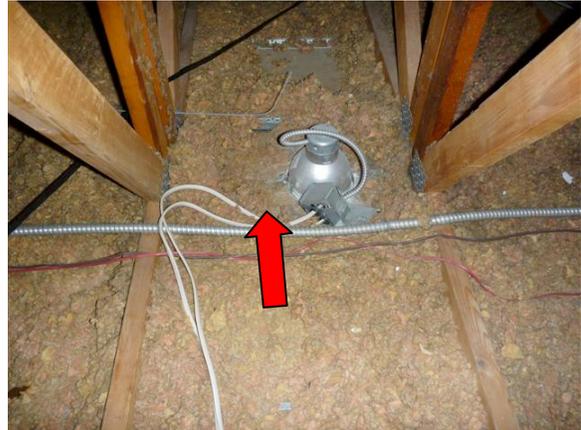
4.2.8 Non-metallic sheathed cable was observed above the finished office space (most of the recessed hall lights). We expect to see this cable protected by conduit in a commercial building. We advise correction.

Photo #5: romex wire in attic

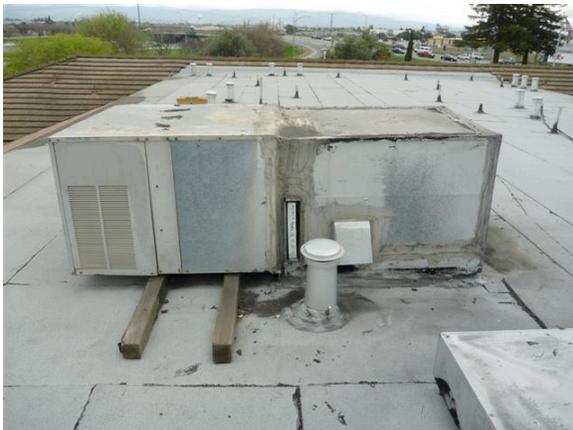
5.2.1 The rooftop HVAC units appear to be in poor condition, replacement should be budgeted for.

Photo #3: aged HVAC

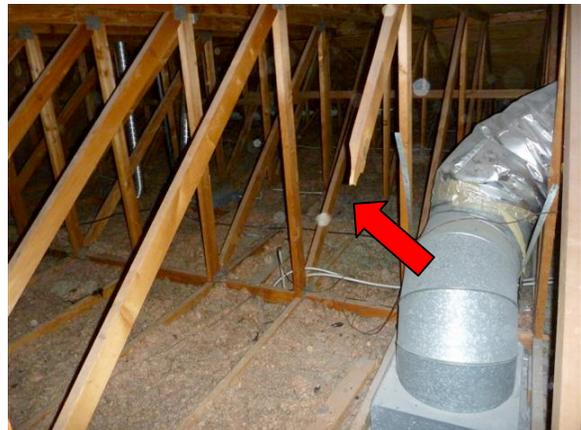
- 3.2.4** At least one roof truss is damaged and in need of professional repair. In order to slow the spread of a possible fire in the attic every so often a fire separation wall is provided. However all of these firewalls have been intentionally damaged. We suggest repair and then installing fire-rated access doors in each firewall.

Photo #6: broken truss

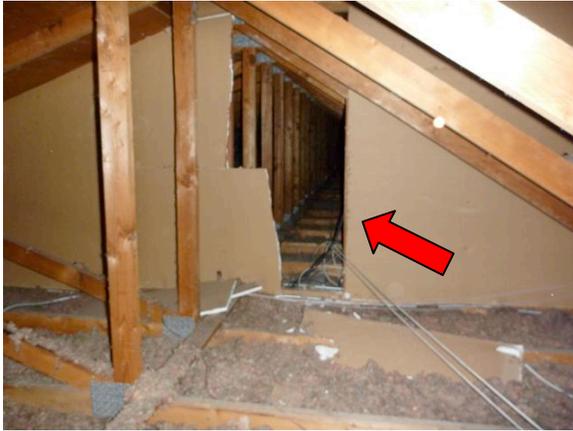
Photo #7: damaged firewall

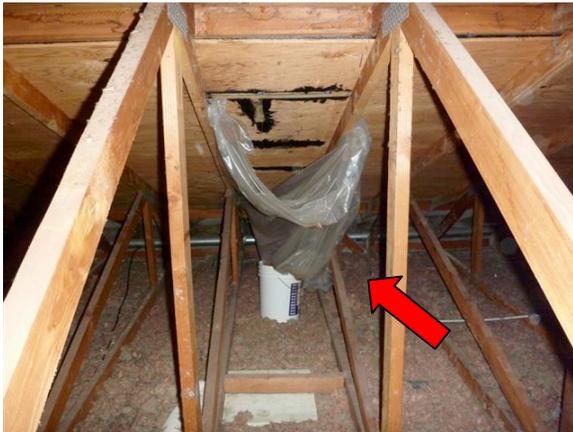
Photo #8: roof leak w/ patches

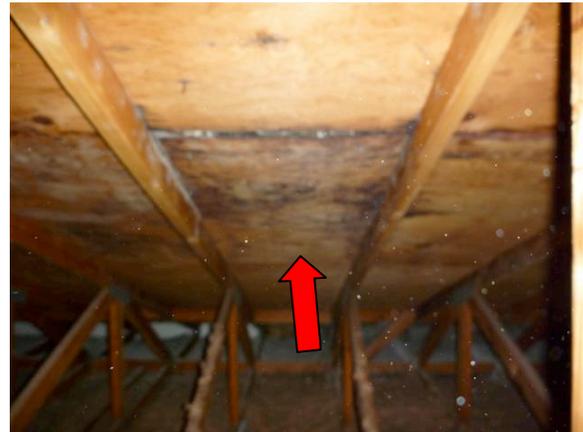
Photo #11: roof leak w/ plywood damage

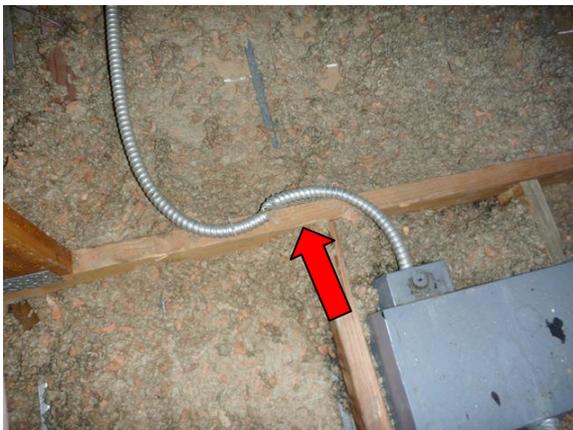
in my viewing of the attic and in the boiler room and at the exterior (and broken conduit in one attic location).

Photo #9: broken conduit at bath fan

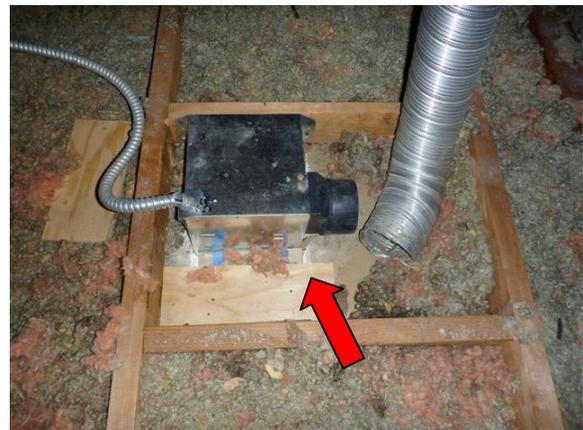
- 6.2.7** The tested toilets all flushed and filled properly. Many of the toilets are loosely mounted to the floor. Correction is advised to prevent a leak. This typically involves removal of the toilet, inspecting for water damage, replacing the inexpensive wax seal and tightly re-securing the toilet base to the plumbing flange.
- 6.2.8** The fan in each bathroom responded to the wall switch, but most were older units and quite noisy. Anticipate replacing all of the older ventilation fans. In addition, many of the fans were expelling the moist air directly into the attic space. Re-attaching the vent hoses is advised.

Photo #12: disconnected bath vent

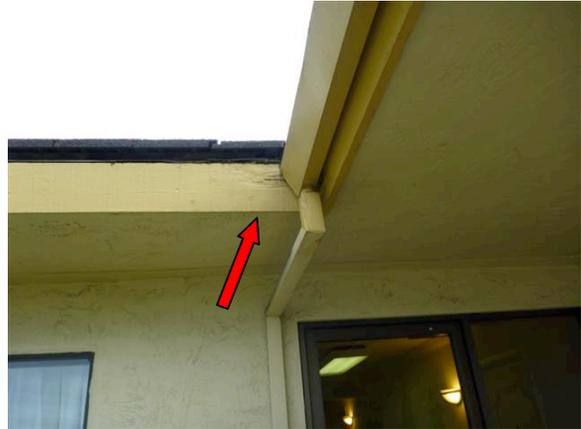
- 3.2.1** We observed damage to the eave in at least two locations at the right side of the right building. We advise repair that involves replacement of wood. The windows do not slide easily in their tracks. Lubrication may help, but this is due to the aging / wear of the windows.

Photo #16: eave damage here

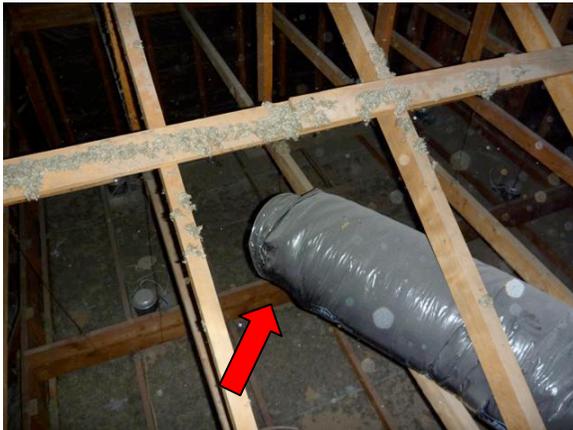
Photo #14: disconnected heating duct

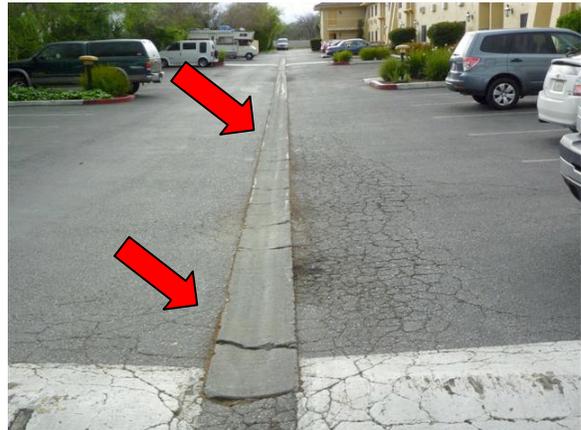
- 9.2.1** The asphalt paving is in generally good condition, except for the area along the left side of the property. We believe the paving surface is deteriorated at the left side due to poor drainage – water pooling on the surface over time. Repair at the left side may be anticipated in the near term. You may consider re-sealing and re-stripping the entire parking surface in order to extend the useful service life. The storm drains along the left may be clogged.

Photo #17: damaged pavement

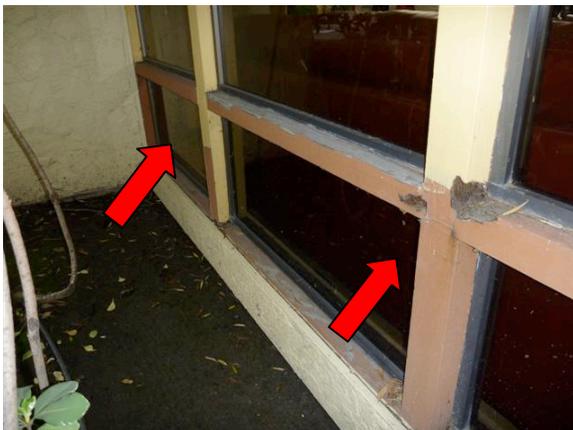
- 3.2.2** We found two windows with broken panes. The wood window trim at the right of the front lobby entry are damaged and in need of replacement. We suspect this was caused by the landscape water sprinklers improperly adjusted and spraying water onto the building here.

Photo #15: damaged window trim - lobby

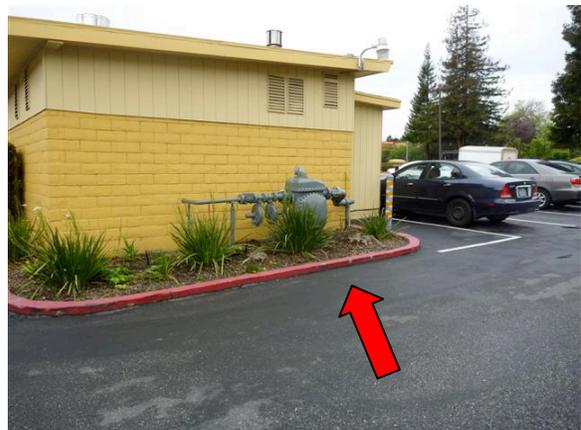
Photo #18: add vehicle barriers

- 4.2.2 We suggest installing additional vehicular barrier/s at the utility transformer vault.
- 4.2.3 Currently, the electrical room is used as storage. We recommend removing all stored items and posting signage stating, "Not to be used for storage". We advise keeping a clear working space of 30" in front of all electrical panels for easy access in an emergency.
