# Property Condition Report

**Inspection Address:** 6610 Florence Drive  
Santa Monica, CA 90405

**Inspection Date:** 6/28/2014

**Report Number:** C-62814

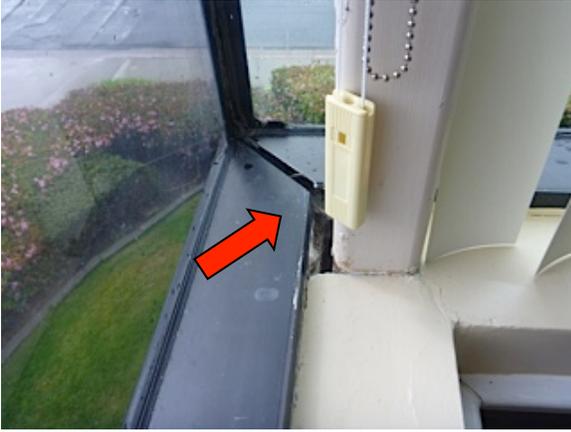
- 3.2.3** We observed evidence of movement at the two left corners as seen by the windowsills having pulled away from the structural corner columns. We suggest consultation with an engineer or qualified contractor who is familiar with this type of construction and following their recommendation/s.

*Photo #7: windowsill away from column*

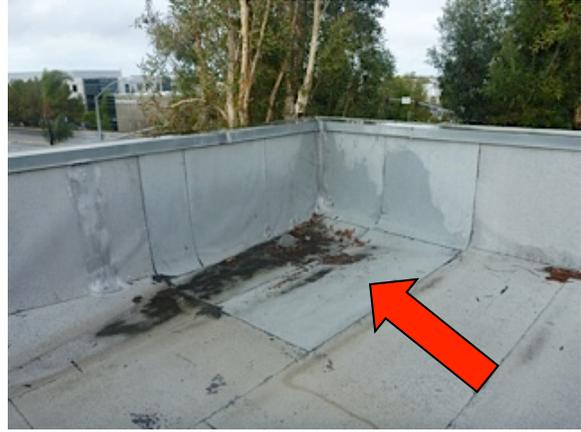
- 7.2.3 Debris has built up on the roof. Debris should be periodically removed to ensure proper functioning of the roof drains. We believe this is the main factor in an active roof drain leaking into the interior office space at the right rear corner – see photo.

*Photo #10: debris at corner drain*

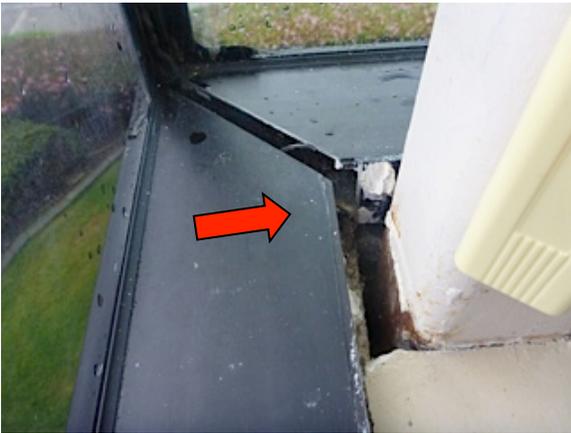
*Photo #8: window sill away from column*

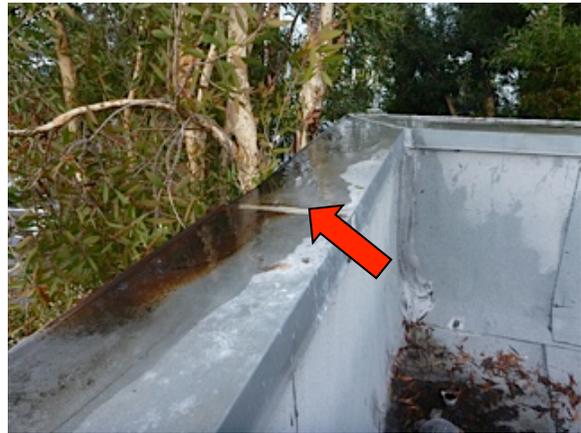
*Photo #11: water pools on parapet*

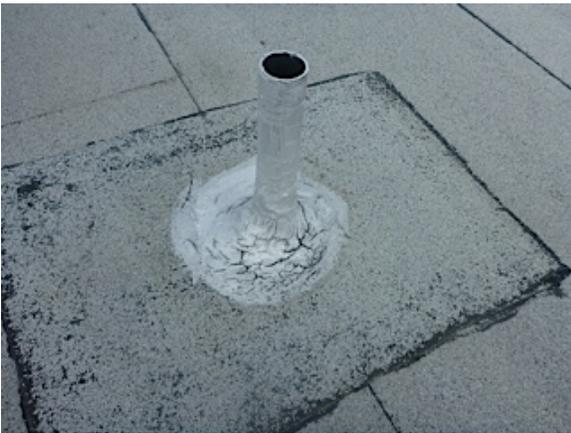
- 7.2.1 The roof has extensive wear characteristics, past inadequate repairs and an active leak at the right rear drain so we are recommending replacement of the roof covering in the short term. Consider installing a Thermoplastic Polyolefin (TPO) or Polyvinyl chloride (PVC) single-ply roofing membrane as they have gained broad industry acceptance for performance as a heat-reflective and energy efficient roofing system as well as having numerous installation and useful lifespan advantages.

*Photo #9: multi-age roof patches*

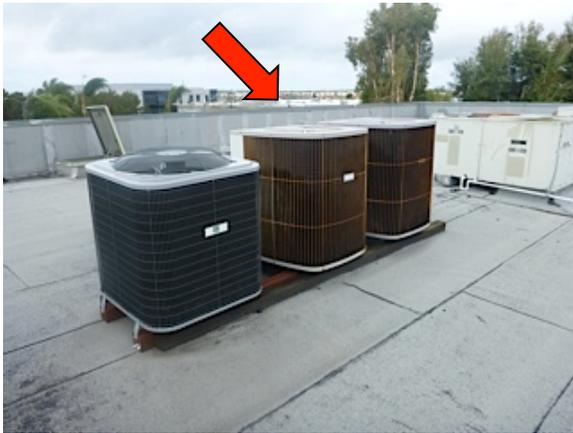
**5.2.2** The rooftop A/C units are not secured to their supports. Additionally, the supports are not flashed properly to the roof. We advise correction to prevent movement and associated damage to the equipment, coolant and electrical lines during a seismic event

*Photo #13: two older A/C units*

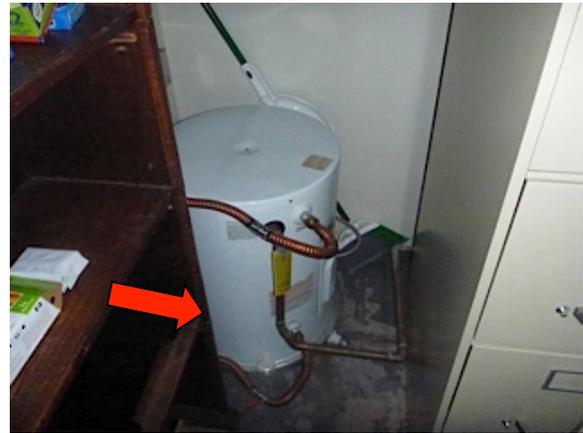
*Photo #16: pan drain not to exterior*

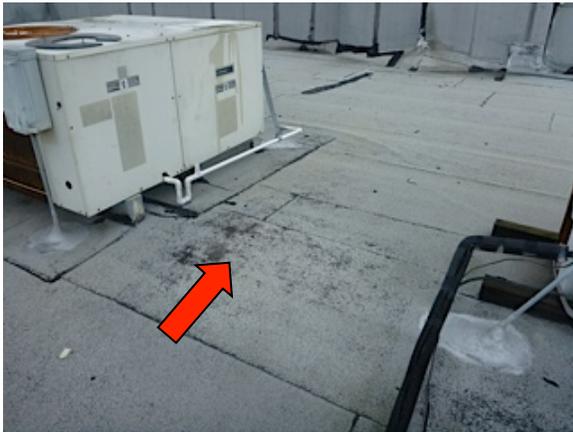
*Photo #14: aging roof surface*

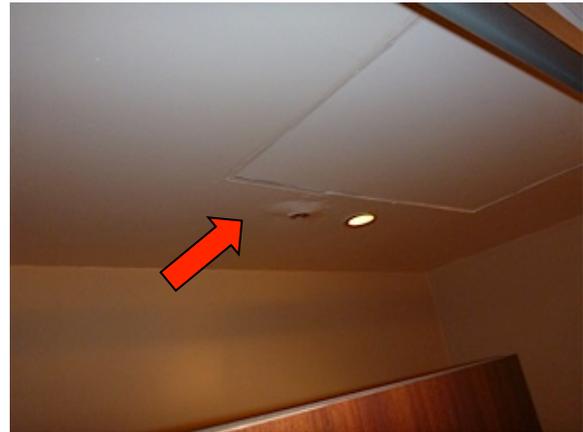
*Photo #17: ceiling repair in bathroom?*

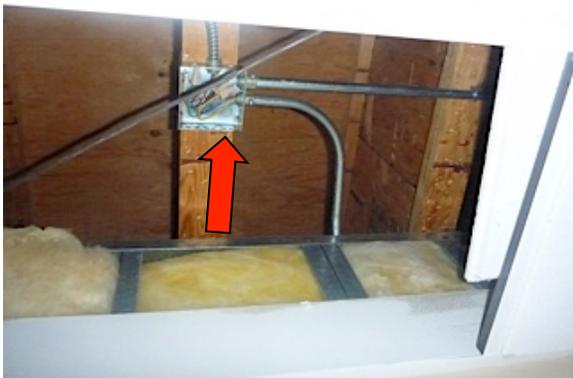
- 4.2.3 An open electrical junction box with bare wires seen in my viewing of sample areas above the ceiling tiles. We advise a comprehensive review of the ceiling plenum area (above the ceiling tiles) and correction of all electrical deficiencies.

*Photo #15: open electrical box*

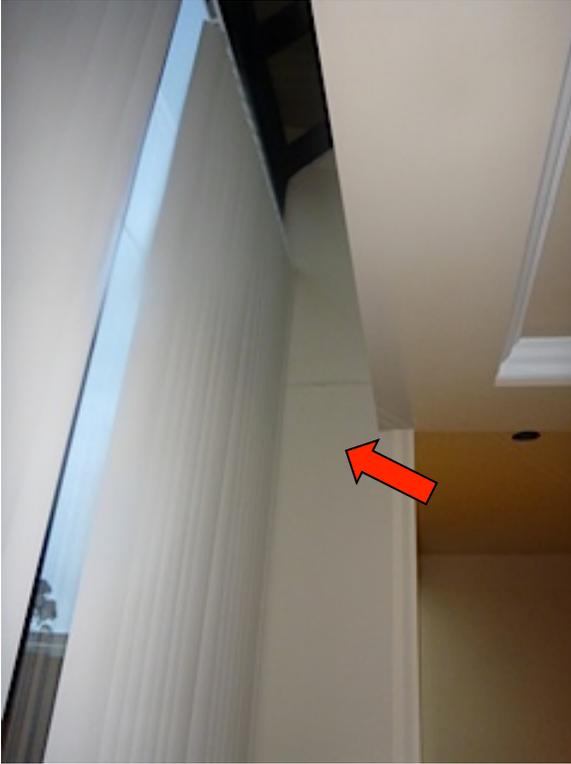
- 8.2.1** Wall stains are evident at the wall of the second story landing (essentially above the lobby). We suspect moisture intrusion and suggest removal of relevant finished surfaces to check and correct any hidden damage.

*Photo #18: staining at landing?*
