**Property Inspection Report**

**10 Estrada St.  
Sunnyvale, CA 94087**

**May 30, 2025**

**Prepared for: Happy Homeowner**

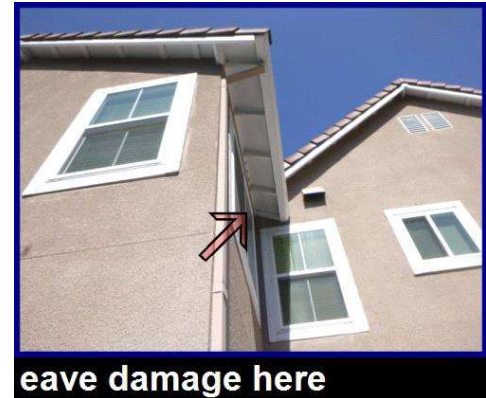
**Localized damage is noted to the eave in one place at the rear** - see photo. We suggest simple repair by a qualified tradesperson. For further commentary refer to a current structural pest control report.

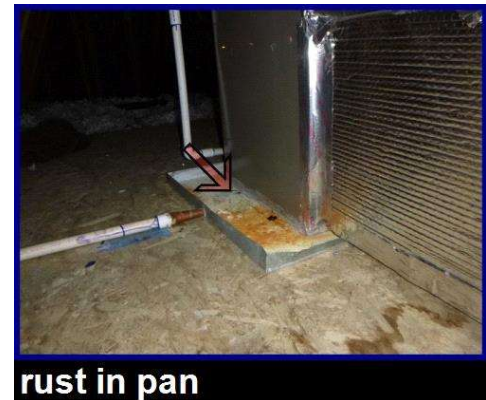
*Rust was noted inside the furnace cabinet and catchment pan. Since this pan was dry during our site visit, we believe that this pan was from the original HVAC appliance. Inquiry with the owner by interested parties regarding the service history may be informative.*

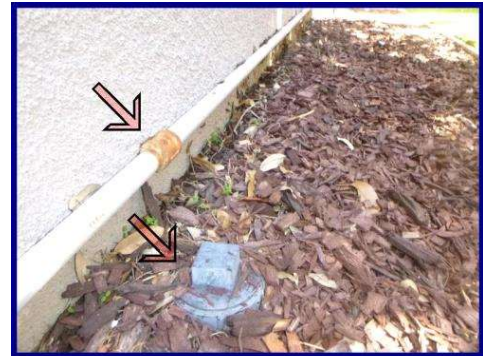
The visible portion viewed by us was ABS. **Unpainted exterior ABS plumbing cleanouts were noted.** Most jurisdictions require painting of all exterior ABS pipes to reduce degradation of the piping from sunlight (UV rays). We suggest simple correction with the appropriate paint.

**Rust is noted at the gas piping connections at the rear exterior - see photo.** No gas smell was detected, but we did not test with any specialized equipment. For enhanced safety / peace of mind we suggest review of this gas pipe section by a gas company representative.

**rust at gas pipe /  
unpainted cleanout**

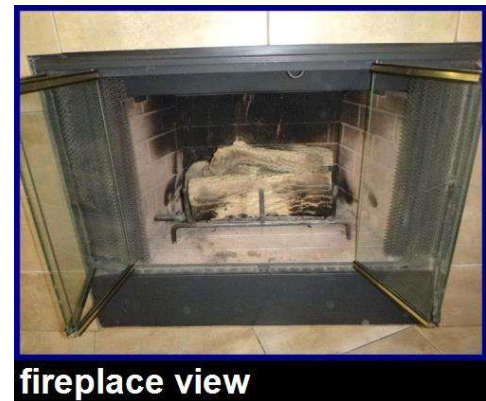
**Damper shuts completely which is not desirable because it is a gas-burning appliance (or has a gas lighter).** For enhanced safety the damper should be modified with a simple clip so that it cannot close completely (easy to accomplish).

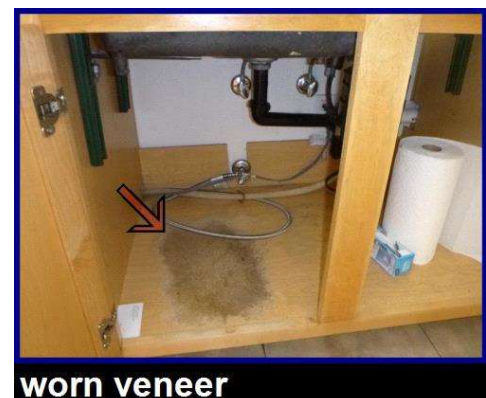
The countertops are Corian and the cabinets are wood. The visible portions of the kitchen countertops and cabinets are in good condition, although *there is wear to the wood veneer at the undersink cabinet floor - see photo.*
