**Commercial & Residential Inspections**

**Property Inspection Report**

**268 Country Road  
Calabasas, CA 91302**

**September 29, 2024**

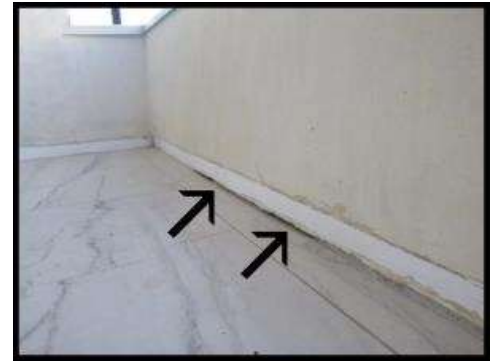
**Several of the balconies are not sealed at the (outer) railing edge. There is a visible gap at the edge of the tile - see photo.** We advise review and correction in accordance with current building standards by a qualified tradesperson / balcony-deck specialist. We imagine that this would be sealing with an exterior-grade caulking or, ideally, a tile mortar mix.

**The balcony over the garage (front) has one broken corner tile that was not repaired securely.** We advise simple correction in accordance with current building standards by a qualified tradesperson / tile specialist.

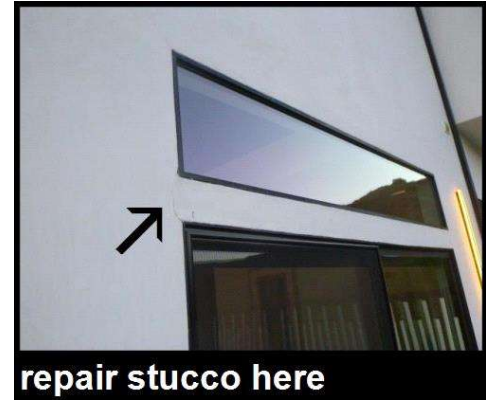
**There is a settling-type crack at the left side (between the office door and the window above).** We recommend review / correction by a qualified stucco repair firm and monitoring for any changes over time.

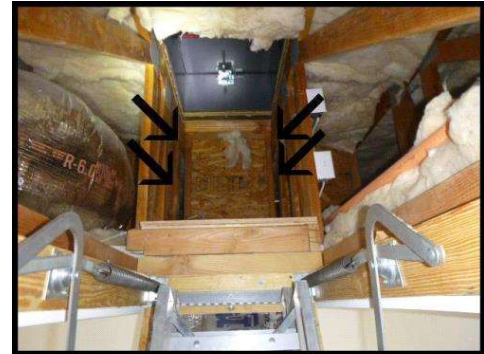
**consider a short ladder here**

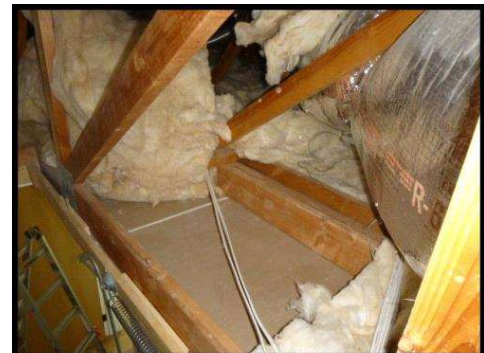
Fiberglass batting insulation. **Insulation coverage is not complete (a few gaps were seen).** A 1% loss of coverage will mean roughly a 5% loss in efficiency and increases home heating and cooling costs. Coverage could be improved to restore full functioning of the insulation layer. It is important to keep insulation clear of any eave / soffit vents, exhaust flues, make-up combustion air screens and any non-IC-rated recessed lighting.

**insulation gap example**

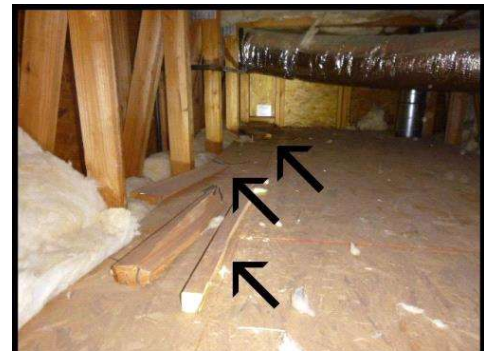
**remove wood scrap from attic here**

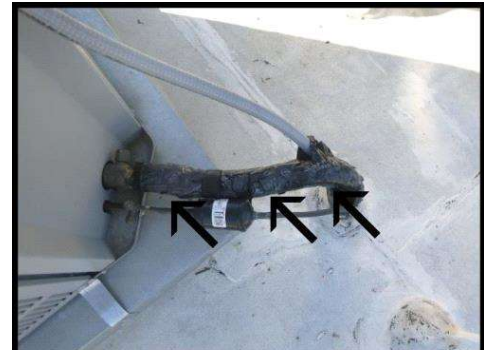
Refrigerant lines connect the evaporator coil and the AC condensing unit. The 'hot' line is the conduit through which heat collected from the living area is conveyed to be released through the AC condensing unit. The 'cold' ('suction') line is the larger of the two and should be insulated. **Installing new insulation and vapor retarder tape is suggested at the 'cold' line (in accordance with modern standards) on both rooftop condensing units to improve unit efficiency.**

**redo insulation with vapor tape**

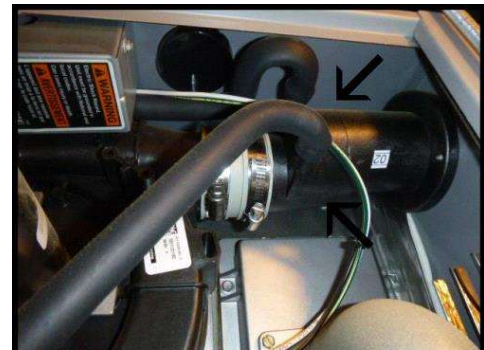
**hose not clamped**

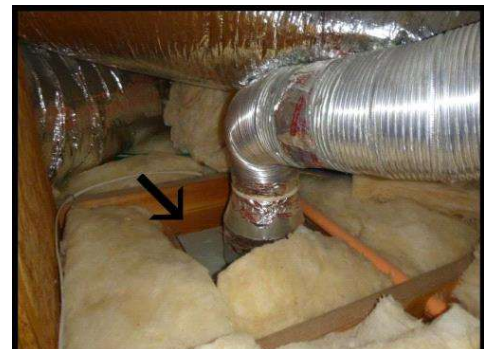
The visible portion consists of flexible metal ducts. The visible sections appeared to be in good condition and functioning as designed - see text at the top of this section. **Insulative wrap/covering of ductwork is missing at two register boxes that we could see.** All ductwork (including register boxes and return air ducts) in unheated spaces should be insulated for full efficiency in accordance with current building standards.

**uninsulated top of register box here**

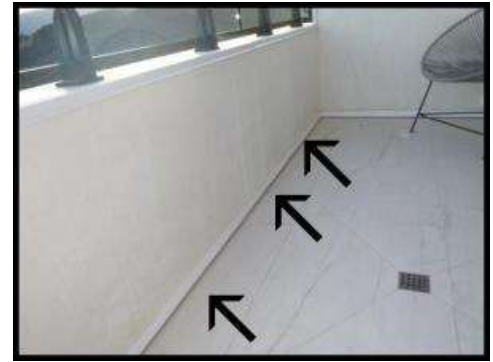
#### Photo #5

gap at edge of balcony tile

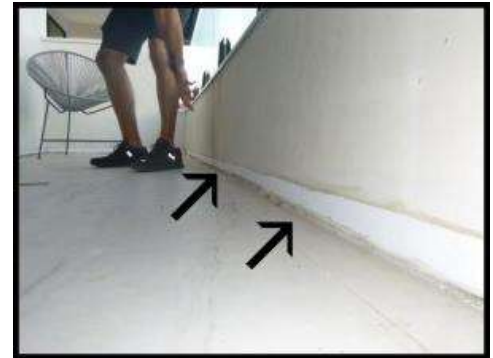
**Photo #6**

why the added caulking at this balcony tile edge?
