# Marine Incidents in Victoria

Fatal Incident in Port Phillip Bay

Involving Recreational Vessel “Adams Den”

Coroner’s Case No. 1505/04

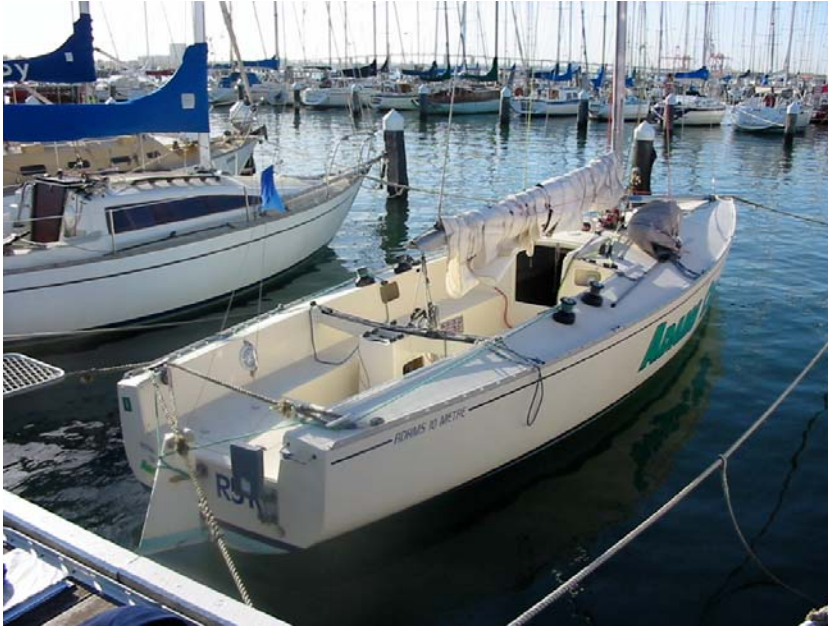
Vessel type - Adams 10 sailing yacht

From the above picture, the following should be noted:

(a) The open nature of the vessel with no guardrails or handholds and low foot rails, having a very large cockpit area, open to the sea at the stern. These provide minimal restraint to prevent a crewmember going overboard if losing balance or stumbling etc.

**Factor 4.1 (a) the design and outfit of the vessel (no guardrails or handholds) provided inadequate restraint to prevent crew members going overboard.**

It is recommended that yachting authorities review the requirements of YA Special Regulations for Category 5 equipment, Section 3.11 “Lifelines, Stanchions and Pulpits” and Section 3.12 “Toe Rails” which for Category 5 are currently only “recommended”. Section 3.17 “Hand Holds” which currently refers to below decks only, should also be expanded to include above deck use, the objective being to provide the boat with a greater degree of man overboard prevention measures.

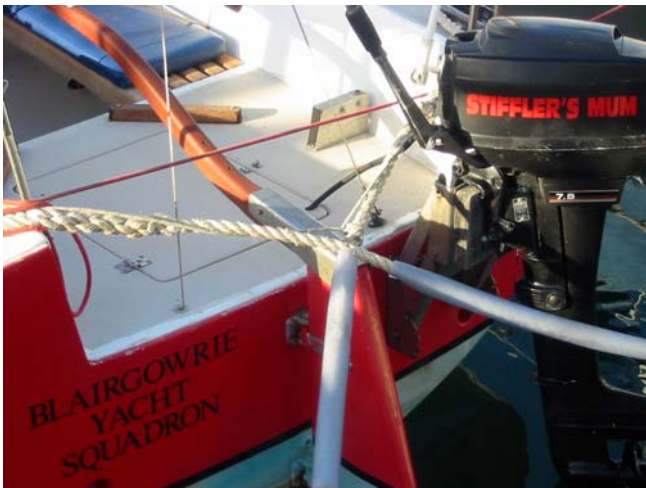
(b) The empty outboard motor bracket on the transom. The motor itself is stowed up forward inside the cabin when racing.

On such yachts, the motor needs to be mounted at the stern for use as shown left on a picture of a motor mounted on a sister vessel. It is impractical however to lift the heavy motor up, carry it back down the cockpit and mount it quickly in a rough sea, in the event of an emergency.

**Factor 4.1 (b) because the rudder broke and it was not practicable to mount the auxiliary motor, the crew were unable to effect a man overboard rescue themselves as they had no way to steer the boat back to retrieve Mr Paul.**

It is recommended that yachting authorities review the requirements of YA Special Regulations for Category 5 equipment, Section 4.14 which mandates emergency steering for “night sailing” only and Category 6 where it is restricted to “recommended”. Alternatively, an expansion of YA Special Regulations Section 3.23 “Engine and Fuel” could be made requiring “Monohulls” in addition to “Multihulls” to mount outboard motors at all times thus providing an auxiliary steering method. The objective being to allow the vessel a chance of returning back to retrieve a man overboard if he falls over the side when the steering tiller breaks.

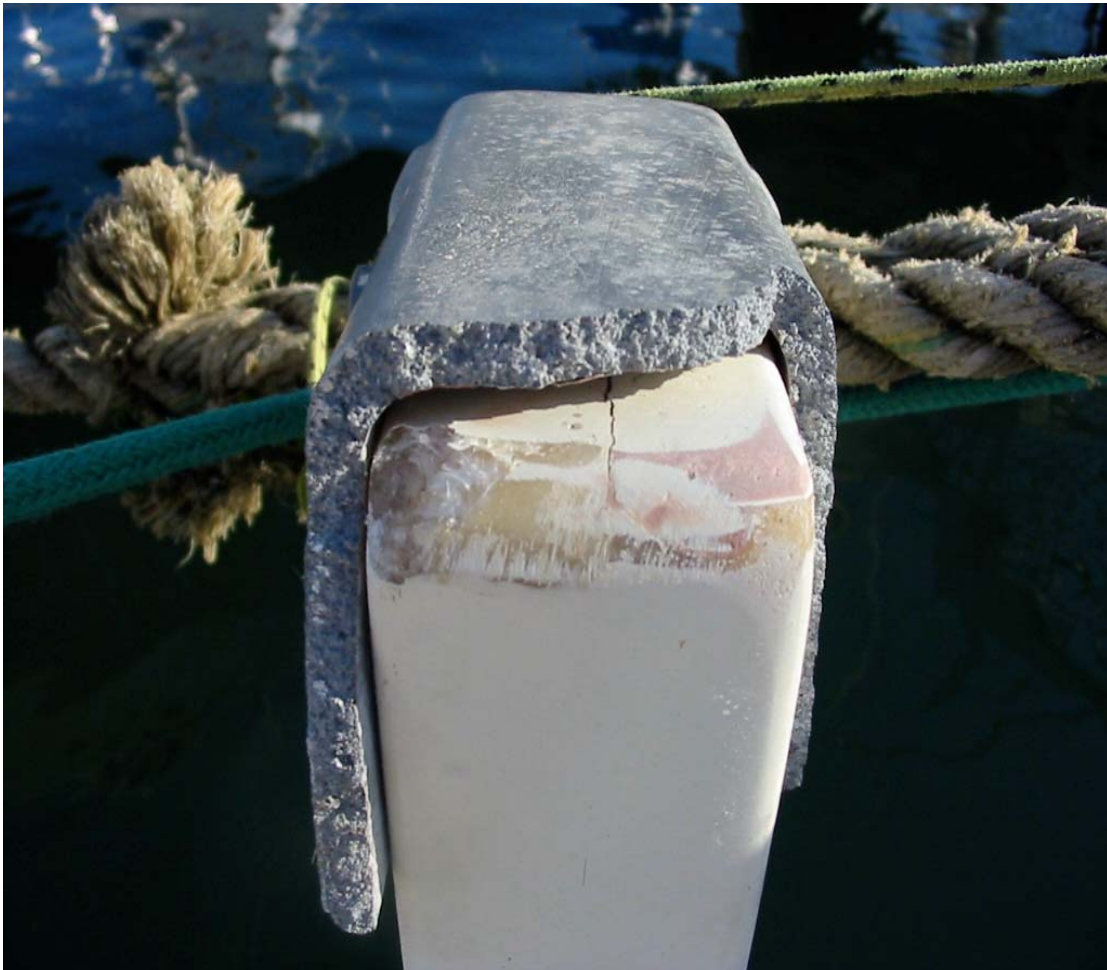
The picture above shows the very grainy structure of the broken cast aluminium rudder head fitting on Adams Den. A fitting of this type would certainly have been under heavy stress at the time of the incident and would need to be at full design strength to eliminate the chance of failure. On close examination this 15 year old fitting does show some hairline cracks behind the broken area, suggesting progressive deterioration over time.

**Factor 4.1 (c) the rudder head fitting of the vessel is of a material and construction (cast aluminium alloy) that requires close inspection as it ages because it is susceptible to corrosion and cracking. This can weaken it beyond its ability to withstand original designed loadings, which appears the case in this incident, causing it to fail.**

The Adams 10 Class Owners Association has already been contacted by the Water Police investigator with a recommendation they inform all owners to check this fitting, especially on older vessels and replace it if it shows any signs of undue deterioration.

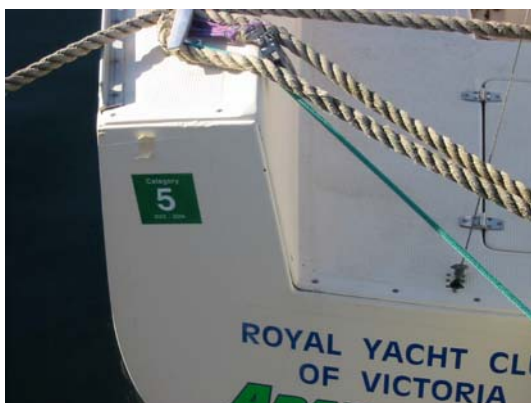
Mr Paul lodged a declaration of compliance for Adams Den of equipment to Yachting Australia Special Regulations Category 5 and was issued with the sticker shown left. (It is noted that the Association Cup race was being run under the lower requirements for Category 6). When examined on 3<sup>rd</sup> May 2004 a number of deficiencies in the equipment required to be on board and available for use were noted. Some related to Category 5 but some even for Category 6.

**Factor 4.1 (d) the vessel could not demonstrate any equipment or method by which crew could be retrieved from the water as required by the Category 6 regulations.**

It is recommended that yachting authorities review the requirements of YA Special Regulations Section 4.26 which for Categories 1 to 6, requires “boats to be able to demonstrate equipment or a method by which crew may be retrieved from the water”. It does not provide any more details such as who should this be demonstrated to, how often, what standard should be achieved (i.e. how quickly, under what circumstances etc.).

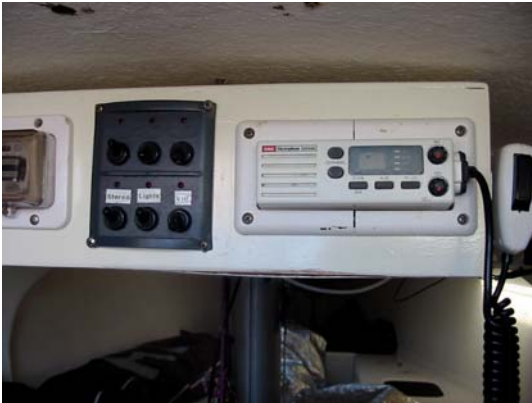
The principal equipment deficiency was the inoperative state of the VHF radio pictured left (required under Category 5 to be on board and operational, but not required under Category 6). Communication had to be made by cellular mobile phone which gives point to point communication only and provides uncertain coverage.

**Factor 4.1 (e) the inoperative radio precluded all direct and immediate communication with the race management team on the water, listening on the designated race control channel 73. Furthermore, no general broadcast “mayday” message on the designated emergency channel 16 could be sent to rescue services such as Coast Radio Melbourne, Water Police or Coast Guard and/or any fellow competitors. This certainly delayed the coordination and mounting of a rescue response.**

It is recommended that yachting authorities review the requirements of YA Special Regulations Section 3.24 “Marine Radio” which currently requires Category 5 vessels to carry an operation VHF radio on board but only “recommends” this for Category 6 craft. The availability of immediate on the water distress communication would add considerably to the safety of all competitors in organized Category 6 and above yacht races.

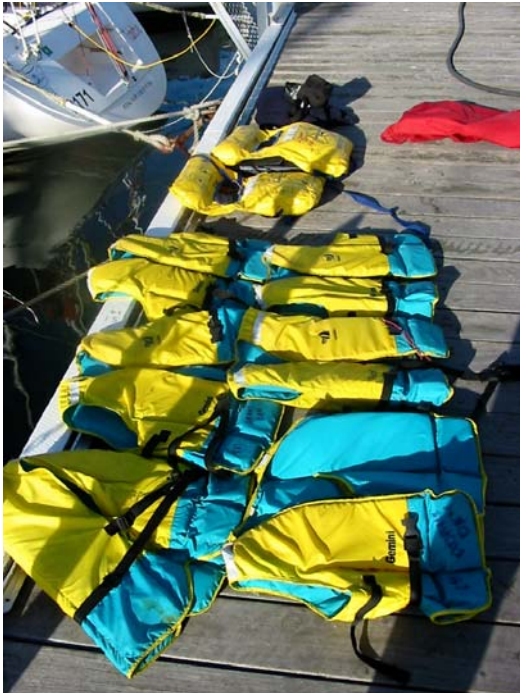
The vessel was equipped with 6 PFDs type 2 and 2 PFDs type 1, as shown left. During the race, all crew on board constantly wore a PFD with the notable exception of Mr Paul. Most of the crew provided their own inflatable PFDs type 1 (constant wear life jackets) such as Stormy Seas vests or yoke types.

**Factor 4.1 (f) Mr Paul did not wear a PFD at any time.**

Marine Safety Victoria has undertaken a review of the requirement for compulsory wearing of PFDs whilst on the water. This has been conducted on a risk management basis and recommendations have been made to the Minister for consideration.

It is recommended that yachting authorities review the requirements of YA Special Regulations Section 5.01 "Personal Flotation Devices" which only require crews of Category 5 vessels to wear PFDs during "night sailing" and require Category 5 (other than night sailing) and Category 6 crews to wear PFDs when the "Y" flag is flown by the race organizer.

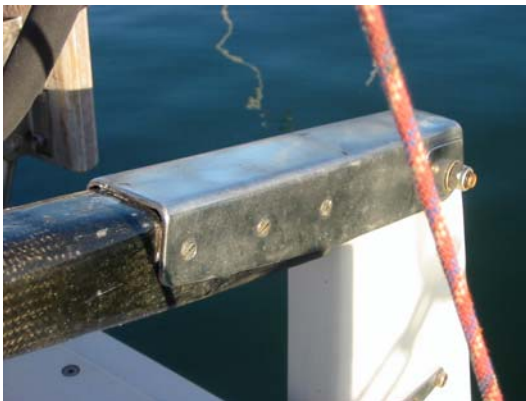
Most other Adams 10 class vessels have been retrofitted over the years with generally stronger and more resilient stainless steel fittings as shown in the left hand picture of a sister vessel.
