**Project Name** | Sand Lake Iron Enhanced Sand Filter

**Date** | 11/21/2019

**Regarding** | 2019 IESF Performance Summary

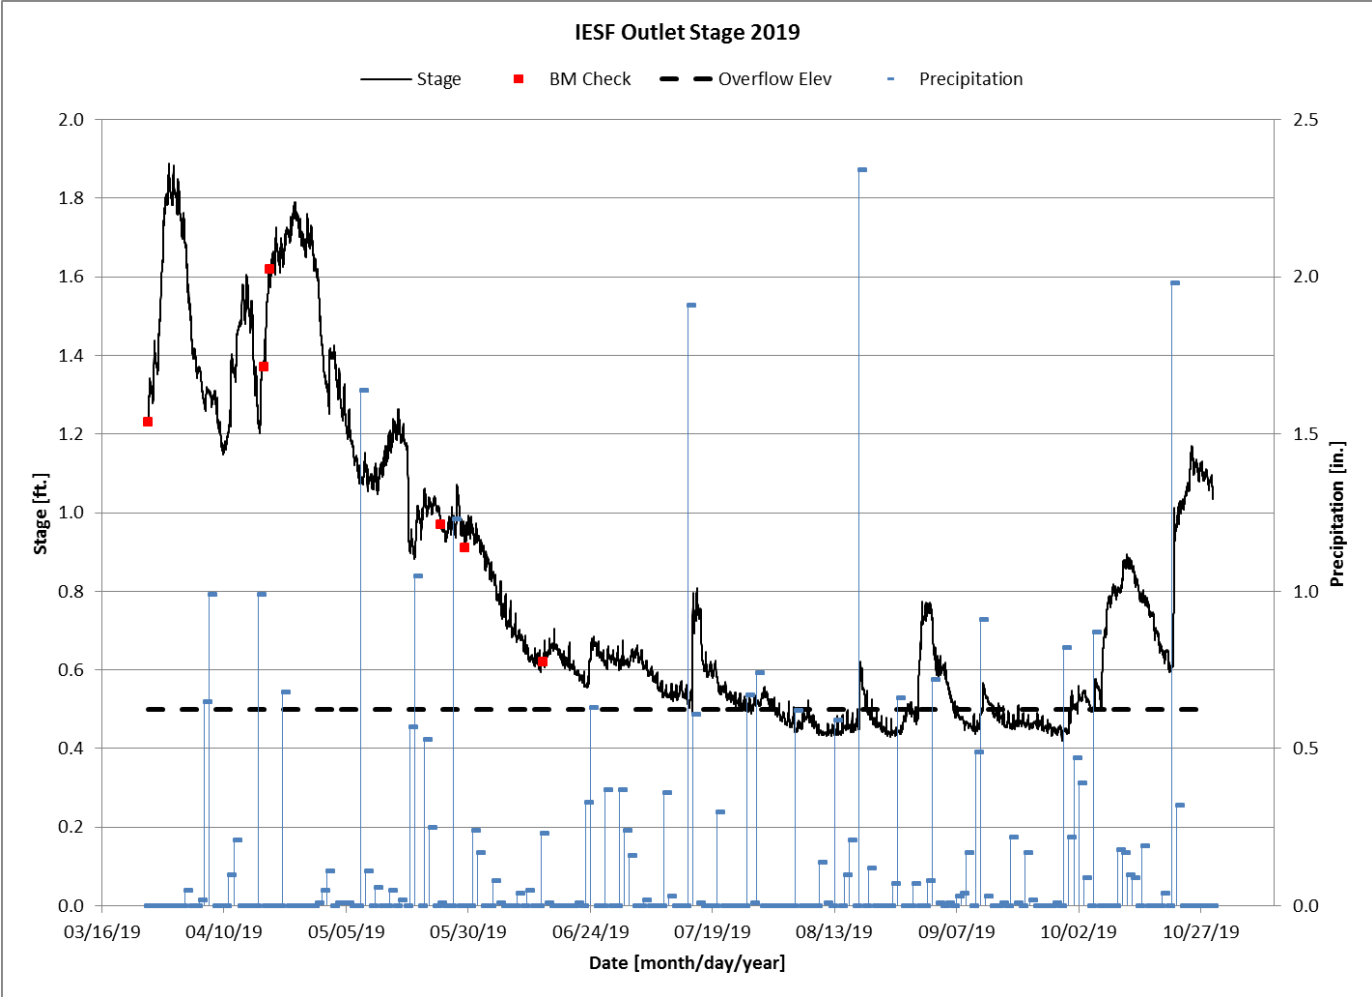
Monitoring of the Sand Lake IESF began on March 25, 2019. A logger was installed inside the outlet manhole structure to calculate discharge out of the IESF. The IESF treated runoff for much of the season, with the exception of several weeks in August and September when stage in the ditch was below the overflow elevation to the filter (as can be seen in Figure 1 where stage in the outlet structure is below the outlet overflow elevation).

Figure 1. Sand Lake IESF outlet stage, 2019
