Your Inspection Report

300 South Schwab Street
Thornton, IL 60476

INSPECTION DATE:
Tuesday, May 22, 2018

GRT Chicagoland Home Inspections Inc.
11633 S Maplewood Ave
Chicago, IL 60655

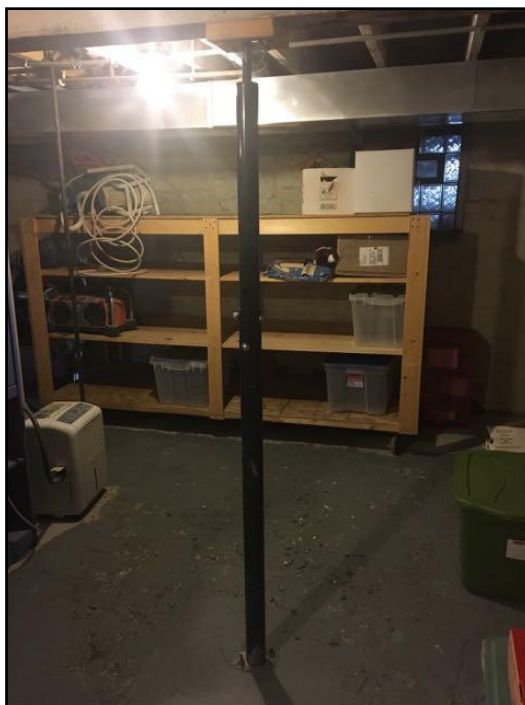
11. Condition: • Temporary columns are being used to support the structural beams.

Location: Rear Basement

Task: Further evaluation

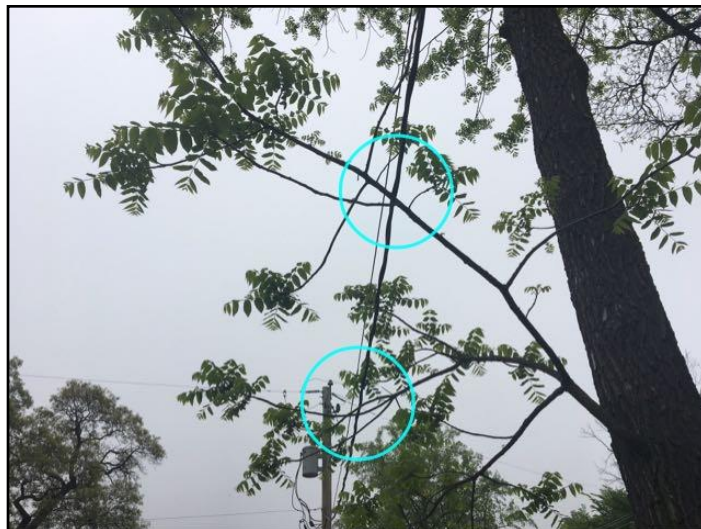
12. Condition: • [Branches / vines interfering with wires](#)

Service drop runs through tree. THIS ITEM IS LIKELY RESPONSIBILITY OF ELECTRIC COMPANY.

Implication(s): Damage to wire | Electric shock | Interruption of electrical service

Location: North Exterior

Task: Improve

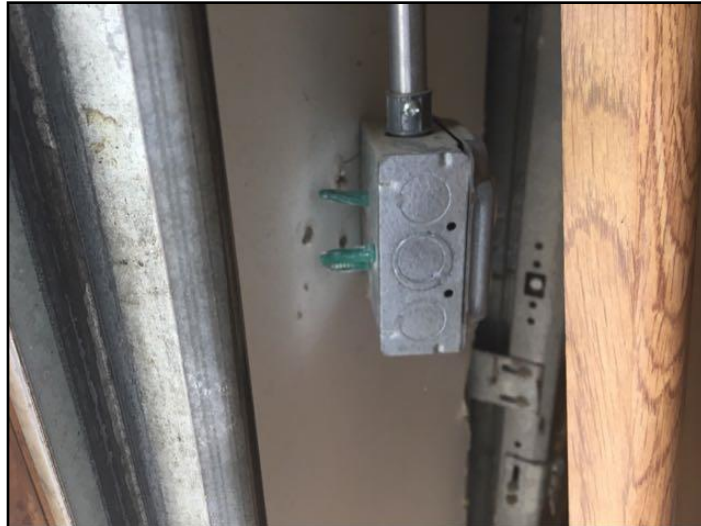
13. Condition: • [Loose](#)

Implication(s): Electric shock | Fire hazard

Location: Garage

Task: Repair

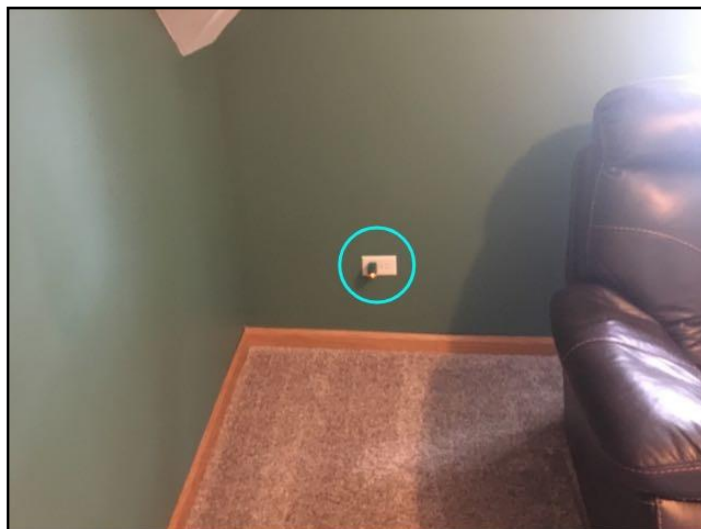
14. Condition: • [Ungrounded](#)

Implication(s): Electric shock

Location: Second Floor Family Room

Task: Repair or replace

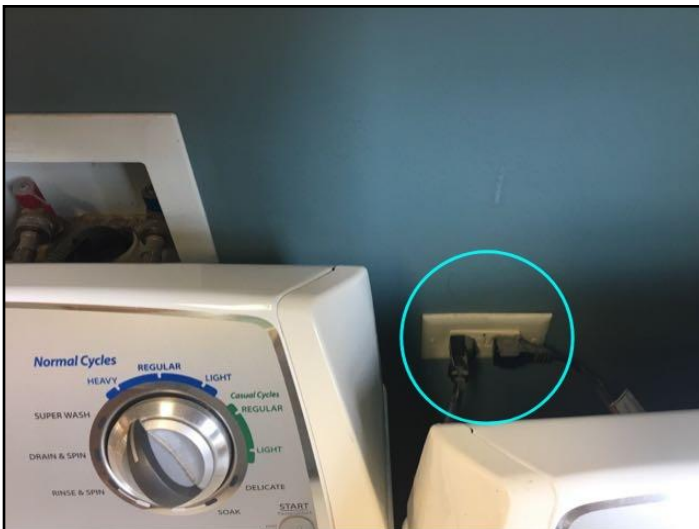
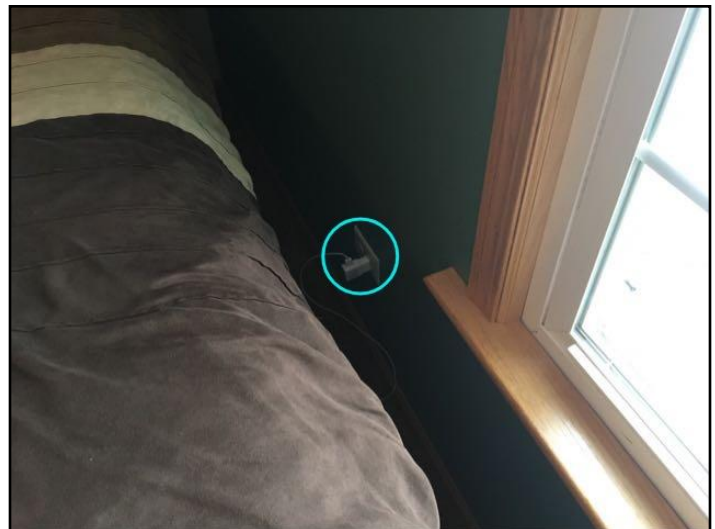
15. Condition: • [Loose](#)

Implication(s): Fire hazard | Electric shock

Location: Laundry Area & Front Second Floor Bedroom

Task: Repair

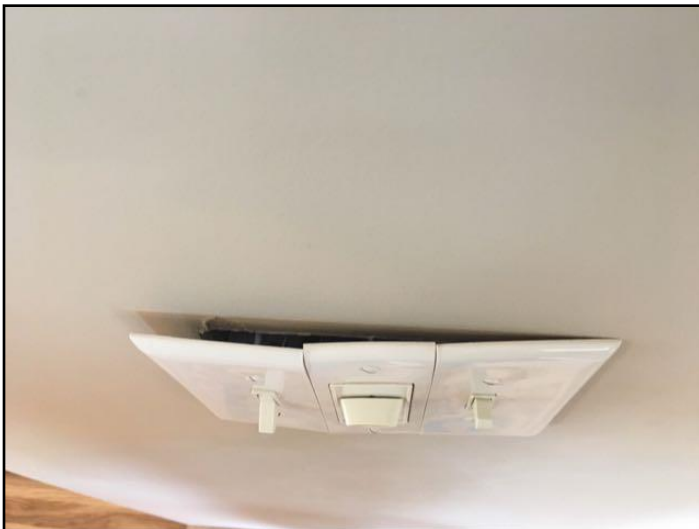
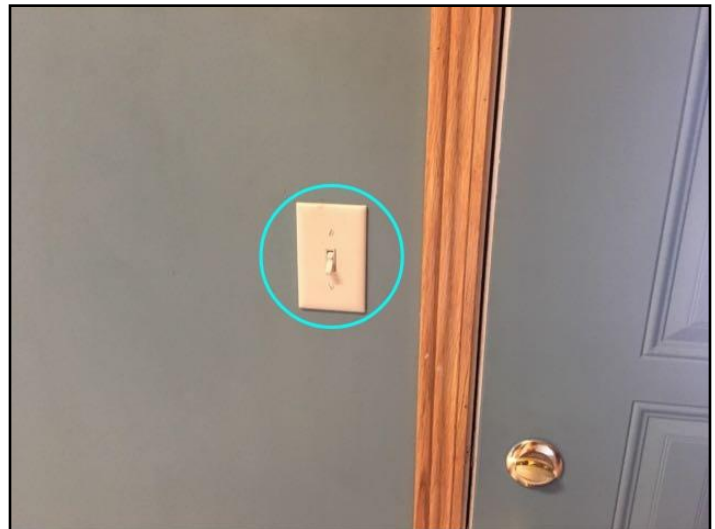
16. Condition: • [Loose](#)

Implication(s): Electric shock

Location: Living Room & Laundry Area

Task: Repair

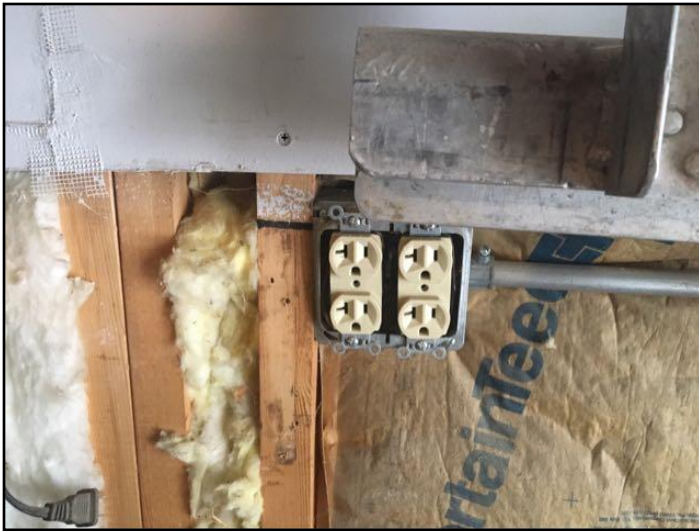
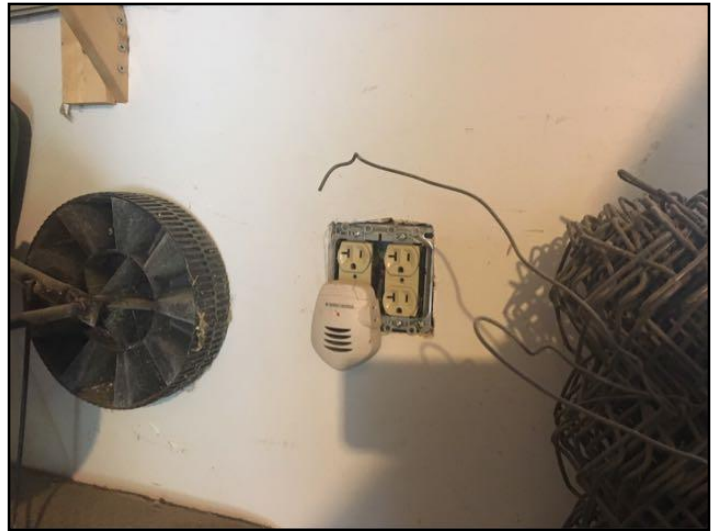
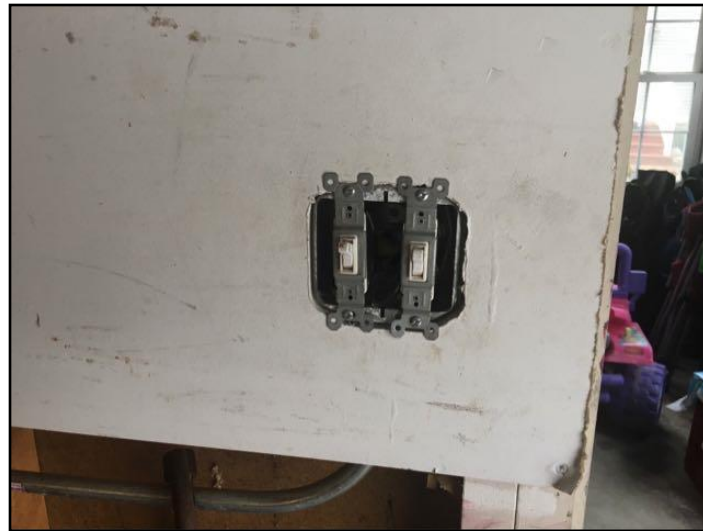
17. Condition: • [Missing](#)

All outlets and switches need a cover plate - Exposed wiring.

Implication(s): Electric shock

Location: Throughout Garage

Task: Replace

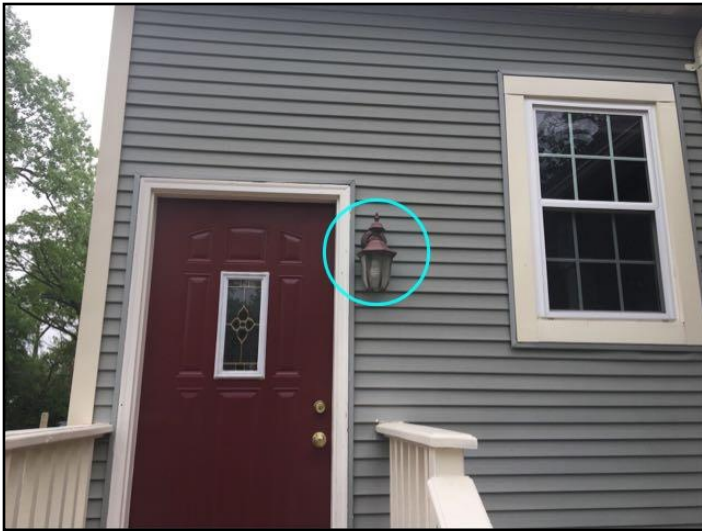
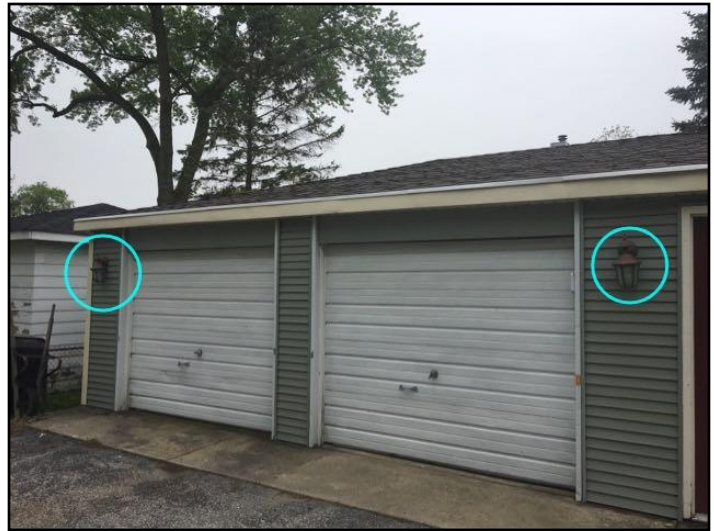
18. Condition: • [Loose](#)

Implication(s): Electric shock | Fire hazard

Location: Southwest Exterior Wall & Garage

Tighten and caulk around the base of exterior lights.

Task: Repair or replace

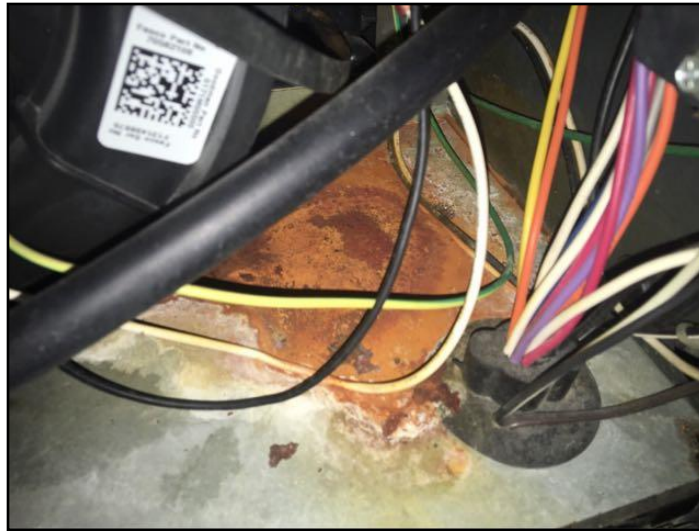
GAS FURNACE \ Cabinet
20. Condition: • [Rust](#)
Implication(s): Reduced system life expectancy | Material deterioration
Location: Basement
Task: Further evaluation

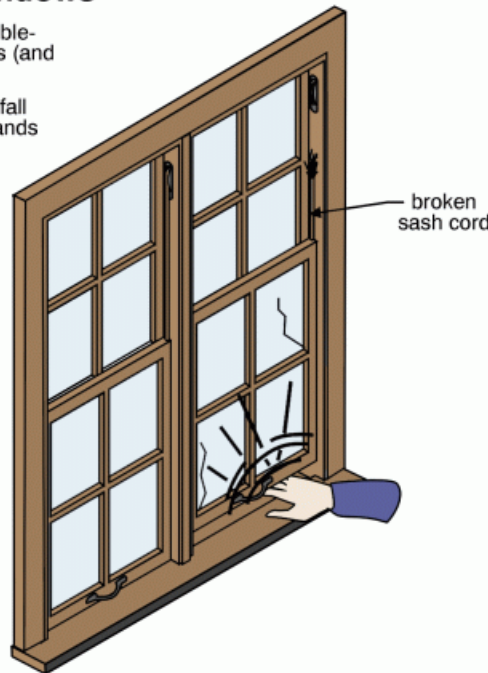
29. Condition: • [Won't stay open](#)

Implication(s): Nuisance | Glass breaking | Physical injury

Location: Second Floor Family Room

Task: Repair or replace

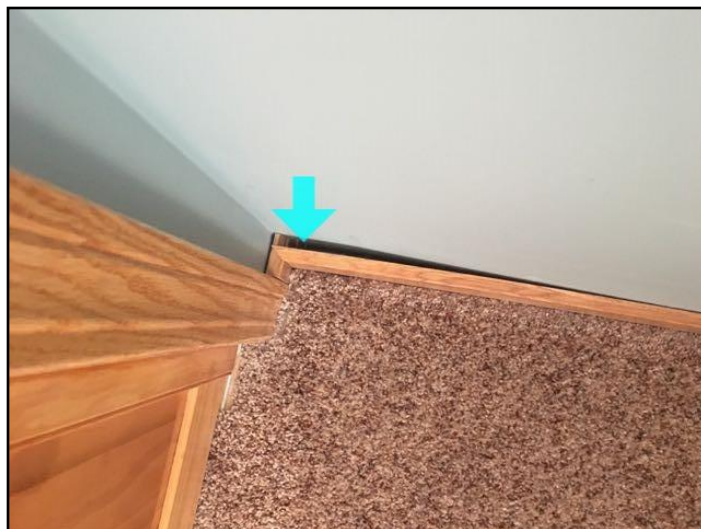
31. Condition: • [Loose](#)

Implication(s): Material deterioration

Location: Second Floor Master Bedroom

Task: Repair or replace

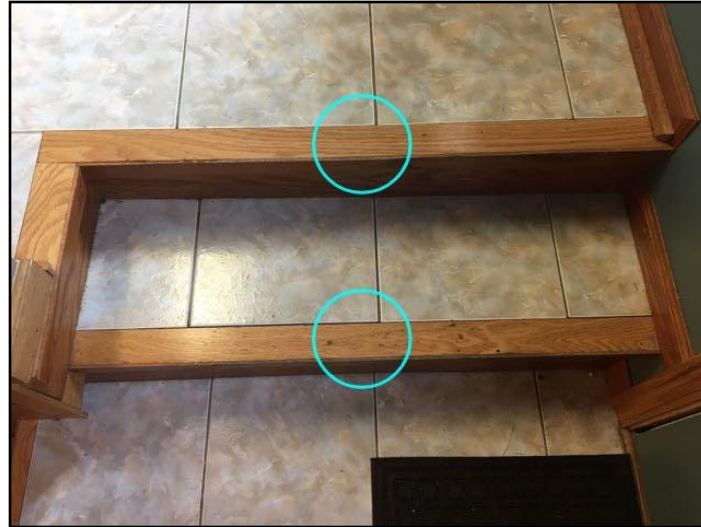
32. Condition: • [Loose](#)

Implication(s): Chance of movement

Location: Basement Staircase

Task: Repair or replace
