Your Inspection Report

8230 South Elizabeth Street
Chicago, IL 60620

INSPECTION DATE:
Saturday, August 25, 2018

RE: Report No. 1260, v.0
8230 South Elizabeth Street
Chicago, IL
60620

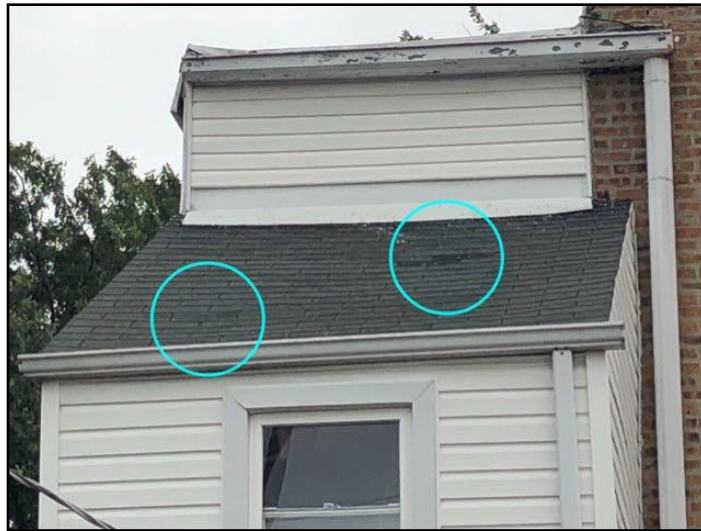
1. Condition: • [Missing, loose or torn](#)

Implication(s): Chance of water damage to contents, finishes and/or structure

Location: Rear Porch Roof

Task: Repair or replace

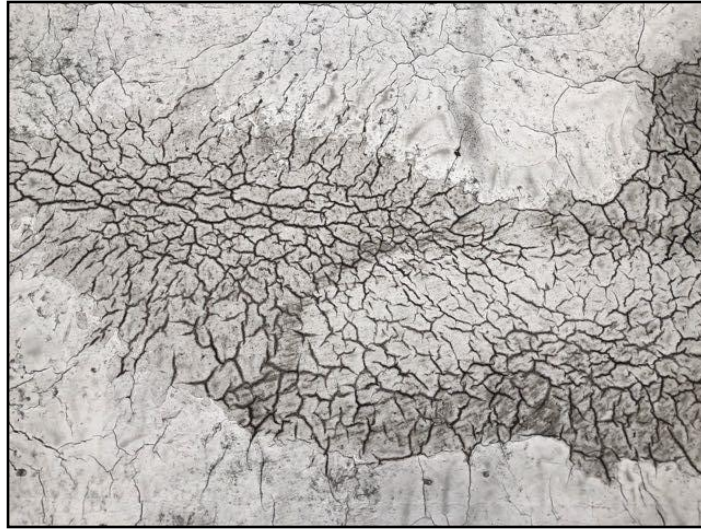
2. Condition: • [Cracks](#)

Alligator cracking in flat roofing.

Implication(s): Chance of water damage to contents, finishes and/or structure

Location: Roof

Task: Further evaluation

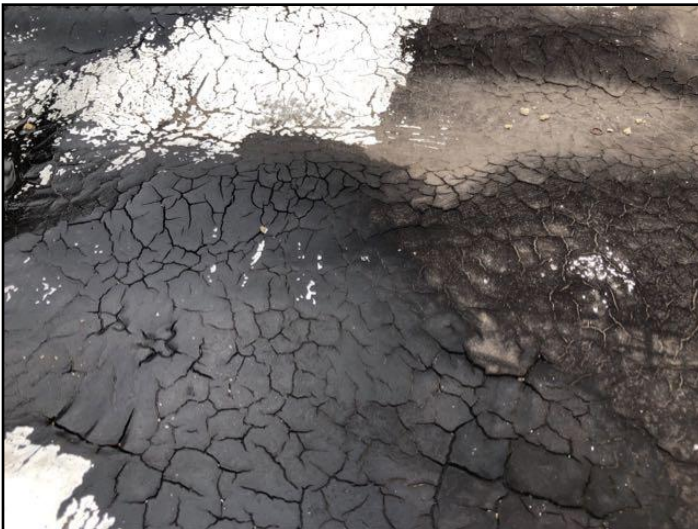
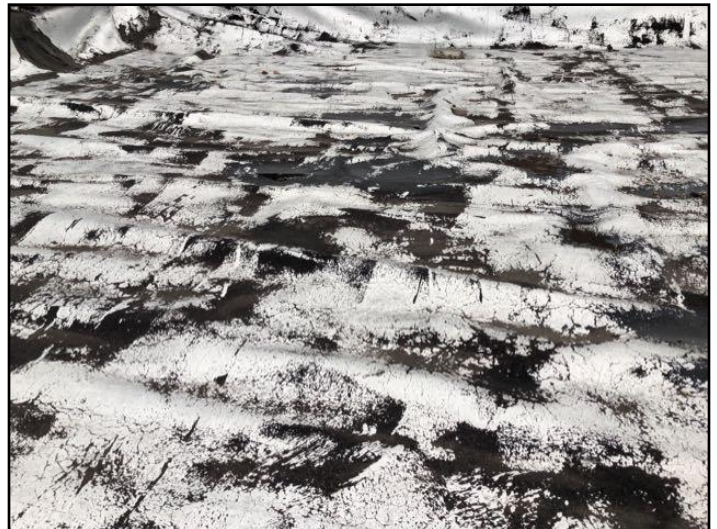
3. Condition: • [Blisters](#)

Air blisters under roofing. Additional condition: Alligator cracking

Implication(s): Chance of water damage to contents, finishes and/or structure

Location: Garage Roof

Task: Further evaluation

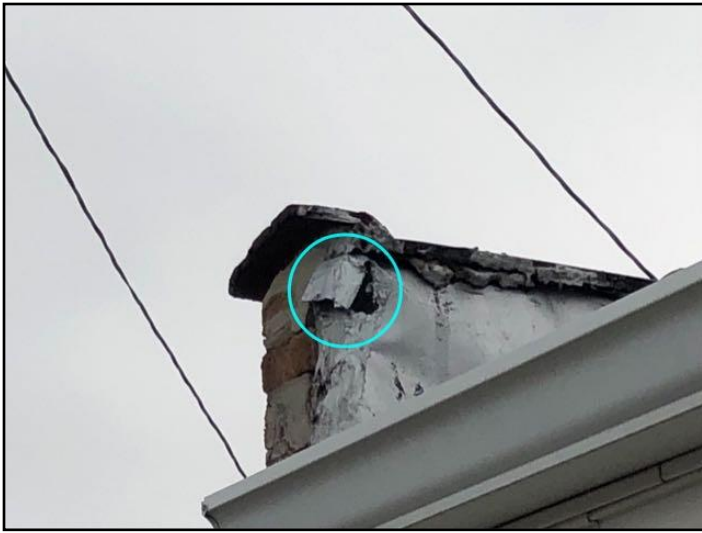
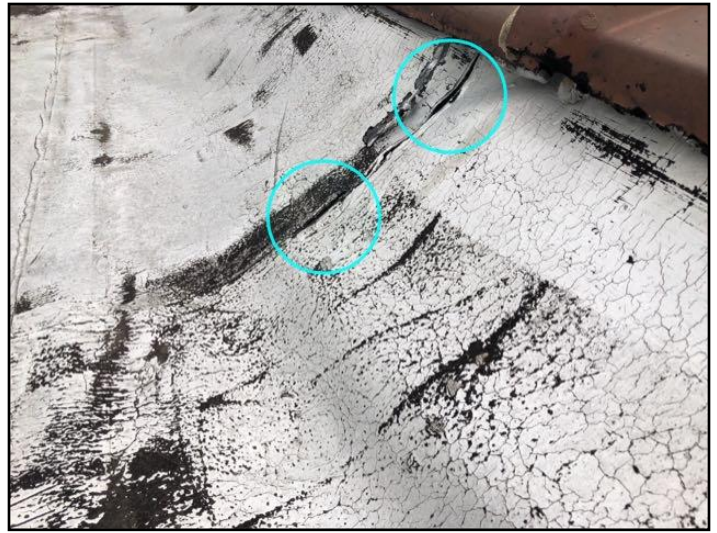
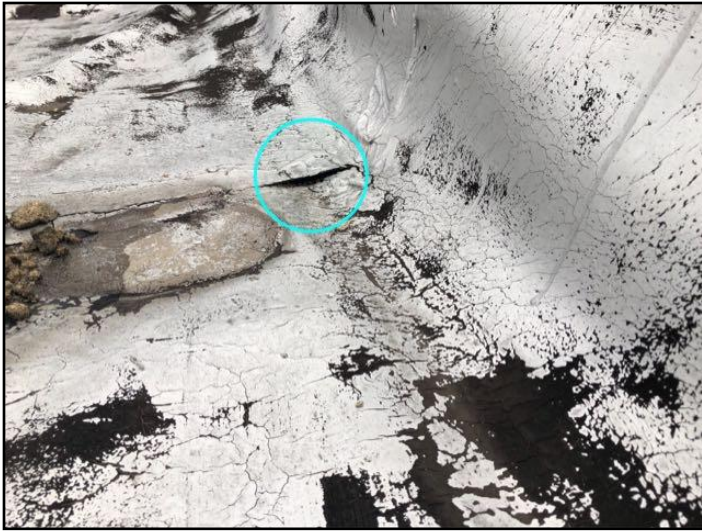
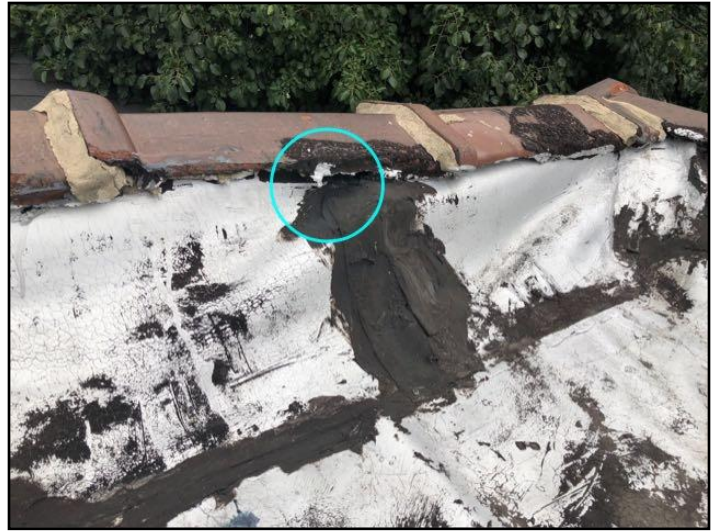
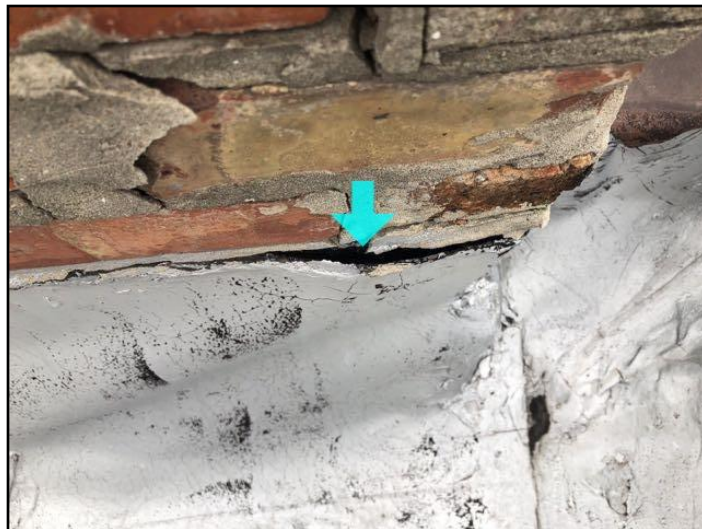
4. Condition: • [Openings at seams or flashings](#)

Implication(s): Chance of water damage to contents, finishes and/or structure

Location: Garage Roof

Task: Repair or replace

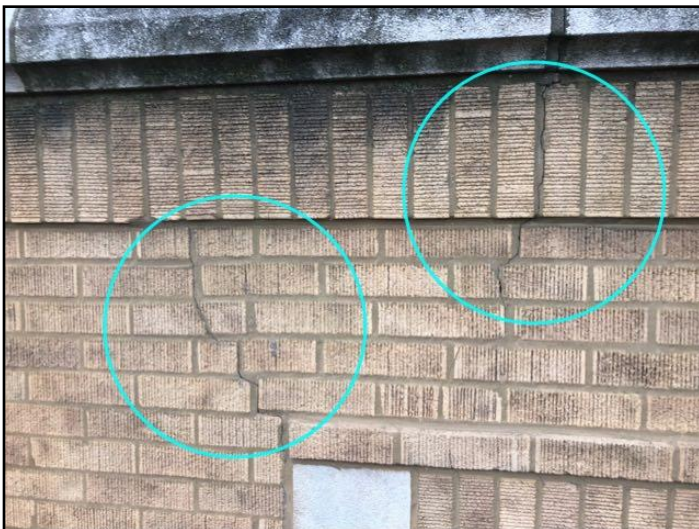
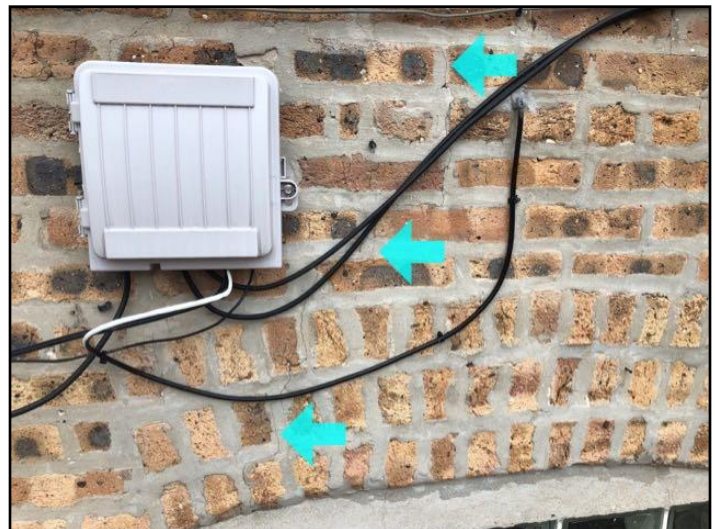
5. Condition: • [Cracked](#)

Location: Front & Rear Exterior Wall

Task: Repair

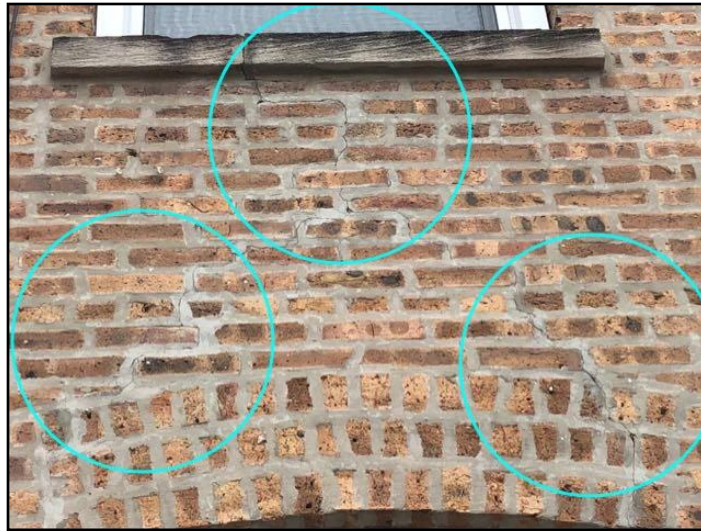
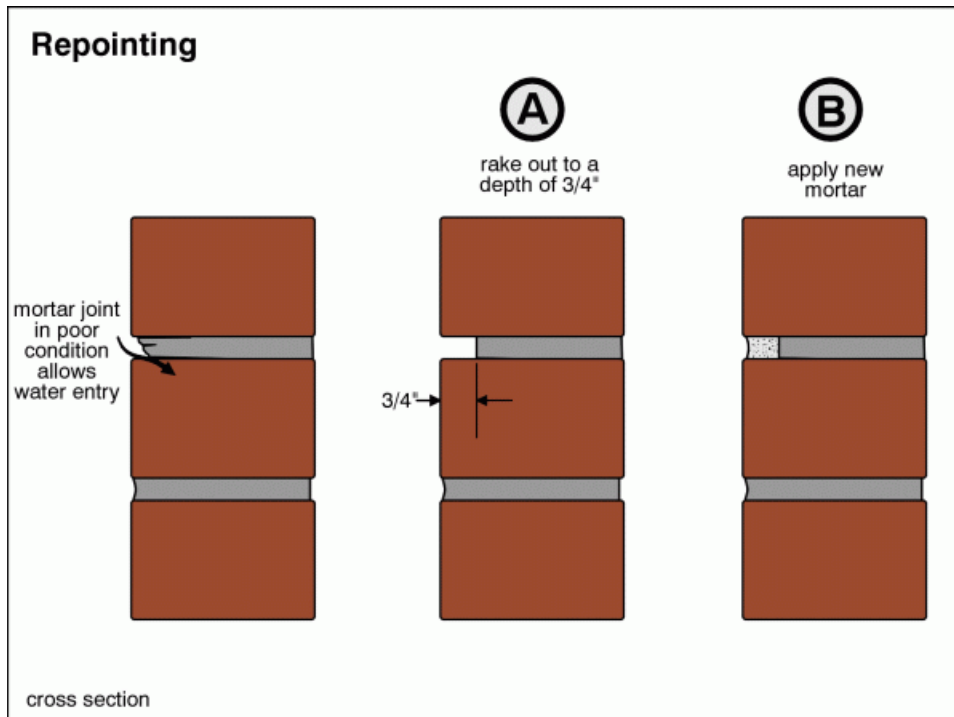
6. Condition: • [Mortar deterioration](#)

Implication(s): Chance of water entering building | Weakened structure | Chance of structural movement

Location: Garage

Task: Repair

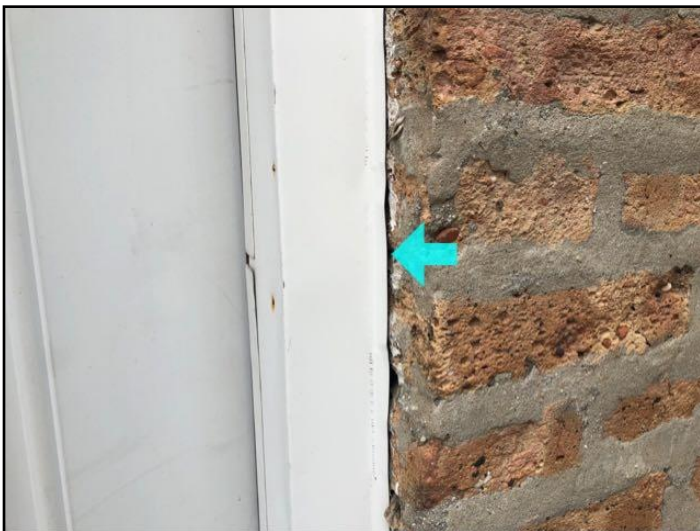
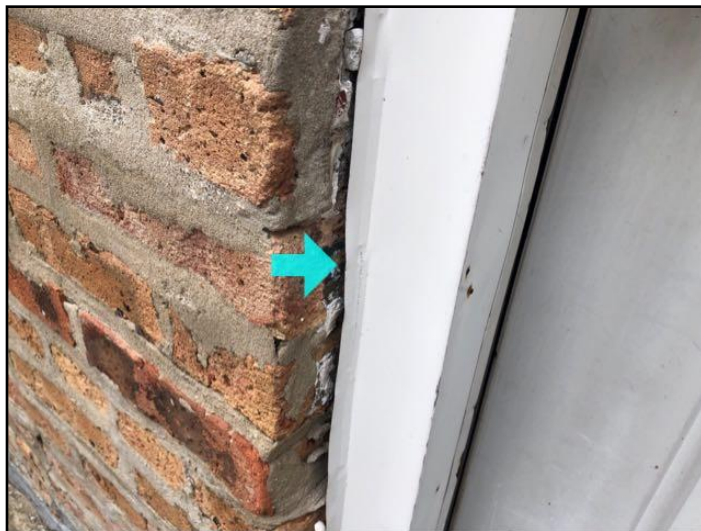
10. Condition: • [Caulking missing, deteriorated or loose](#)

Implication(s): Chance of damage to finishes and structure

Location: Garage

Task: Improve

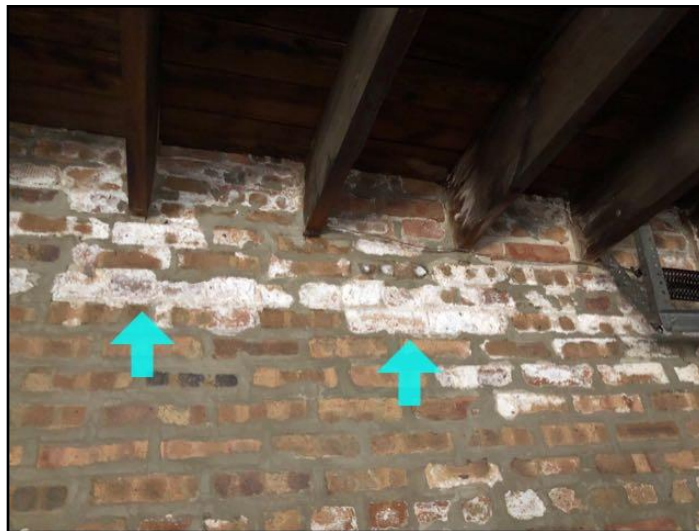
11. Condition: • Efflorescence

Location: Garage

Task: Further evaluation

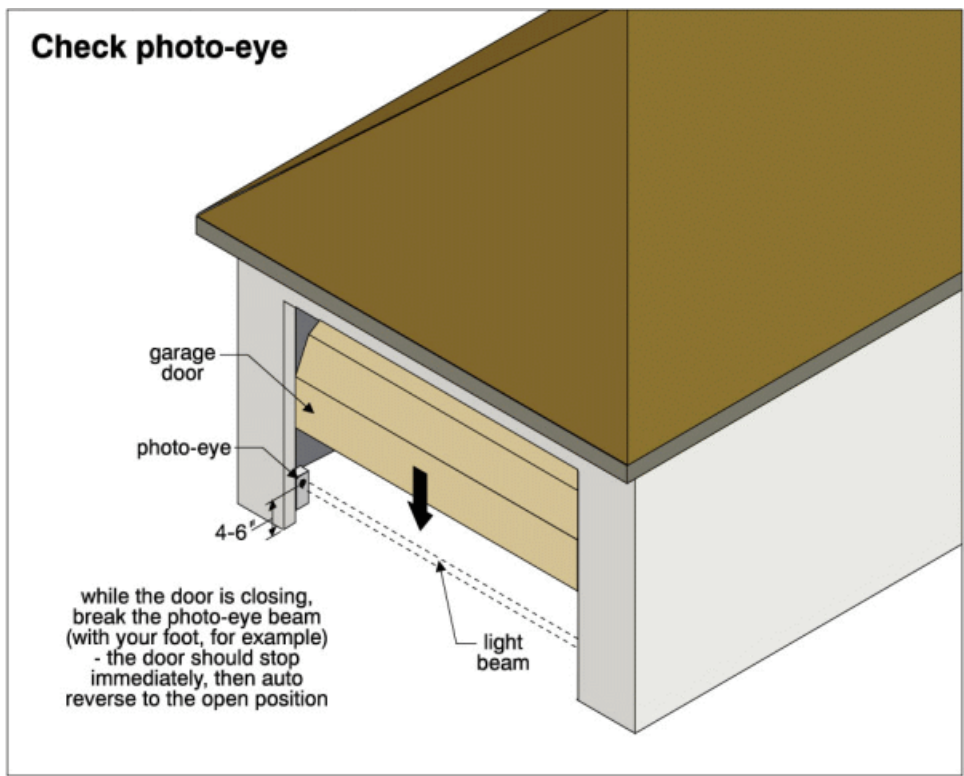
Condition: • [Fails to auto reverse](#)

Older garage door opener is not equipped with auto-reverse laser eye sensors.

Implication(s): Physical injury

13. **Condition:** • [Fails to auto reverse](#)

Location: Garage

Task: Repair or replace

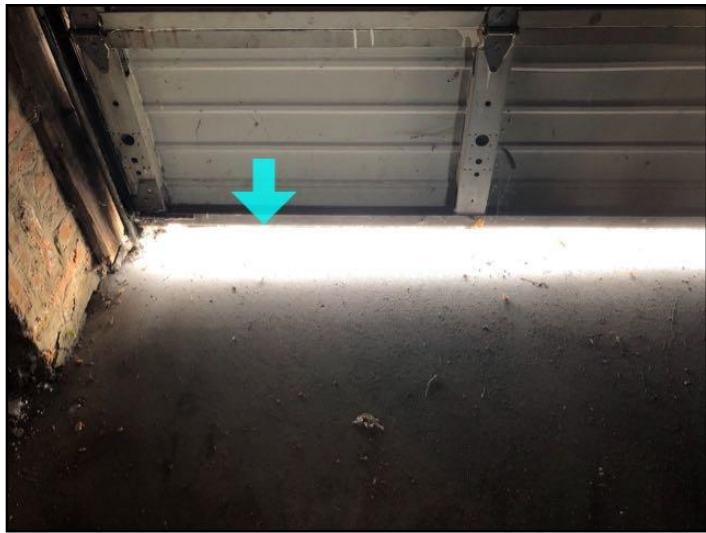
14. Condition: • [Adjustment needed to open or close limit](#)

Implication(s): System inoperative | Physical injury

Location: Garage

Task: Improve

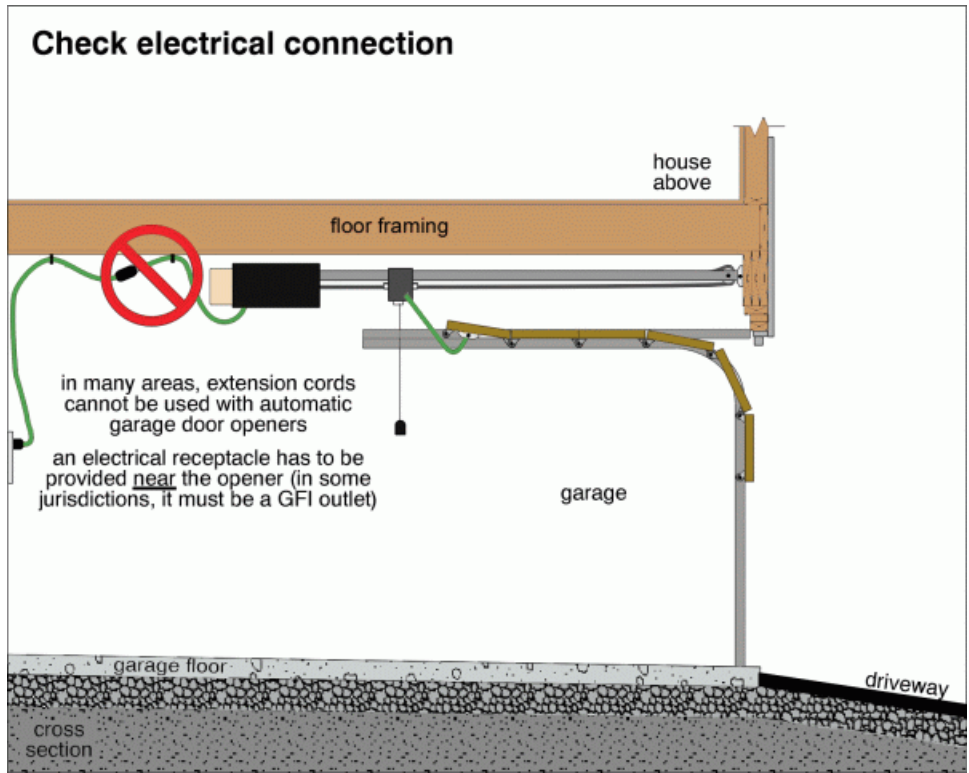
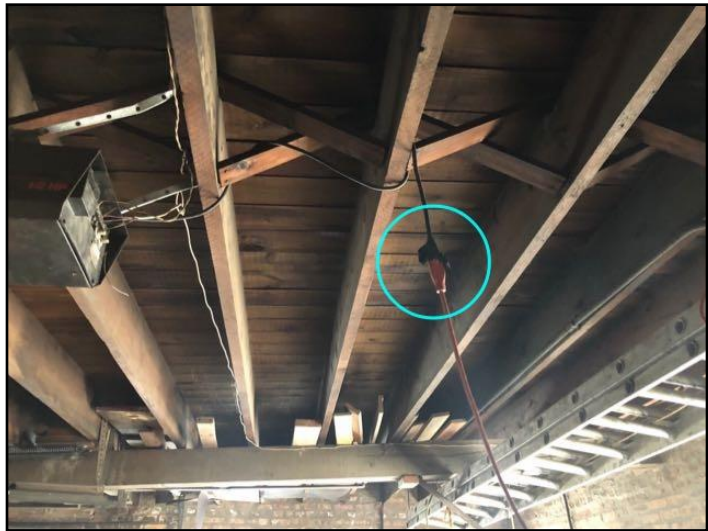
15. Condition: • [Extension cord for opener](#)

No dedicated outlet for garage door opener.

Implication(s): Electric shock

Location: Garage
Task: Repair or replace

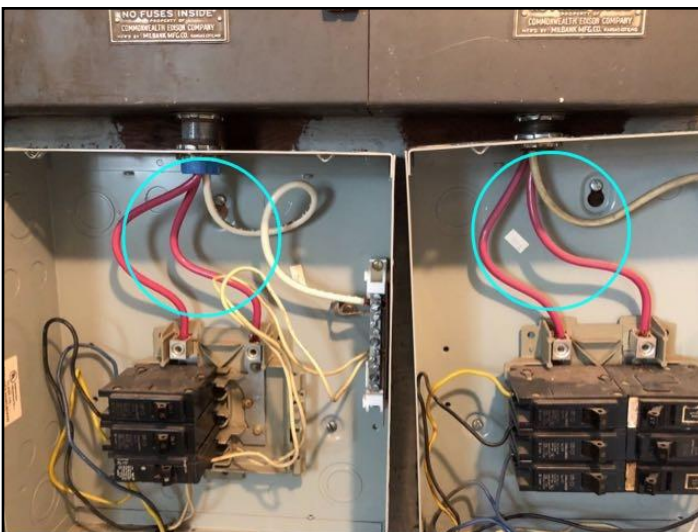
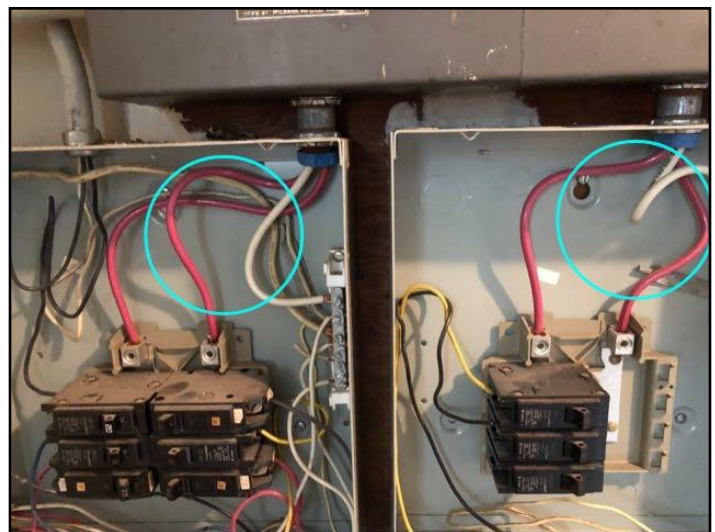
Service wires entering panel appear to be rated for 60 Amps, by today's standards the minimum panel rating for unit panels would be 100 Amps.

17. Condition: • [Inadequate service size](#)

Location: Rear Basement

Task: Further evaluation

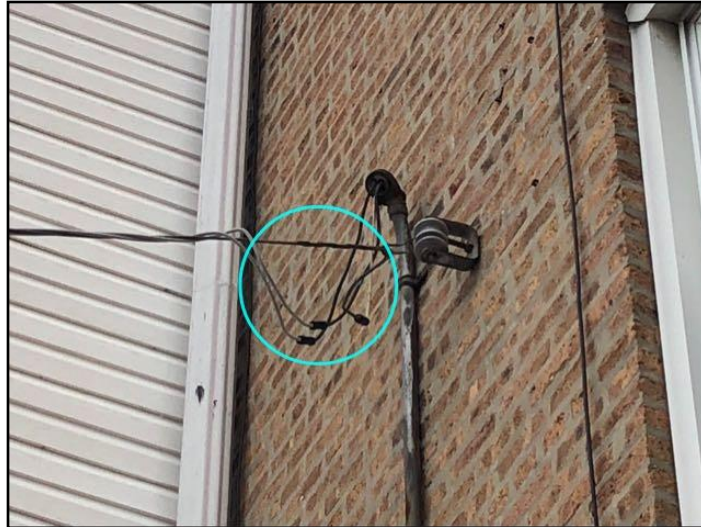
18. Condition: • [Marginal service size](#)

Service drop and service wires entering building appear to be only rated for 100 Amps, multi-unit buildings would ideally have a larger service size. SERVICE DROP IS LIKELY RESPONSIBILITY OF ELECTRIC COMPANY.

Location: Rear Exterior

Task: Further evaluation

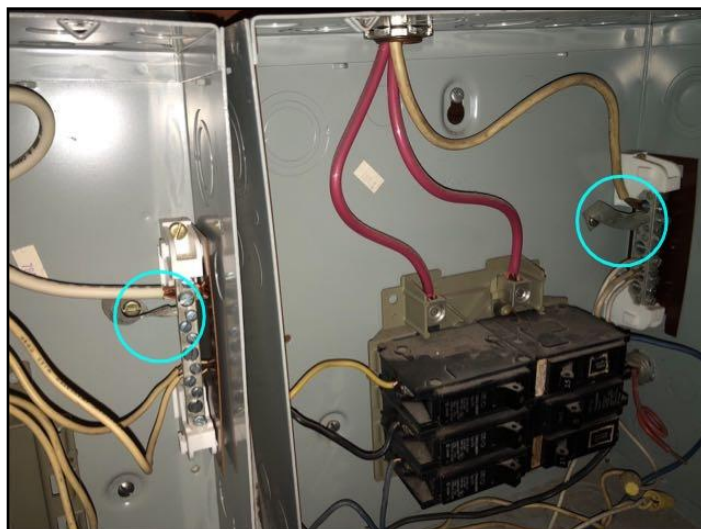
19. Condition: • [Neutral and ground wires bonded at subpanel](#)

Location: Rear Basement

Task: Further evaluation

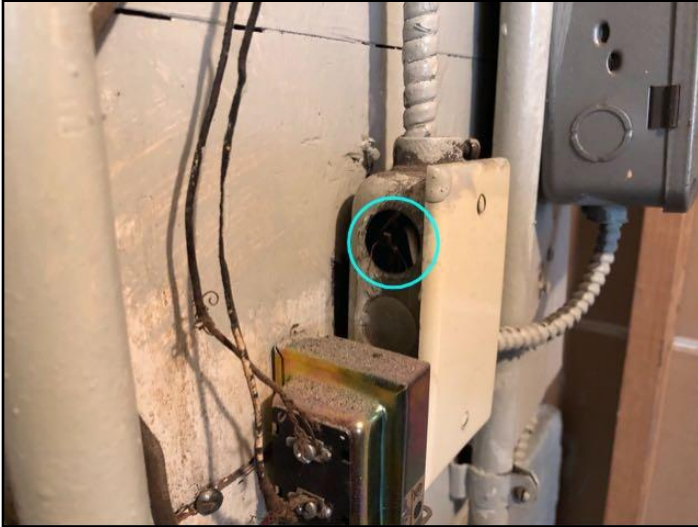
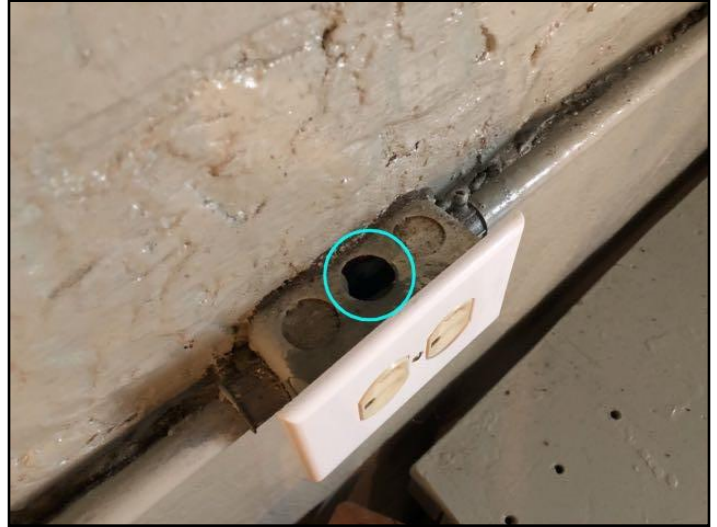
20. Condition: • [Cover loose or missing](#)

Missing knock outs on junction boxes - Exposed wiring.

Implication(s): Electric shock | Fire hazard

Location: Rear Basement

Task: Repair or replace

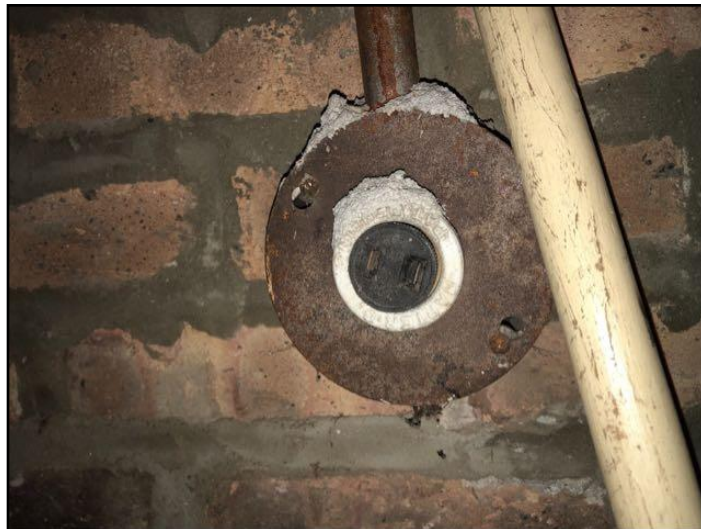
21. Condition: • Two prong ungrounded outlets noted in the house. Based on the age of the house, the outlets are "functioning as intended", but by today's electrical standards, an upgrade to three prong grounded outlets should be considered.

Location: Garage

Task: Upgrade

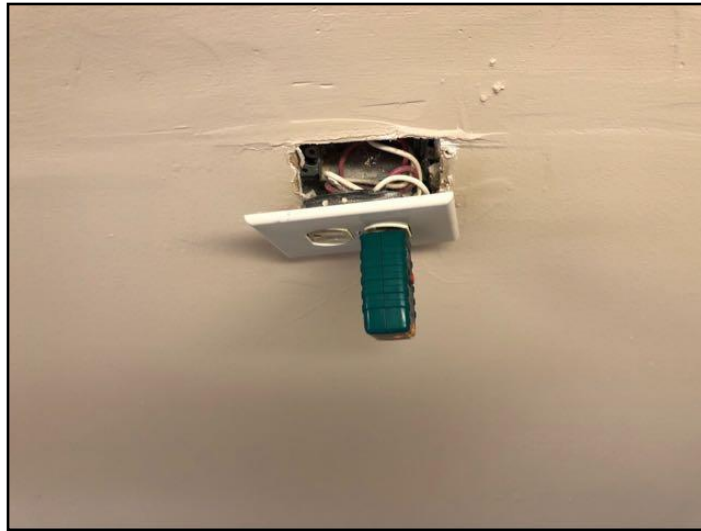
22. Condition: • [Loose](#)

Implication(s): Electric shock | Fire hazard

Task: Repair or replace

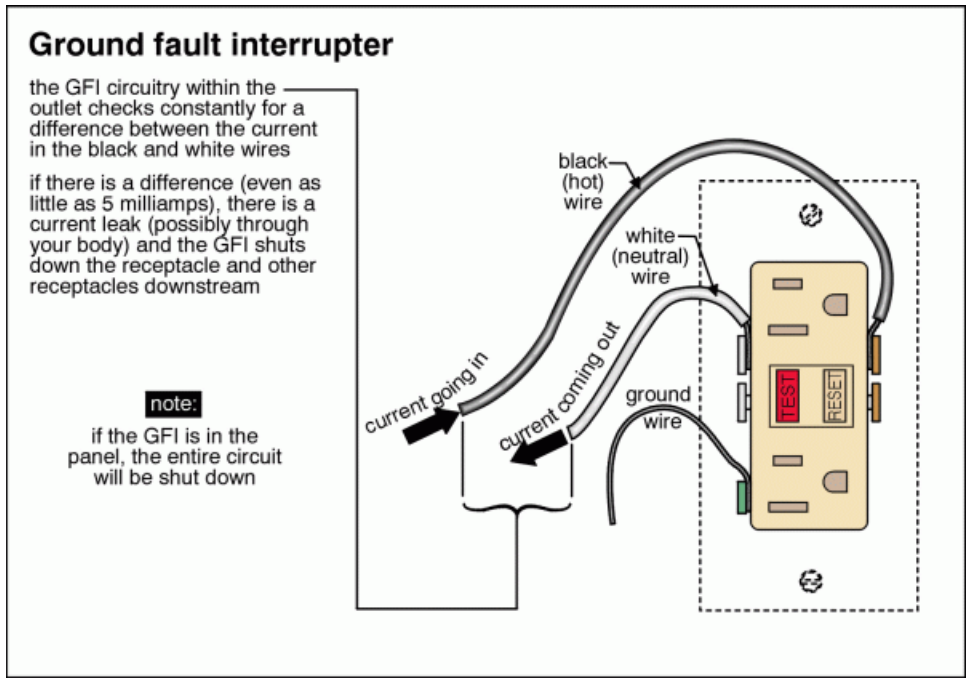
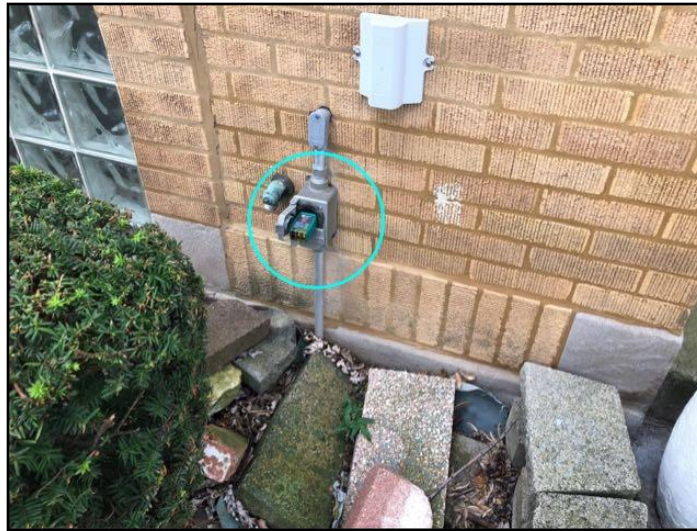
23. Condition: • [GFCI/GFI needed \(Ground Fault Circuit Interrupter\)](#)

Any outlet that can be exposed to contact with water must be GFI protected.

Location: Front Exterior

Task: Replace

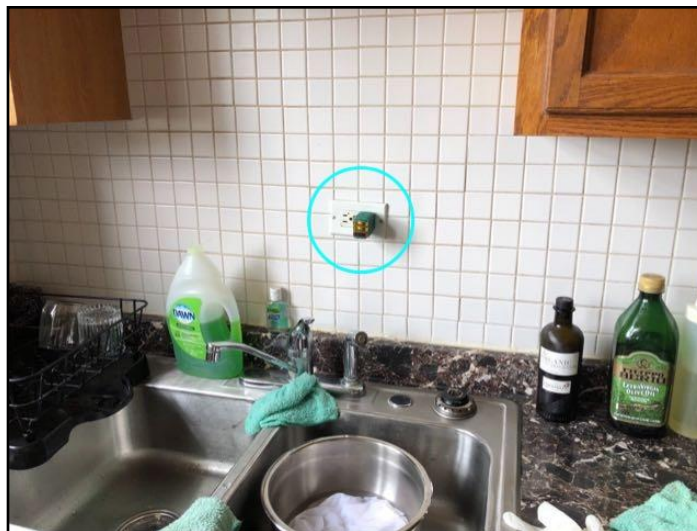
24. Condition: • [Test faulty on GFCI/GFI \(Ground Fault Circuit Interrupter\)](#)

This GFI outlet is not functioning properly.

Location: Second Floor Kitchen

Task: Replace

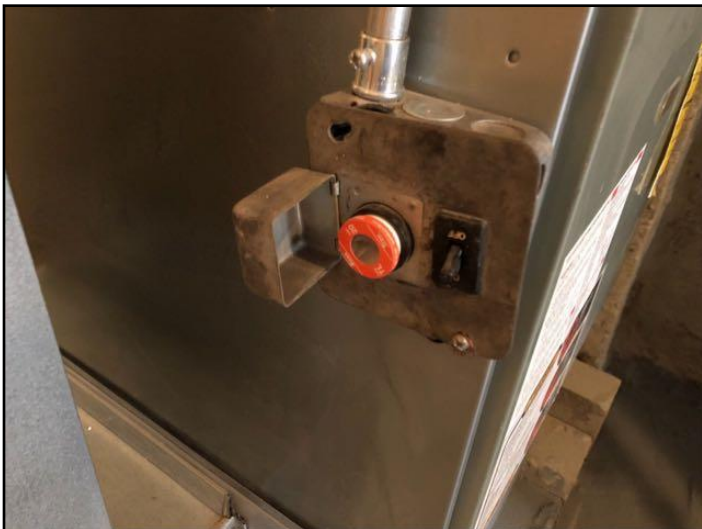
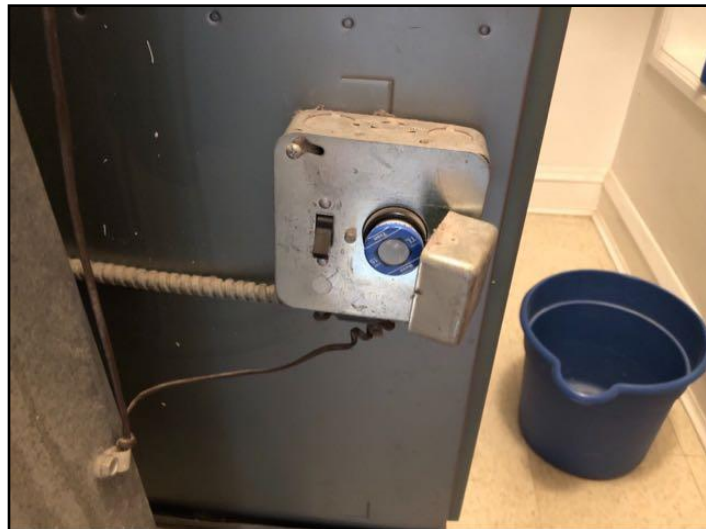
Fused shut off switches for furnaces are obsolete by today's standards.

26. Condition: • [Obsolete](#)

Implication(s): Equipment failure | Electric shock | Fire hazard

Location: Furnace Rooms

Task: Repair or replace

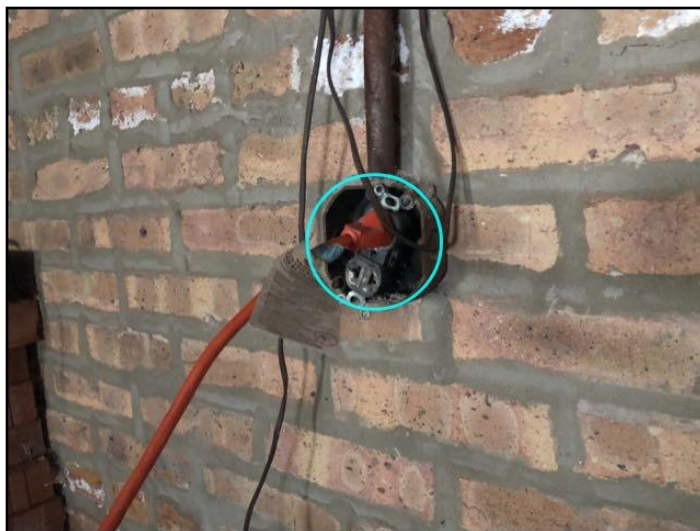
27. Condition: • [Missing](#)

Location: Garage

Task: Replace

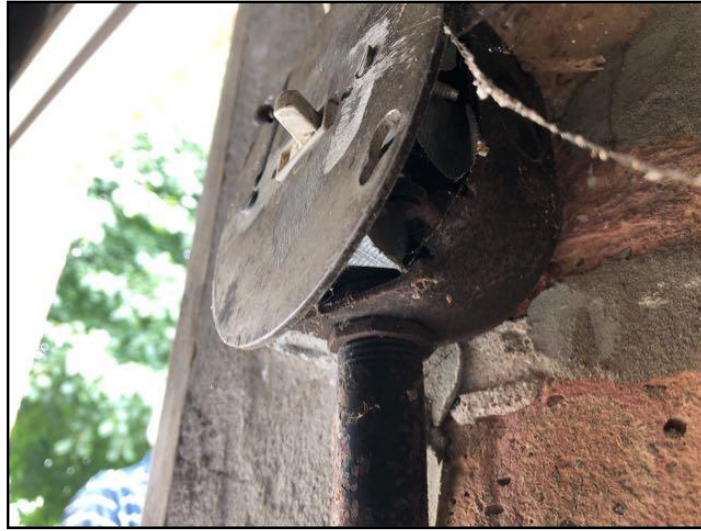
28. Condition: • [Loose](#)

Implication(s): Electric shock

Location: Garage

Task: Repair or replace

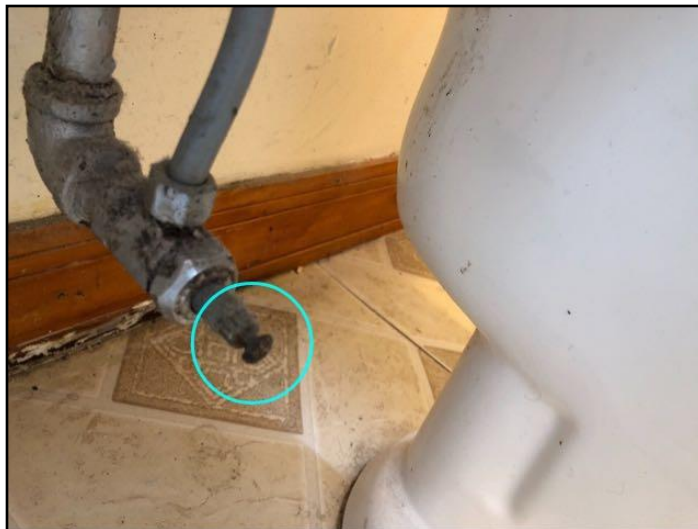
34. Condition: • [Missing or cannot be located](#)

Implication(s): Chance of water damage to contents, finishes and/or structure | Difficult to service

Location: Throughout Building

Task: Repair or replace

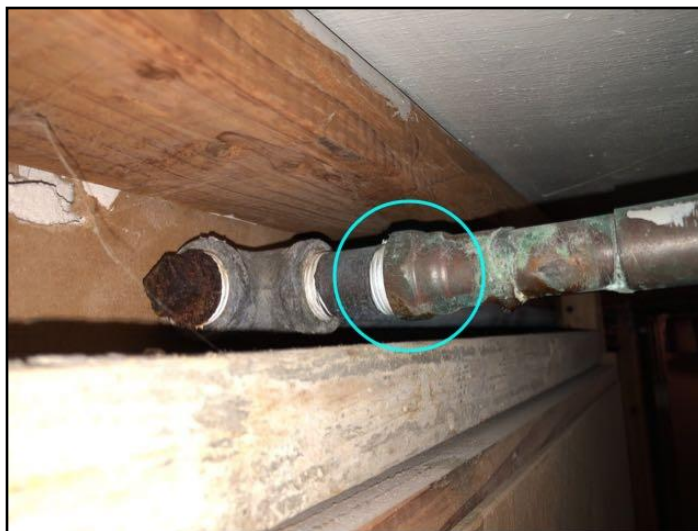
35. Condition: • No dielectric unions where copper and galvanized steel water pipes meet.

Location: Basement Furnace Room

Task: Repair or replace

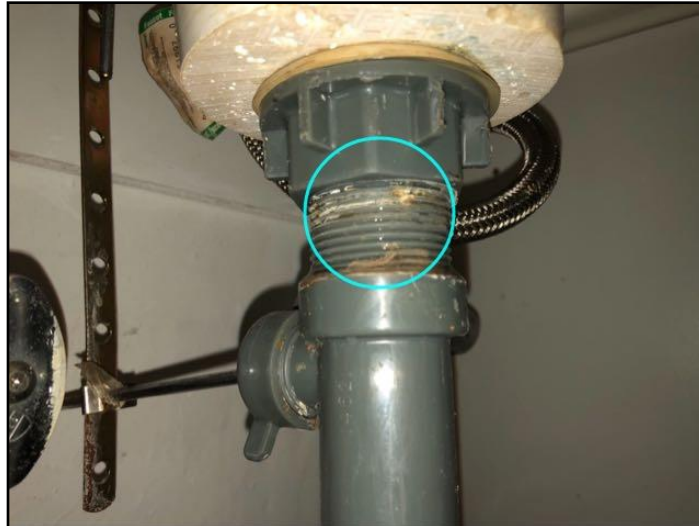
37. Condition: • [Leak](#)

Leak under bathroom sink.

Location: Third Floor Bathroom

Task: Repair or replace

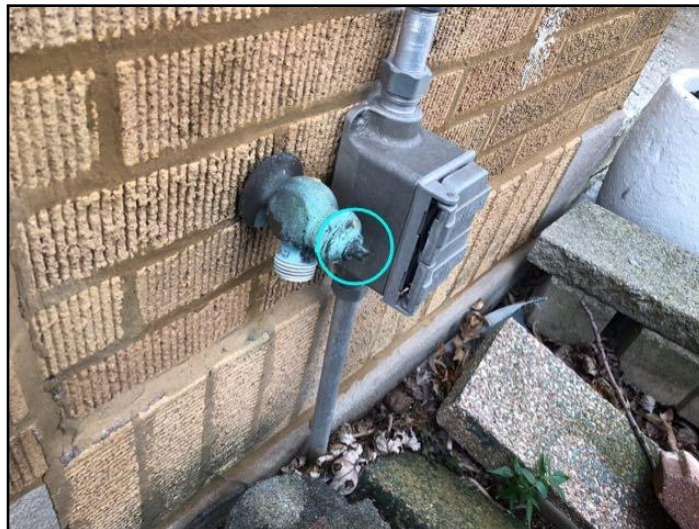
38. Condition: • Damaged/missing handle

Location: Front Exterior Wall

Task: Repair or replace

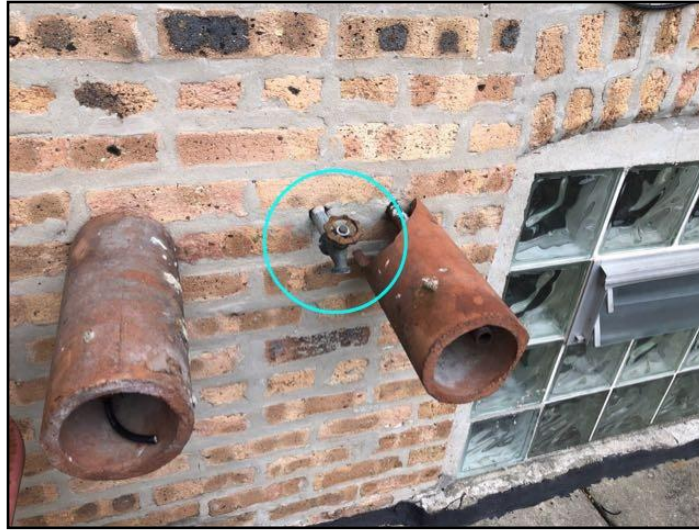
39. Condition: • [Inoperative](#)

Implication(s): Equipment inoperative

Location: Rear Exterior Wall

Task: Repair or replace

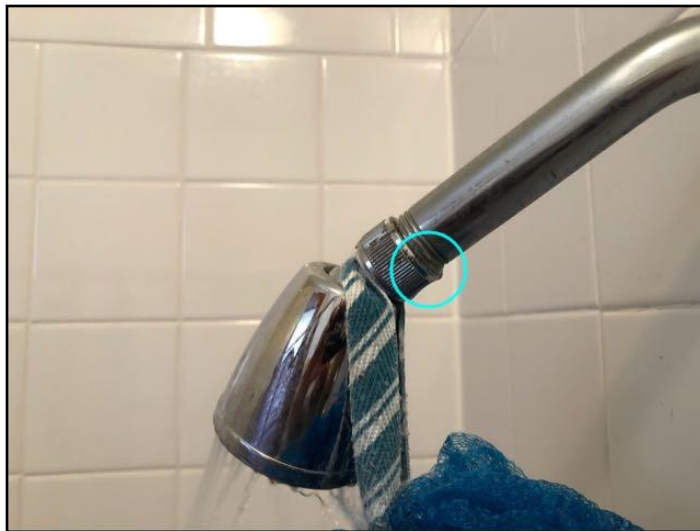
43. Condition: • [Leak](#)

Leaking shower head.

Implication(s): Chance of water damage to contents, finishes and/or structure

Location: First Floor Bathroom

Task: Repair or replace

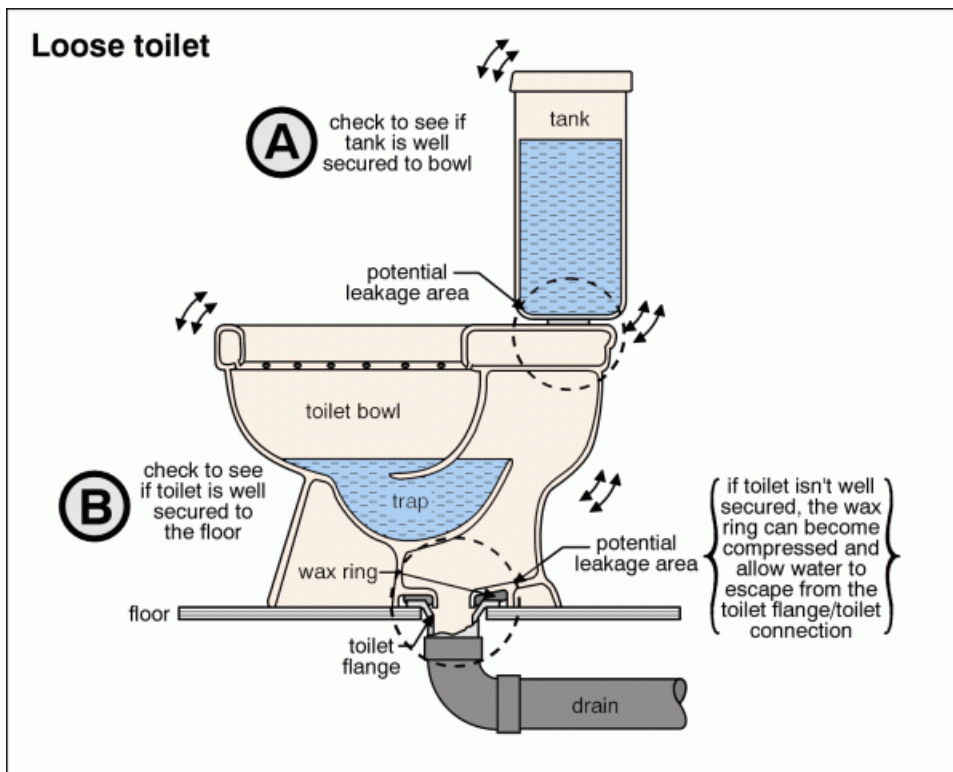
44. Condition: • [Loose](#)

Toilet in basement bathroom is loose to floor.

Implication(s): Chance of water damage to contents, finishes and/or structure | Sewage entering the building

Location: Basement Bathroom

Task: Repair

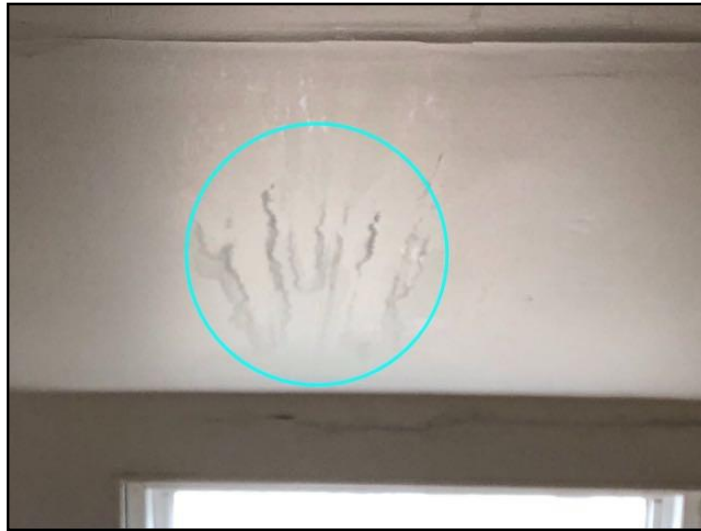
45. Condition: • Water stains

Stains appear to be under area with missing shingles.

Implication(s): Chance of water damage to contents, finishes and/or structure

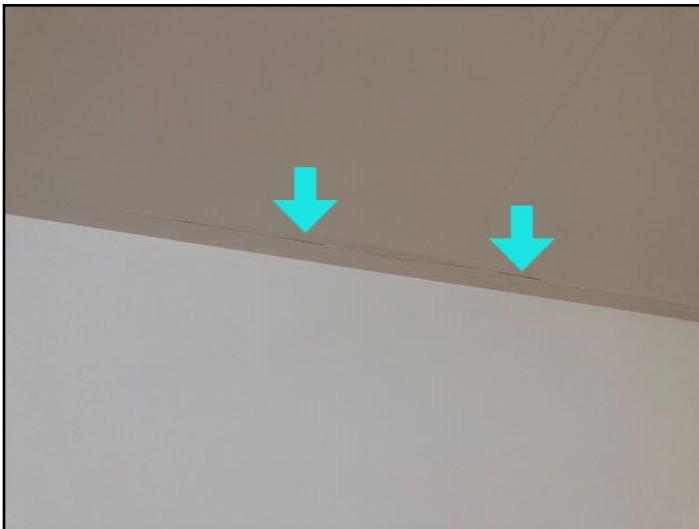
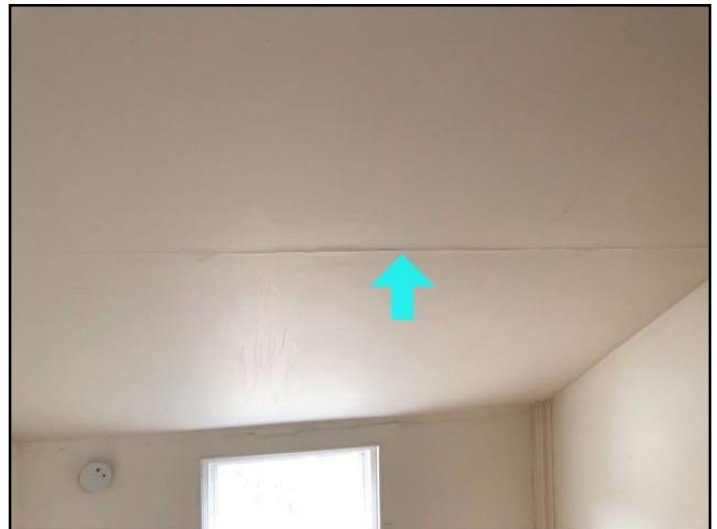
46. Condition: • [Poor joints](#)

Implication(s): Damage or physical injury due to falling materials

Location: Rear Porch

Task: Improve

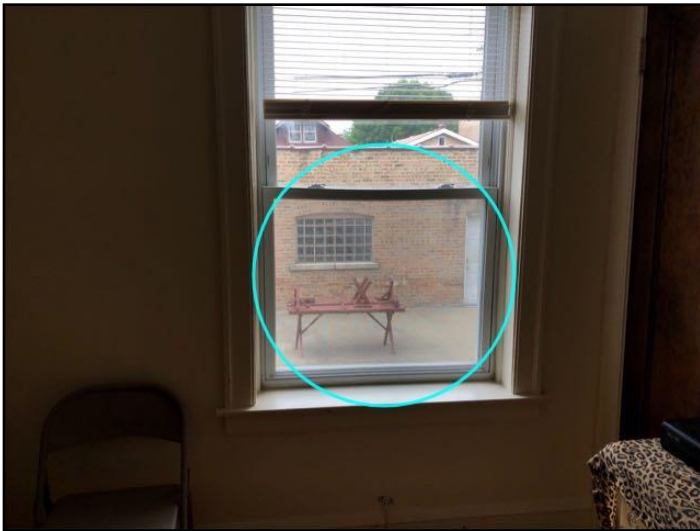
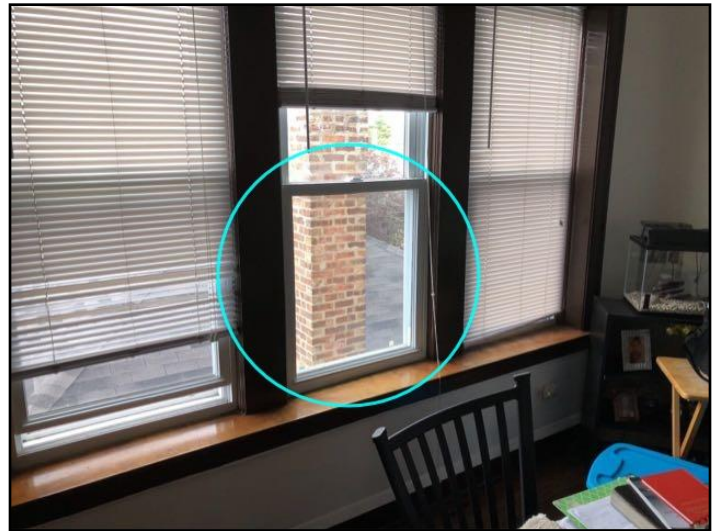
49. Condition: • [Won't stay open](#)

Task: Repair or replace

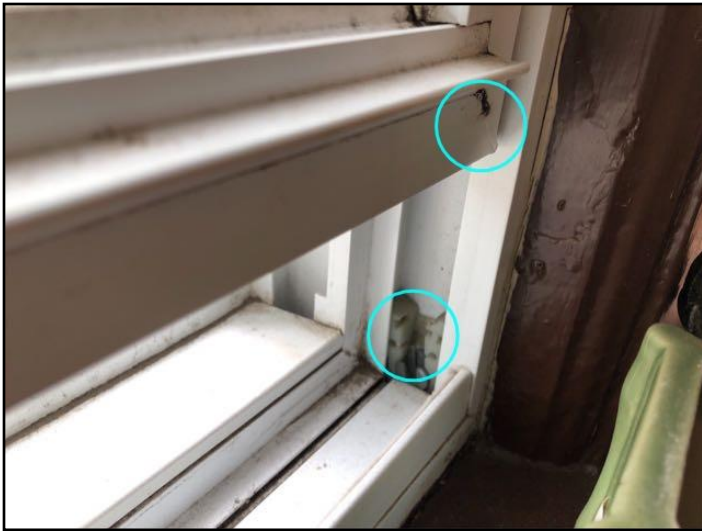
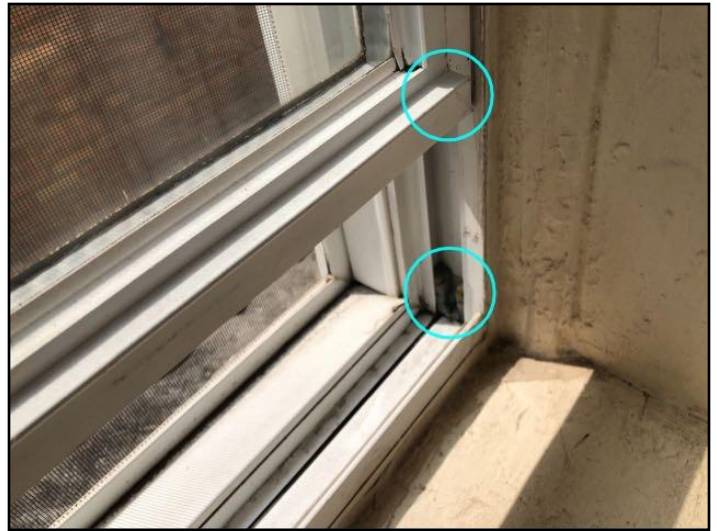
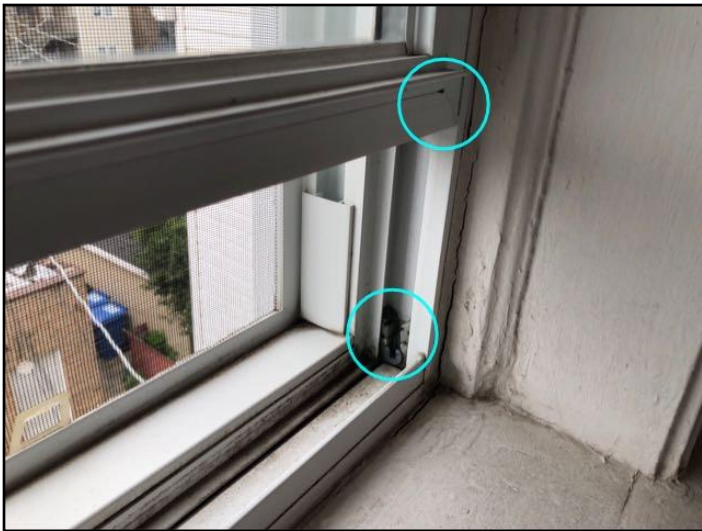
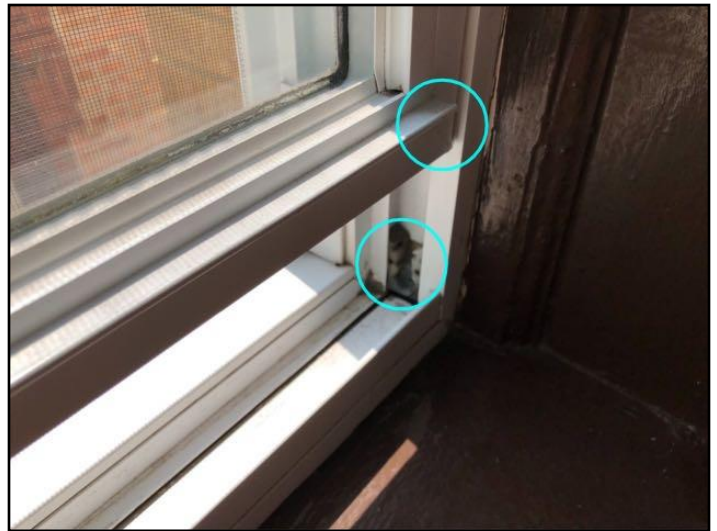
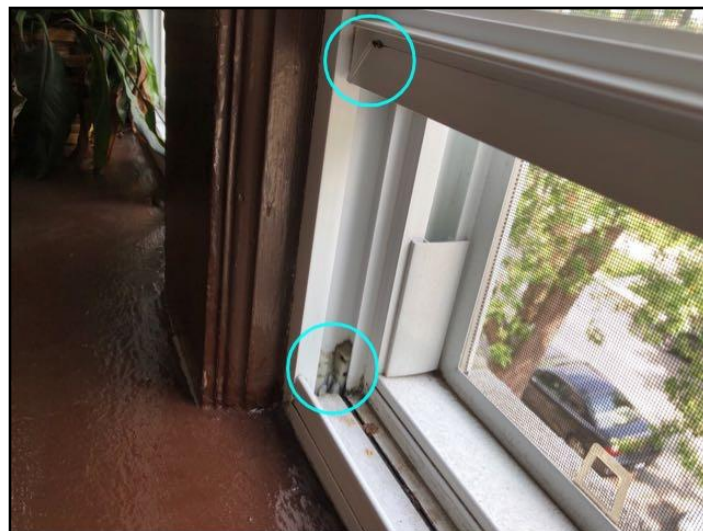
50. Condition: • [Loose fit](#)
Implication(s): Chance of damage to finishes and structure
Location: Various Windows
Task: Repair or replace
