Your Inspection Report

8230 South Elizabeth Street
Chicago, IL 60620

INSPECTION DATE:
Saturday, August 25, 2018

RE: Report No. 1260, v.0
8230 South Elizabeth Street
Chicago, IL
60620

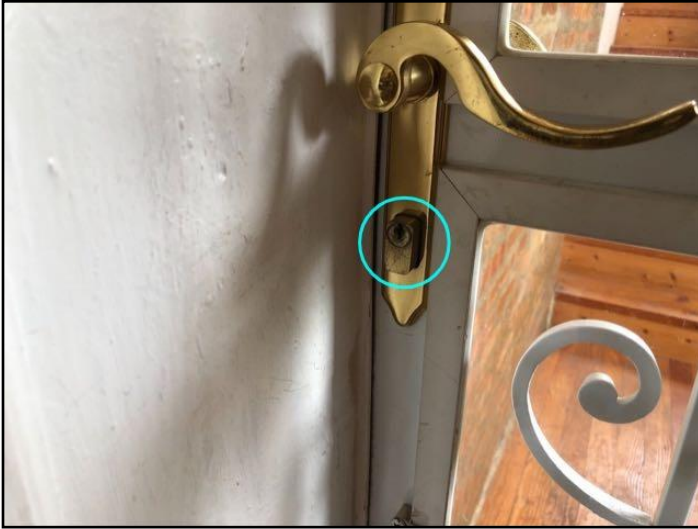
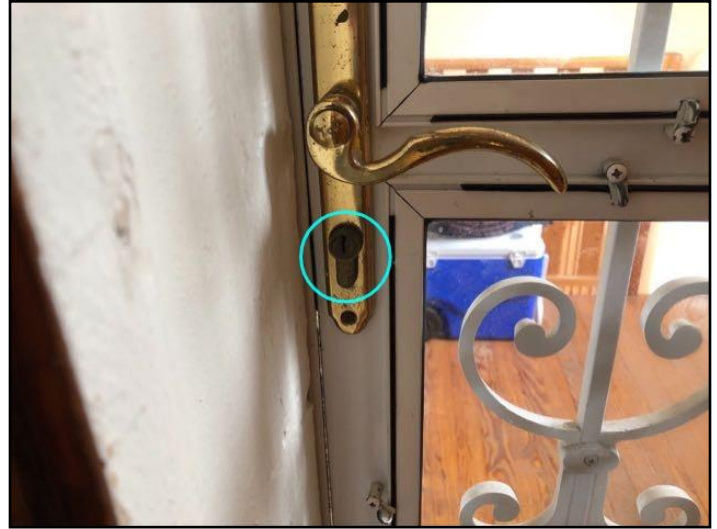
51. Condition: • Keyed deadbolt locks on interior of home present a fire escape hazard.

Location: Rear Porch

Task: Repair or replace

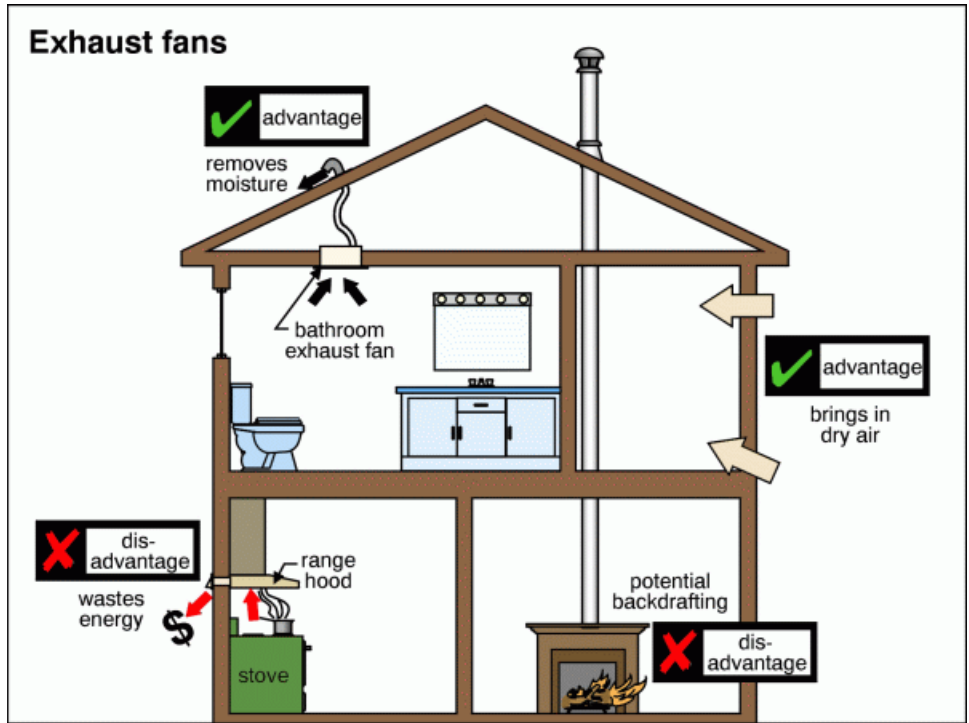
54. Condition: • [Missing](#)

Implication(s): Chance of condensation damage to finishes and/or structure

Location: Second Floor & Third Floor Bathrooms

Task: Repair or replace

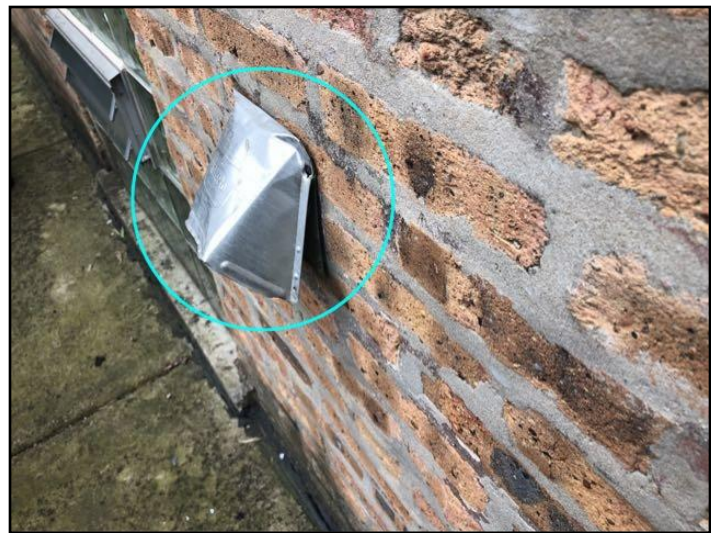
55. Condition: • [Weather hood missing or loose](#)

Implication(s): Chance of water damage to contents, finishes and/or structure | Chance of pests entering building

Location: North Exterior Wall

Task: Replace
