192 S Foster Street
Dothan, AL 36301
334-447-9405
Inspector: Buck Meyers

Table of Contents

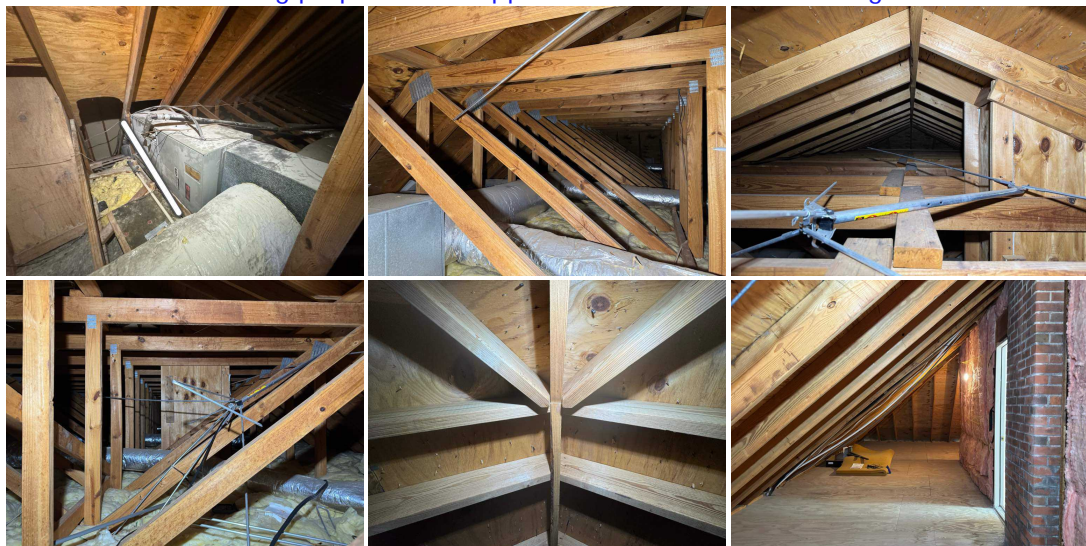
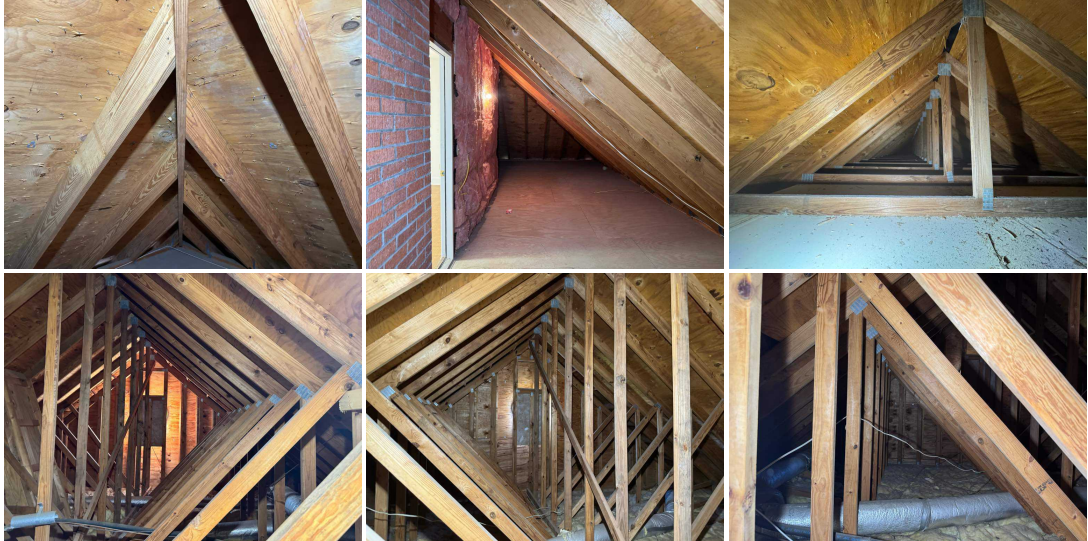
Satisfactory, Marginal Roof Framing: Truss, Rafter - [Modified/omitted truss webbing for HVAC installation.](#)
[Recommend installing proper cross support for the modified webbing.](#)

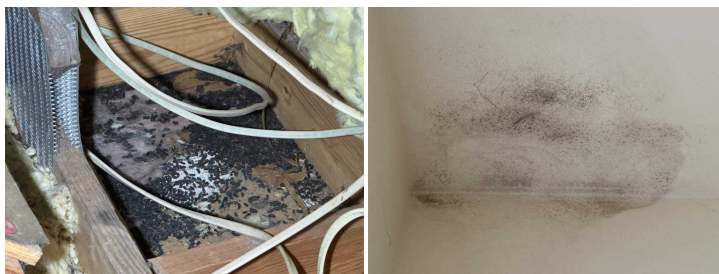
Not Inspected, Marginal Ventilation: Soffit vents, Ridge vents - Recommend that a licensed contractor that specializes in insulation/ building envelopes to assess the lack of insulation and ventilation in this area (THIS MAY BE BY DESIGN). A mechanical ventilation system with dehumidification may be needed to properly manage humidity levels that could lead to environmental conditions conducive to microbial growth. Visible microbial growth observed in pool equipment room and on drywall in attic.

Evidence of rodents noted at soffit.

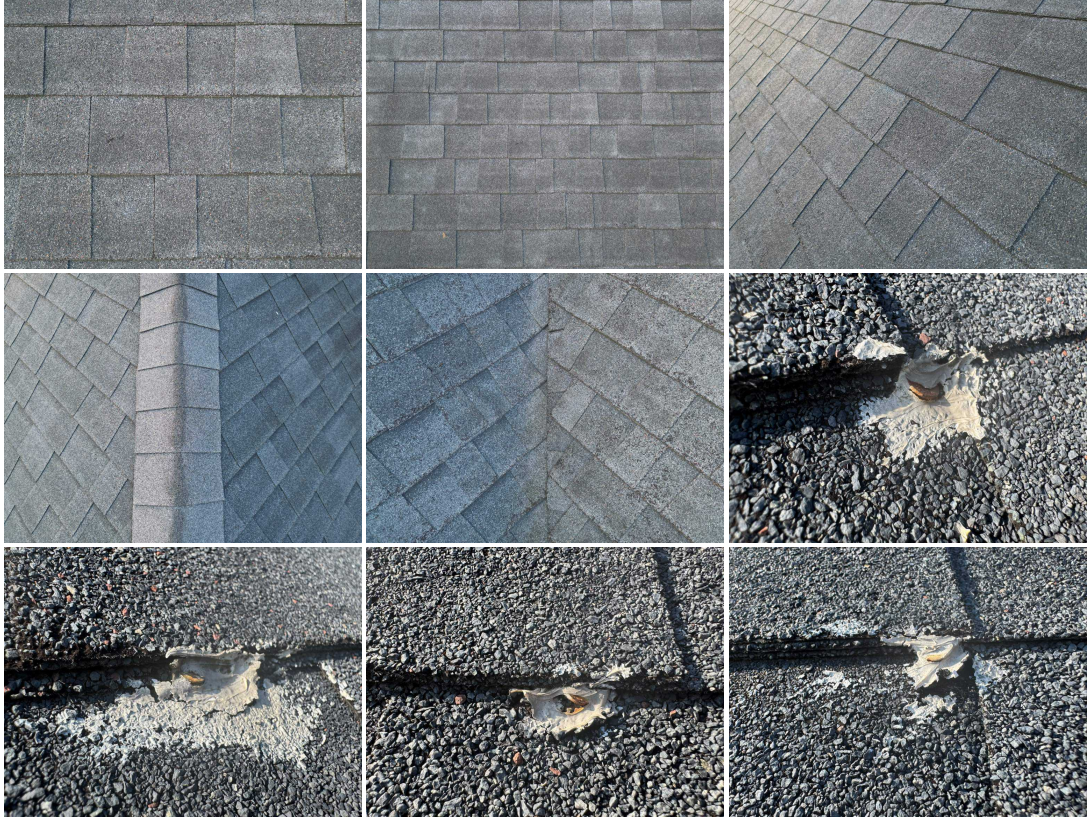
Satisfactory, Marginal Material: Multi Layer/Architectual Shingle - [Wear and granular loss appears normal for estimated age of materials.](#)

[Recommend that a licensed roofer further evaluate and seal errant fasteners noted across surface.](#)

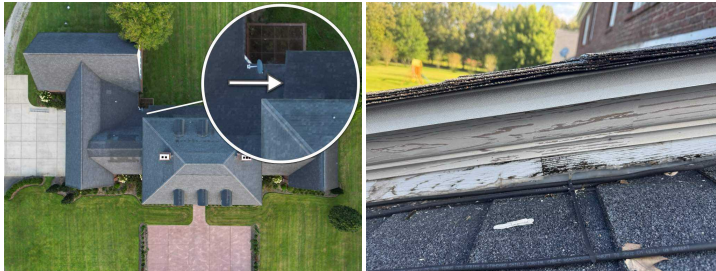
Satisfactory, Marginal Flashing: Lead, Metal - [No visible flashing/improper clearances between materials at rake edge/shingles.](#)

[Recommend repair.](#)

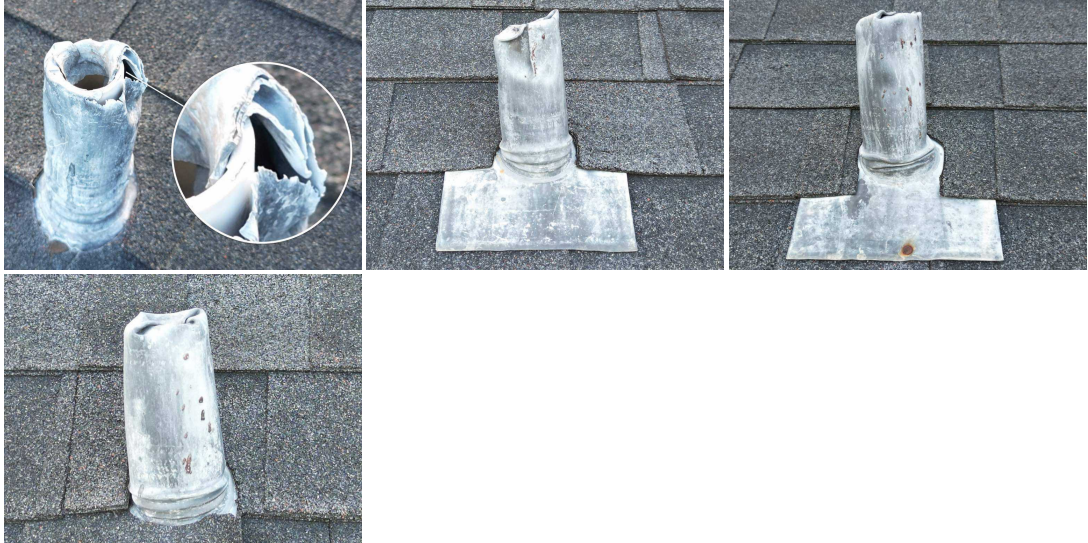
Satisfactory, Marginal Plumbing Vents: PVC, Lead Boots - [Recommend that a licensed roofer repair damaged lead boot to prevent potential moisture intrusion.](#)

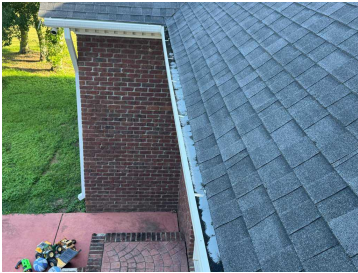
Gutters: Metal, Partial coverage. Although not required, adding gutters and downspouts to the home/rest of the home would greatly help the removal of rain water from the foundation area preventing future water penetration issues. Something to consider.

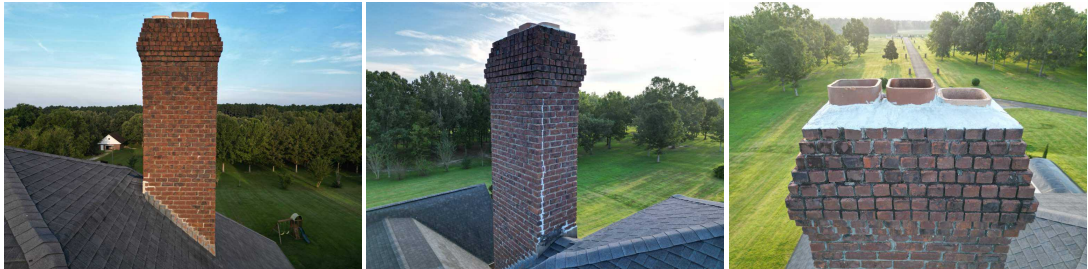
Satisfactory, Marginal Chimney: Brick - [Evidence of past tuck point repairs noted.](#)

[Recommend installing a screen/rain cap to prevent small animal/rain access to chimney flue](#)

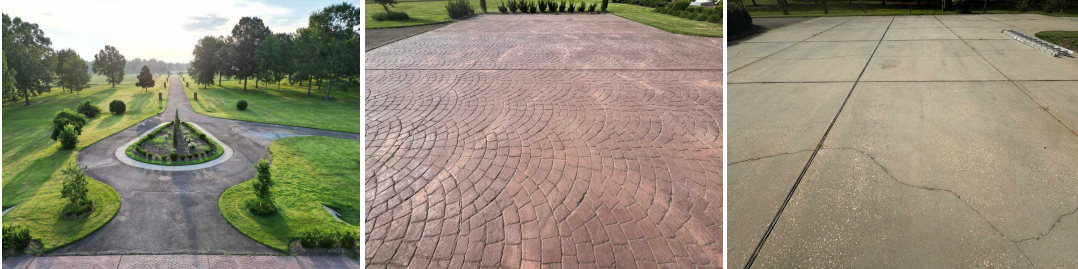
Driveway: Asphalt, Concrete - Typical cracks, less than 3/8 inch. Recommend sealing all cracks.

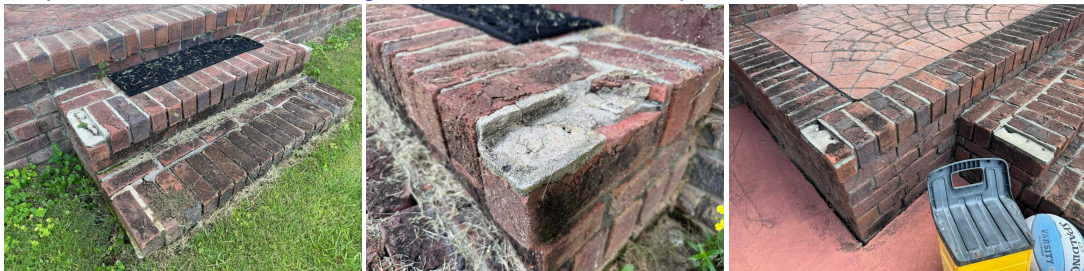
Satisfactory, Marginal Steps: Brick - [Loose/missing bricks](#). [Recommend repair](#).

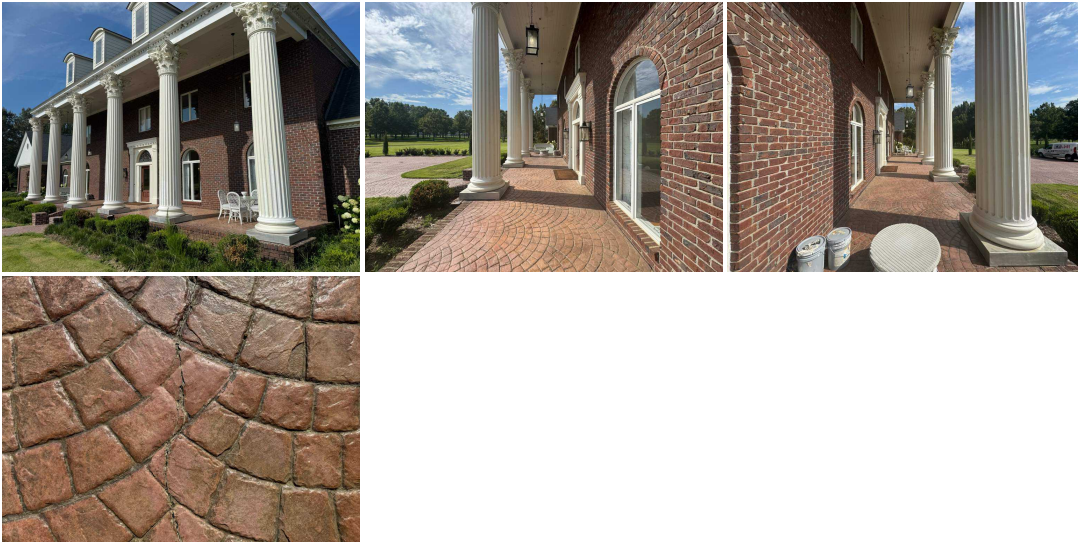
Porch: Concrete - Typical cracks, less than 3/8 inch. Recommend sealing.

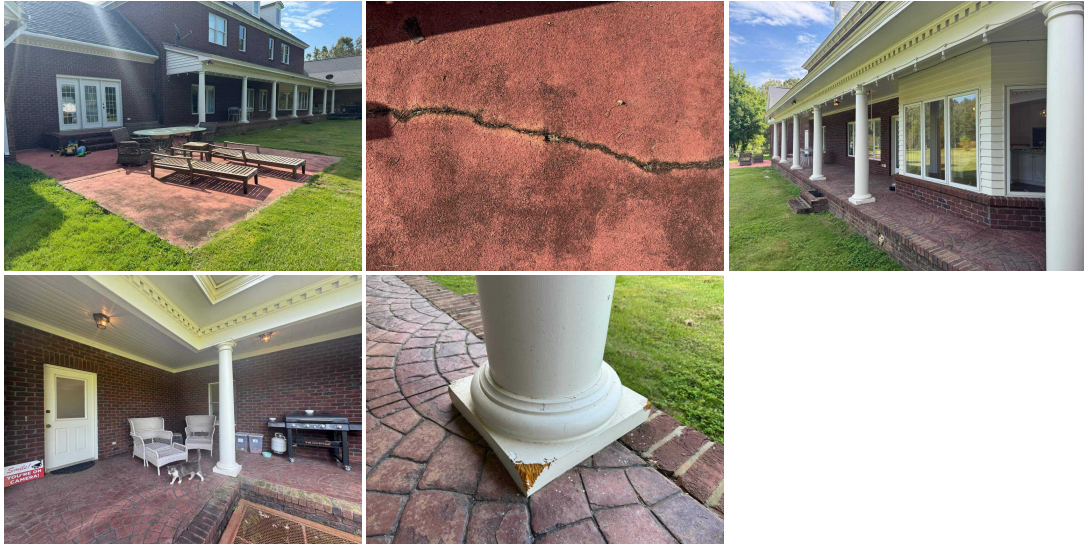
Satisfactory, Marginal Patio: Concrete - Typical cracks, less than 3/8 inch. Seal all gaps and cracks to prevent moisture penetration.

Damage noted at column plinths.

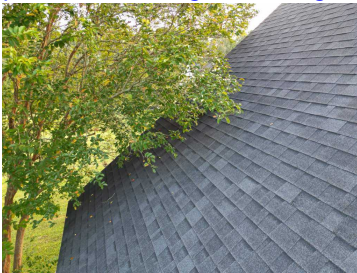
Vegetation: Trees, Shrubs - [Recommend trimming tree limbs at least 3 feet from roof surface prevent possible damage to shingles.](#)

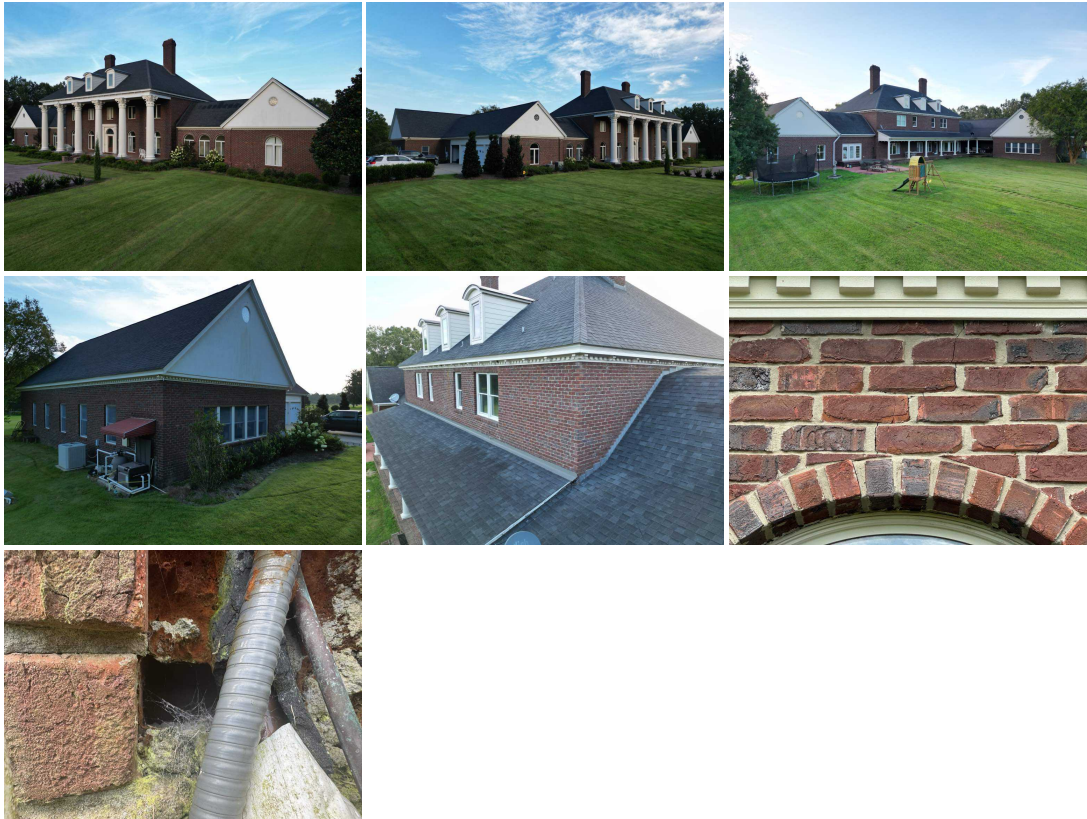
Satisfactory, Marginal Exterior Surface Brick Step cracks noted in the brick veneer. Step cracks typically occur with normal movement and may not be an indication of structural issues. We do recommend that a licensed contractor evaluate the cracks in the brick veneer, determine a cost estimate and the best course of action for repairs.

Recommend sealing penetrations where HVAC refrigerant lines terminate at exterior.

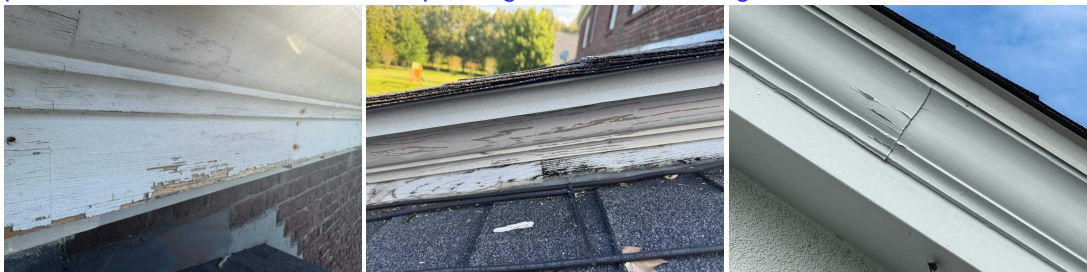
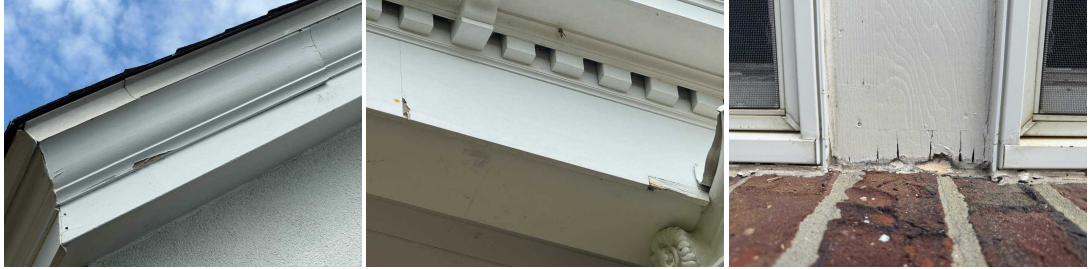
Satisfactory, Marginal Trim, Fascia, and Soffits Wood - Recommend repaired to moisture damaged components and paint maintenance as needed to prolong the life of existing materials.

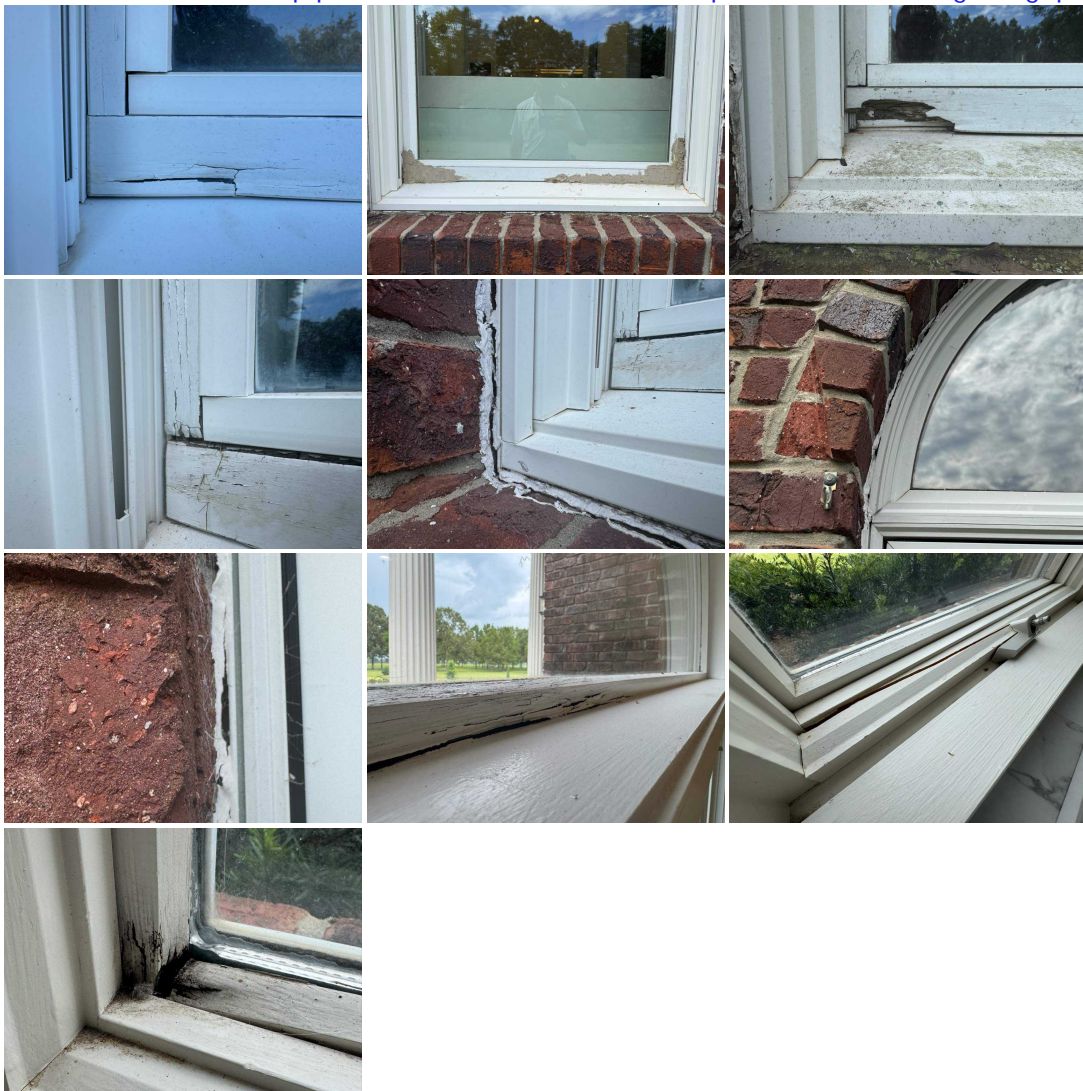
Windows: Wood - Moisture damage/wood rot noted at some window bottom rails and stiles. Recommended a licensed contractor further evaluate and provide a cost estimate for repairs.

Recommend re-caulking and including caulking as part of regular maintenance around all windows and doors. This will help prevent moisture, insects and spiders from entering the gaps.

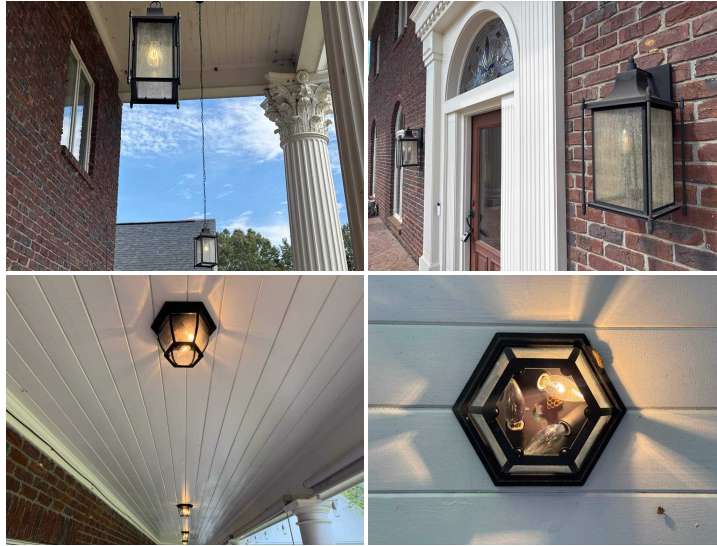
Satisfactory, Not Inspected, Marginal Exterior Lighting: Surface mount - Bulbs missing or burned out at time of inspection, recommend replacing the bulbs and retesting. If the light still does not function, repair or replacement may be necessary.

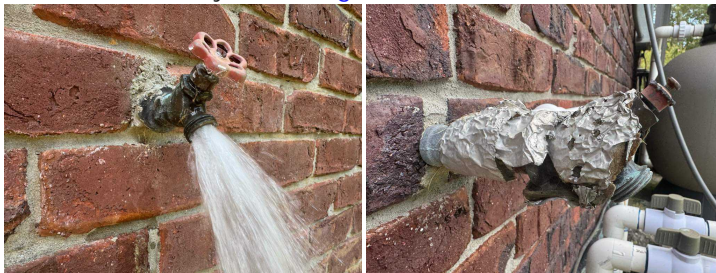
Satisfactory, Marginal Hose Bibs: Rotary - Missing handle. Recommend installing and testing.

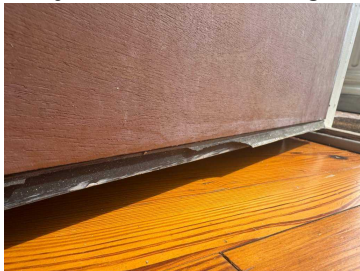
Satisfactory, Marginal Entry Doors: Wood with glass entry door. [Recommend replacing door sweep.](#)

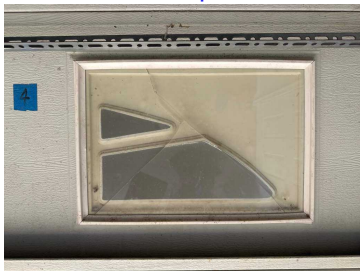
Satisfactory, Marginal Garage Doors: Metal - [Minor impact damage and broken glass noted at door number four.](#)
[Recommend repair.](#)

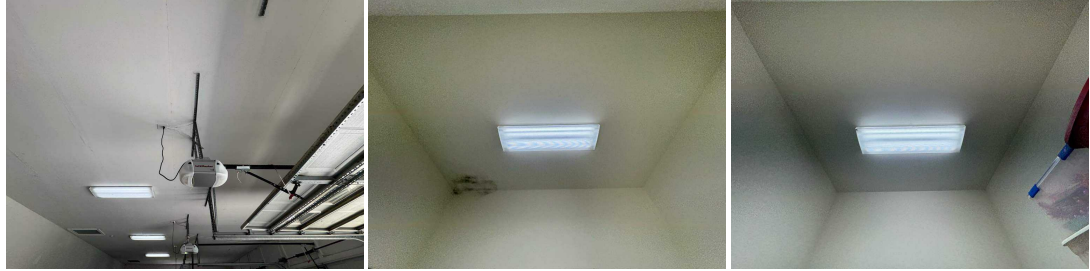
Satisfactory, Marginal Ceiling: Drywall - [Loose seam tape and/or plaster/mud/finish.](#) [Recommend repair.](#)

[Recommend remediation of visible microbial growth in pump room](#)

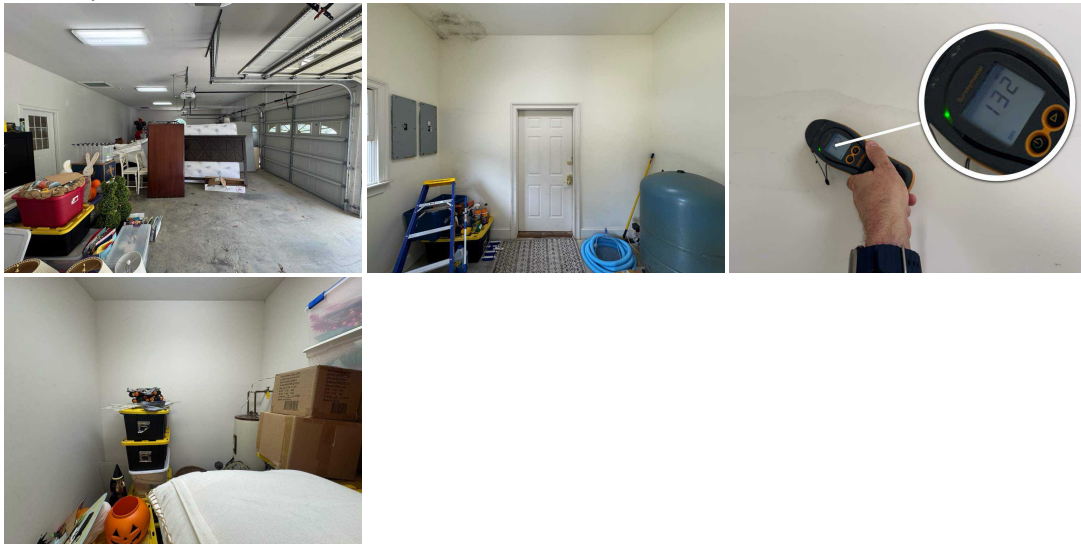
Walls: Drywall - Evidence of past moisture intrusion. No active water leak was detected at the time of the inspection.

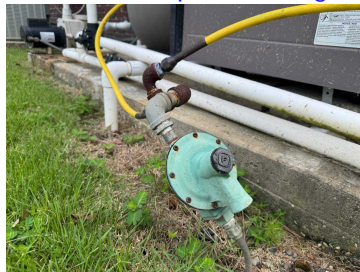
Satisfactory, Marginal Gas Service Lines: Copper, CSST - Recommend installing a barrier at pool equipment to prevent accidental impact damage to gas lines.

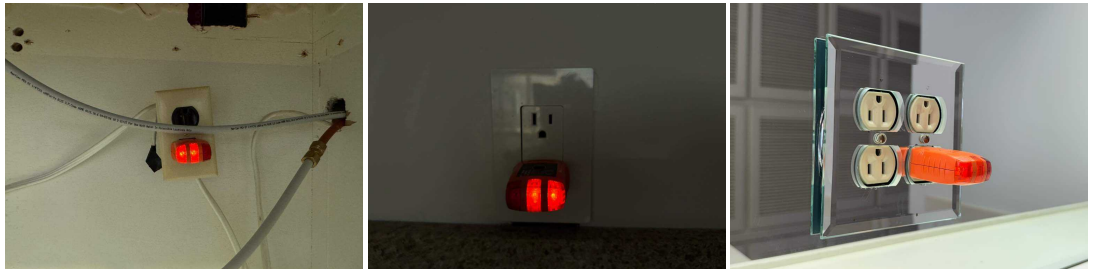
Satisfactory, Safety Hazard 120 VAC Branch Circuits: Copper - **Missing GFCI protection noted at kitchen receptacle and receptacle in primary bathroom. Recommend correction by a licensed electrician.**

Recommend that a licensed electrician further evaluate and repair damaged, worn, and loose receptacles and install the appropriate face plates to prevent hazards.

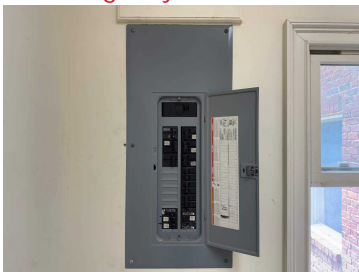
Garage Electric Panel

Satisfactory, Safety Hazard Manufacturer: Square D - **Partially labeled panel, recommend completely labeling in case of emergency.**

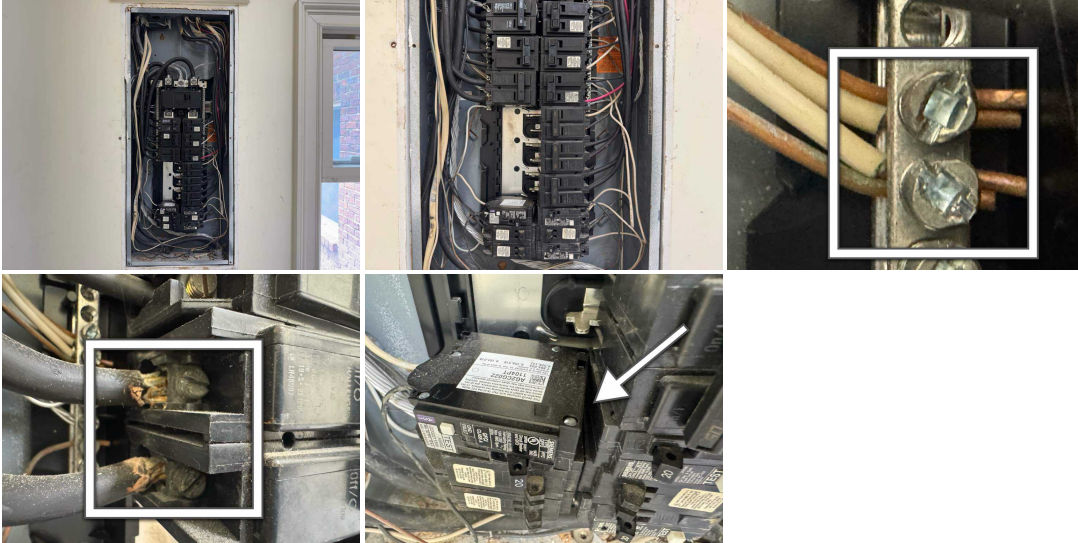
Safety Hazard Breakers: Copper and Aluminum - Grounds/Neutrals landed under same lug at terminal bar. This is an incorrect configuration. Recommend that a licensed electrician separate.

Corrosion present on some conductors. Recommend that a licensed electrician clean.

GFCI breaker is not properly seated on busbar. Recommend that a licensed electrician repair.

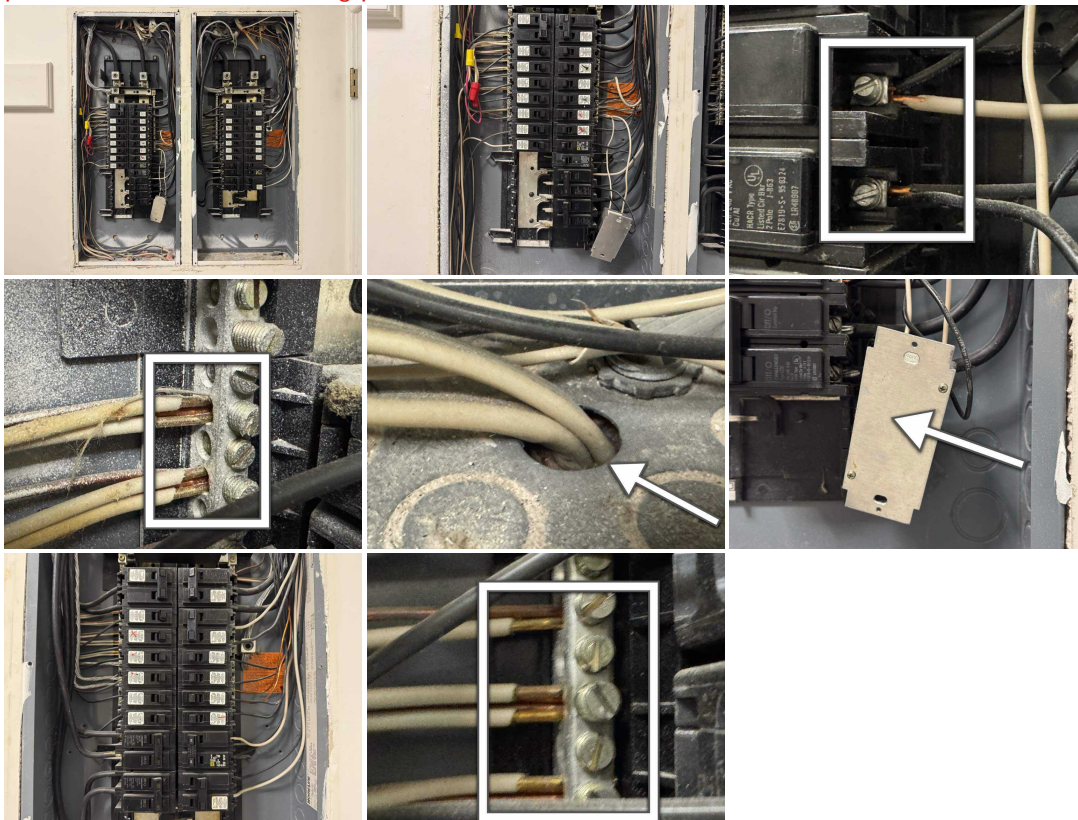
Safety Hazard Breakers: Copper and Aluminum - Double taps are present at breakers. These circuits need to be moved to their own circuit breaker and cannot share a breaker. It is recommended that a qualified electrical contractor evaluate the electrical, the new circuits and properly connect the new circuits to an individual breaker for each circuit.

Low voltage and high voltage mixed in the panel. Recommend a licensed electrical contractor evaluate and separate the different types of voltage.

Combined neutrals in grounds at the terminal bar. In a sub panel conductors should be configured with grounds separated and neutrals floated. Recommend repair by license electrician.

Double tapped neutrals at the bus bar. This is a potential hazard. Recommend that a licensed electrician separate them and secure them under their own individual lugs.

Chafing protection (Romex/Conductor connector) is required on wires of that enter the electrical panel. Recommend chafing protection the installed.

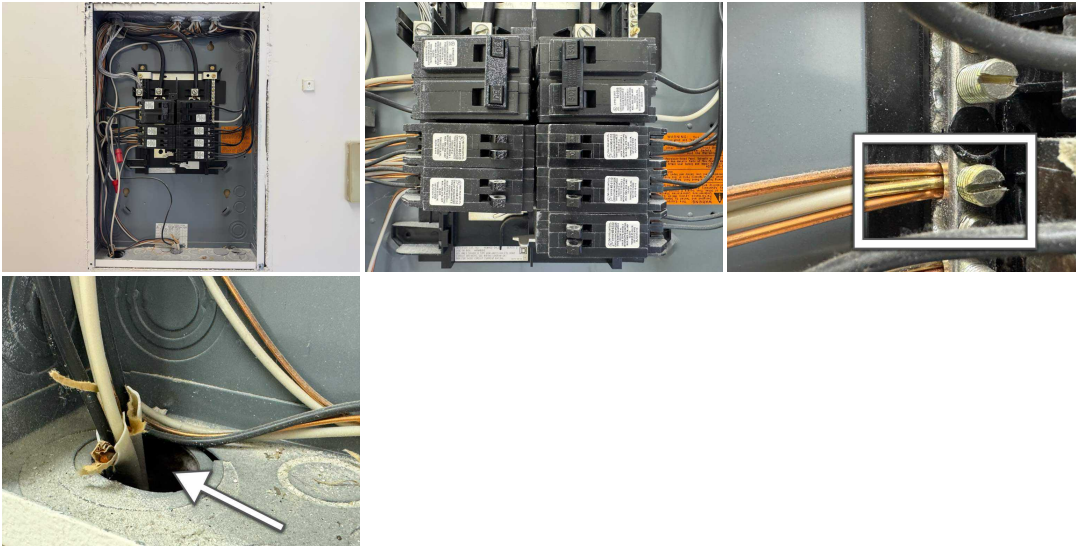
Laundry Electric Panel

Safety Hazard Breakers: Copper and Aluminum - Combined neutrals in grounds at the terminal bar. In a sub panel conductors should be configured with grounds separated and neutrals floated. Recommend repair by license electrician.

Double tapped neutrals at the bus bar. This is a potential hazard. Recommend that a licensed electrician separate them and secure them under their own individual lugs.

Chafing protection (Romex/Conductor connector) is required on wires of that enter the electrical panel. Recommend chafing protection the installed.

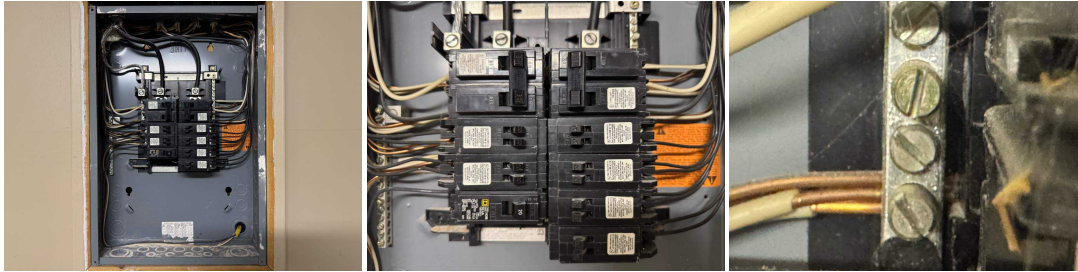
2nd Floor Electric Panel

Safety Hazard Breakers: Copper and Aluminum - Combined neutrals in grounds at the terminal bar. In a sub panel conductors should be configured with grounds separated and neutrals floated. Recommend repair by license electrician.

Double tapped neutrals at the bus bar. This is a potential hazard. Recommend that a licensed electrician separate them and secure them under their own individual lugs.

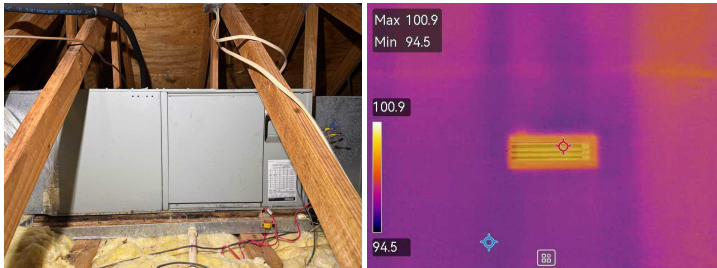
Poor HVAC System Operation: Recommend Service - The unit is currently in service beyond the typical design life of 15-20 years. Recommend the unit be evaluated by a licensed HVAC company.

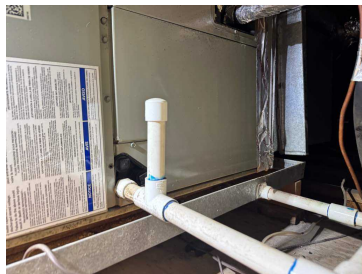
Satisfactory, Marginal Condensate Removal: PVC - No drain pan installed. Recommend installing.

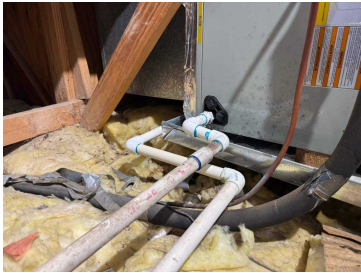
Satisfactory, Marginal Condensate Removal: PVC - Although not required, we recommend installing an overflow prevention switch in the condensation line to prevent future damage in the event of a clogged drain line.

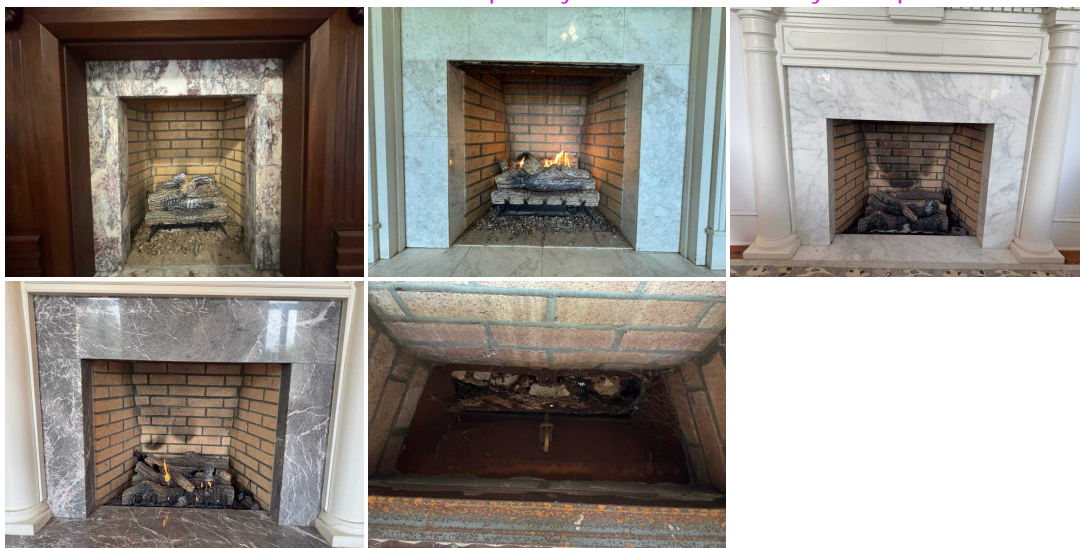
Not Inspected, Marginal Fireplace Construction: Brick - Flue in north chimney appears to be compromised.
Recommend further evaluation and repair by a licensed chimney sweep.

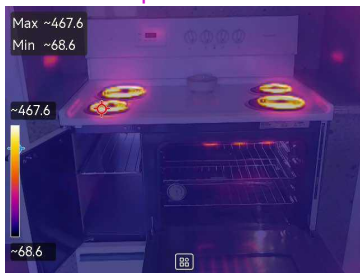
Satisfactory, Poor Cooktop/Rangetop: Electric, Oven/Cooktop single unit - Lower oven element did not function at the time of inspection. Recommend repair.

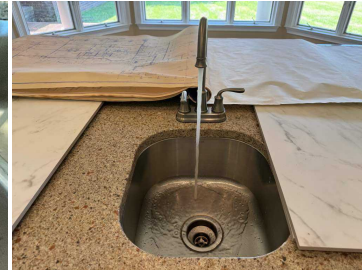
Satisfactory, Poor Sink & Fixtures: Stainless Steel - Sprayer handle is broken. Recommend repair.

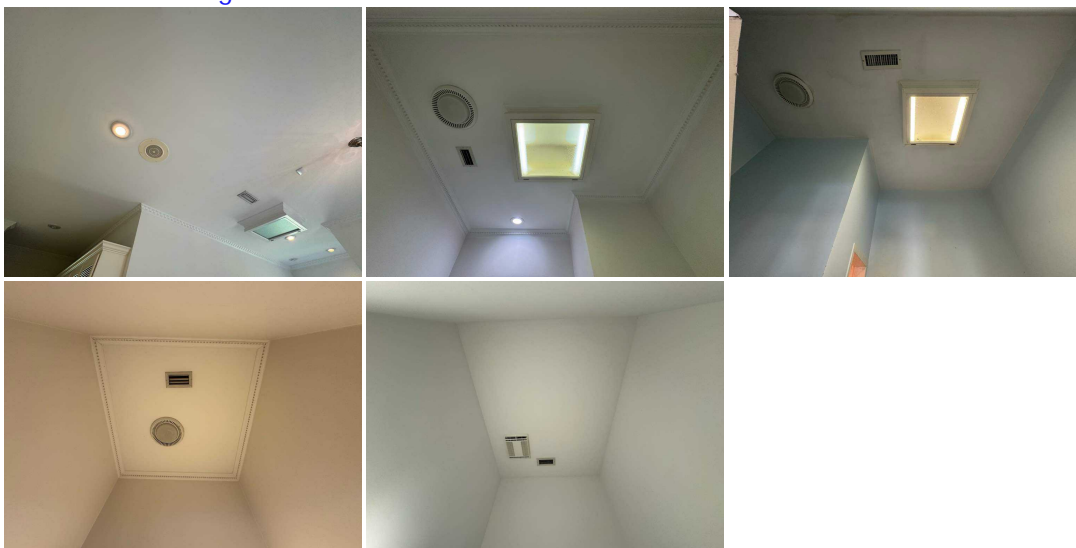
Satisfactory, Marginal Ceiling: Drywall - [Some lights are inoperative at the time of inspection. Recommend changing bulb and retesting.](#)

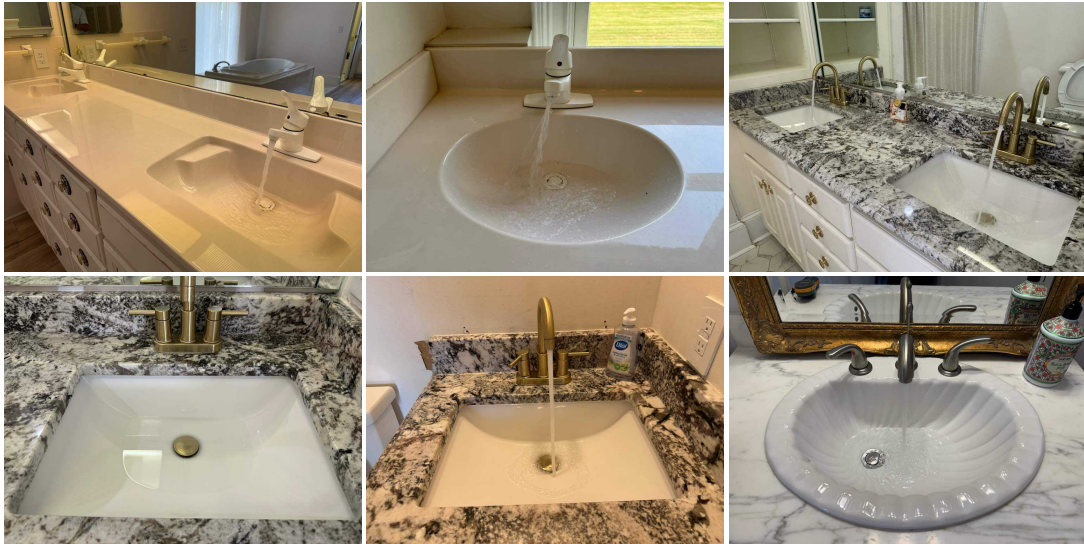
Missing aerator noted at some faucets. Recommend installing for a uniform spray pattern.

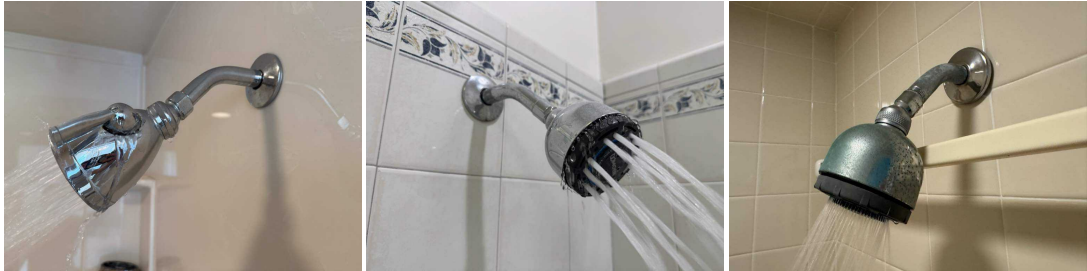
Satisfactory, Marginal Shower Plumbing Single handled faucet - Leaking showerhead noted in primary bathroom. Recommend repair.

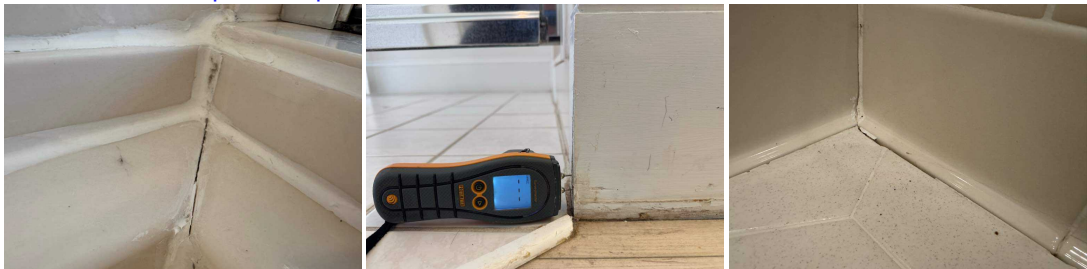
Satisfactory, Marginal Separate Shower Fiberglass/Acrylic Surround, Tile - Brooke been caulking and grout maintenance to prevent potential moisture intrusion from surround.

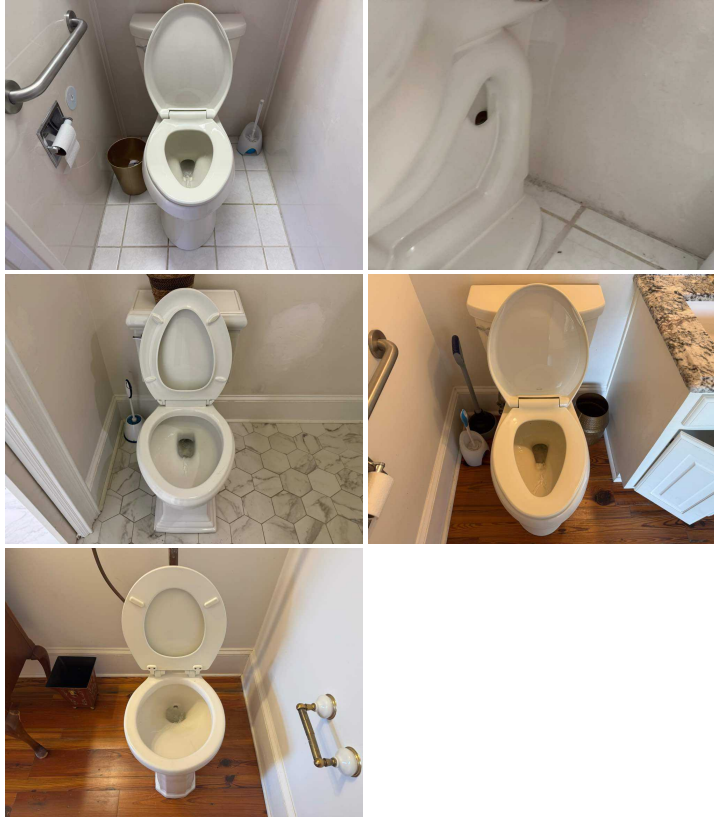
Recommend securing loose toilets to flanges to prevent potential damage to wax seals

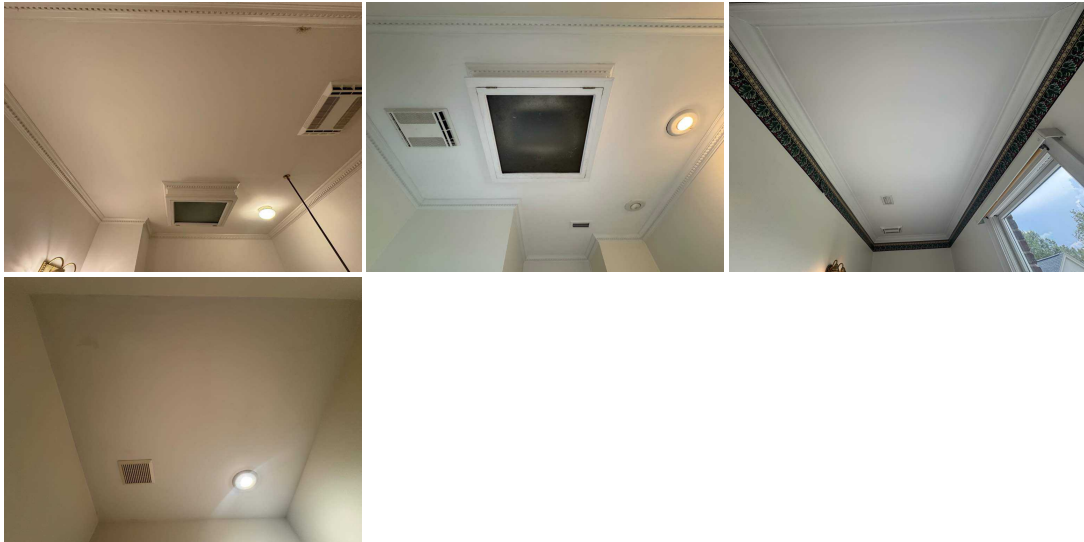
Satisfactory, Marginal Ceiling: Drywall - Some lights are inoperative at the time of inspection. Recommend changing bulb and retesting.

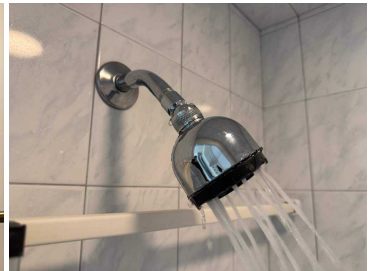
Satisfactory, Marginal Shower Plumbing Single handled faucet - [Recommend cleaning mineral deposits from showerhead in southeast bathroom and retesting.](#)

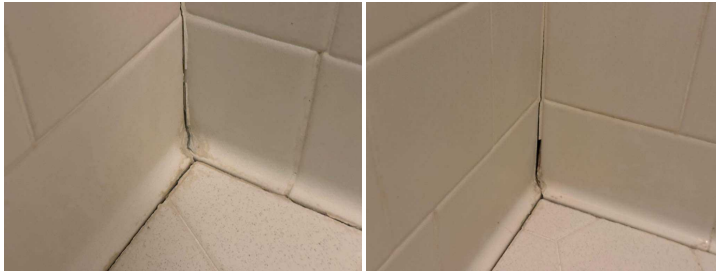
Satisfactory, Marginal Separate Shower Tile - Recommend grout maintenance as needed prior to use to prevent moisture intrusion.

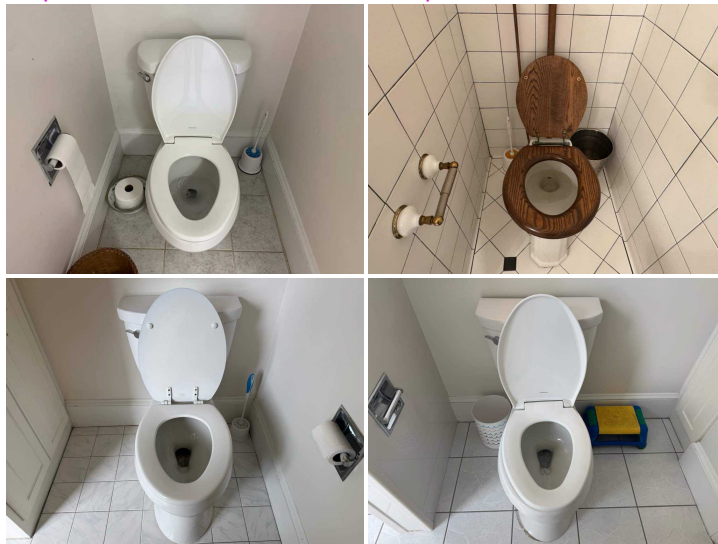
Satisfactory, Not Inspected, Marginal, Poor Toilets: Floor Mount - Toilets in Southwest in northeast bathroom did not function as designed. Recommend repair.

Supply valve at toilet in third floor bathroom was off at the time of inspection. This toilet was not inspected.

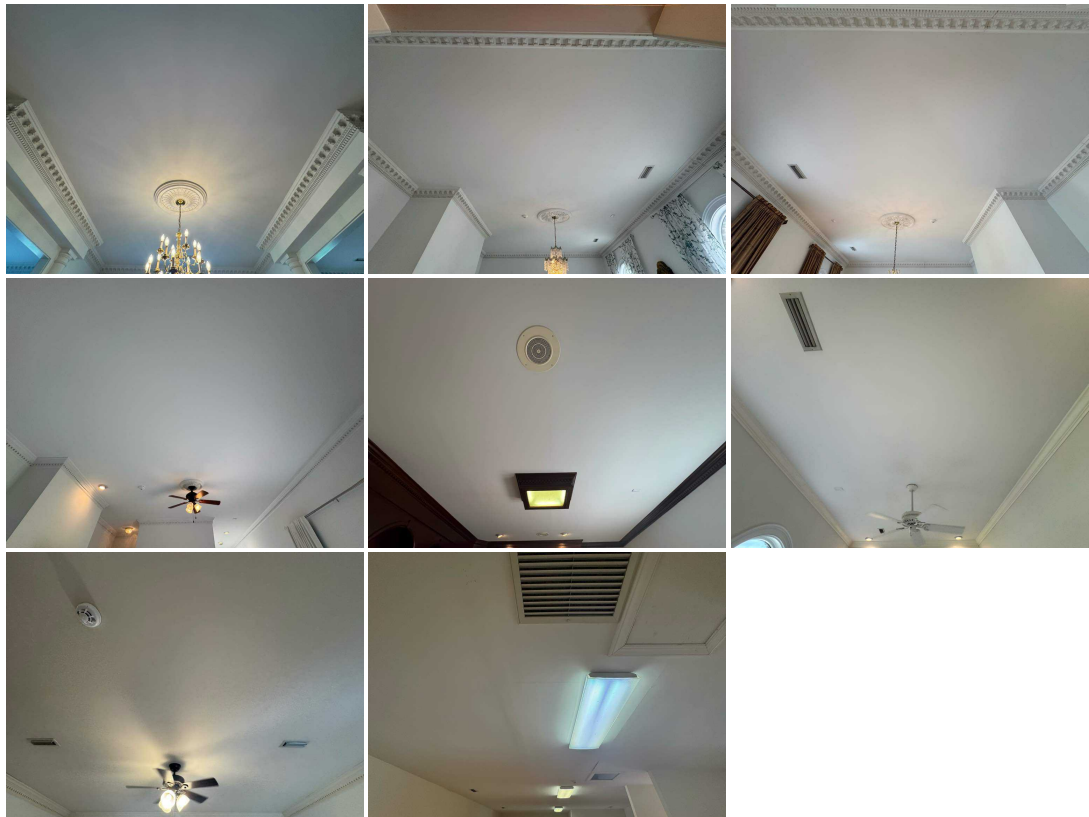
Satisfactory, Marginal Ceiling: Drywall - [Loose/failing drywall noted at third floor. Recommend repair.](#)

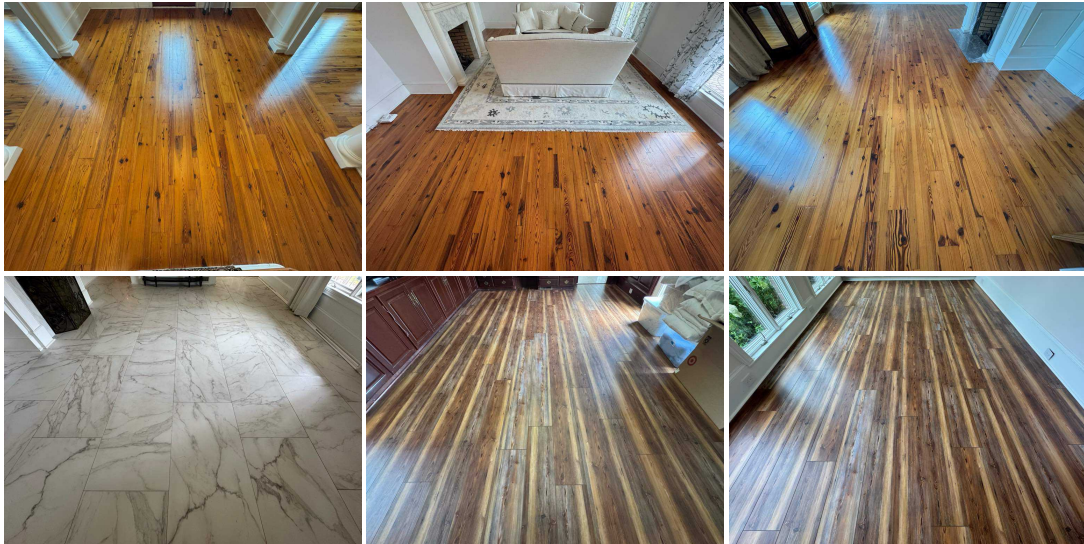
Satisfactory, Marginal Floor: Wood, Tile, Laminate / Vinyl floor covering. [Recommend installing missing thresholds.](#)

[Large tears in linoleum flooring noted at third floor.](#)

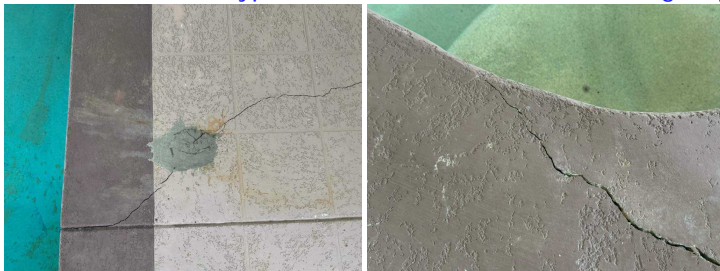
Deck: Concrete - [Typical cracks. Recommend sealing to prevent water penetration.](#)

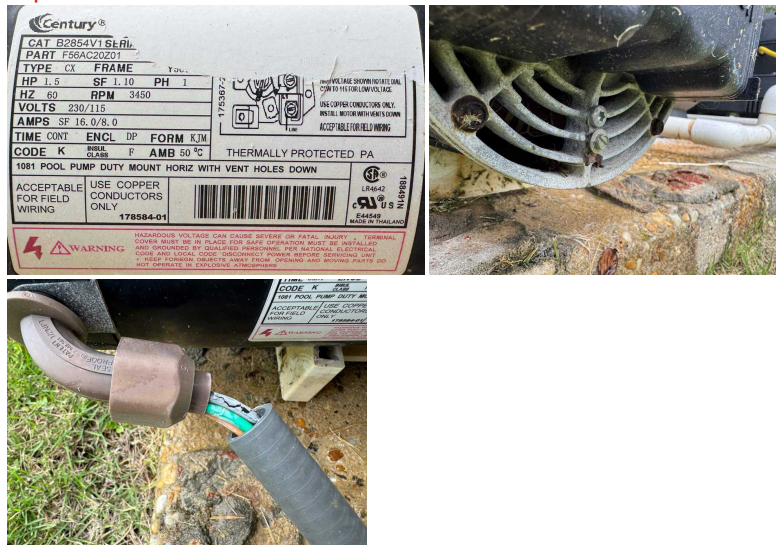
Pump motor is nearing the end of its useful life. Be prepared for repairs or replacement in the near future.

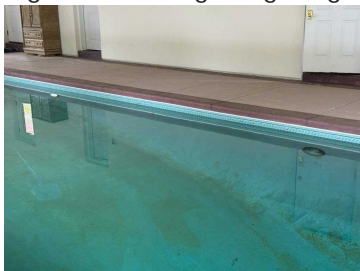
Poor Lights: Submerged lighting - Inoperative. Recommend a licensed pool contractor evaluate and repair.
