Kirkpatrick Dam and Spillway Condition Assessment September 2015

Inspection Date: July 27-28, 2015

Subject: Florida Department of Environmental Protection Contract No. DC 827
Task Assignment No. 4
Kirkpatrick Dam and Spillway Condition Assessment Report, September 2015

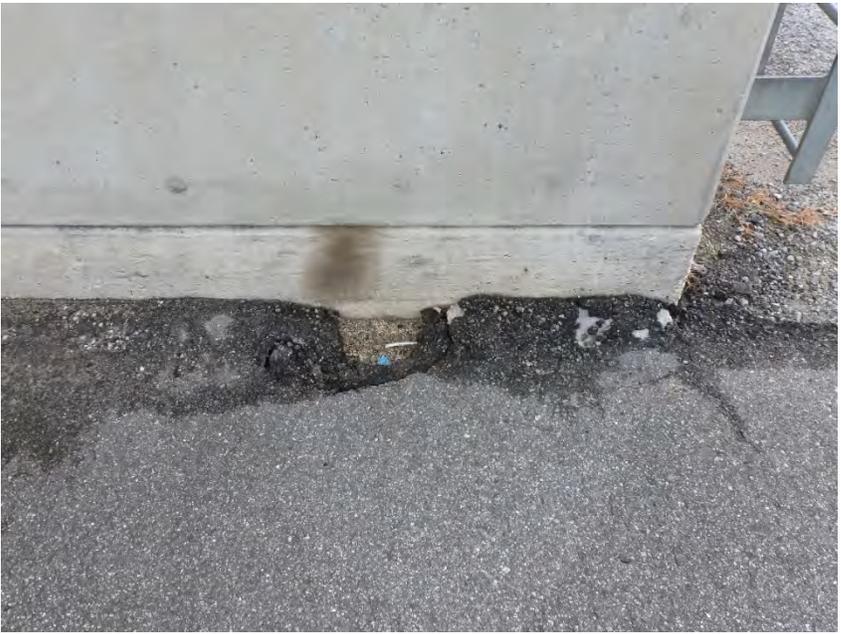
Checklist Item: CV2		
Rating: CV-3	Date: 07-27-2015	
Description: Crest roadway at Control Building has apparent pothole (approx. 6" dia.) due to base erosion.

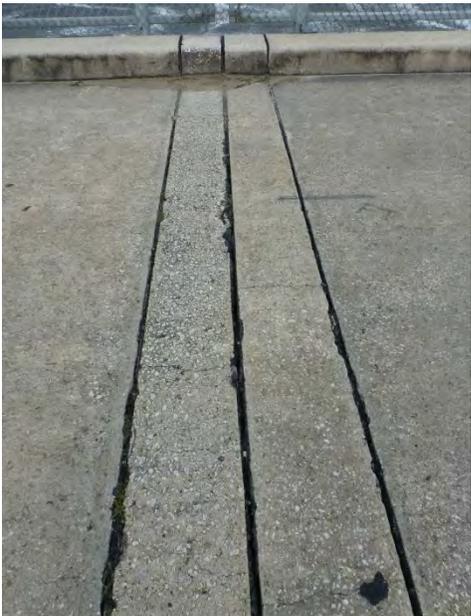
Checklist Item: CV3		
Rating: CV-3	Date: 07-27-2015	
Description: Deteriorated/missing expansion joint seal on service bridge deck numerous locations.

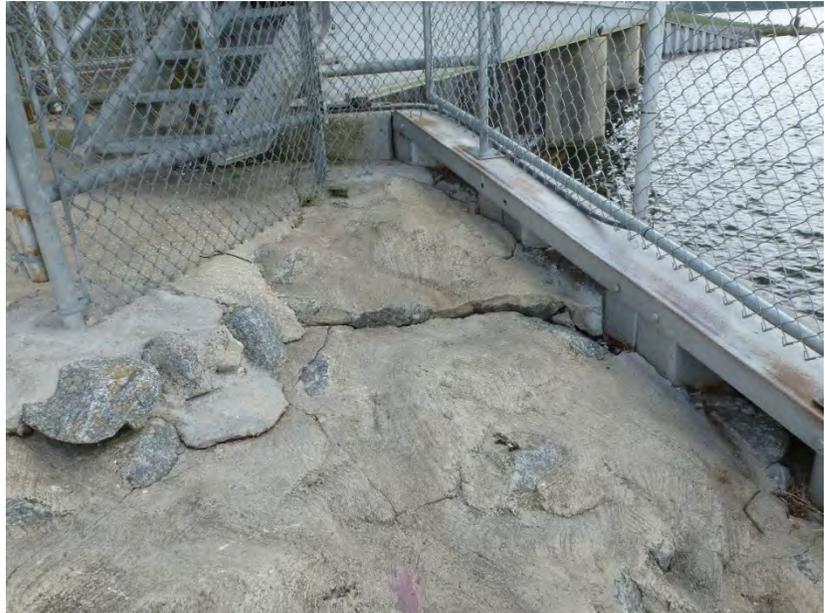
Description:
Fracturing of concrete infilled riprap revetment on upstream east side of structure.

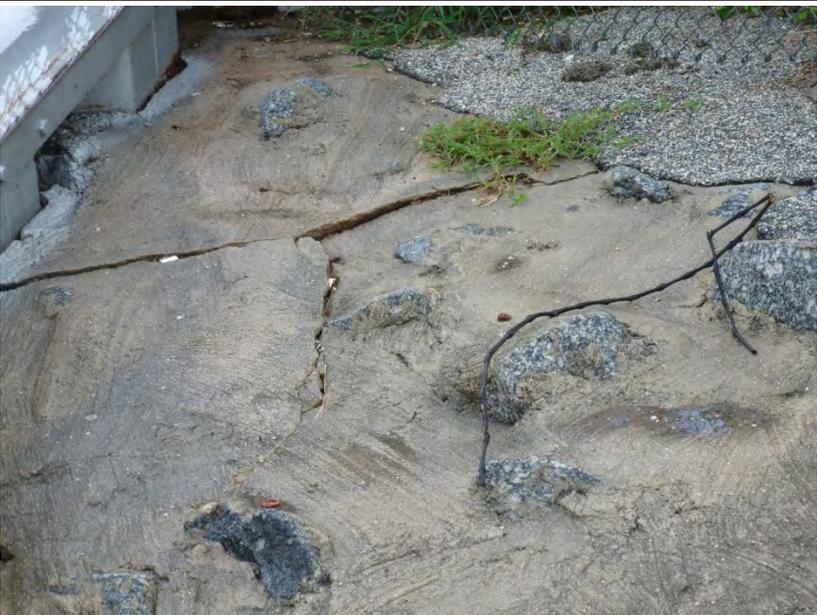
Description:
Fracturing of concrete infilled riprap revetment on upstream west side of structure.

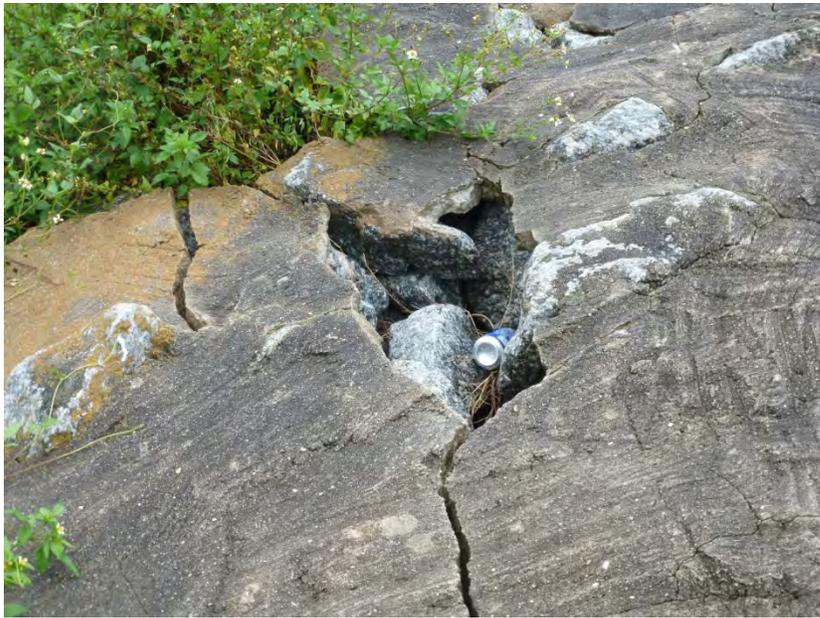
Description:
Fractured and missing concrete infill of riprap revetment on downstream west side of structure.

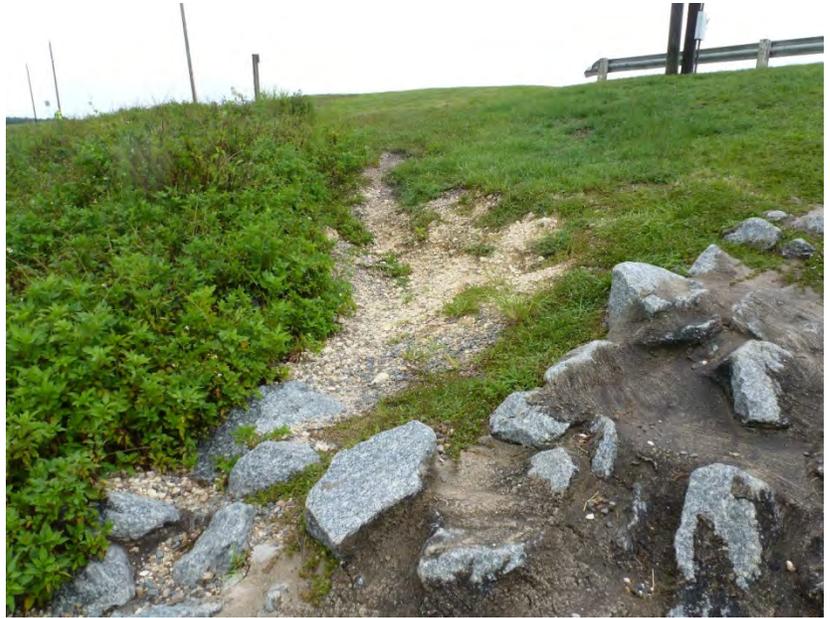
Description:
Erosion of embankment adjacent to riprap revetment on downstream west side of structure.

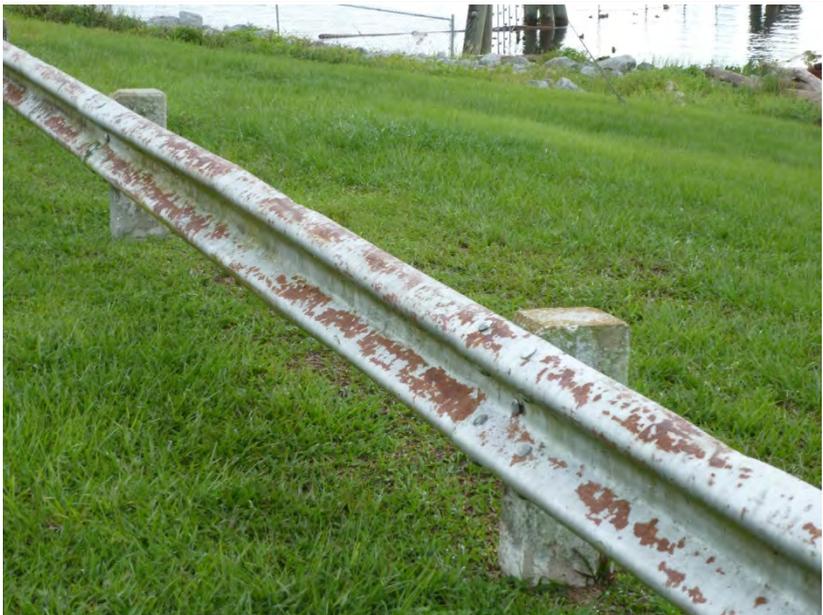
Description:
Guardrail corrosion paint peeling various locations.

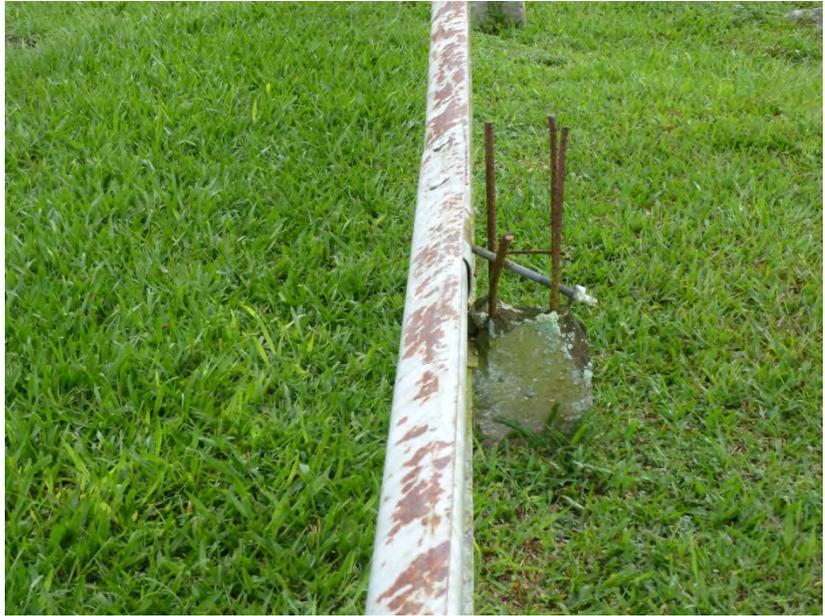
Description:
Guardrail post deteriorated east side of structure.

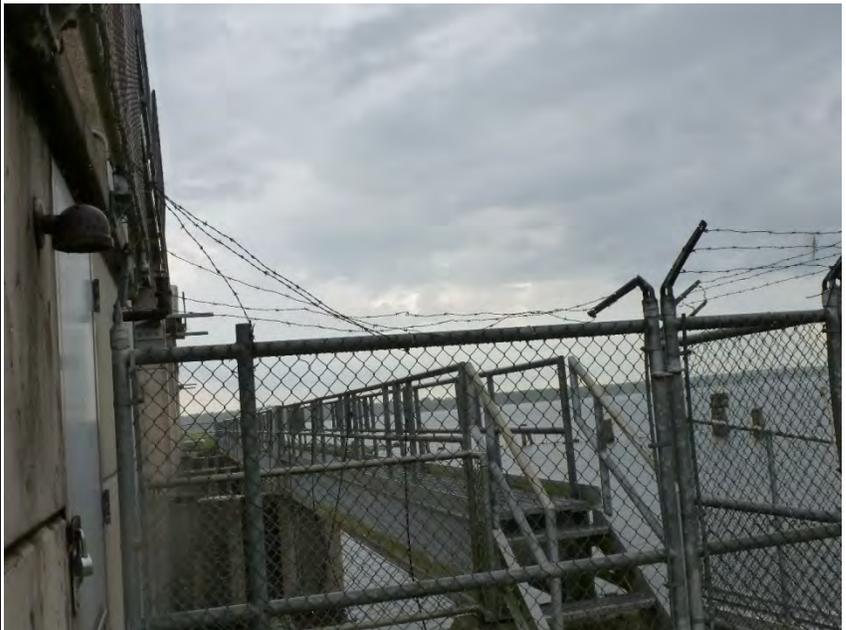
Description:
Barbed wire is damaged at structure access gate near Control House.

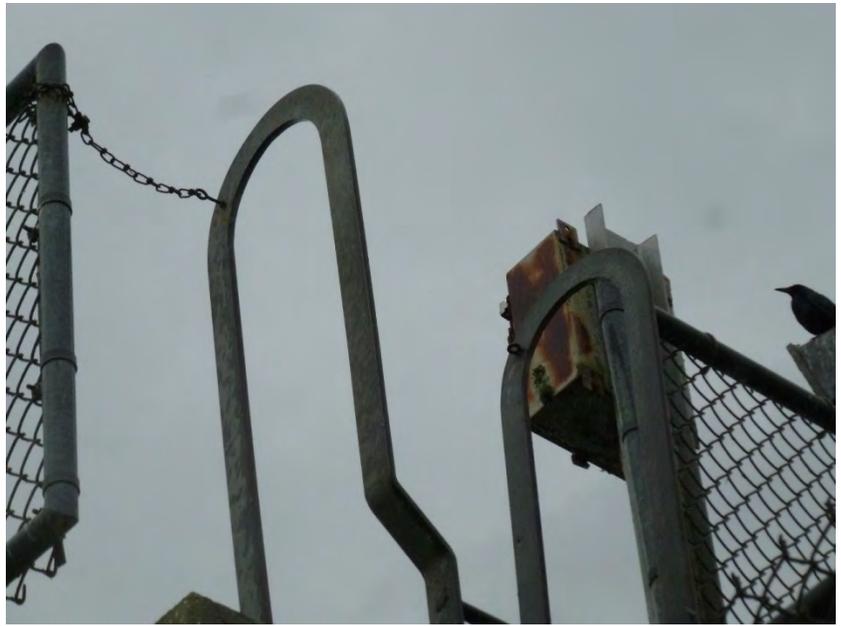
Description:
Missing safety chain on ladders to Operating Platform structure access.

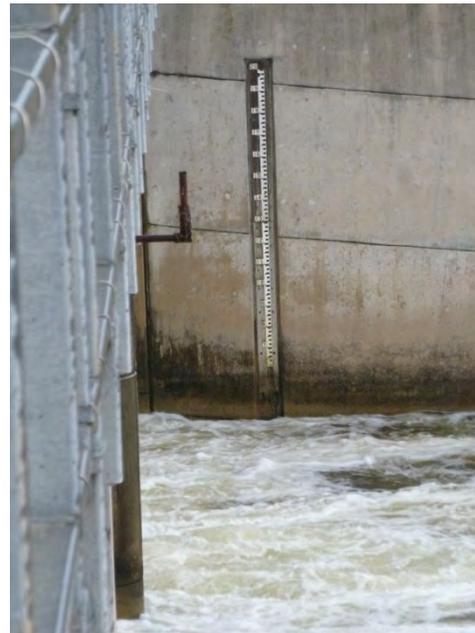
Description:
Downstream staff gage missing bottom numbers.

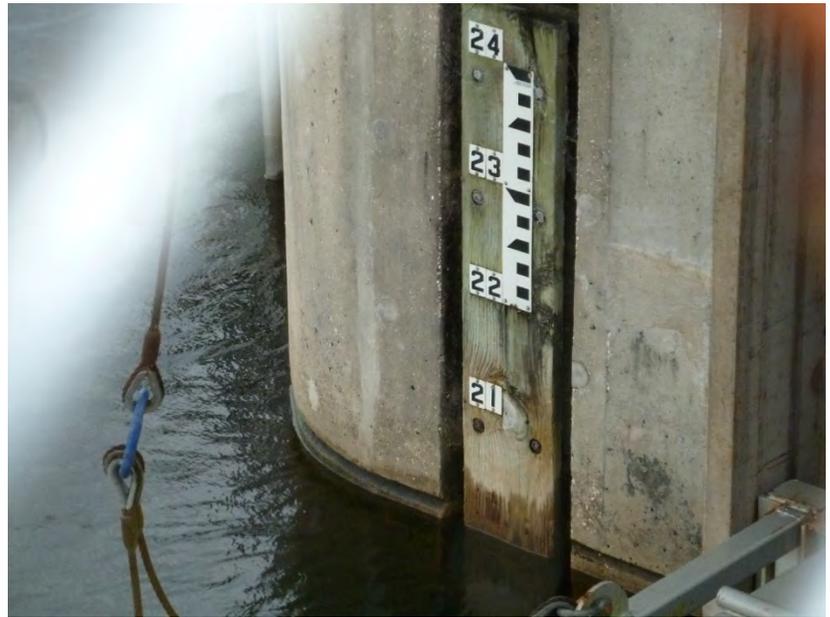
Description:
Upstream staff gage missing bottom numbers.

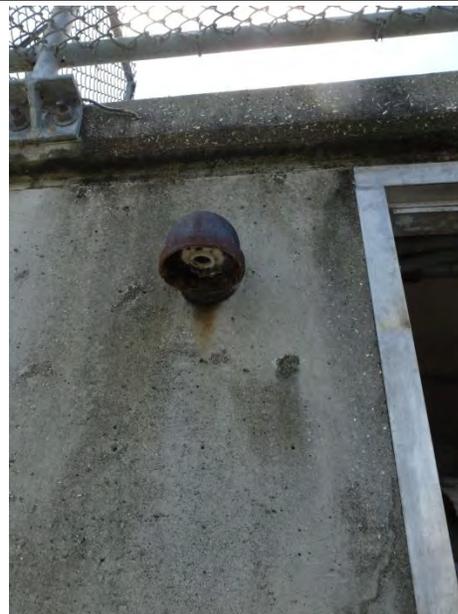
Description:
Control Building light fixture in disrepair and bulb is missing.

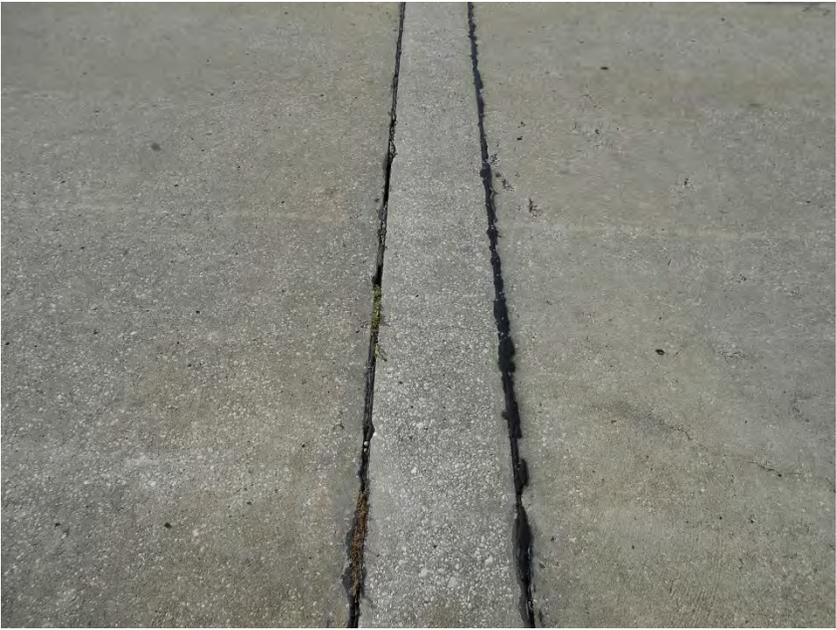
Checklist Item: ST1		
Rating: ST-2	Date: 07-27-2015	
Description: Service bridge poured rubber deck joint sealant deteriorated at the abutments and piers.

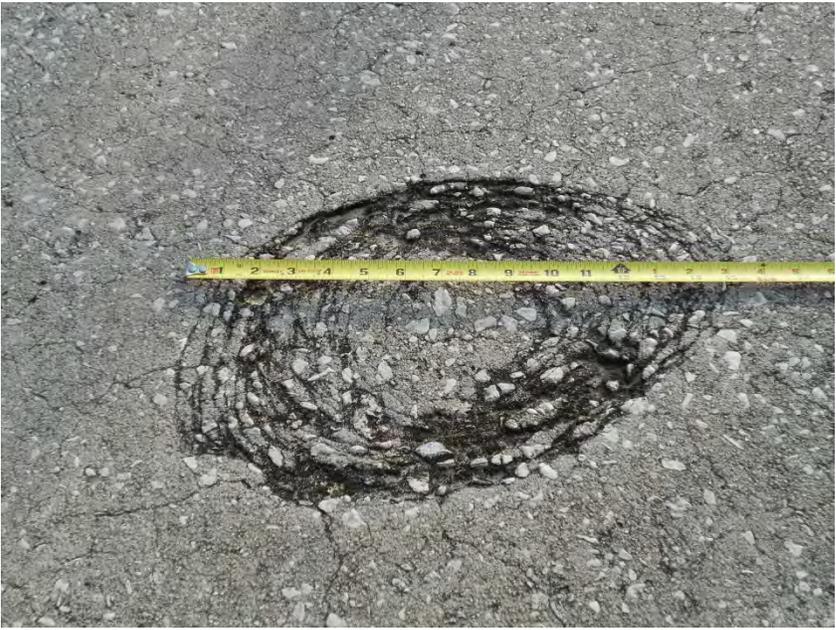
Checklist Item: ST3		
Rating: ST-3	Date: 07-27-2015	
Description: Damaged area of service bridge deck top concrete (possibly from an impact), 15" x 10", east lane, Near Pier 1.

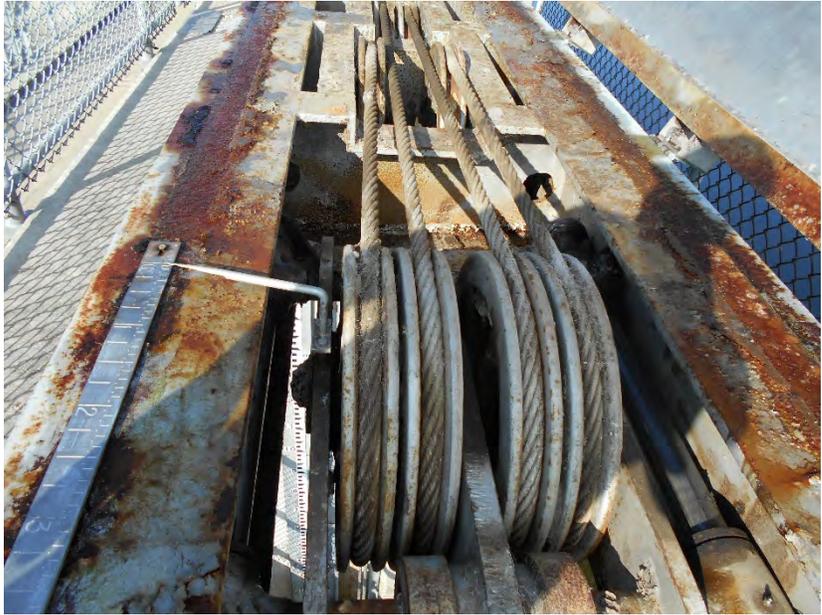
<p>Rating: ME-1</p>	<p>Date: 07-27-2015</p>		
<p>Description: Hydraulic Hoist: Frame is slightly corroded. No. 2 frame shown, typical at all frame locations.</p>

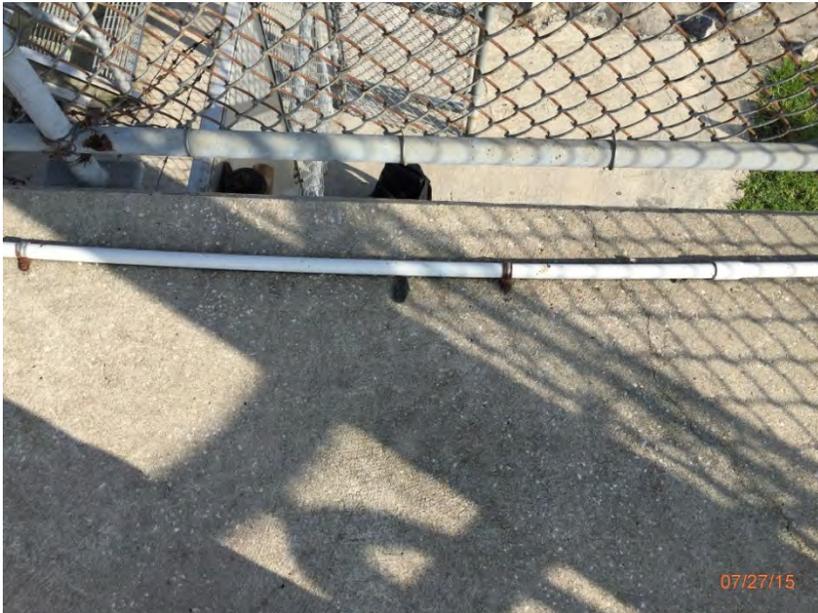
<p>Rating: EL-2</p>	<p>Date: 07-27-2015</p>		
<p>Description: Several conduit supports throughout structure exhibit moderate to heavy corrosion.</p>

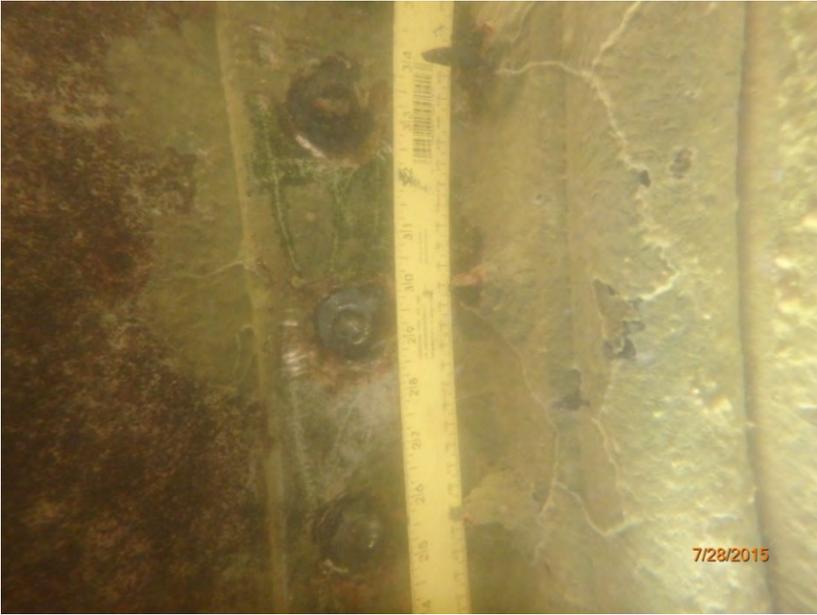
Checklist Item: UW1		
Rating: UW-4	Date: 07-28-2015	
Description: The bolts holding the side seal on all four (4) upstream gates have severe corrosion with up to 90% section loss.

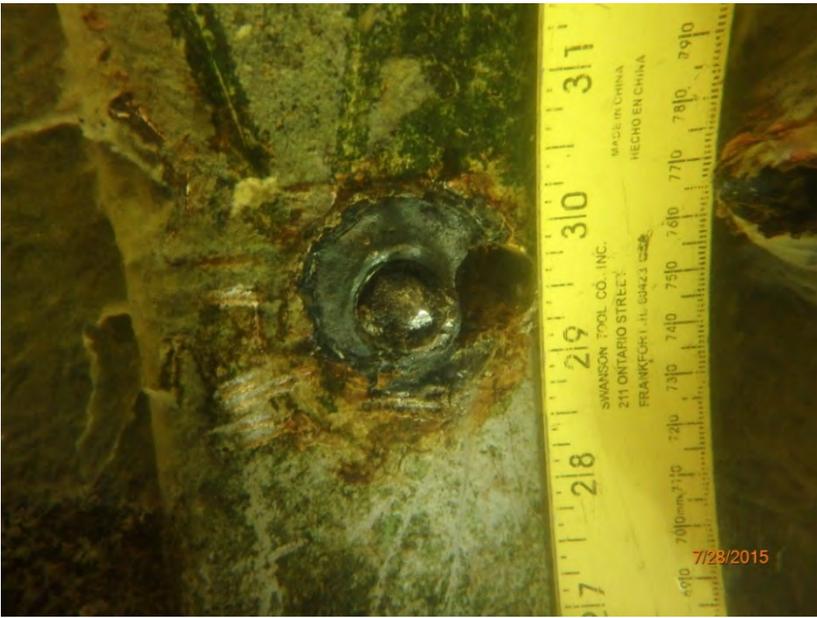
Checklist Item: UW1		
Rating: UW-3	Date: 07-28-2015	
Description: The bolts holding the side seal on all four (4) upstream gates have severe corrosion with up to 90% section loss.
