10 January 2018

**Slope Stability and Erosion Control Review and Best Practices Guide
Hunts Cove Hill, Cochin, SK**

File S2259

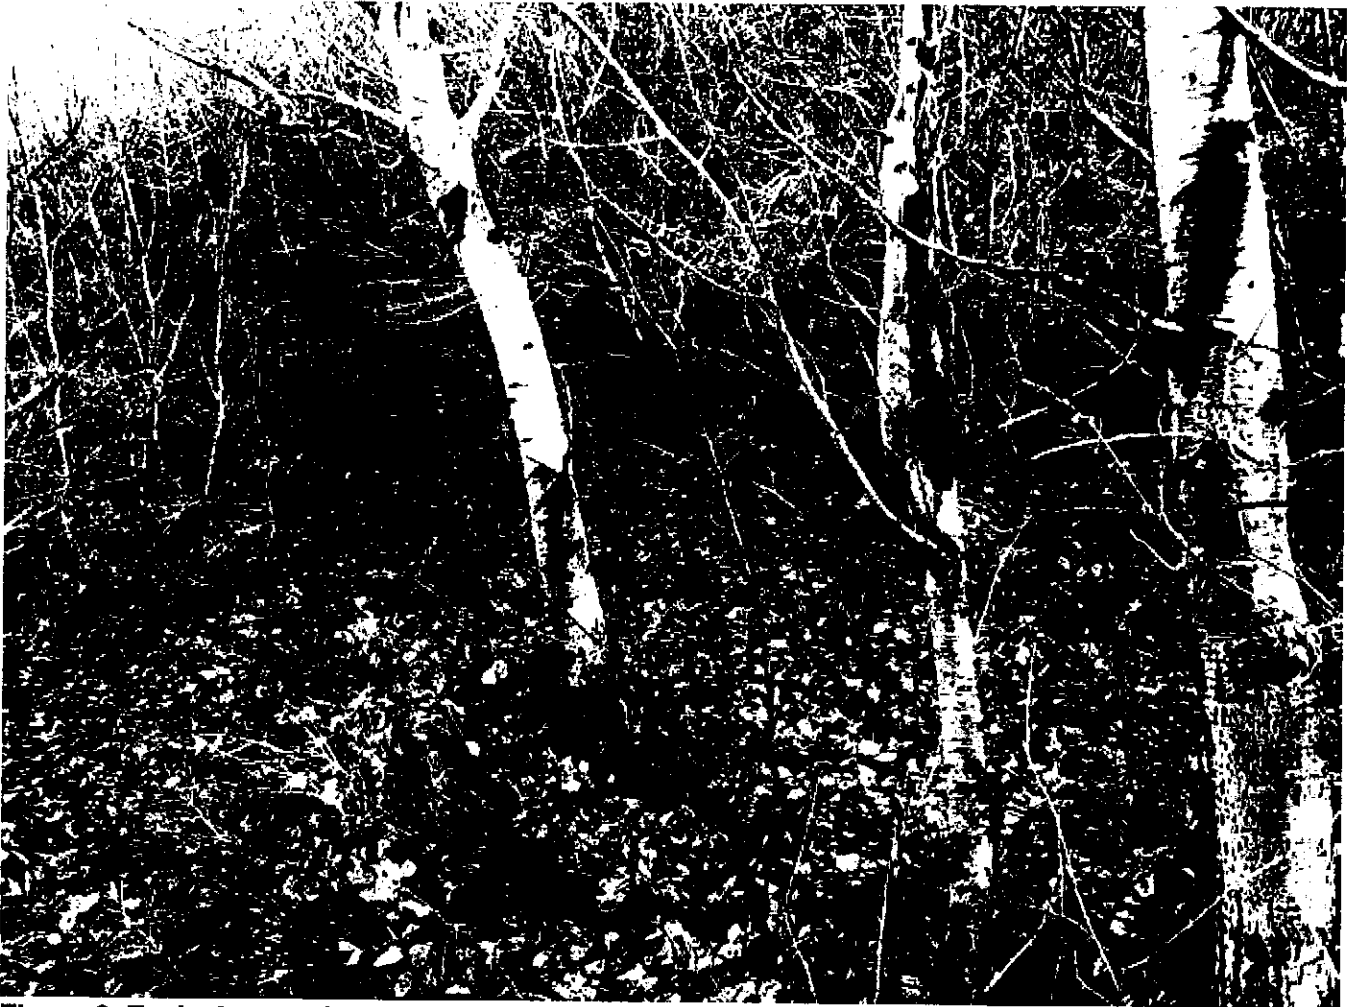
Some past slope movement was visible during the site assessment, possibly due to erosion activity, at various locations along the upslope above Hunts Cove Crescent and Archdekin Drive. These movements were identified by hooked tree trunks and the presence of small head scarps, which are typical indicators of past slope movement. The identified head scarps were in the range of approximately 100 mm to 250 mm in height, with no horizontal separation. No toe bulges or tension cracking was apparent. A photo showing a typical scarp is shown in Figure 2.

Figure 2: Typical scarp, hooked tree trunks. Upslope of the north end of Archdekin Drive.

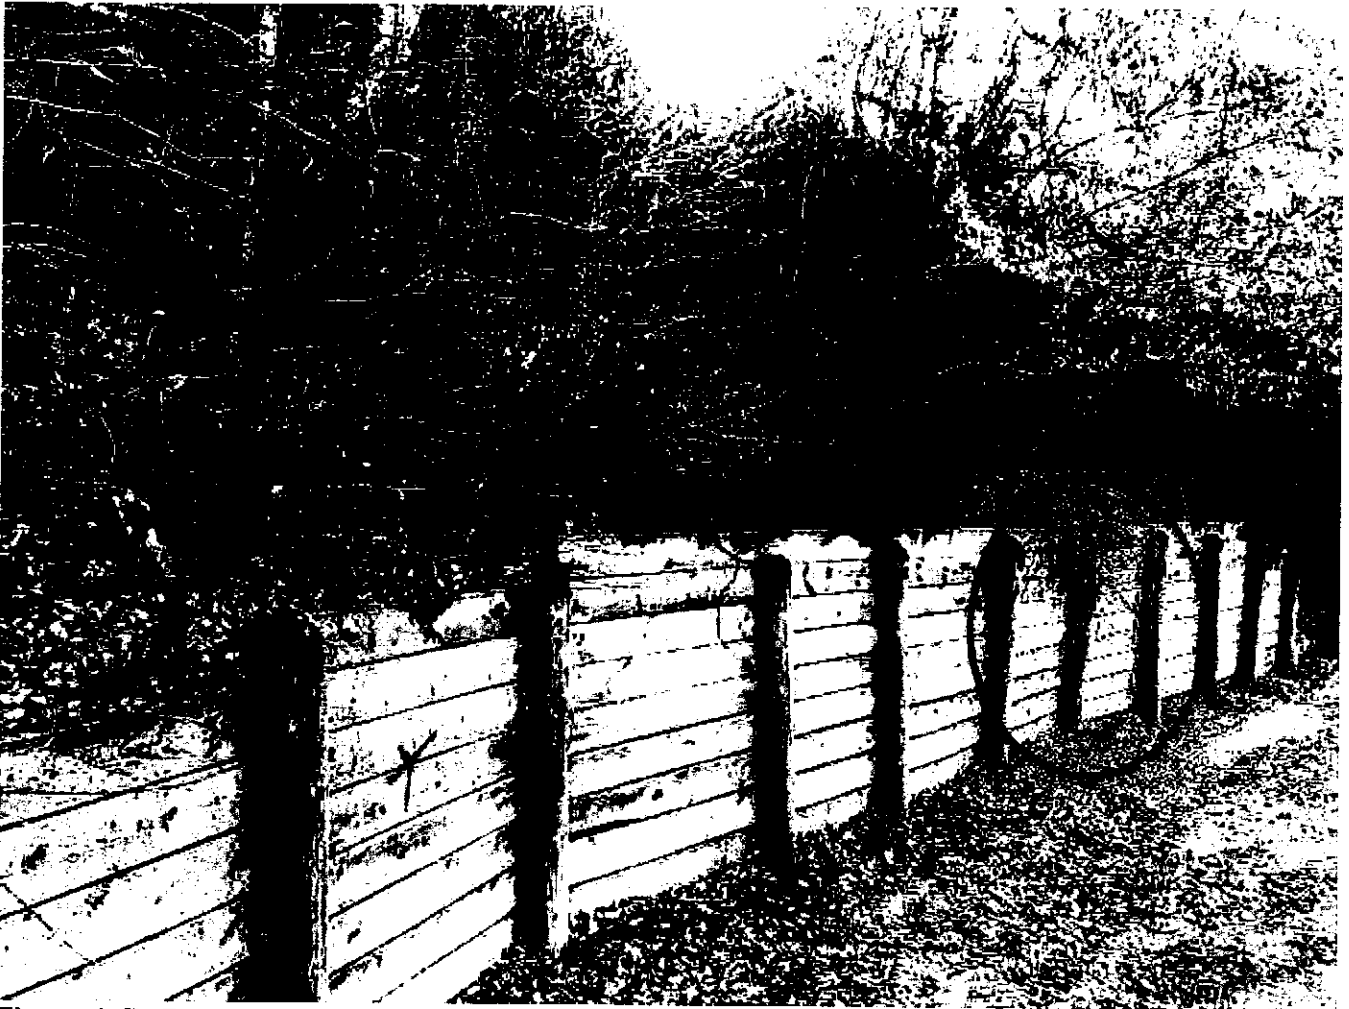
Another retaining wall, further south than the failed retaining wall on Hunts Cove Crescent, was observed to have deflected towards the road slightly, as seen in Figure 4. Some scarps and hooked tree trunks were apparent in the backslope above the wall. While the condition of this wall would not be considered failed, the deflection of the wall and visible evidence of movement above it indicate that the slopes on Hunts Cove Hill are prone to slope failures with modification to the current topography.

Figure 4: Deflected retaining wall, south end of Hunts Cove Crescent.
