**10 January 2018**

**Slope Stability and Erosion Control Review and Best Practices Guide  
Hunts Cove Hill, Cochin, SK**

**File S2259**

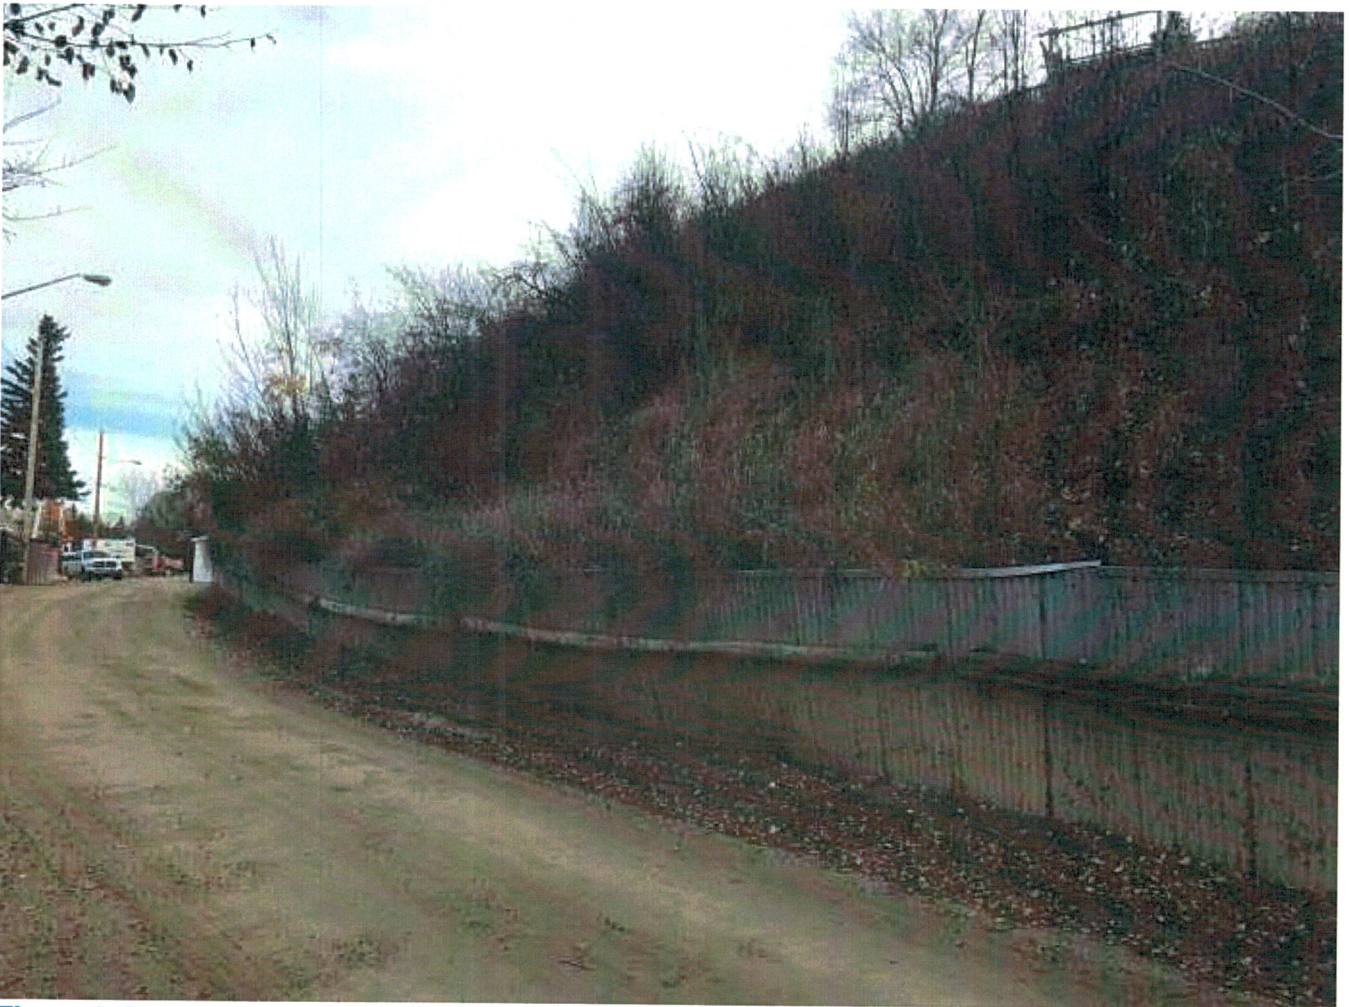
- The south end of Hunts Cove Crescent, where slope movement in the east upslope above the road had blocked the ditch, which caused excessive erosion and siltation of the road during rain events. This area has been remediated and is under monitoring.
- The retaining wall along Hunts Cove Crescent (Figure 1) where a section of the retaining wall had failed and deflected excessively outward from the slope. Slope failures were visible in the upslope above the retaining wall. Discussion of the retaining wall failure is included later in this report.

**Figure 1: Failed retaining wall on Hunts Cove Crescent.**

The failure in the retaining wall along the north end of Hunts Cove Crescent, as discussed above (Figure 1) may have occurred due to insufficient design/construction, or lack of drainage, or both. Retaining walls must be constructed with provisions for drainage through the face of the wall, to avoid mounding of groundwater behind the wall, which can destabilize the slopes above.

The approximate 2 m high wall was deflected excessively as shown in Figure 1, and slope failure was visible above the wall, as shown below in Figure 6.

The design of a new retaining wall is beyond the scope of this project, so the following recommendations are provided as a general guide only. We recommend that further study be undertaken to assess remediation requirements for the wall and upslope, which would include a slope stability study at this particular location, analysis of retaining wall requirements by a structural engineer, and provision of design drawings and specifications for a new retaining wall. Many options for retaining wall design and construction area available, and could be discussed in more detail during design. A proposal outlining scope and costs for this work can be provided if required.

Replacement of the retaining wall should be completed in short sections, or "panels," to minimize upslope disturbance. Panels should be no more than 5 m wide.

- Remove a 5 m wide section of the failed wall.
- Cut back the base of the failed slope to allow space for placement of a 0.5 m wide drainage layer of granular material (clean sand or gravel) against the new wall. Nonwoven geotextile shall be placed between the native soil and the drainage material.
- Construct the new 5 m section of wall.
- Place the geotextile and granular drainage layer.
- Rebuild the slope by stripping the topsoil and organic material from above the 5 m panel, removing and recompacting the disturbed material, and placing and compacting common fill up to the top of the head scarp. Compacting may consist of "bucket packing" with a hydraulic excavator.
- Replace the stripped material and seed the new slope.
- Continue this sequence for the entire length of the new wall.

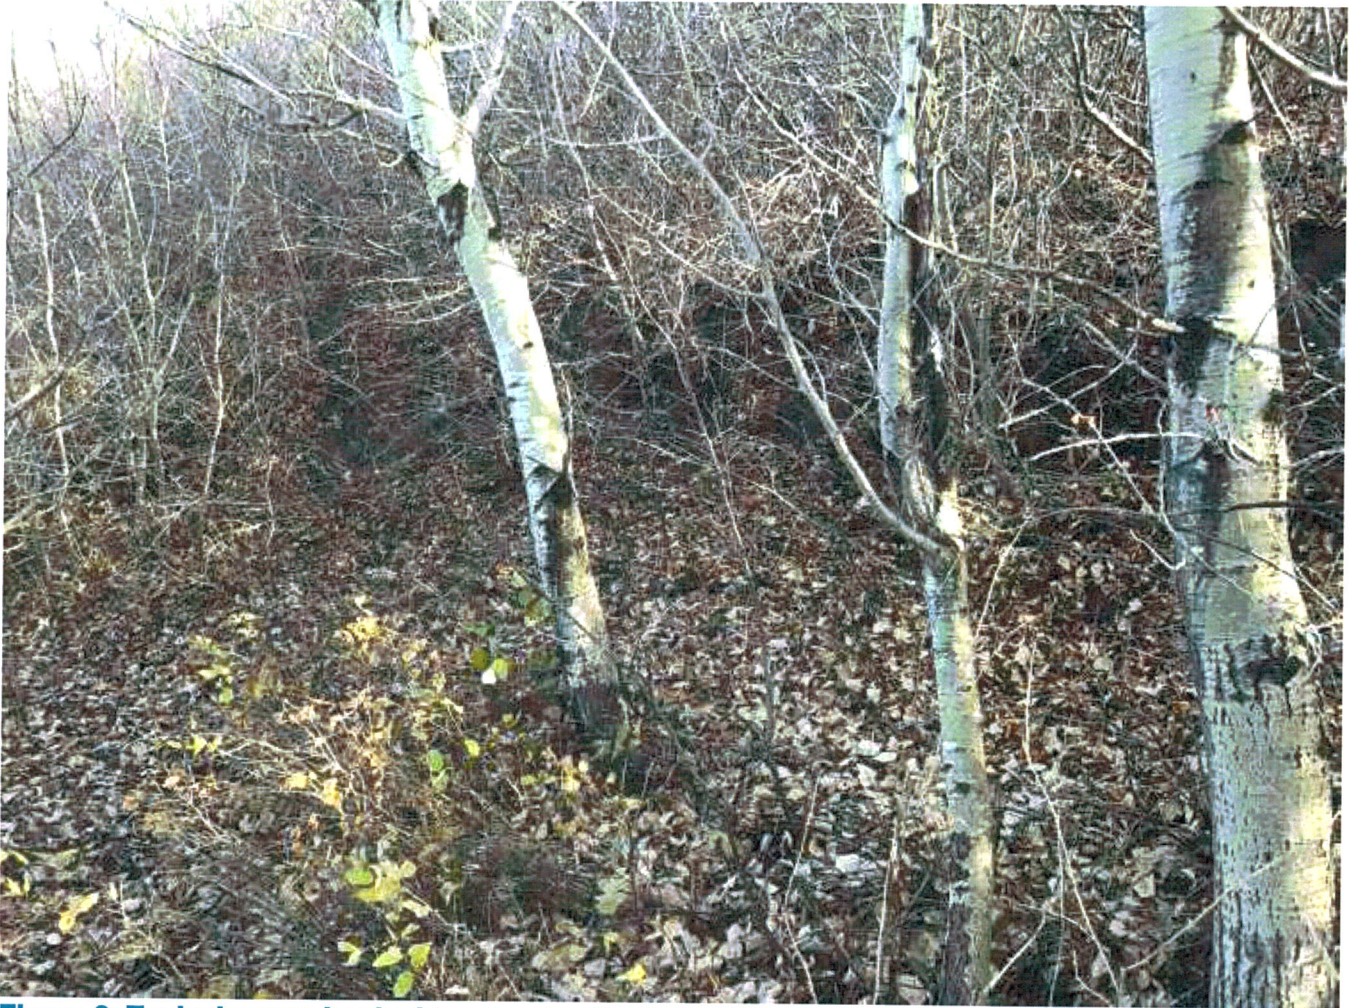
Some past slope movement was visible during the site assessment, possibly due to erosion activity, at various locations along the upslope above Hunts Cove Crescent and Archdekin Drive. These movements were identified by hooked tree trunks and the presence of small head scarps, which are typical indicators of past slope movement. The identified head scarps were in the range of approximately 100 mm to 250 mm in height, with no horizontal separation. No toe bulges or tension cracking was apparent. A photo showing a typical scarp is shown in Figure 2.

**Figure 2: Typical scarp, hooked tree trunks. Upslope of the north end of Archdekin Drive.**

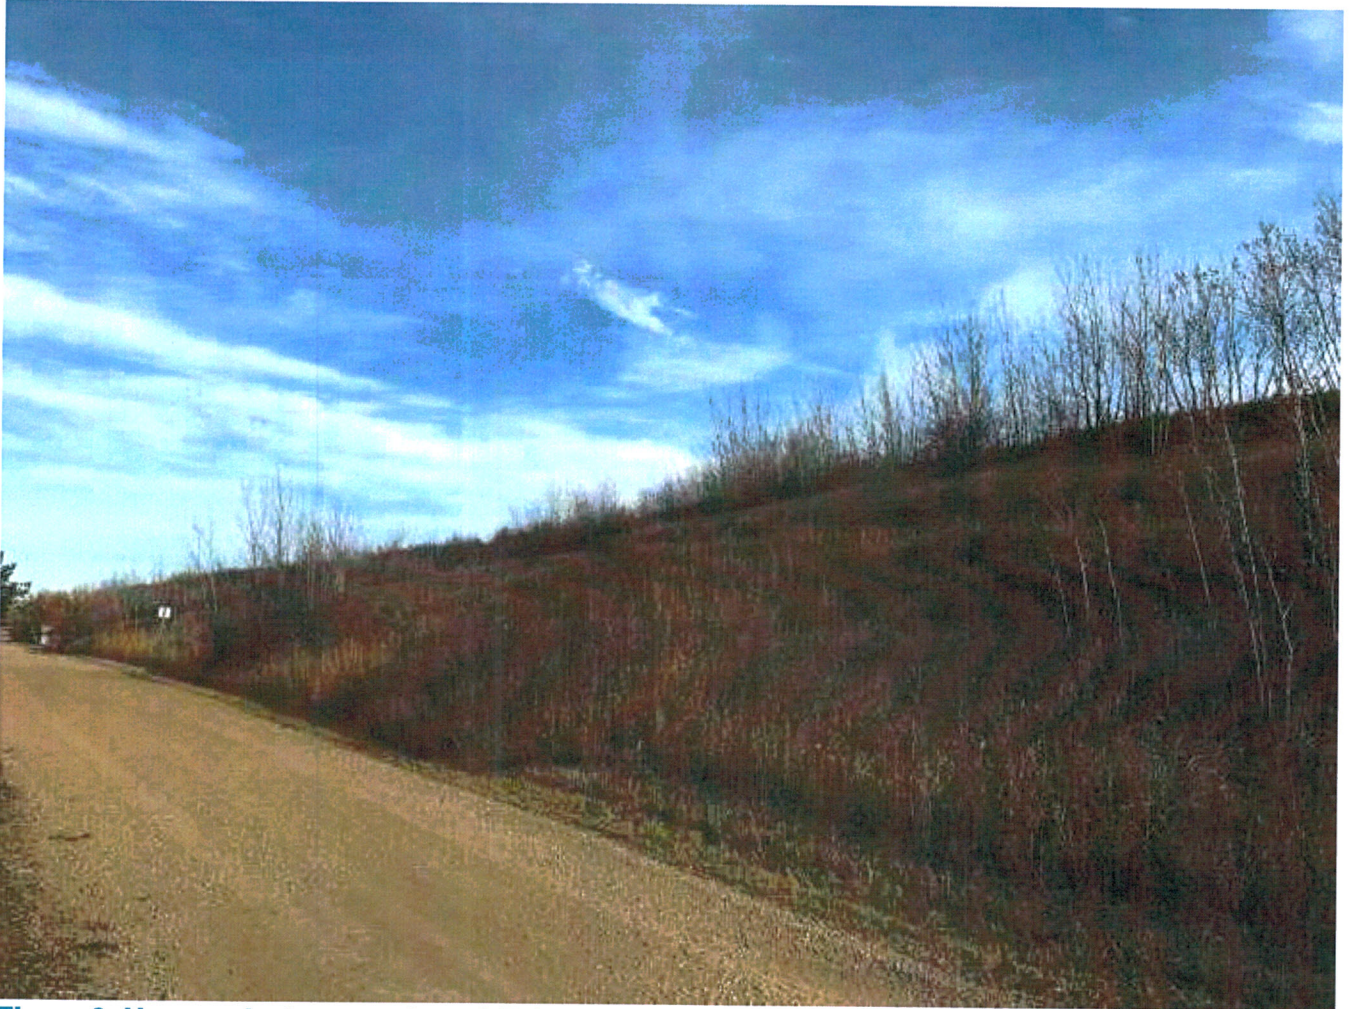
The topography of Hunts Cove Hill is generally hummocky, which could indicate past slope movement; however, it is not possible to tell if this hummocky terrain was created from erosion, landslides or both. A photo showing typical hummocky terrain is shown in Figure 3.

**Figure 3: Hummocky topography uphill from Archdekin Drive.**

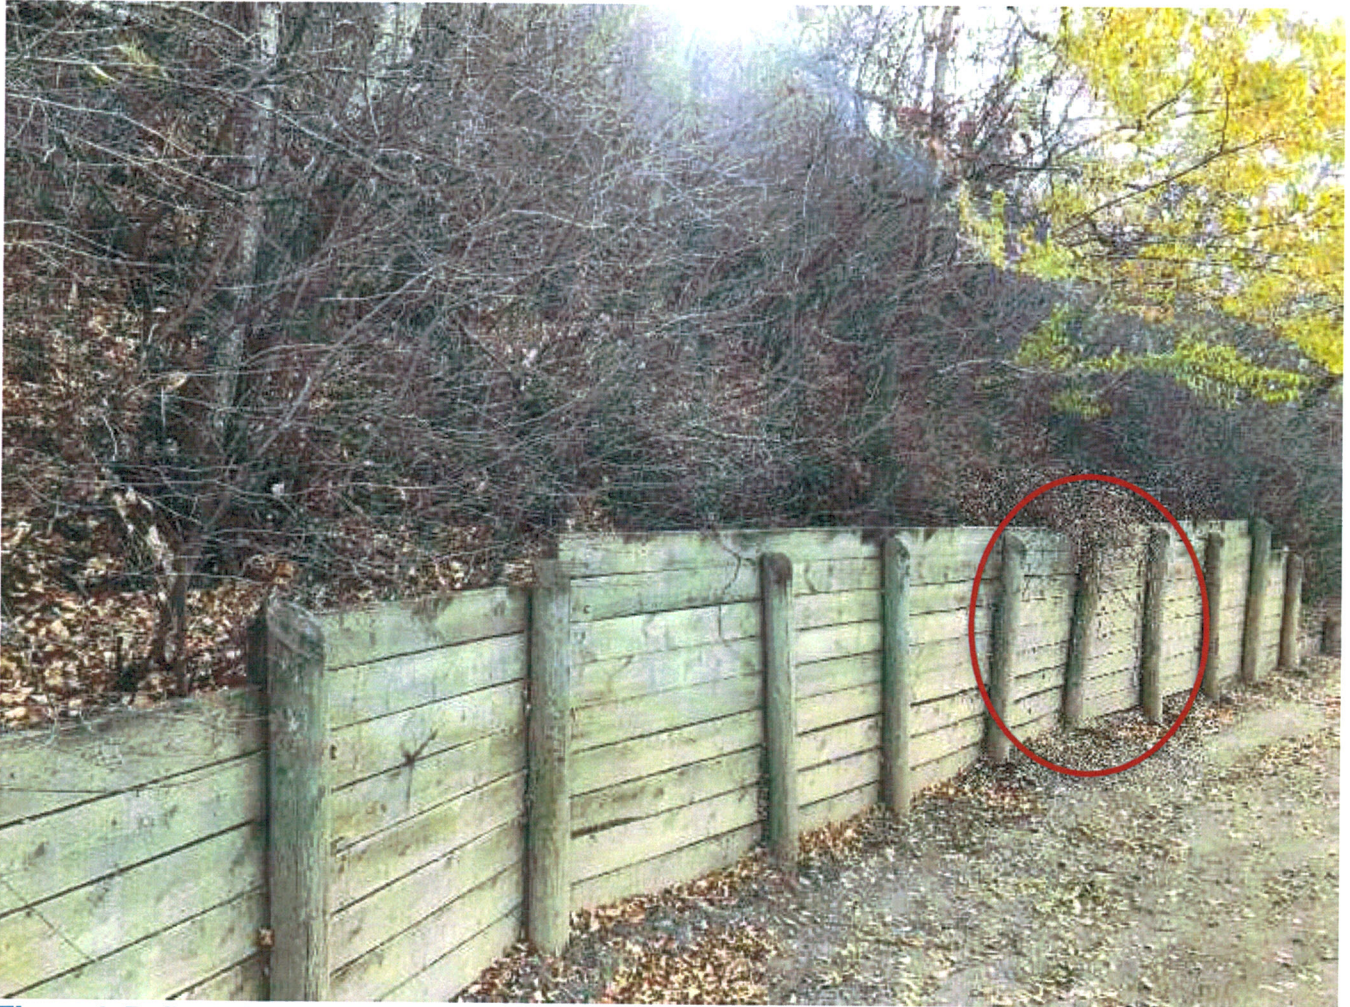
Another retaining wall, further south than the failed retaining wall on Hunts Cove Crescent, was observed to have deflected towards the road slightly, as seen in Figure 4. Some scarps and hooked tree trunks were apparent in the backslope above the wall. While the condition of this wall would not be considered failed, the deflection of the wall and visible evidence of movement above it indicate that the slopes on Hunts Cove Hill are prone to slope failures with modification to the current topography.

**Figure 4: Deflected retaining wall, south end of Hunts Cove Crescent.**

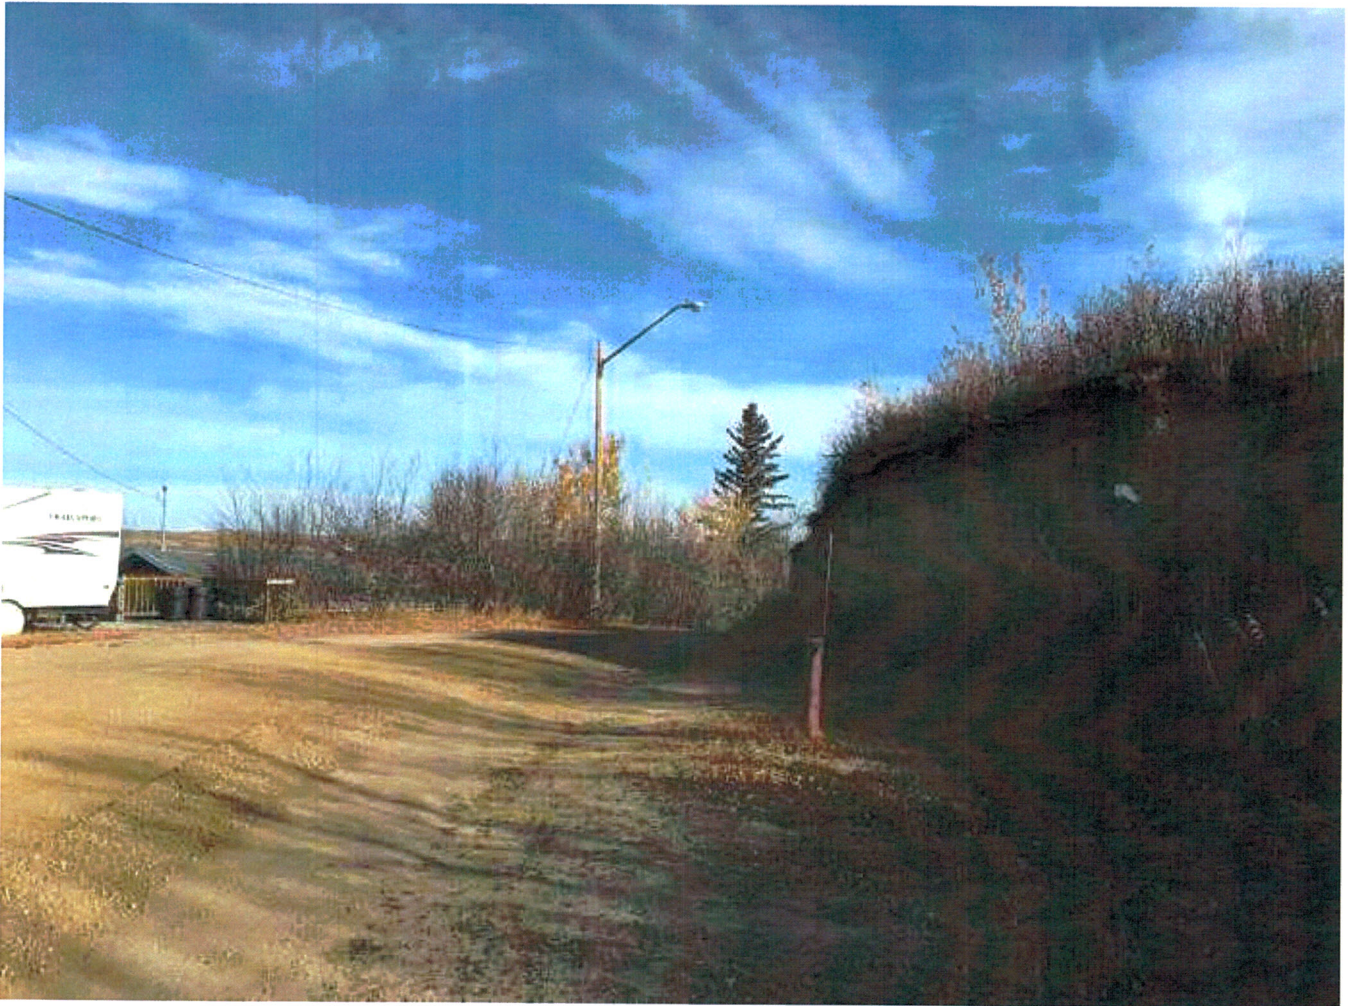
The soil in some exposed sections of the hillside appeared to consist of predominantly silty sand with some clay, such as the open cliff near the end of Archdekin Drive (Figure 5), and behind the failed retaining wall. PMEL also identified significant deposits of silt in the area. These materials are readily erodible, meaning small changes to the ground surface or vegetation could result in excessive erosion and formation of erosion gullies. Silts and sands will generally possess a higher permeability than glacial tills, meaning they could conduct water more readily. Water bearing soil layers can act as a weak layer in landslides, or contribute to saturation and softening of other soil layers, which in turn can create a weak layer.

**Figure 5: Exposed cliff, north end of Archdekin Drive, silty sand with some clay.**

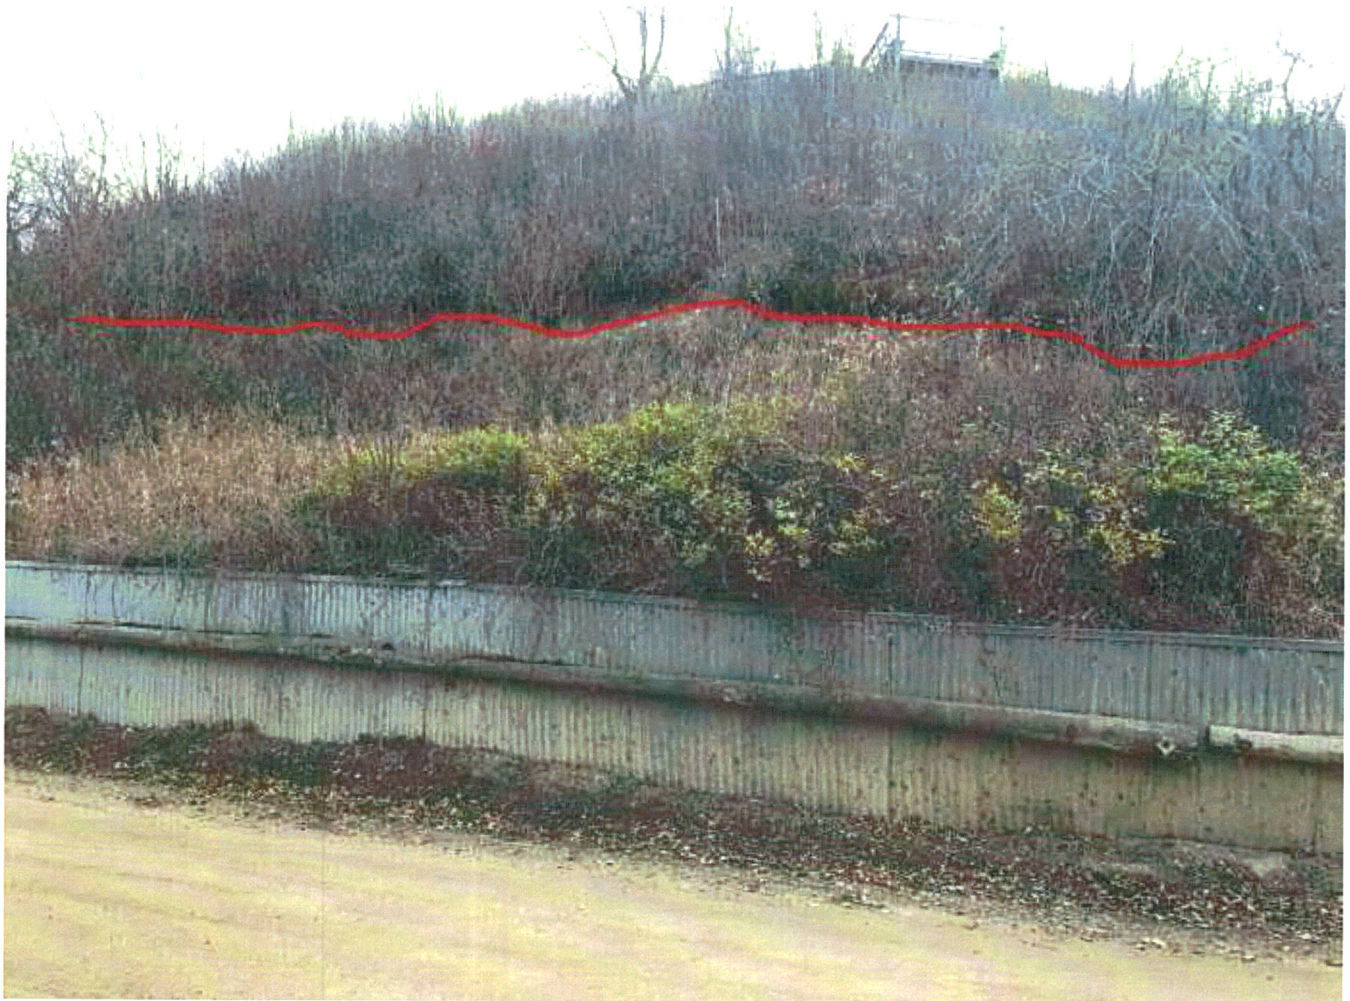
**Figure 6: Slope failure above retaining wall on Hunts Cove Crescent.**

The retaining wall consisted of corrugated steel sheet without obvious provision for drainage. The steel sheet was supported by horizontal timbers with ½" steel tieback rods at approximate 2.5 m intervals. Penetration details of the steel sheet and rods is unknown. The top of the head scarp of the slope failure was approximately 6 m in height above the roadway, and the horizontal distance from the retaining wall to the head scarp was approximately 4 m to 7 m. Measurement of the vertical and horizontal displacement of the head scarp was not possible due to heavy vegetation. The elevation difference between Hunts Cove Crescent and Archdekin Drive was approximately 18 m. Trailers, cottages and patios were present along the hill crest on Archdekin Drive above the failed retaining wall, as can be seen in Figure 6. Further movement of the retaining wall could put these properties at risk.
