# Stone Creek Canyon HOA

## Level 1 Reserve Study

**Report Period – 01/01/2022 – 12/31/2022**

**Report prepared on – Tuesday, February 15, 2022**

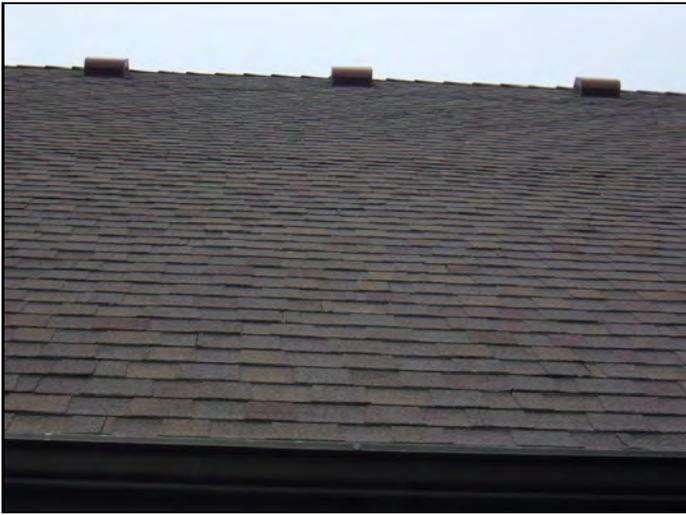
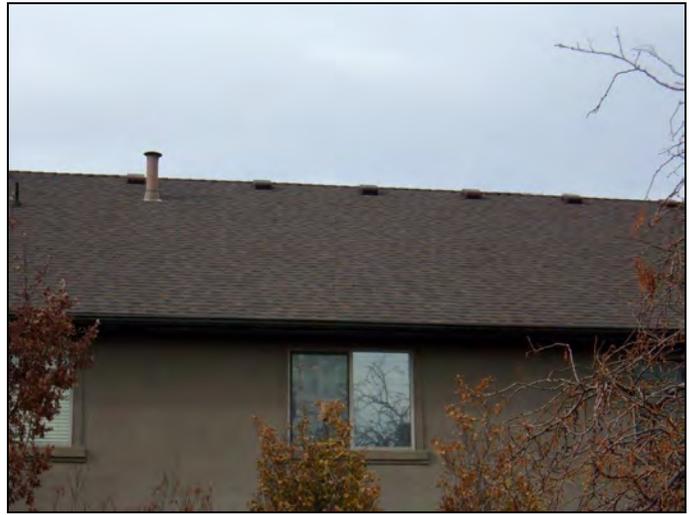
Comp #: 105 Roofs - 2009-2010 - Replace

The roofs are in good to fair condition. We recommend funding to replace this component approximately every 20 - 25 years. Remaining life based on current age.

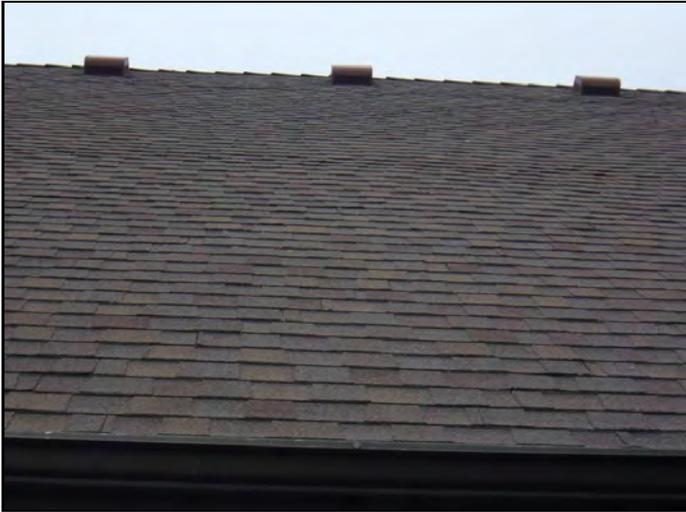
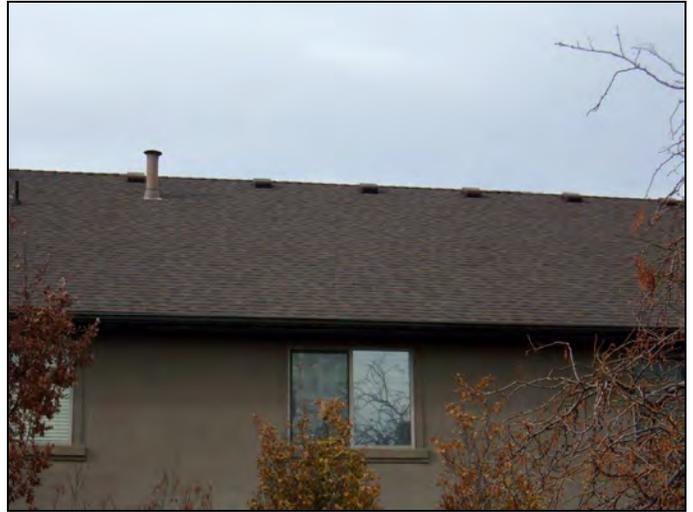
Comp #: 105 Roofs - 2016-2019 - Replace

The roofs are in good condition. We recommend funding to replace this component approximately every 20 - 25 years. Remaining life based on current age.

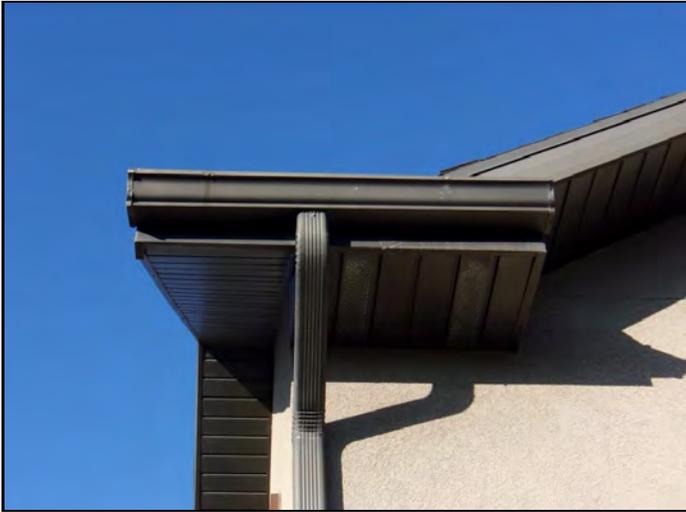
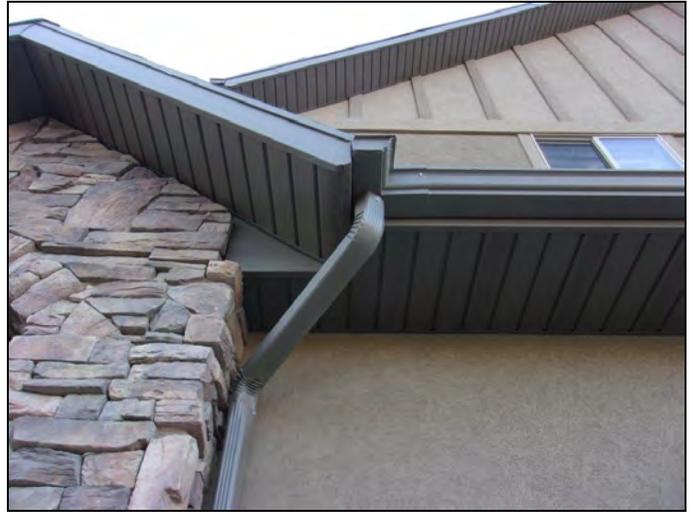
Comp #: 120 Rain Gutters/Downspouts - 2009-2010 - Replace

The rain gutters and downspouts are in good condition. We recommend funding to replace this component approximately every 25 - 30 years. Remaining life based on current age.

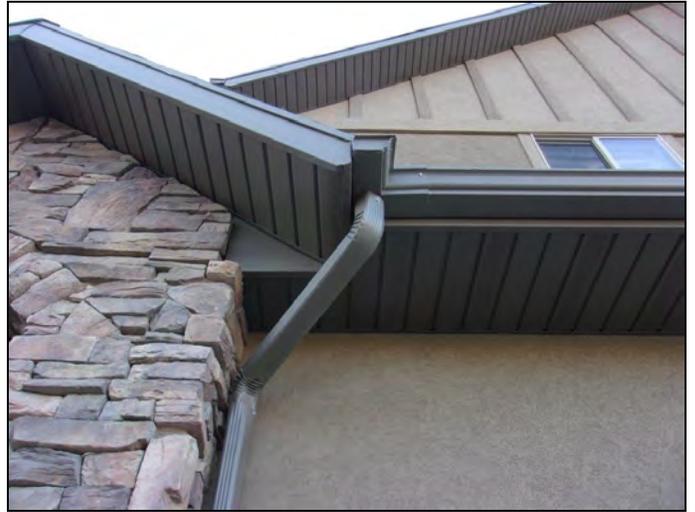
Comp #: 120 Rain Gutters/Downspouts - 2016-2019 - Replace

The rain gutters and downspouts are in good condition. We recommend funding to replace this component approximately every 25 - 30 years. Remaining life based on current age.

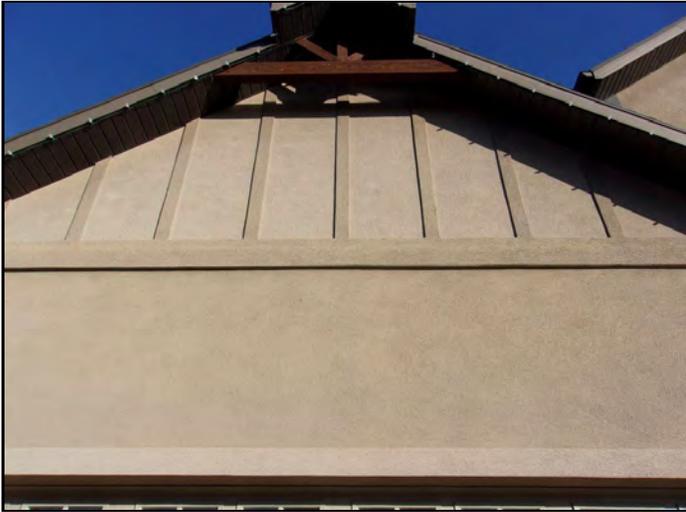
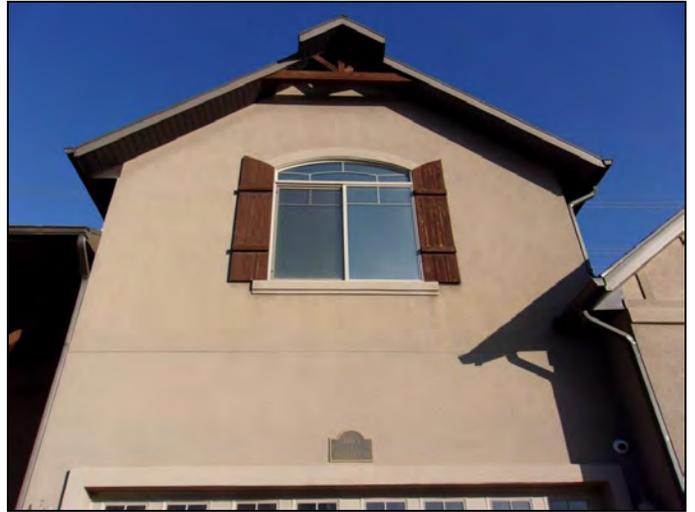
Comp #: 201 Stucco Surfaces - 2009-2010 - Repair/Repaint

The stucco surfaces are in good to fair condition. We recommend funding to repair/repaint this component approximately every 12 - 15 years. Remaining life based on current age and condition.

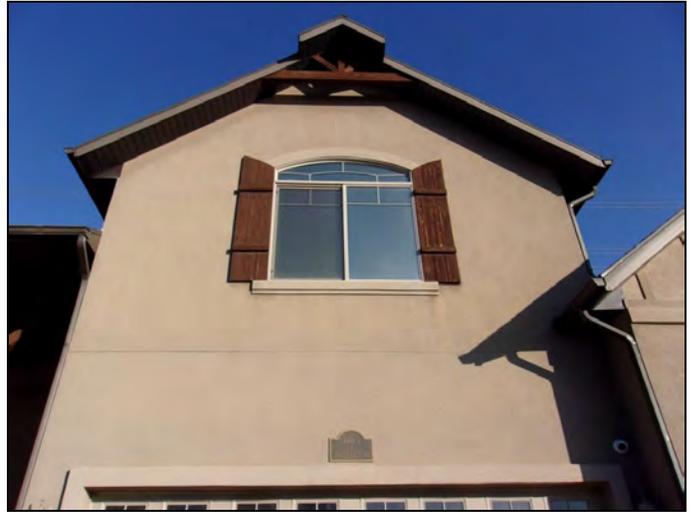
Comp #: 201 Stucco Surfaces - 2016-2019 - Repair/Repaint

The stucco surfaces are in good to fair condition. We recommend funding to repair/repaint this component approximately every 12 - 15 years. Remaining life based on current age.

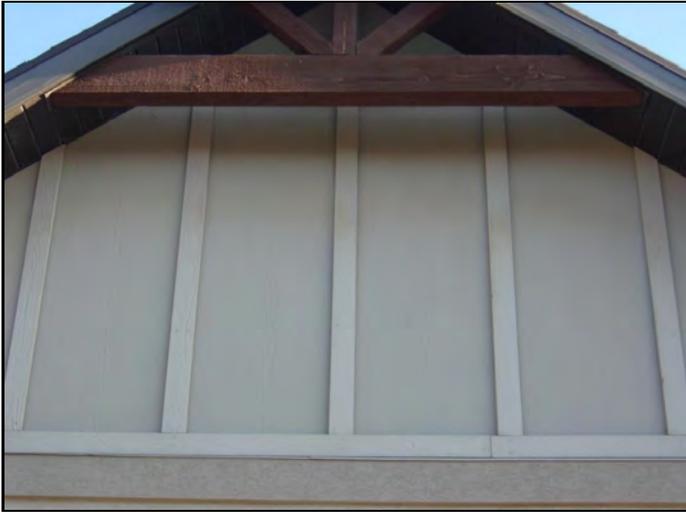
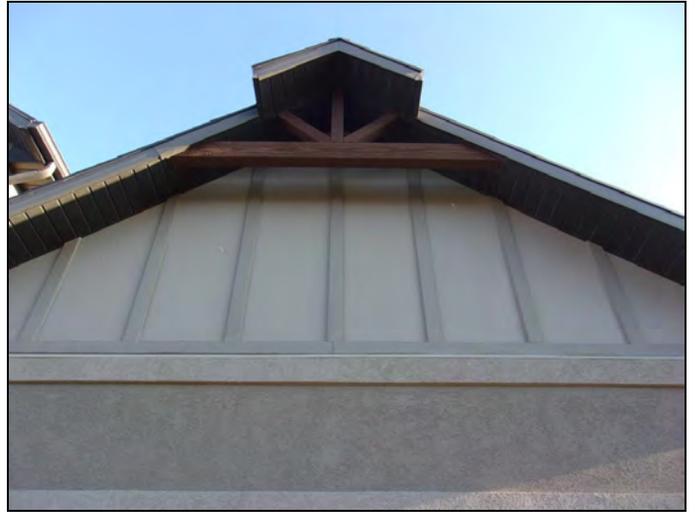
Comp #: 215 Siding - 2009-2010 - Repair/Repaint

The siding painted surfaces are in fair to poor condition. We recommend funding to repair/repaint this component approximately every 8 - 10 years. Remaining life is based on current age.

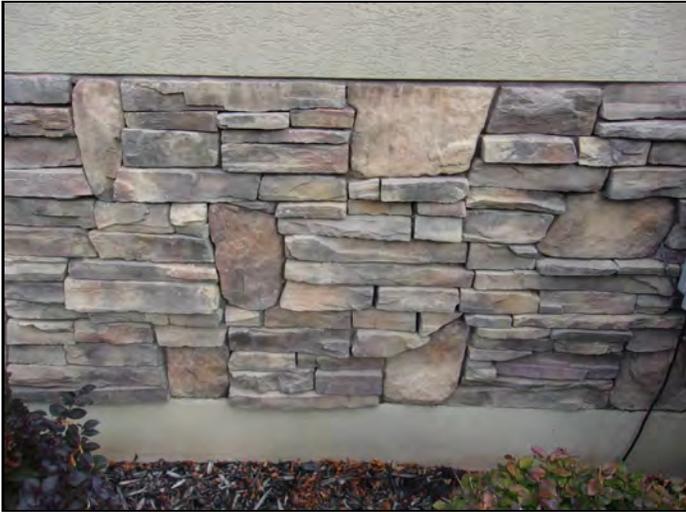
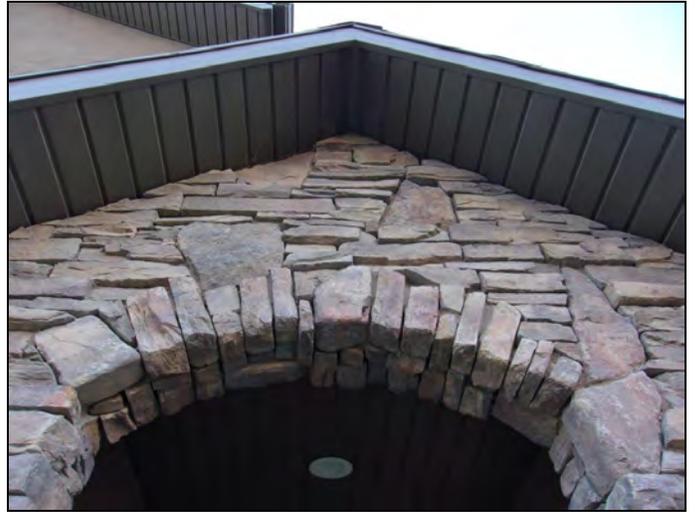
Comp #: 304 Faux Stone - Replace

This component has an extended useful life. We recommend making repairs as necessary as an operating expense.

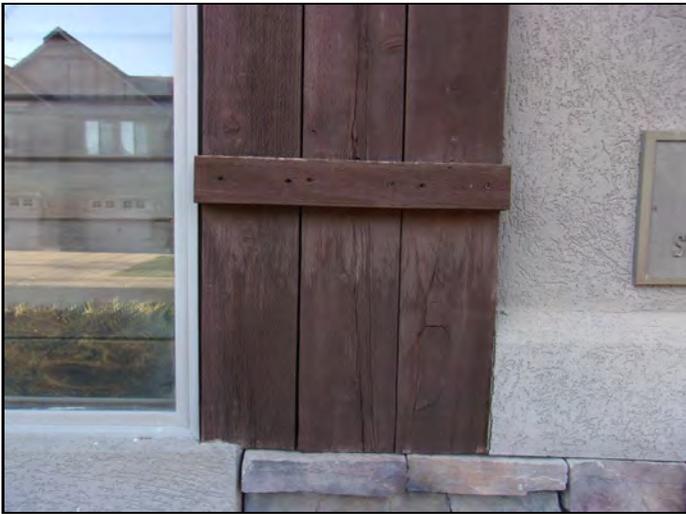
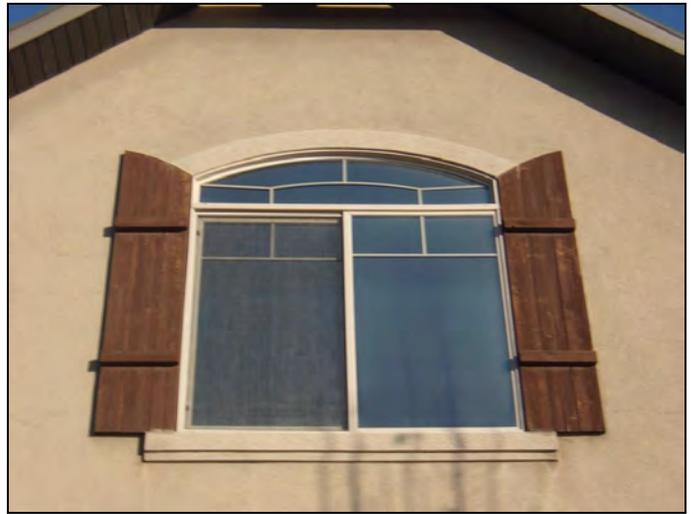
Comp #: 390 Wood Shutters - 2009-2010 - Replace

The shutters are in good to fair condition. We recommend funding to replace this component approximately every 20 - 30 years. Remaining life based on current age.

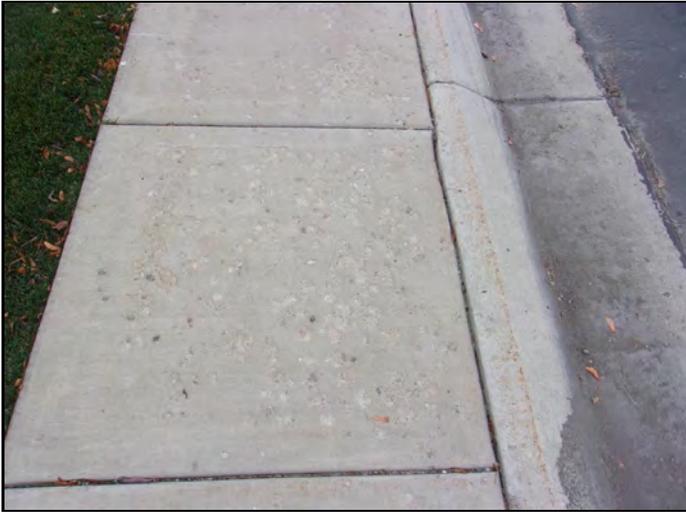
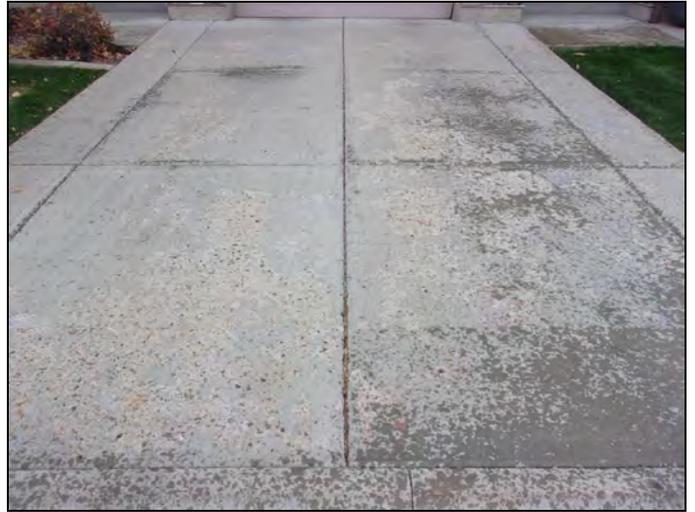
Comp #: 403 Concrete - Partial Repair/Replace

The concrete is in good condition. This component has an extended useful life under normal conditions. We recommend funding to make repairs and partially replace this component approximately every 10 years. Remaining life based on current age.

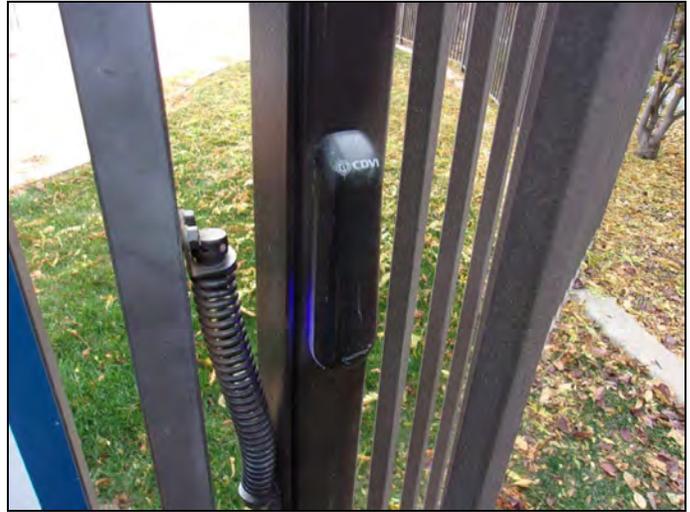
Comp #: 508 Access Control System - Replace

The access control system is in working condition. We recommend funding to replace this component approximately every 10 - 12 years. Remaining life based on current age and condition.

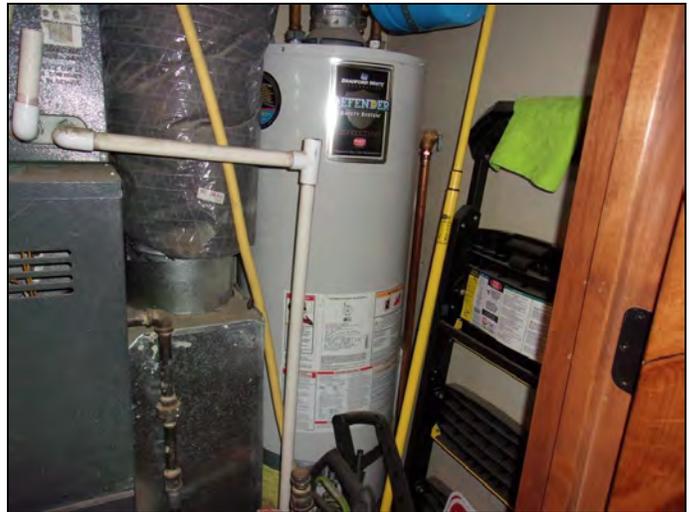
Comp #: 703 Water Heater - Replace

The water heater is in working condition. We recommend funding to replace this component approximately every 12 years. Remaining life based on current age.

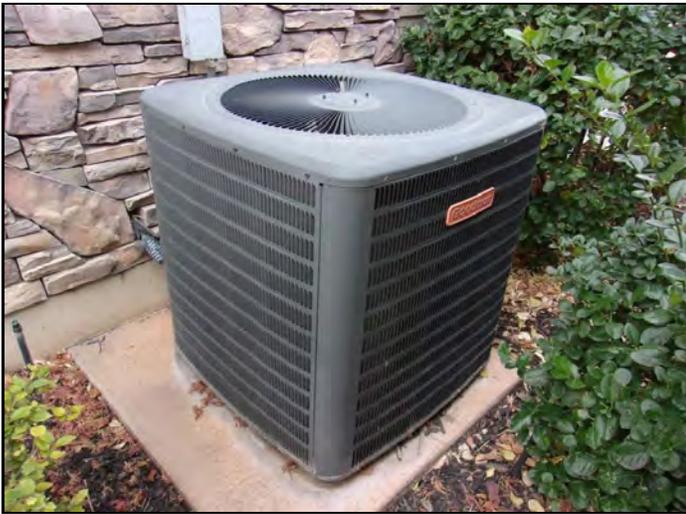
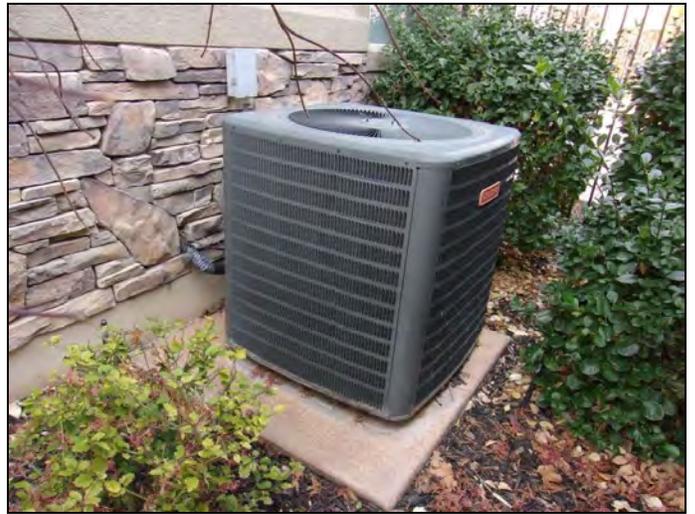
Comp #: 705 HVAC Condenser - Replace

The HVAC condenser is in working condition. We recommend replacing this component approximately every 20 years. Remaining life based on current age.
