Stone Creek Canyon HOA

Level 2 Reserve Study

Report Period – 01/01/2025 – 12/31/2025

Type of Study	Update w/Site Visit
Date of Property Inspection	12/11/2024
Prepared By	Dale Gifford
Analysis Method	Cash Flow
Funding Goal	Full Funding

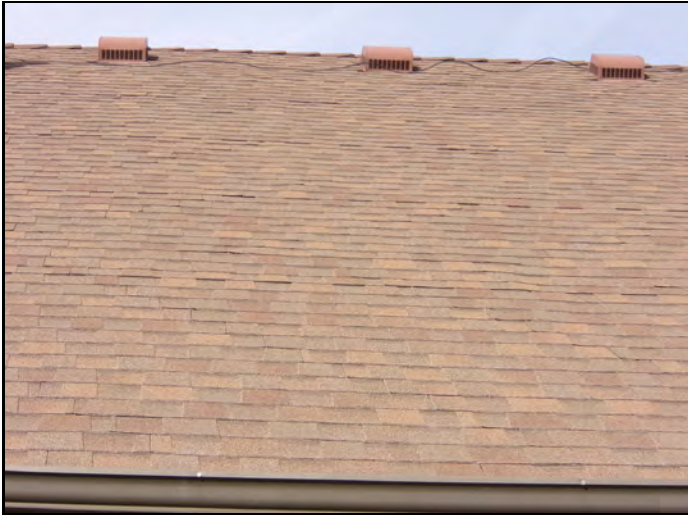
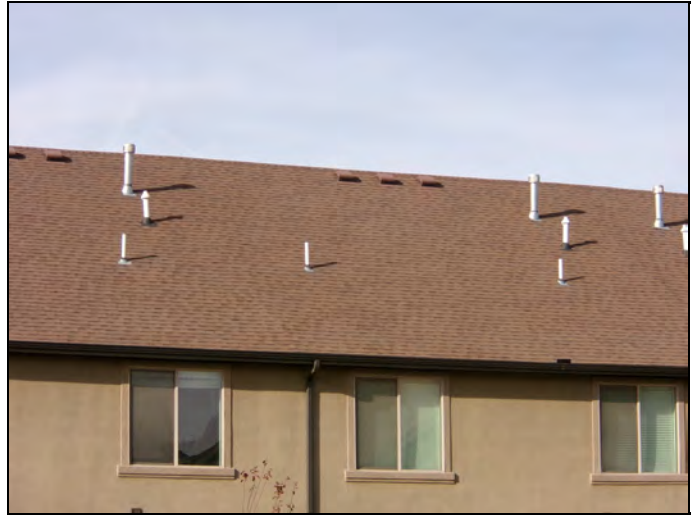
Comp #: 105 Roofs - 2009-2010 - Replace

The roofs appear to be in fair condition. We recommend funding to replace this component approximately every 20 - 25 years. Remaining life based on current age.

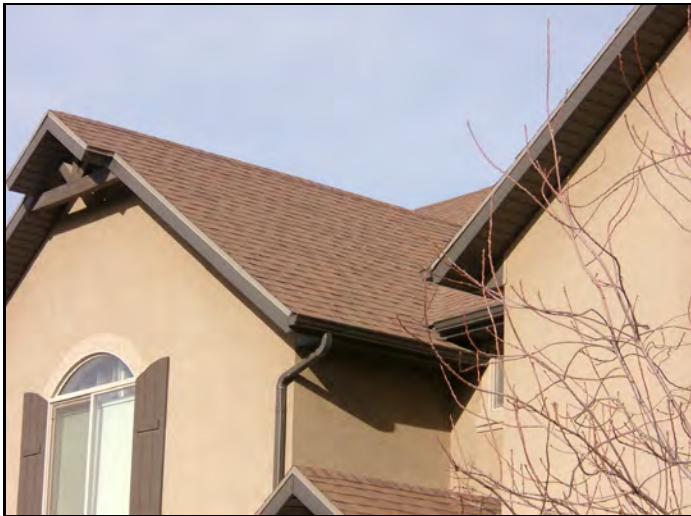
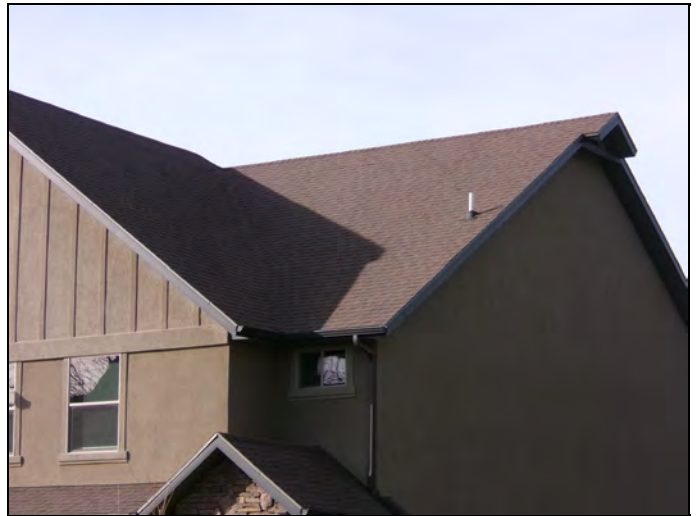
Comp #: 105 Roofs - 2016-2019 - Replace

The roofs appear to be in good condition. We recommend funding to replace this component approximately every 20 - 25 years. Remaining life based on current age.

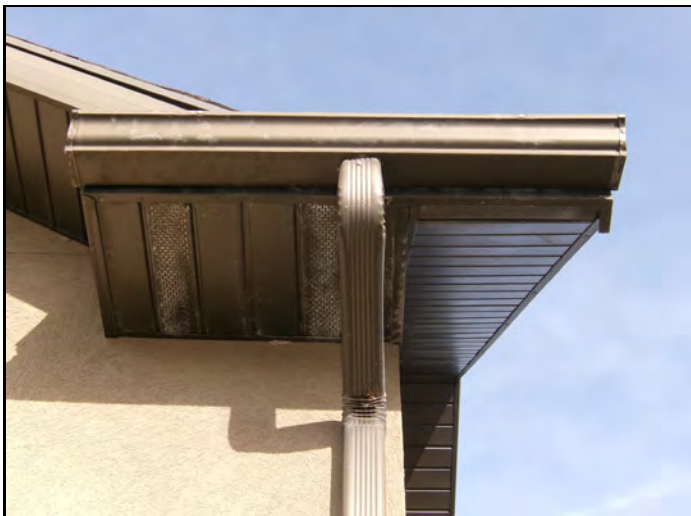
Comp #: 120 Rain Gutters/Downspouts - 2009-2010 - Replace

The rain gutters and downspouts are in good to fair condition. We recommend funding to replace this component approximately every 25 - 30 years. Remaining life based on current age.

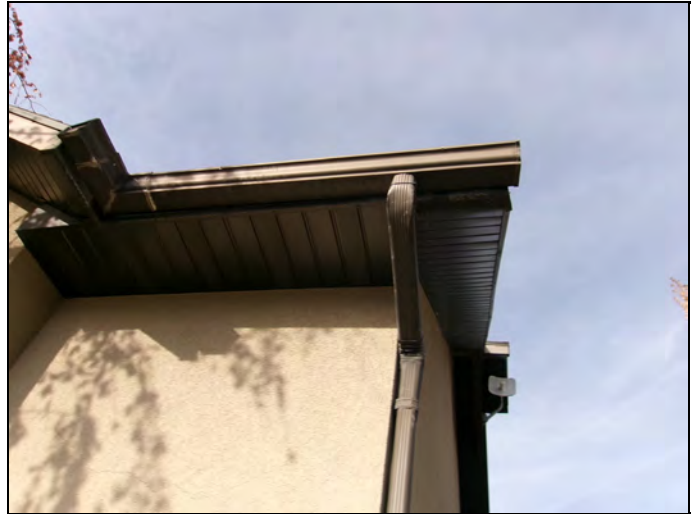
Comp #: 120 Rain Gutters/Downspouts - 2016-2019 - Replace

The rain gutters and downspouts are in good condition. We recommend funding to replace this component approximately every 25 - 30 years. Remaining life based on current age.

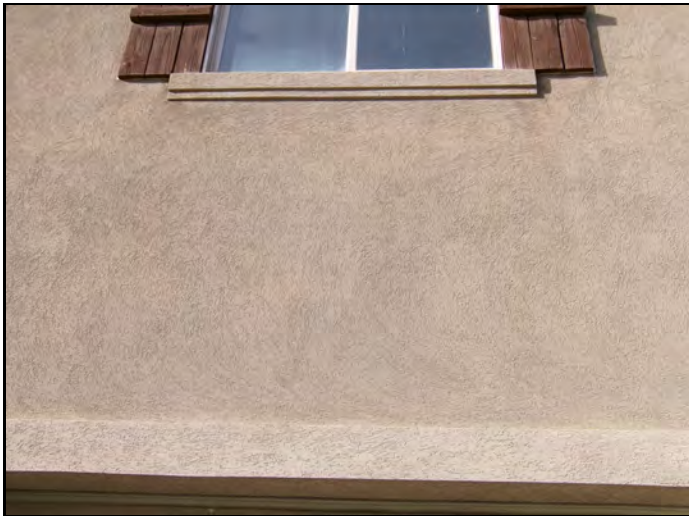
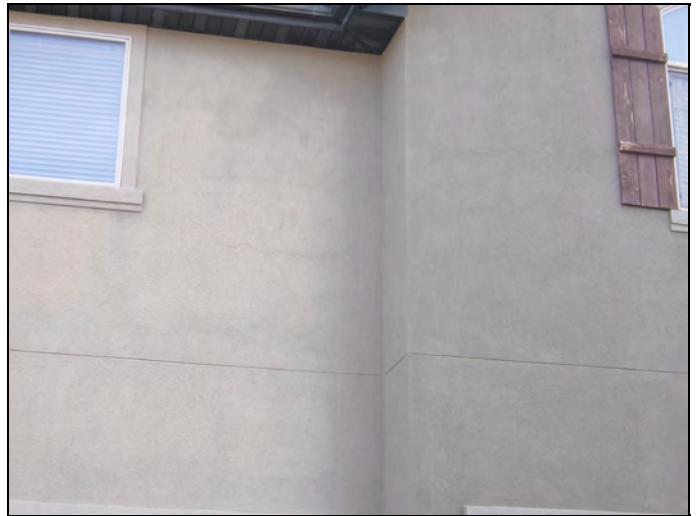
Comp #: 201 Stucco Surfaces - 2009-2010 - Repair/Repaint

The stucco surfaces are in good to fair condition. We recommend funding to repair/repaint this component approximately every 12 - 15 years. Remaining life based on current age and condition.

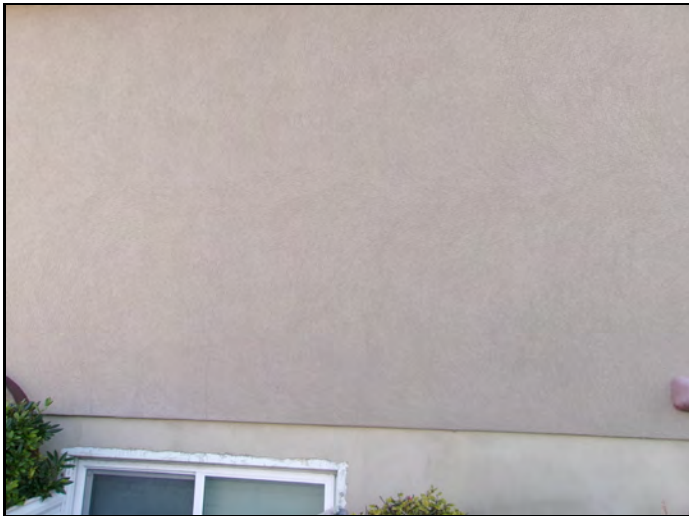
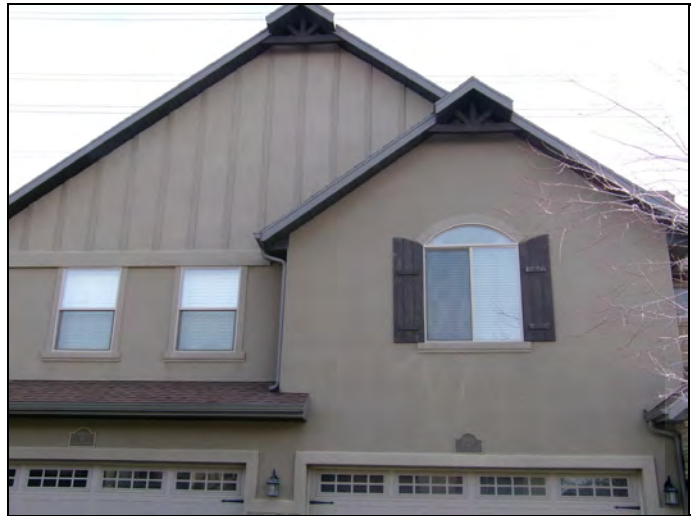
Comp #: 201 Stucco Surfaces - 2016-2019 - Repair/Repaint

The stucco surfaces are in good to fair condition. We recommend funding to repair/repaint this component approximately every 12 - 15 years. Remaining life based on current age.

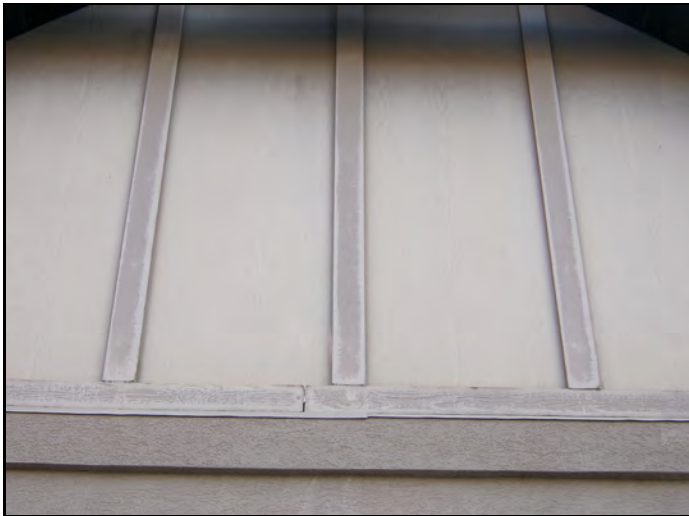
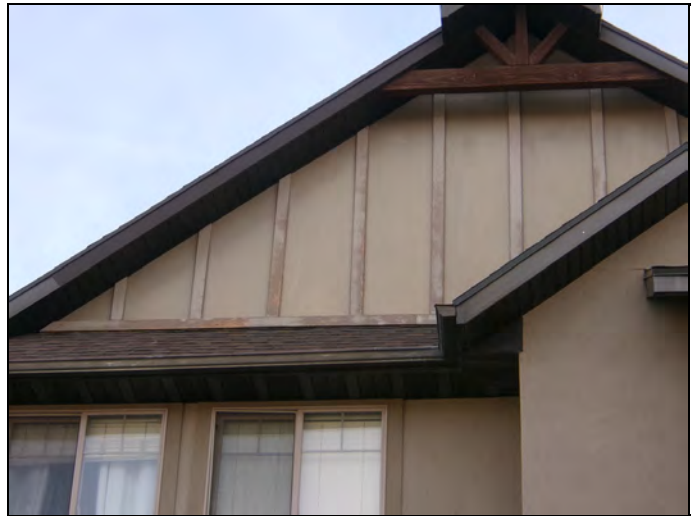
Comp #: 290 Gable Fixtures - Replace

Research with the client reveals this component will be replaced in 2025. This is a one-time project.
