Re: **Cormorant Lake Dam**  
**Dam Inspection Report**  
NID ID No.: LA00395  
St. Tammany Parish

# LADOTD DAM INSPECTION AND EVALUATION REPORT

Inspection Date: 12/15/2021

Name of Dam: Cormorant Lake  
Downstream Hazard: Low  
NID ID #: LA00395  
Parish: St. Tammany  
DOTD District: 62  
District Contact: Jennifer Branton, P.E.

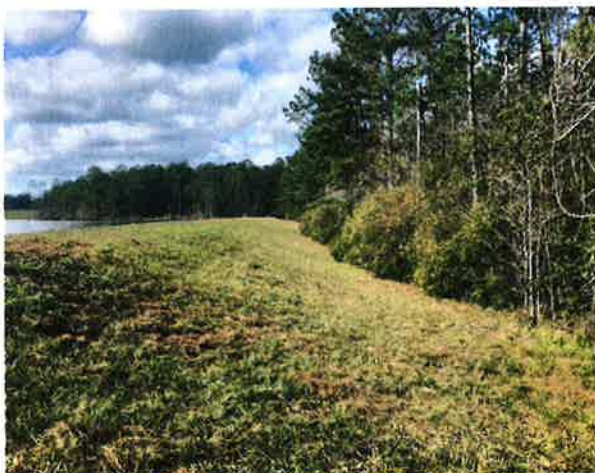
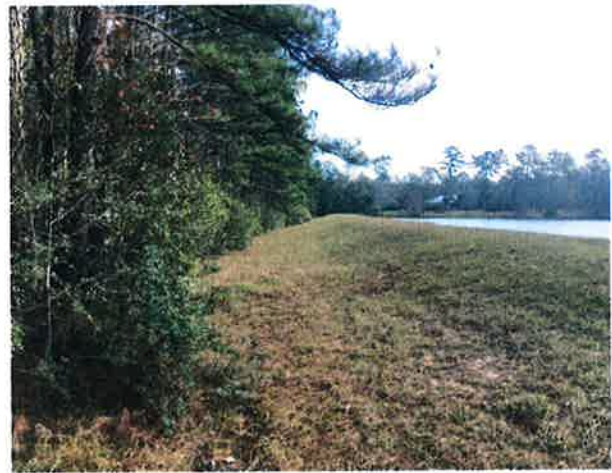
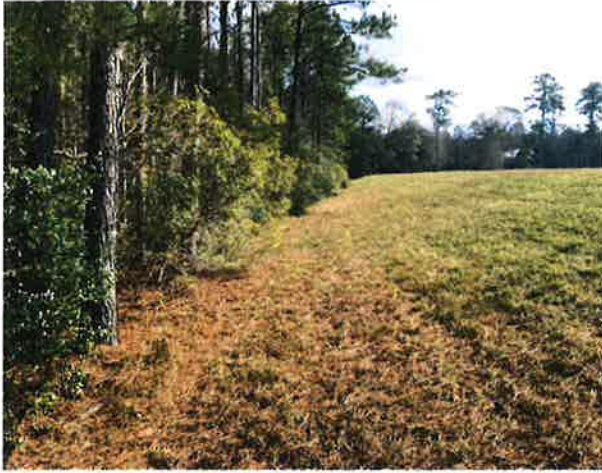
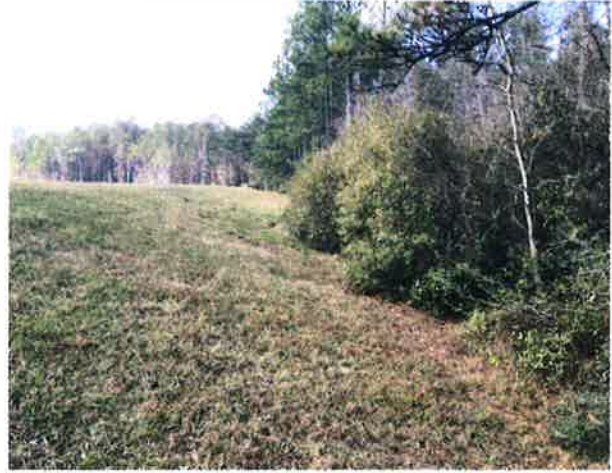
**Embankment Description:** Earthen embankment with grass coverage.  
**Embankment Slope:** 3H: 1V  
**Berm Description:** None  
**Berm Slope:** None  
**Toe Area:** The area at the embankment toe and beyond is densely vegetated with trees and brush.  
**Comments:** Trees encroaching on slope.  
**Deficiencies (1):**

Type	Description	Corrective Action
Unwanted Vegetation (Major)	Significant vegetation growth (>6 in. Dia.) located within the dam section. Large overhanging branches or fallen trees maybe present, which can reduce dam efficiency and/or impact maintenance operations.	Remove vegetation by cutting, trimming or using approved herbicide. Remove unwanted vegetation from the dam section, or within 15 ft. of the embankment toe to facilitate maintenance operations.

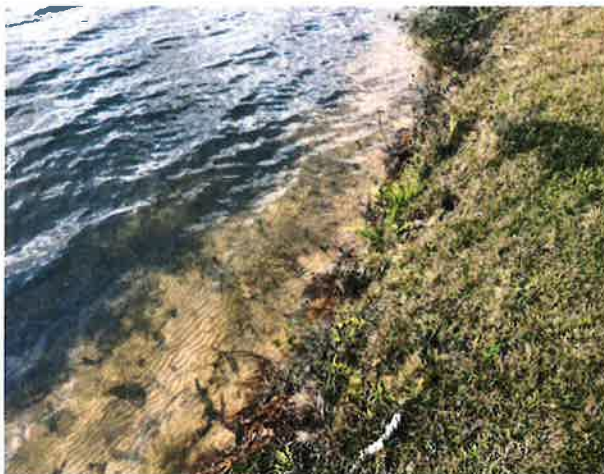
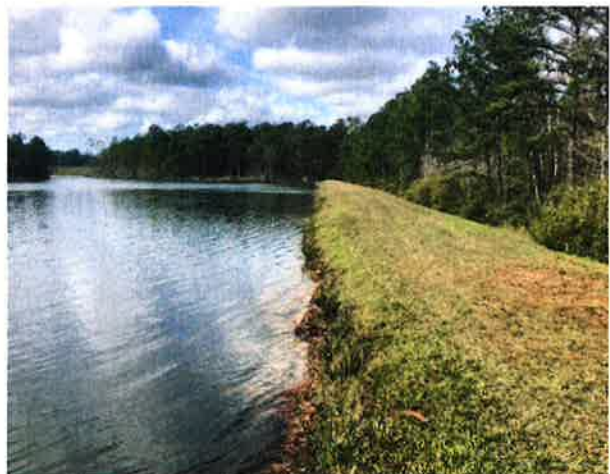
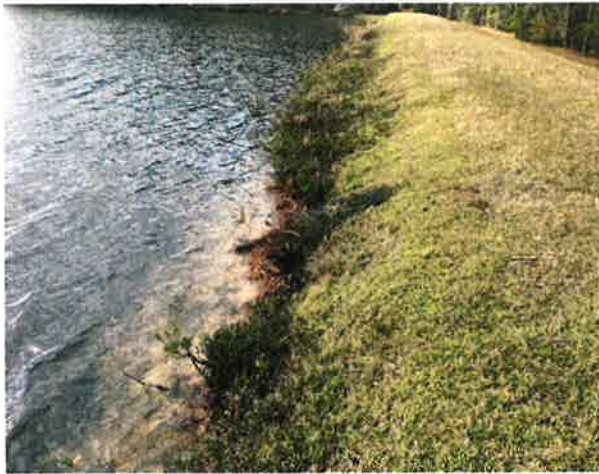
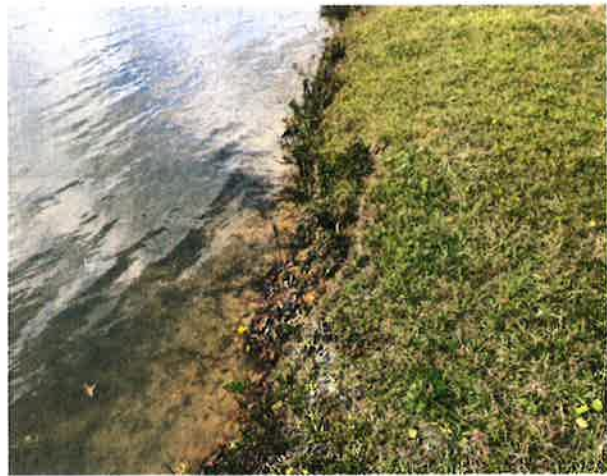
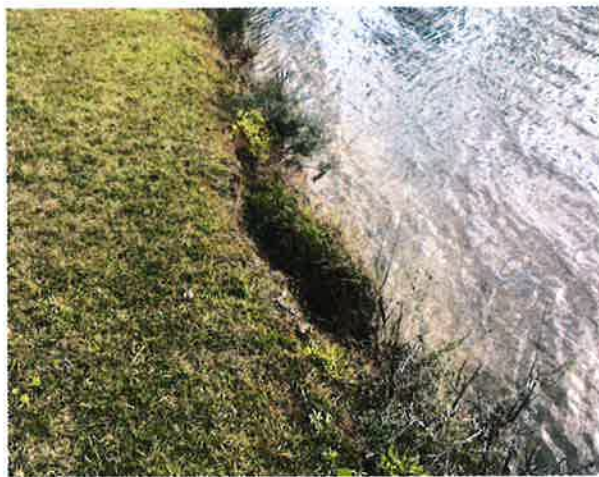
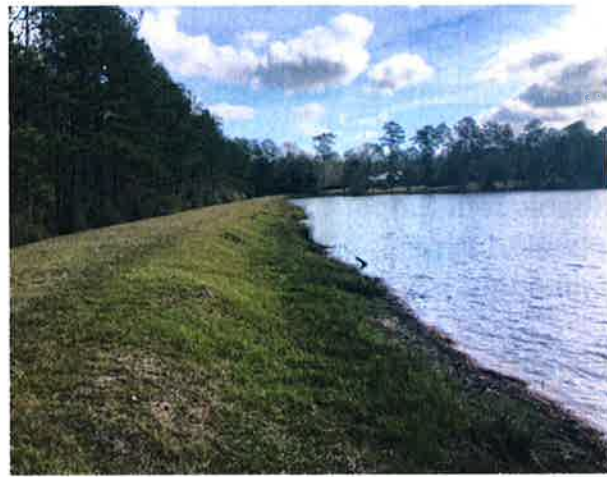
**Embankment Description:** Earthen embankment with grass coverage.  
**Embankment Slope:** 2H: 1V  
**Protection Type:** None  
**Comments:** Very gradual slope visible under the water, vertical above water due to wave erosion.

Type	Description	Corrective Action
Wave Induced Erosion (Minor)	Minor wave induced erosion generally < 6 - 12 in. deep.	Backfill area to original geometry and stabilize bank to prevent further erosion. Consider armoring with riprap, soil cement or other appropriate methods. Monitor area for further deterioration.

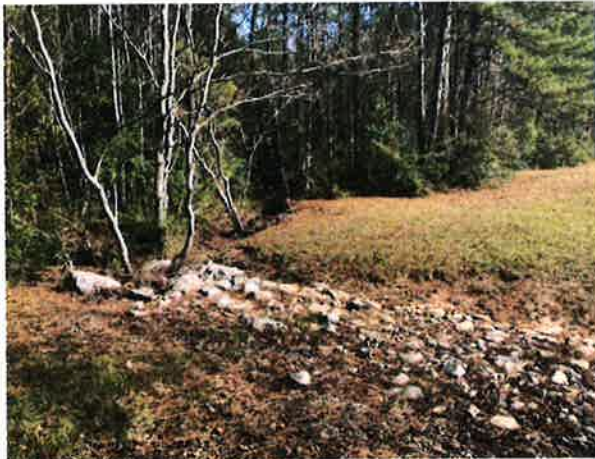
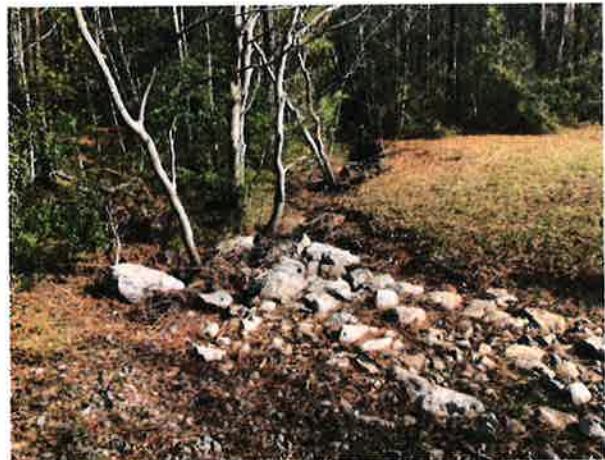
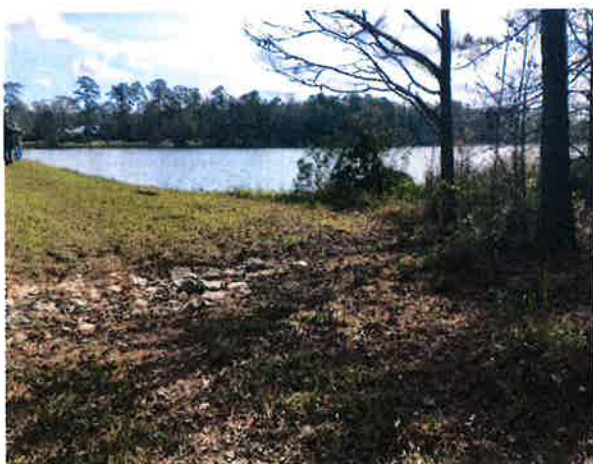
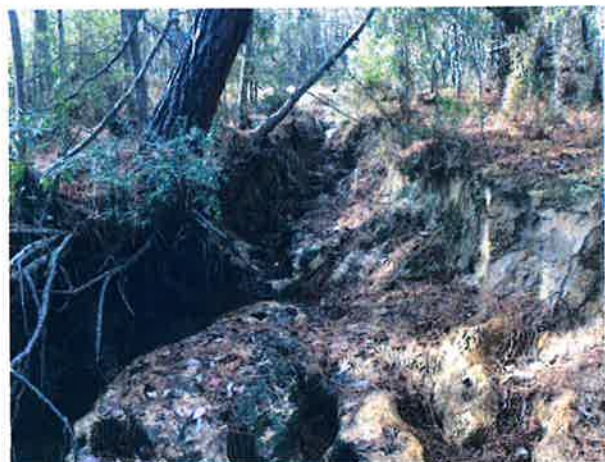
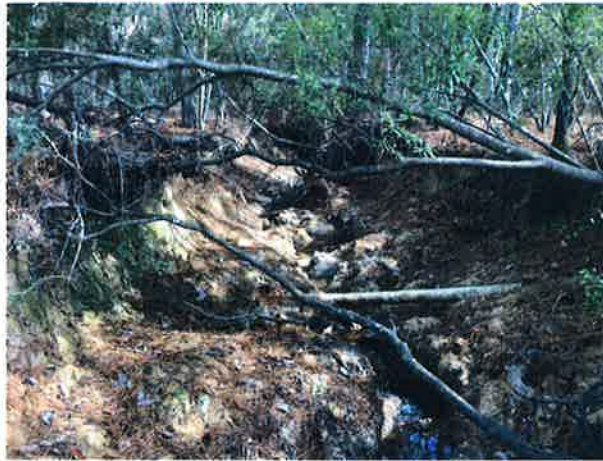
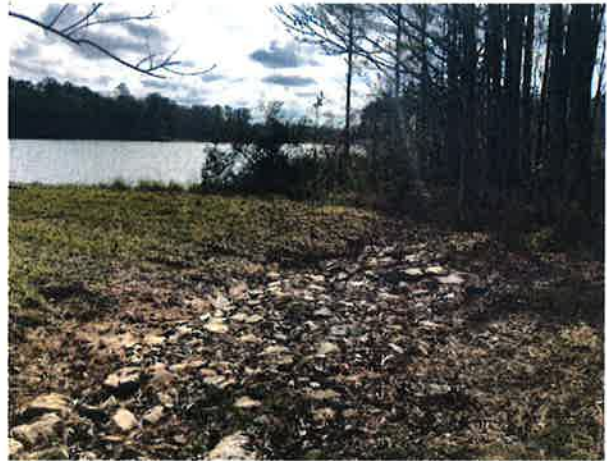
**Stilling Basin:** None  
**End Sill:** None  
**Approach Channel:** None  
**Discharge Channel:** Earthen streambed leading to Simmons Creek  
**Gates and Operations:** None  
**Spillway Drains:** None  
**Comments:** Headcut erosion in channel: 4-foot deep, 15-foot wide plunge pool; 60 feet downstream of rock in spillway

Type	Description	Corrective Action
Head Cutting	Head cutting erosion was observed along the flow path.	Backfill area to design grade, compact in lifts and establish/install adequate erosion protection to the affected area and re-establish sod cover.

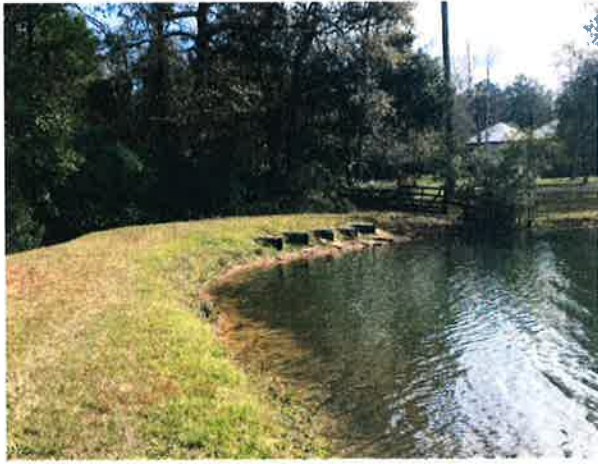
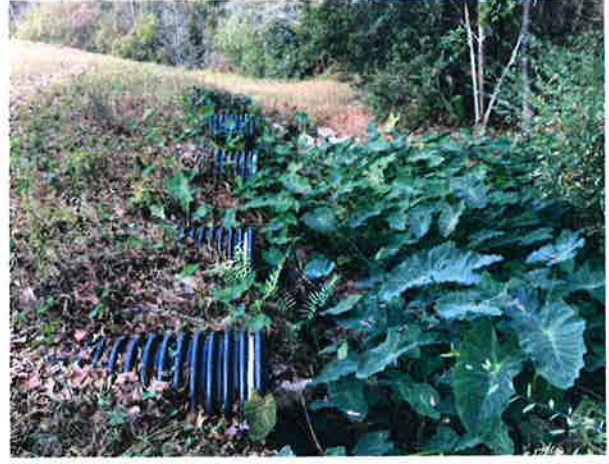
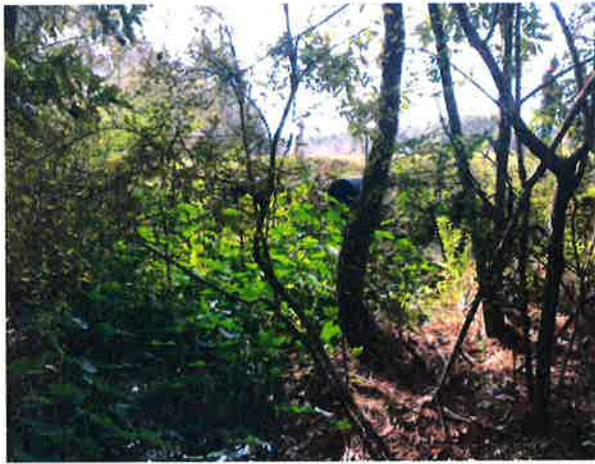
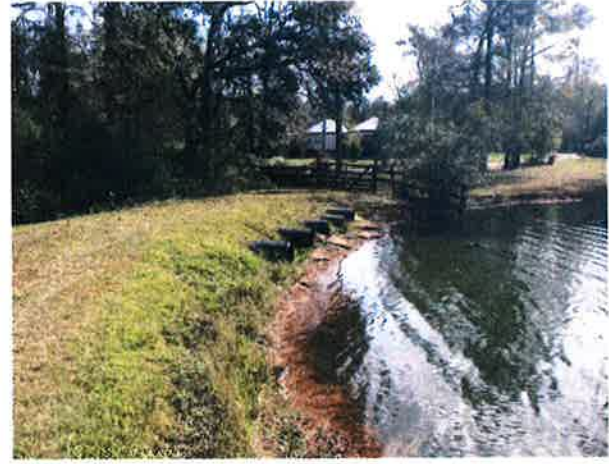
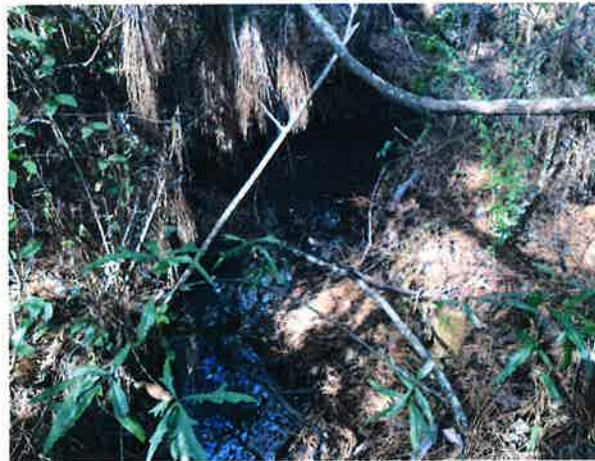
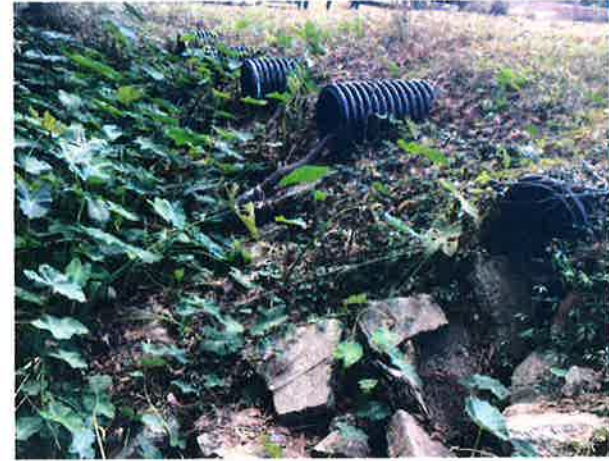
**Spillway Classification:** Auxiliary  
**Spillway Type:** Uncontrolled  
**Spillway Description:** Five 18-inch diameter corrugated plastic pipe (CPP) cross drains.  
**Crest Description:** None  
**Stilling Basin:** None  
**End Sill:** None  
**Approach Channel:** None  
**Discharge Channel:** Earthen streambed to Simmons Creek  
**Gates and Operations:** None  
**Spillway Drains:** None  
**Comments:** Replaced with five 18-inch-diameter corrugated plastic pipes in 2018. Mr. Beale states the other auxiliary flows first now. Minor headcut erosion in channel; 1-foot deep, 50-feet downstream.

Type	Description	Corrective Action
Head Cutting	Head cutting erosion was observed along the flow path.	Backfill area to design grade, compact in lifts and establish/install adequate erosion protection to the affected area and re-establish sod cover.
