Re: Crane Lake Dam  
**Dam Inspection Report**  
NID ID No.: LA00398  
St. Tammany Parish

# LADOTD DAM INSPECTION AND EVALUATION REPORT

Inspection Date: 12/15/2021

Name of Dam: Crane Lake  
Downstream Hazard: Low  
NID ID #: LA00398  
Parish: St. Tammany  
DOTD District: 62  
District Contact: Jennifer Branton, P.E.

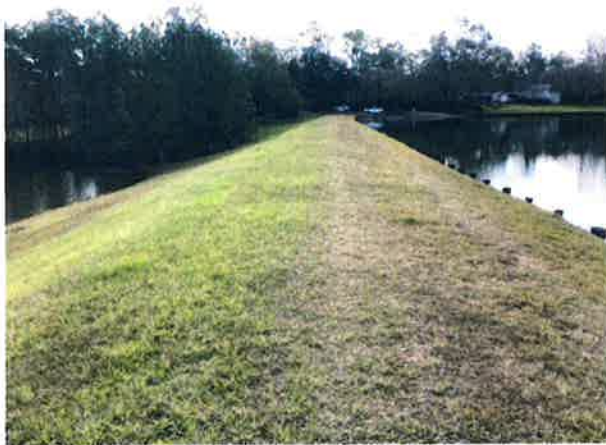
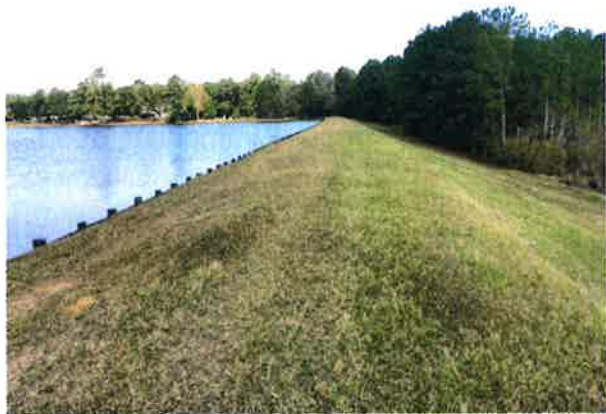
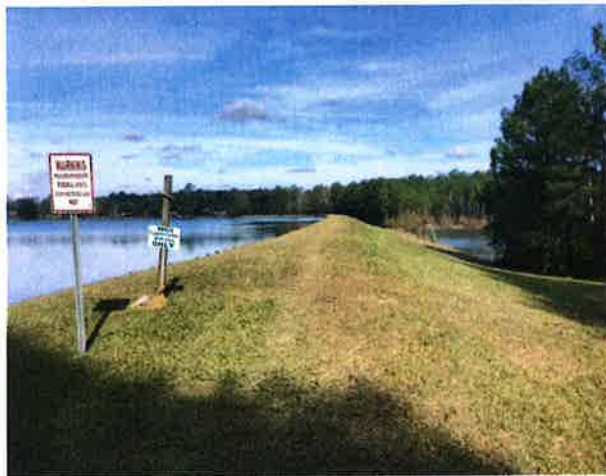
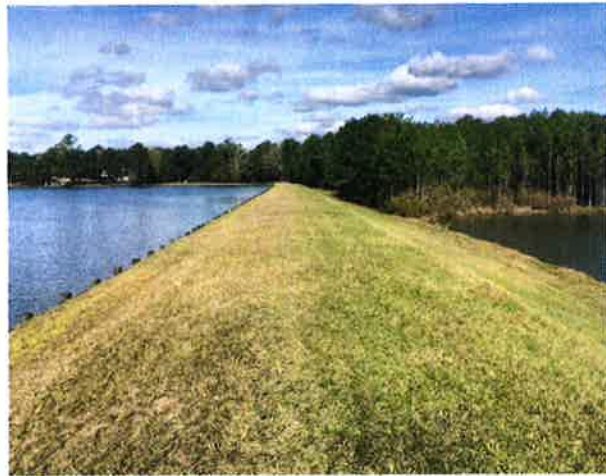
**Crown Length (Ft.):** 1,270  
**Crown Description:** Earthen crown with grass coverage.  
**Fence:** None  
**Abutment:** Both abutments appear satisfactory.  
**Comments:** No additional comments.

*No deficiencies identified*

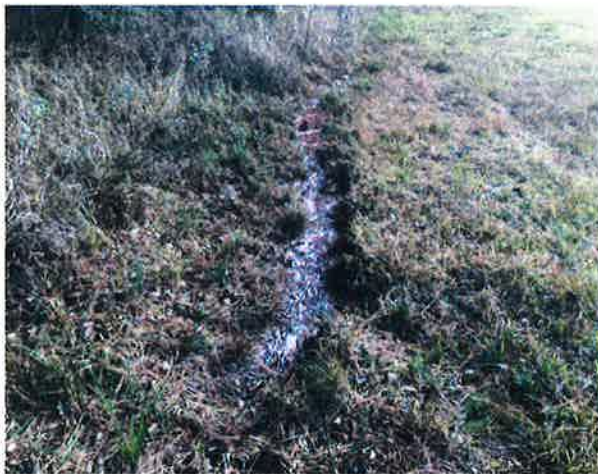
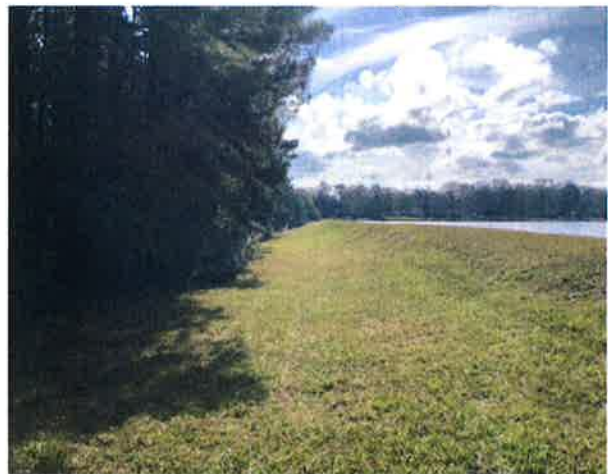
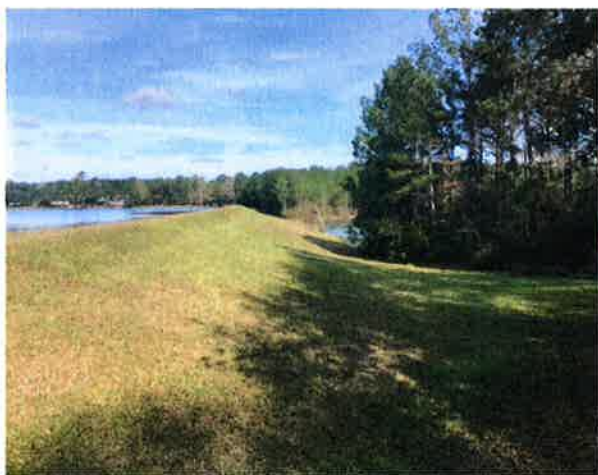
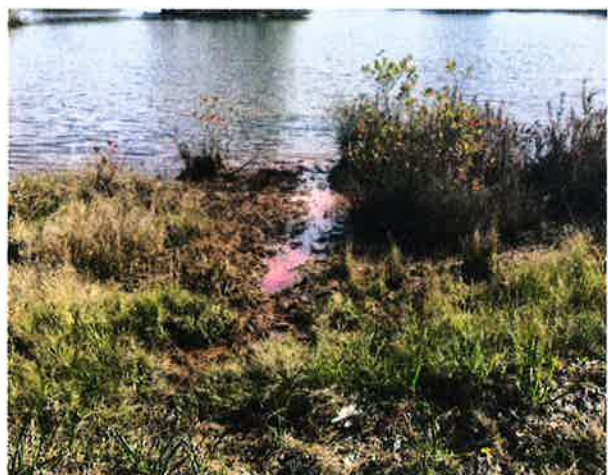
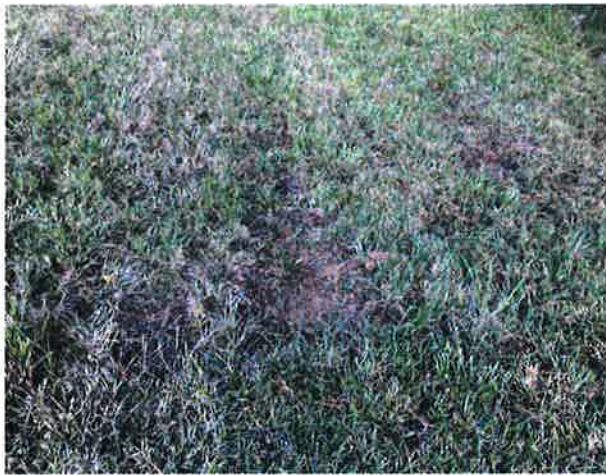
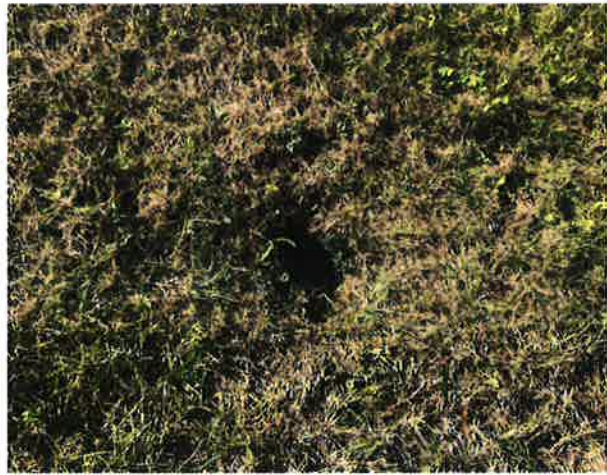
**Embankment Description:** Earthen embankment with grass coverage.  
**Embankment Slope:** 3H: 1V  
**Berm Description:** None  
**Berm Slope:** None  
**Toe Area:** The area at the embankment toe is Cormorant Lake.  
**Comments:** Probable seepage on both ends.

Type	Description	Corrective Action
Seepage (No Soil Transport)	Evidence of seepage or saturated areas indicating possible seepage at or beyond the dam toe or along or near conduits, concrete structures, etc. No evidence of soil transport was observed.	Evaluate permanent solution to control seepage monitor these areas regularly especially when reservoir level is elevated.
Animal Burrows	Animal burrows are present which may lead to seepage or slope stability problems, and they require immediate attention.	Excavate, inspect, backfill, compact in lifts and re-establish sod cover. Establish/improve animal abatement program.

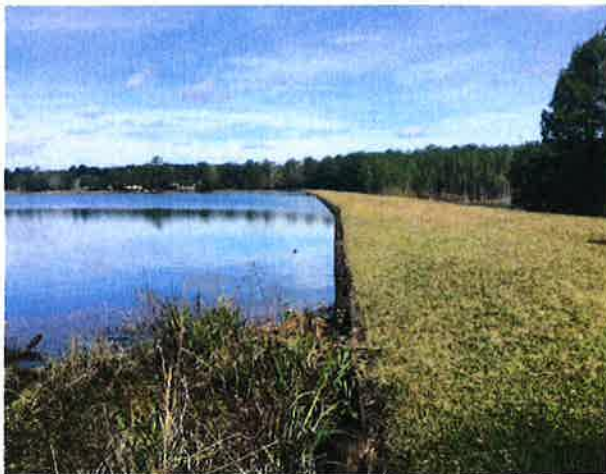
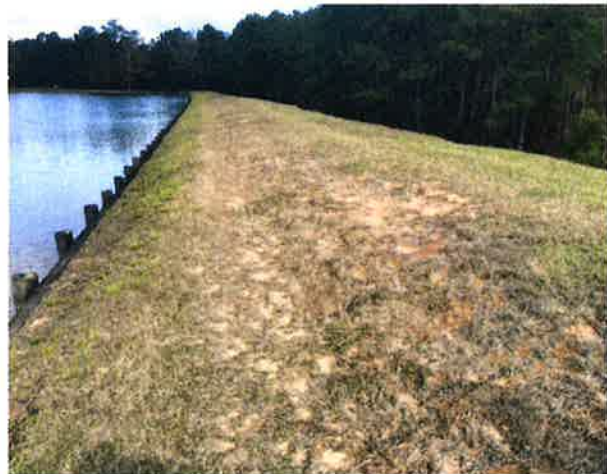
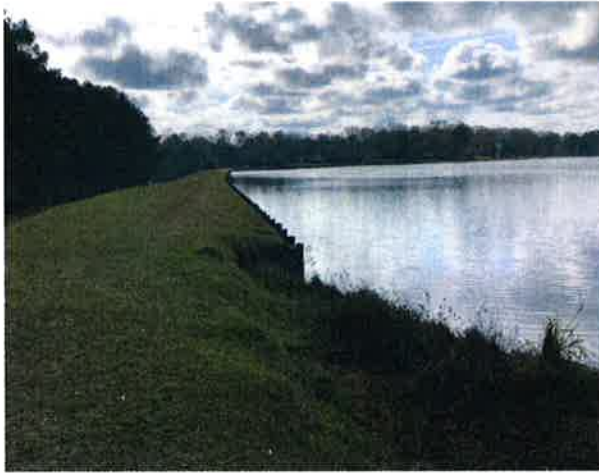
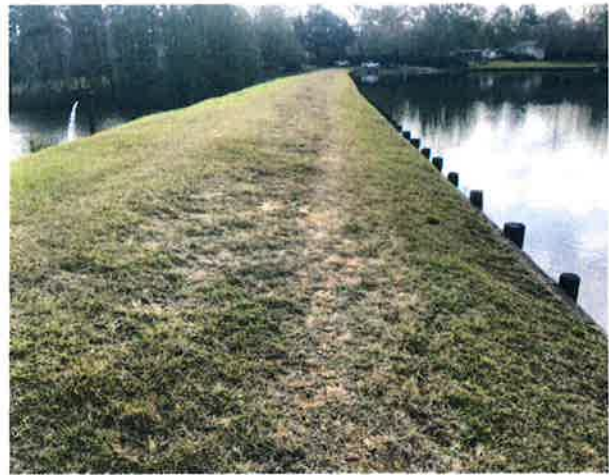
<b>Embankment Description:</b>	Earthen embankment with grass coverage and a timber bulkhead.
<b>Embankment Slope:</b>	Vertical (timber bulkhead)
<b>Protection Type:</b>	The upstream shore protection consists of a treated timber bulkhead.
<b>Comments:</b>	No additional comments.

*No deficiencies identified*

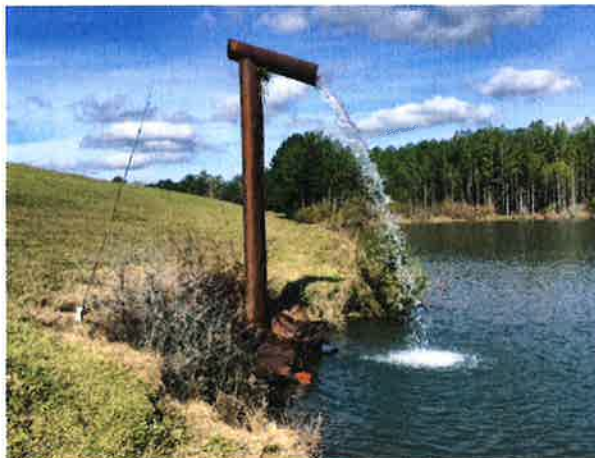
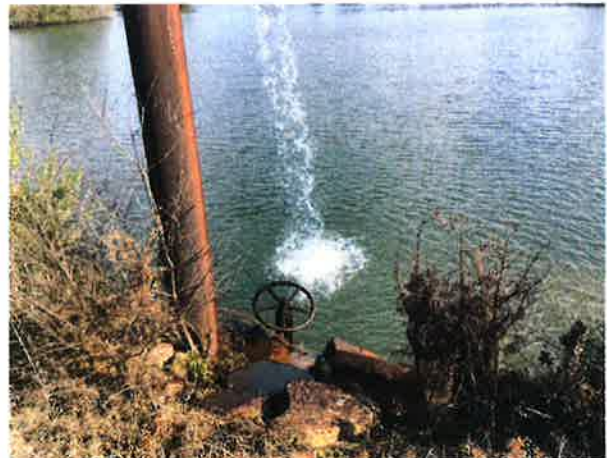
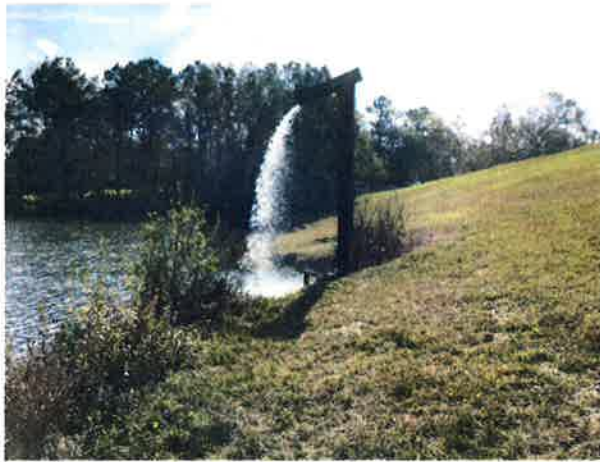
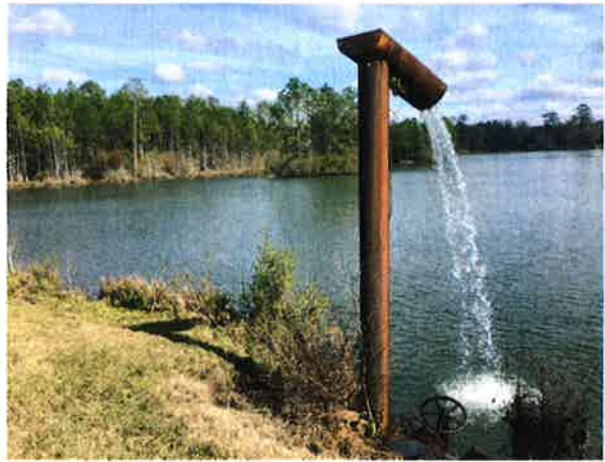
<b>Spillway Classification:</b>	Primary
<b>Spillway Type:</b>	Uncontrolled
<b>Spillway Description:</b>	14-inch diameter steel riser pipe with a half-pipe discharge chute.
<b>Crest Description:</b>	The top of the riser pipe and discharge chute appears satisfactory.
<b>Stilling Basin:</b>	None
<b>End Sill:</b>	None
<b>Approach Channel:</b>	None
<b>Discharge Channel:</b>	None. The spillway discharges directly into Cormorant Lake.
<b>Gates and Operations:</b>	None
<b>Spillway Drains:</b>	None
<b>Comments:</b>	No additional comments.

*No deficiencies identified*

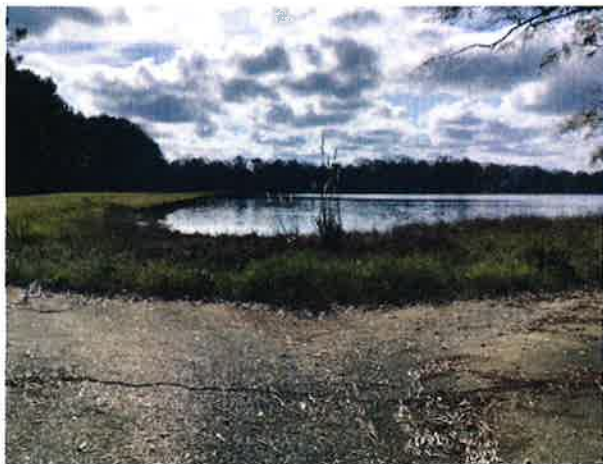
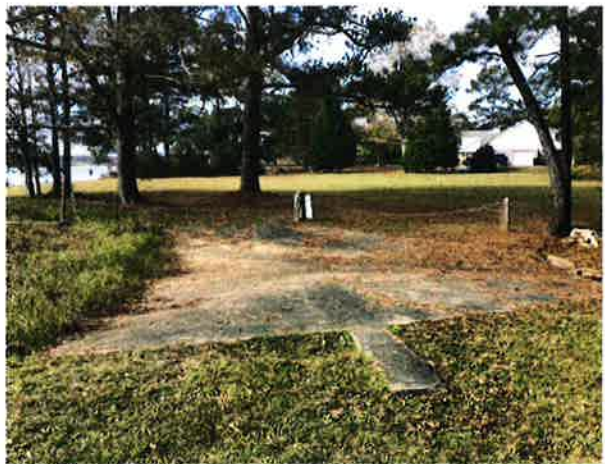
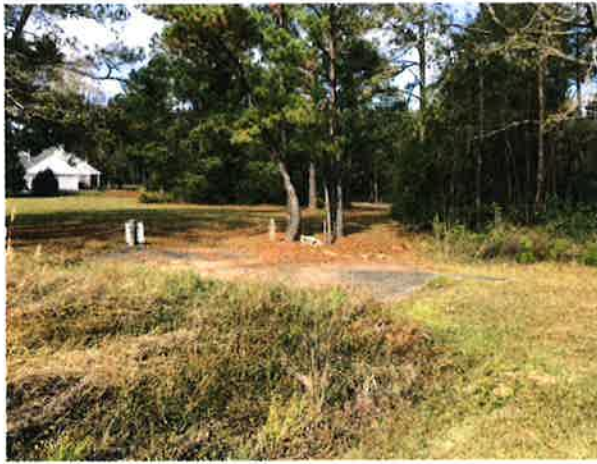
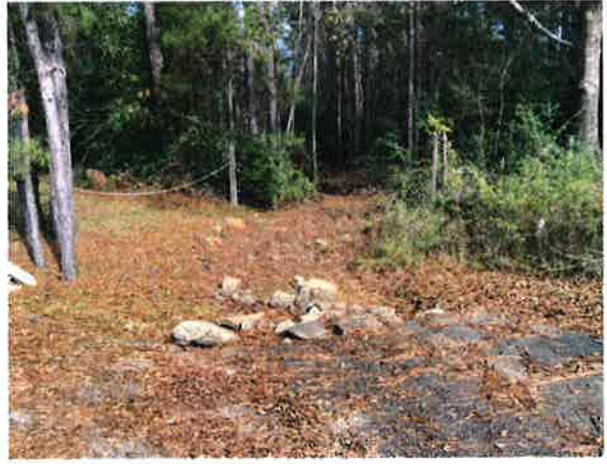
**Spillway Classification:** Auxiliary  
**Spillway Type:** Uncontrolled  
**Spillway Description:** 35-foot wide concrete broad crested weir.  
**Crest Description:** Concrete broad crested weir.  
**Stilling Basin:** None  
**End Sill:** None  
**Approach Channel:** None  
**Discharge Channel:** Earthen swale that flows into Cormorant Lake  
**Gates and Operations:** None  
**Spillway Drains:** None  
**Comments:** No additional comments.

*No deficiencies identified*

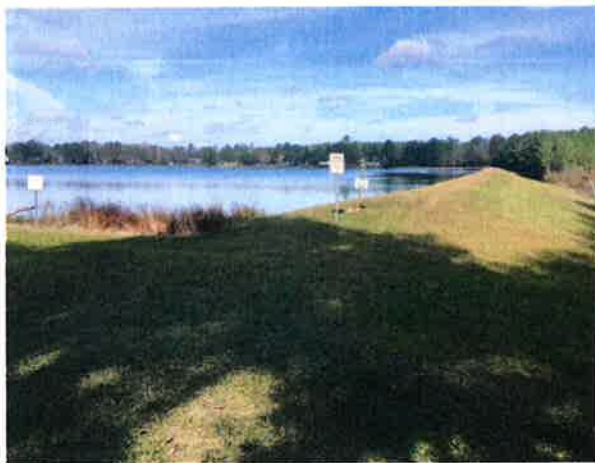
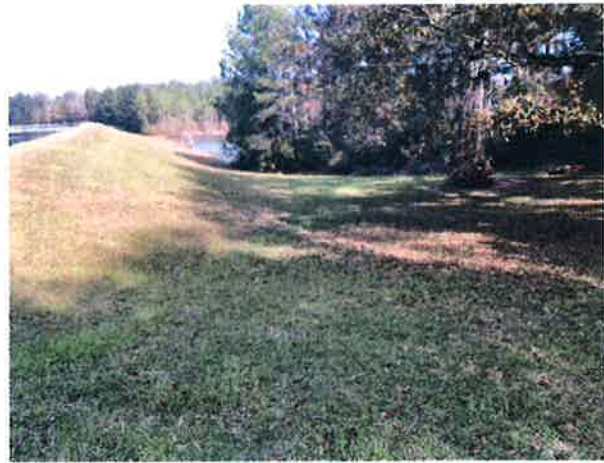
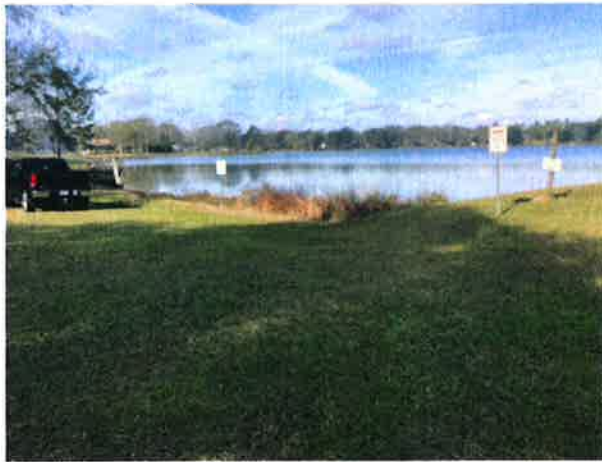
**Spillway Classification:** Auxiliary  
**Spillway Type:** Uncontrolled  
**Spillway Description:** 30-foot wide earthen broad crested weir  
**Crest Description:** Earthen broad crested weir  
**Stilling Basin:** None  
**End Sill:** None.  
**Approach Channel:** None  
**Discharge Channel:** Earthen swale that discharges into Cormorant Lake.  
**Gates and Operations:** None  
**Spillway Drains:** None  
**Comments:** No additional comments.

*No deficiencies identified*

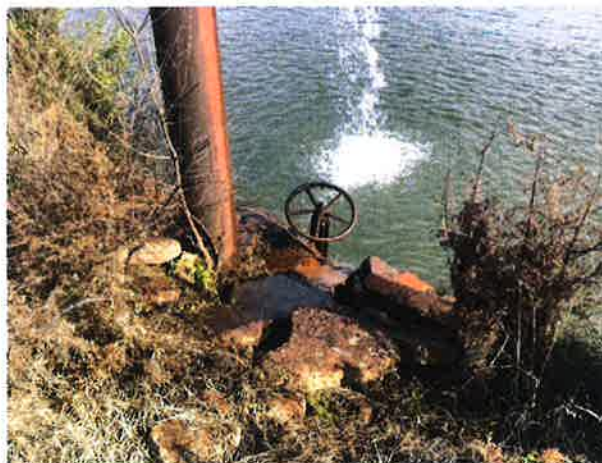
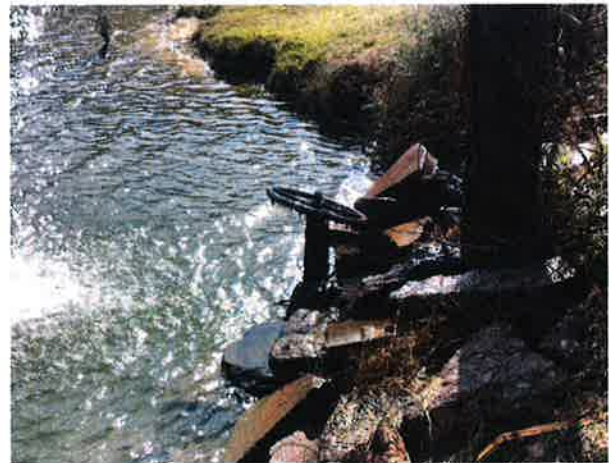
The valve appears operational.

*No deficiencies identified*

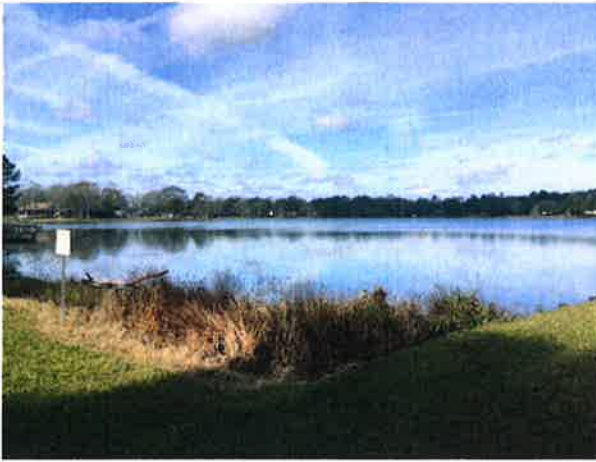
Reservoir Photo 1

The reservoir slopes appear to be in satisfactory condition and fulfilling their intended purpose.

The reservoir banks appear to be in satisfactory condition and fulfilling their intended purpose.

There were no visible areas of sedimentation occurring within the reservoir at the time of the inspection.
