Re: **Egret Pond Dam**  
**Dam Inspection Report**  
NID ID No.: LA00399  
St. Tammany Parish

# LADOTD DAM INSPECTION AND EVALUATION REPORT

Inspection Date: 12/15/2021

Name of Dam: Egret Pond  
Downstream Hazard: Low  
NID ID #: LA00399  
Parish: St. Tammany  
DOTD District: 62  
District Contact: Jennifer Branton, P.E.

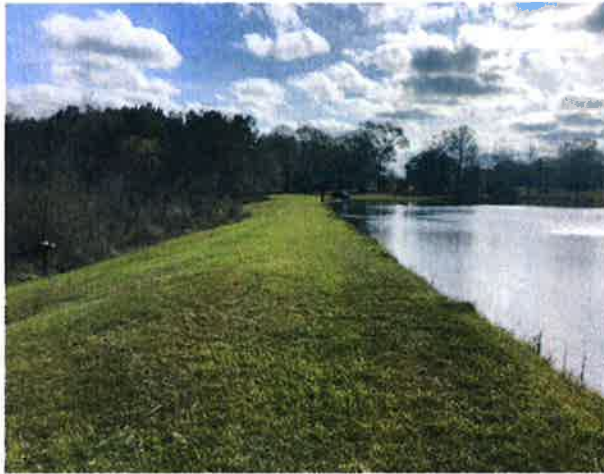
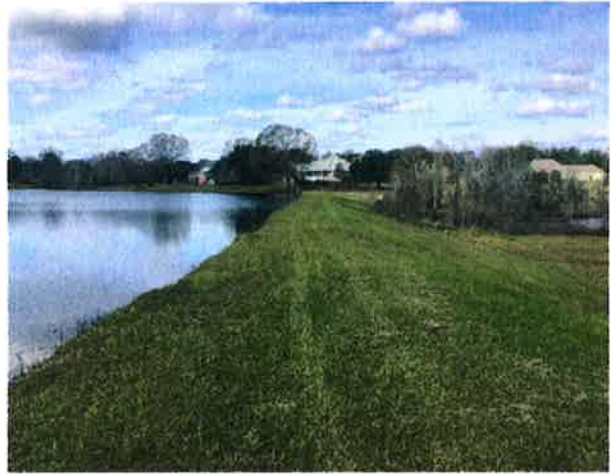
<b>Crown Width (Ft.):</b>	13
<b>Crown Length (Ft.):</b>	525
<b>Crown Description:</b>	Earthen crown with grass coverage
<b>Fence:</b>	None
<b>Abutment:</b>	Both abutments appear to be in fair condition
<b>Comments:</b>	No additional comments

*No deficiencies identified*

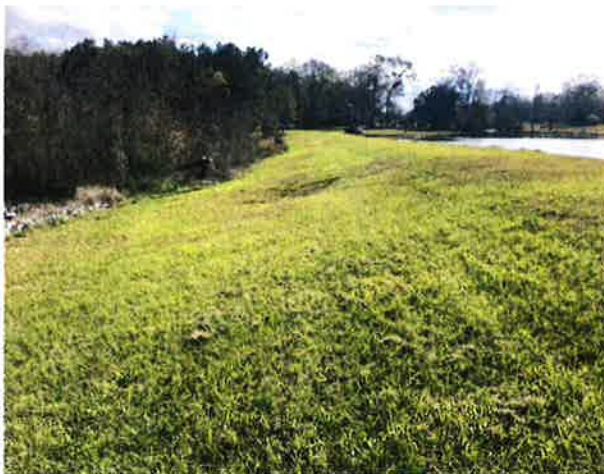
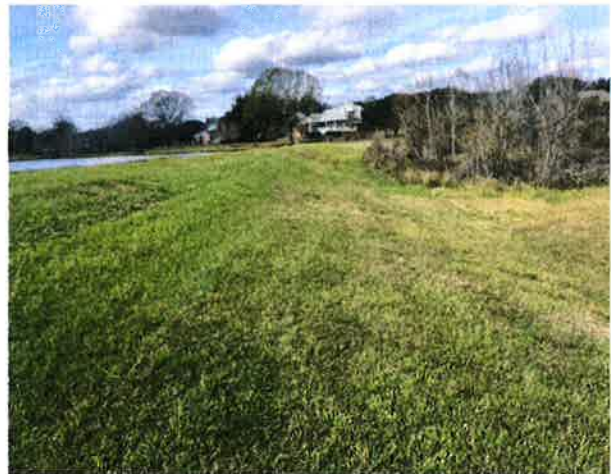
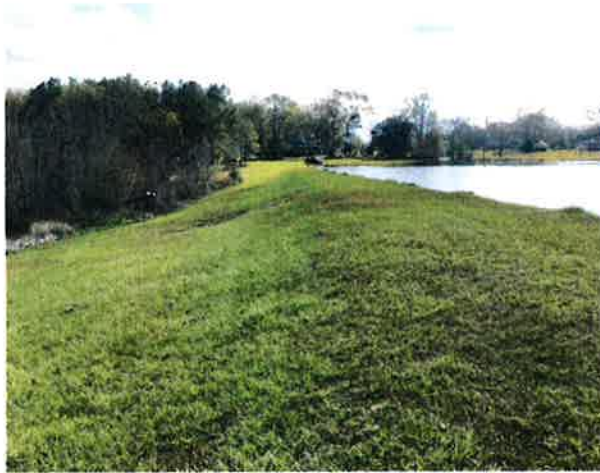
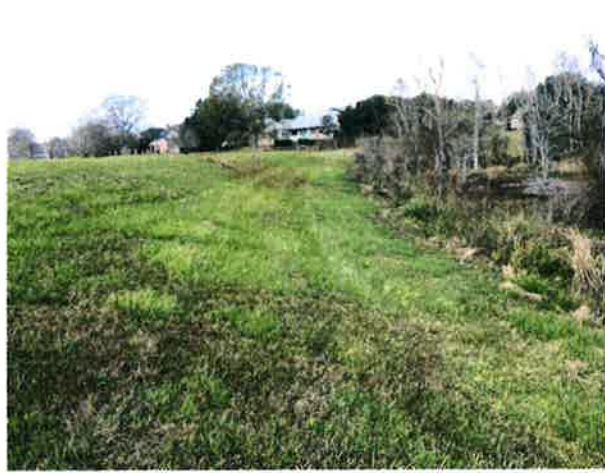
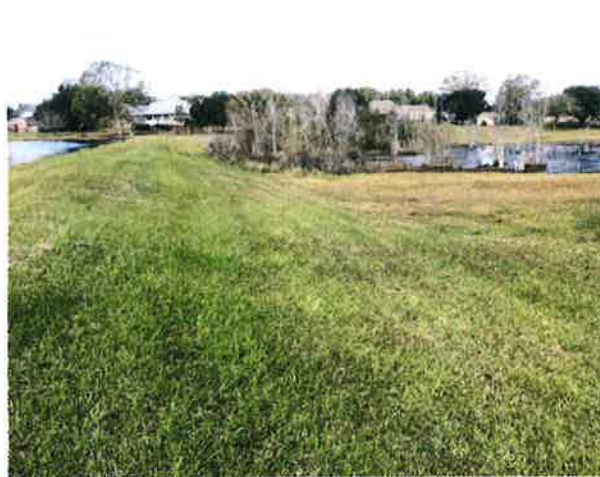
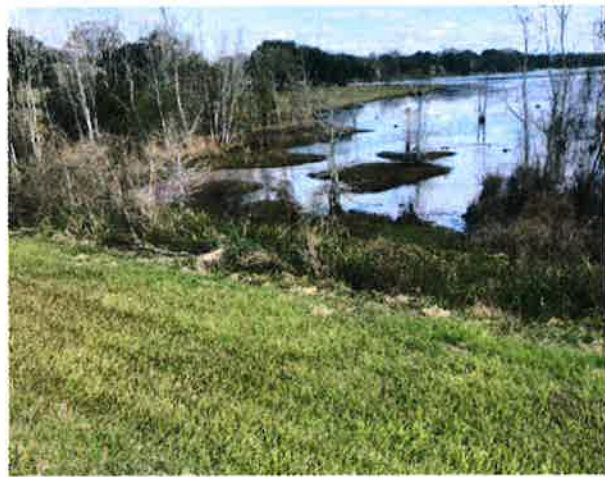
<b>Embankment Description:</b>	Earthen embankment with grass coverage.
<b>Embankment Slope:</b>	4H: 1V
<b>Berm Description:</b>	None
<b>Berm Slope:</b>	None
<b>Toe Area:</b>	The area at the downstream toe is Crane Lake.
<b>Comments:</b>	No additional comments.

*No deficiencies identified*

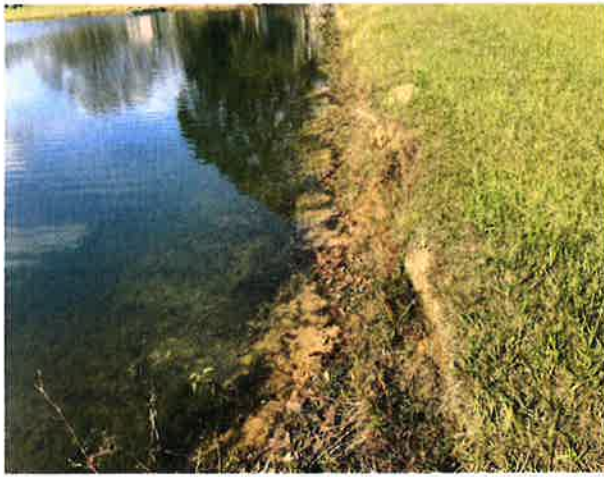
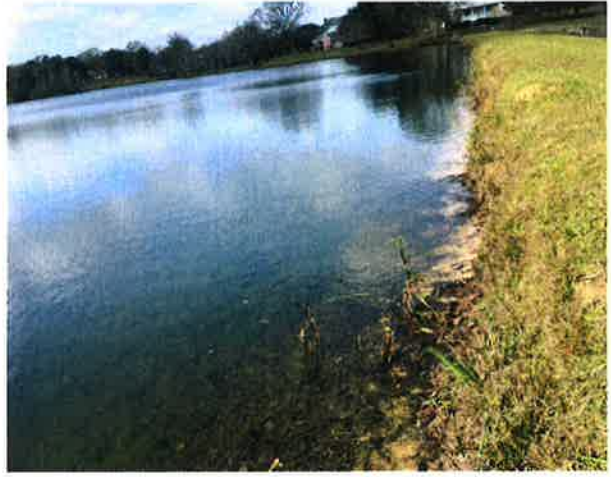
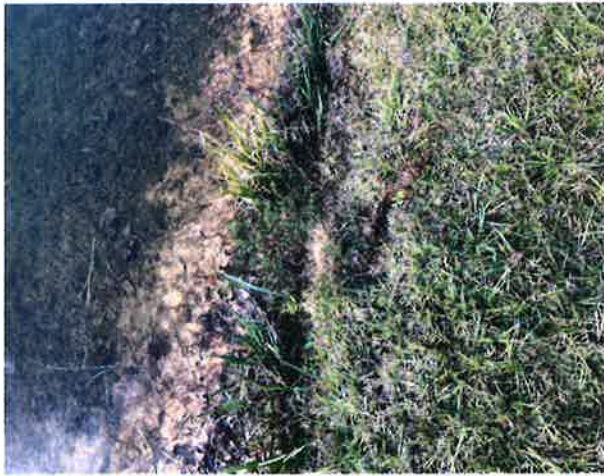
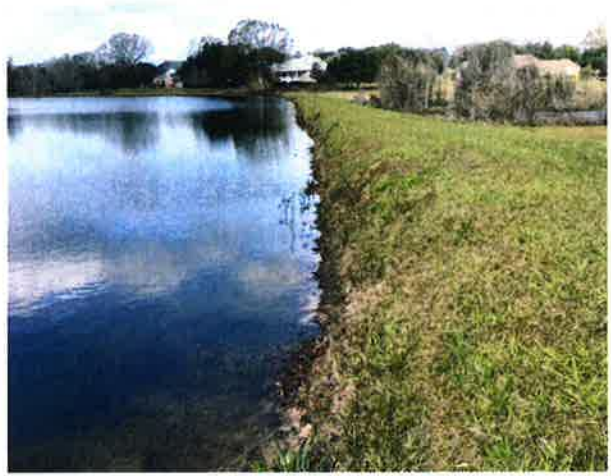
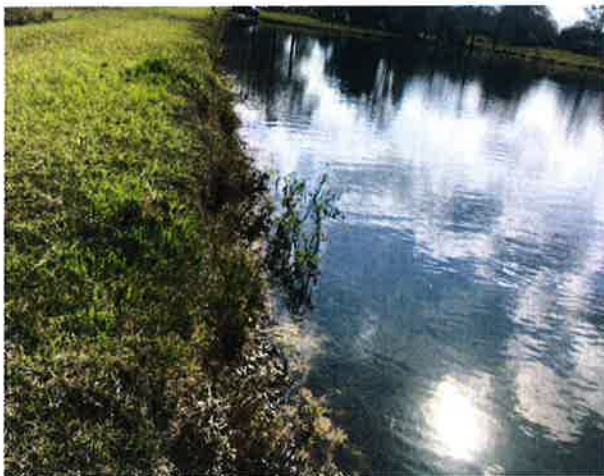
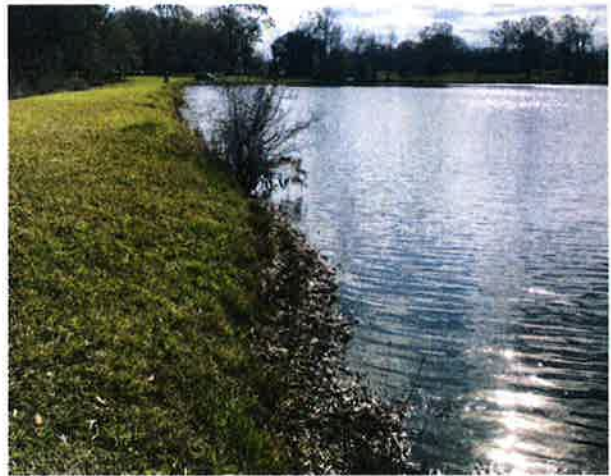
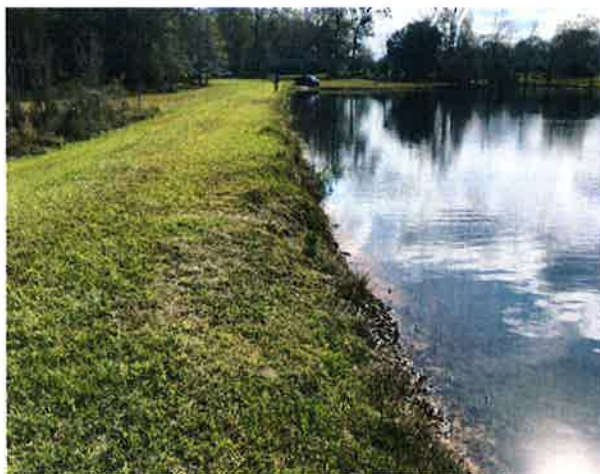
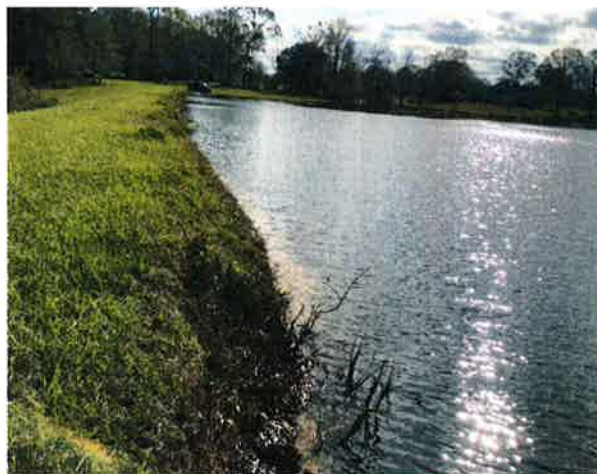
**Embankment Description:** Earthen embankment with grass coverage.  
**Embankment Slope:** Varies due to wave erosion.  
**Protection Type:** None  
**Comments:** The neighborhood is contemplating installing a plastic bulkhead to prevent further wave erosion.  
**Deficiencies (1):**

Type	Description	Corrective Action
Wave Induced Erosion (Minor)	Minor wave induced erosion generally < 6 - 12 in. deep.	Backfill area to original geometry and stabilize bank to prevent further erosion. Consider armoring with riprap, soil cement or other appropriate methods. Monitor area for further deterioration.

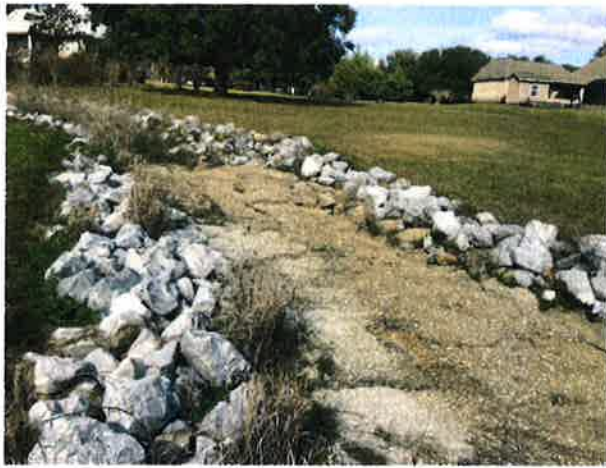
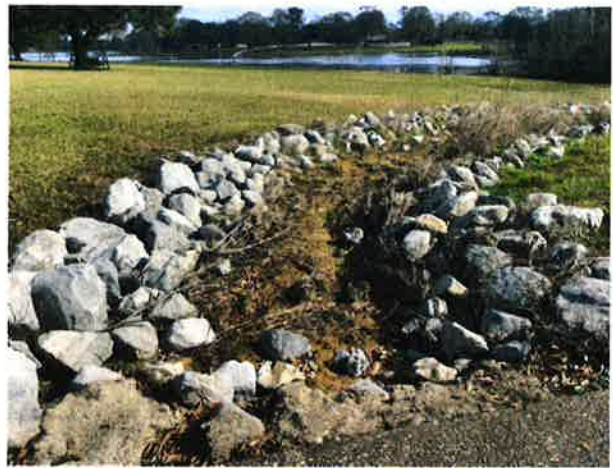
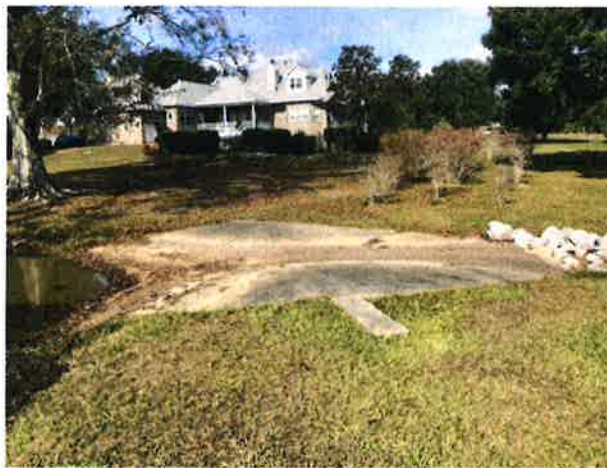
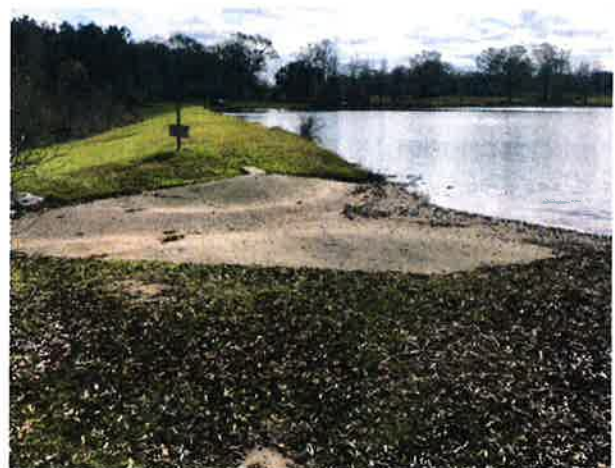
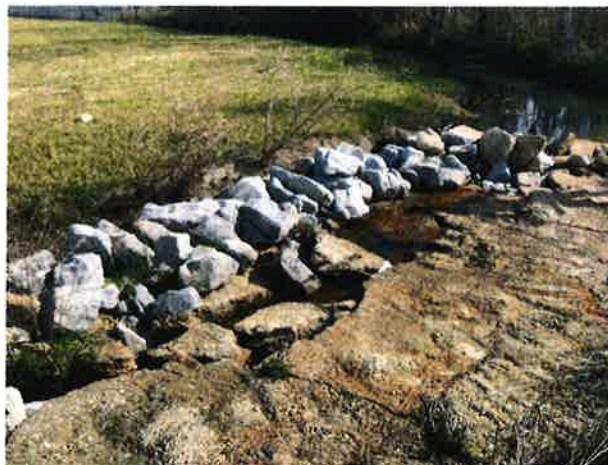
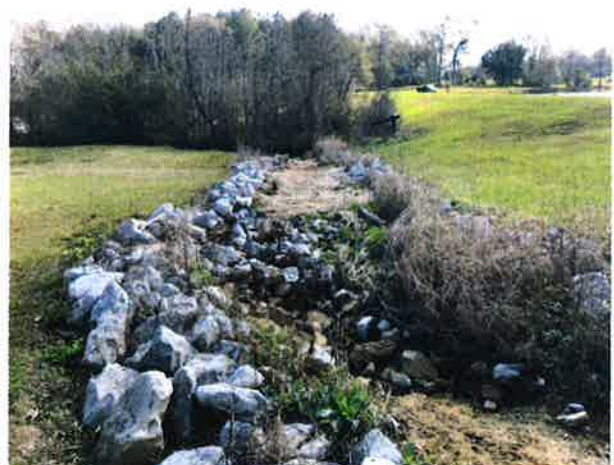
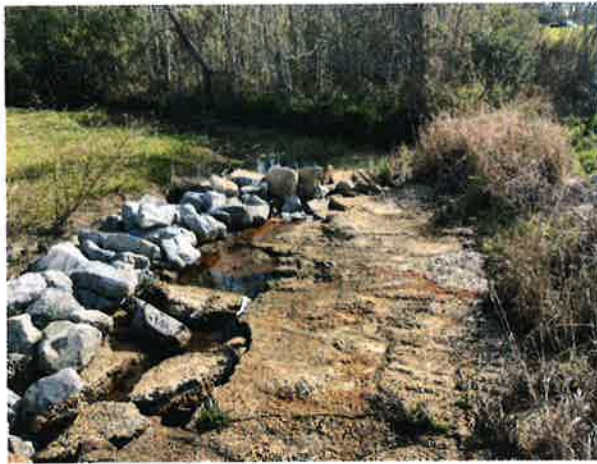
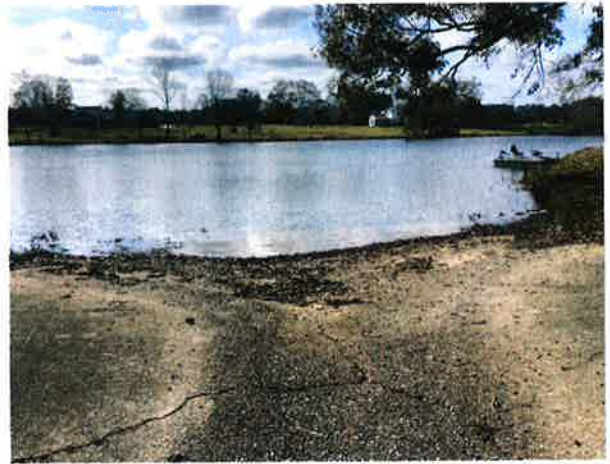
**Comments:** Concrete was poured in the discharge channel downstream of the riprap; there is evidence that the discharge flows beneath the concrete in the channel, as the slab is being undermined.

Type	Description	Corrective Action
Riprap - Displaced/Missing/Ineffective	Riprap for erosion control is missing and/or deteriorated allowing erosion to occur.	Replace missing riprap with appropriately sized riprap to the original design geometry.

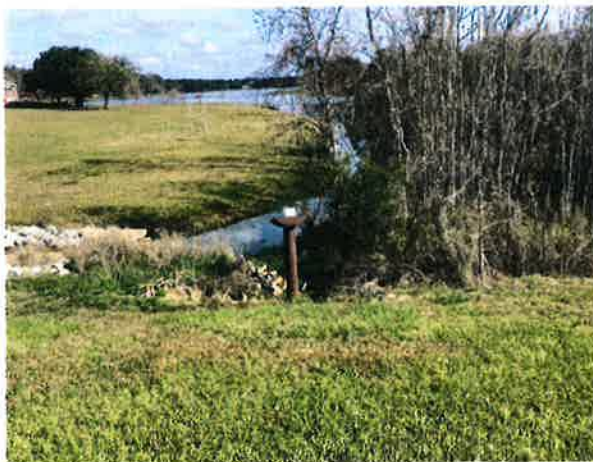
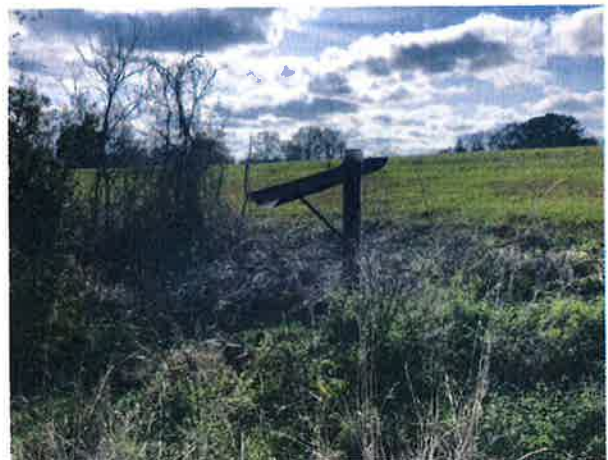
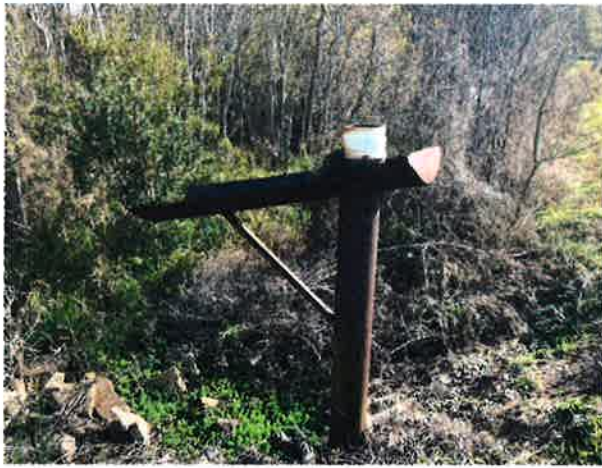
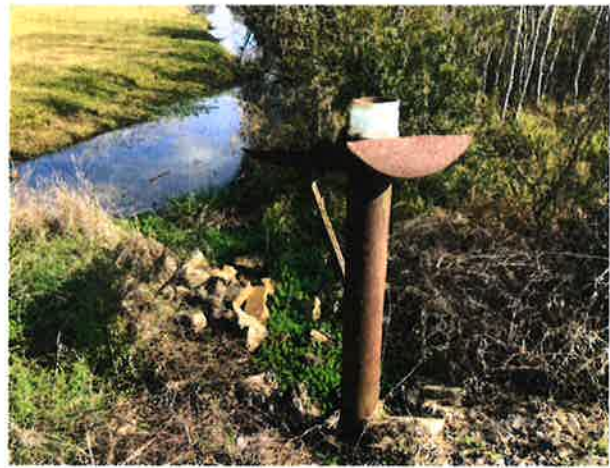
**Spillway Classification:** Primary  
**Spillway Type:** Uncontrolled  
**Spillway Description:** 8-inch diameter steel riser pipe with a half-pipe discharge chute.  
**Crest Description:** The top of the riser pipe and the discharge chute appear satisfactory.  
**Stilling Basin:** None  
**End Sill:** None  
**Approach Channel:** None  
**Discharge Channel:** None. The pipe discharges directly into Crane Lake.  
**Gates and Operations:** None  
**Spillway Drains:** None  
**Comments:** A PVC sleeve was installed on the riser pipe to increase the lake elevation.

*No deficiencies identified*

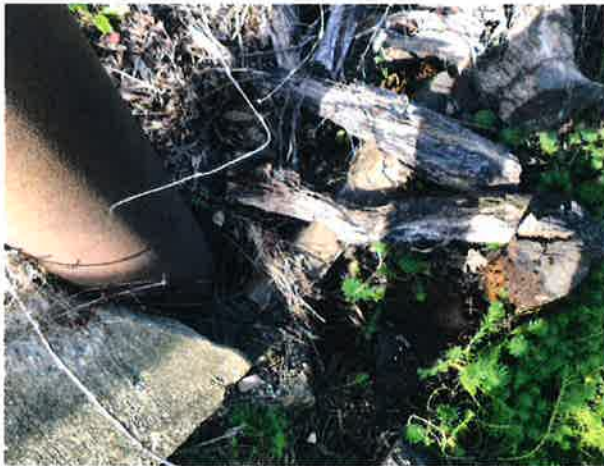
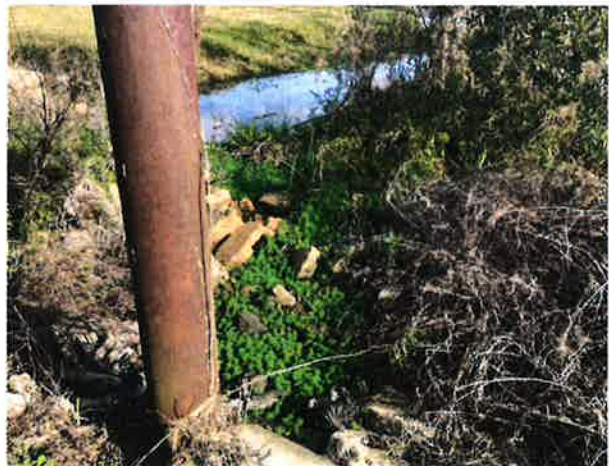
<b>Type and Description:</b>	An 8-inch diameter steel pipe and gate valve are located at the base of the riser pipe.
<b>Intake Structure:</b>	The upstream end of the riser pipe was submerged.
<b>Outlet Channel:</b>	None, discharges directly into the downstream Crane Lake.
<b>Gates and Related Devices:</b>	The gate valve was buried in riprap during the inspection.
<b>Comments:</b>	Valve is buried, should be uncovered for use.

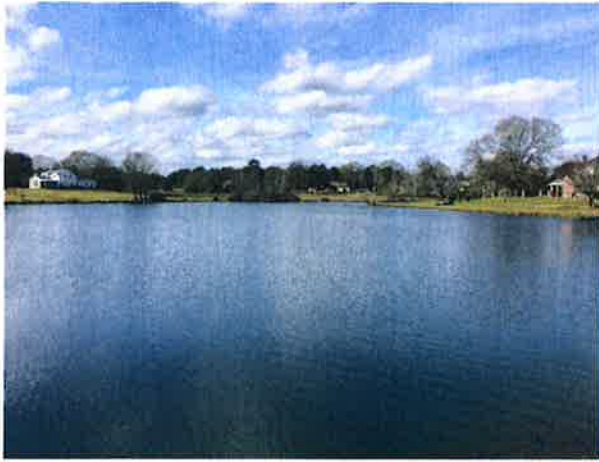
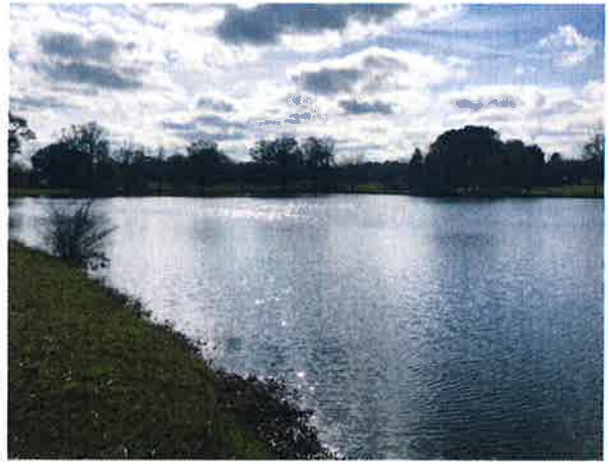
The reservoir slopes appear to be in satisfactory condition and fulfilling their intended purpose.

The reservoir banks appear to be in satisfactory condition and fulfilling their intended purpose.

There were no visible areas of sedimentation occurring within the reservoir at the time of the inspection.
