Re: **Heron Lake Dam**  
**Dam Inspection Report**  
NID ID No.: LA00396  
St. Tammany Parish

# LADOTD DAM INSPECTION AND EVALUATION REPORT

Inspection Date: 12/15/2021

Name of Dam: Heron Lake  
Downstream Hazard: Low  
NID ID #: LA00396  
Parish: St. Tammany  
DOTD District: 62  
District Contact: Jennifer Branton, P.E.

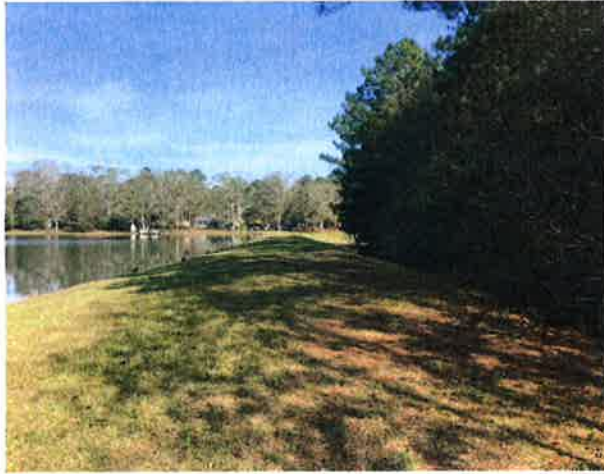
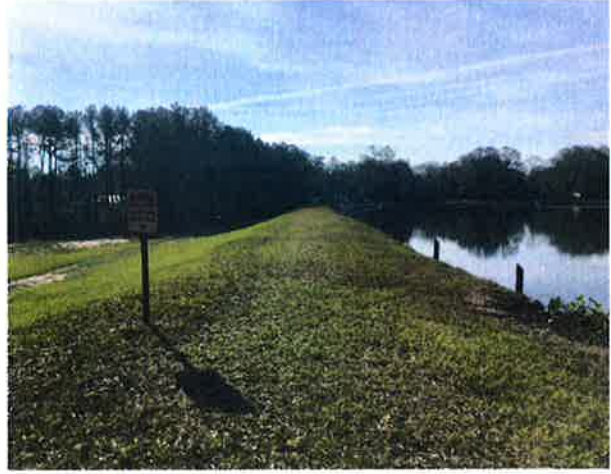
<b>Crown Width (Ft.):</b>	14
<b>Crown Length (Ft.):</b>	760
<b>Crown Description:</b>	Earthen crown with grass coverage
<b>Fence:</b>	None
<b>Abutment:</b>	Both abutments appear satisfactory.
<b>Comments:</b>	No additional comments.

*No deficiencies identified*

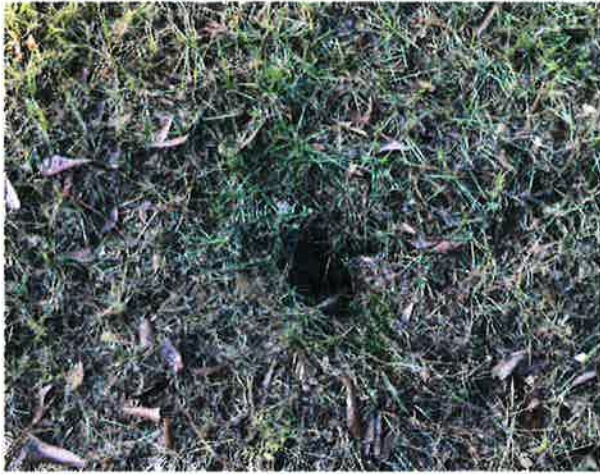
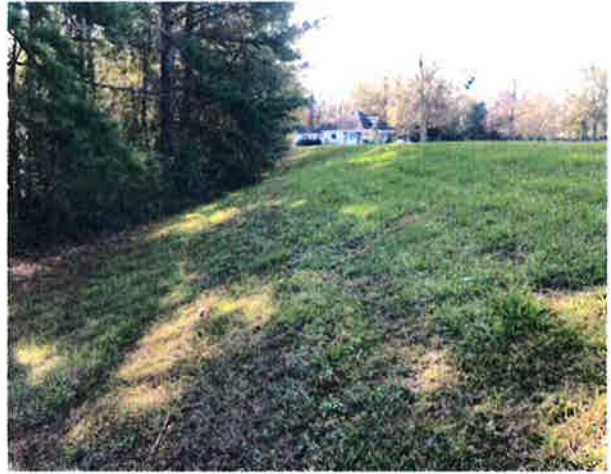
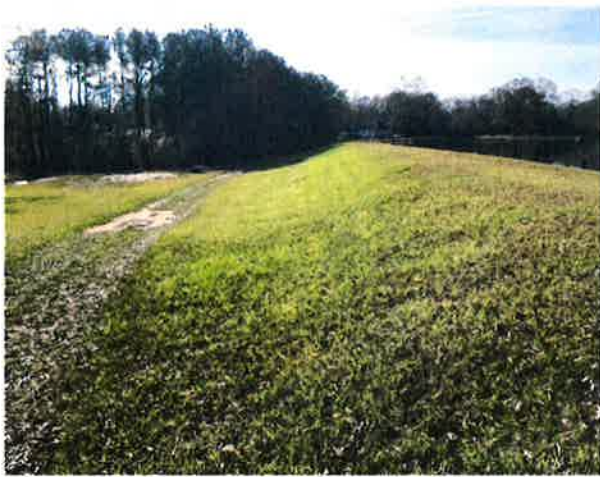
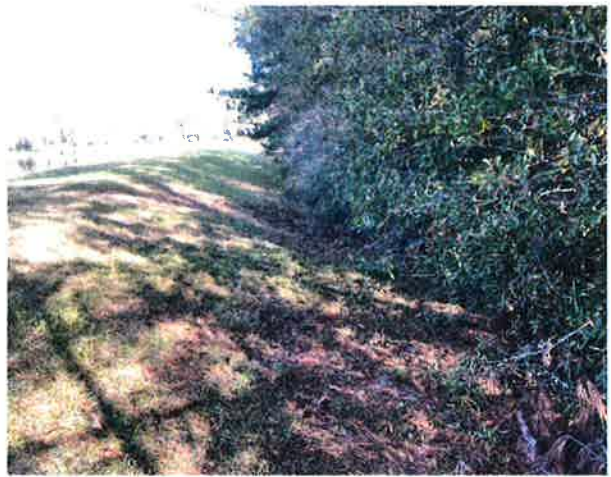
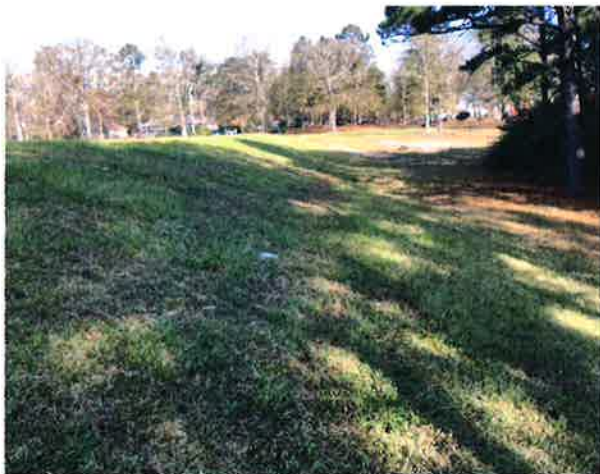
Type	Description	Corrective Action
Animal Burrows	Animal burrows are present which may lead to seepage or slope stability problems, and they require immediate attention.	Excavate, inspect, backfill, compact in lifts and re-establish sod cover. Establish/improve animal abatement program.

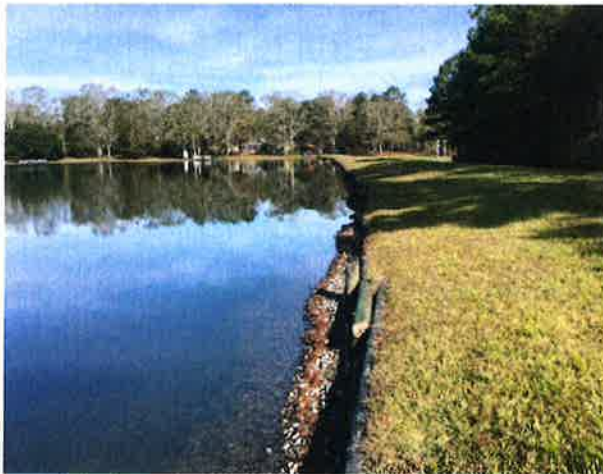
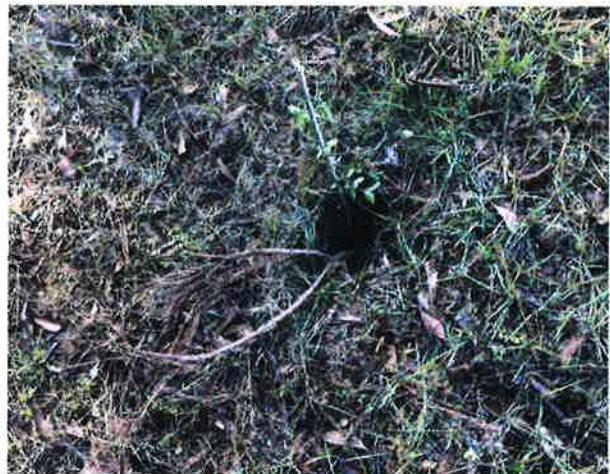
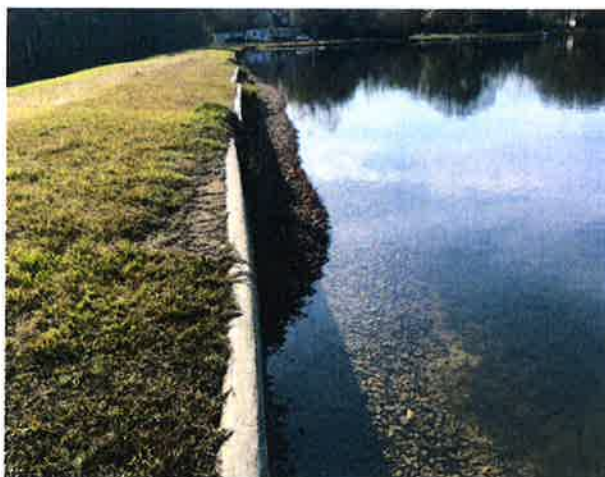
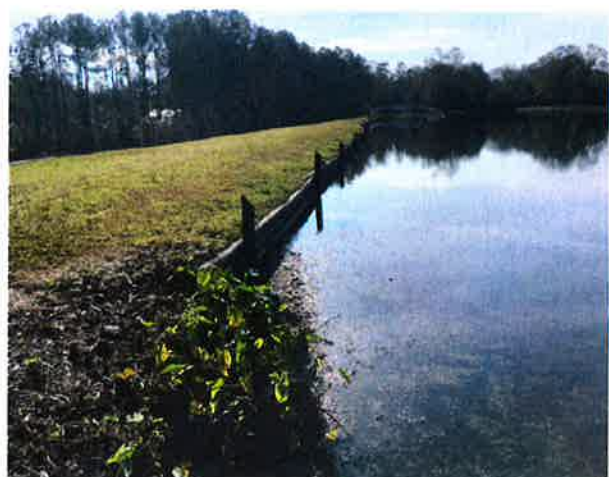
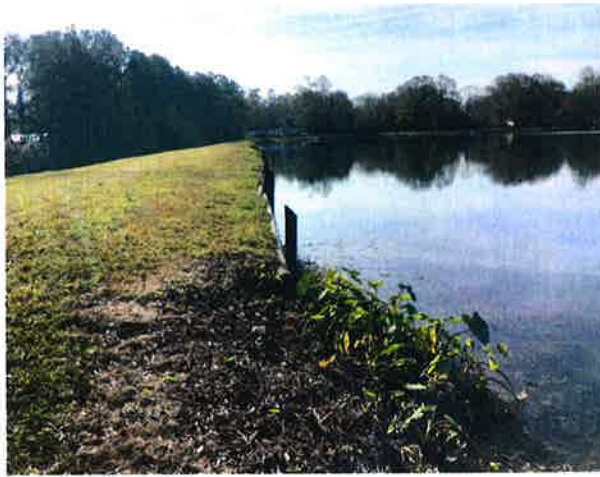
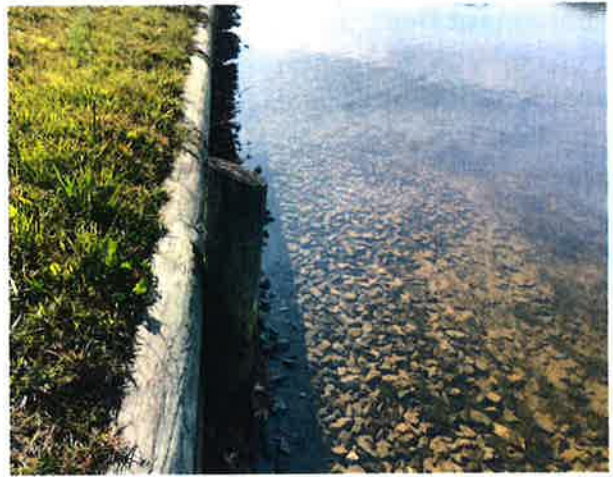
Type	Description	Corrective Action
Animal Burrows	Animal burrows are present which may lead to seepage or slope stability problems, and they require immediate attention.	Excavate, inspect, backfill, compact in lifts and re-establish sod cover. Establish/improve animal abatement program.

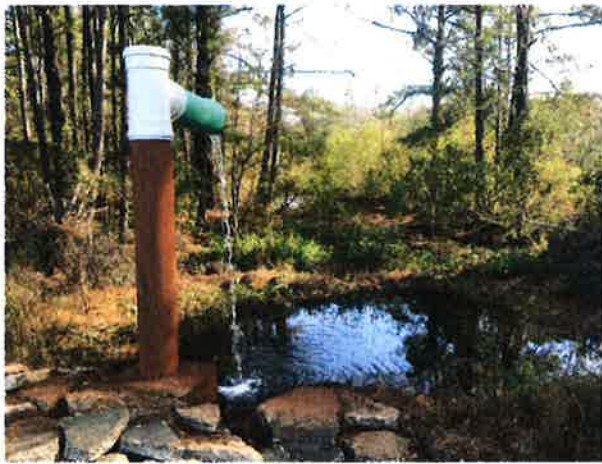
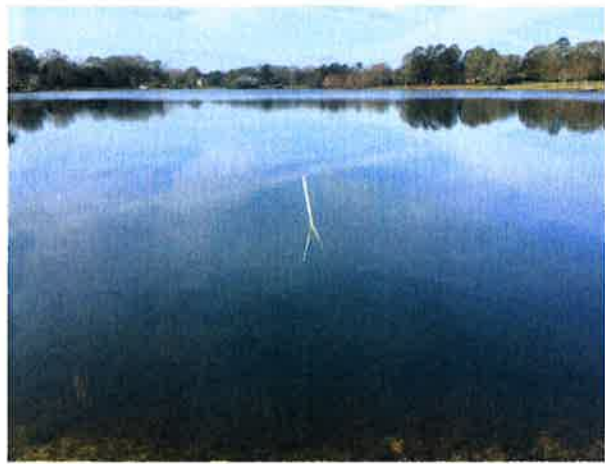
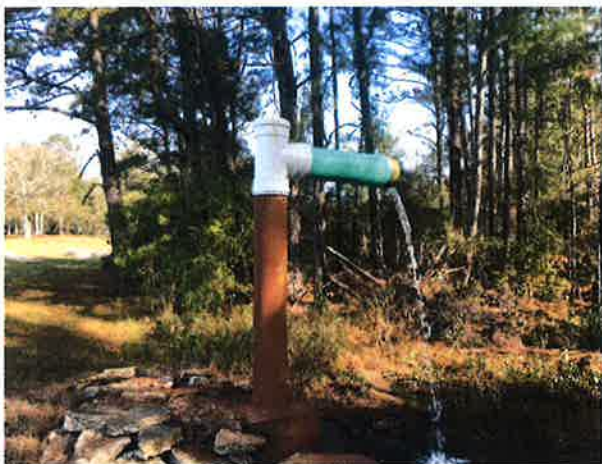
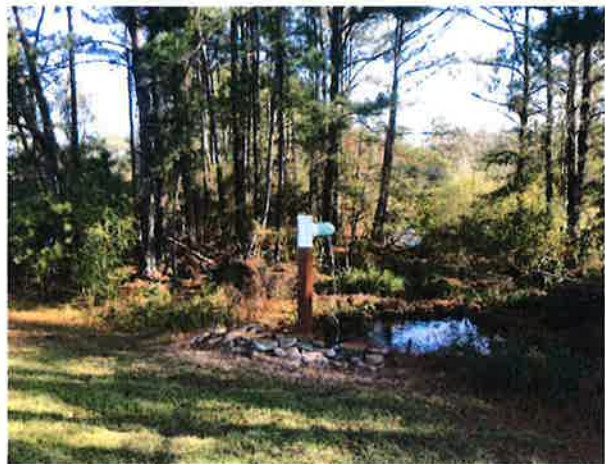
<b>Spillway Classification:</b>	Primary
<b>Spillway Type:</b>	Uncontrolled
<b>Spillway Description:</b>	8-inch diameter steel pipe that runs through the embankment and is connected to a 12-inch diameter PVC riser pipe with a half-pipe chute discharge.
<b>Crest Description:</b>	The top of the riser pipe and the discharge chute appear adequate.
<b>Stilling Basin:</b>	None
<b>End Sill:</b>	None
<b>Approach Channel:</b>	None
<b>Discharge Channel:</b>	None. The pipe discharges directly into Cormorant Lake.
<b>Gates and Operations:</b>	None
<b>Spillway Drains:</b>	None
<b>Comments:</b>	The riser pipe portion has been replaced with a 12-inch PVC pipe and discharge chute.

*No deficiencies identified*

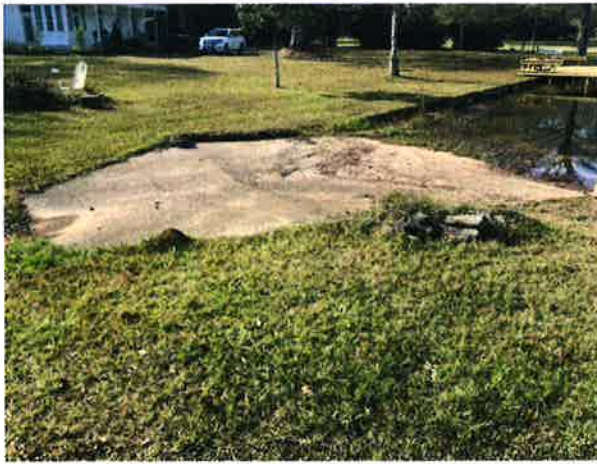
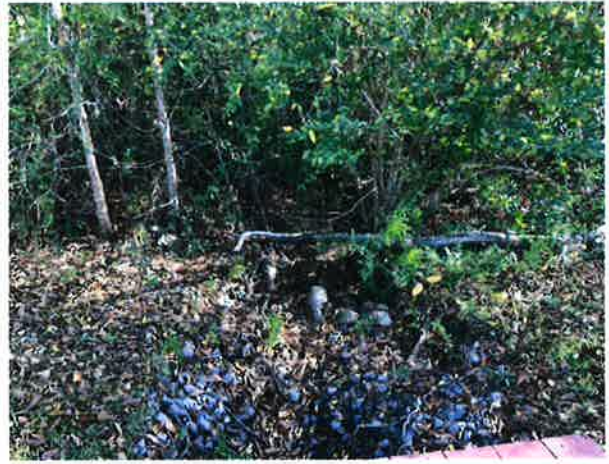
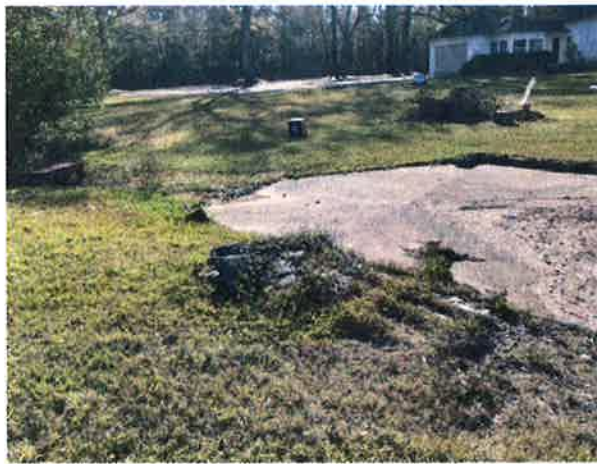
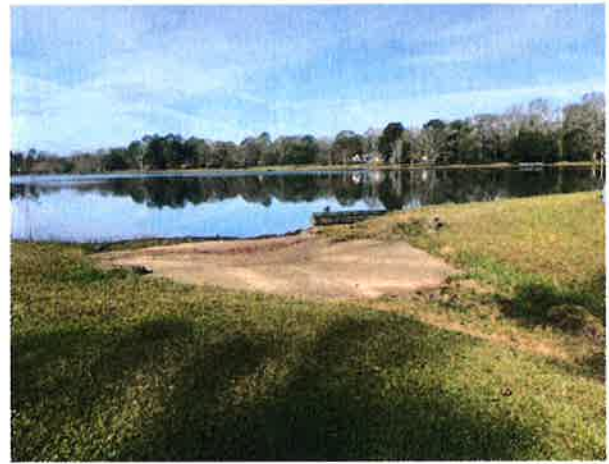
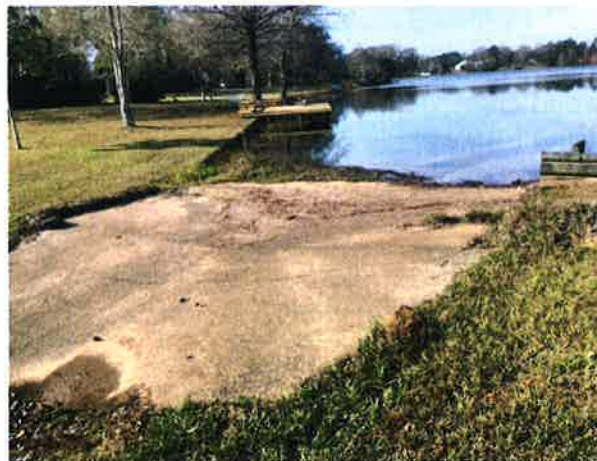
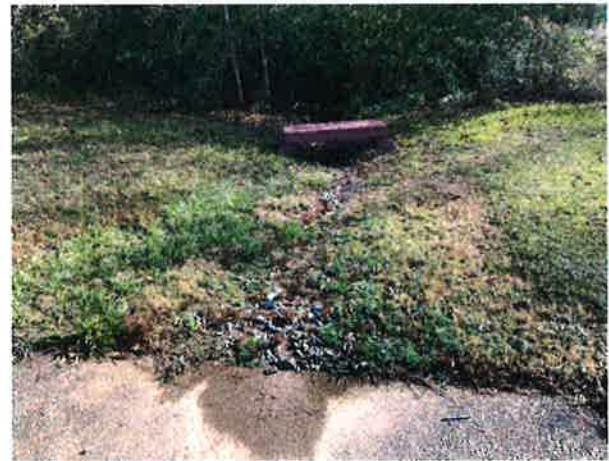
**Spillway Classification:** Auxiliary  
**Spillway Type:** Uncontrolled  
**Spillway Description:** 20-foot wide concrete broad crested weir  
**Crest Description:** The concrete broad crested weir appears  
**Stilling Basin:** None  
**End Sill:** None  
**Approach Channel:** None  
**Discharge Channel:** Earthen swale that flows into Cormorant Lake.  
**Gates and Operations:** None  
**Spillway Drains:** None  
**Comments:** No additional comments.

*No deficiencies identified*

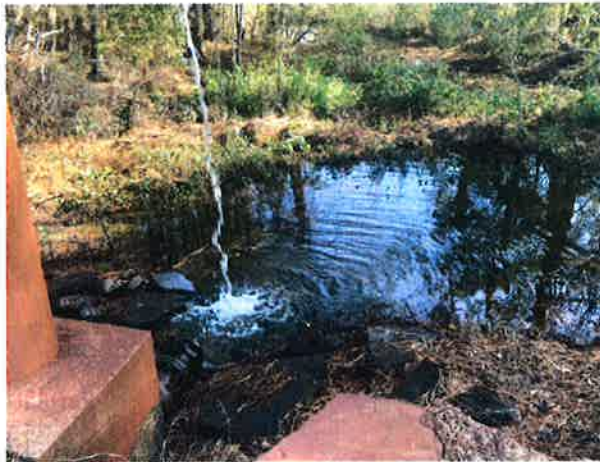
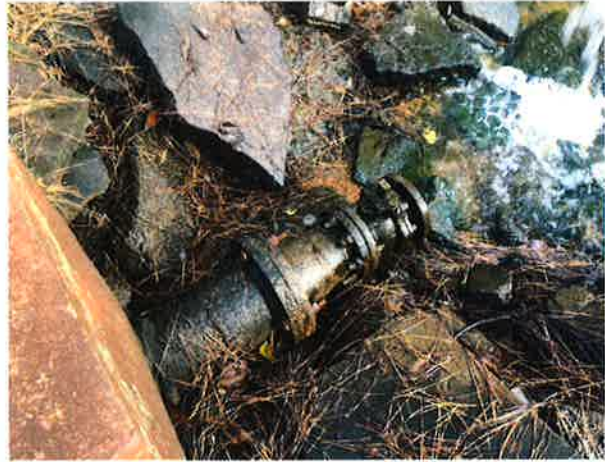
<b>Intake Structure:</b>	The intake is the upstream end of the riser pipe.
<b>Outlet Channel:</b>	The pipe discharges directly into the downstream Cormorant Lake.
<b>Gates and Related Devices:</b>	The gate valve appears functional.
<b>Comments:</b>	No additional comments.

*No deficiencies identified*

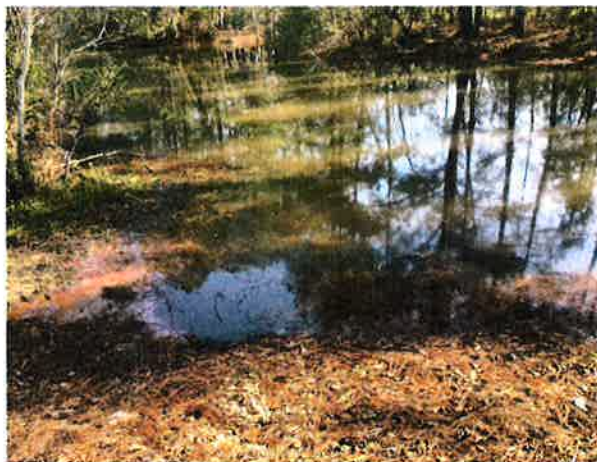
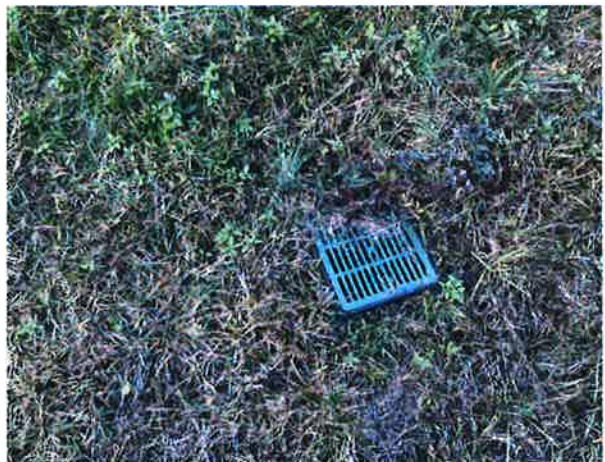
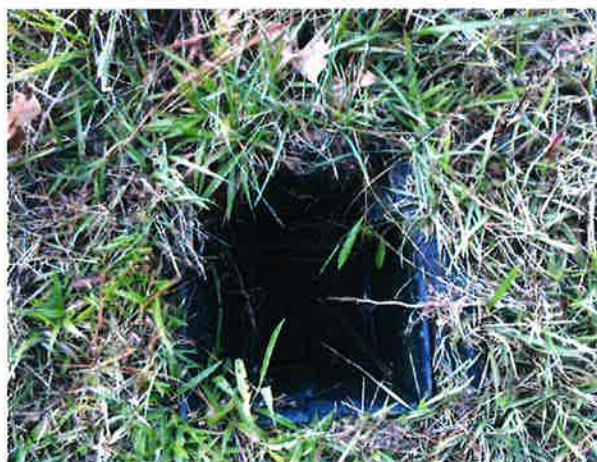
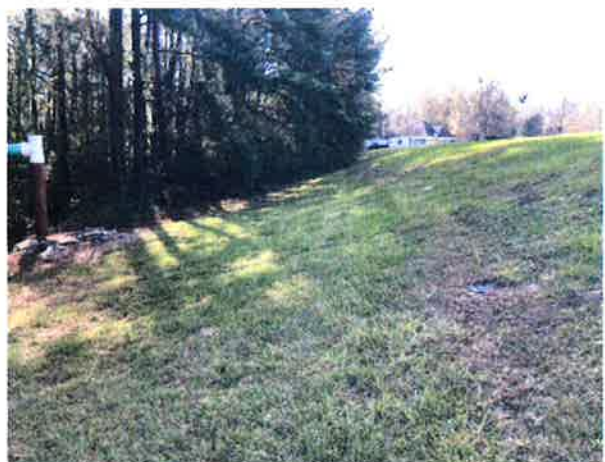
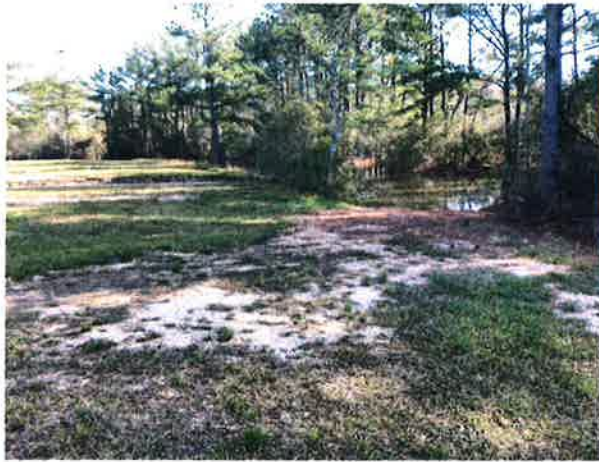
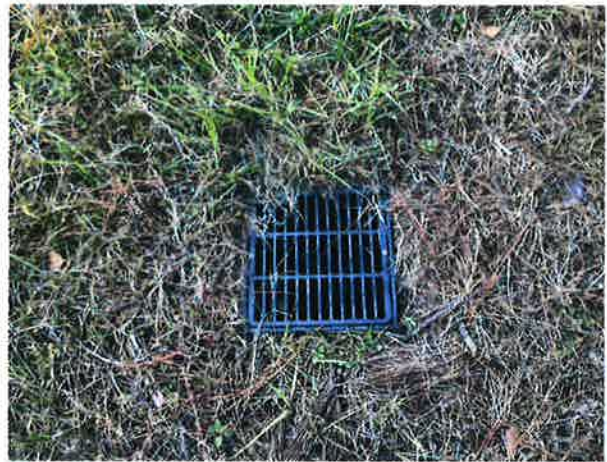
**Name:** French drain  
**Location/Description:** Downstream slope  
**Latitude:** 30.59743  
**Longitude:** -89.96113  
**Comments:** French drain through embankment. It discharges through a 4-inch-diameter corrugated plastic pipe.

*No deficiencies identified*

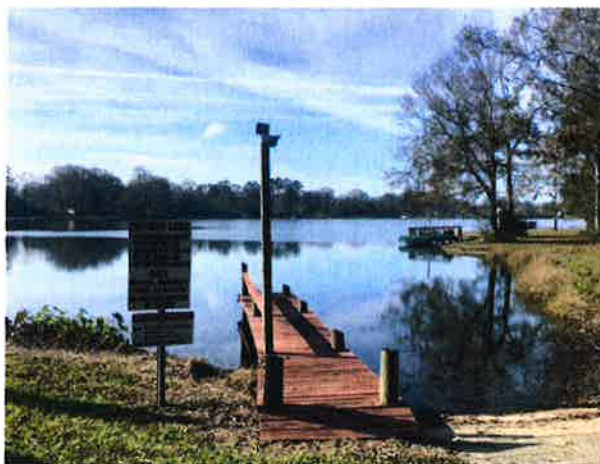
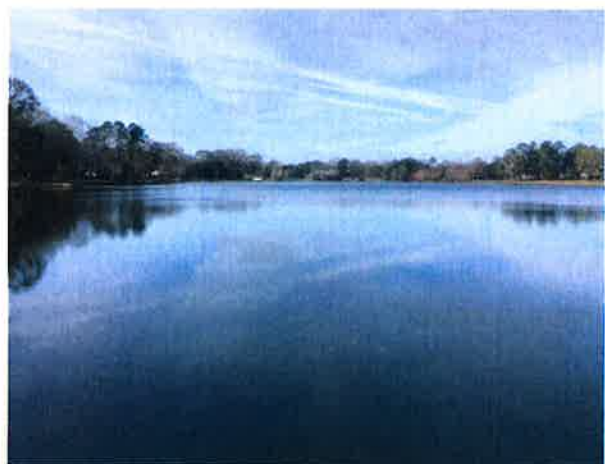
The reservoir slopes appear to be in satisfactory condition and fulfilling their intended purpose.

The reservoir banks appear to be in satisfactory condition and fulfilling their intended purpose.

There were no visible areas of sedimentation occurring within the reservoir at the time of the inspection.
