## **Other Observed Issues**

## **Plans versus Observed Construction**

## **Post Inspection Issues**

## **Rear Elevation Load Bearing Wall** **Family Room**

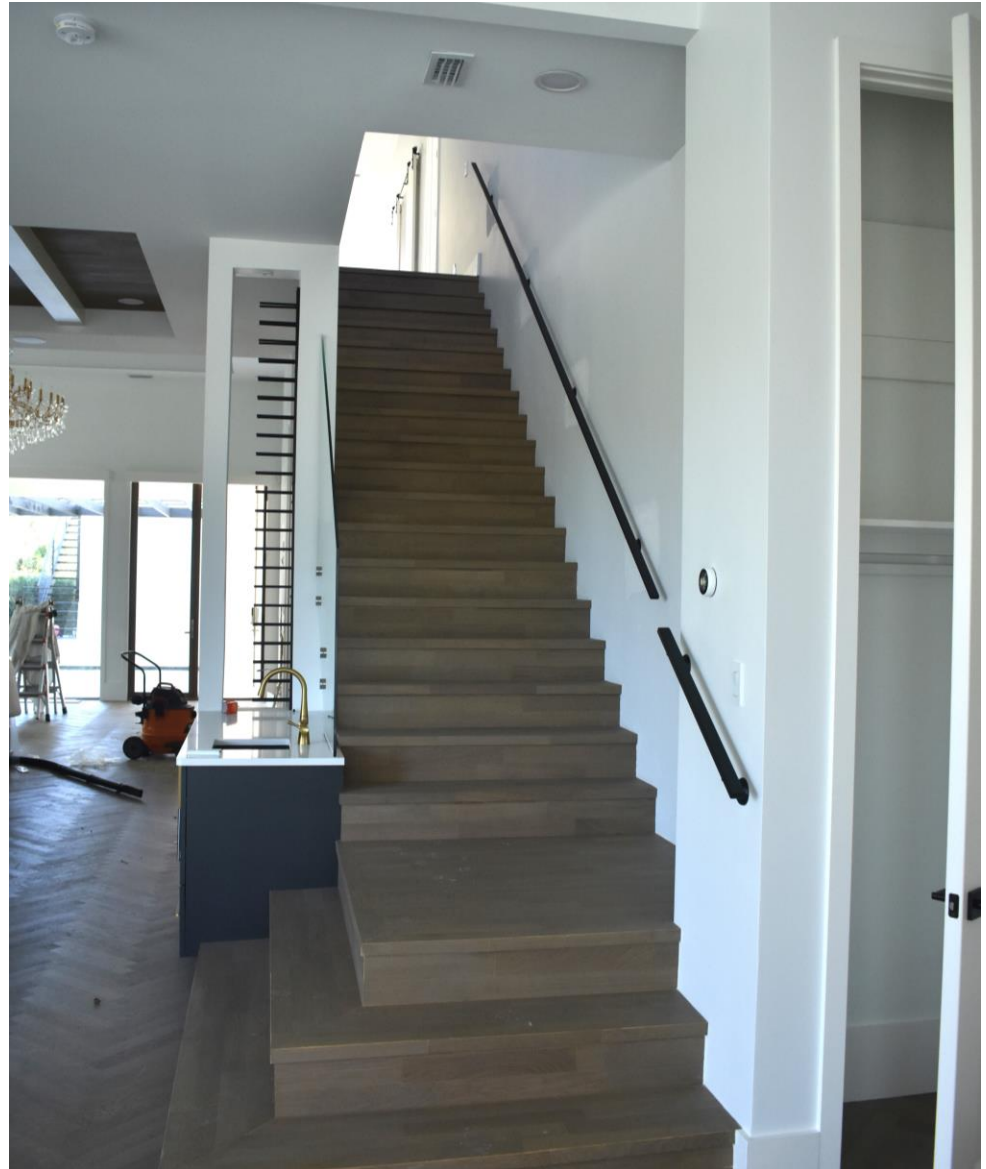
## 2084 Other Observed Issues

**Stairway at the bottom landing was revised to ostensibly allow for better access in two directions.**

**Not shown on the original or as-built drawings.**

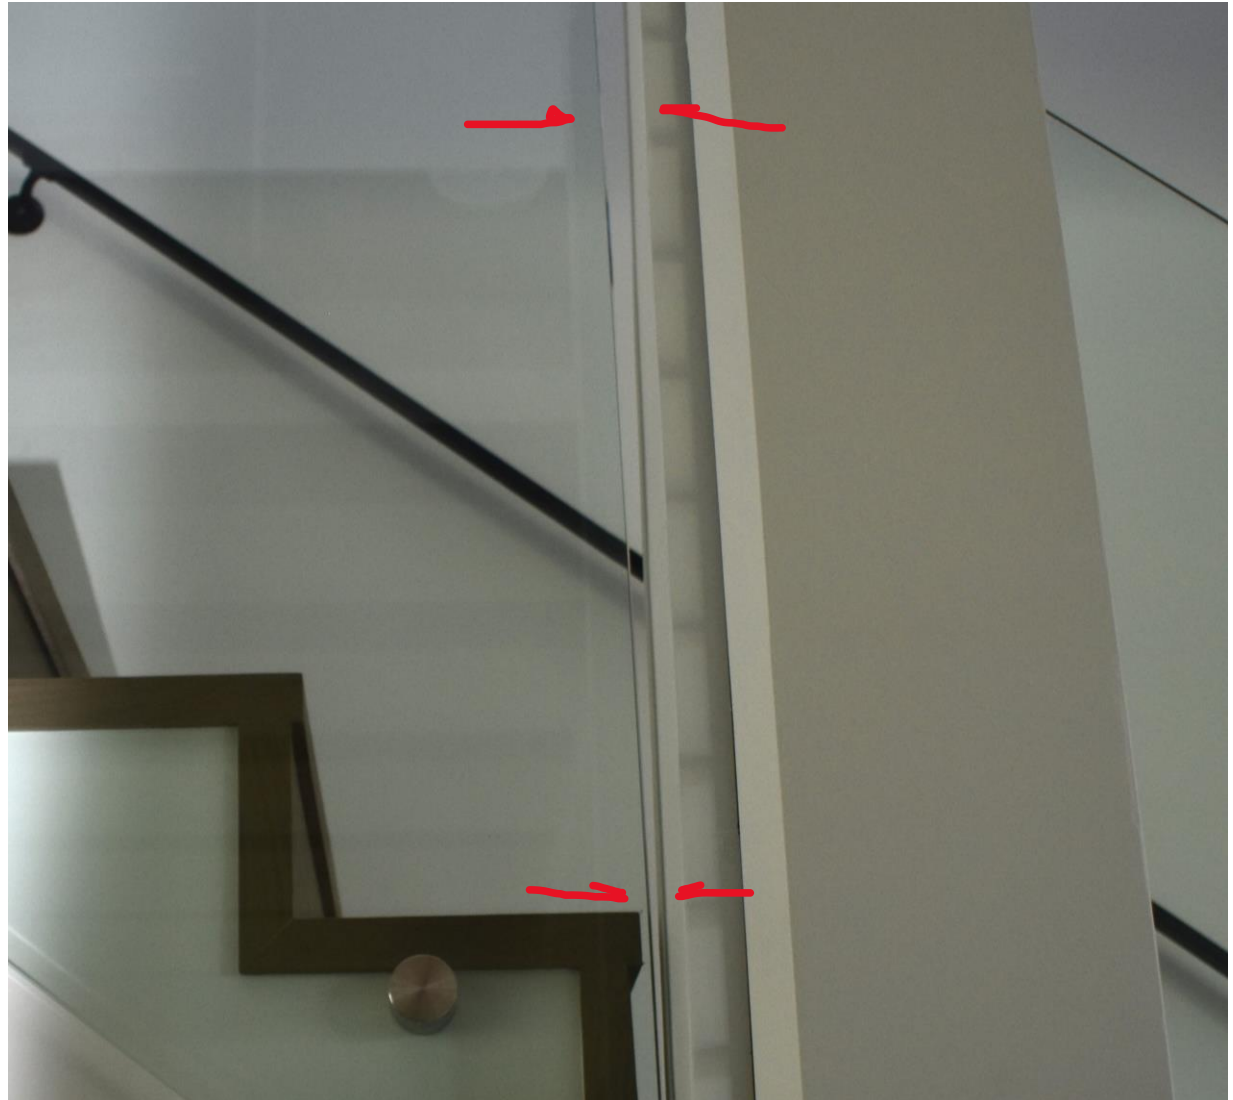
## 2080 Other Observed Issues

Original plans call for a metal handrail, cables and posts.

Glass handrail installed. Installation fit and finish less than desirable.

Note inconsistent gap at intersection with wall.

This was installed with

No Engineering

No Permit changes

No Inspections

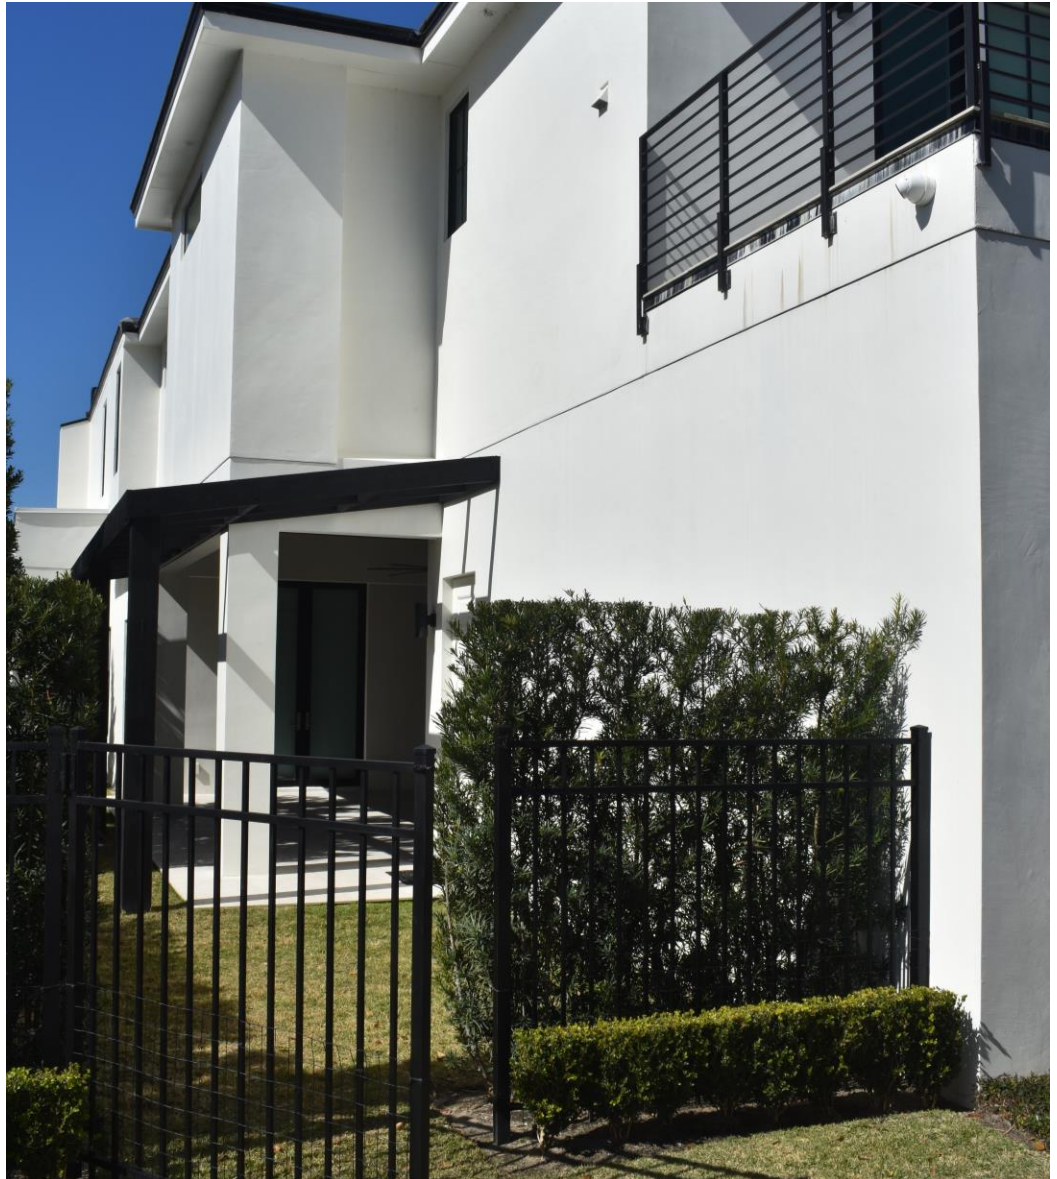
## 2054 Other Observed Issues

**There was no site improvement plan to review in the original or as-built drawings. However, a more substantial fence design is shown on multiple drawings.**

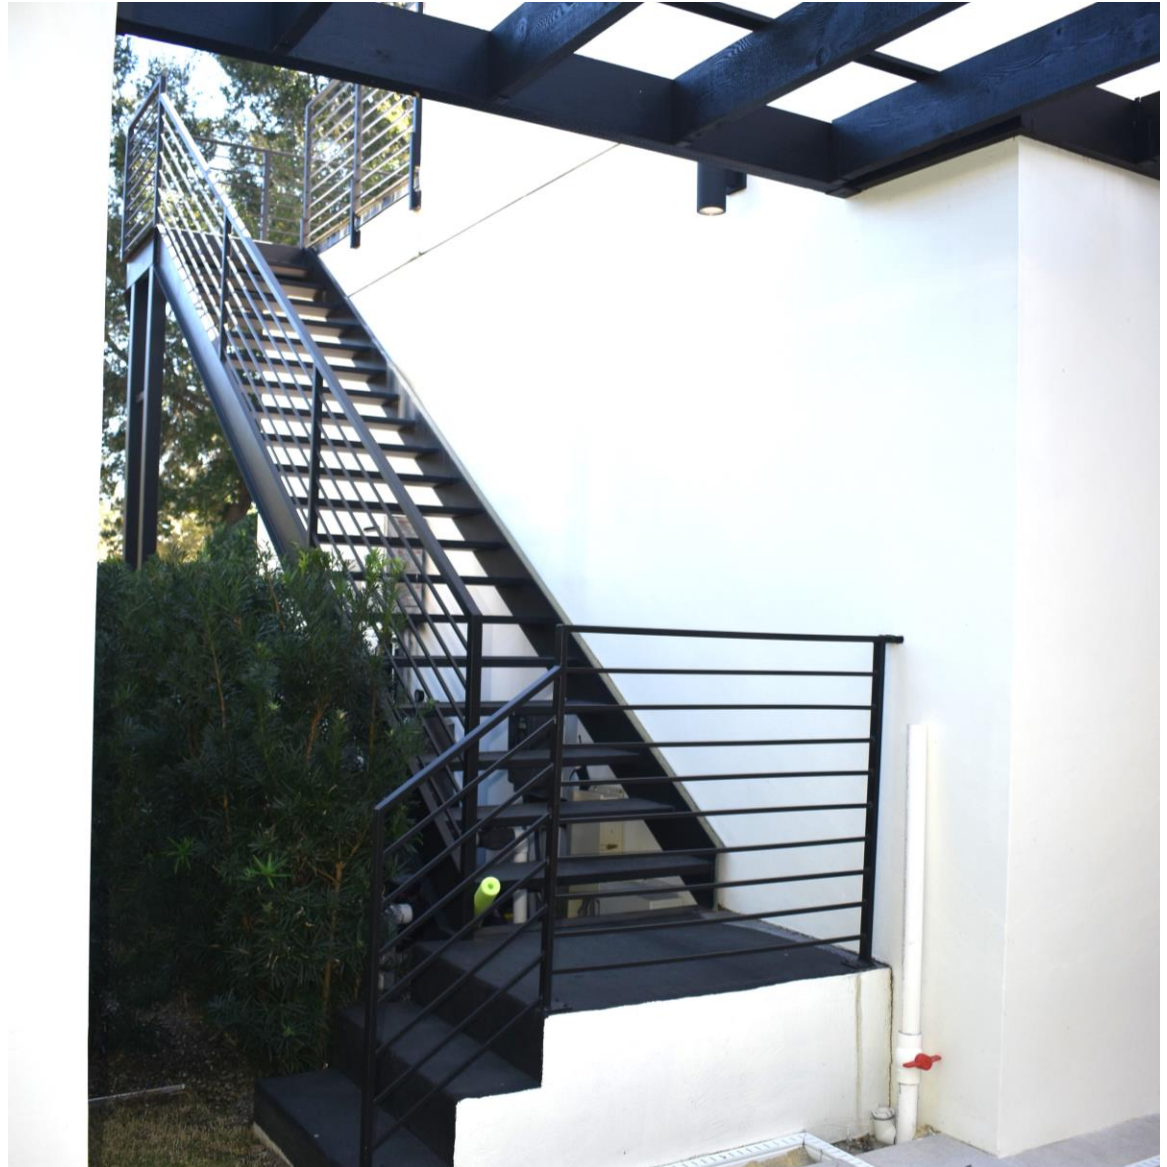
## 2045 Other Observed Issues

This stairway was installed on the opposite wall of the garage as originally intended.

As built drawing notes the relocation but no other useful details are given with respect to attachment to the masonry wall or foundations.

No Engineering

Installed after Certificate of Occupancy issued

Work completed AFTER Closing/Settlement on property

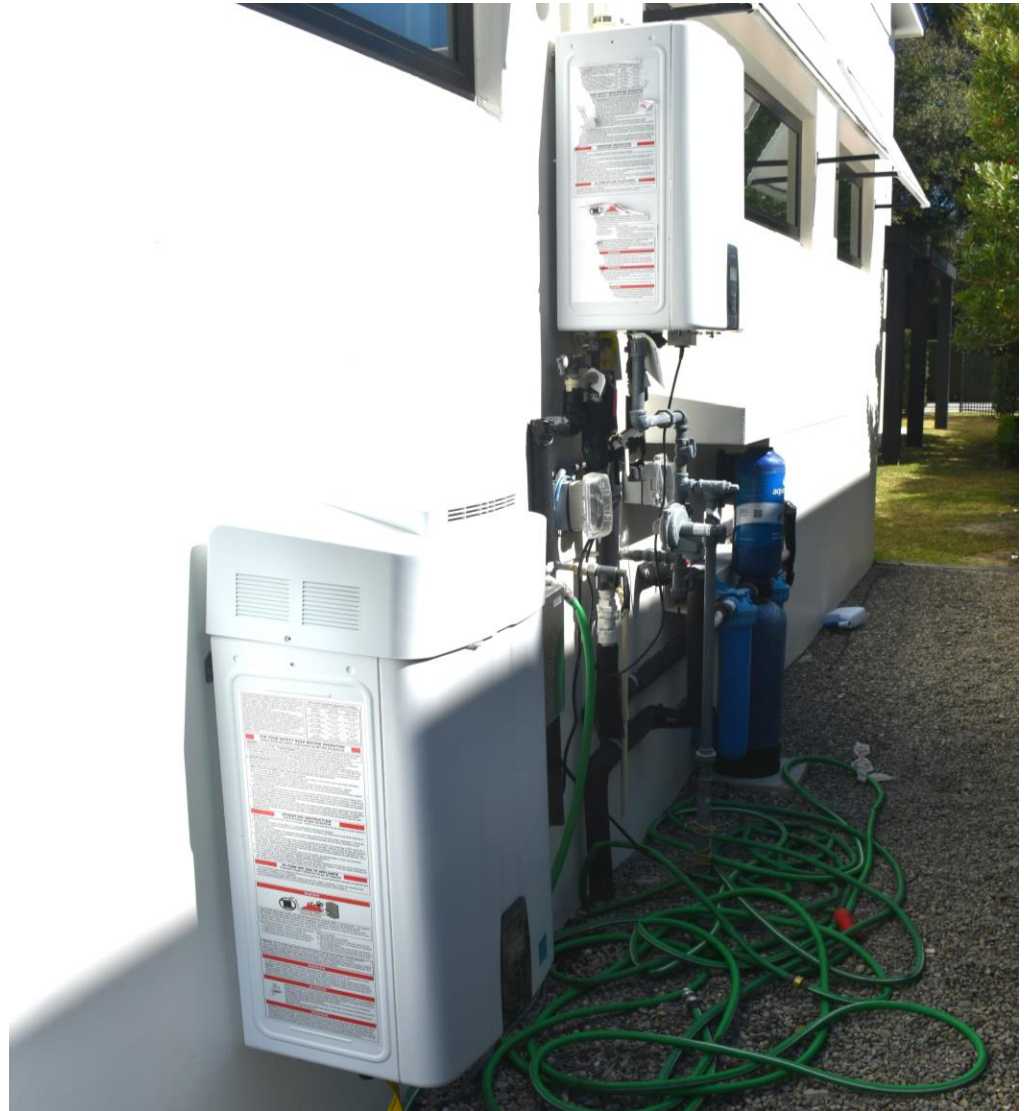
## 2059 Other Observed Issues

Two tankless hot water heaters are noted for installation per Drawing A1.

Only one heater has been plumbed with no tie-in points noted for the second unit.

Typically, when two units are used one is either dedicated to the master bedroom or by floor level. No plumbing drawings were provided.

Stop Work Order was issued by City of Winter Park ~ is still open and must be addressed

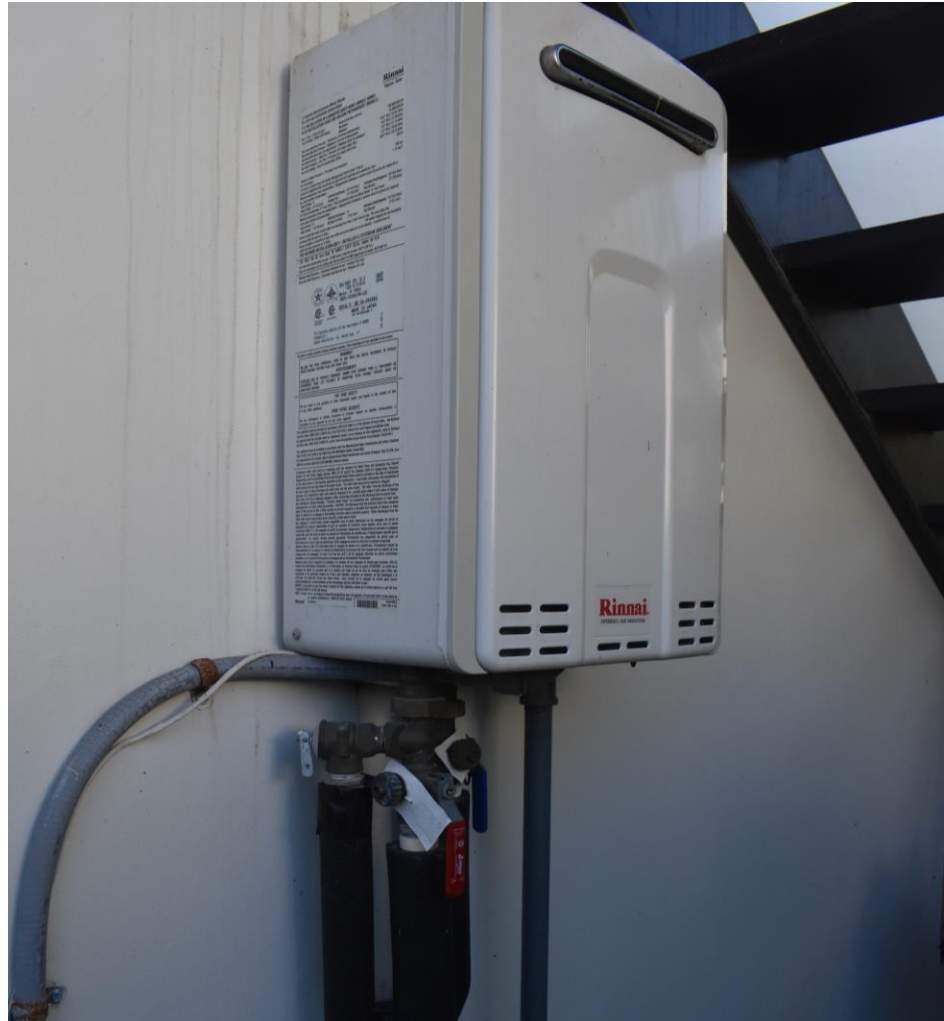
## 2046 Other Observed Issues

**Third tankless hot  
water heater installed under the  
exterior stairway on garage.**

**Not shown on original or as-built  
drawings.**

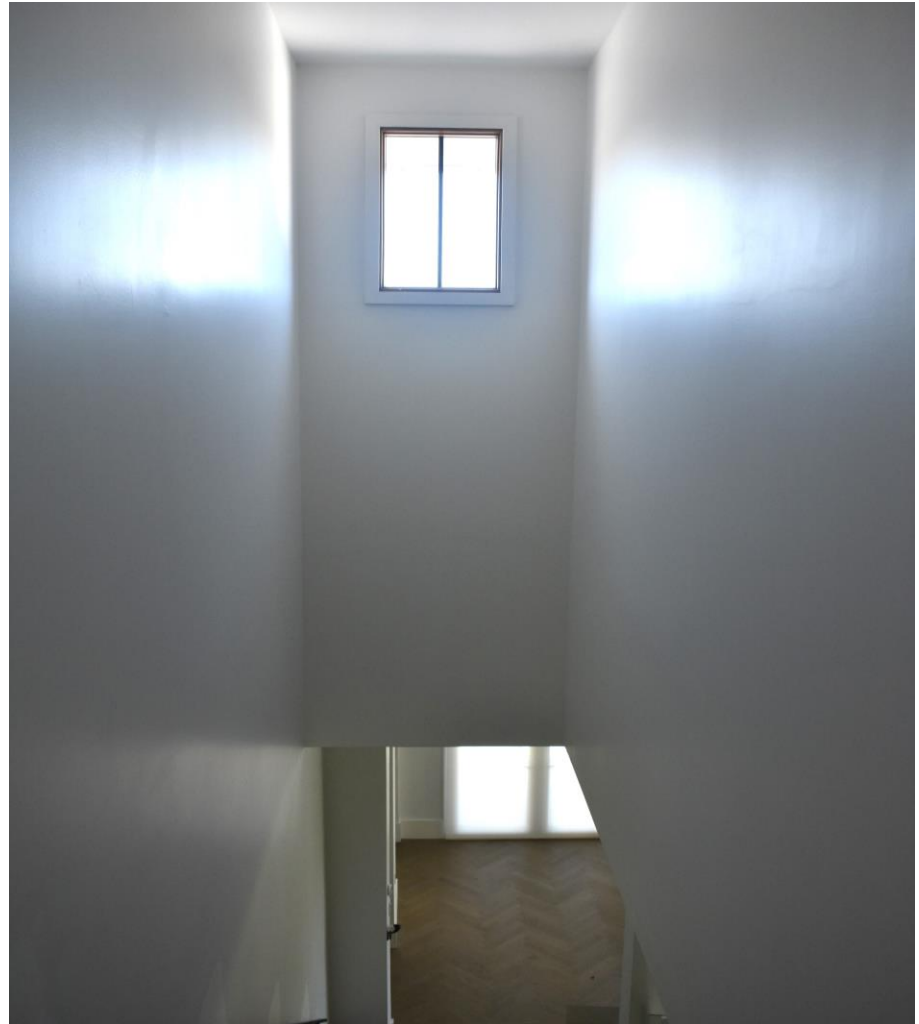
## 2085 Other Observed Issues

**This window is in a load bearing wall and is shown on a front elevation drawing but not on any other drawings.**

**The significance is that the window is not on the lintel plan or structural plan. Materials and methods used unknown.**

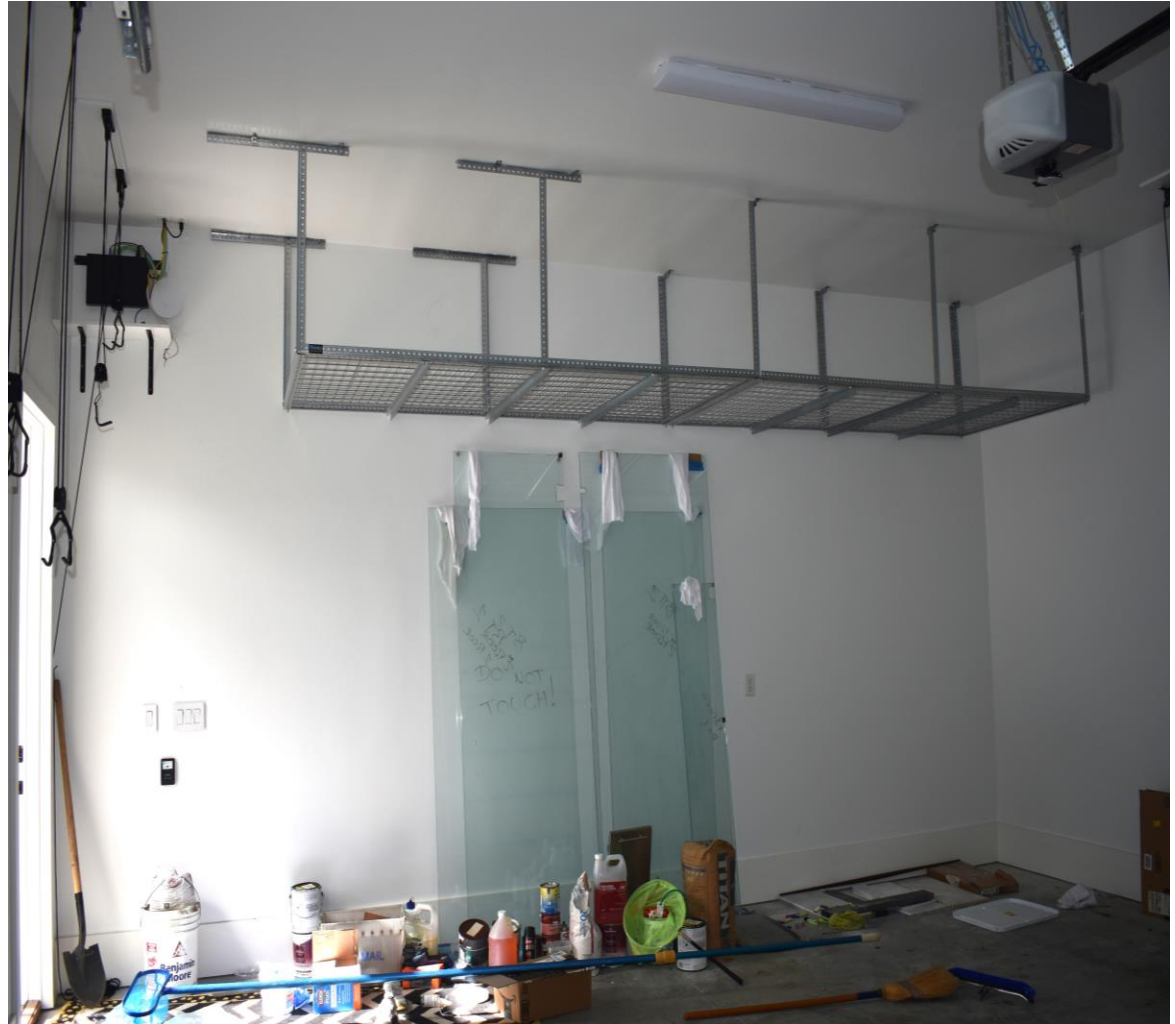
# 2018 Fit & Finish

Shower doors not installed.

Paint supplies for touchups

This alone would not allow a  
Certificate of Occupancy to  
be issued

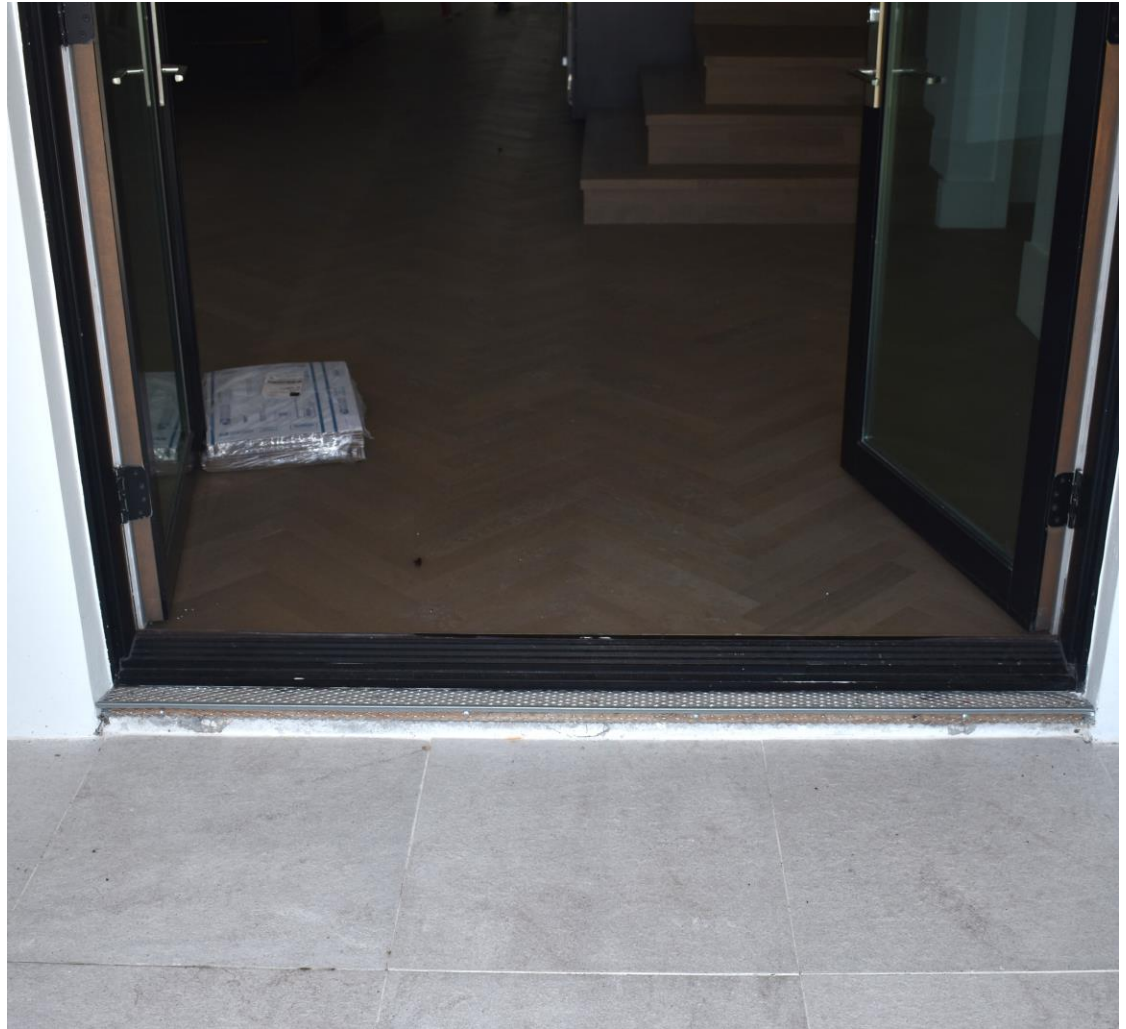
## 2033 Other Observed Issues

**Main entrance threshold incomplete for finishes.**

**The wood in contact with the concrete slab for the threshold is required by Code to be pressure treated. No indication found this is the case.**

**This alone would not allow a Certificate of Occupancy to be issued**

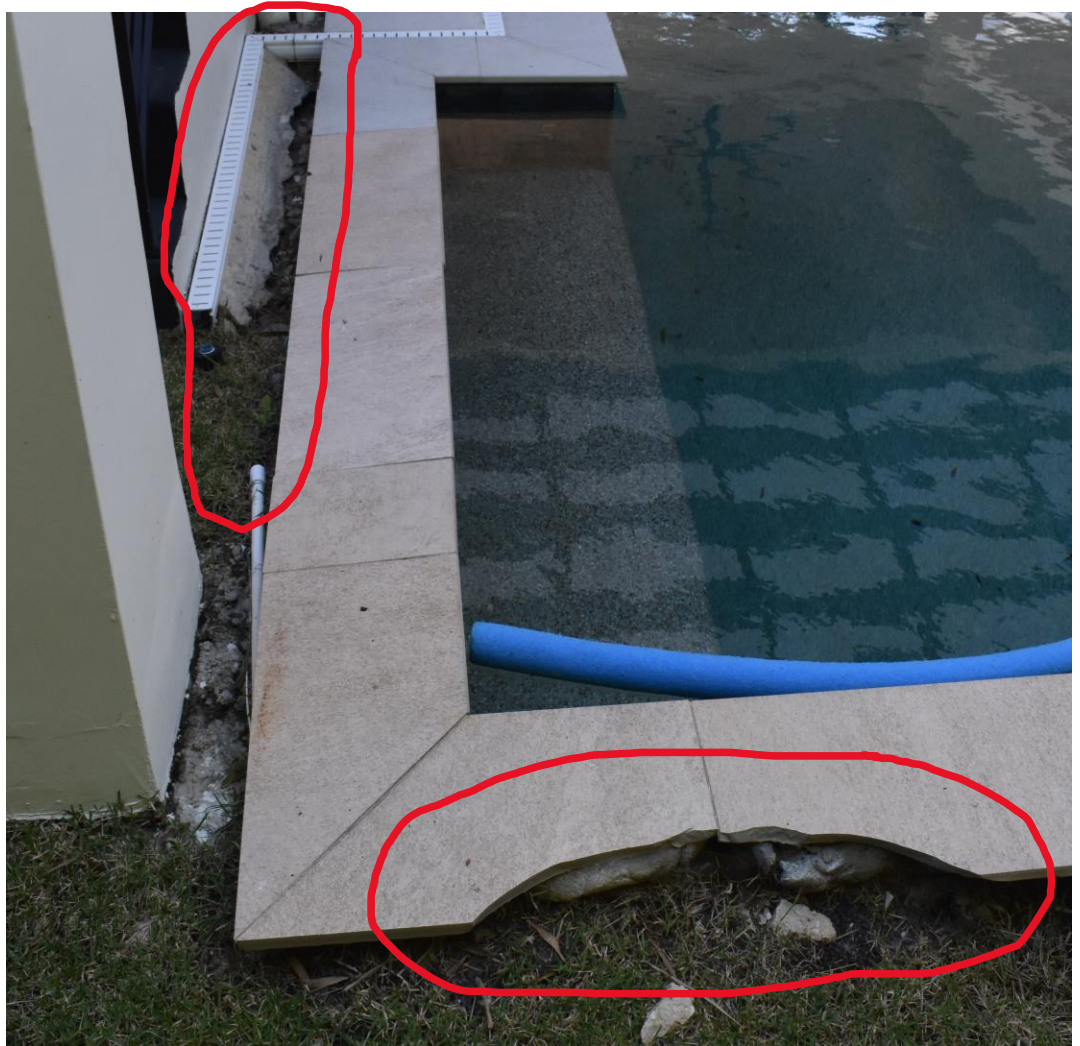
## 2050 Fit & Finish

Tile border for inground pool not properly bedded.

Unsupported tile has broken.

The pool area deck and access to the exterior stairwell is incomplete.

An open portion confirms by location of drain that the pool deck is incomplete.

This alone would not allow a Certificate of Occupancy to be issued

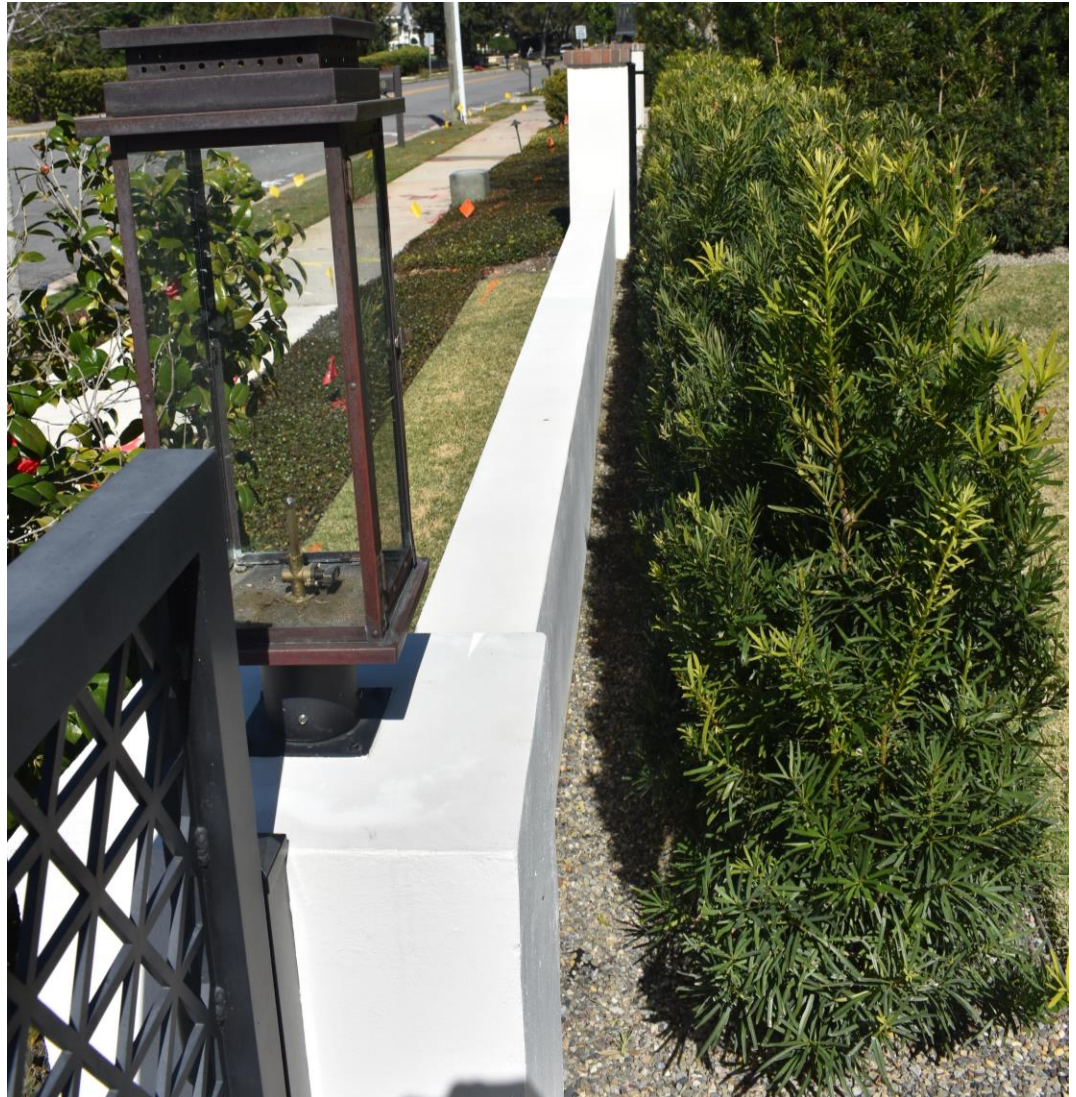
## 2070 Other Issues

**Front wall not in the original or as-built plans.**

**Permit NOT acquired but no way to determine compliance to Code.**

**Gas lights on wall do not work.**

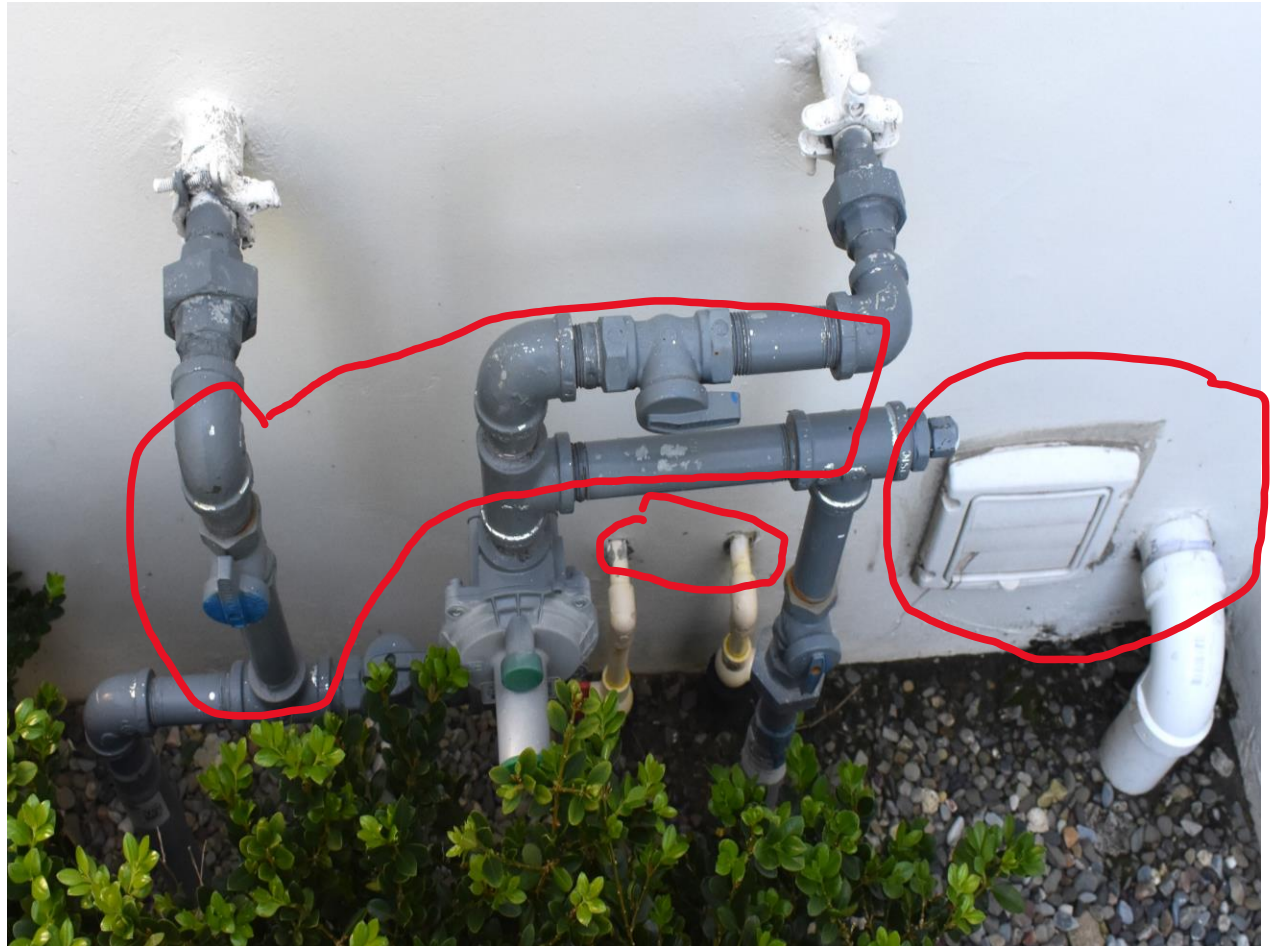
## 2072 Observed Issues - Fit & Finish

Typical for several areas  
where the wall penetrations  
are not caulked.

Preparation and painting of  
poor quality.

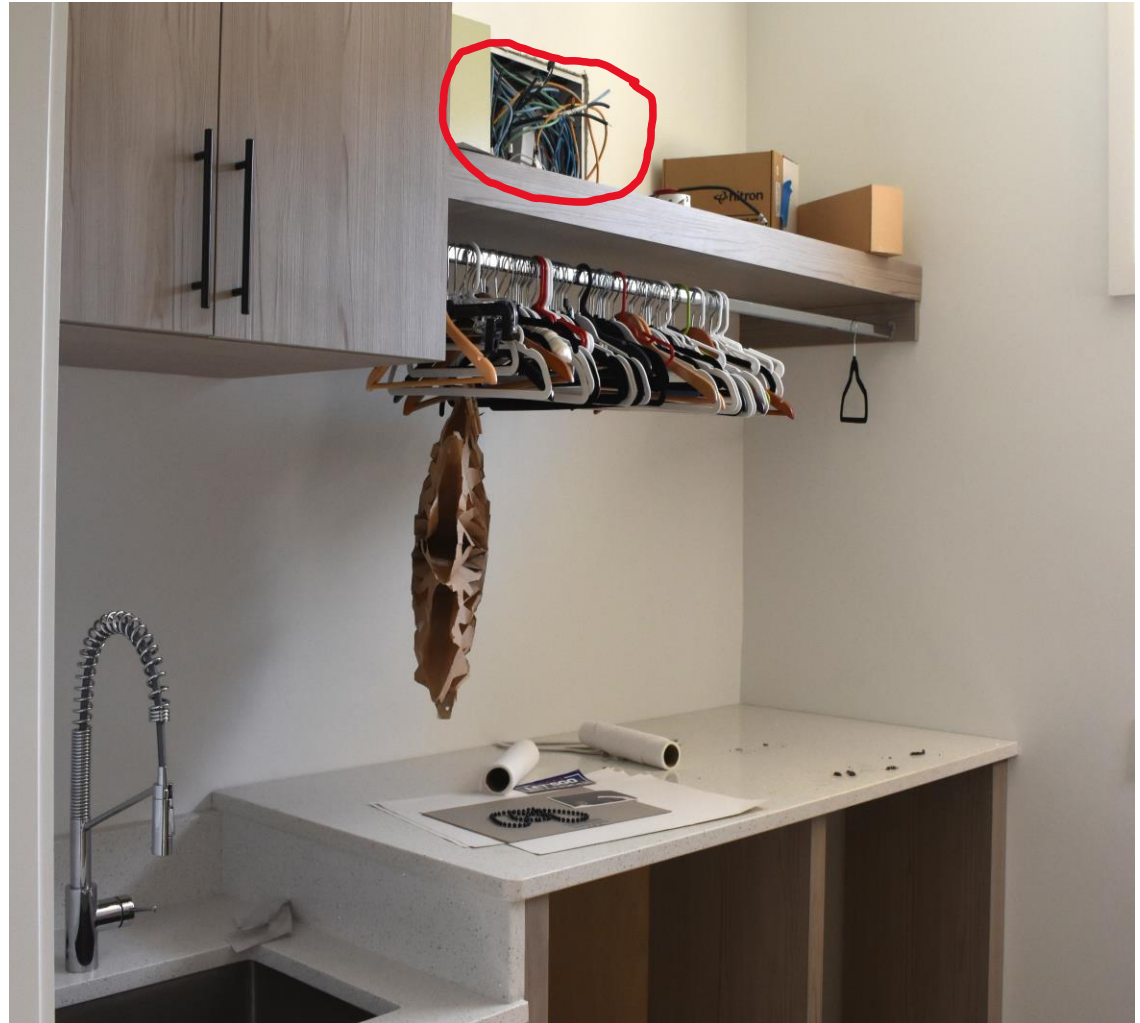
## 2086 Observed Issues

Open Panel with exposed wire hanging out.

Probably low voltage but definitely incomplete work.

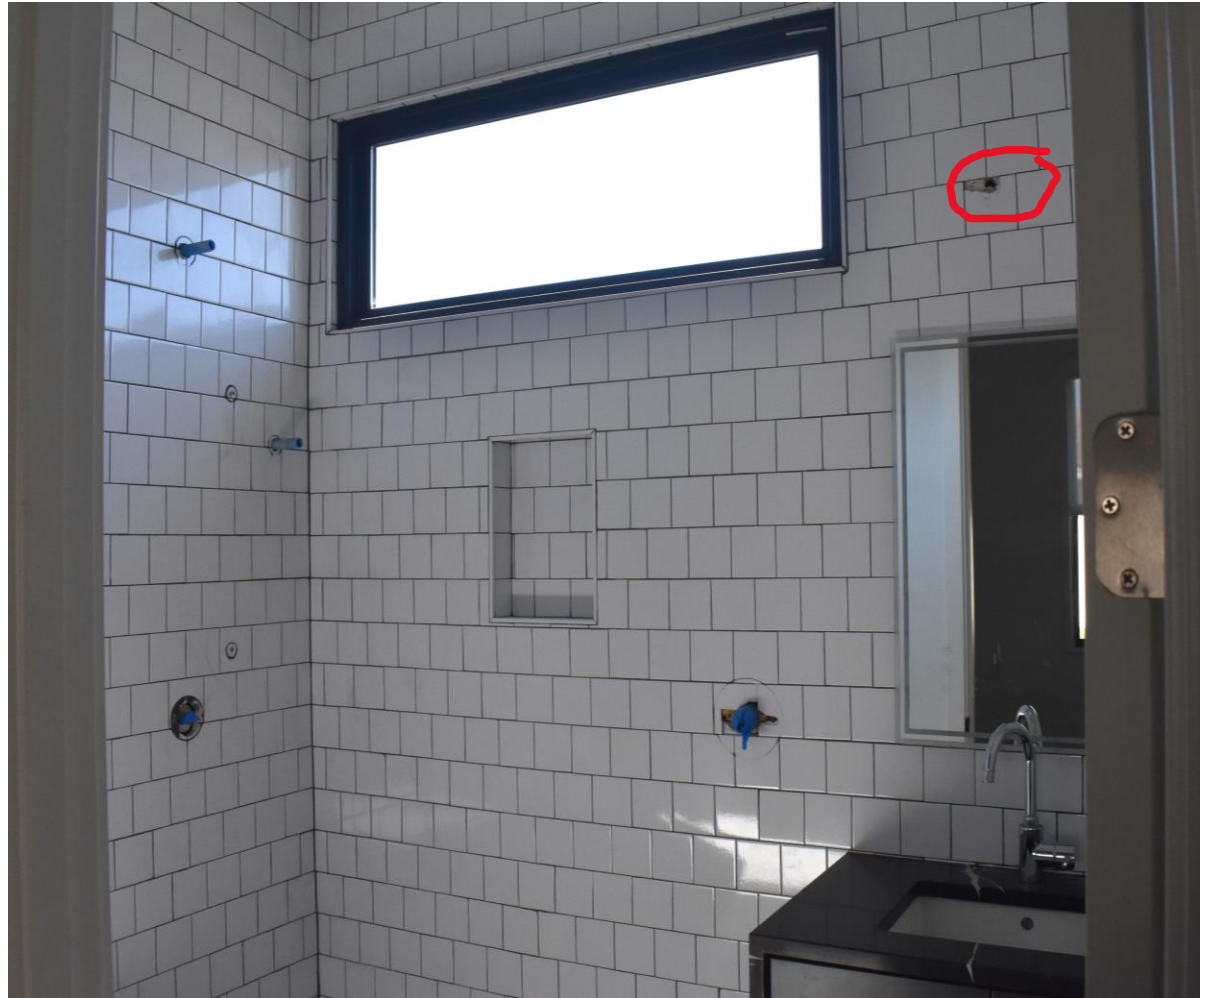
## 2092 Other Issues Fit & Finish

### Tile work does not meet Level 5 Fit & Finish

Typically, installers try to avoid installing tile less than half the width or use a different size.

Choice of black grout amplifies defective work.

Broken tile.

Missing fixtures.

Missing glass shower enclosure.

Issue of poor workmanship not limited to this bathroom.

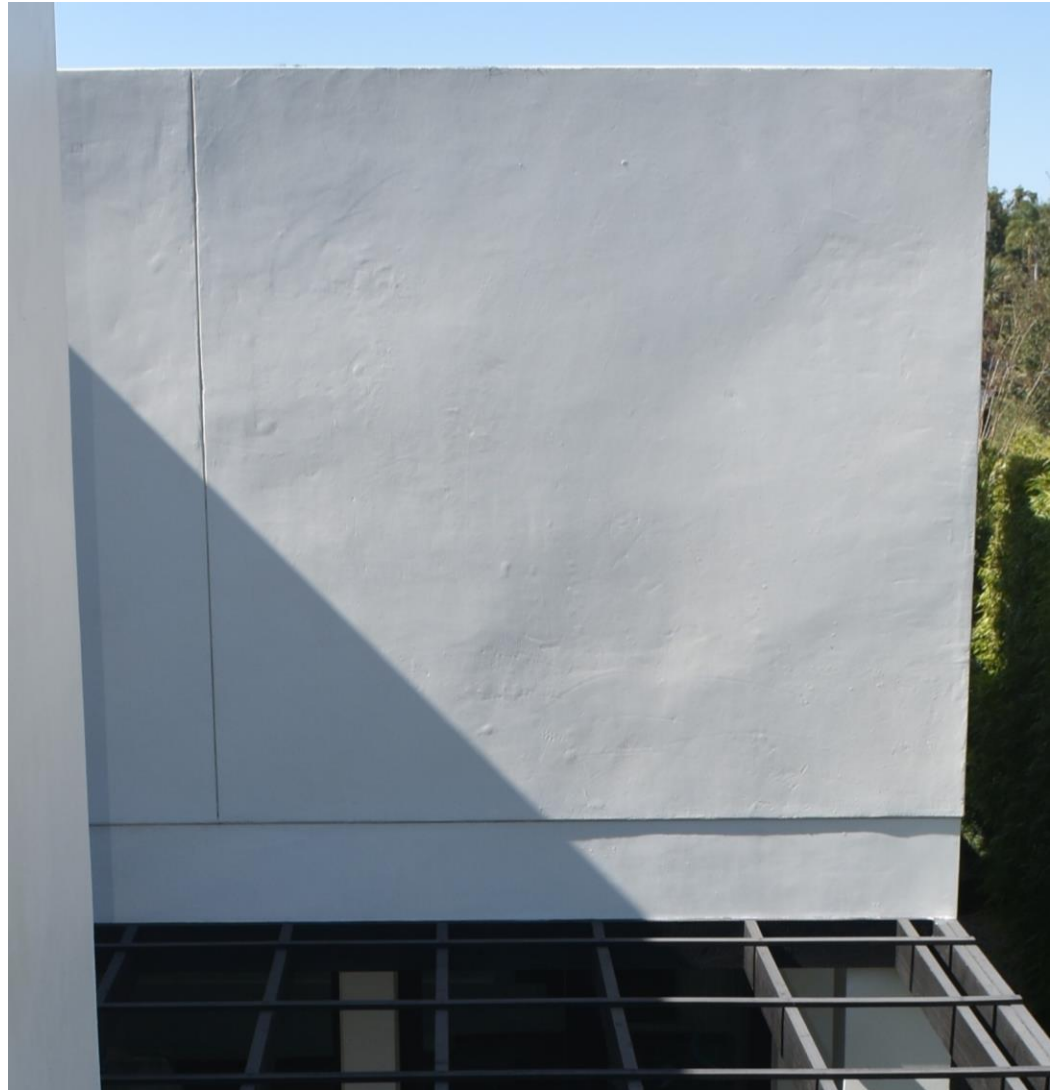
## 2096A Observed Issues

Visual evidence of previous repair of exterior finish noted for several areas.

Finish work is not consistent with Level 5 requirements

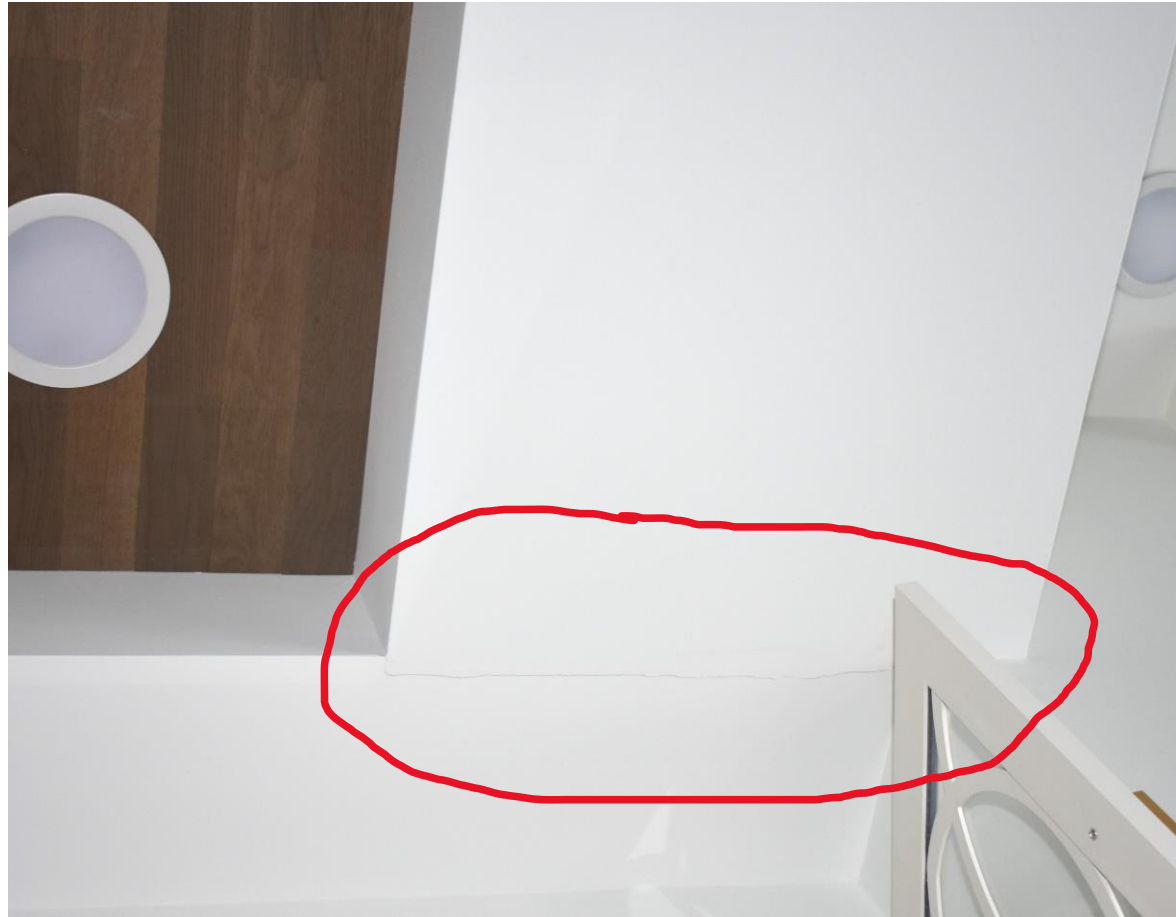
## 2129 Observed Issues

Crack in drywall on soffit  
in kitchen.

Indicates movement.

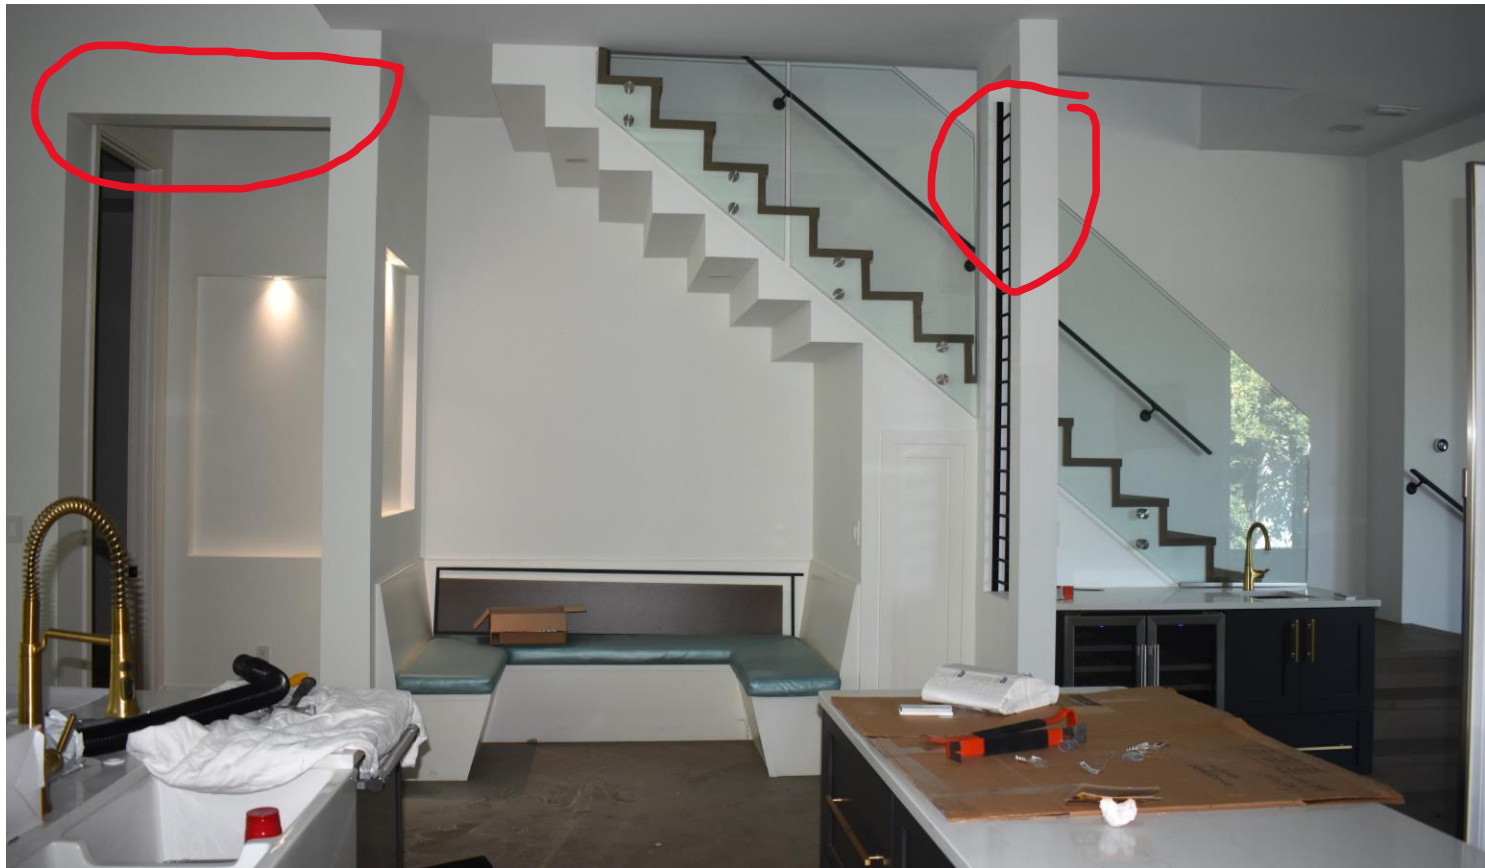
# 2078 Plans versus Observed Construction

The wall pictured from left to right is load bearing and shall contain areas where multiple King studs are used, The bedroom egress wall, the short-wet bar wall are also load bearing. Three pre-engineered laminated columns are also designated for use. At least two laminated posts designed for 3100 SP are missing.

City of Winter Park Building Inspectors failed to enforce Drawings/Engineering

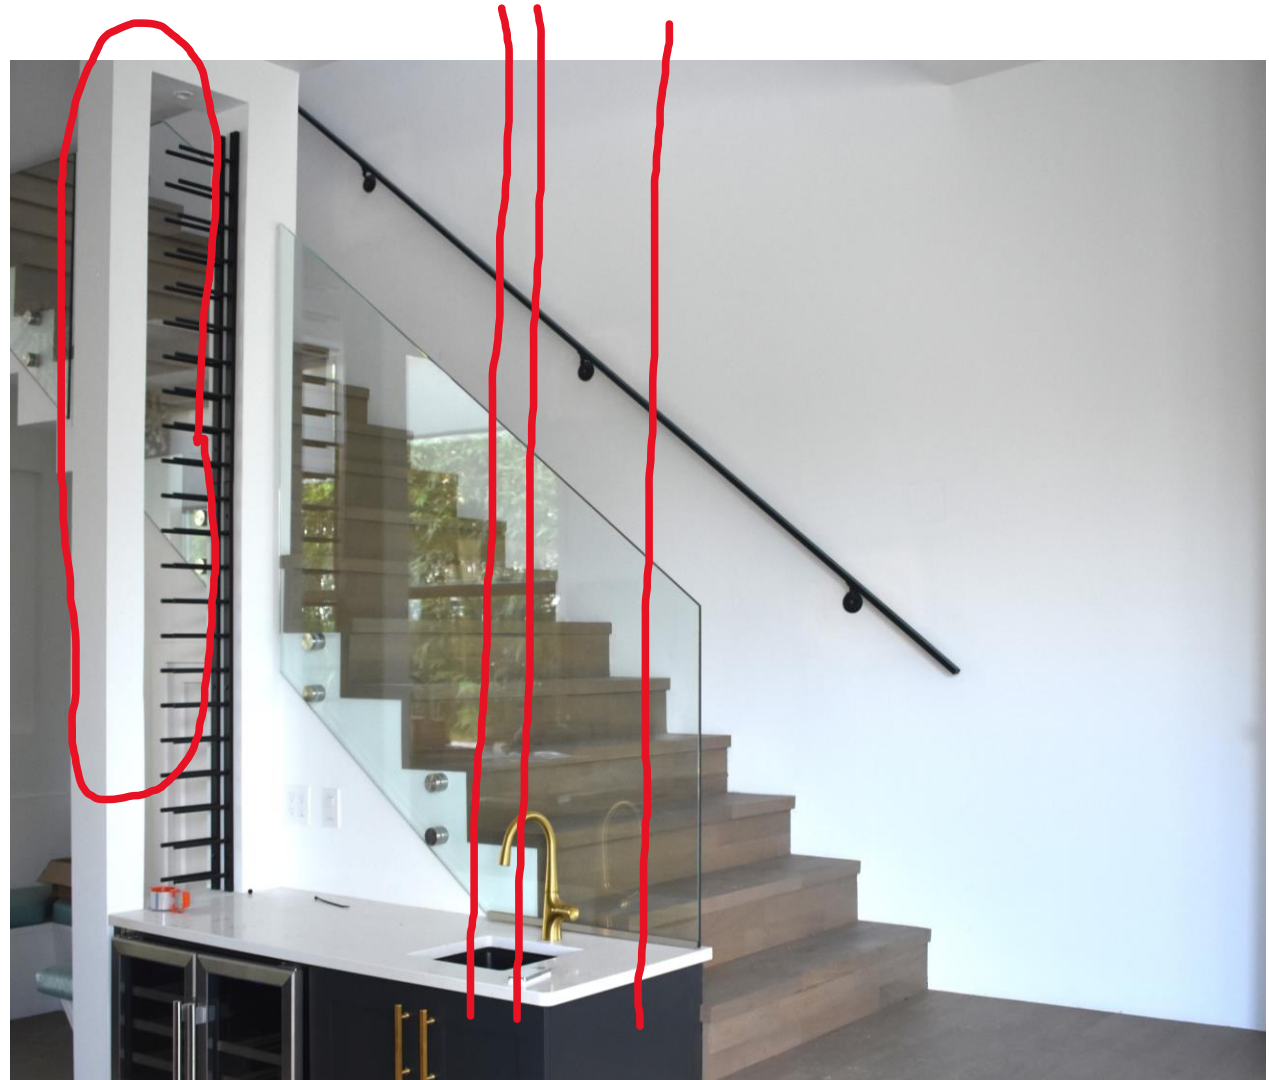
## 2128 Wet Bar Area

Wire rack installed in lieu of required laminate post for structural integrity.

A short load bearing wall was not installed that contained a pre-engineered laminate post.

These structural changes were completed without any review by the truss engineer or architect. No drawing or details provided for what was completed.

These three load bearing walls support the main floor ceiling structure, roof trusses and roofing system.

Elimination and re-design of these load bearing walls significantly compromises the load bearing capability and is a serious code violation.

Life safety issue as well.

City of Winter Park failed to enforce compliance with plans submitted
