## **Other Observed Issues**

## **Plans versus Observed Construction**

## **Post Inspection Issues**

## **Rear Elevation Load Bearing Wall** **Family Room**

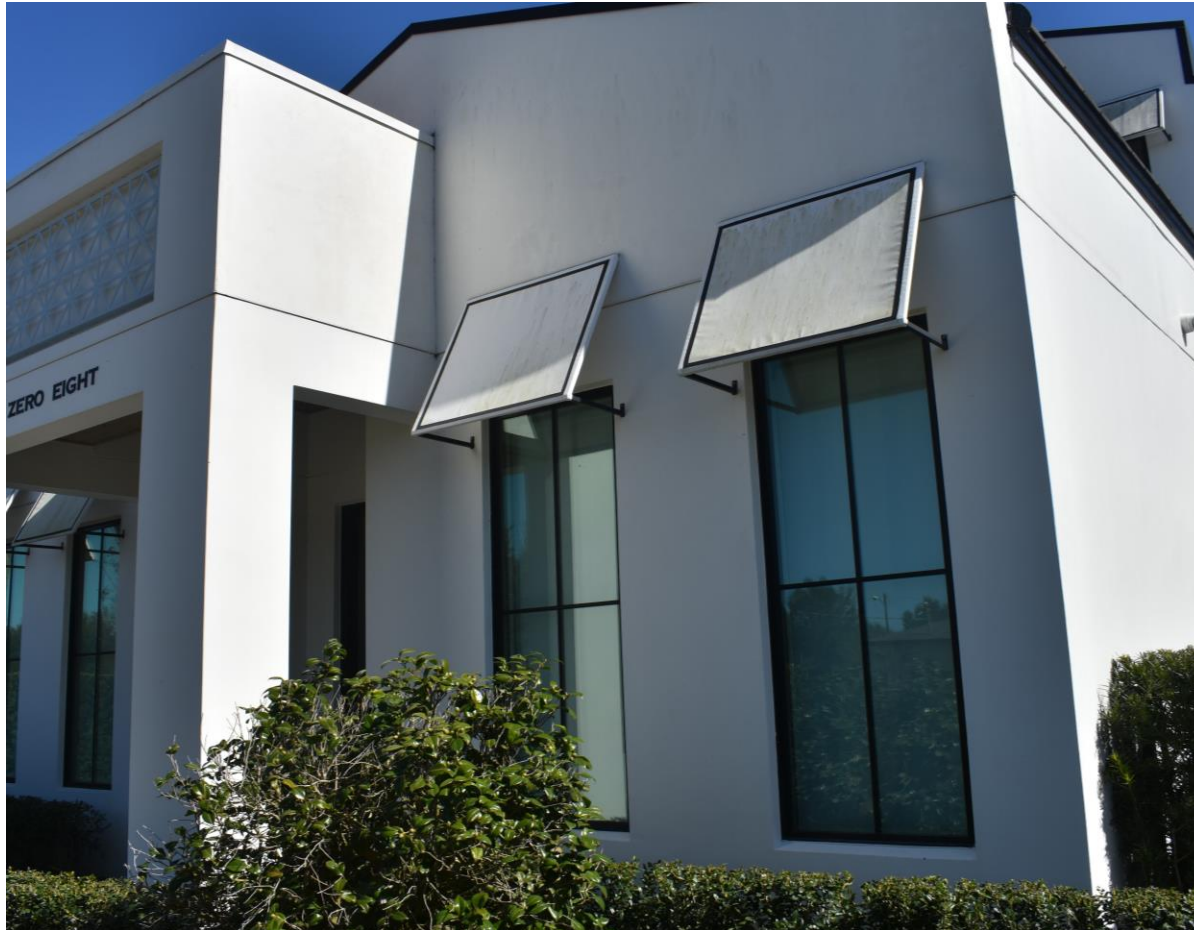
## 2068 Plans versus Observations- Front Elevation

Each window and main entrance door were to have a transom window. The substitute windows and door are larger and would require the same type of alteration of the masonry wall to fit as observed for other walls. This would compromise the lintel and side column widths for load bearing support. The signed cut sheet does eliminate the main entrance transom. No details or drawing revisions were issued. Serious code violation at a minimum.

**City of Winter Park failed to enforce compliance with plans submitted**

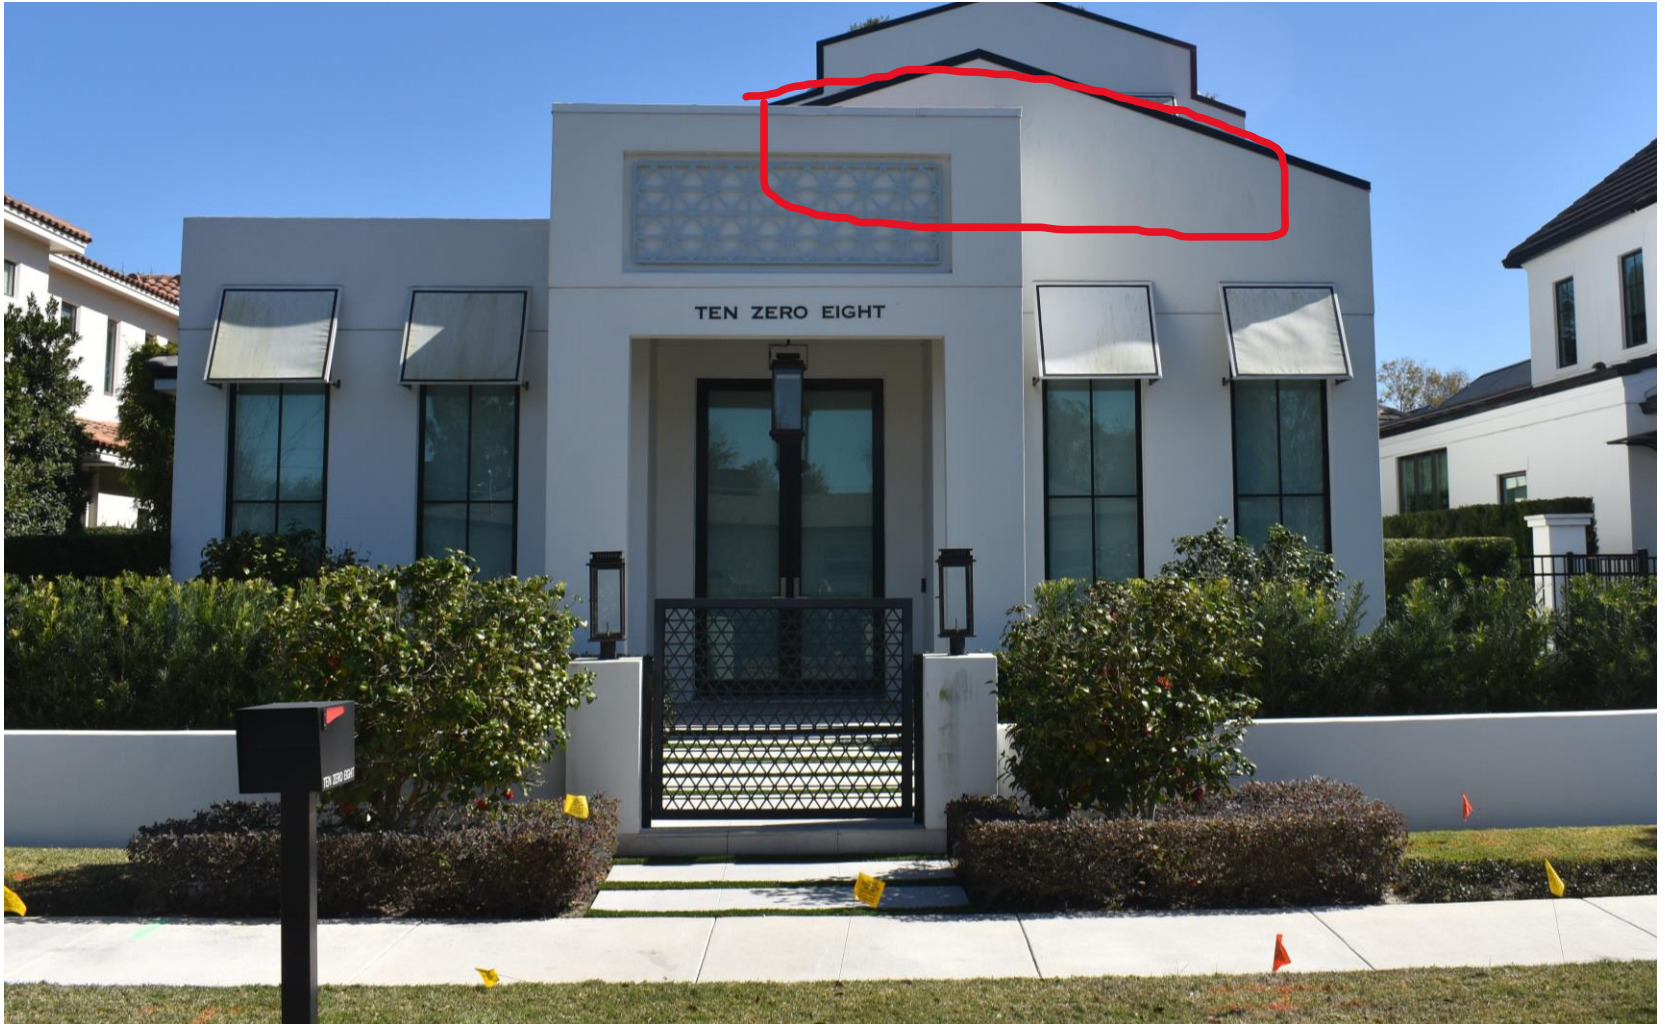
## 2069 Plans versus Observed

The original and as-built plans show this roof design as a gable end, meaning it would be sloped towards the front and not vertical as observed. This change was completed without review by stakeholders as this requires the approval of the truss manufacturer, the architect, developer, and local building department. No evidence that this occurred. Clear code violation.

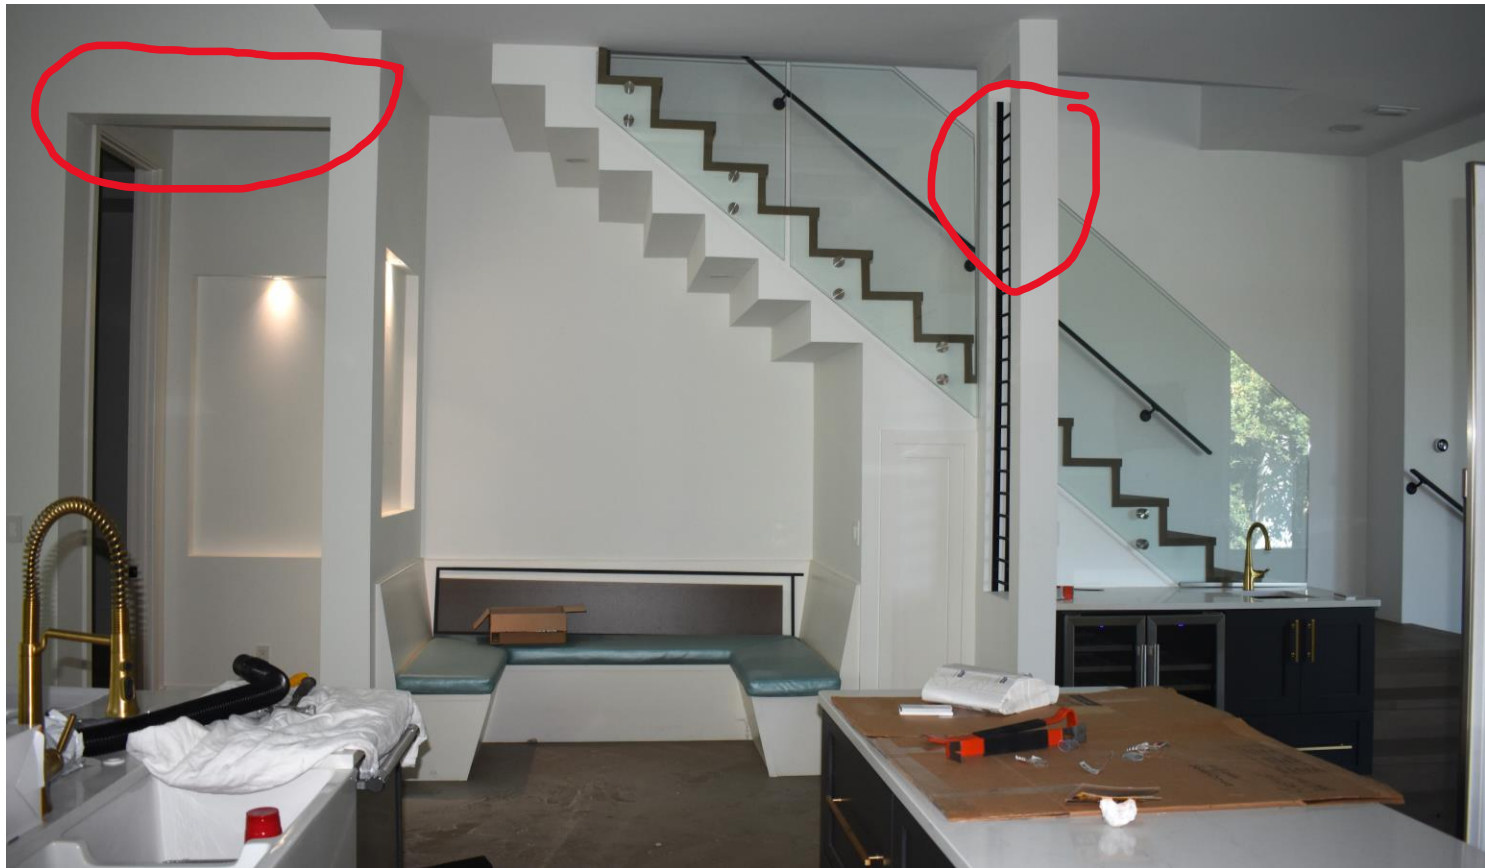
# 2078 Plans versus Observed Construction

The wall pictured from left to right is load bearing and shall contain areas where multiple King studs are used, The bedroom egress wall, the short-wet bar wall are also load bearing. Three pre-engineered laminated columns are also designated for use. At least two laminated posts designed for 3100 SP are missing.

City of Winter Park Building Inspectors failed to enforce Drawings/Engineering

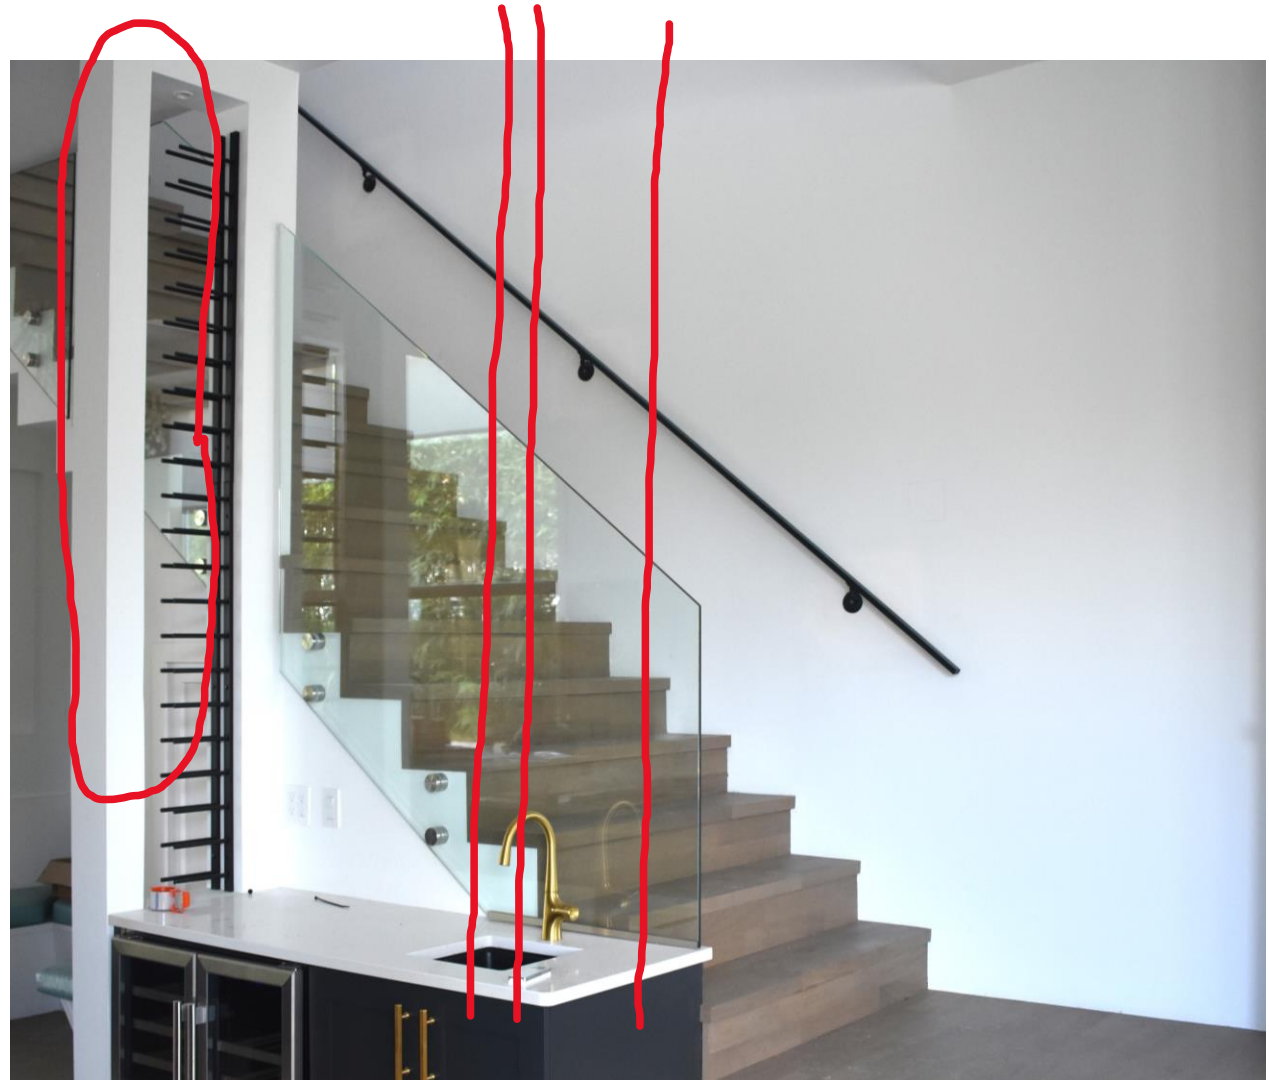
## 2128 Wet Bar Area

Wire rack installed in lieu of required laminate post for structural integrity.

A short load bearing wall was not installed that contained a pre-engineered laminate post.

These structural changes were completed without any review by the truss engineer or architect. No drawing or details provided for what was completed.

These three load bearing walls support the main floor ceiling structure, roof trusses and roofing system.

Elimination and re-design of these load bearing walls significantly compromises the load bearing capability and is a serious code violation.

Life safety issue as well.

City of Winter Park failed to enforce compliance with plans submitted

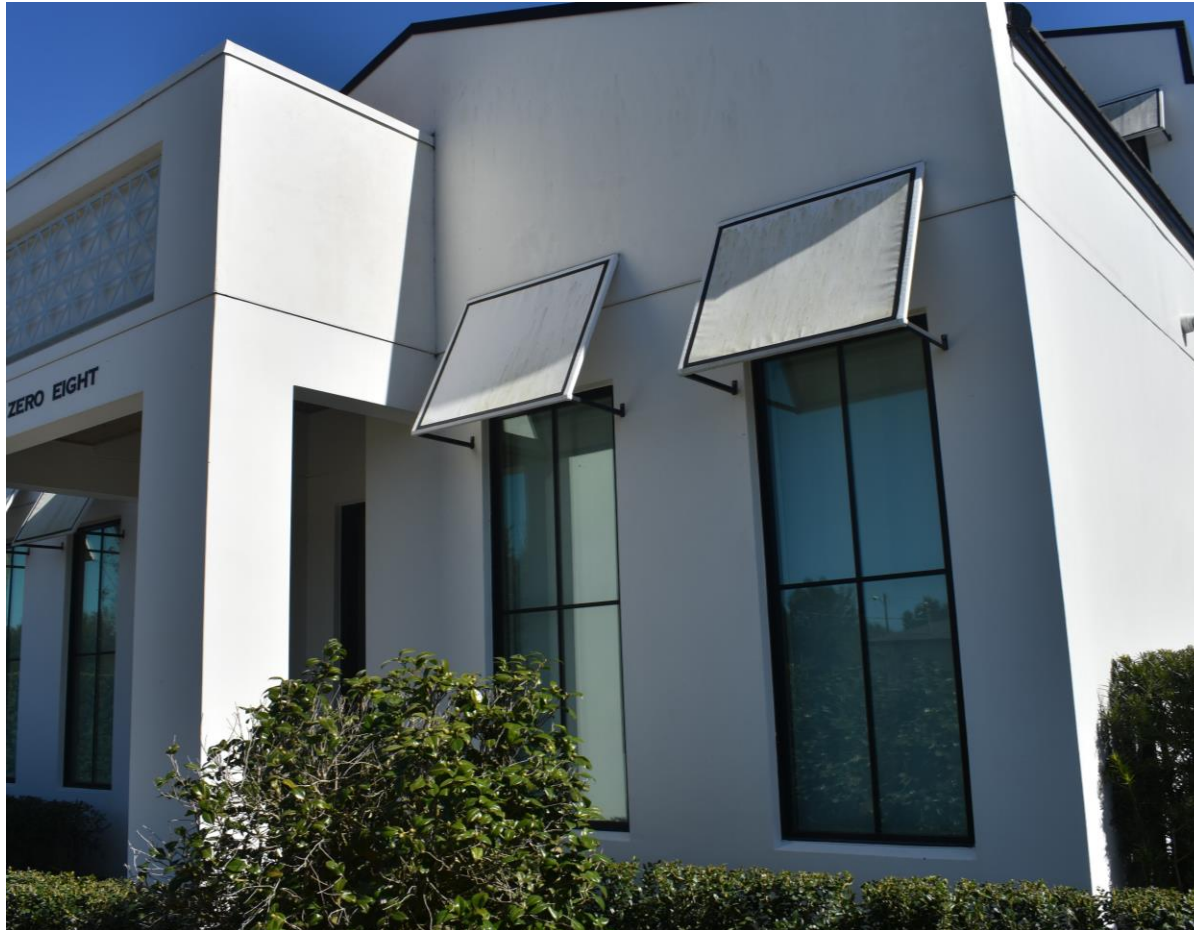
## 2068 Plans versus Observations- Front Elevation

Each window and main entrance door were to have a transom window. The substitute windows and door are larger and would require the same type of alteration of the masonry wall to fit as observed for other walls. This would compromise the lintel and side column widths for load bearing support. The signed cut sheet does eliminate the main entrance transom. No details or drawing revisions were issued. Serious code violation at a minimum.

**City of Winter Park failed to enforce compliance with plans submitted**

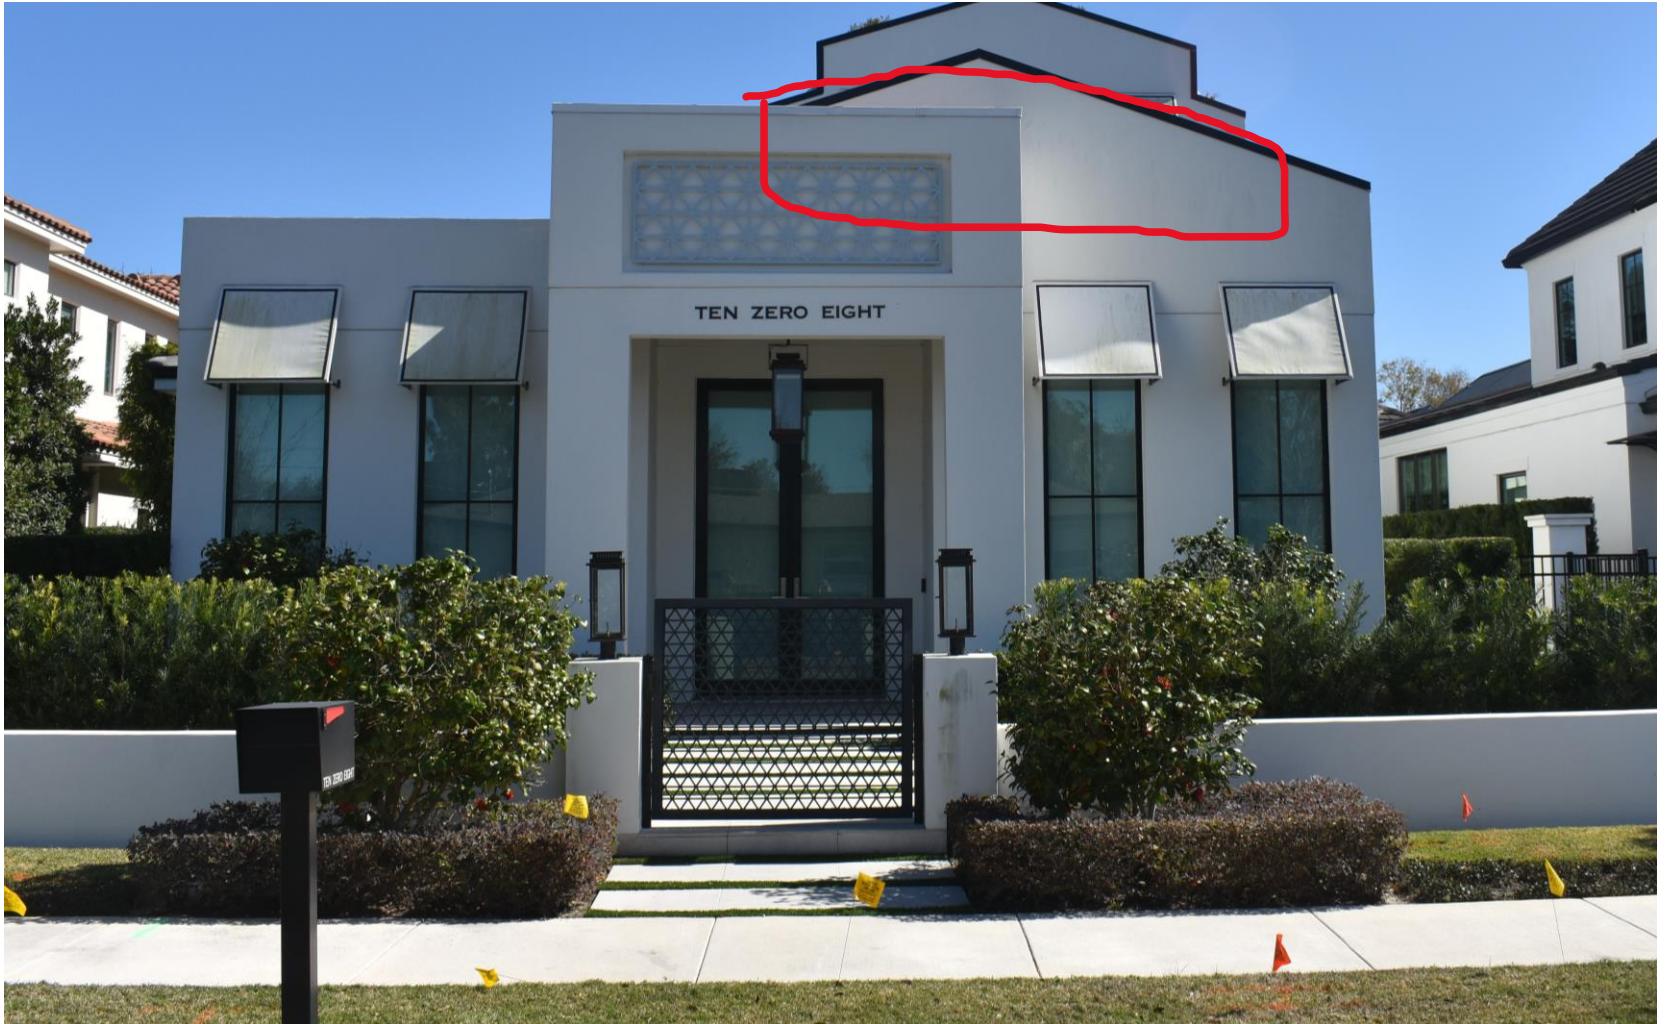
## 2069 Plans versus Observed

The original and as-built plans show this roof design as a gable end, meaning it would be sloped towards the front and not vertical as observed. This change was completed without review by stakeholders as this requires the approval of the truss manufacturer, the architect, developer, and local building department. No evidence that this occurred. Clear code violation.

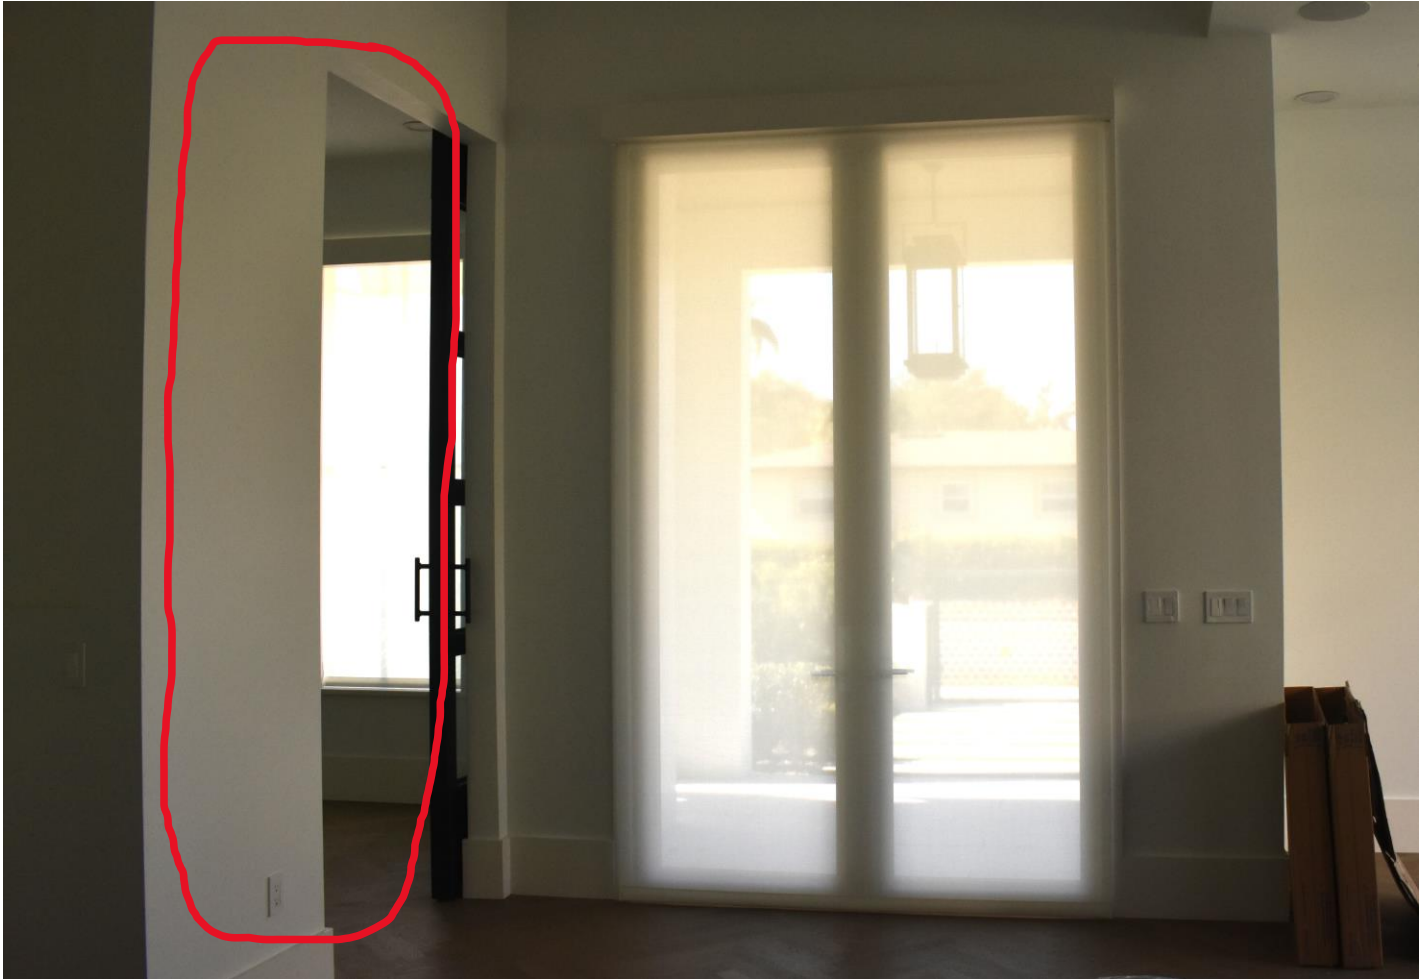
## 2082 Post Inspection Issues

**This section of the wall was intended to be recessed per every document reviewed but was completed as a flush wall.**

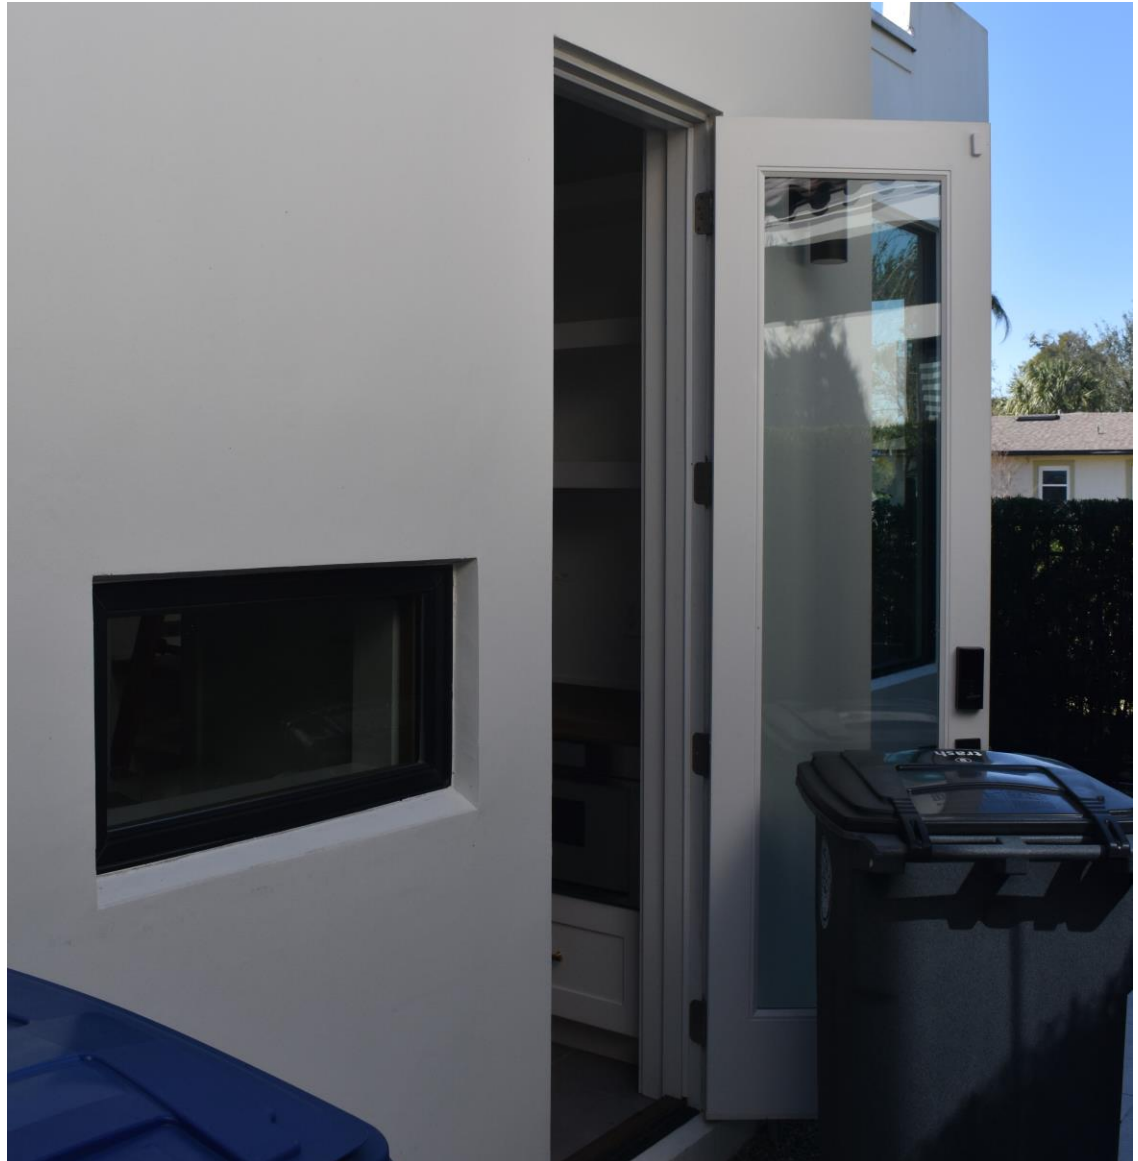
# 2036 Post Inspection Issues

This added exterior door for the Panty is shown on the Cabinetry & Design drawing but not on the signed Cut Sheet.

Oddly, it is shown on the As-built drawing, but the door swing is opposite as installed.

This was installed with

No Engineering

No Permit changes

No Inspections

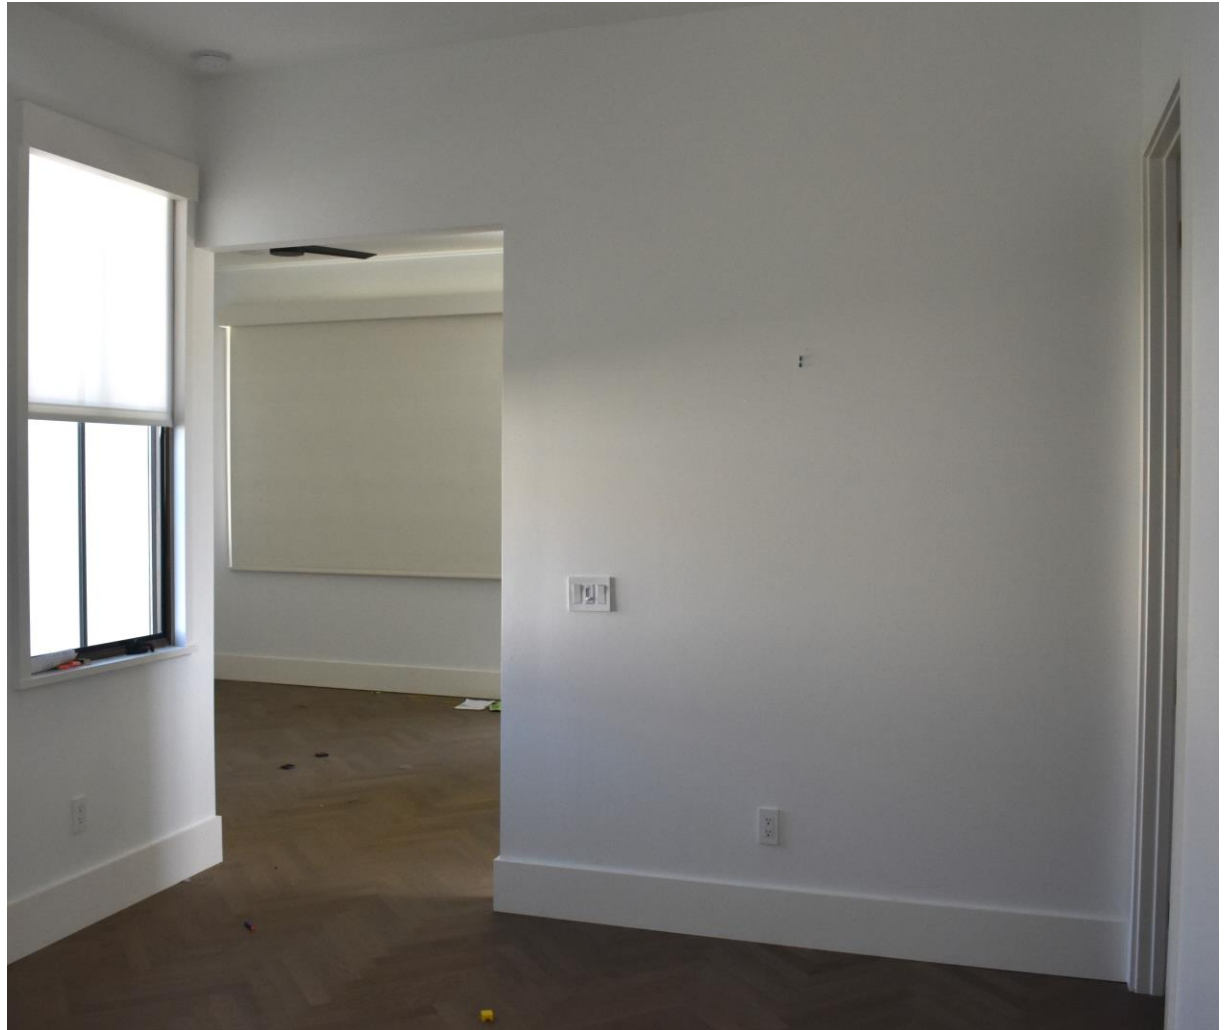
# 2093 Post Inspection Issues

**This doorway was moved several feet down the same wall and is not compliant to the signed Cut Sheet.**

**The move appears to be have occurred for better egress to the In-Law Suite above the garage.**

**The interior and exterior door was removed with the relocation of the exterior stairs to maintain a second entrance.**

**This significant floor plan change was not addressed in the as-built drawings.**

**This was installed with**

**No Engineering**

**No Permit changes**

**No Inspections**

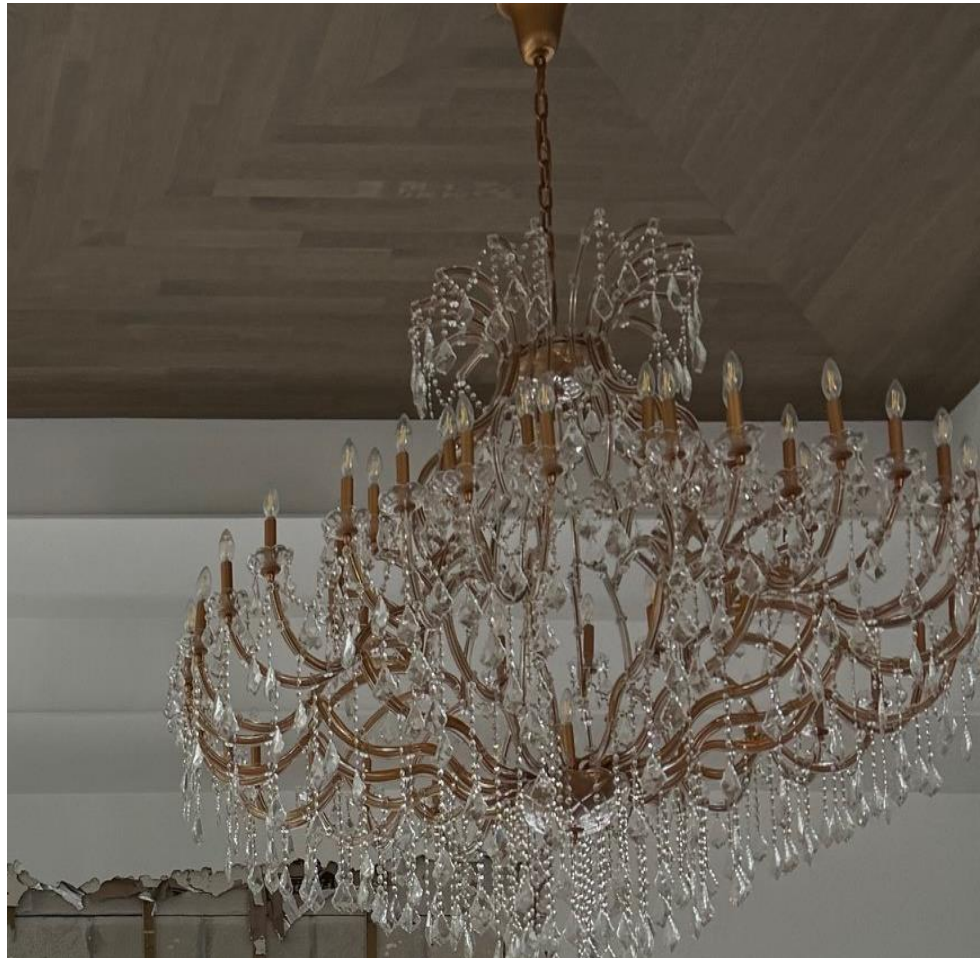
# 0310D Post Inspection Issues

The signed Cut Sheet for this chandelier does not address any special mounting requirement

The original or as-built drawing do not have a detail drawing to address the use of additional blocking.

This is a heavy fixture above the family room and without any electrical drawings or vendor cut sheet to review to suggest compliance.

We will not be able to comment on the adequacy of support. This would be a concern given the level of deviation from plans.

**No Engineering Shown in Cut Sheet**

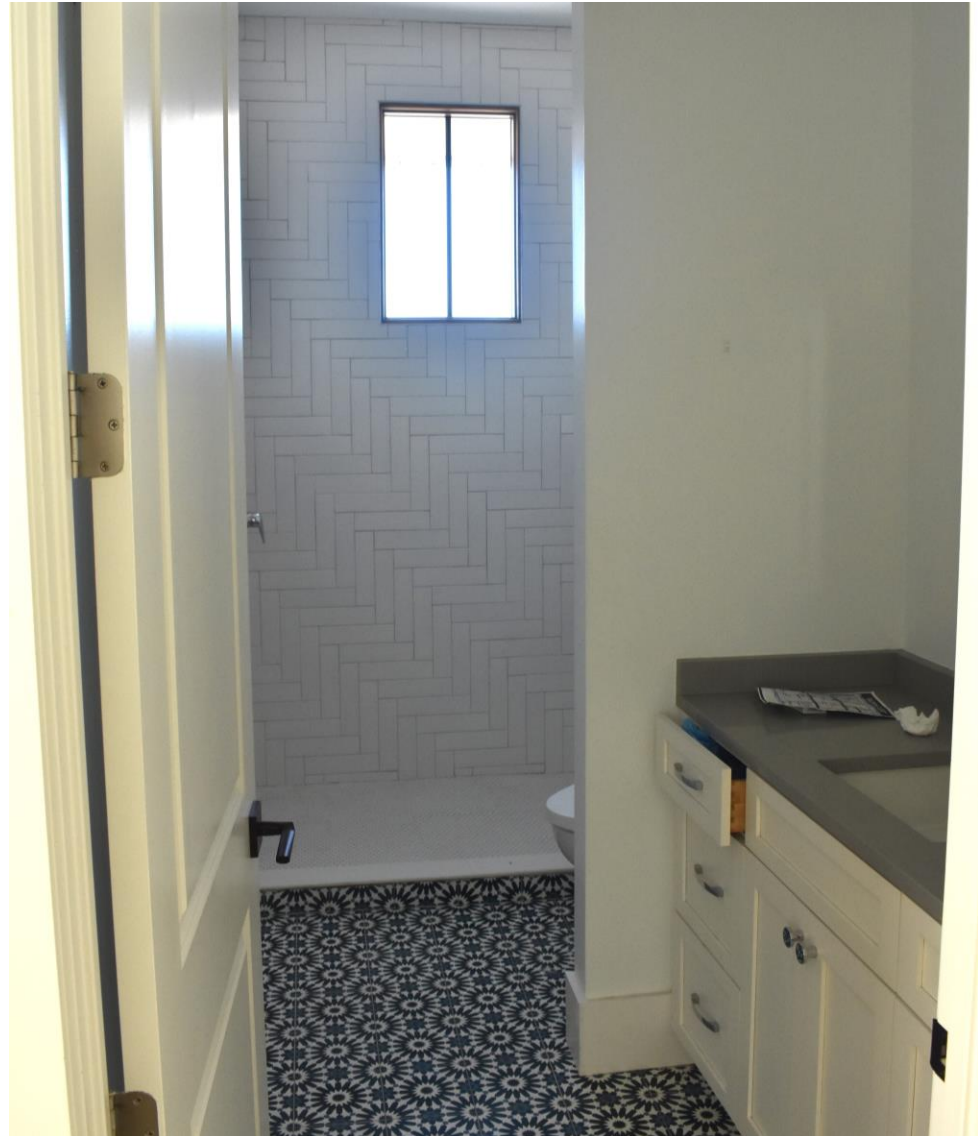
# 2087 Post Inspection Issues

**No interior door hardware Cut Sheets provided.**

**A mismatch of hinge color and door hardware exists in several locations.**

**A very odd outcome. Certainly not Level 5 Fit & Finish.**

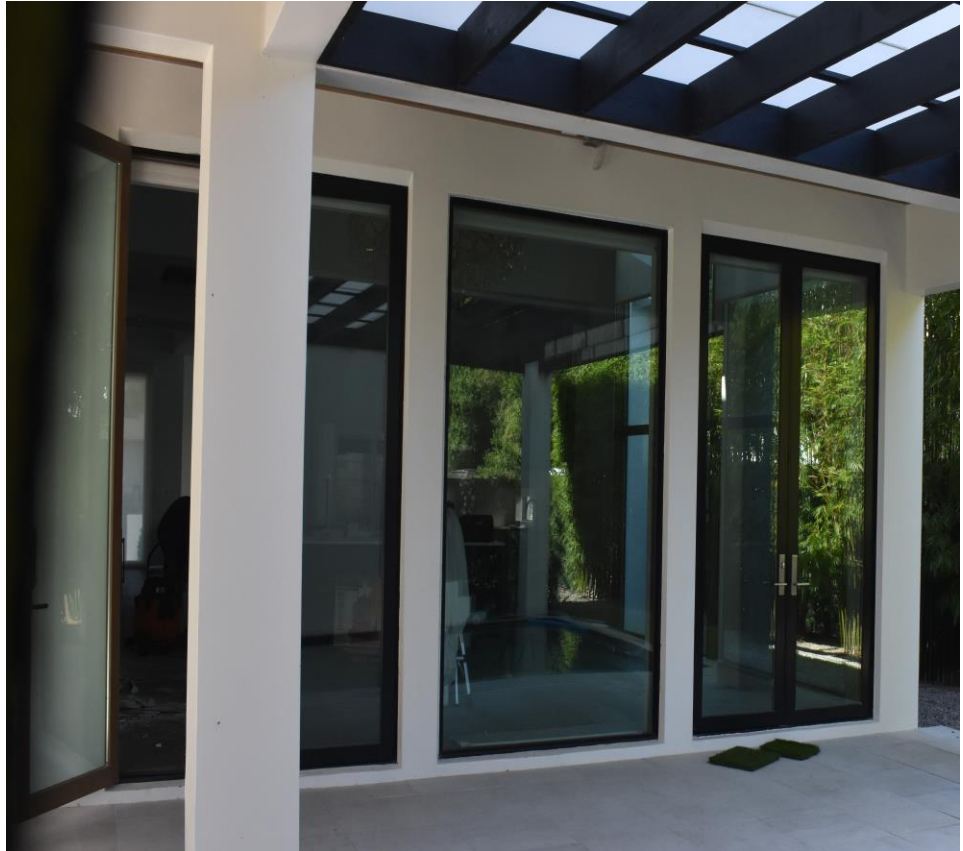
## 2052 Rear Exterior View

The substitute window and double doors are not shown on the original or as-built drawings.

Also not accurately built in accordance with the cut-sheet.

This is a code violation.

**City of Winter Park failed to enforce compliance with plans submitted**

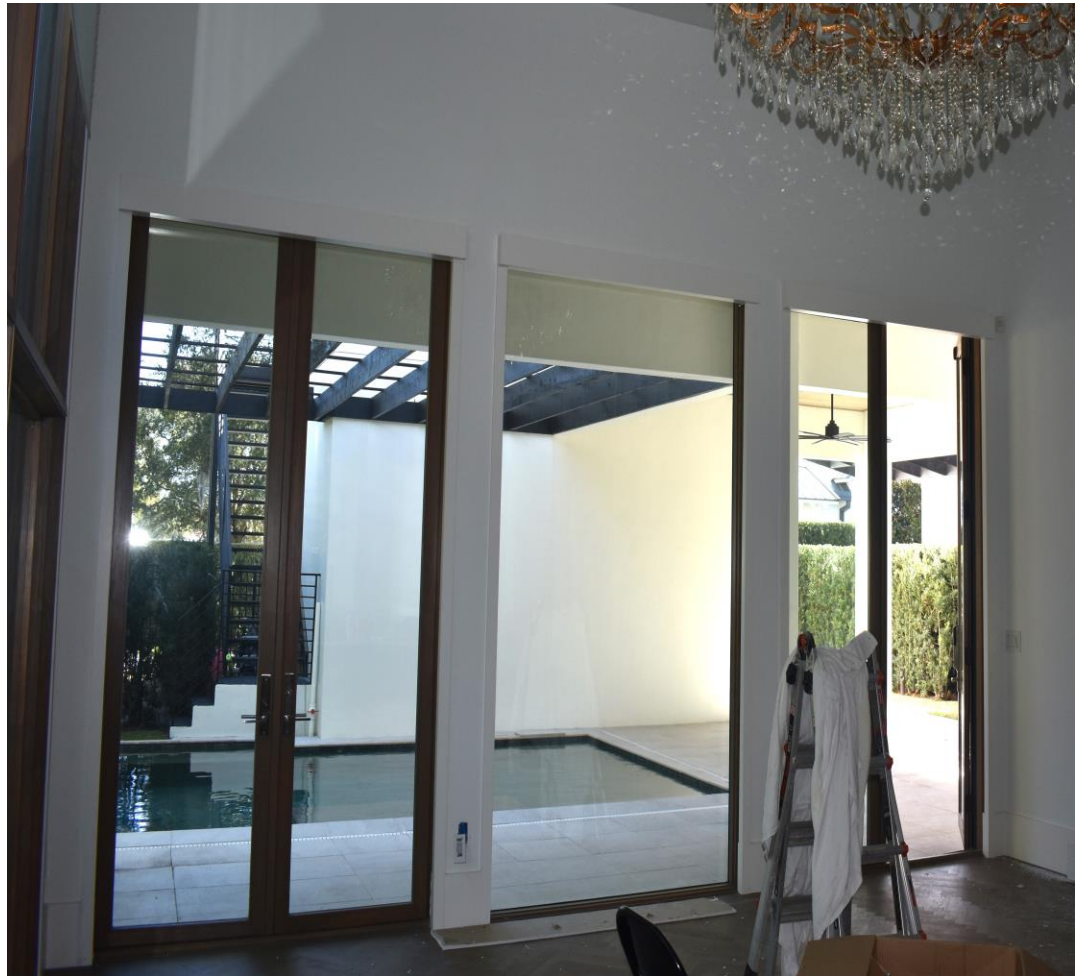
# 2077 Rear Elevation Interior View

The original and as-built drawings indicate that each of the double doors and center section of the wall would have a transom window.

The cut sheet indicates that there is no window of any type to be installed between the double doors.

No detail or approved document is provided for this significant change.

This action is a code violation, violates industry standards and is a life safety issue.

**City of Winter Park failed to enforce compliance with plans submitted**

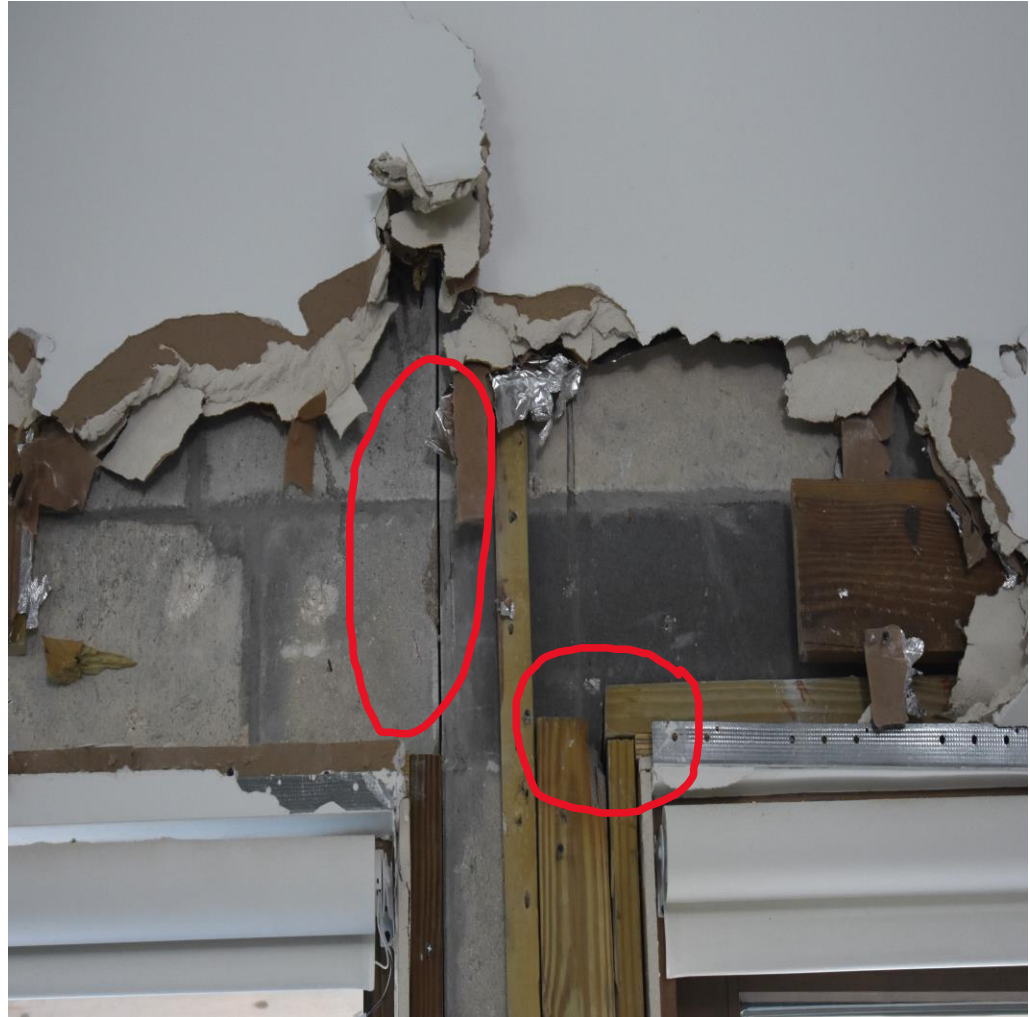
## 2108 Rear Elevation Wall Exposed

This initial view shows that the masonry wall was saw cut vertically well above the window area.

The precast engineered lintel has been notched for the door width to allow a wood door frame to be added for the larger than designed door for the opening. Typical for the other door.

No lintel above the center window.

This attempt to install larger doors and window than originally designed is a significant undocumented code violation at a minimum and is a life safety issue.

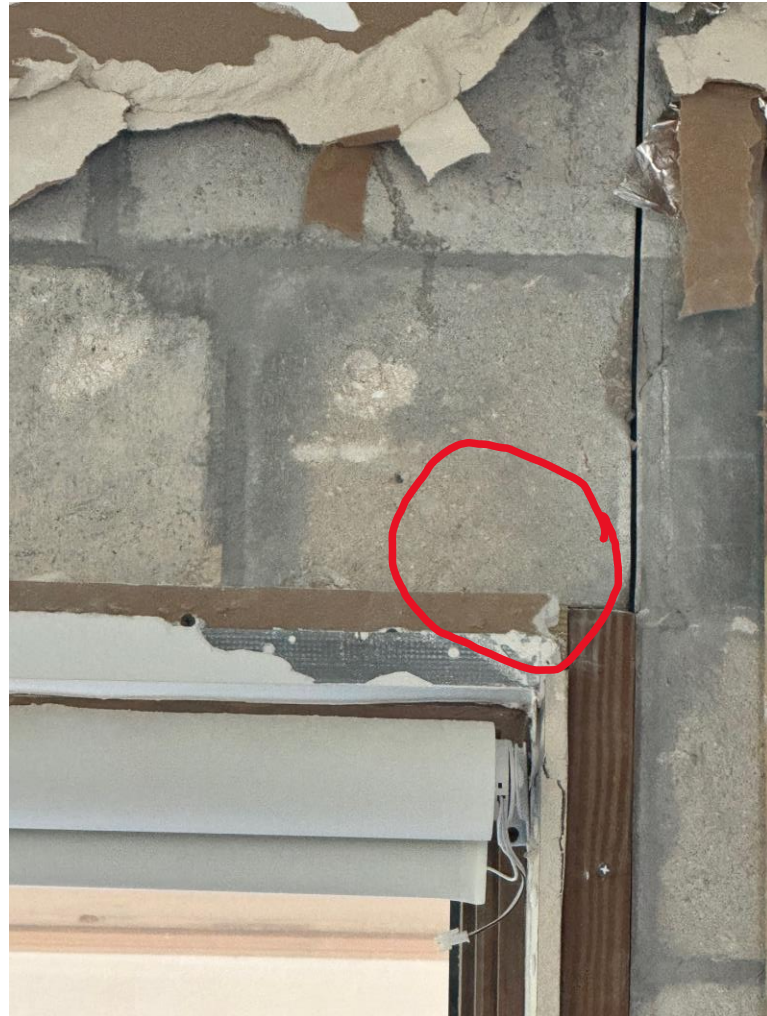
## 0302 Rear Wall Elevation

The saw cut above the window was measured to be 2-3 inches deep on the 8x8x16 block.

The wood frame for the window is not installed per industry standards as the top board should be over the vertical board for proper support.

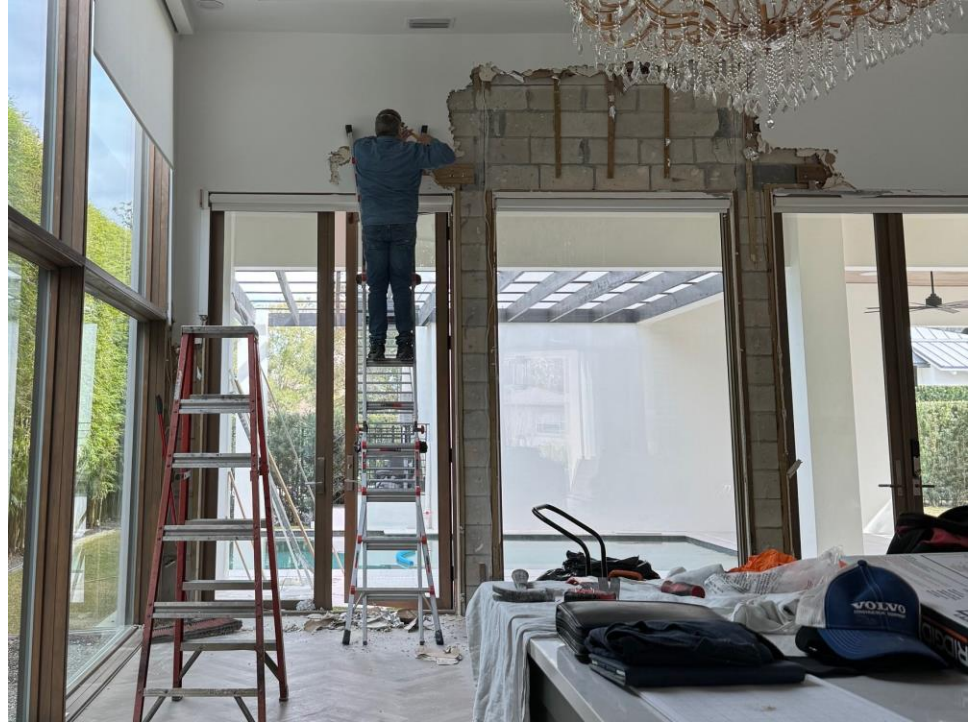
## 0310A Rear Elevation Wall Exposed

To install the oversized window the contractor saw cut the existing masonry wall on the left and right sides and extended the cut four courses above the window and horizontally.

Then removed the wall section by mechanical means.

With no details or approval or calculations to address this significant structural change the load bearing capacity of this wall has been severely compromised and poses a life safety issue.

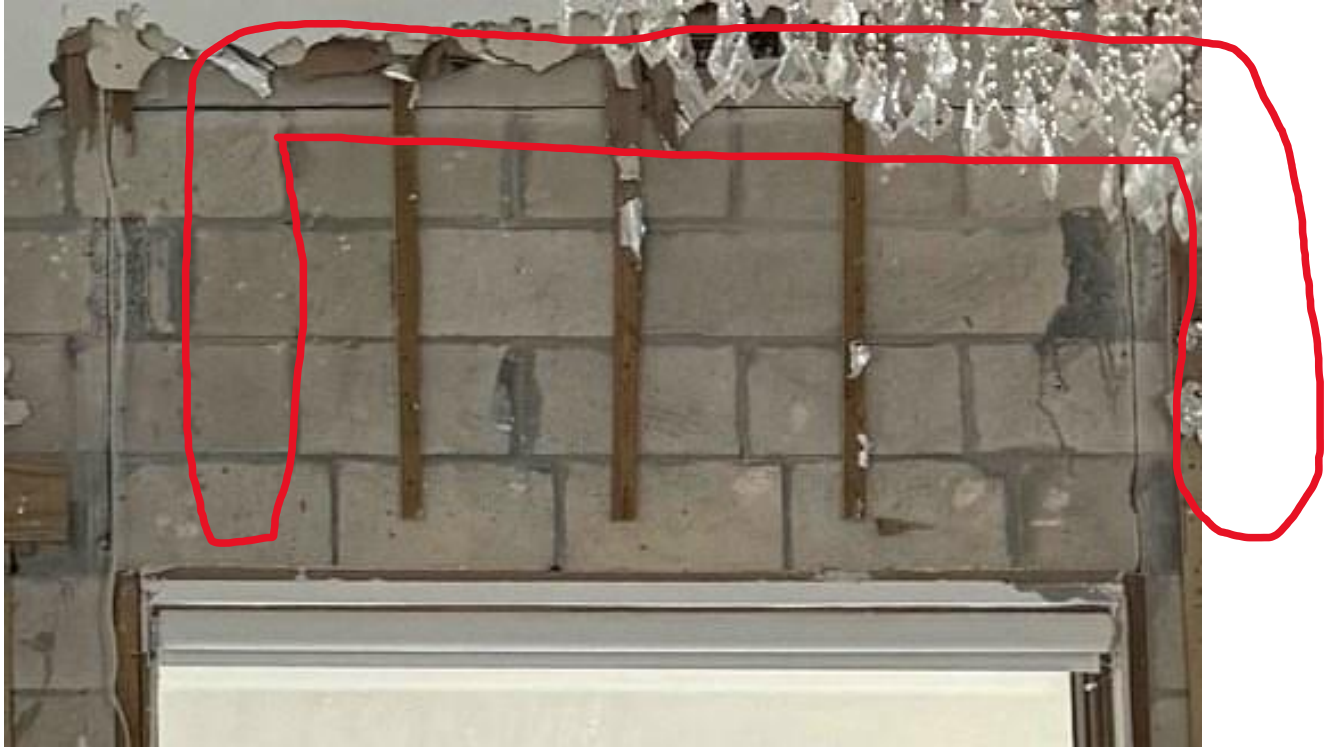
## 0310B Rear Wall Elevation Saw Cut

Closer view of the unnecessary over cut made with a masonry saw on the rear wall for the center window. The cut is 2-3 inches deep.

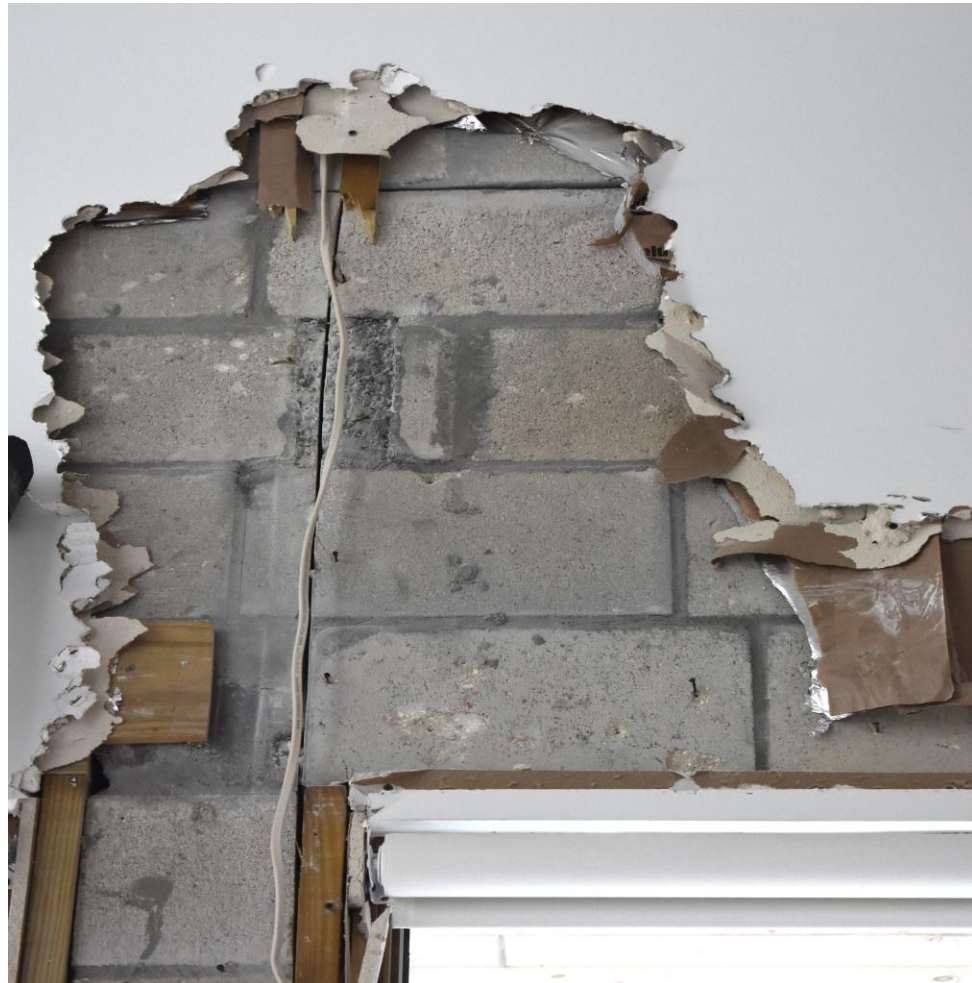
## 2114 Rear Wall Elevation

The precast engineered lintel for the double door left of the center window was also notched and is a clear code violation. The cut invalidates the designed structural integrity.
