## **Interior Load Bearing Wall- Family Room**

**These photographs are directly related to the same section of this report  
as identified above.**

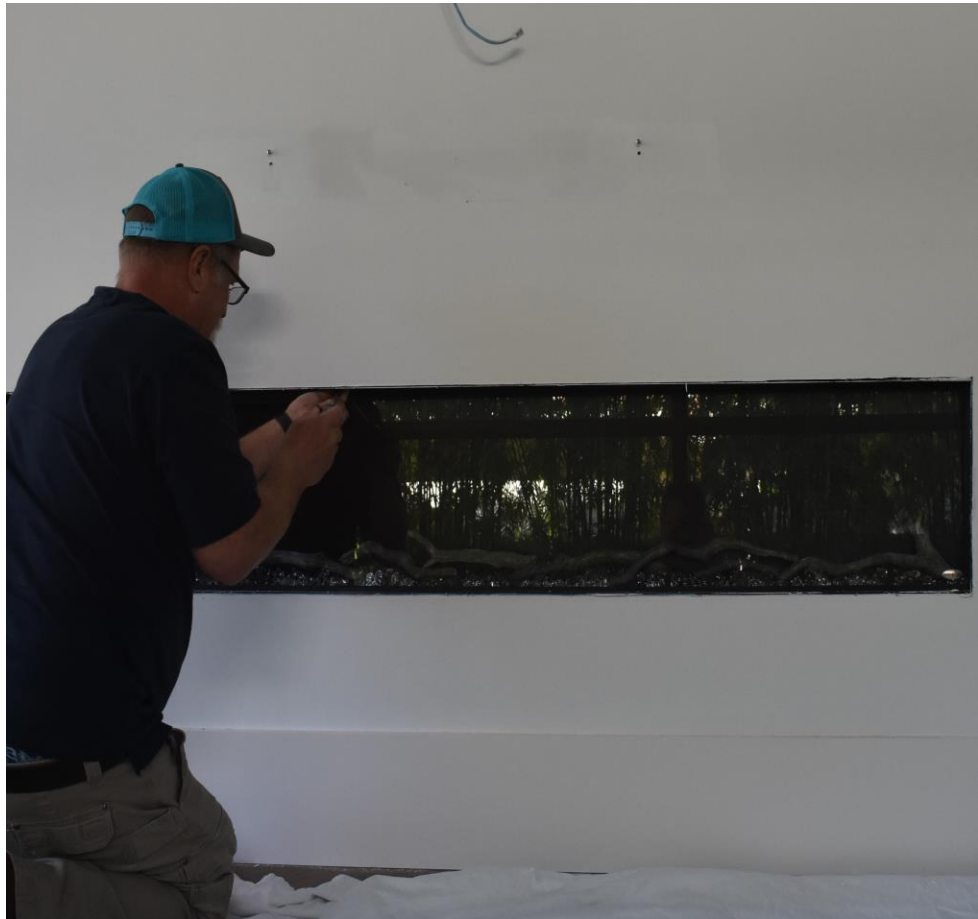
## 2019 Wall Mounted Fireplace

**Not identified in the original or as-built drawings.**

**Also, not identified in any cut sheet.**

**Therefore, was not a permitted improvement.**

**Clear Code Violation.**

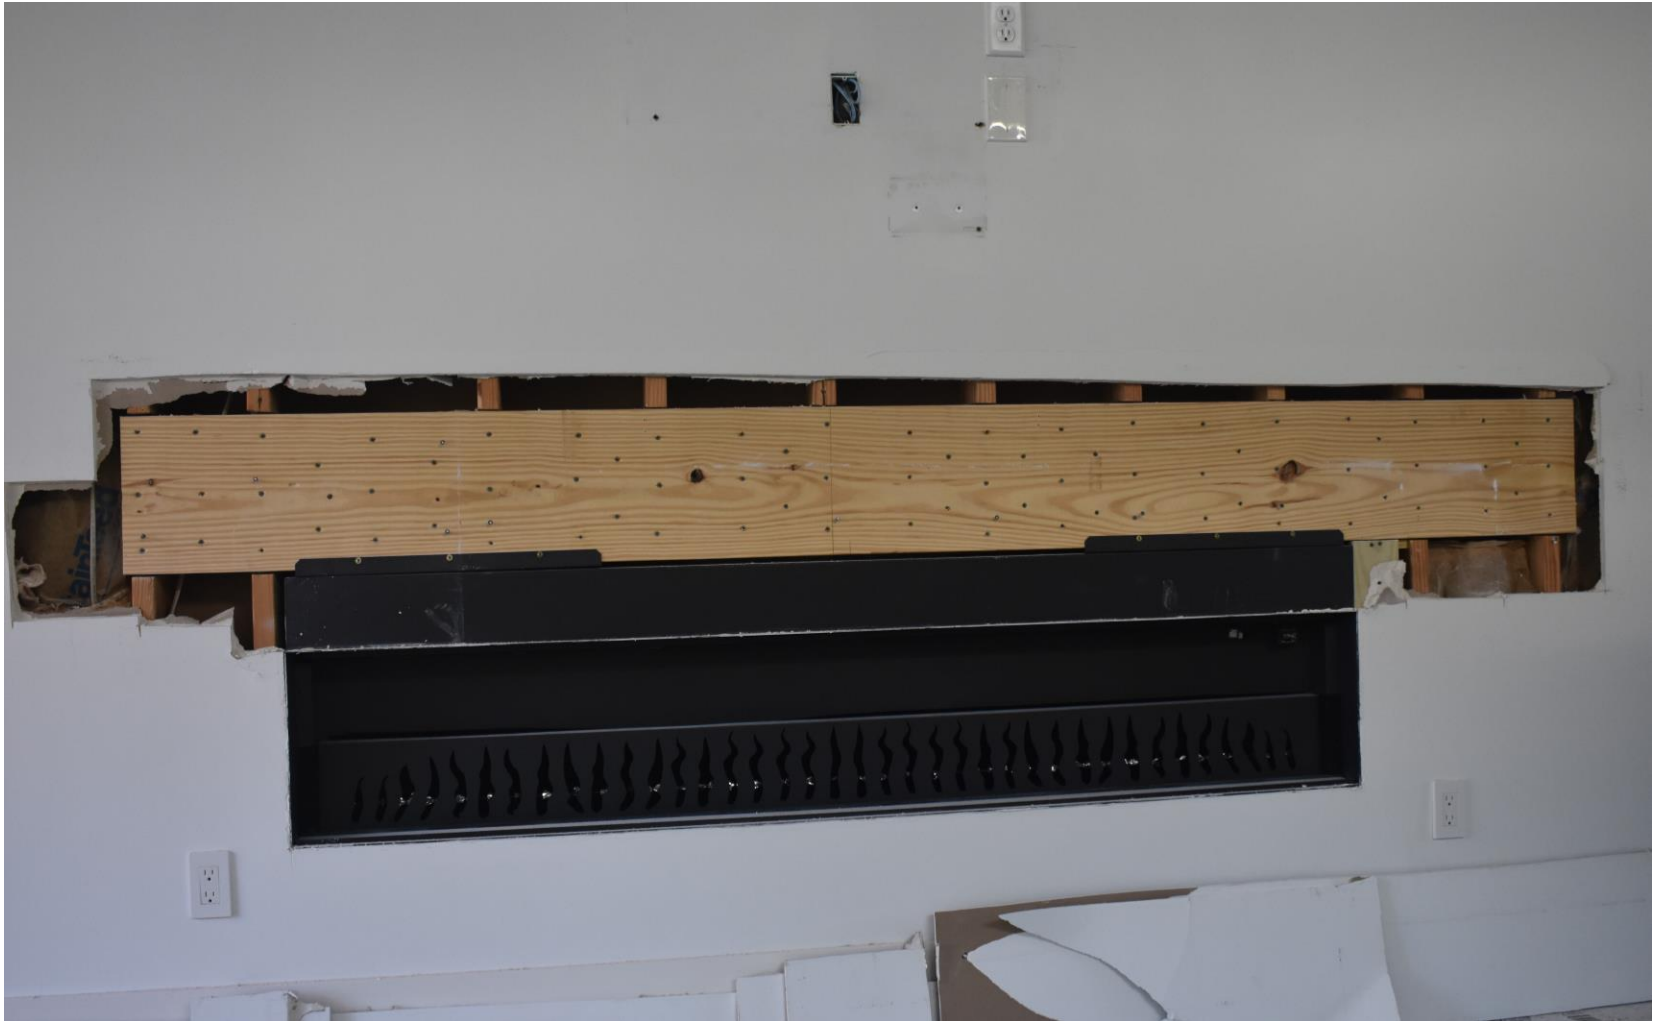
## 2023 Compromised Stud Wall

Initial view of the fireplace insert with the header exposed.

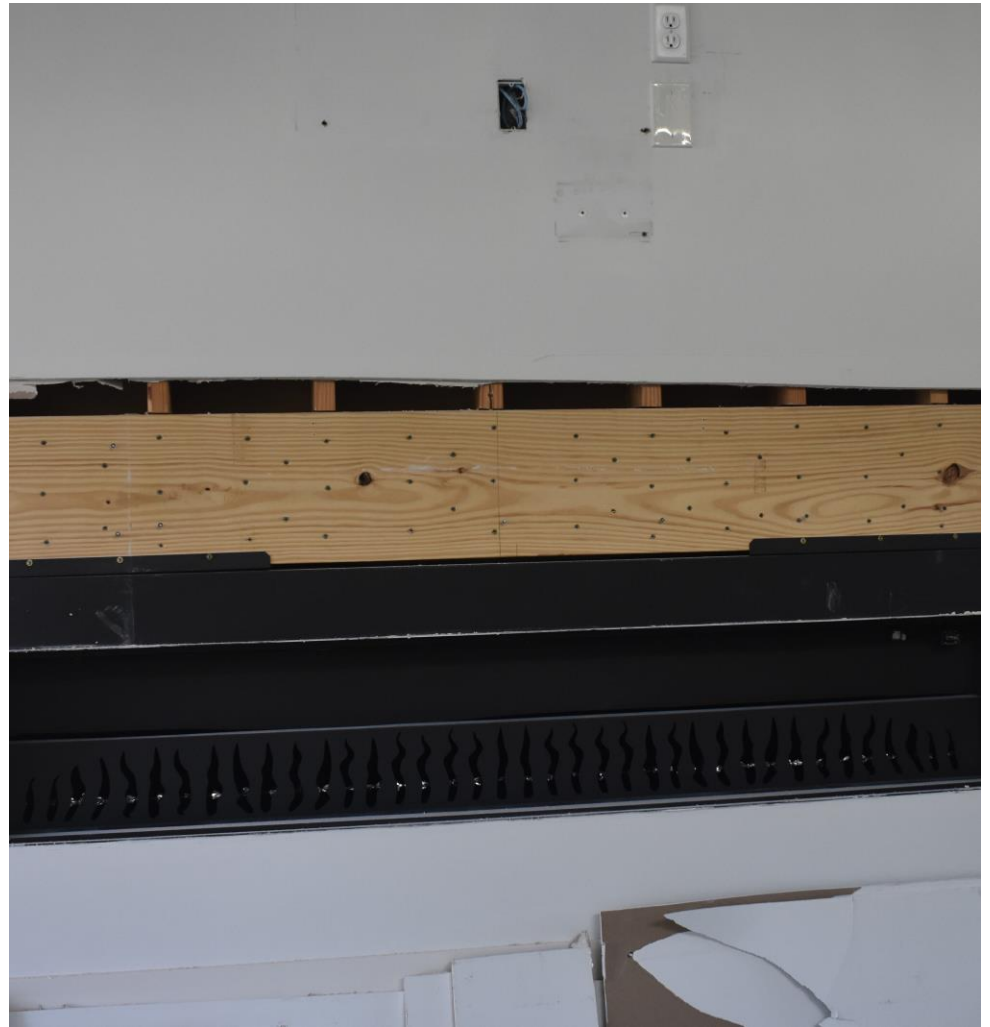
# 2023 Compromised Stud Wall

Wall is designed as load bearing using 2x6 studs on 12-inch centers from top of wall to slab.

The header used is two 2 x 12s that are screwed together.

Studs were cut out to accommodate the fireplace insert.

Severely compromised wall that no longer functions as load bearing.

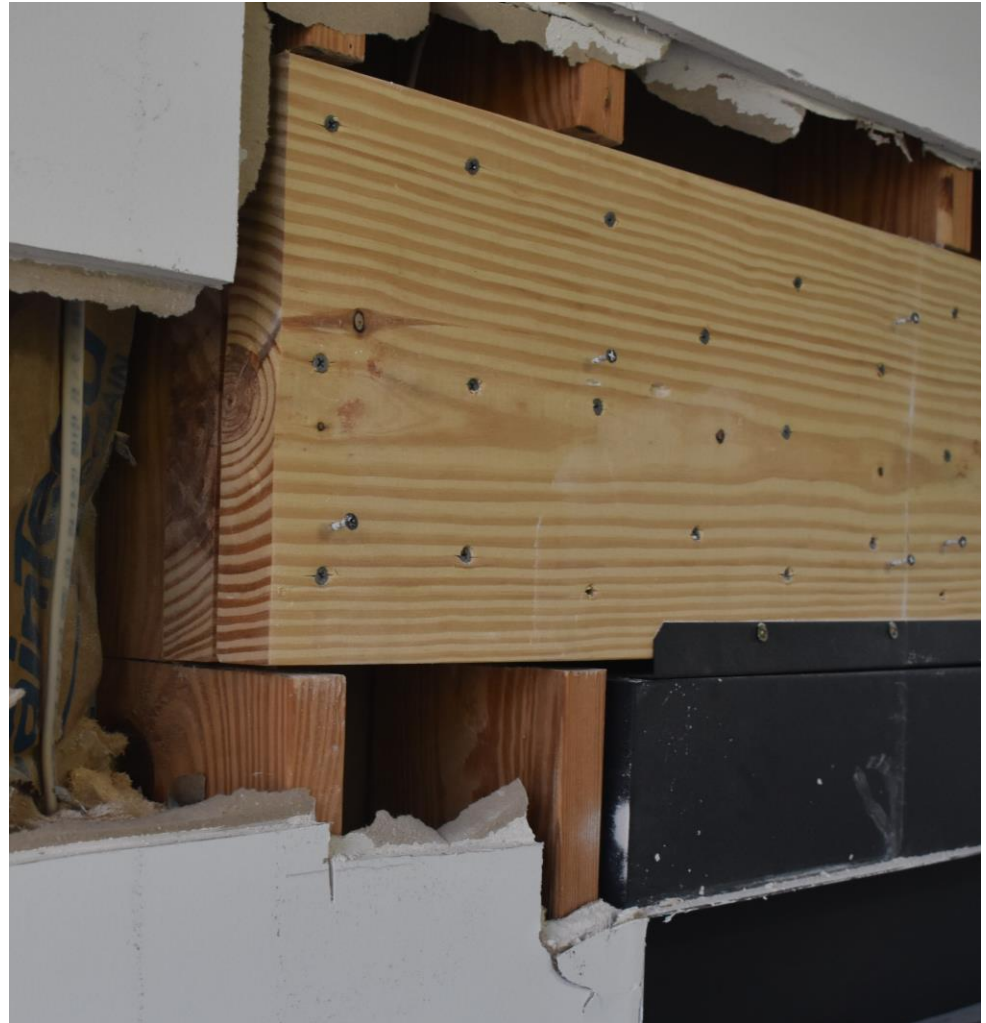
# 2027 Compromised Stud Wall

**Note that header used is not the full width of the wall.**

**No King Stud or Jack stud is used.**

**Clear code violation. Also, requires that the number of jack studs and king studs be calculated. (See Useful Definitions)**

**Would require review by the Engineer of record and approval of the Winter Park Building Department for this significant structural change.**

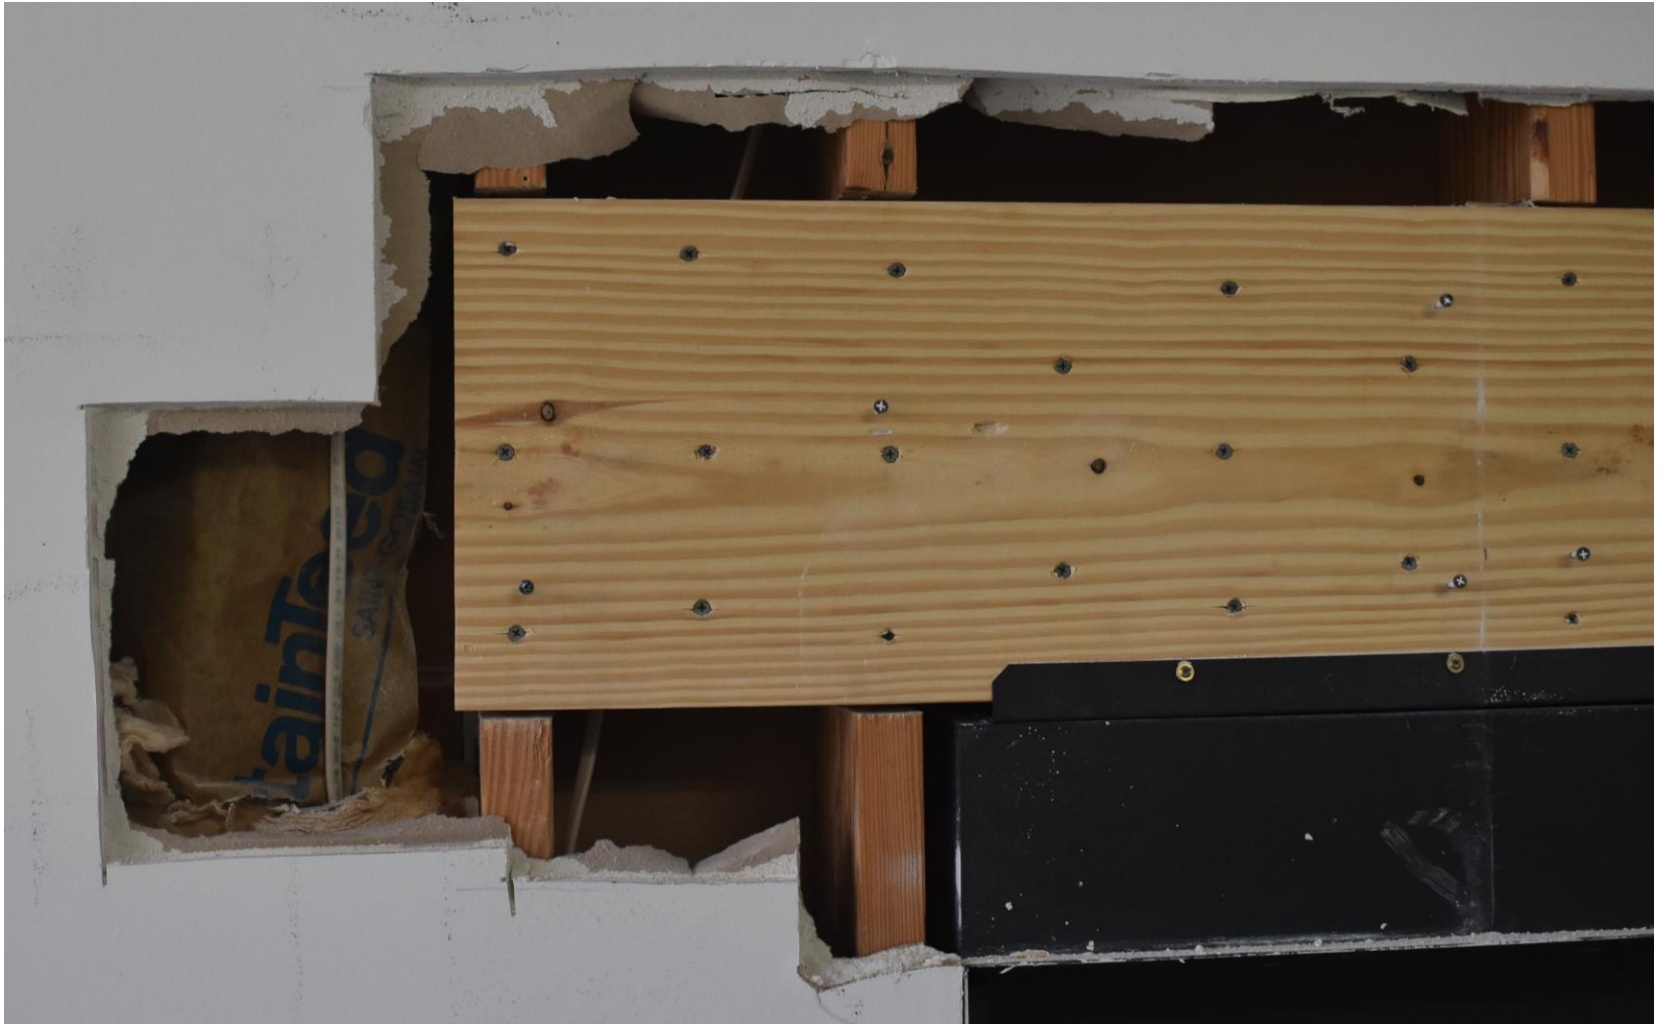
## 2024 Compromised Stud Wall

**Note the gaps between the header and studs.**

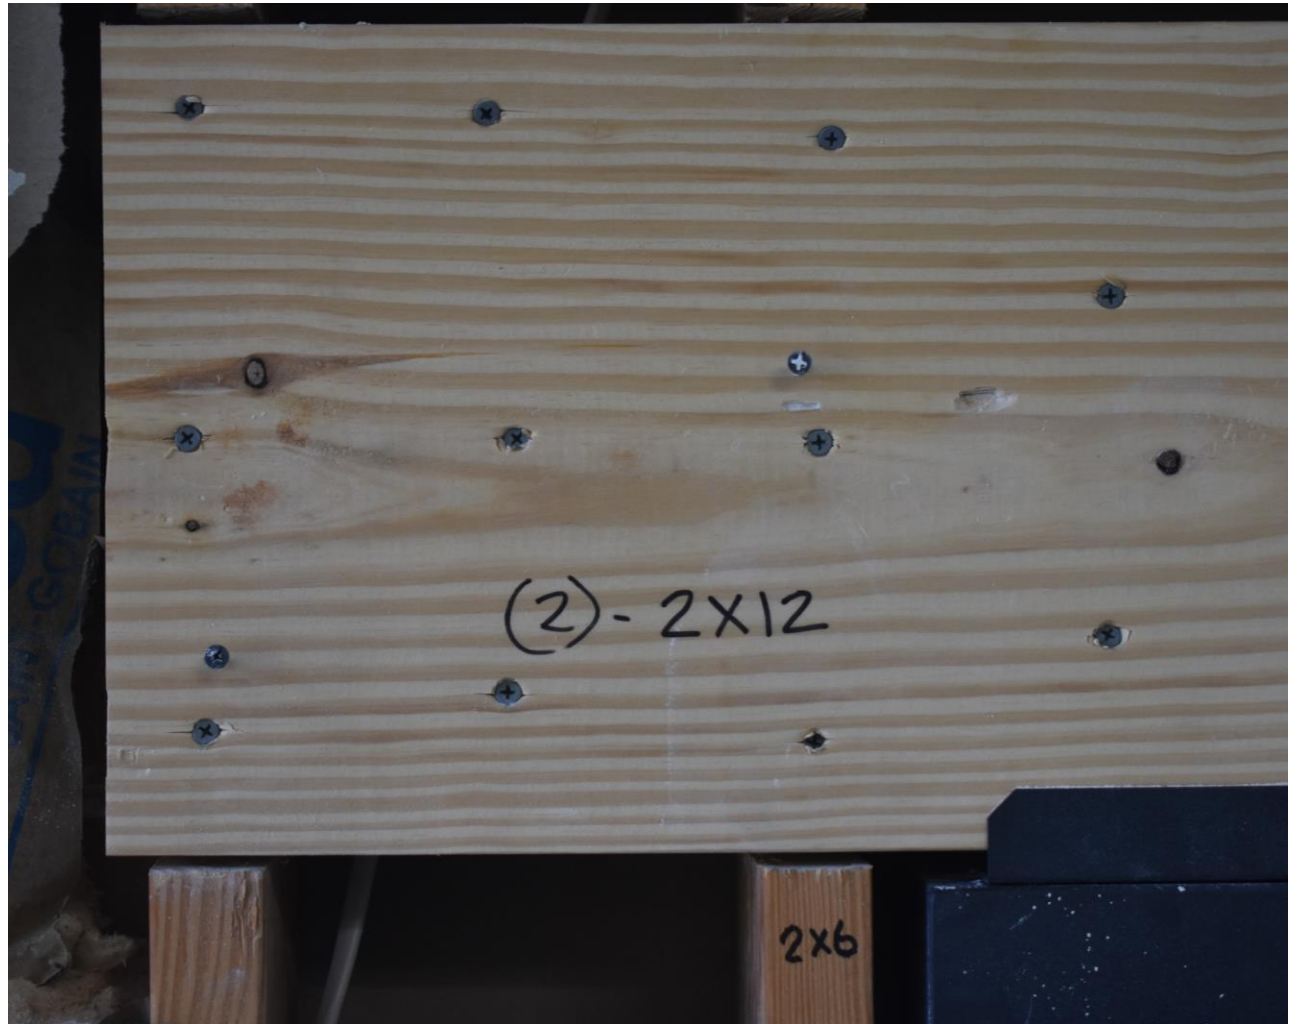
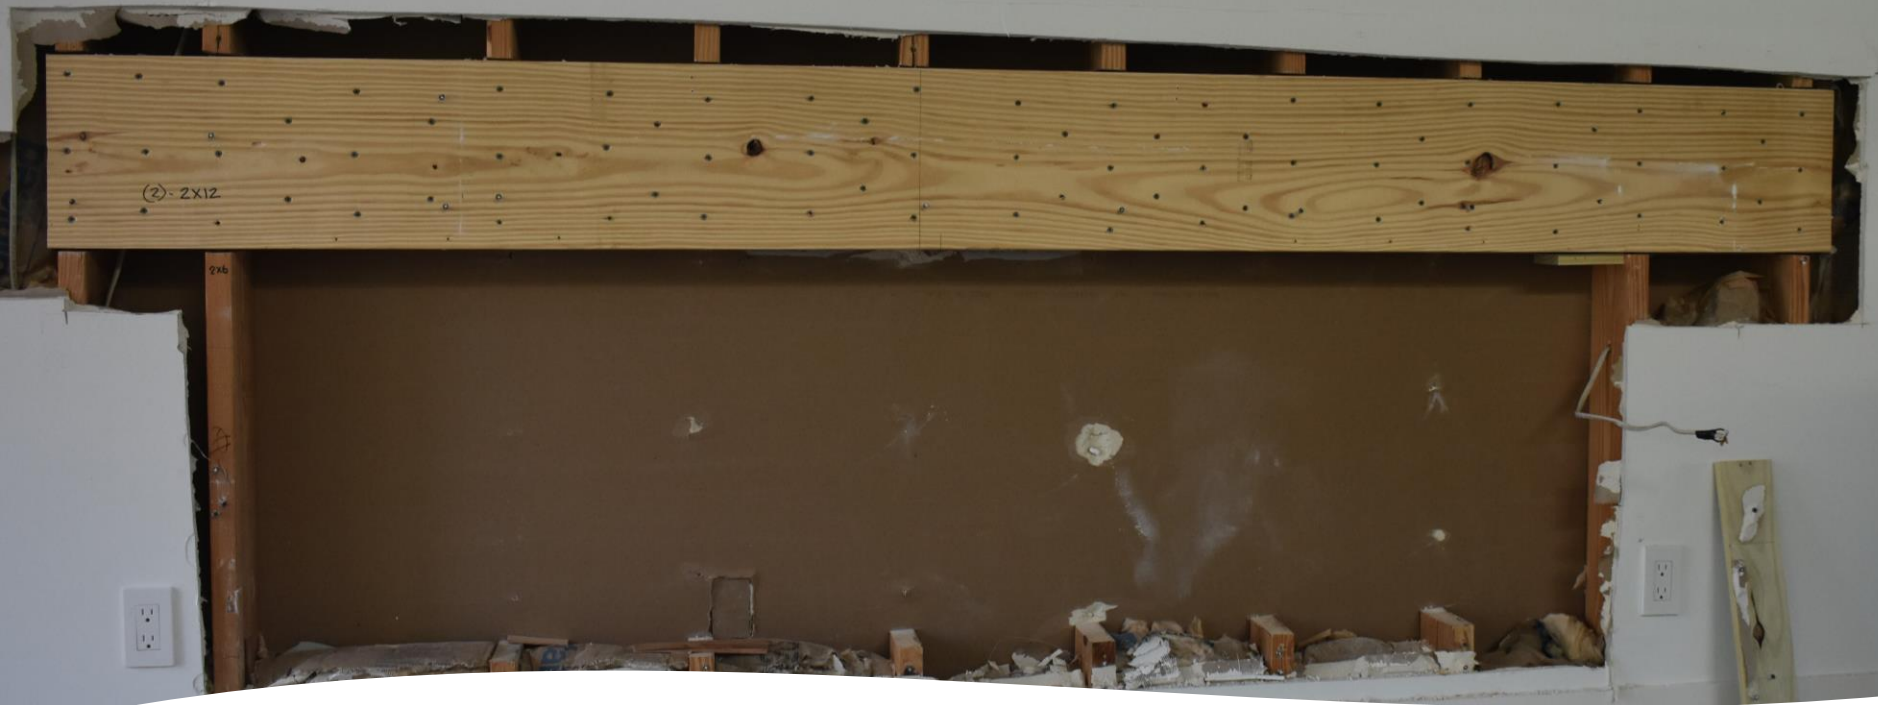
## 2028 Compromised Stud Wall

Observed installation

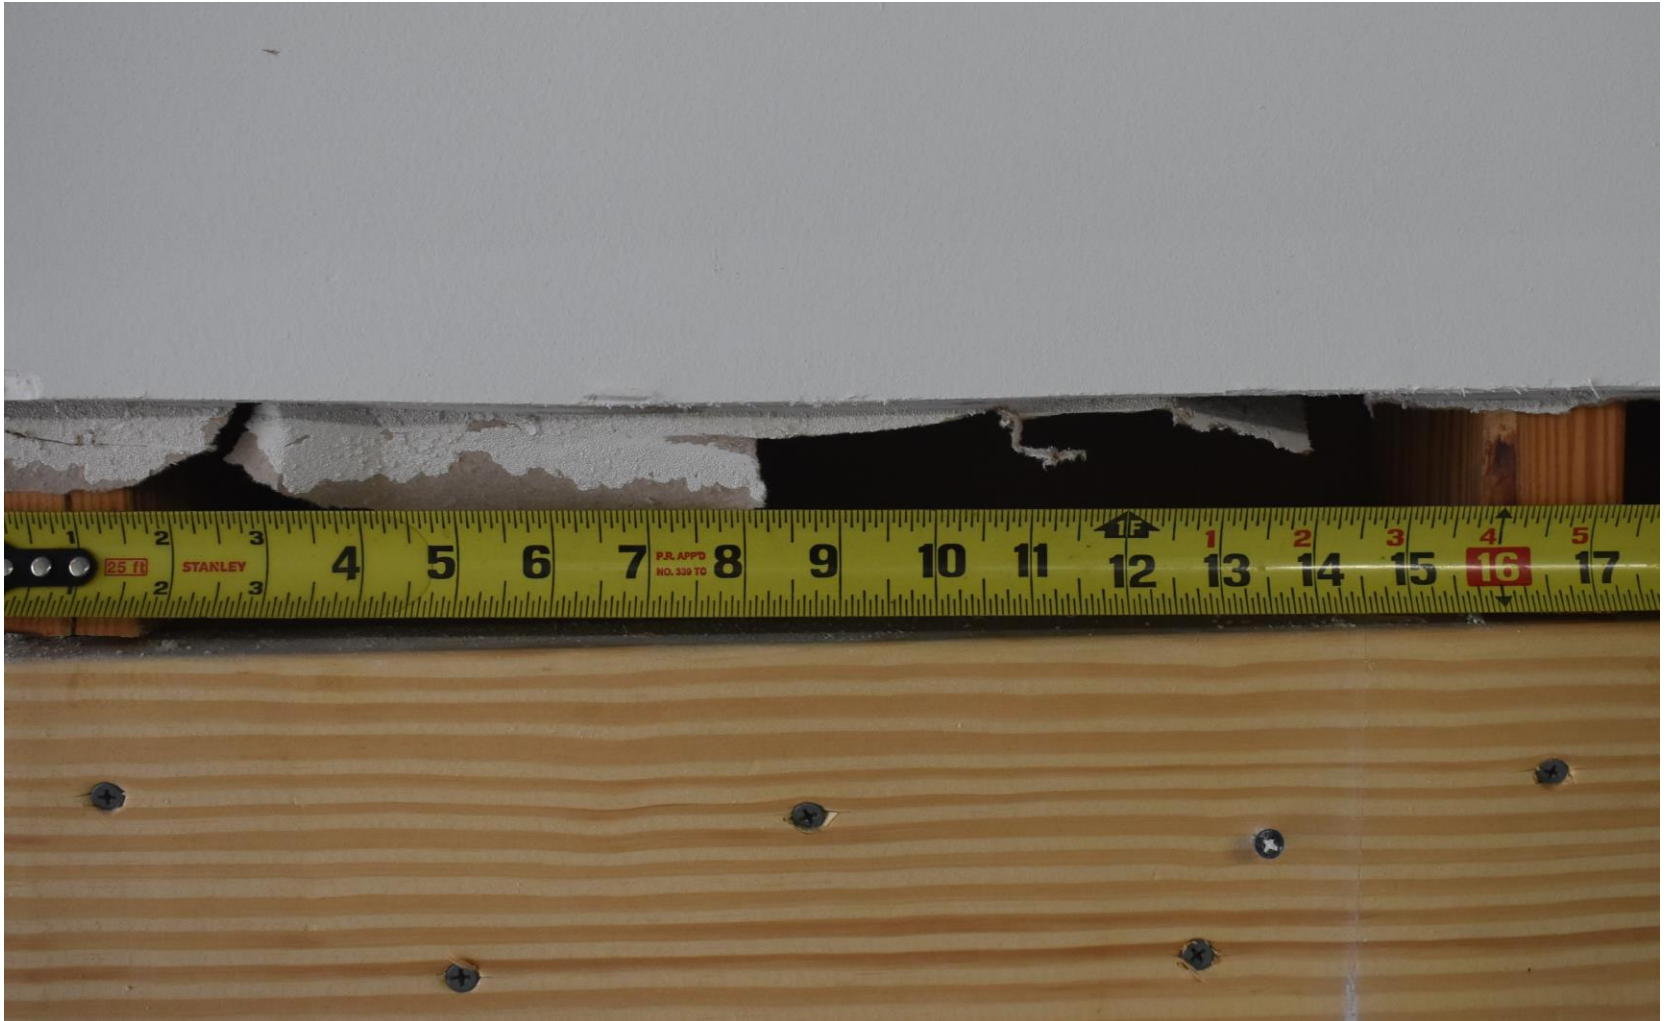
## 2020 Compromised Stud Wall

One stud on load bearing wall not spaced on 12-inch center per drawing. No variation allowed on spacing.

City of Winter Park should have found this during the framing inspection

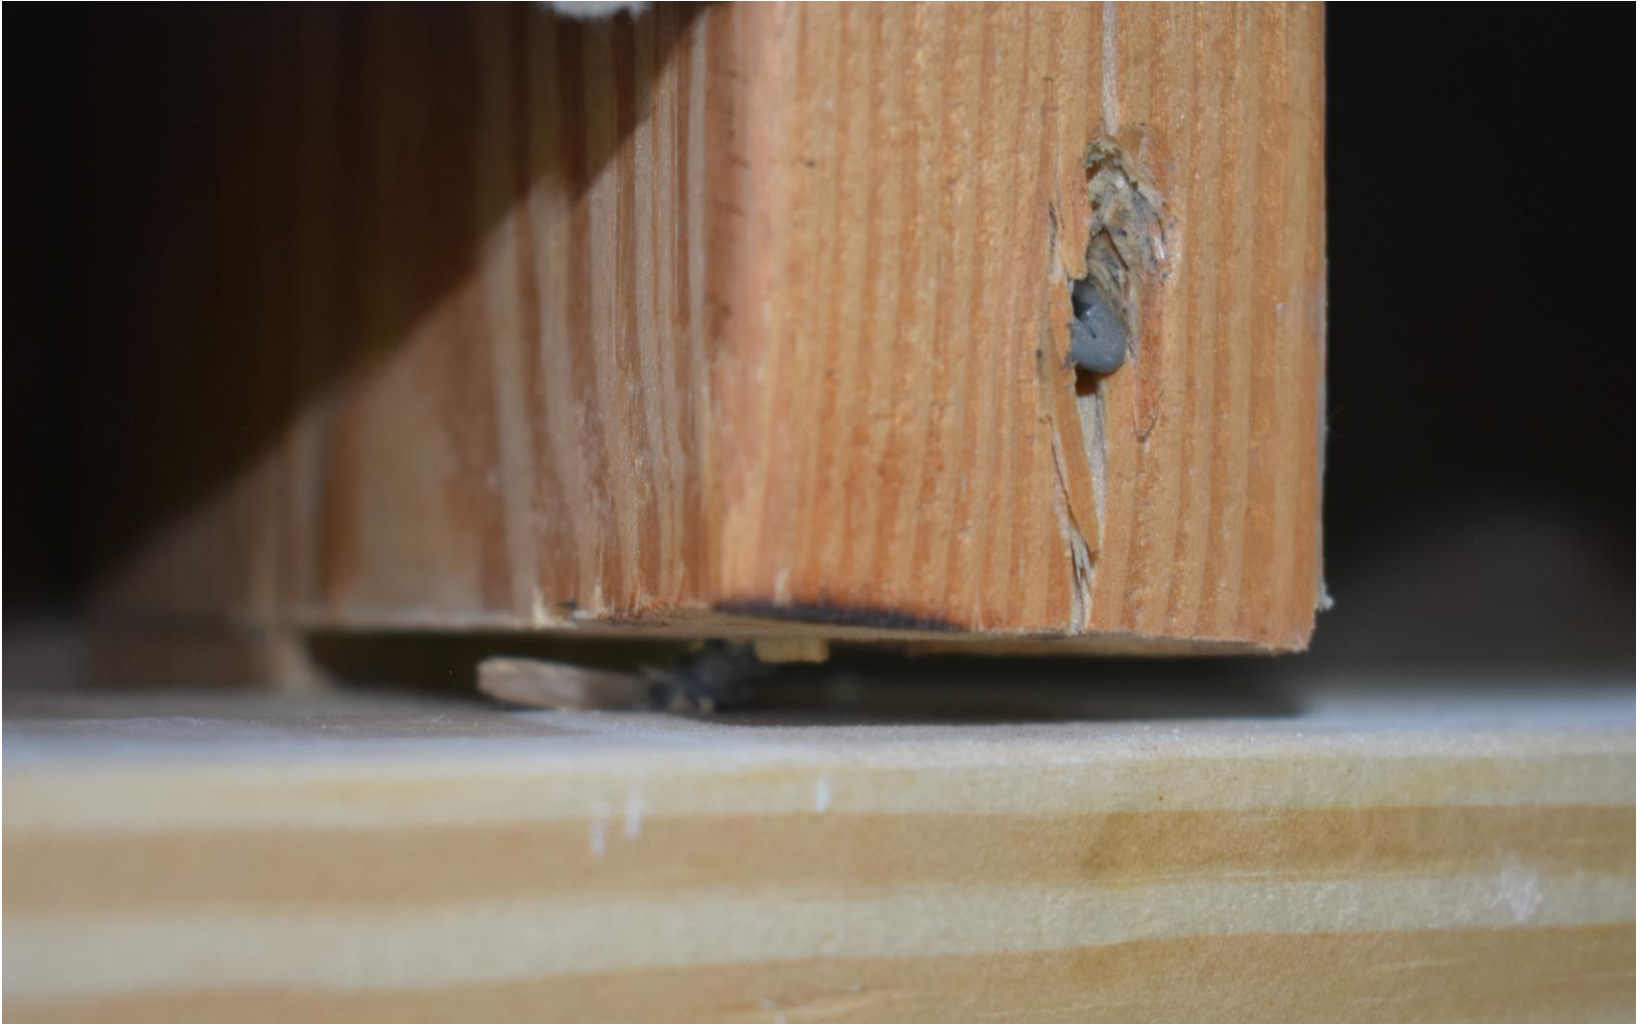
## 2021 Compromised Stud Wall

Wood screw used to secure the header to the stud split the wood. Also note the gap between the stud and header. This violates code and general industry standards.

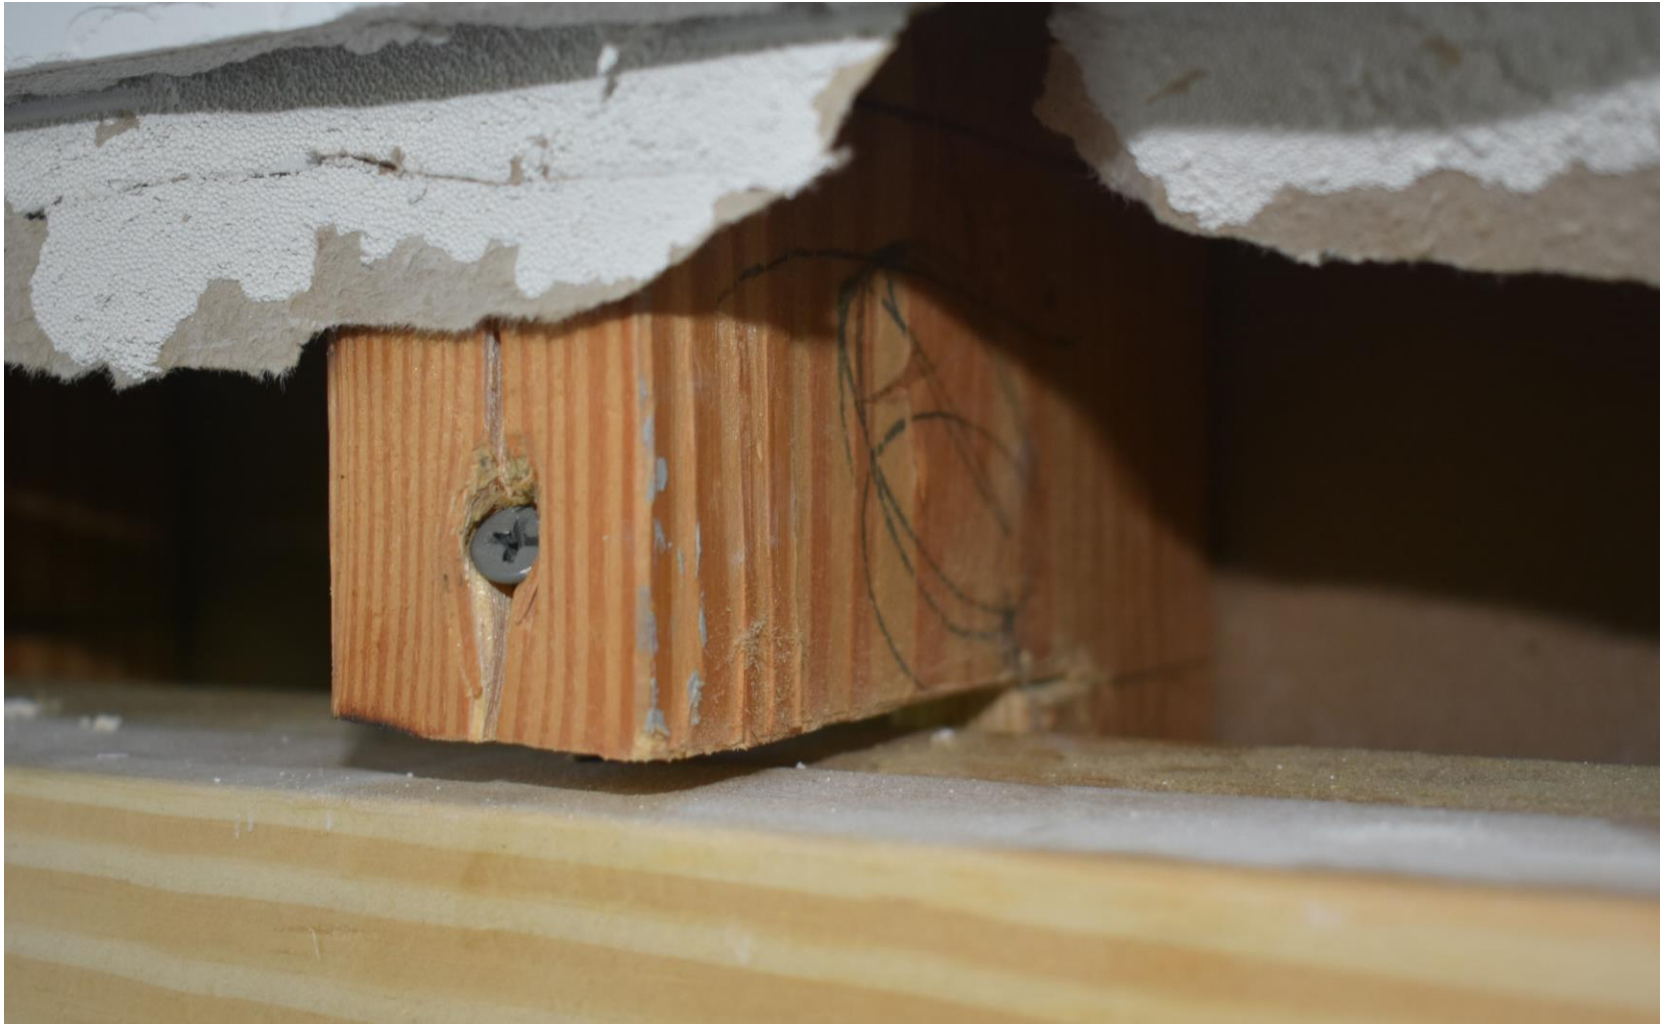
## 2031 Compromised Stud Wall

**Another compromised connection between stud and header.**

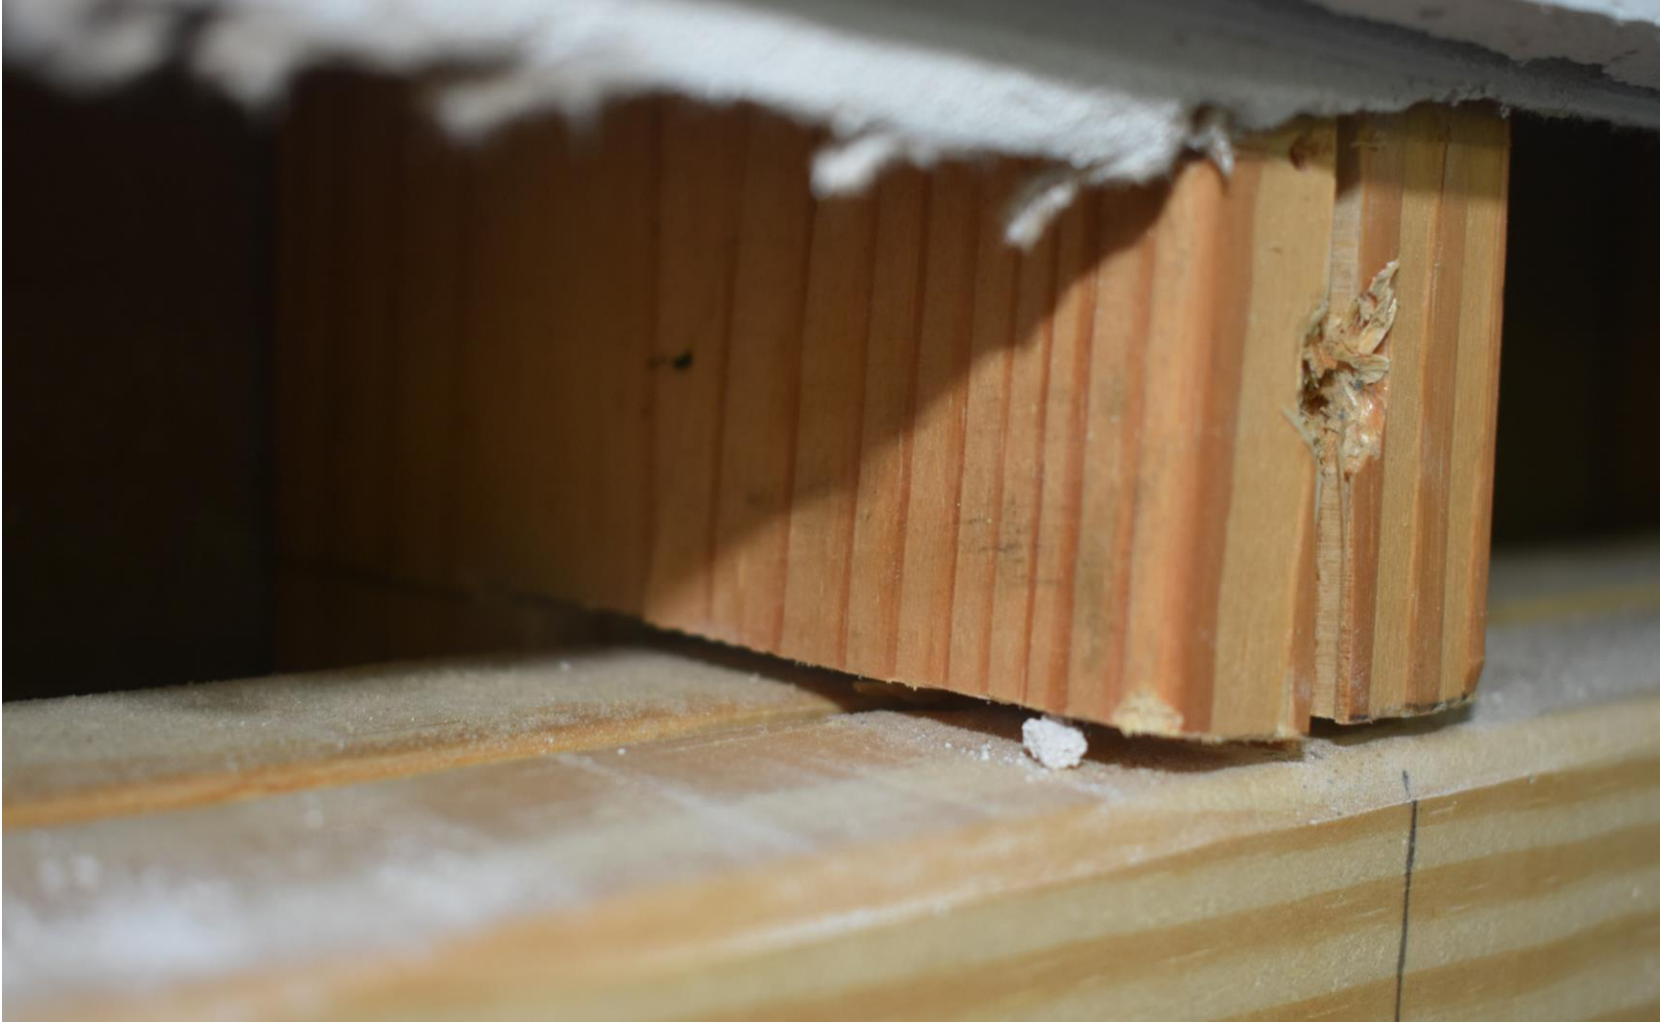
## 2032 Compromised Stud Wall

Gap issue and split stud.

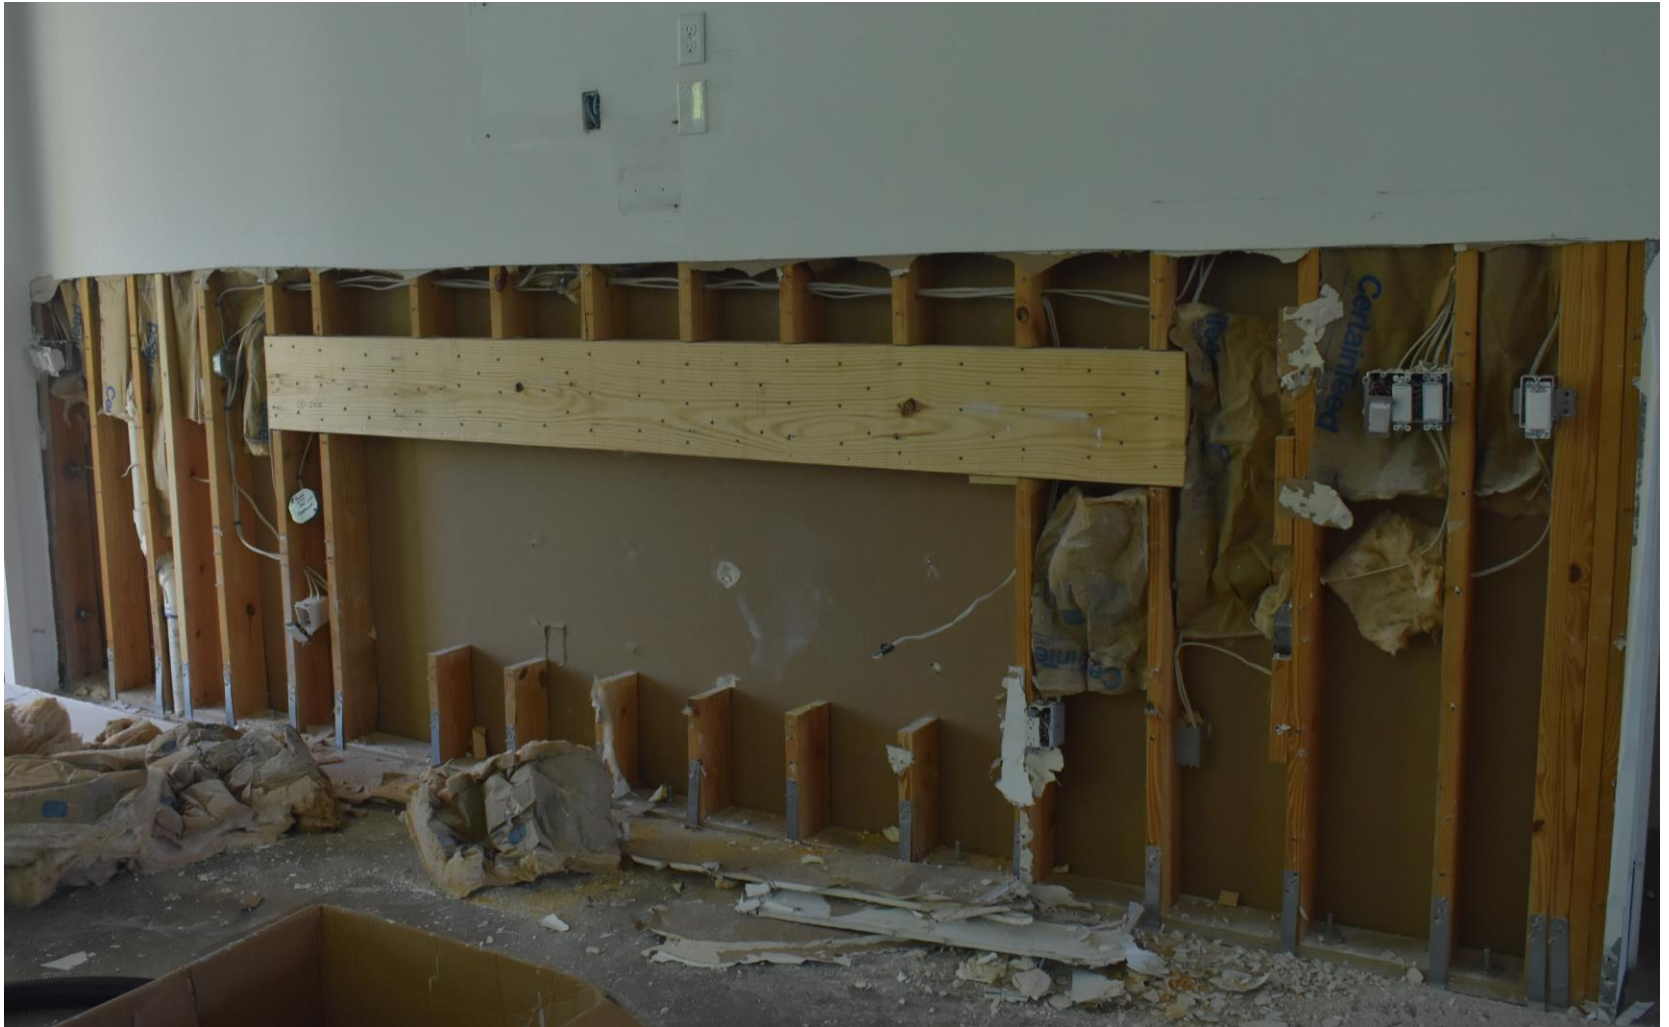
## 2101 Compromised Stud Wall Exposed

Drywall removed for a height of roughly 4 feet to reveal construction methods, materials and compliance to code.

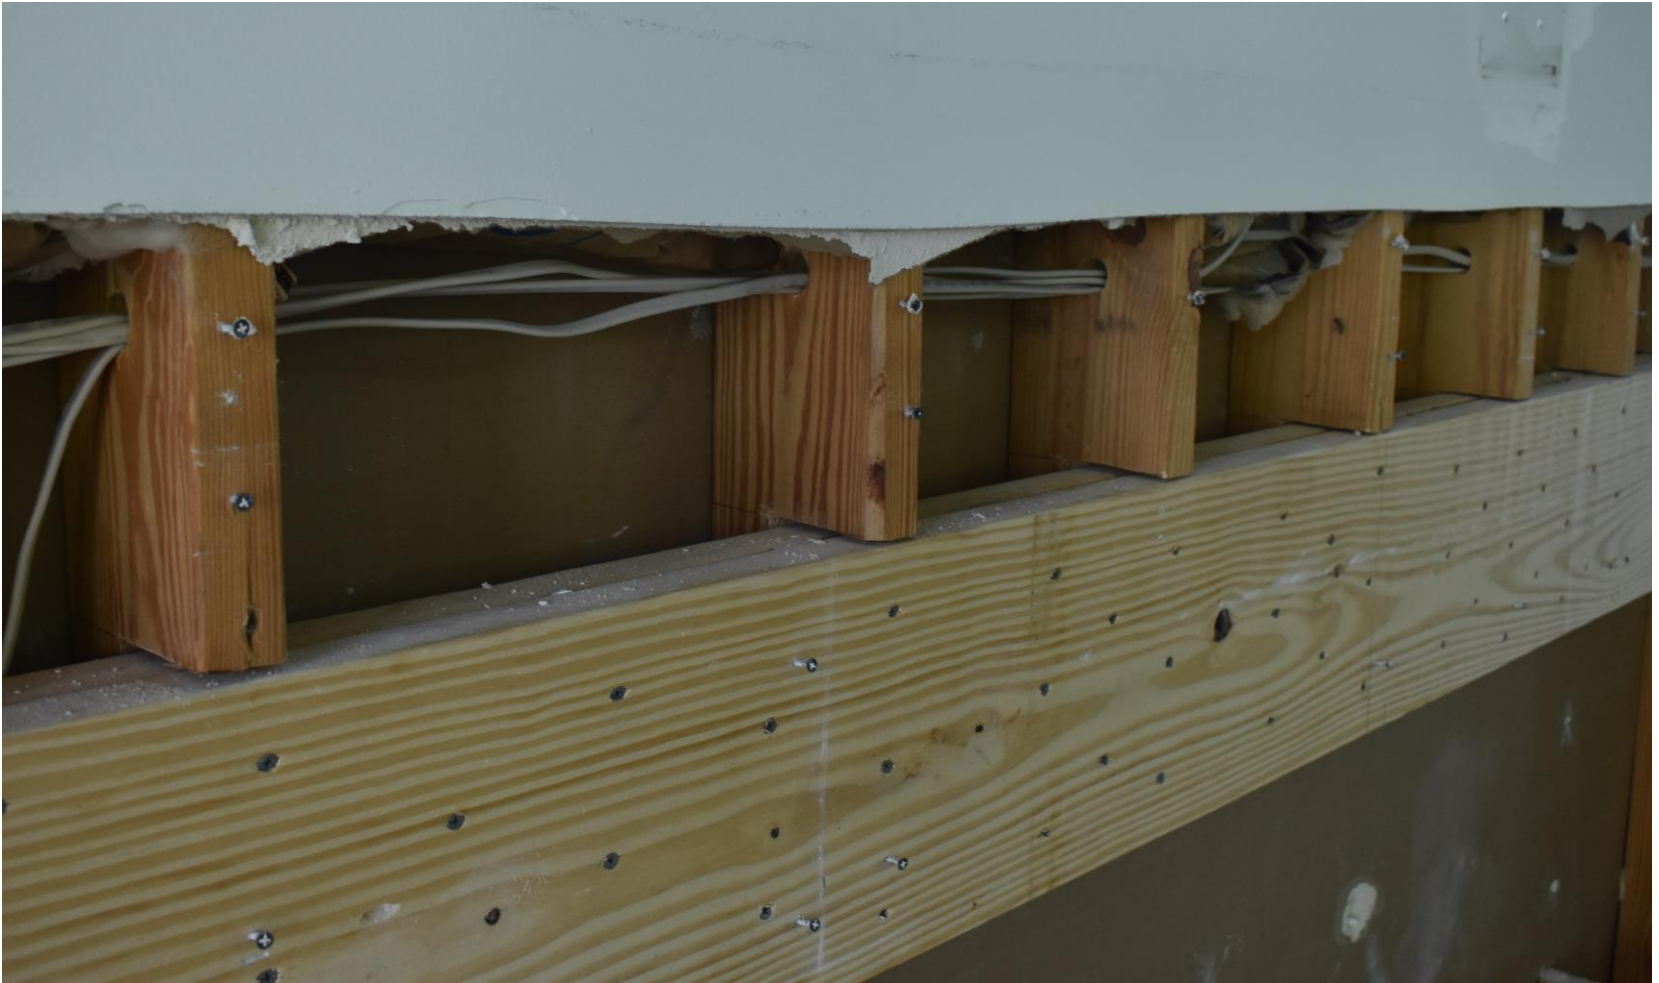
## 2107 Compromised Stud Wall

Gaps ranging from one quarter inch to three sixteenth of an inch for every top or bottom connection to a stud. The load does not transfer through a gap. The header is supported by four notched studs without the use of a King or Jack studs. The header is undersized and improperly supported. Clear code violation.

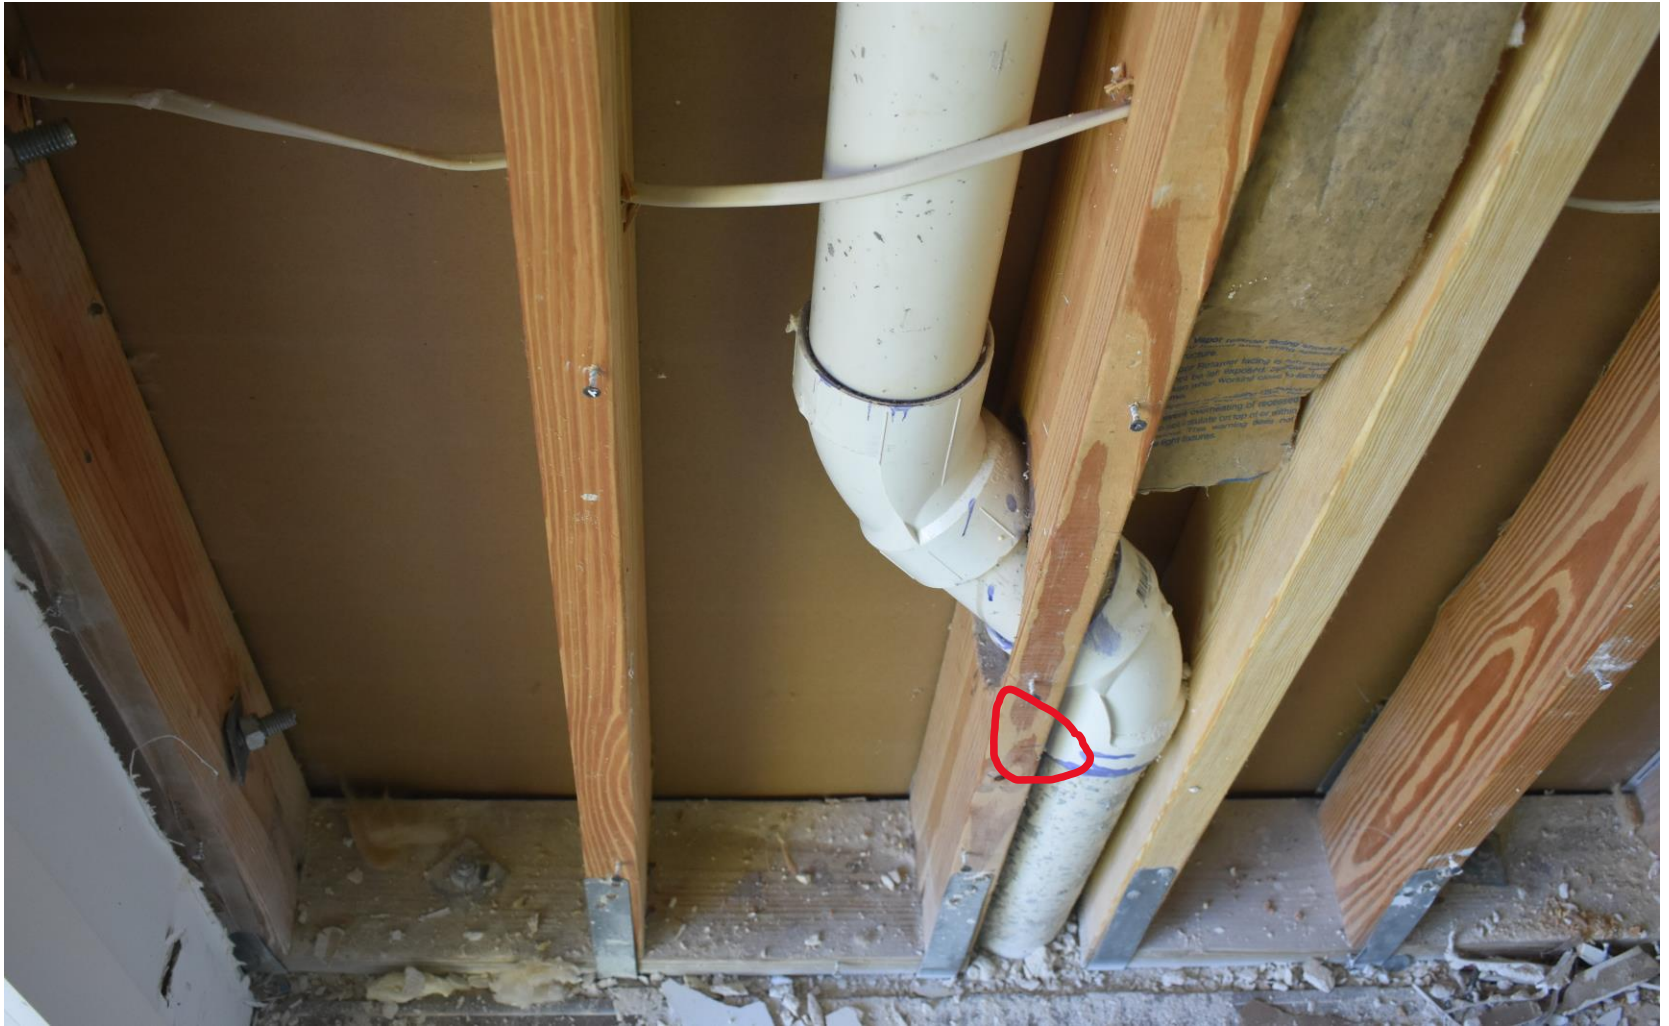
## 2106 Compromised Stud Wall Plumbing

The plumbing rough-in missed the stud spacing and required the load bearing stud to be compromised. The adjacent stud does not appear to run from the base to the top of wall due to blocking in place. Therefore, without a King stud the wall is compromised and does not meet code. Also, no nail plate to protect the pipe from potential screw damage.

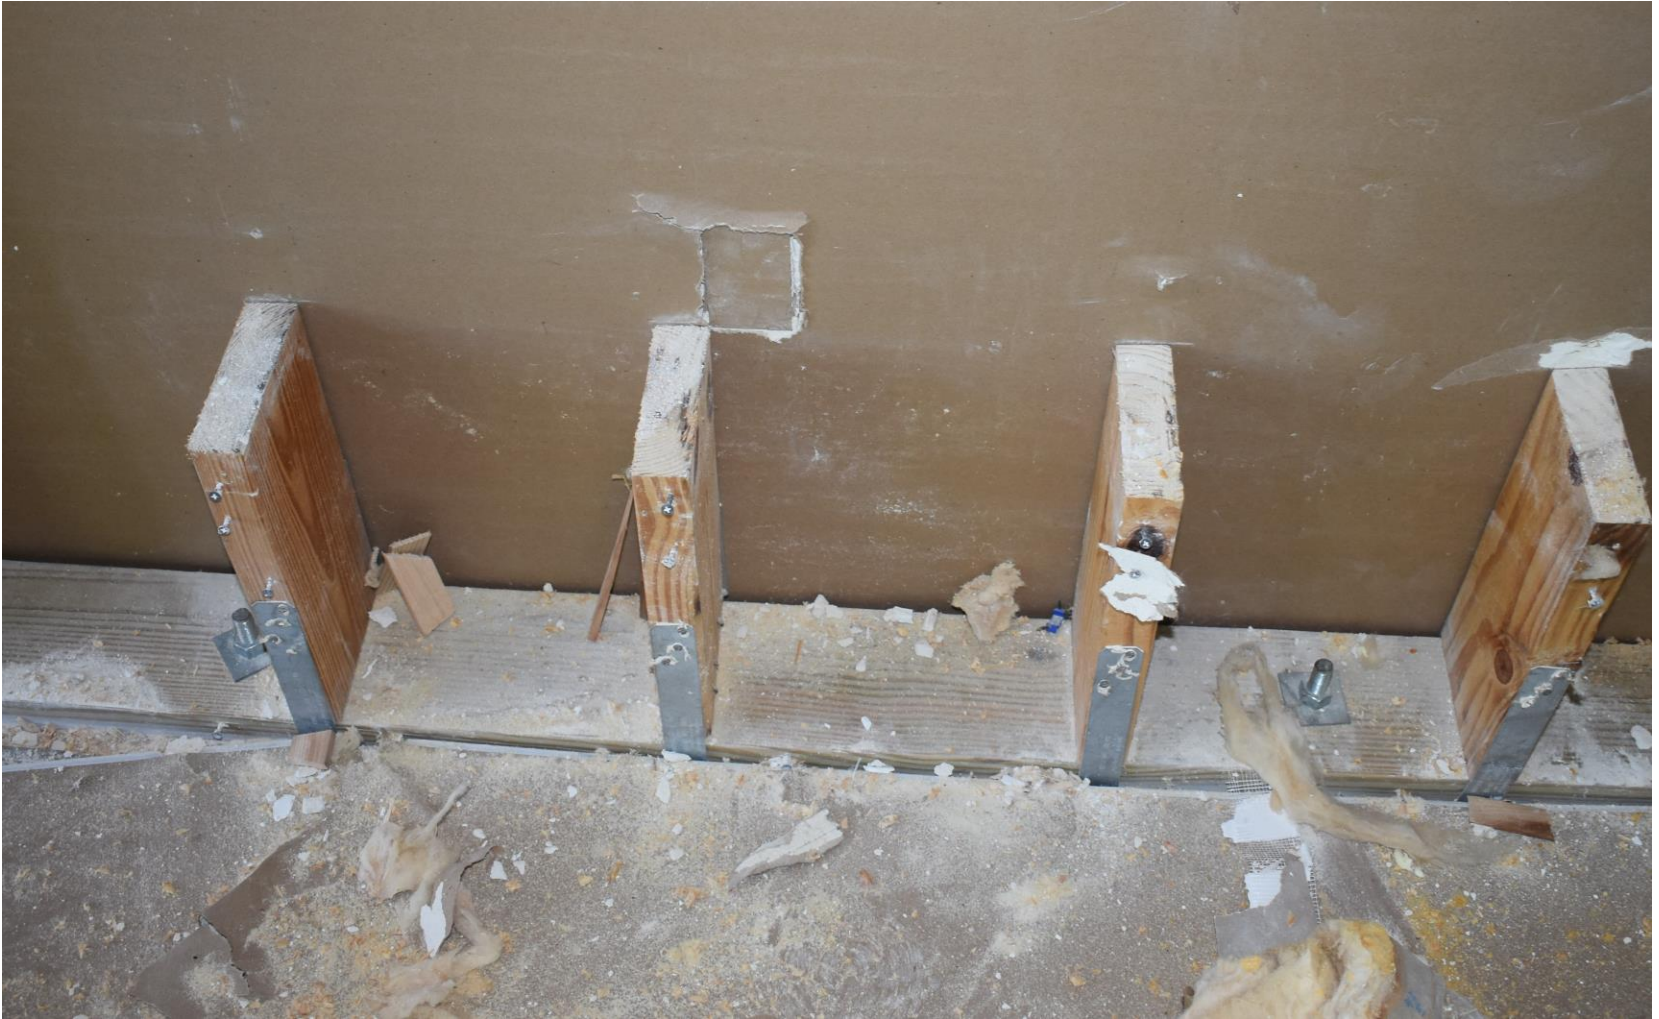
## 2104 Compromised Stud Wall

Closer view of studs that were cut for the fireplace insert and the lack of wood frame to house the insert. Drywall no longer connected to a stud where missing. PT wood base is anchored for this section.
