## **Interior Load Bearing Wall- Family Room**

**These photographs are directly related to the same section of this report  
as identified above.**

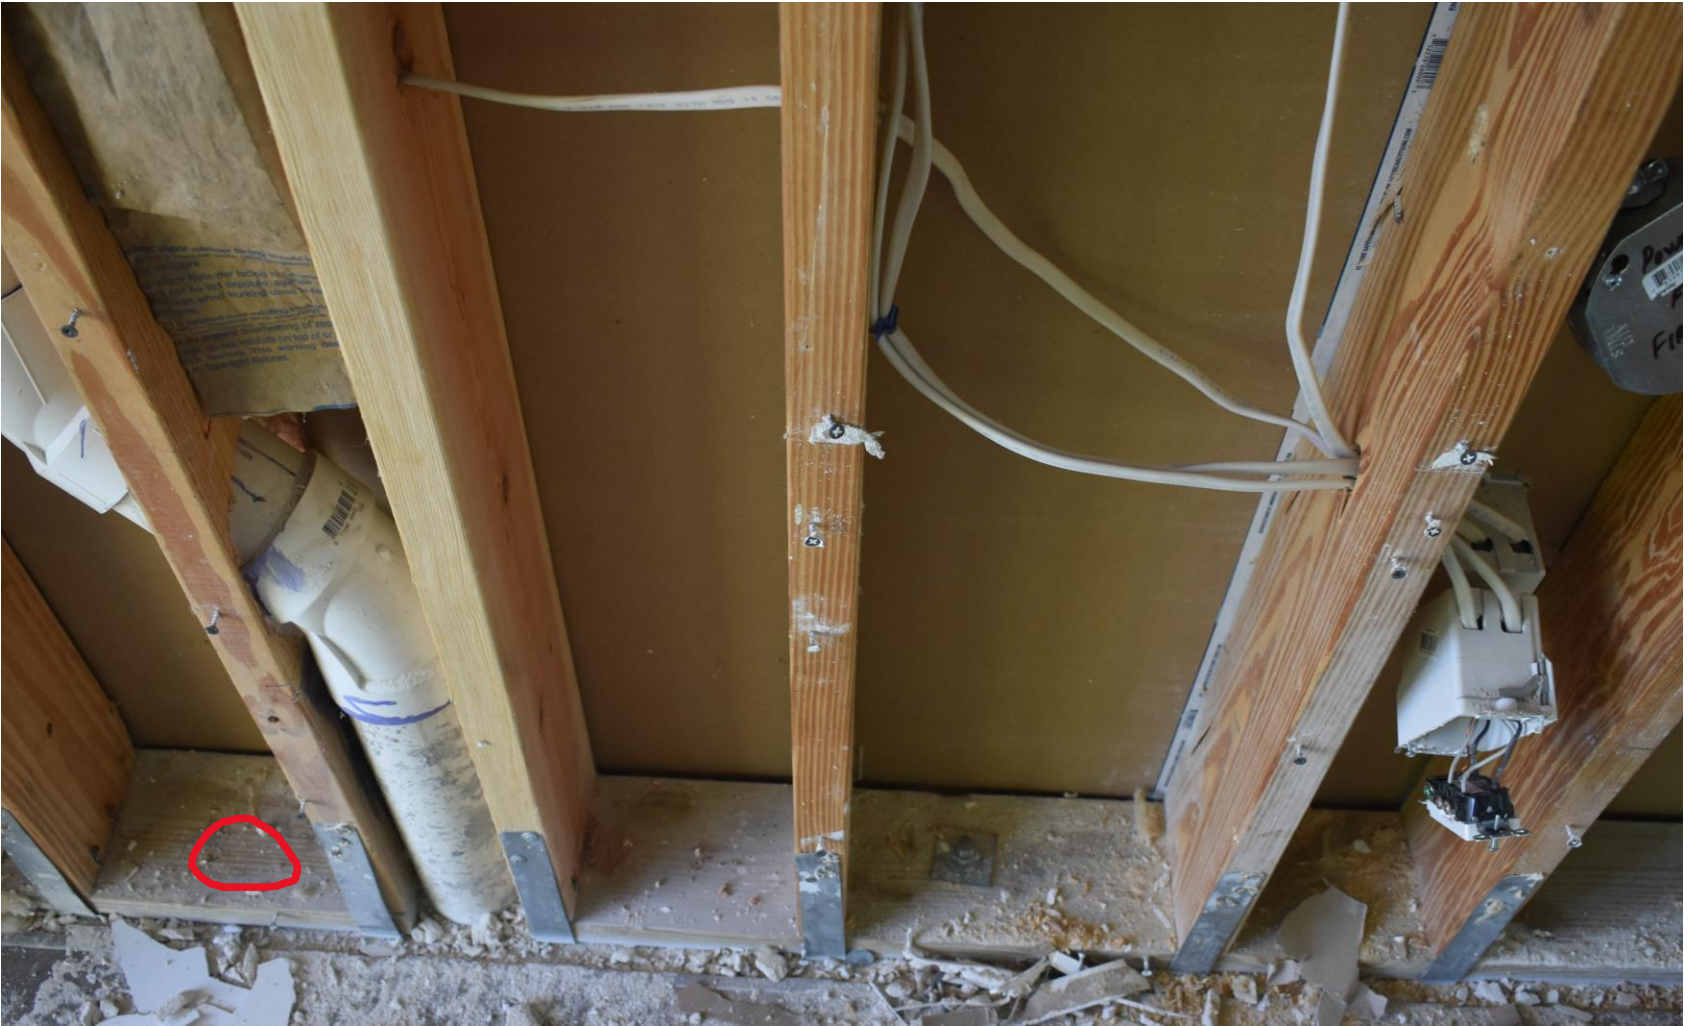
## 2105 Compromised Stud Wall

The pressure treated wood base must be secured with an anchor where the plumbing rough-in penetrates the floor.

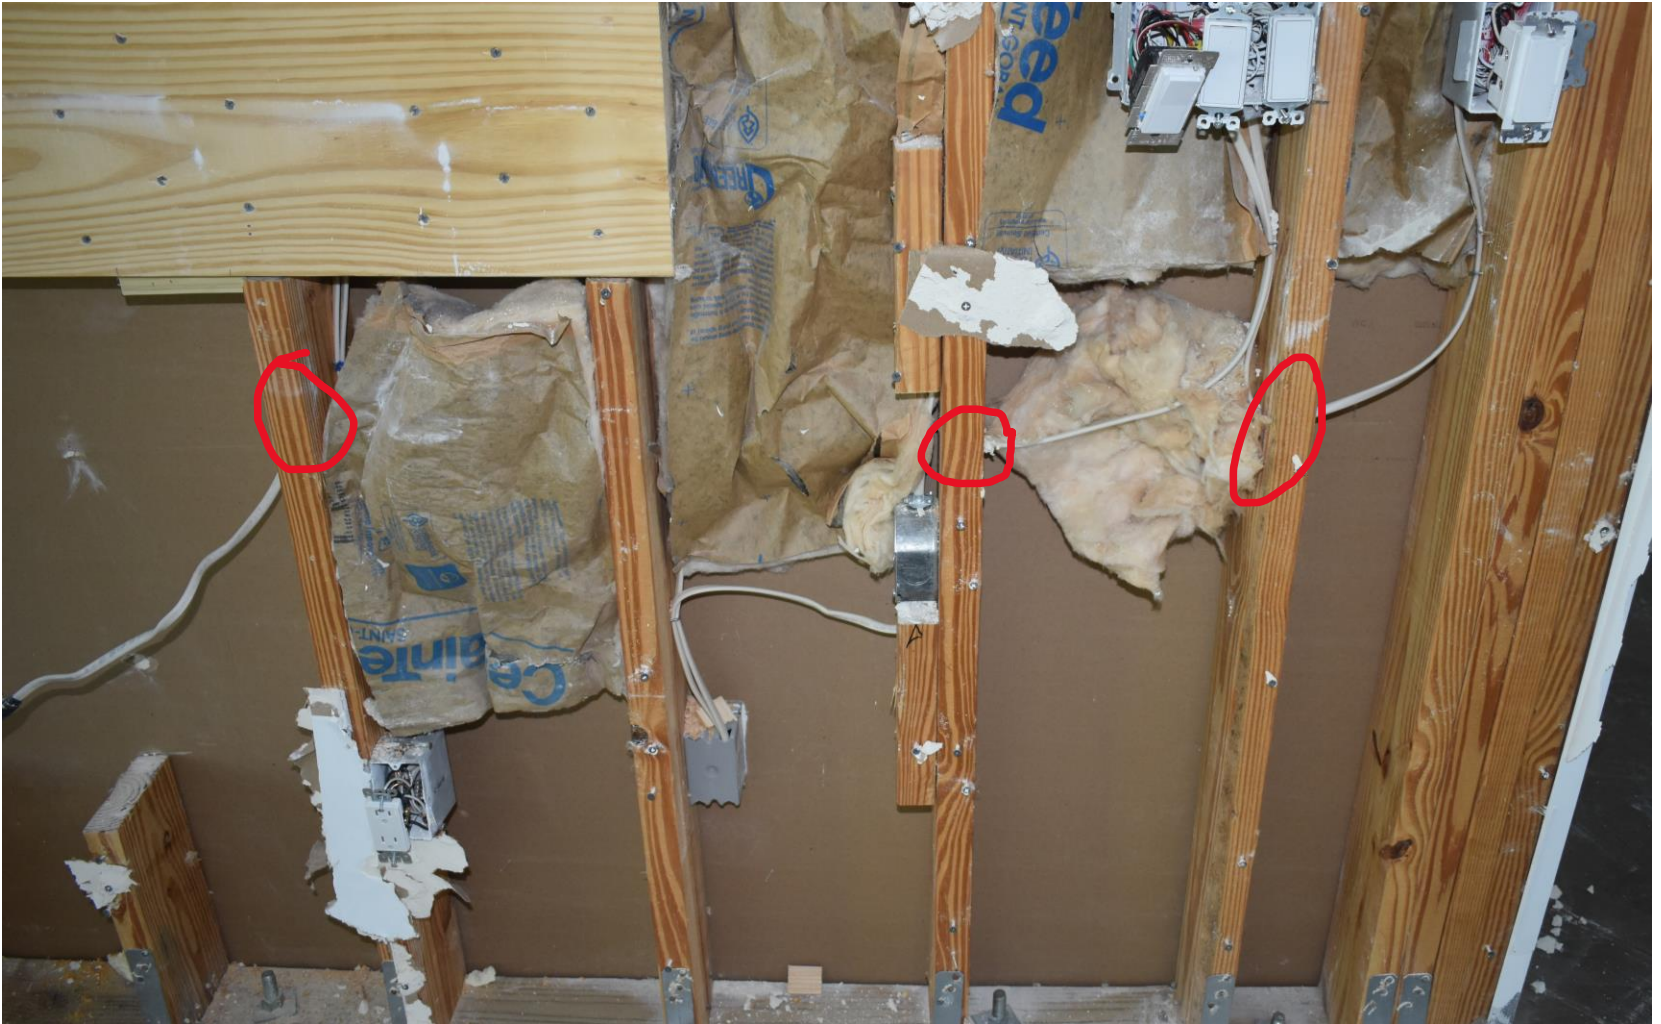
## 2102 Compromised Electrical

No nail plates added to studs to protect wire from potential damage from nail or screw. Base plate is anchored for this section as required by Code.

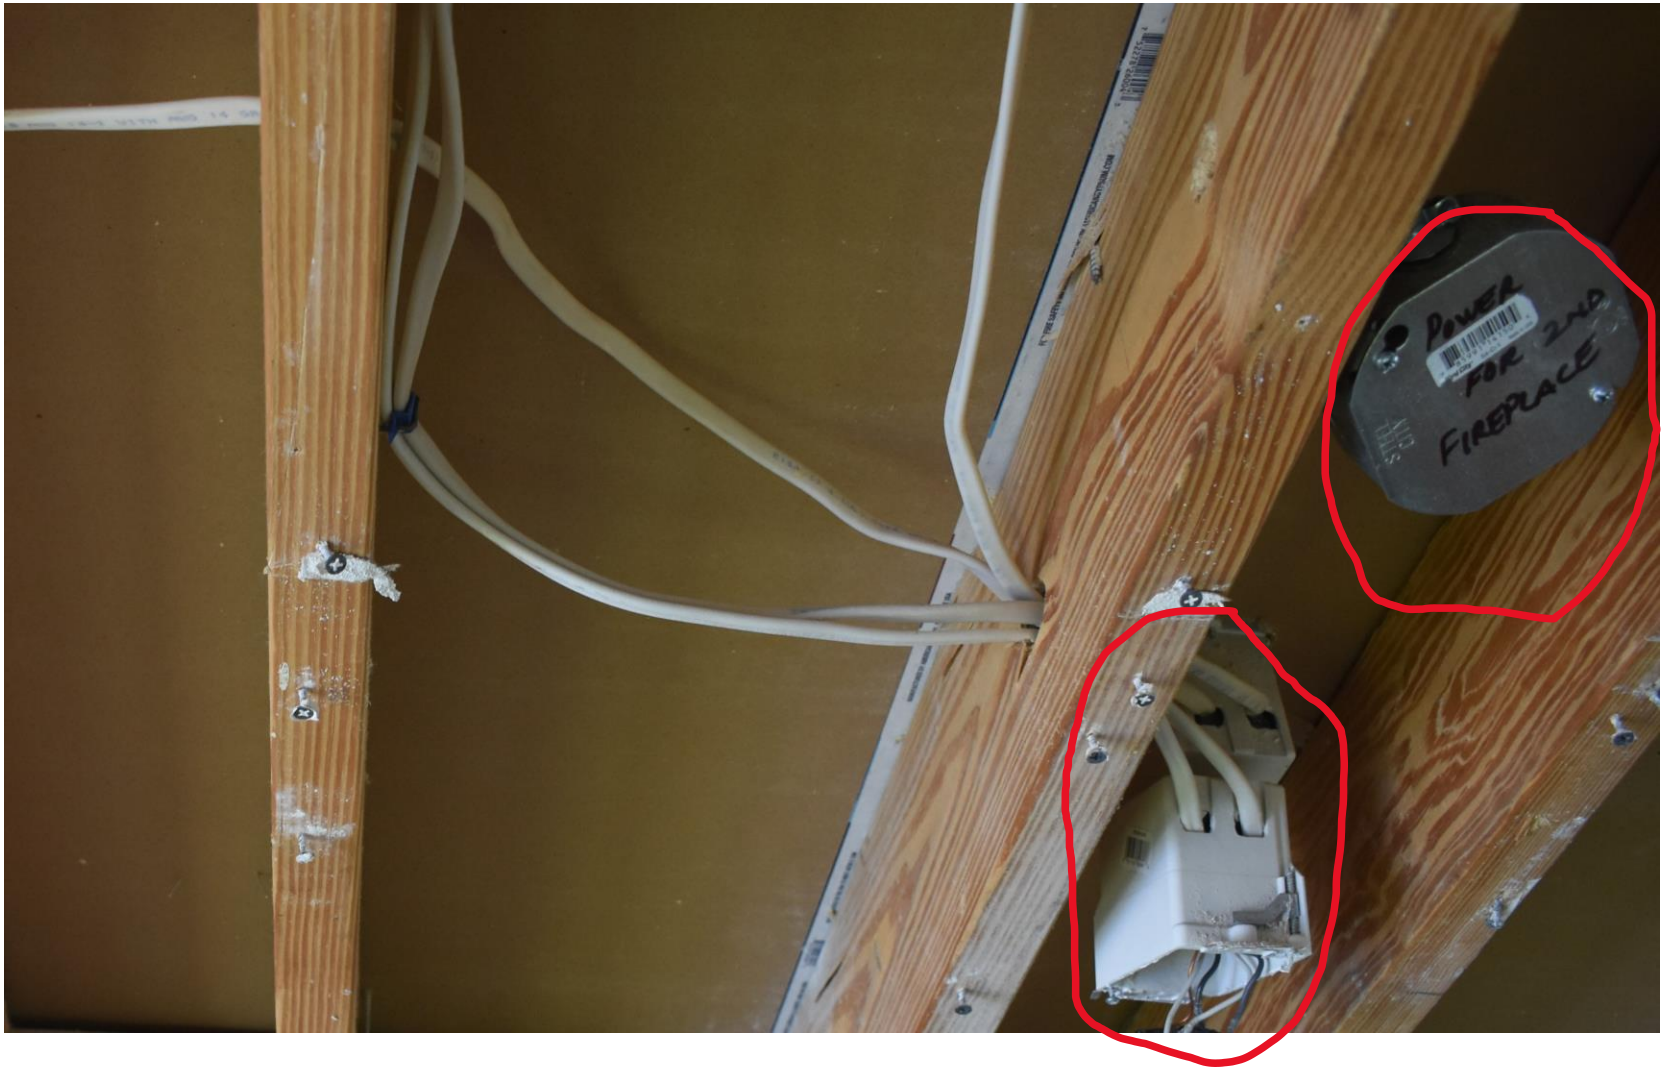
## 2105A Compromised Stud Wall Electric

Note marking on junction box stating power for fireplace that was found when we removed the drywall. Also, the outlet and junction box must be secured to the stud and nail plate added per code.

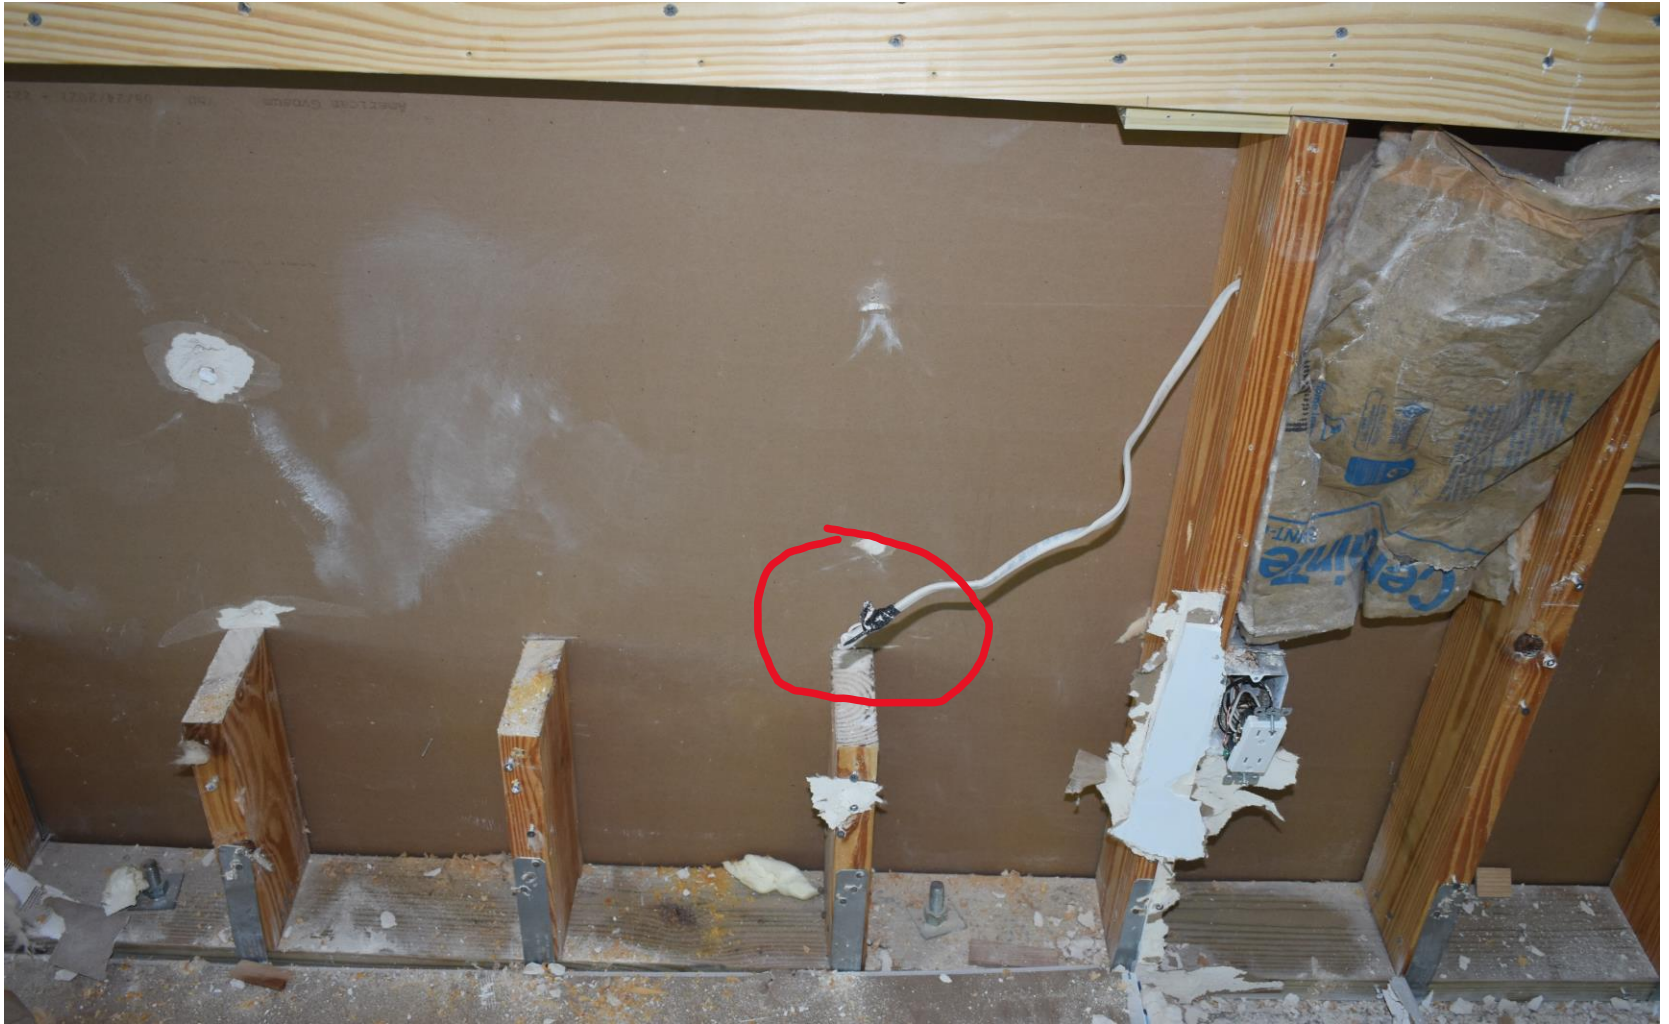
## 2103 Compromised Wall Electric

The wire in the middle of the picture was directly terminated to the fireplace and not to a junction box per code.

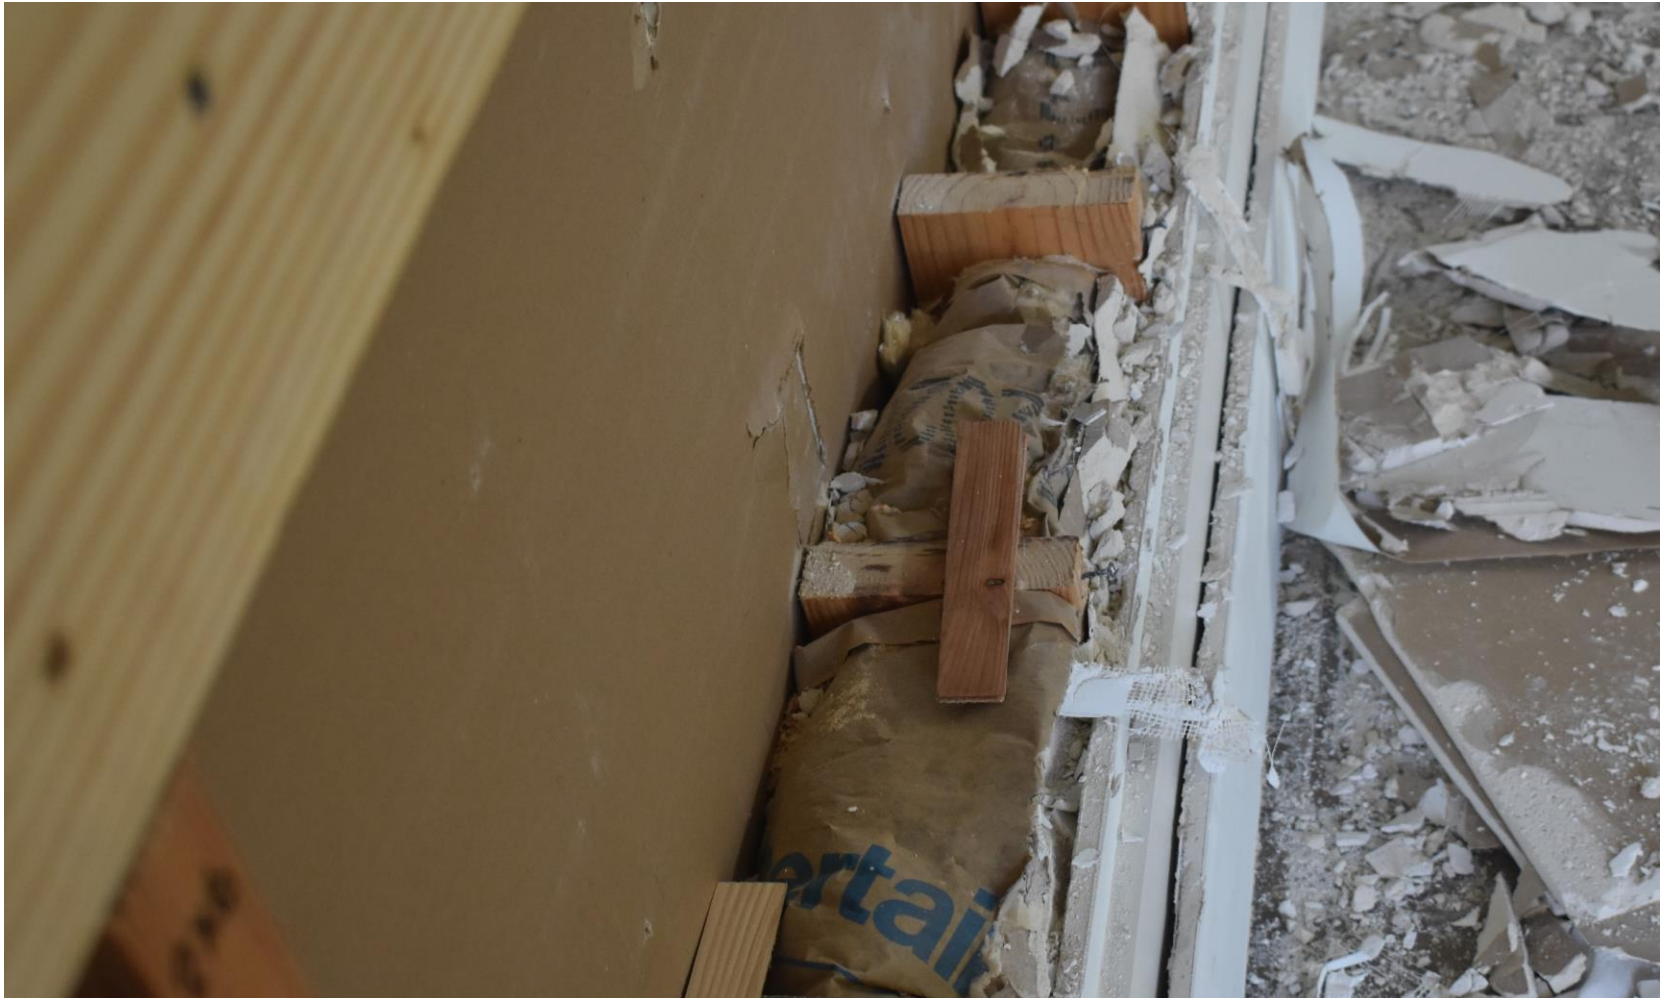
## 2030 Compromised Stud Wall Insulation

**Without a wood frame, the paper back facing of the insulation is in direct contact with the fireplace insert for the length of the unit.**

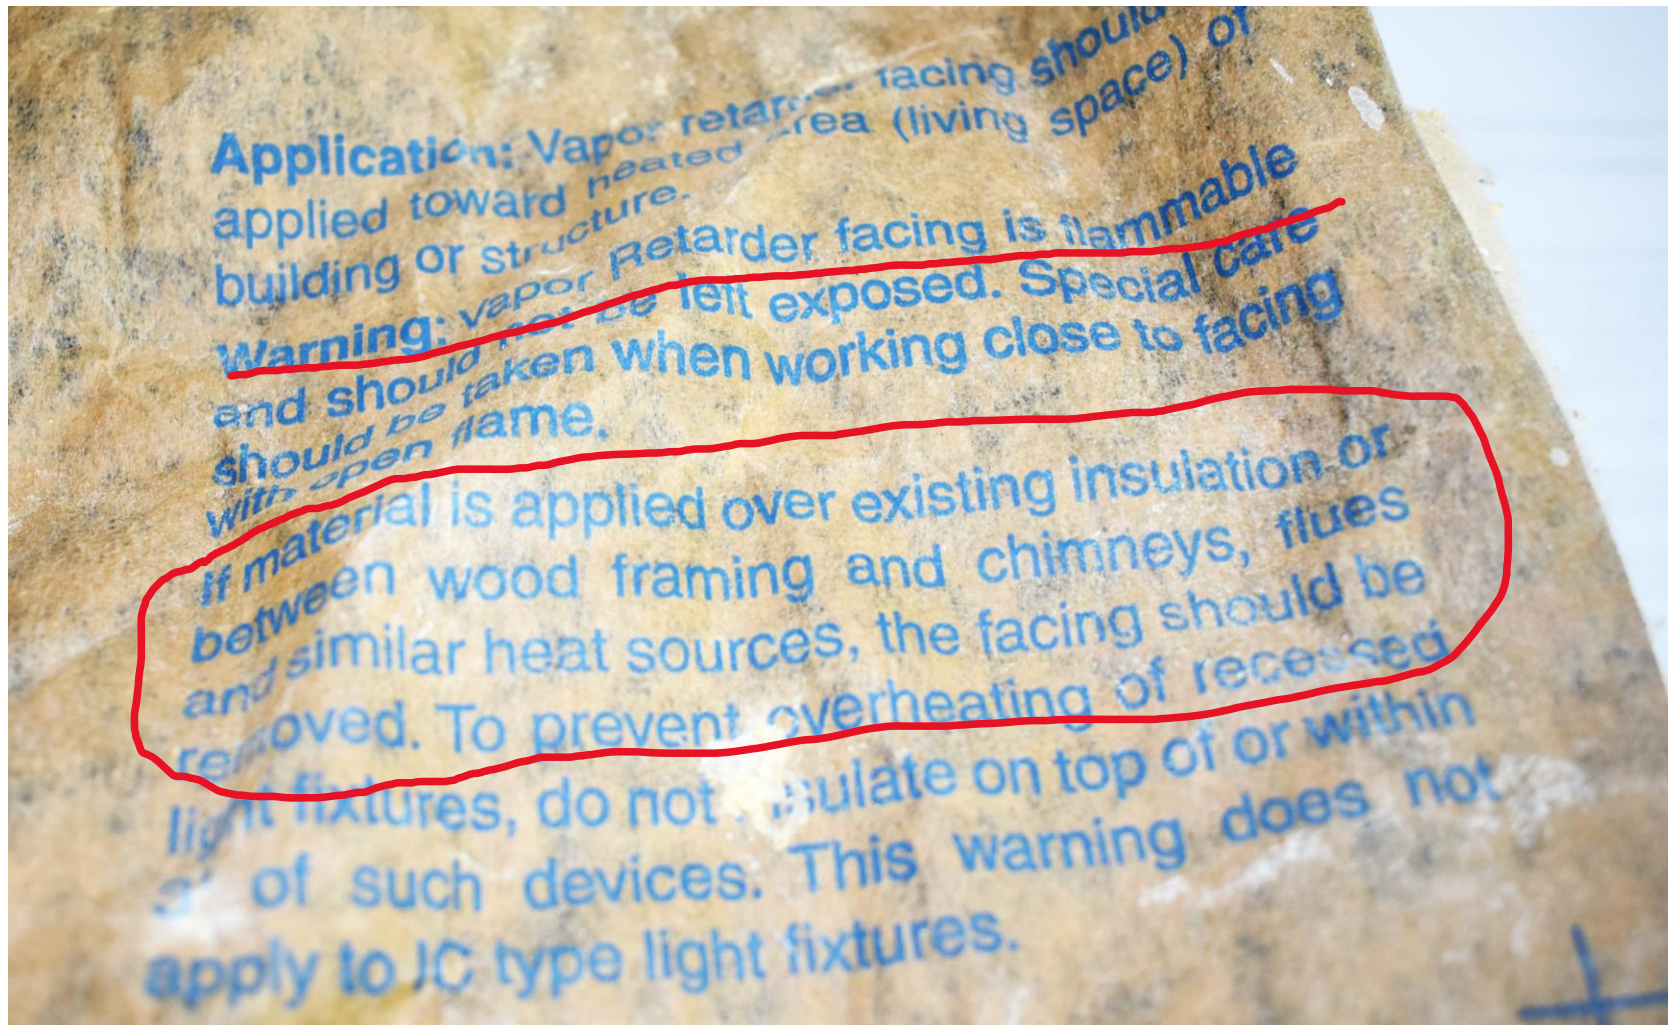
## 2110 Compromised Wall Insulation

This product is in direct contact with a heat source (fireplace) therefore the paper facing must be removed due to flammability. This is a significant life safety issue.
