## **Plans versus Observed Construction**

# 2078 Plans versus Observed Construction

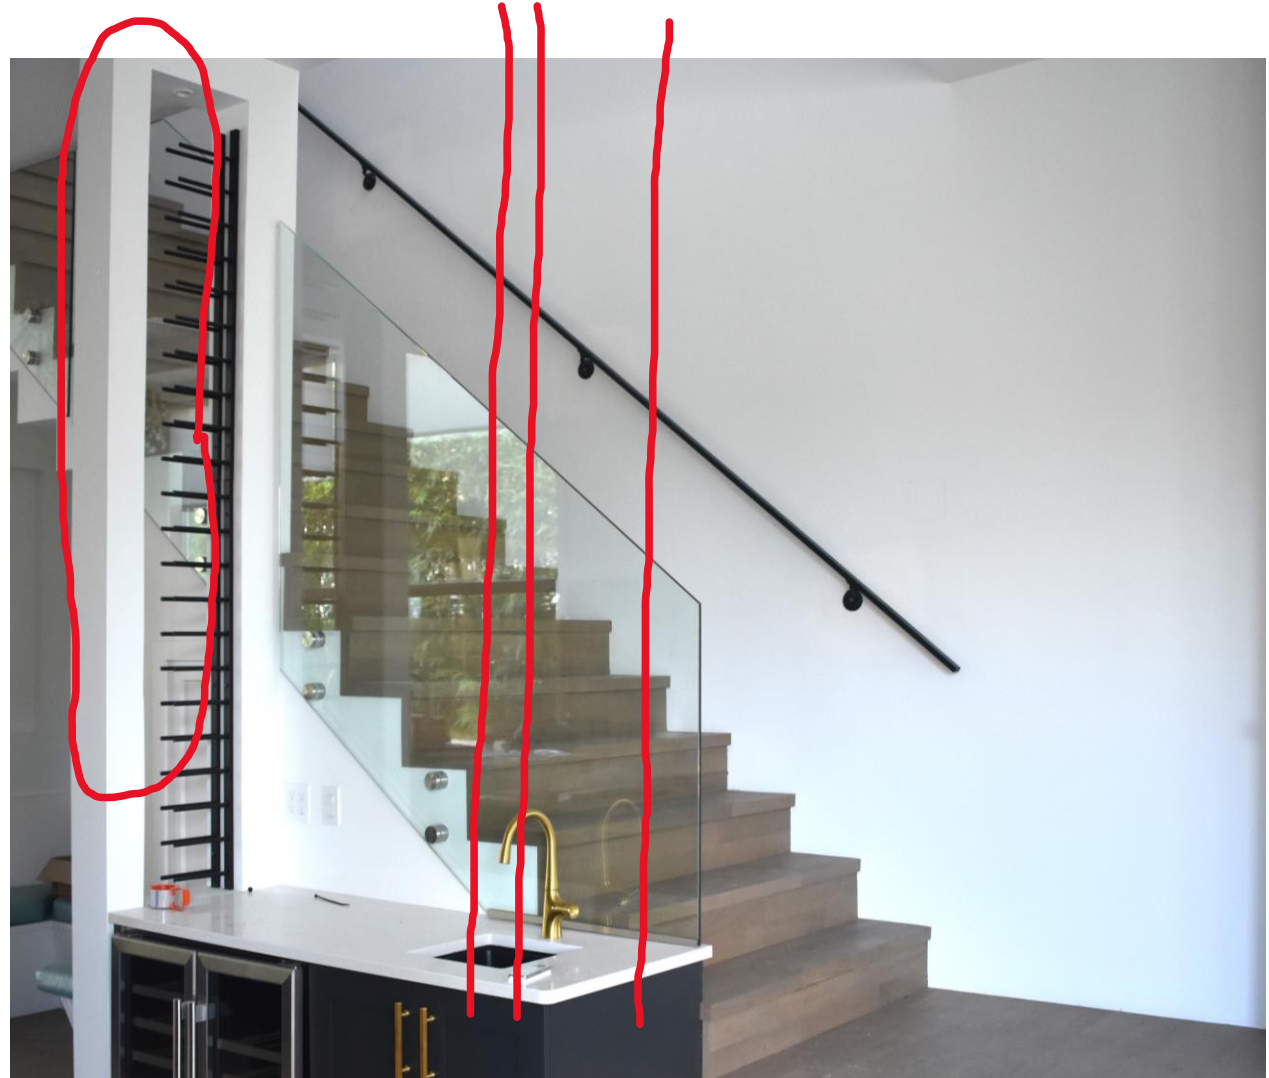
## 2128 Wet Bar Area

Wire rack installed in lieu of required laminate post for structural integrity.

A short load bearing wall was not installed that contained a pre-engineered laminate post.

These structural changes were completed without any review by the truss engineer or architect. No drawing or details provided for what was completed.

These three load bearing walls support the main floor ceiling structure, roof trusses and roofing system.

Elimination and re-design of these load bearing walls significantly compromises the load bearing capability and is a serious code violation.

Life safety issue as well.

City of Winter Park failed to enforce compliance with plans submitted
