## **Rear Elevation Load Bearing Wall** **Family Room**

**These photographs are directly related to  
the same section of this report identified above.**

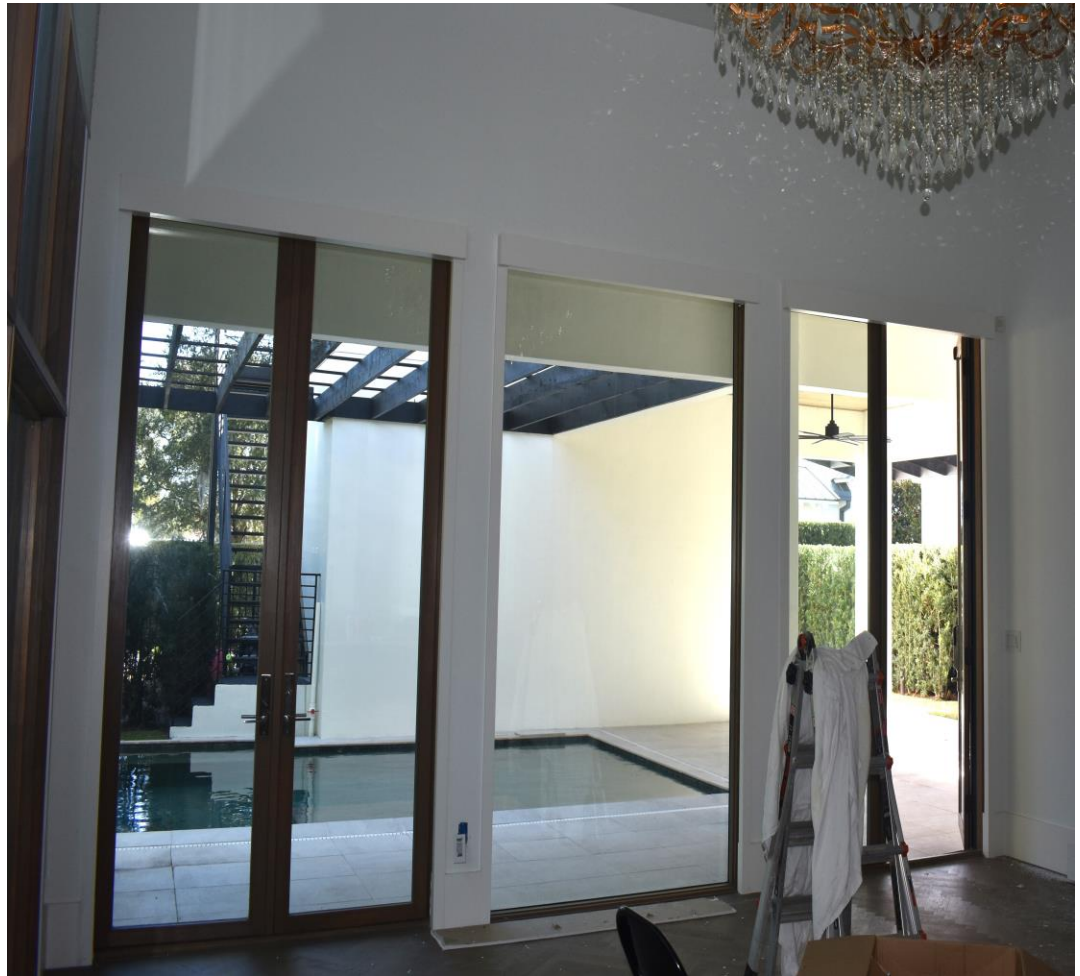
# 2077 Rear Elevation Interior View

The original and as-built drawings indicate that each of the double doors and center section of the wall would have a transom window.

The cut sheet indicates that there is no window of any type to be installed between the double doors.

No detail or approved document is provided for this significant change.

This action is a code violation, violates industry standards and is a life safety issue.

**City of Winter Park failed to enforce compliance with plans submitted**

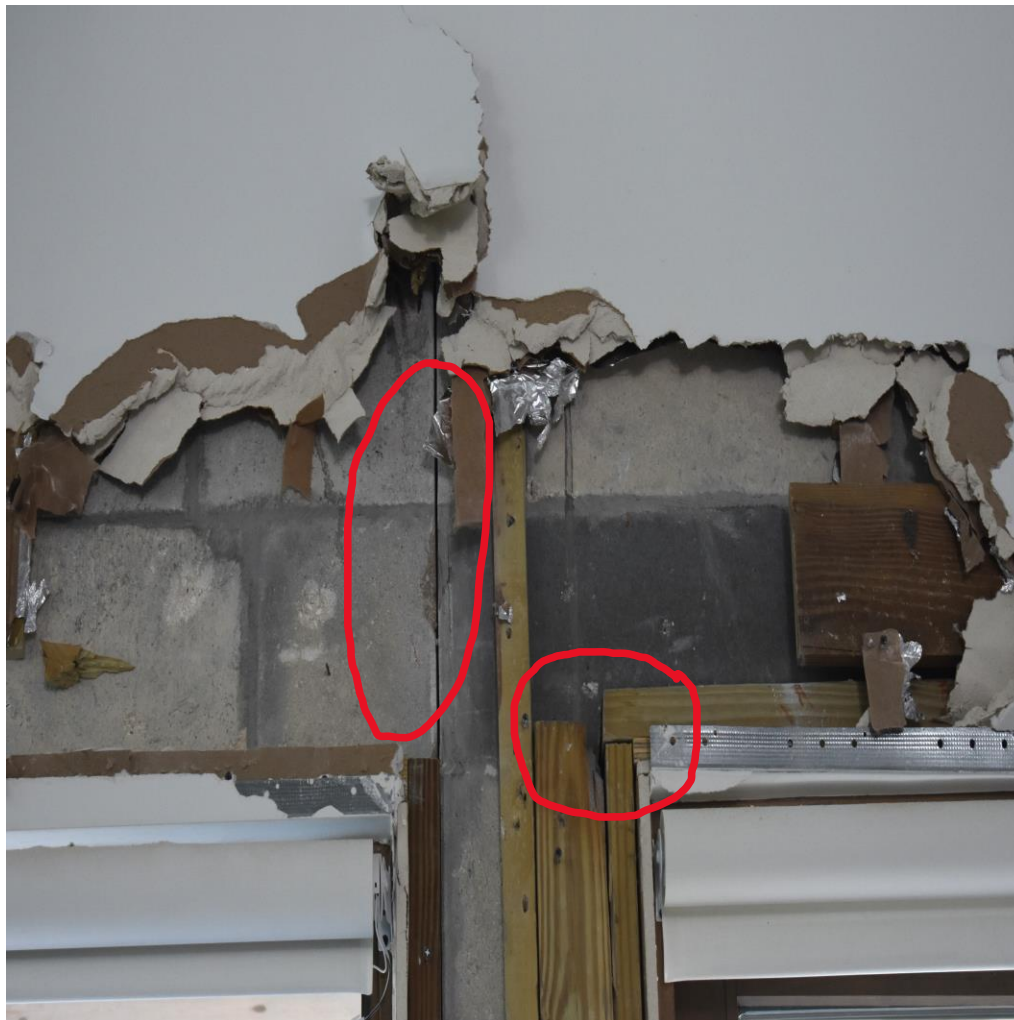
## 2108 Rear Elevation Wall Exposed

This initial view shows that the masonry wall was saw cut vertically well above the window area.

The precast engineered lintel has been notched for the door width to allow a wood door frame to be added for the larger than designed door for the opening. Typical for the other door.

No lintel above the center window.

This attempt to install larger doors and window than originally designed is a significant undocumented code violation at a minimum and is a life safety issue.

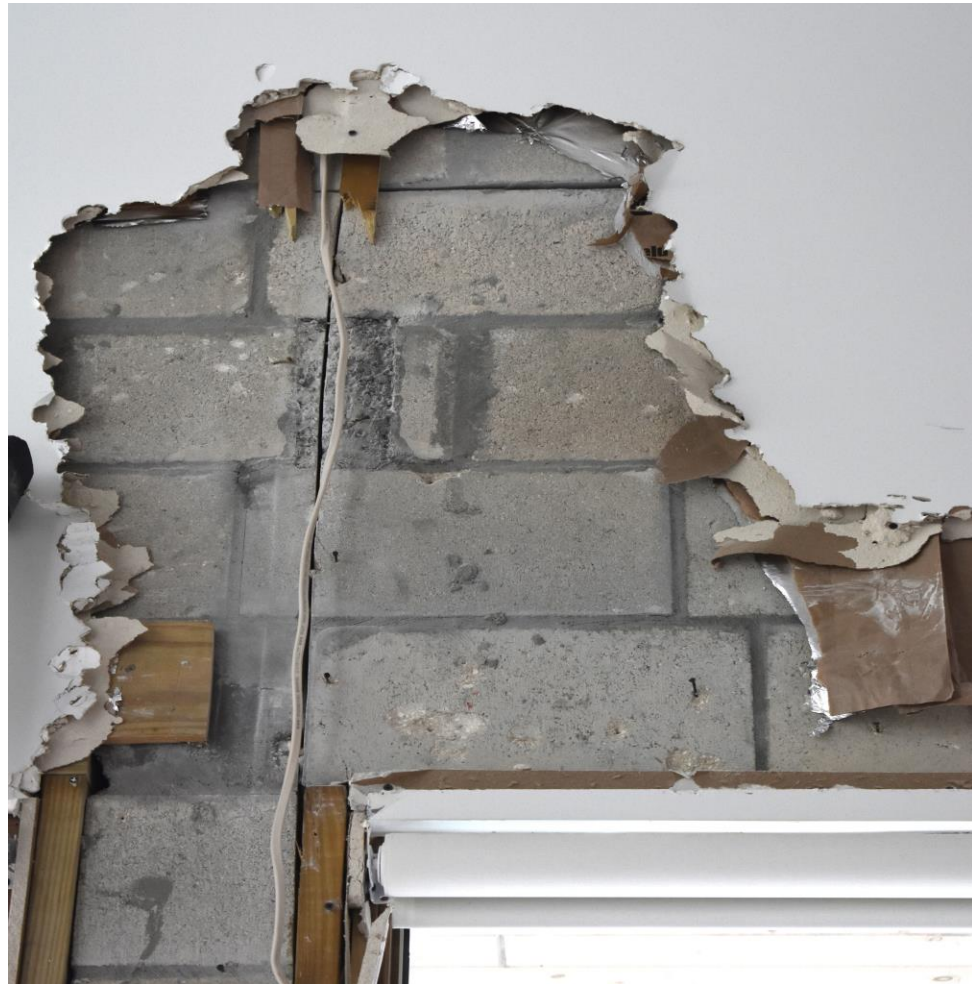
## 2114 Rear Wall Elevation

The precast engineered lintel for the double door left of the center window was also notched and is a clear code violation. The cut invalidates the designed structural integrity.
