## **Side Elevation Load Bearing Wall- Family Room**

# **Load Bearing Wall Observations**

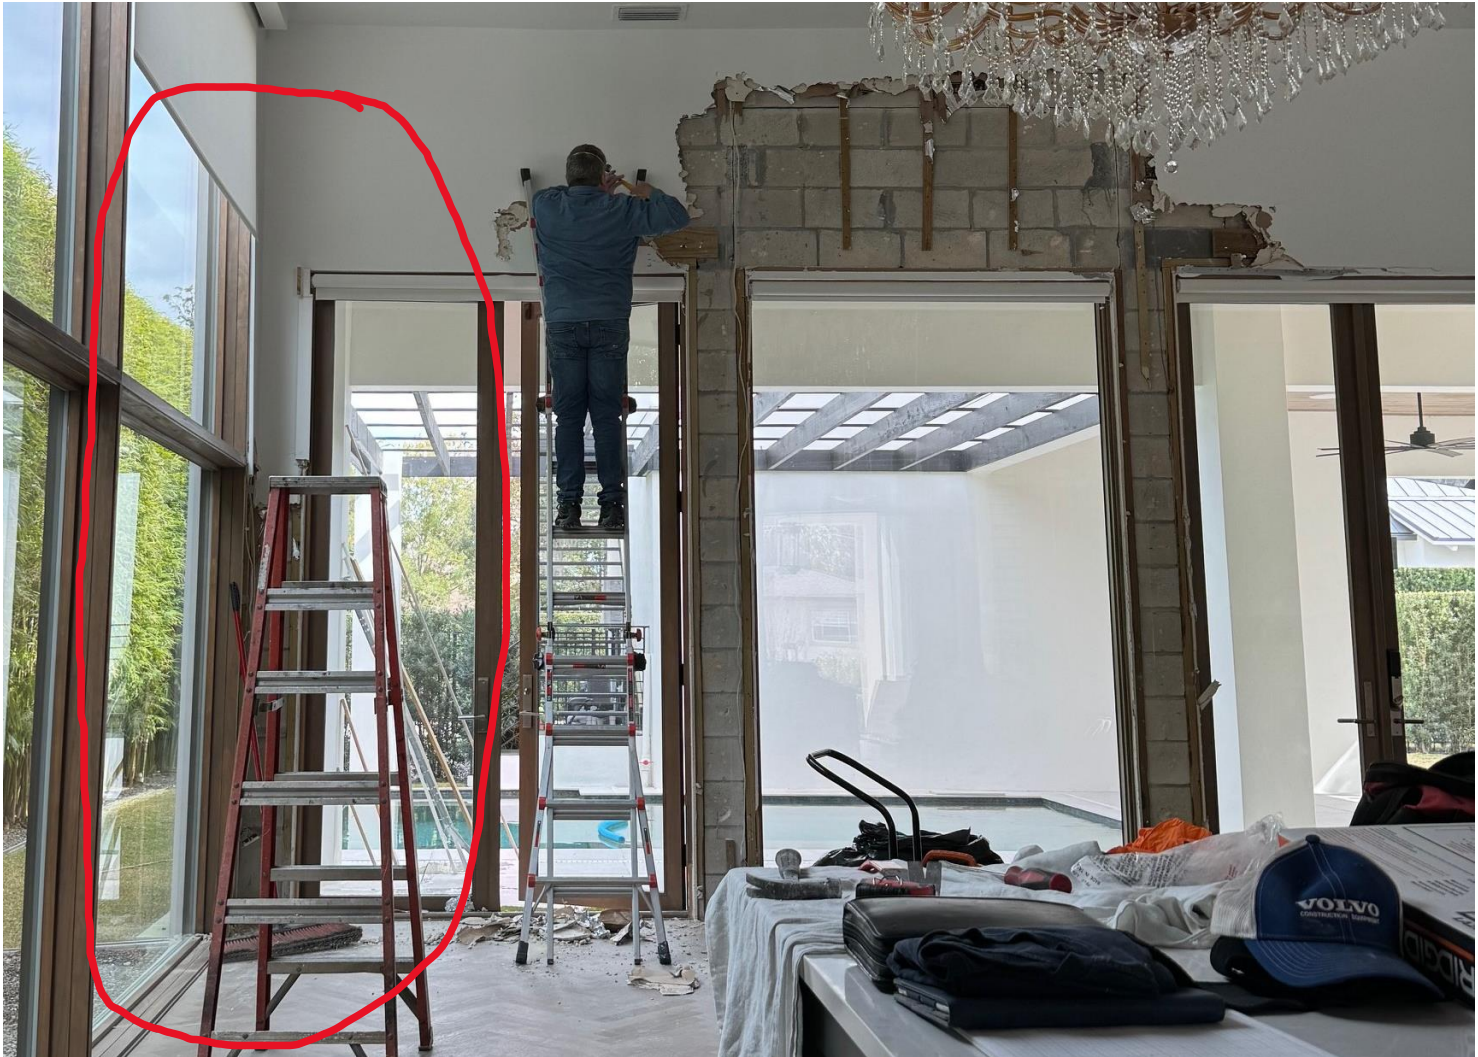
## 0310A Side Elevation Window

Window on side elevation is in contact with the wood flooring.

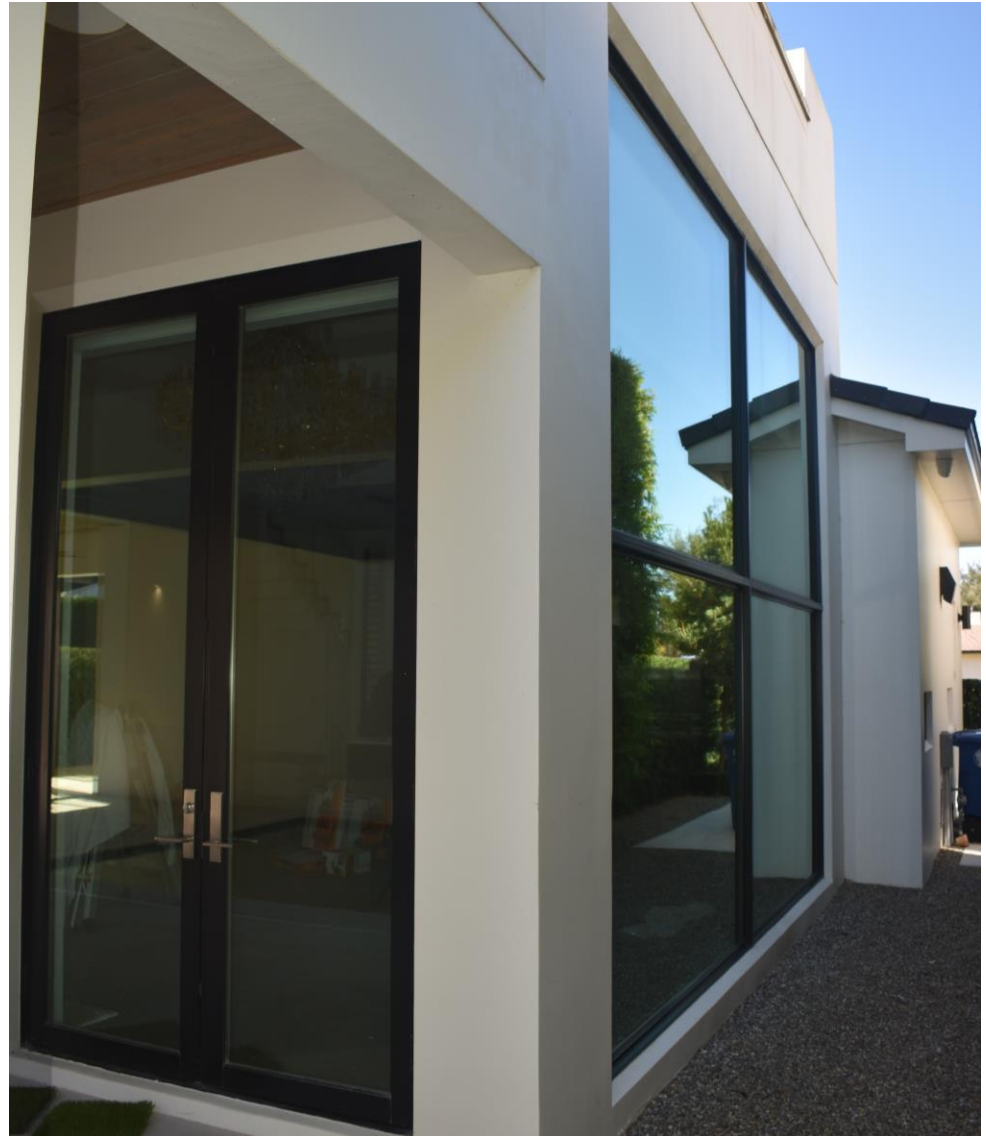
# 2044 Side Elevation Load Bearing Wall

Exterior view of the substitute window installed for the Family Room. Not shown on the original or as-built drawings but a pencil sketch reflects the intent to install this 16-foot wide by 13-foot-tall window on a cut sheet.

Note the proximity to grade with an active irrigation system. The window planned per the original drawings was to be two 8-foot by 10-foot windows. Windows would be installed roughly 2-feet above the slab on grade.

The opening created for this change required saw cutting of the opening and would have necessitated removal of the precast engineered lintel. The block wall sides would also have to be overcut to accommodate the actual width of the window requiring a new wood frame.

The support wall on either side of the window was measured and compared to structural drawing and is not as wide as designed.

The original design allowed 48% of this wall to be load bearing. Now 26% remains as load bearing. No longer adequate as a load bearing wall.

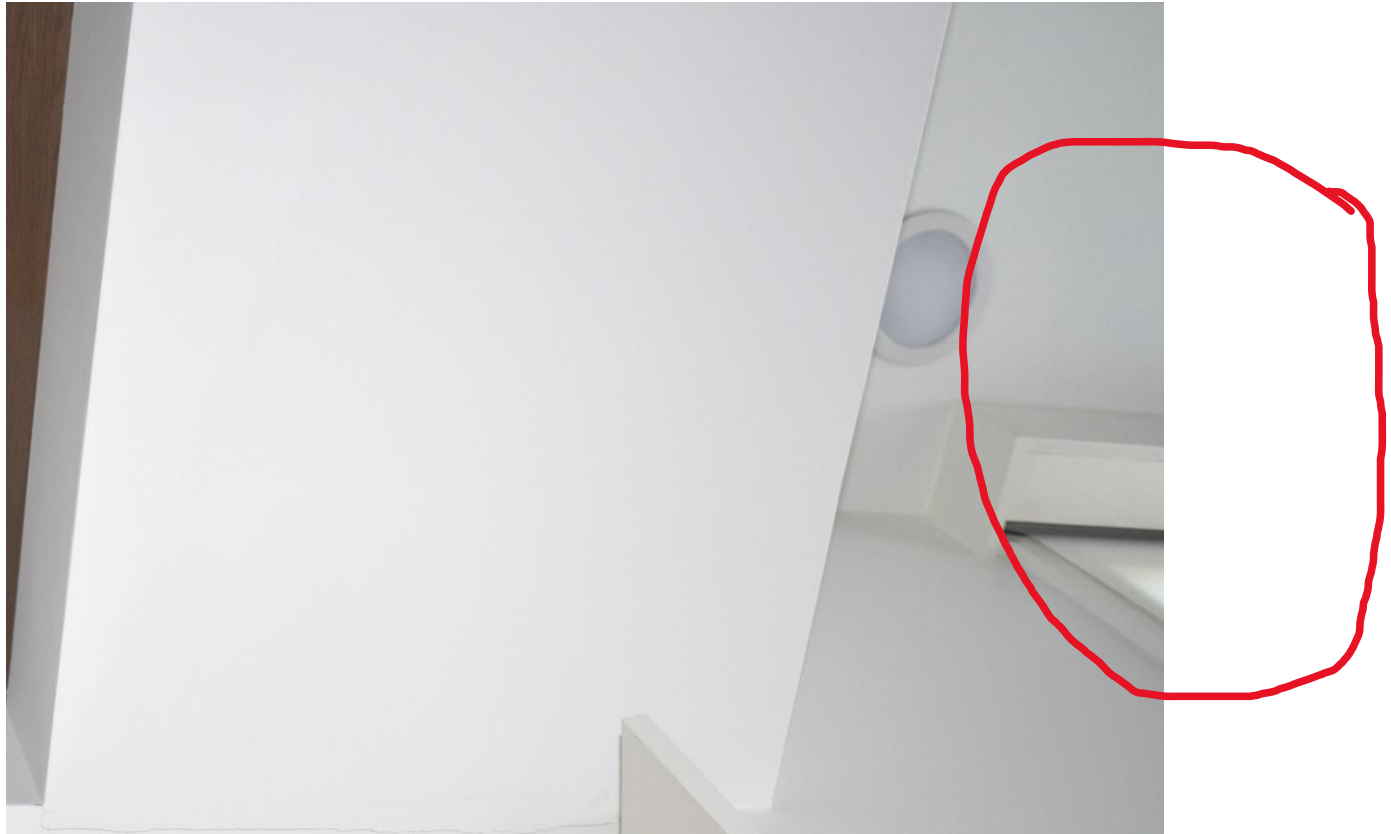
## 2129A Side Elevation Window

**This picture shows the top of the window that is in direct contact with the drop ceiling for the family room. We decided not expose this area due to the height, amount of demolition needed and concern for our safety. This exterior wall has been significantly compromised for load bearing capacity and is a life safety issue.**

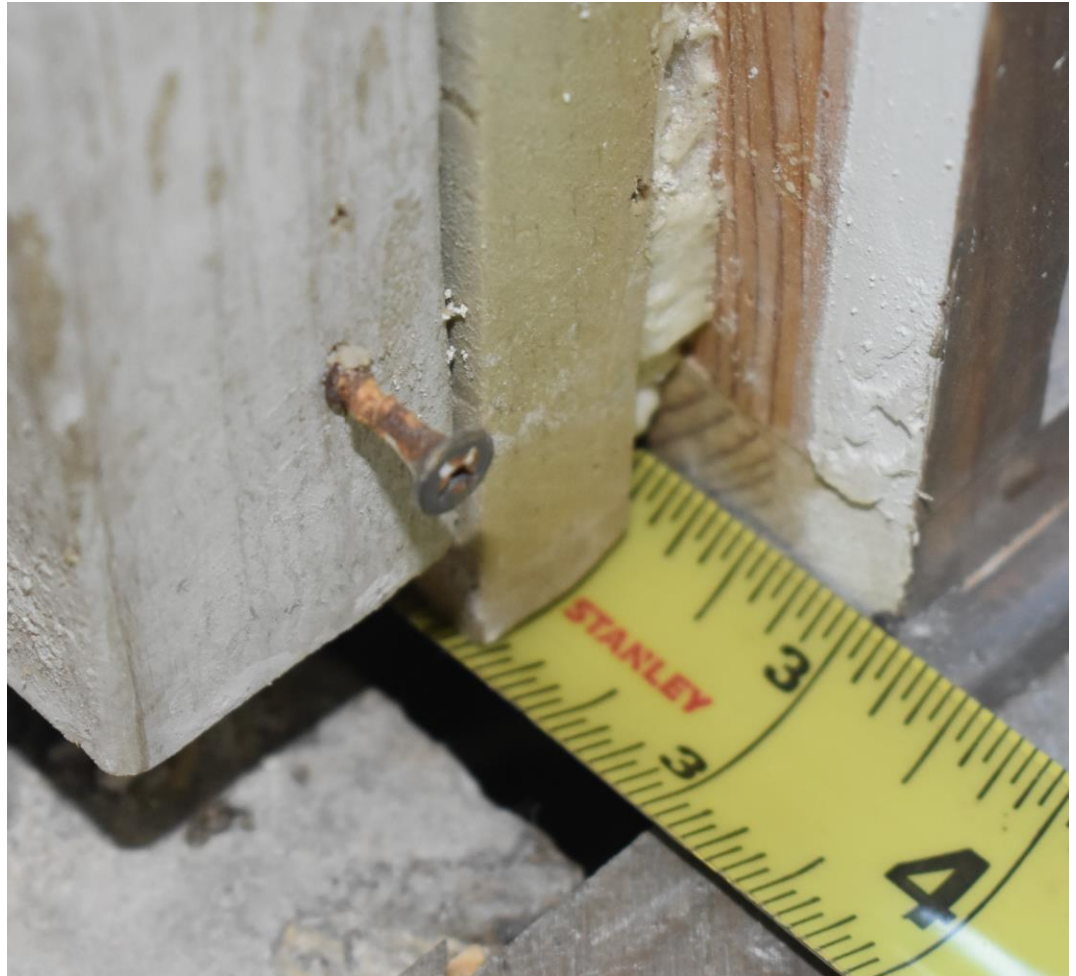
## 2019 Side Elevation Window at Floor

**This picture is of the interior slab and flooring after the drywall was removed.**

**The slab on grade has been cut for the width of the window at least 3-inches wide. Highly unusual and concerning. Next page will show the depth.**

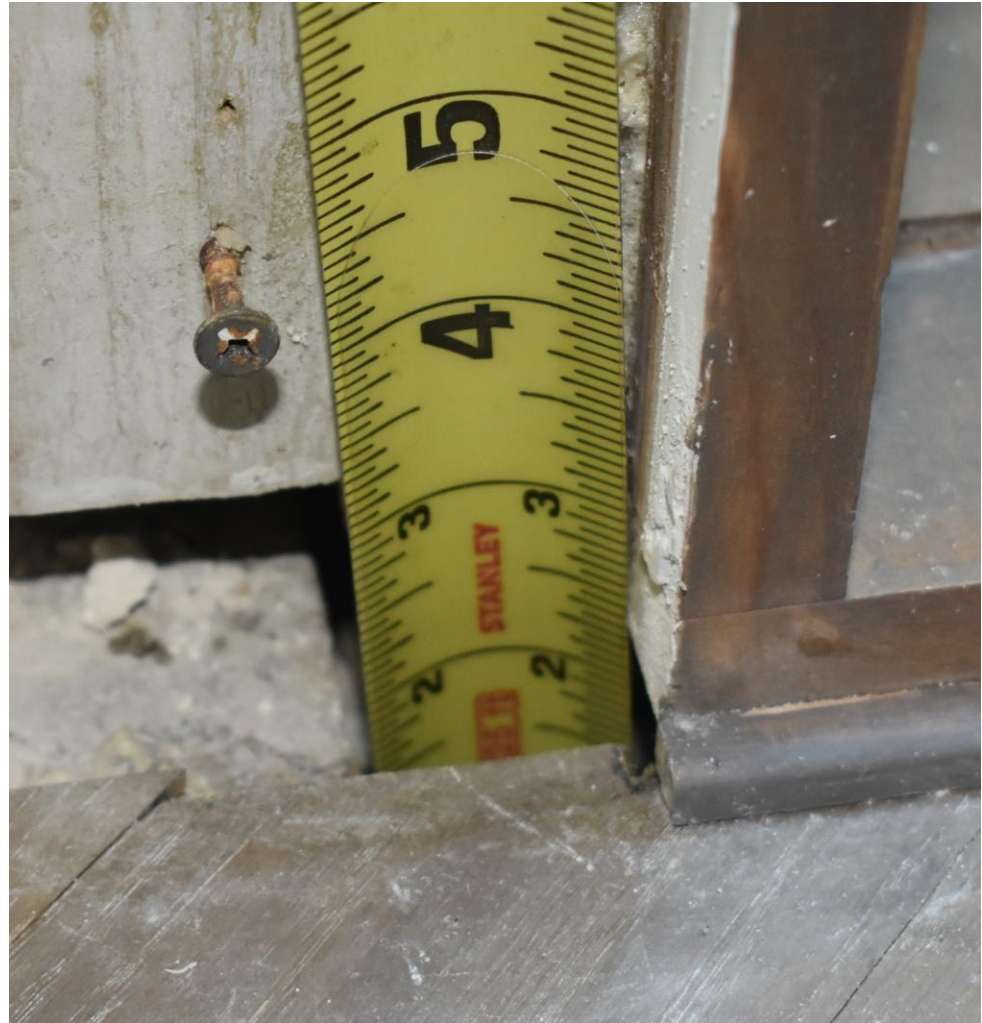
## 2120 Side Elevation Window at Floor

Depth of the saw cut on slab is 2-inches.

This pocket was created as the substitute window was too tall and would interfere with the ceiling design in the Family Room.

This is a significant code violation.

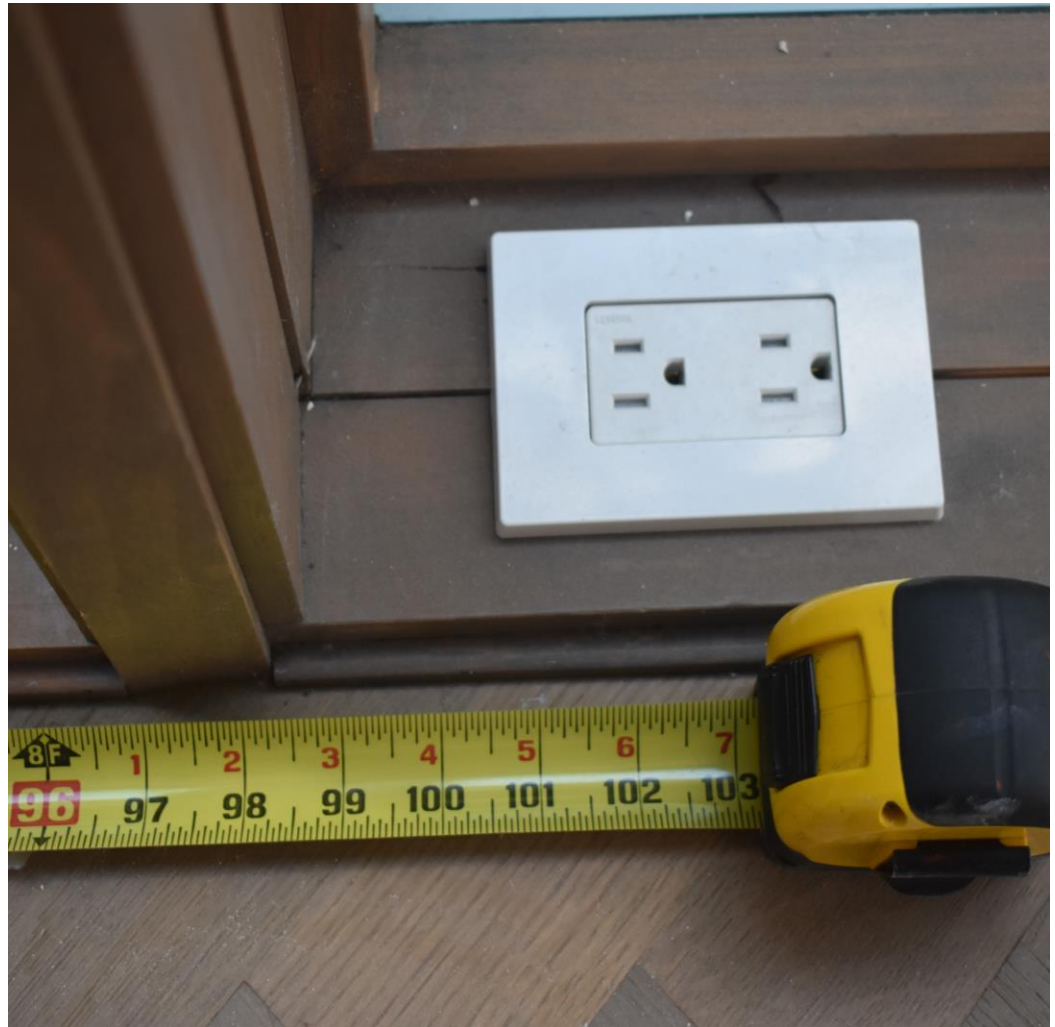
## 2122 Side Elevation Window at Floor

**This outlet would have been in the 2-foot-high wall between the floor and window base in the original drawings.**

**The outlet has been installed in the window trim to allow the wiring and outlet box to be installed in the notched concrete slab.**

**No special consideration given to protect the outlet from damp conditions as a result of proximity to the irrigation system.**

**Damp conditions observed on the pressure treated wood in contact with the slab. Area within the notch and visible ends show discoloration consistent with mold or mildew.**

**Clear code violations and life safety issue.**

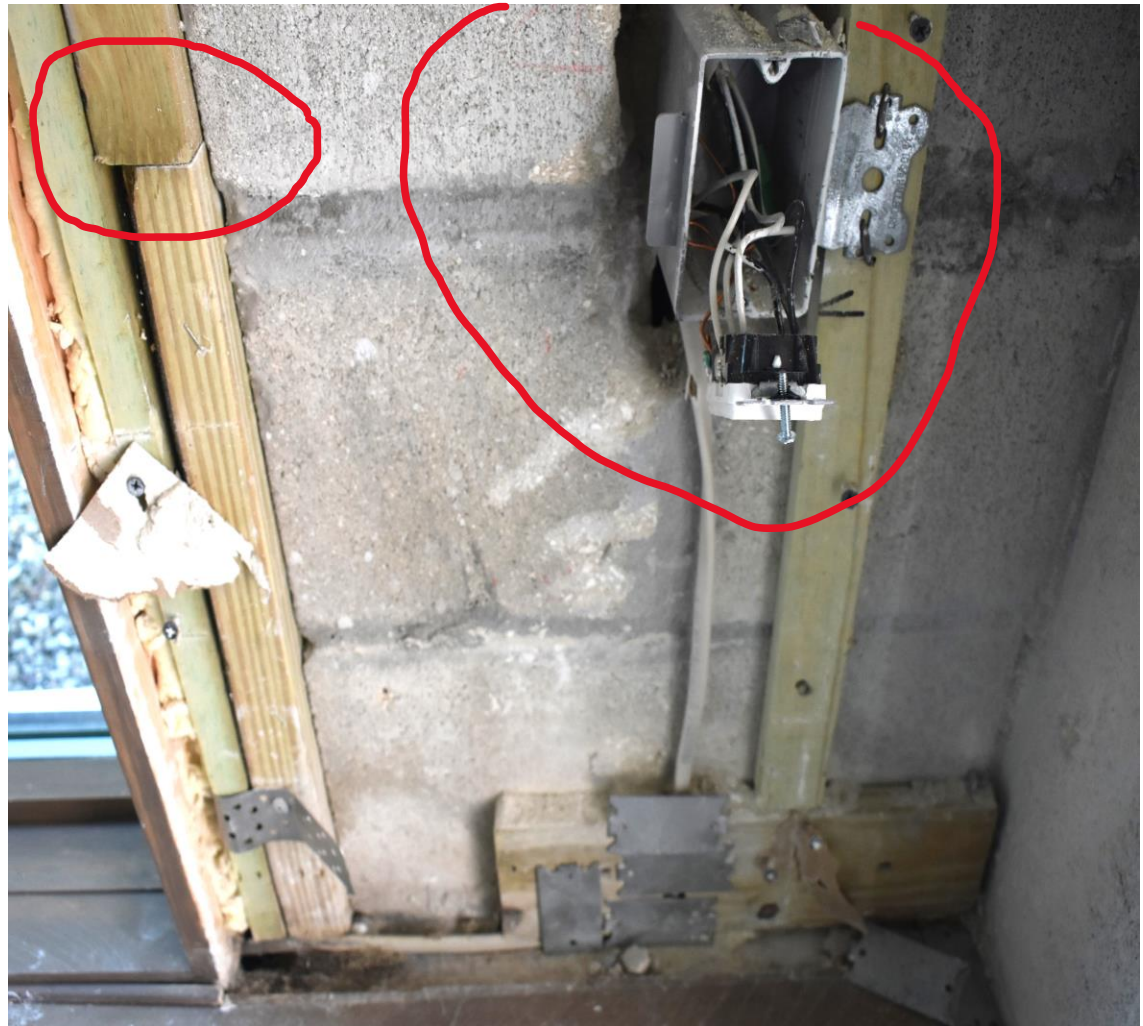
## 2123 Side Elevation Wall

Electrical box was set by knocking a hole in the block wall.

This section of the wall on either side of window is where concrete and rebar is used per code for structural integrity as it relates to load bearing capacity.

A shallow junction box should have been used as this outlet is not on the electrical plan in the original drawings. This is a code violation.

Not a general industry standard to use multiple PT wood pieces for a frame. This should be one piece.
