Property Inspection Report

9204 Golfview Circle, Covington GA 30014

01/15/2019

11519

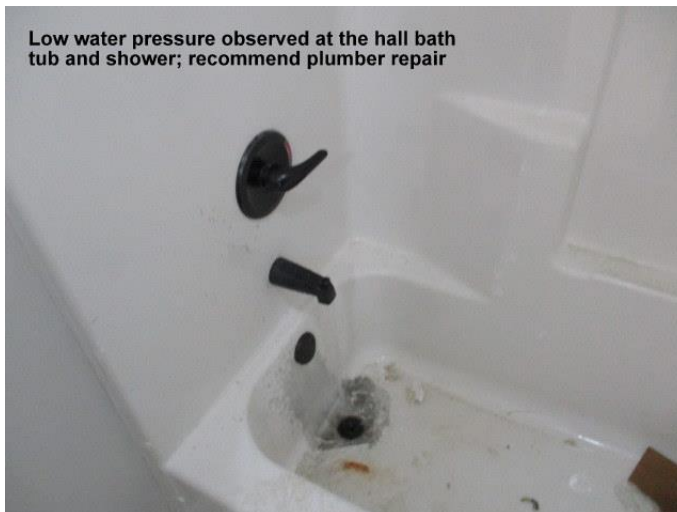
Low water pressure observed at the hall bath tub and shower; recommend plumber repair

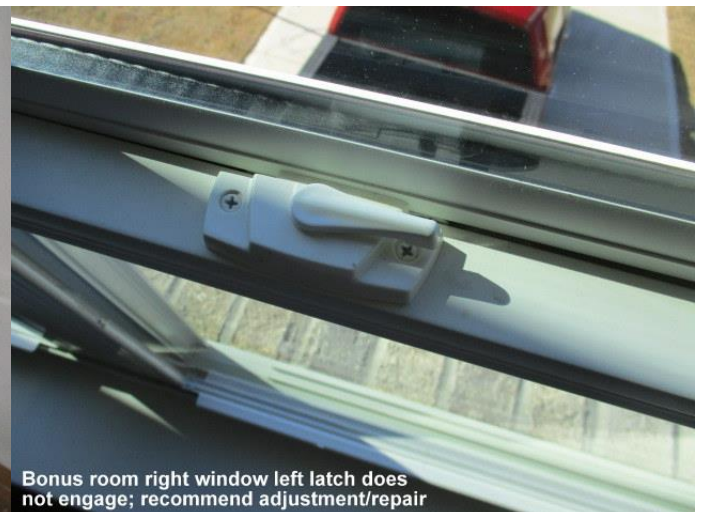
Bonus room right window left latch does not engage; recommend adjustment/repair

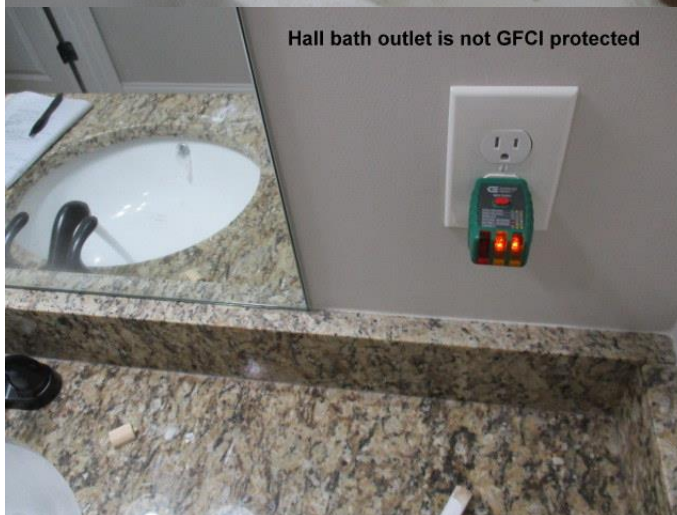
Hall bath outlet is not GFCI protected

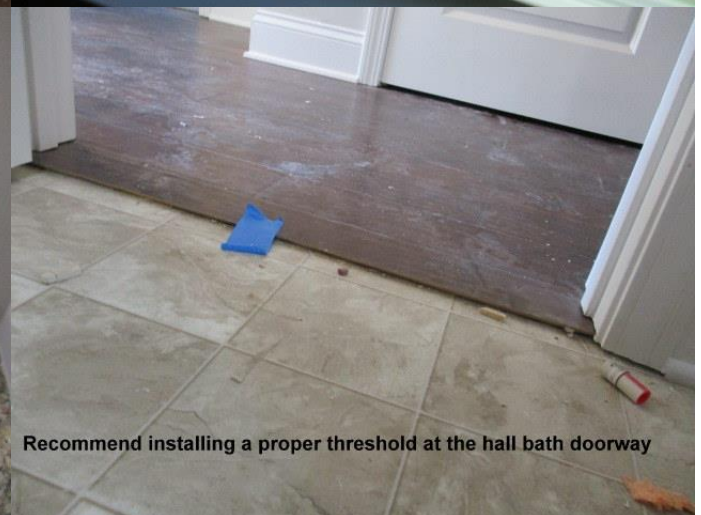
Recommend installing a proper threshold at the hall bath doorway

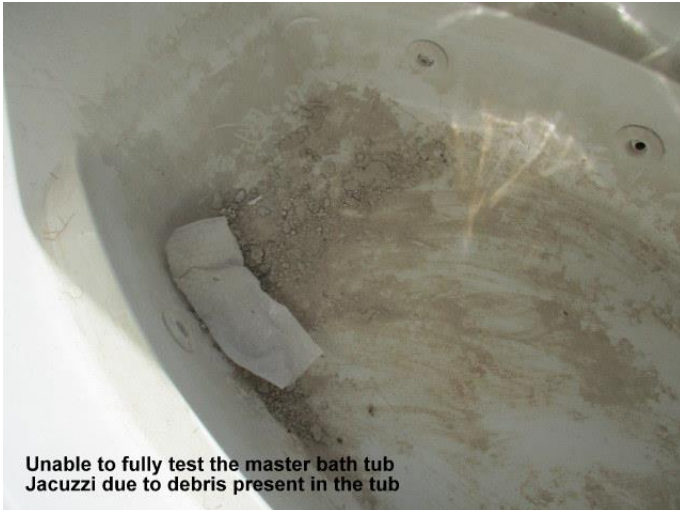
Unable to fully test the master bath tub Jacuzzi due to debris present in the tub

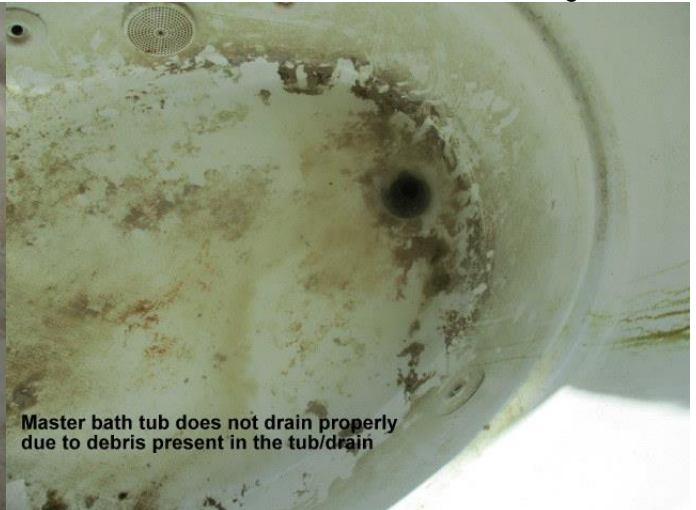
Master bath tub does not drain properly due to debris present in the tub/drain

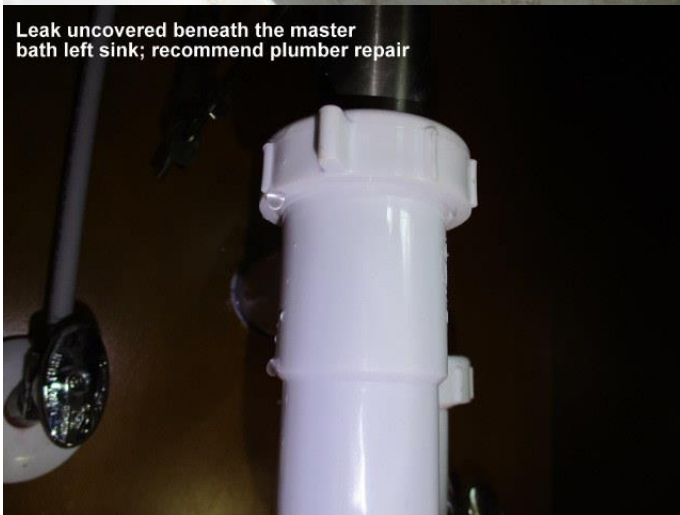
Leak uncovered beneath the master bath left sink; recommend plumber repair

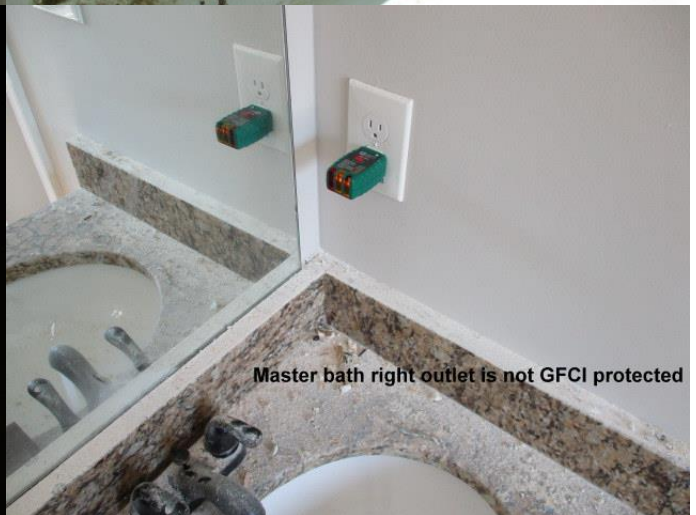
Master bath right outlet is not GFCI protected

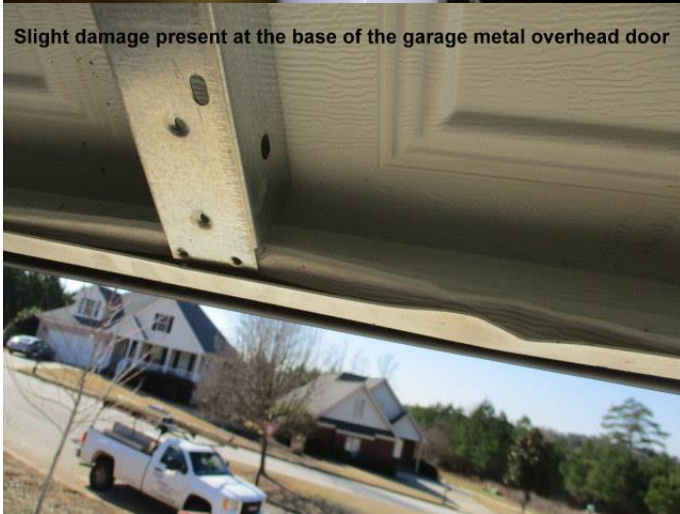
Slight damage present at the base of the garage metal overhead door

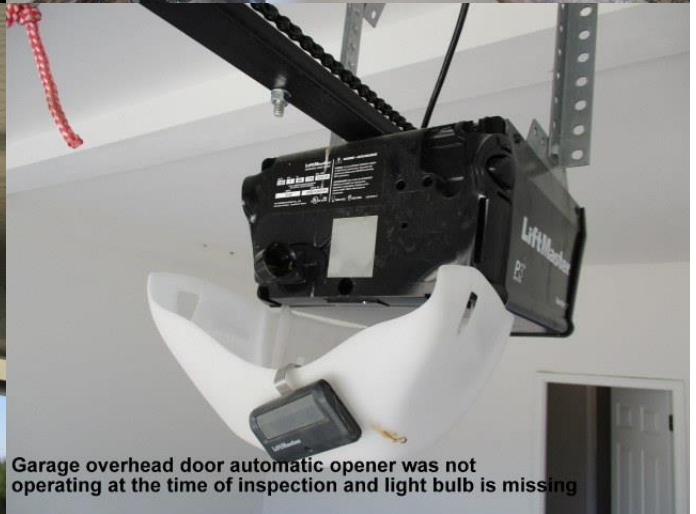
Garage overhead door automatic opener was not operating at the time of inspection and light bulb is missing

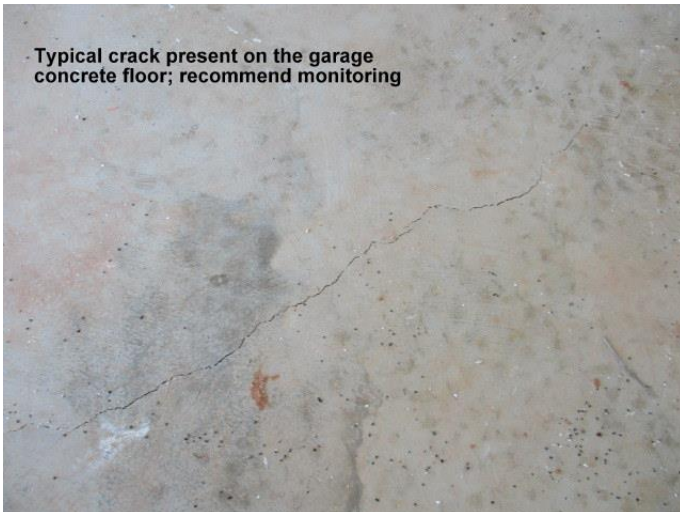
Typical crack present on the garage concrete floor; recommend monitoring

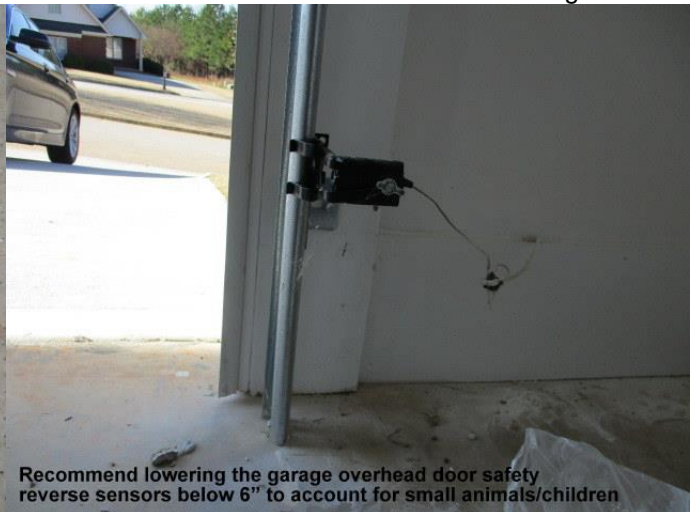
Recommend lowering the garage overhead door safety reverse sensors below 6" to account for small animals/children

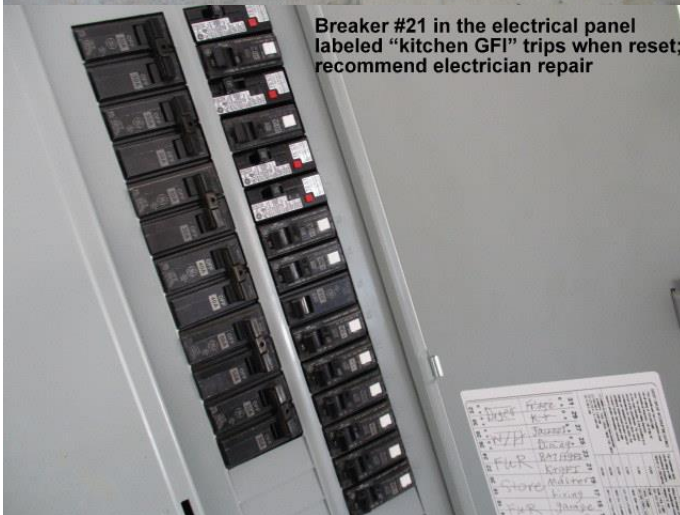
Breaker #21 in the electrical panel labeled "kitchen GFI" trips when reset; recommend electrician repair

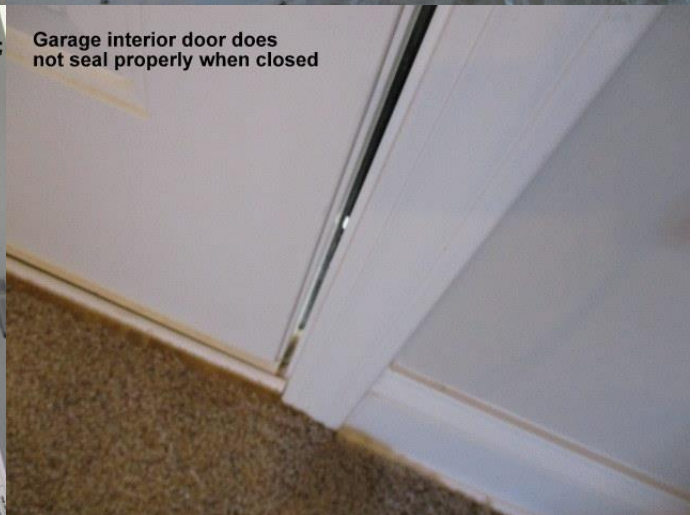
Garage interior door does not seal properly when closed

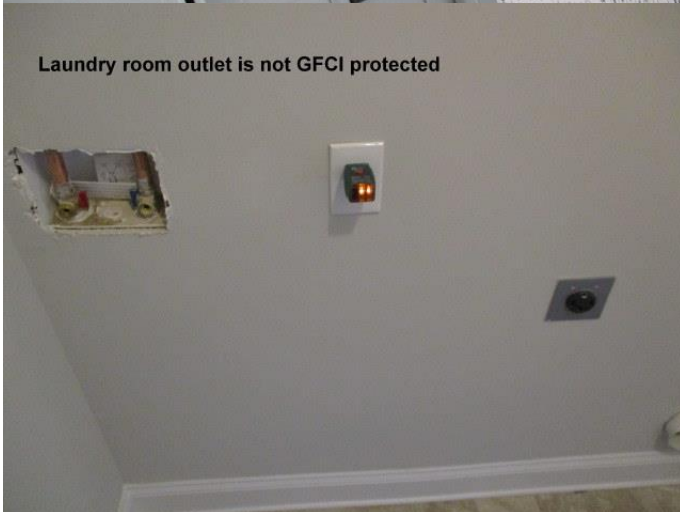
Laundry room outlet is not GFCI protected

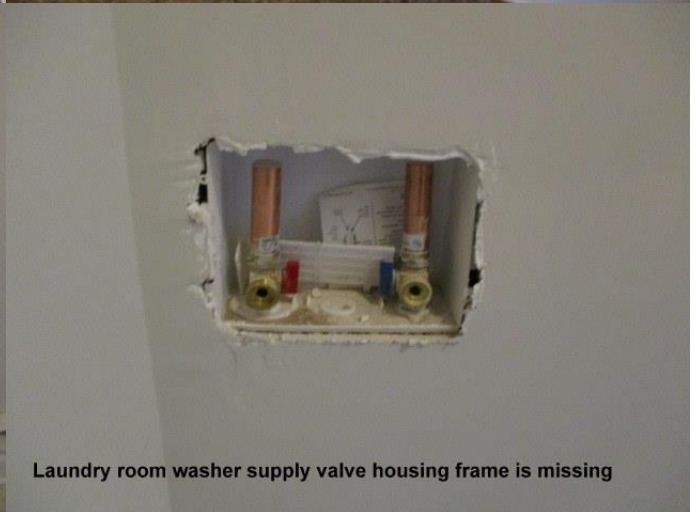
Laundry room washer supply valve housing frame is missing

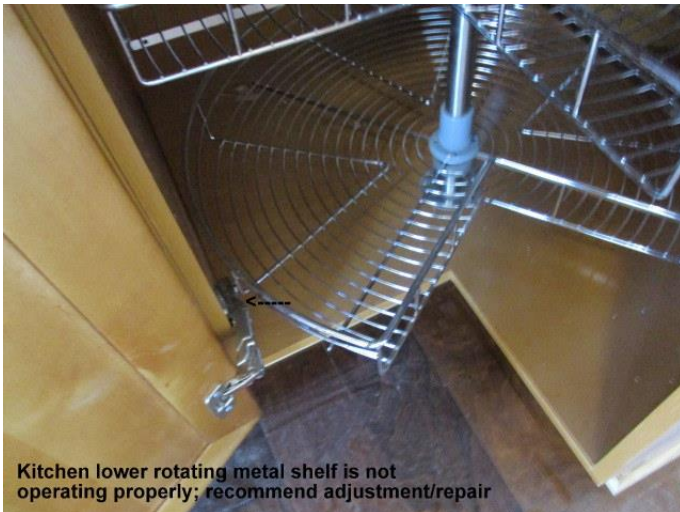
Kitchen lower rotating metal shelf is not operating properly; recommend adjustment/repair

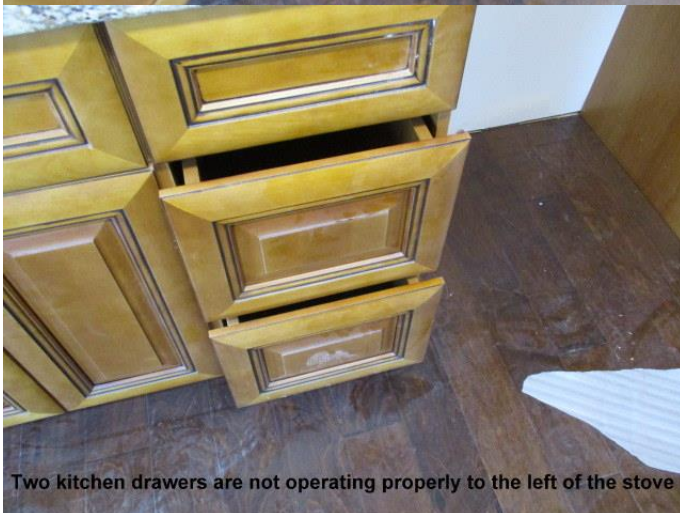
Two kitchen drawers are not operating properly to the left of the stove

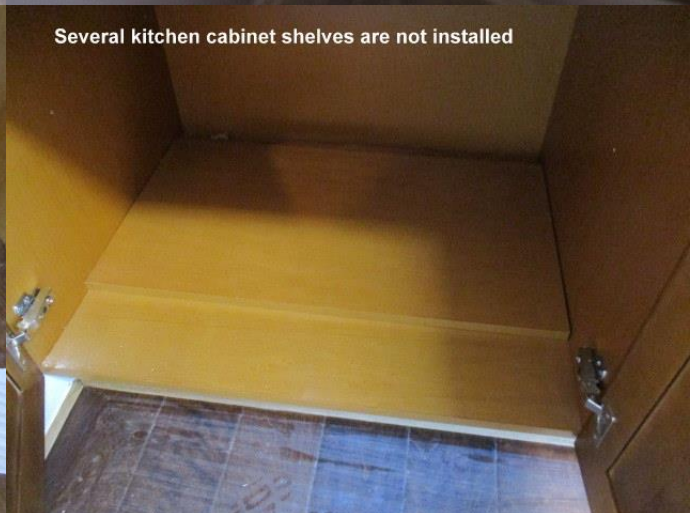
Several kitchen cabinet shelves are not installed

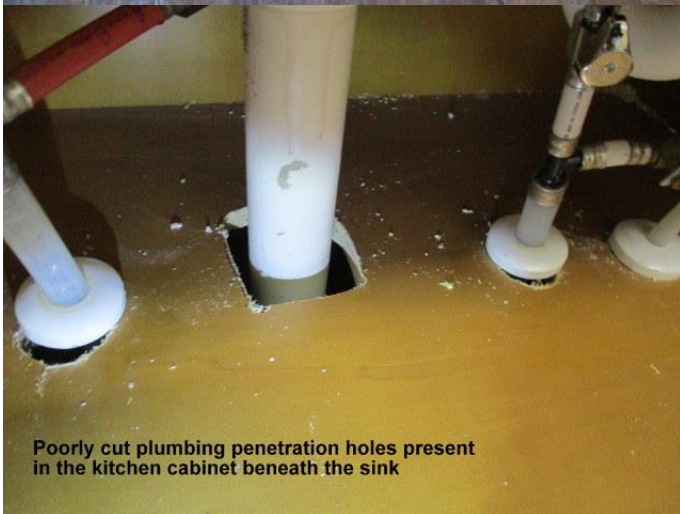
Poorly cut plumbing penetration holes present in the kitchen cabinet beneath the sink

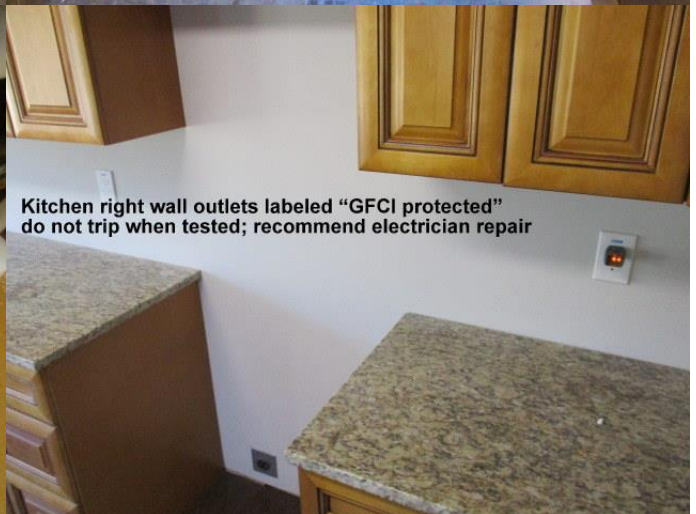
Kitchen right wall outlets labeled "GFCI protected" do not trip when tested; recommend electrician repair

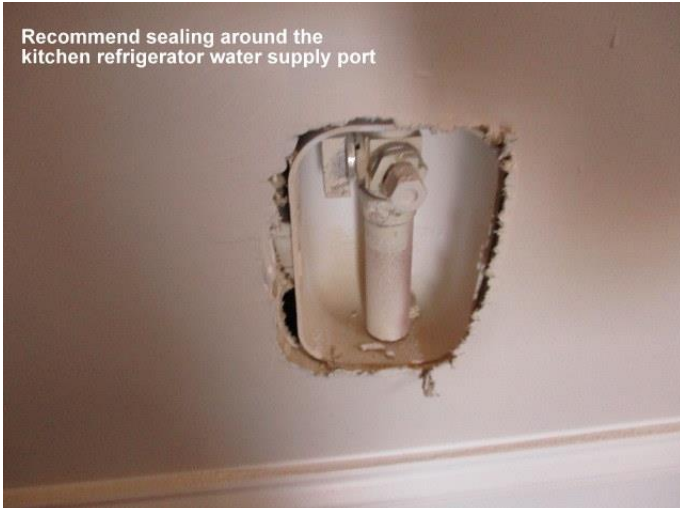
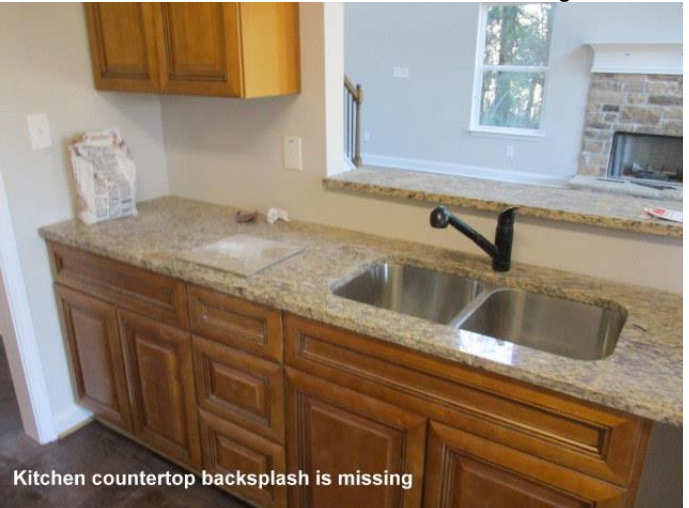
Kitchen countertop backsplash is missing

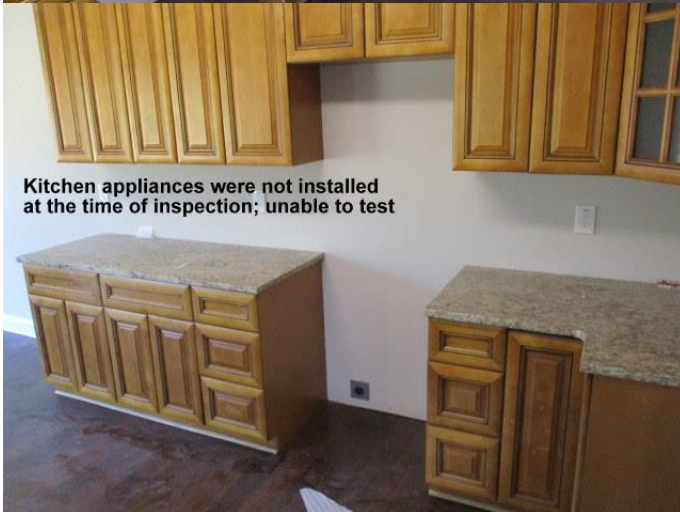
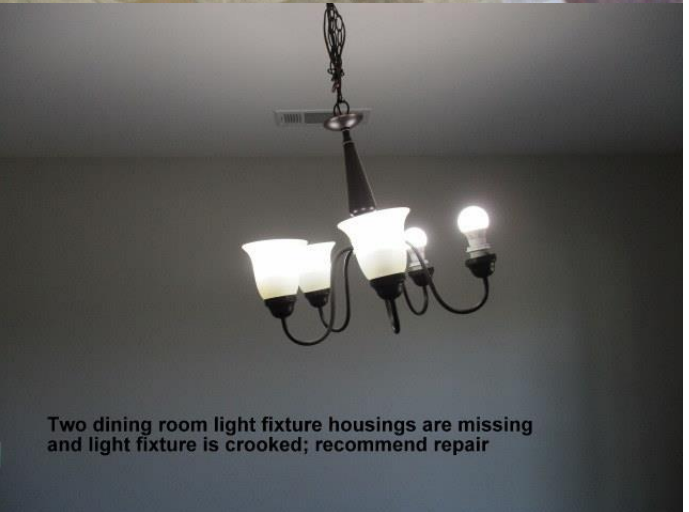
Two dining room light fixture housings are missing and light fixture is crooked; recommend repair

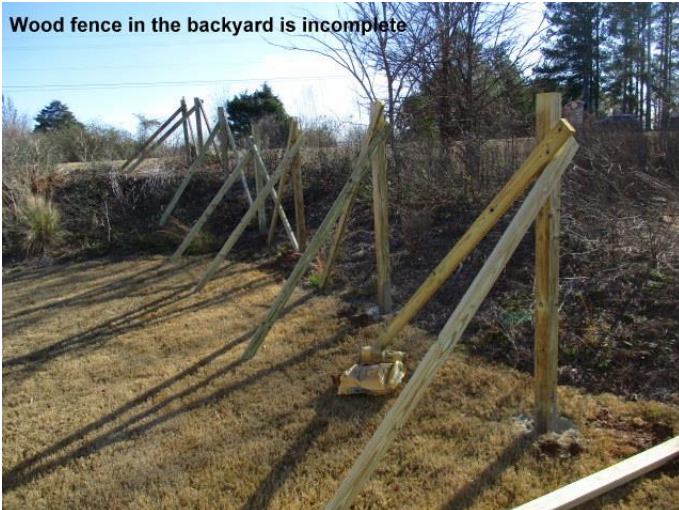
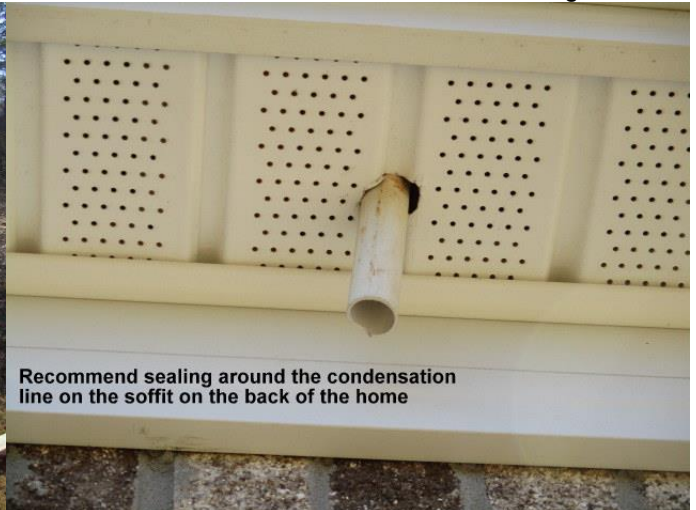
Recommend sealing around the condensation line on the soffit on the back of the home

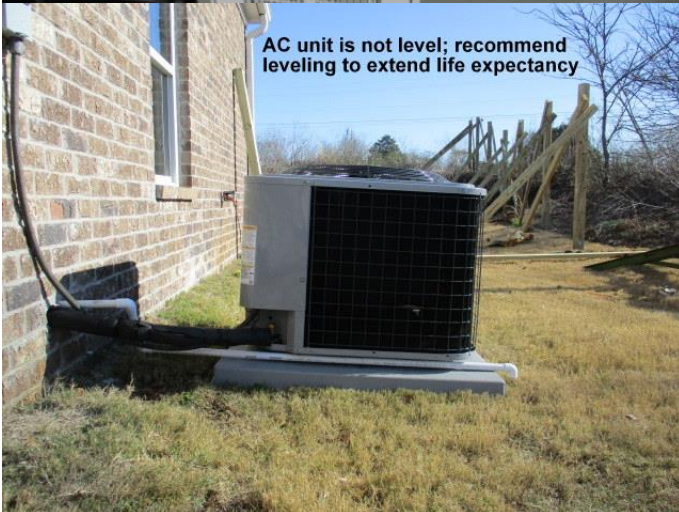
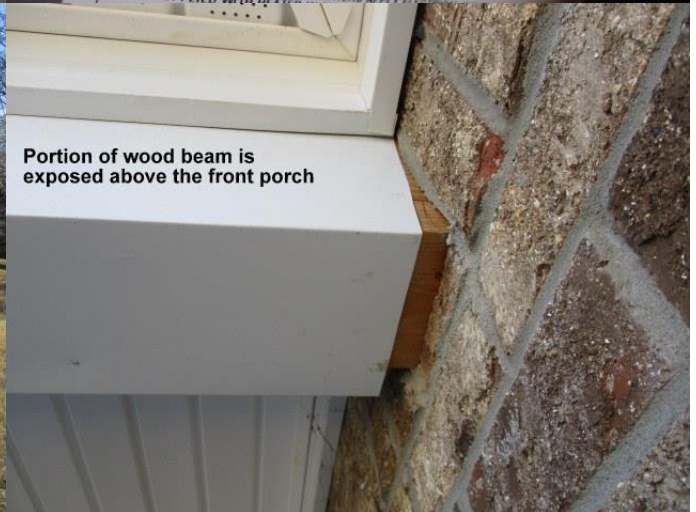
Portion of wood beam is exposed above the front porch

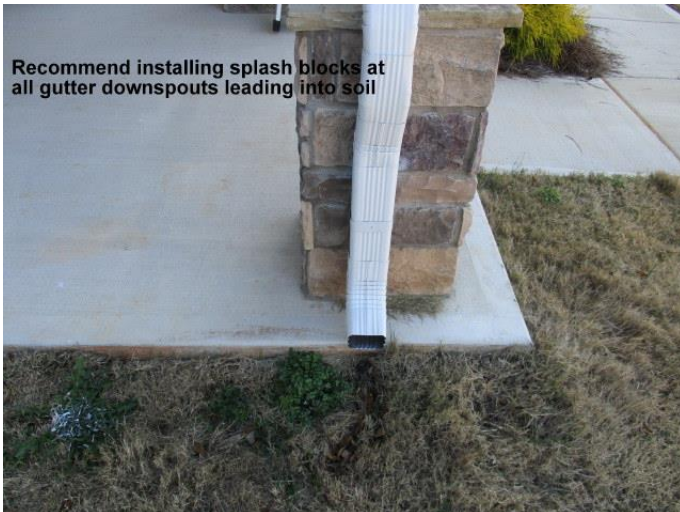
Recommend installing splash blocks at all gutter downspouts leading into soil

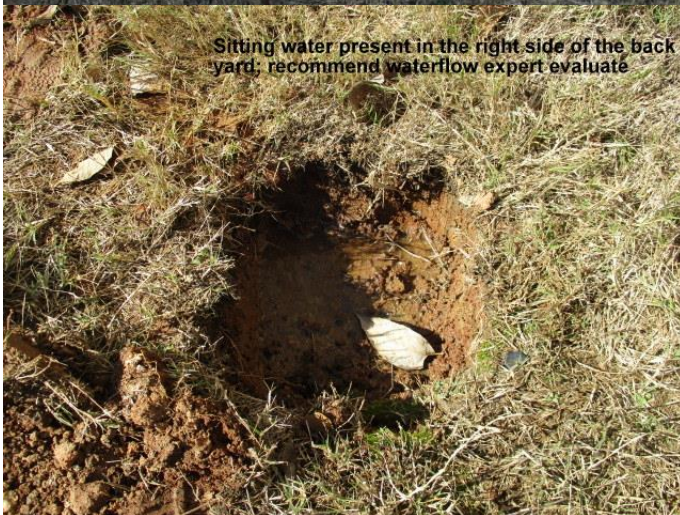
Sitting water present in the right side of the back yard. recommend waterflow expert evaluate

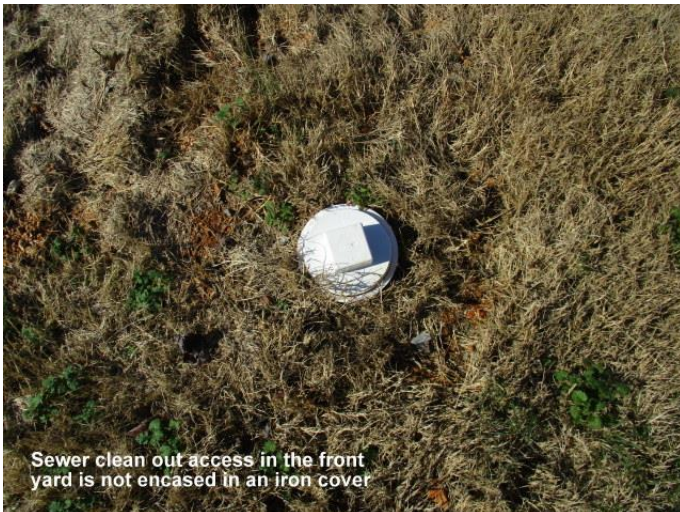
Sewer clean out access in the front yard is not encased in an iron cover

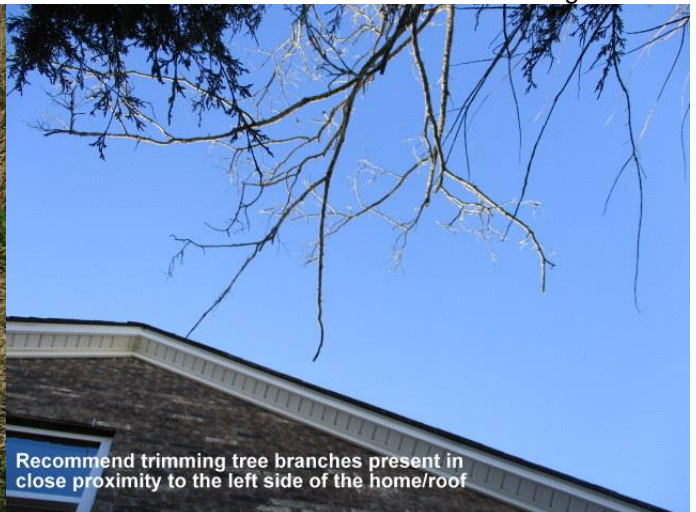
Recommend trimming tree branches present in close proximity to the left side of the home/roof

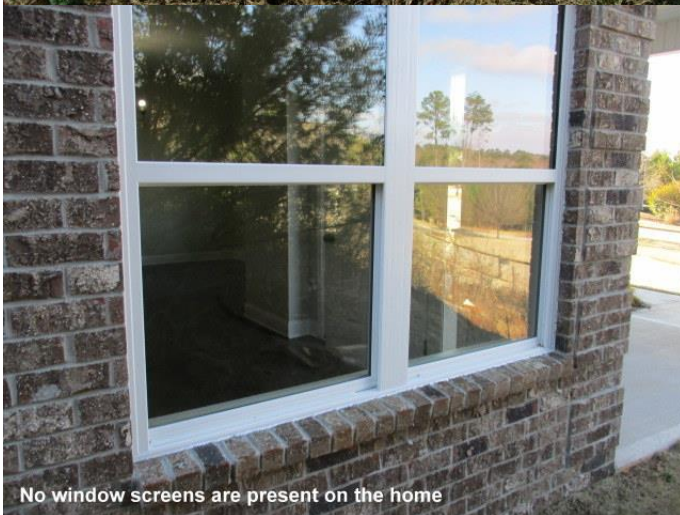
No window screens are present on the home

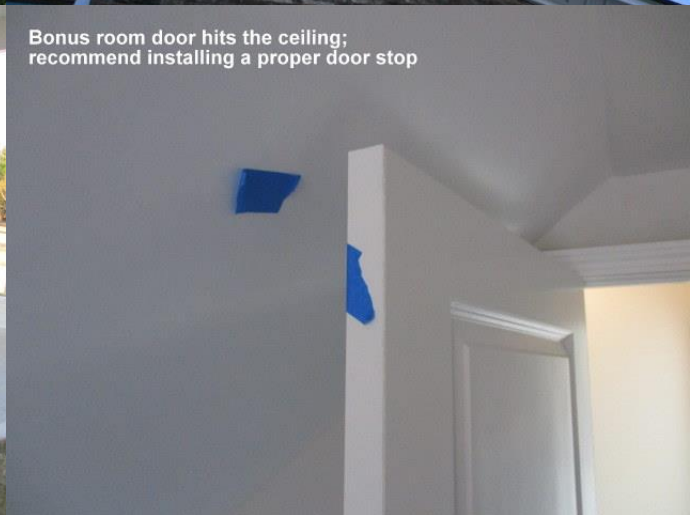
Bonus room door hits the ceiling; recommend installing a proper door stop
