## **Property Inspection Report**

62 Wolf Ridge Court, Dallas GA

5/06/2020

31123

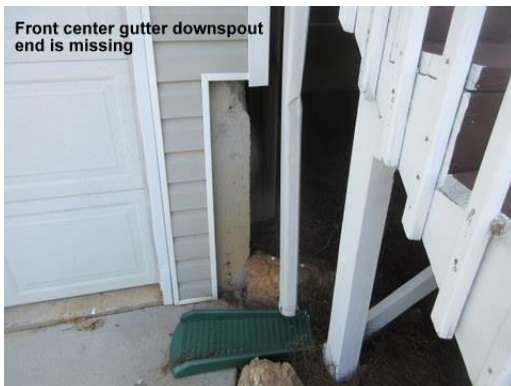
Front center gutter downspout end is missing

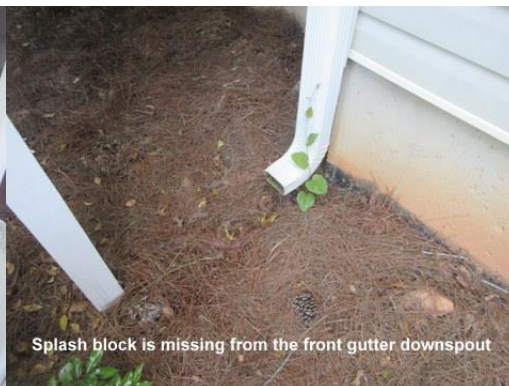
Splash block is missing from the front gutter downspout

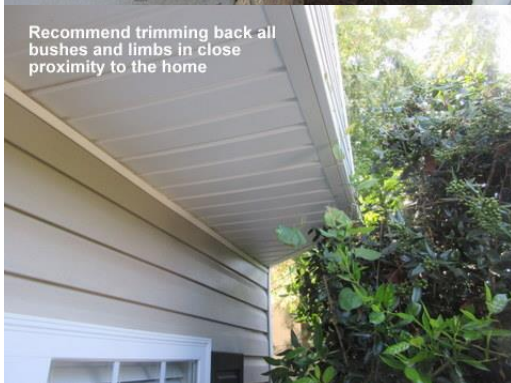
Recommend trimming back all bushes and limbs in close proximity to the home

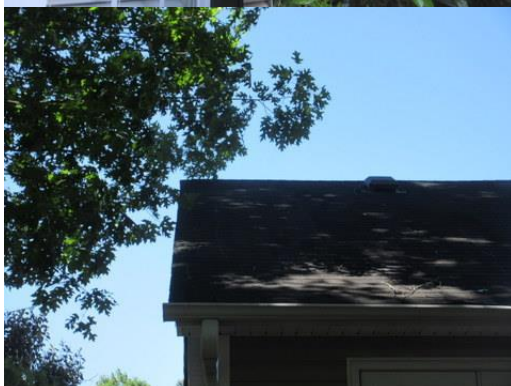
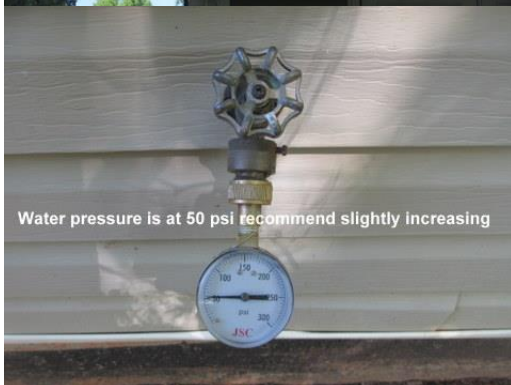
Water pressure is at 50 psi recommend slightly increasing

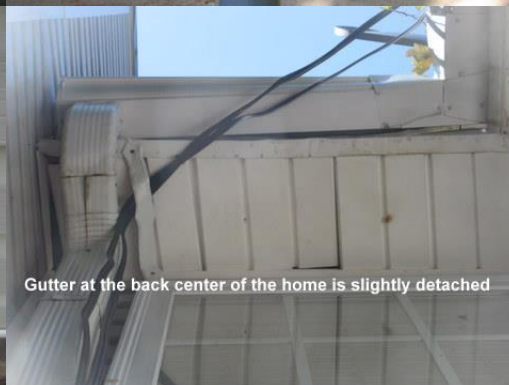
Gutter at the back center of the home is slightly detached

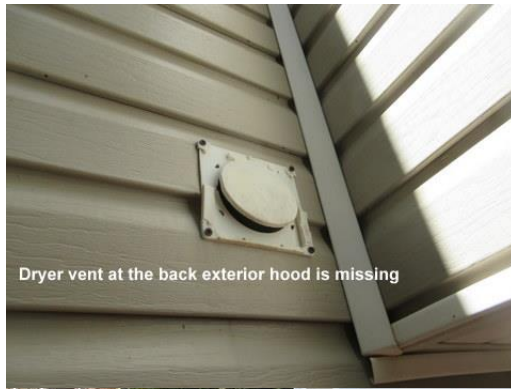
Dryer vent at the back exterior hood is missing

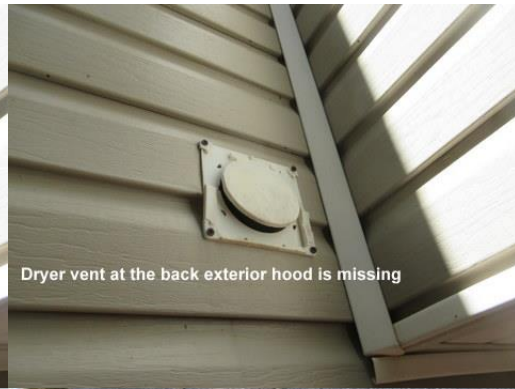
Dryer vent at the back exterior hood is missing

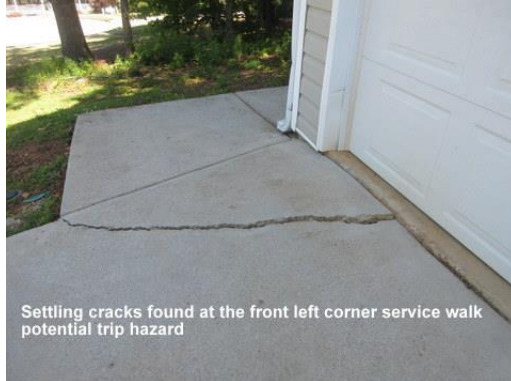
Settling cracks found at the front left corner service walk potential trip hazard

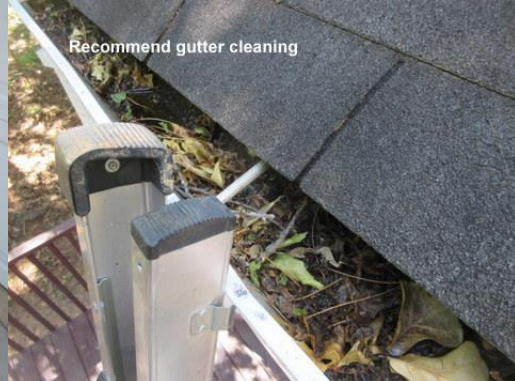
Recommend gutter cleaning

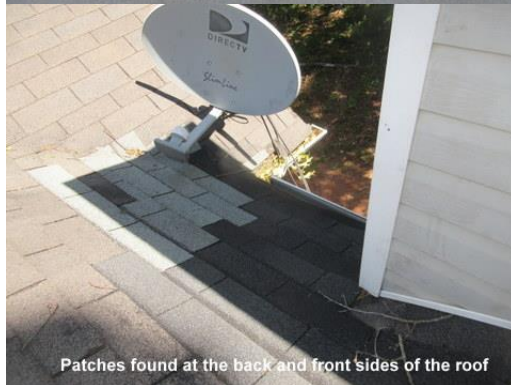
Patches found at the back and front sides of the roof

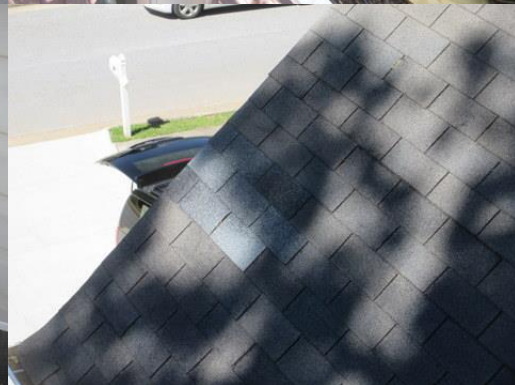
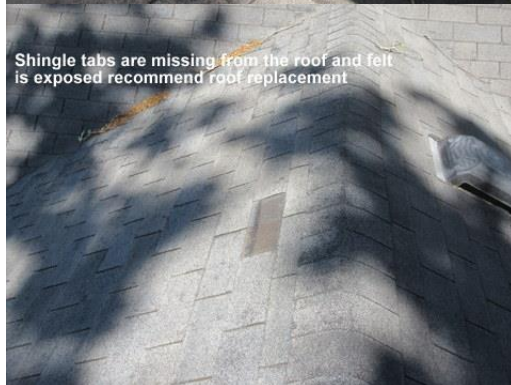
Shingle tabs are missing from the roof and felt is exposed recommend roof replacement

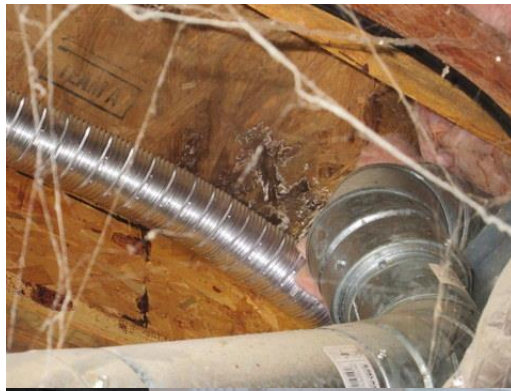
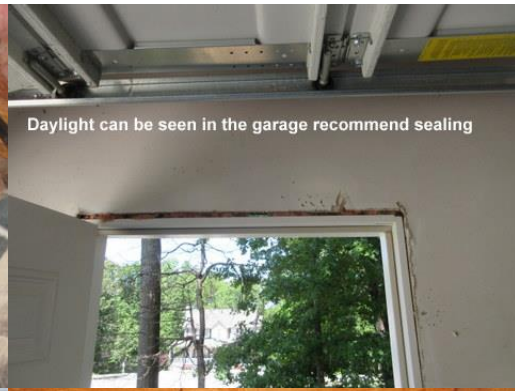
Daylight can be seen in the garage recommend sealing

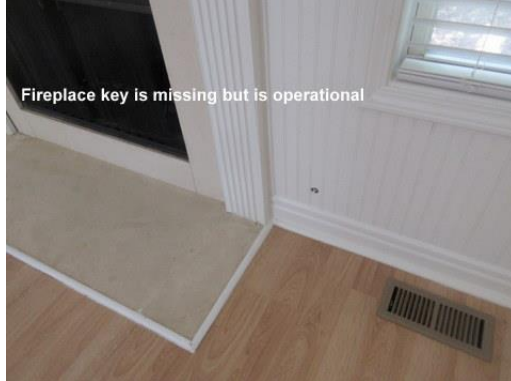
Fireplace key is missing but is operational

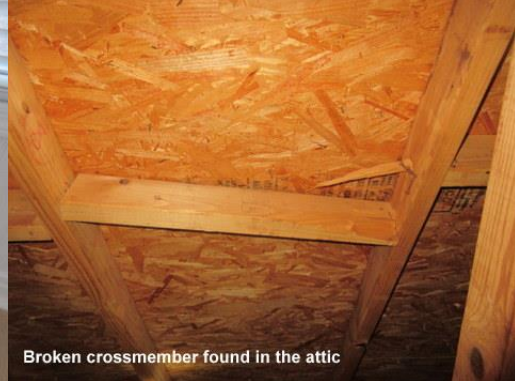
Broken crossmember found in the attic
