Jun 20th, 2023

1234 Skywalker Drive, Tampa, 34654

Home Inspection Report

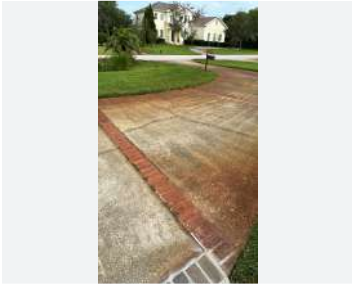
1.1 DRIVEWAY

- Typical cracking noted

Requires Attention

- Common cracks and stains present
Recommend sealing crack(s) and resurfacing as needed

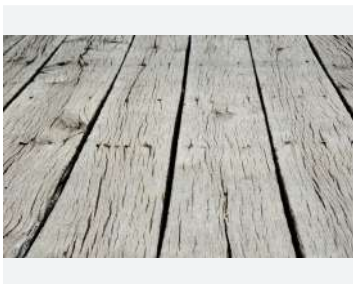
1.6 DECK/BALCONY

- **Moisture damage**

Significant moisture damage and wood rot was noted at the deck. Recommend evaluation and repair by a licensed contractor or deck specialist.

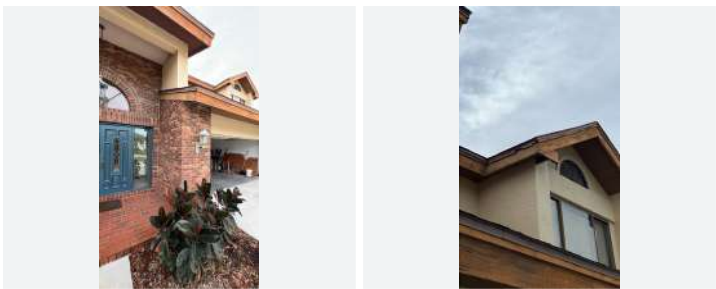
2.1 TYPE

- Water damaged/deteriorated trim

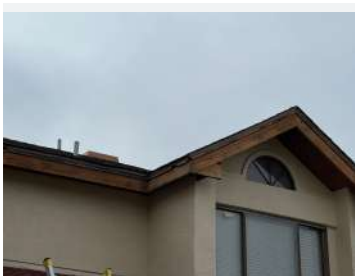
2.2 SOFFITS/FASCIA

- Wood rot was noted at portions of the fascia trim. See a licensed contractor for evaluation and repair/replacement as needed.

Requires Attention

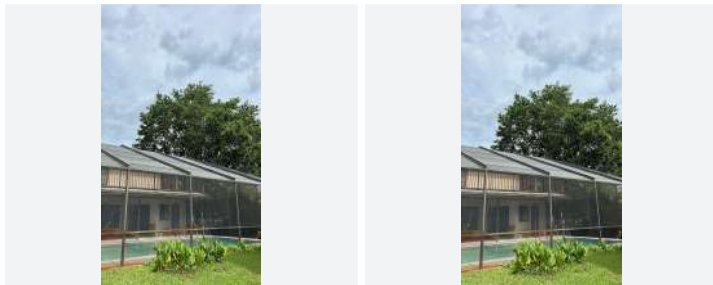
2.5 TREES AND VEGETATION

- **Overgrown/Overhanging Tree Limbs**

Requires Attention

Tree limbs are overhanging the roof and could damage roofing material. Recommend evaluation by an arborist.

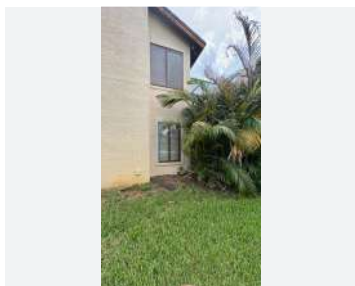
- **Vegetation Too Close to House**

Plants and vegetation are in contact with the home. Recommend trimming 1-2 feet from exterior walls.

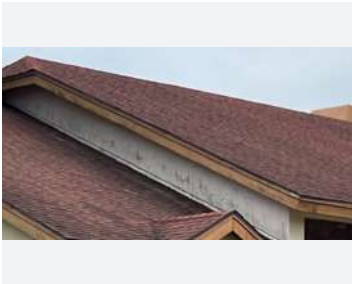
3.1 TYPE

- **Roof at/near end of useful life**

Recommendation

The roof shows advanced signs of aging and is within 3-5 years of the end of

life expectancy. Recommend evaluation and saving for replacement by a licensed/qualified roofer.

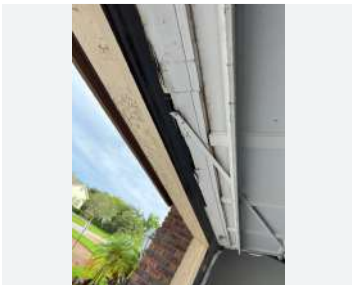
4.1 TYPE

- **Water Damage to Base of Garage Door**

Water damage was noted to the base of the garage door. Recommend evaluation and repair by a licensed contractor or garage door specialist.

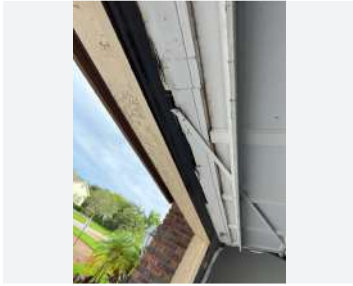
4.2 GARAGE DOORS

- **Water Damage to Base of Garage Door**

Requires Attention

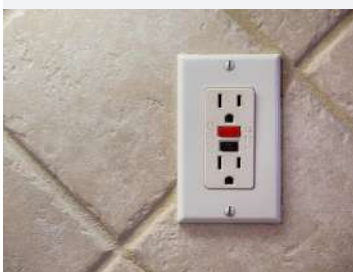
6.3 GFCI/AFCI

- The main level guest bathroom GFCI outlet does not trip when tested. Recommend evaluation and repair by a licensed electrician.

Location - Bathroom

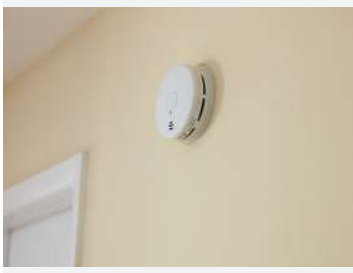
6.5 SMOKE DETECTORS

- Missing/Low battery

Requires Attention

Location - 2nd Floor

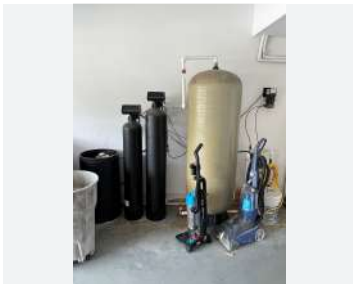
7.2 MAIN WATER SHUTOFF

- **Filtration System Not Inspected**

Inspection of the water filtration system goes beyond the scope of the inspection. Recommend servicing as needed by a licensed plumber.

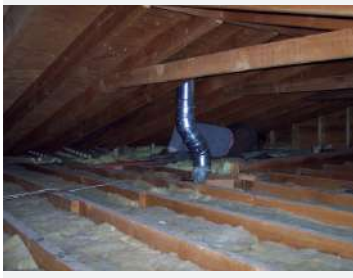
8.3 INSULATION

DEPTH: 6 inches

- Recommend additional insulation be installed in the attic. See an insulation specialist for installation.

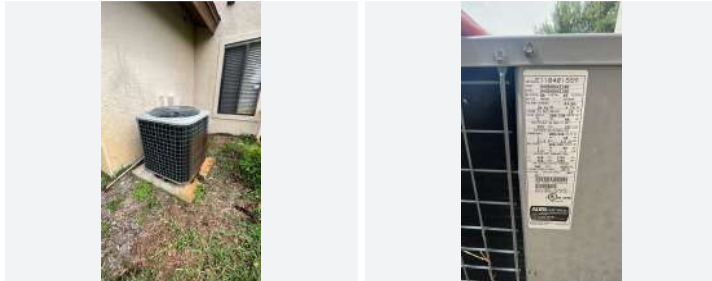
9.4 COOLING SYSTEM

- Unit is nearing the end of its design life

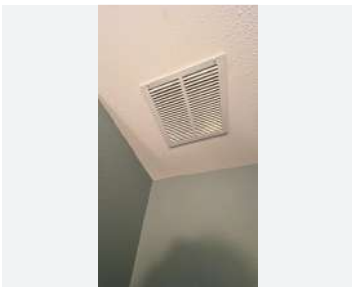
10.7 VENTILATION

- Fan inoperative in the first floor half bathroom. Recommend repair/replacement by a licensed contractor.

Recommendation

Location - 1st Floor, Bathroom

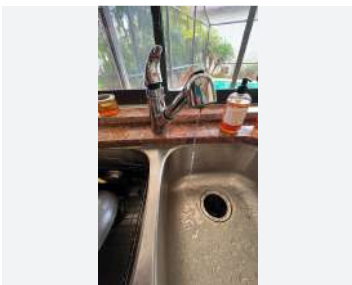
11.4 SINK

- **Low Water Pressure**

Low water pressure was noted at the kitchen sink when the water filtration system back-flushes. Recommend evaluation and repair by a licensed plumber.

Requires Attention

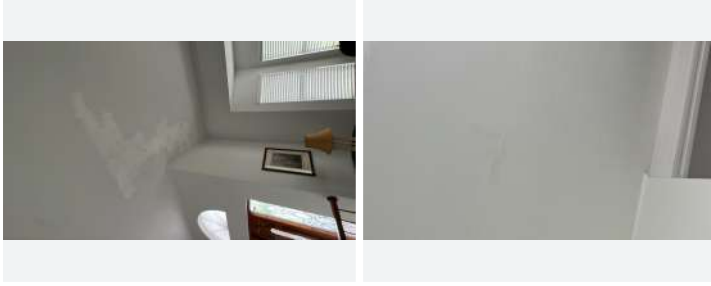
12.2 CEILING

- Nail pop(s) observed
- Evidence of past or present water damage

Requires Attention

Location - Living room

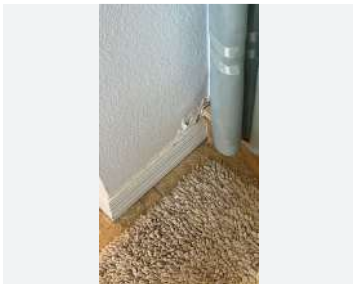
12.3 WALLS

- **Peeling Paint in Master Bathroom**

Peeling paint was noted by the shower in the primary en suite. Recommend sanding and repainting by a qualified handyman or painter.

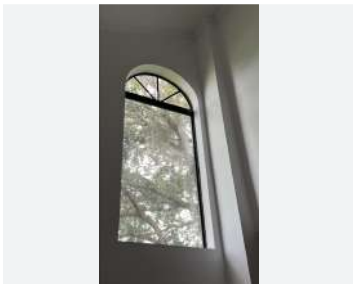
12.6 WINDOWS

- **Cracked Living Room Window**
Cracked, broken, or missing glass

Requires Attention

Location - Living room

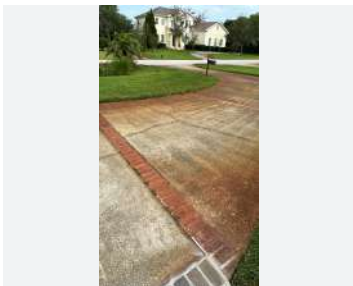
1.1 DRIVEWAY

- Typical cracking noted

Requires Attention

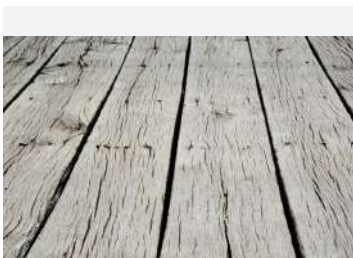
1.6 DECK/BALCONY

- Moisture damage

Significant moisture damage and wood rot was noted at the deck. Recommend evaluation and repair by a licensed contractor or deck specialist.

Safety

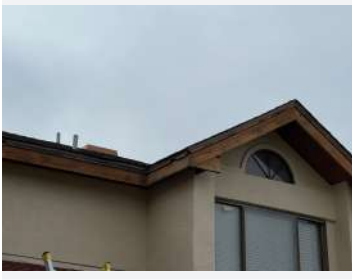
2.2 SOFFITS/FASCIA

- Wood rot was noted at portions of the fascia trim. See a licensed contractor for evaluation and repair/replacement as needed.

Requires Attention

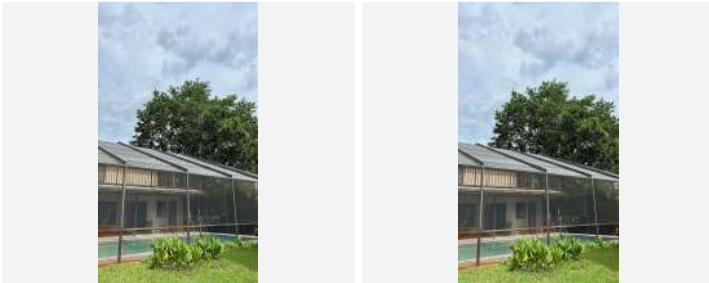
2.5 TREES AND VEGETATION

- **Overgrown/Overhanging Tree Limbs**

Tree limbs are overhanging the roof and could damage roofing material. Recommend evaluation by an arborist.

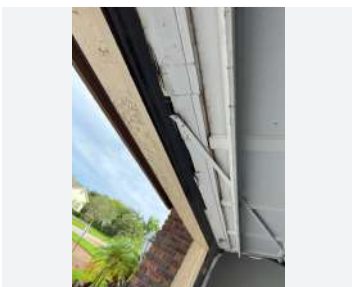
4.2 GARAGE DOORS

- **Water Damage to Base of Garage Door**

Requires Attention

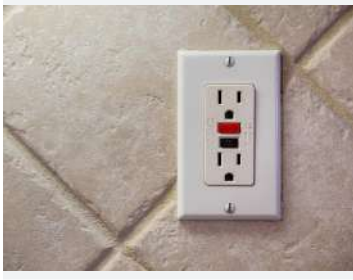
6.3 GFCI/AFCI

- The main level guest bathroom GFCI outlet does not trip when tested. Recommend evaluation and repair by a licensed electrician.

Safety

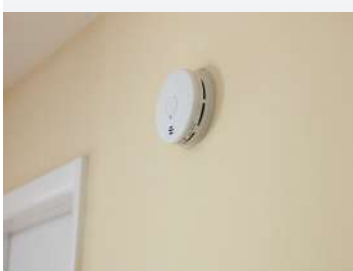
6.5 SMOKE DETECTORS

- Missing/Low battery

Requires Attention

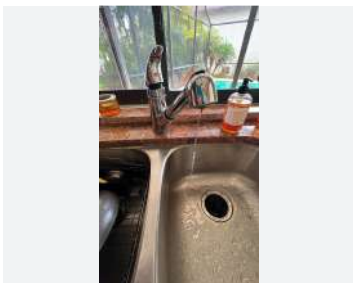
11.4 SINK

- Low Water Pressure

Low water pressure was noted at the kitchen sink when the water filtration system back-flushes. Recommend evaluation and repair by a licensed plumber.

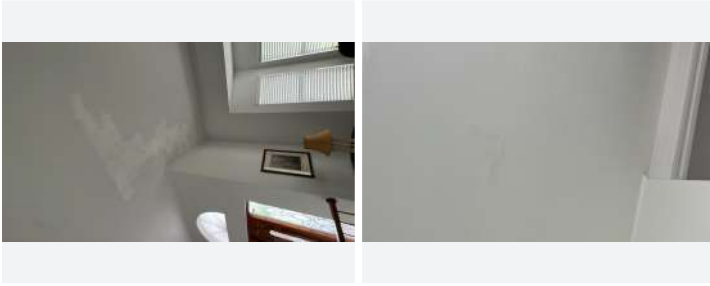
12.2 CEILING

- Evidence of past or present water damage

Requires Attention

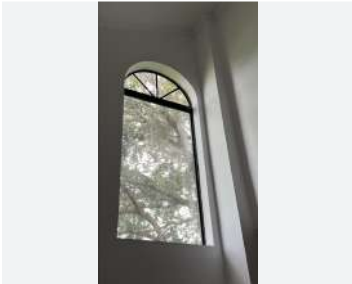
12.6 WINDOWS

- **Cracked Living Room Window**
Cracked, broken, or missing glass

Requires Attention
