Jun 20th, 2023

123 Easy St, Tampa, 33647

Home Inspection Report

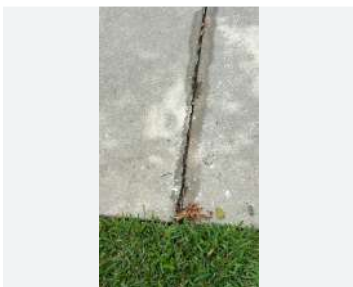
- **Raised Sections of Driveway Noted**

Requires Attention

Heave(s) in concrete causing a trip hazard were noted at the driveway. Recommend evaluation and repair by a paving specialist.

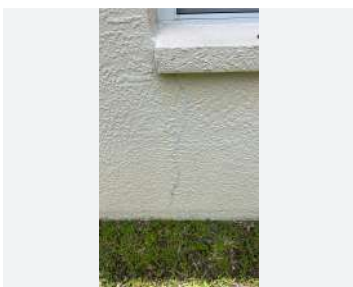
- Normal Settlement

Settlement cracking of less than 1/8 inch was noted. This is typical of this structure and siding material. Recommend monitoring for any ongoing settlement.

Maintenance

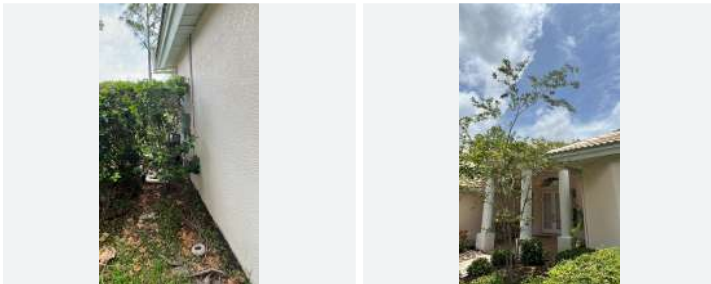
- Trim Hedges Away From House

Recommendation

Recommend having a landscaping professional cut bushes and trees away from the siding and roofing.

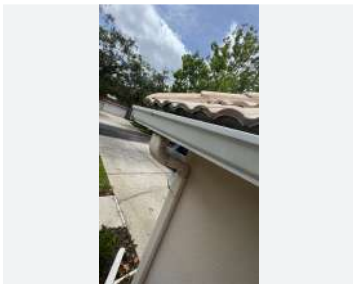
- Need Cleaning

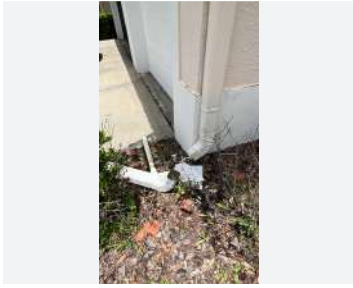
Recommendation

- Extend drain(s) to move water away from foundation

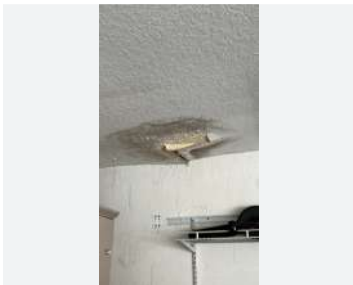
Location - Garage

- Active Leak Noted

Previous water penetration noted in the garage. Stained area(s) was wet at the time of inspection. Recommend evaluation and repair by a licensed contractor.

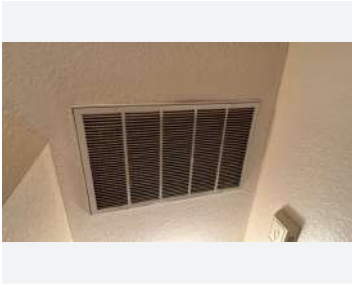
- Filter is extremely dirty

Maintenance

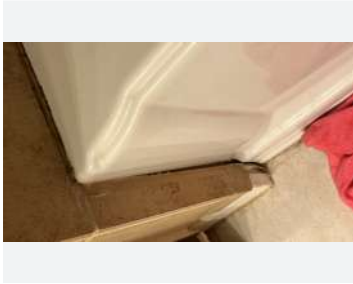
- Grout repair(s) required. Recommend that a qualified contractor evaluate and estimate repairs.

Requires Attention

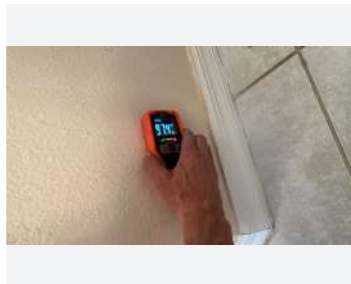
- Shower Leaking

Requires Attention

A slow leak was noted at the shower head in the primary en suite, with water penetrating the wall. Recommend evaluation and repair by a licensed plumber.

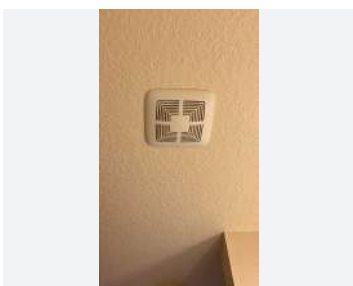
Maintenance

- Recommend cleaning the exhaust fan and cover

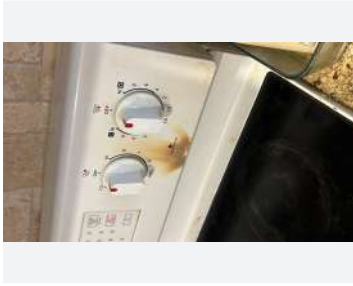
- Scorching on Control Board

Scorching was noted on the control board of the kitchen range. This did not appear to effect function at the time of inspection. Recommend monitoring for further issues.

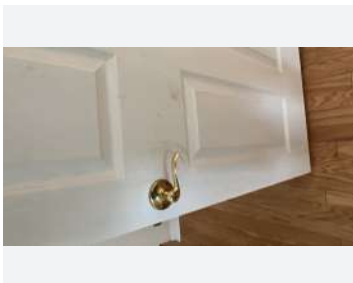
- **Cosmetic Defects**

Cosmetic defects were noted on several of the interior doors. Recommend repainting by a qualified painter.

Maintenance

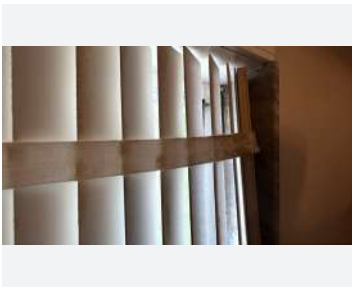
- **Mold Like Substance**

Suspected mold/mildew growth was noted on several of the windows and treatments. Recommend evaluation and cleaning by a mold abatement professional.

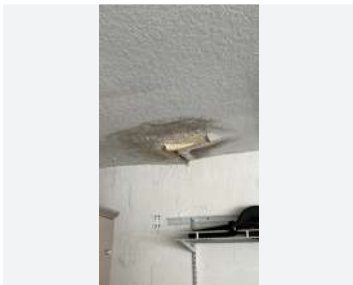
Location - Garage

- **Active Leak Noted**

Safety
 Previous water penetration noted in the garage. Stained area(s) was wet at the time of inspection. Recommend evaluation and repair by a licensed contractor.

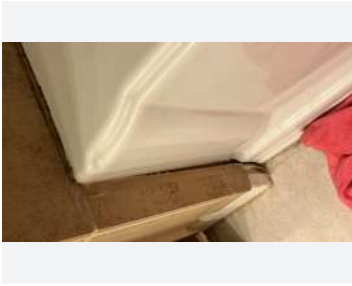
- Grout repair(s) required. Recommend that a qualified contractor evaluate and estimate repairs.

Requires Attention

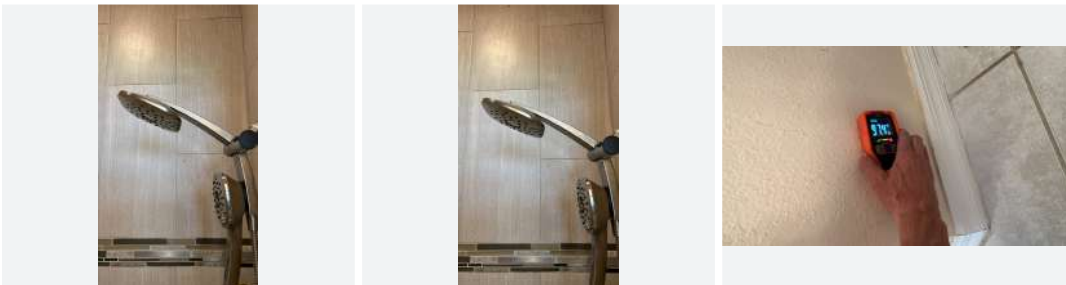
- **Shower Leaking**
A slow leak was noted at the shower head in the primary en suite, with water penetrating the wall. Recommend evaluation and repair by a licensed plumber.

Requires Attention
