### Kodiak Home Inspection Services, LLC

Property address: **1234 Property Drive  
Nesconset, NY 11767**

Inspection date: **Friday, November 10, 2017**

## Property Inspection Report

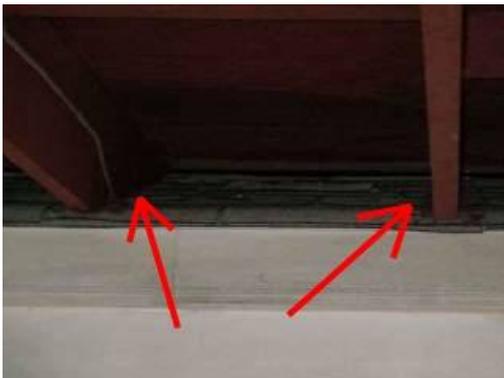
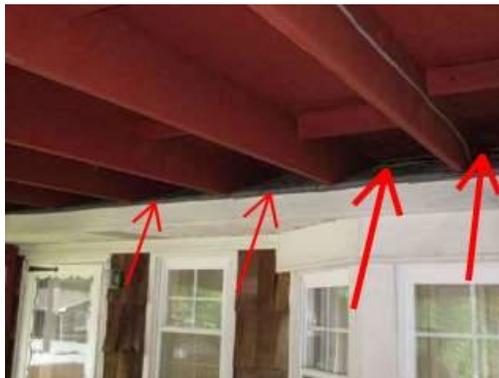
Based on non-standard construction observed, modifications to this property may have been made without the owner having attained permits or inspections from the municipality. Work may have been performed by someone other than a qualified contractor or person. Consult with the property owner about this, and if necessary research permits.

Covered deck roofing system does not appear to have been installed properly. Advised client to check with town to determine if proper permits were pulled, inspections completed, and CO's signed off on the modification/addition.

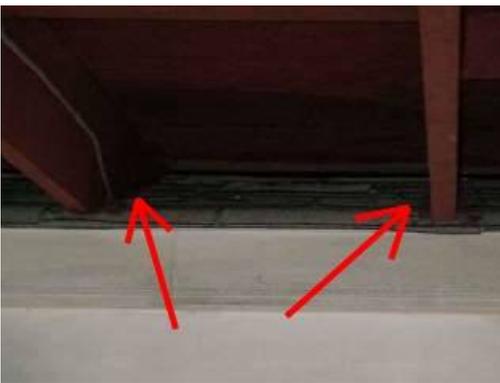
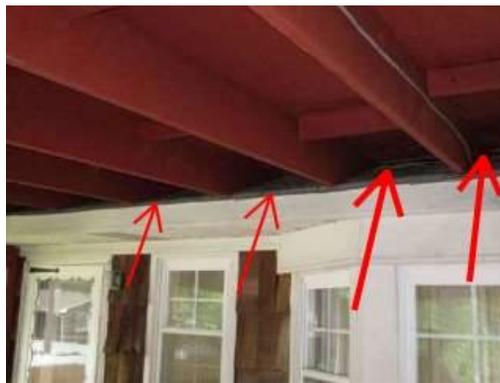
One or more deck, patio and/or porch covers were non-standard. Recommend that a qualified person repair or replace as necessary, and per standard building practices.

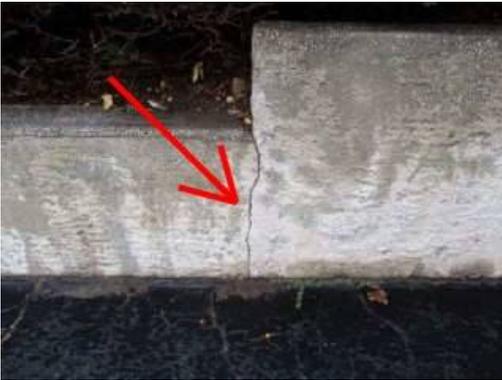
Photo 5-1

Driveway retaining wall shows minor vertical cracking. This cracking should be monitored and repaired to prevent further deterioration.

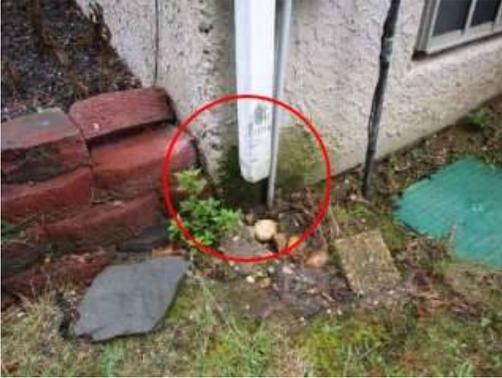
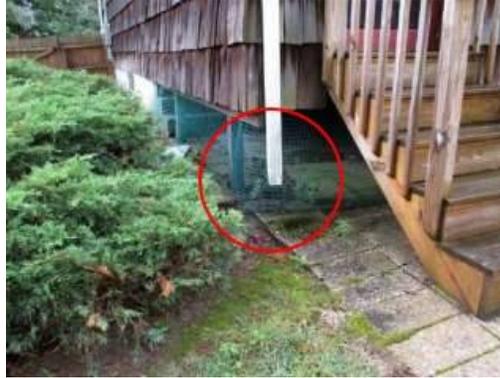
Extensions such as splash blocks or drain pipes for one or more downspouts were missing. Water can accumulate around the building foundation or inside crawl spaces or basements as a result. Recommend that a qualified person install, replace or repair extensions as necessary so rainwater drains away from the structure.

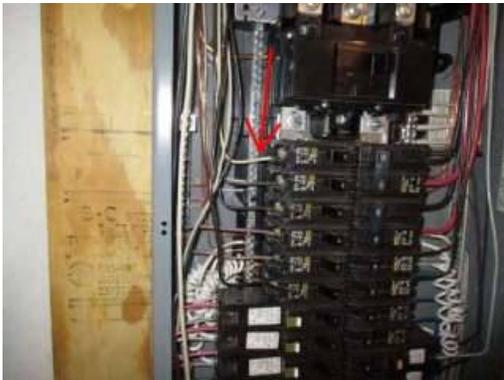
Photo 7-1

Substandard wiring was found at the . For example, main disconnect panel. This is a safety hazard. Recommend that a qualified electrician evaluate and repair as necessary and per standard building practices.

Neutral conductor that is connected to the breaker should be taped with black electrical tape to indicate it is being used as a hot wire.

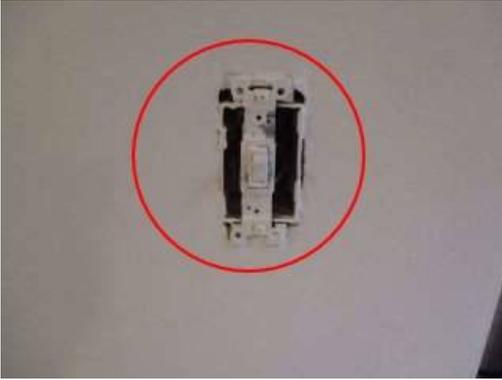
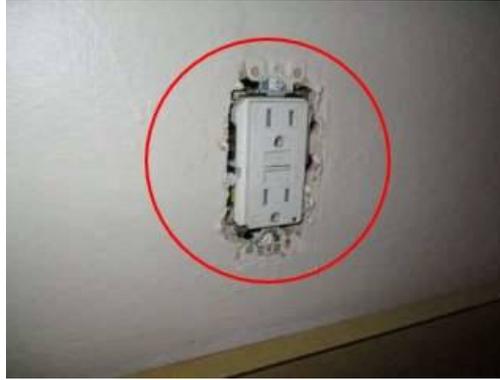
One or more cover plates for switches, receptacles or junction boxes were missing or broken. These plates are intended to contain fire and prevent electric shock from occurring due to exposed wires. Recommend that a qualified person install cover plates where necessary.

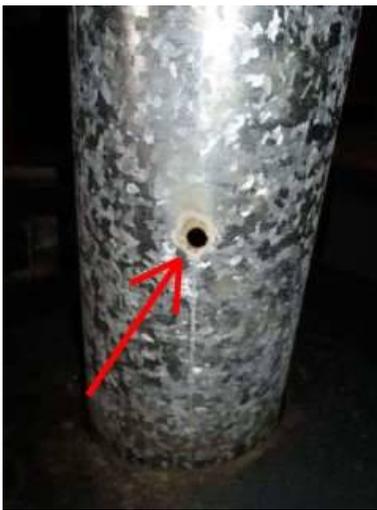
Photo 13-1

Boiler venting shows efficiency hole not sealed. This hole can allow flue gases to vent into the building. Seal tape should be used to seal the hole.

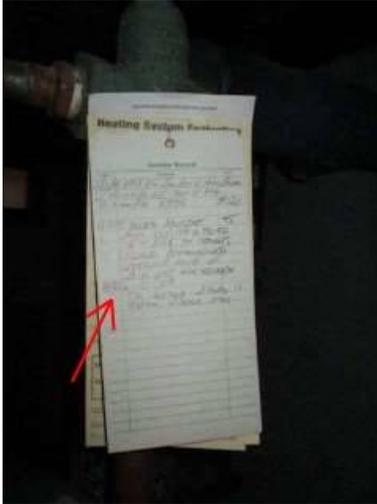
Photo 14-1

The last service date of the gas or oil-fired forced air furnace appeared to be more than 1 year ago, or the inspector was unable to determine the last service date. Ask the property owner when it was last serviced. If unable to determine the last service date, or if this system was serviced more than 1 year ago, recommend that a qualified HVAC contractor inspect, clean, and service this system, and make repairs if necessary. For safety reasons, and because this system is fueled by gas or oil, this servicing should be performed annually in the future. Any needed repairs noted in this report should be brought to the attention of the HVAC contractor when it's serviced. For more information visit:

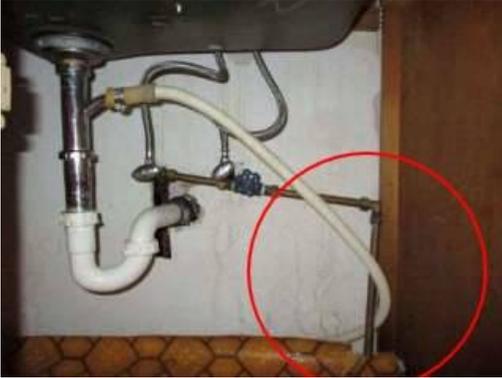
Photo 16-1

The inspector was unable to determine if the dishwasher's drain line had a high loop or air gap (e.g. drain line not visible). A high loop is created by routing the drain line up to the bottom surface of the counter top above and securely fastening it to that surface. An air gap is a device that makes the drain line non-continuous. Both of these prevent waste-water backflow from entering the dishwasher, and possibly flooding out of the dishwasher if/when a siphon occurs. Some newer dishwashers have these devices built in. Recommend reviewing the dishwasher's installation instructions, consulting with the property owner and/or having a qualified contractor evaluate further to determine if a high loop and air gap are installed or needed. If not installed, and none is built into the dishwasher, then recommend that a qualified contractor install a high loop and air gap per standard building practices.

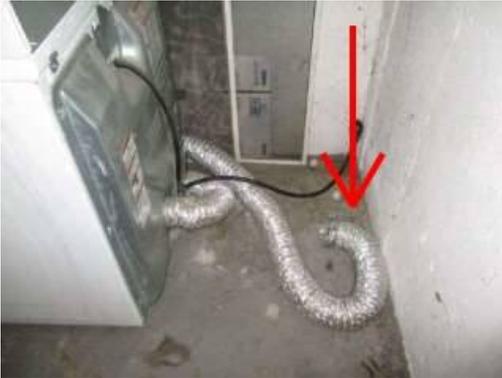
Photo 17-1

The clothes dryer exhaust duct was disconnected in one or more places. Clothes dryers produce large amounts of moisture which should not enter structure interiors. Moisture can accumulate and result in mold, bacteria or fungal growth. Recommend that a qualified person make permanent repairs as necessary. For more information, visit:

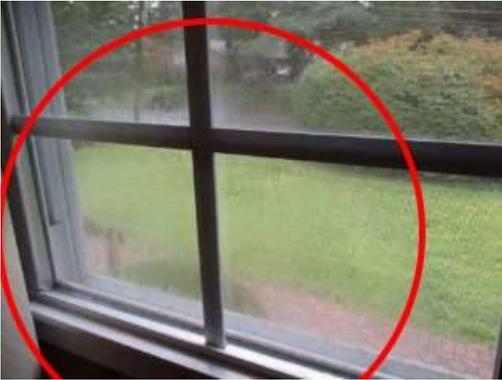
Photo 18-1

Condensation or staining was visible between multi-pane glass in one or more windows. This usually indicates that the seal between the panes of glass has failed or that the desiccant material that absorbs moisture is saturated. As a result, the view through the window may be obscured, the window's U-value will be reduced, and accumulated condensation may leak into the wall structure below. Recommend that a qualified contractor evaluate and repair windows as necessary. Usually, this means replacing the glass in window frames.
