HOME INSPECTION SERVICES, LLC

Property Inspection Report

Property address: **1234 Property Drive
Babylon, NY 11702**

Inspection date: **Thursday, November 9, 2017**

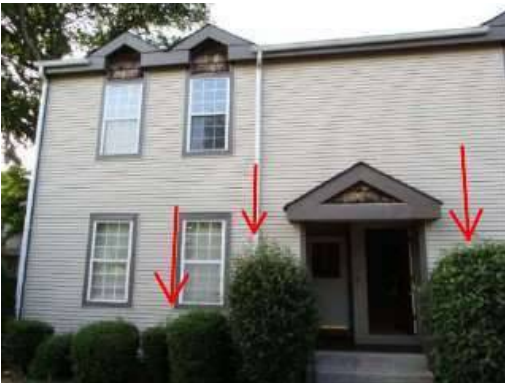
Photo 3-1

- Vegetation such as trees, shrubs and/or vines was in contact with or close to the building exterior. Vegetation can serve as a pathway for wood-destroying insects and can retain moisture against the exterior after it rains. This is a conducive condition for wood-destroying organisms. Recommend pruning, moving or removing vegetation as necessary to maintain at least 6 inches of space between it and the building exterior. A 1-foot clearance is better.

Vegetation such as trees, shrubs and/or vines was in contact with or close to the building exterior. Vegetation can serve as a pathway for wood-destroying insects and can retain moisture against the exterior after it rains. This is a conducive condition for wood-destroying organisms. Recommend pruning, moving or removing vegetation as necessary to maintain at least 6 inches of space between it and the building exterior. A 1-foot clearance is better.

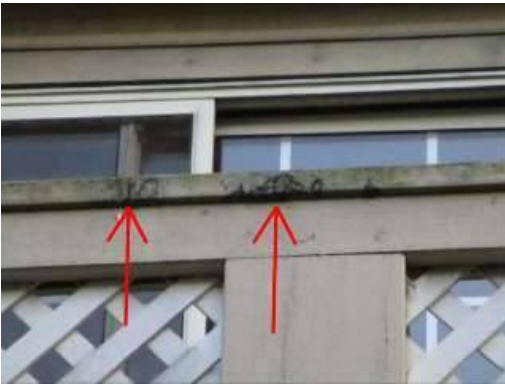
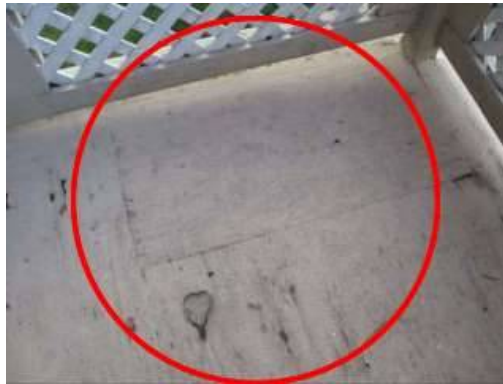
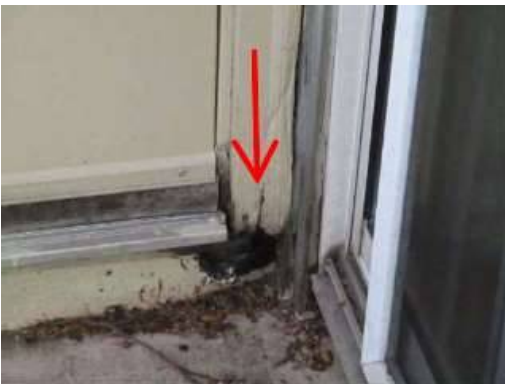
- Fungal rot was found in decking boards, support posts, plywood sheathing and/or trim at one or more decks or porches. Recommend that a qualified contractor evaluate and repair as necessary. All rotten wood should be replaced.

Fungal rot was found in decking boards, support posts, plywood sheathing and/or trim at one or more decks or porches. Recommend that a qualified contractor evaluate and repair as necessary. All rotten wood should be replaced.

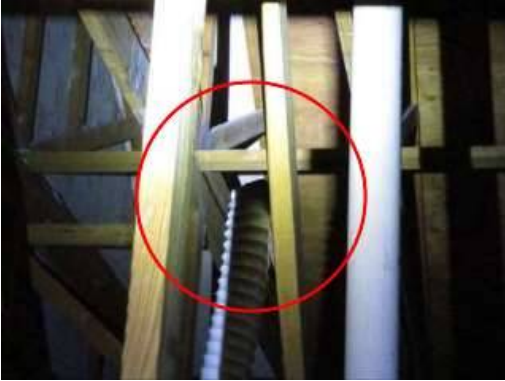
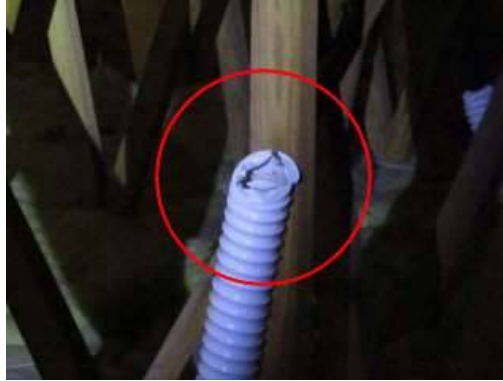
- Both bathroom vent fans are being vented directly into the attic, instead of out of the building. This can cause excess moisture to build in the attic causing moisture damage to the attic and improper roof damage.

Both bathroom vent fans are being vented directly into the attic, instead of out of the building. This can cause excess moisture to build in the attic causing moisture damage to the attic and improper roof damage.

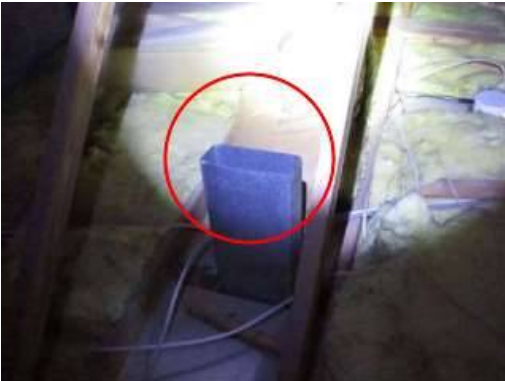
Photo 6-1

- Microwave vent fan is being vented directly into the attic, instead of out of the building. This can cause excess moisture to build in the attic causing moisture damage to the attic and improper roof damage.

Microwave vent fan is being vented directly into the attic, instead of out of the building. This can cause excess moisture to build in the attic causing moisture damage to the attic and improper roof damage.

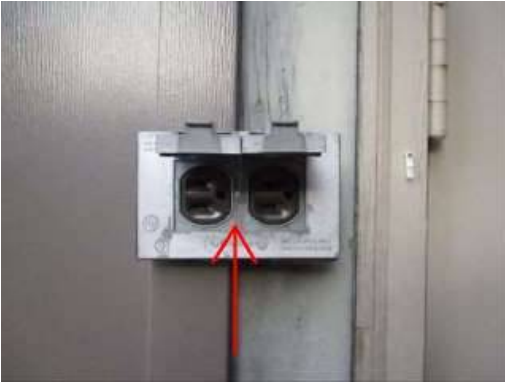
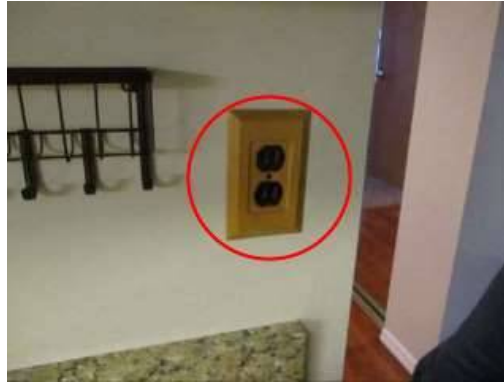
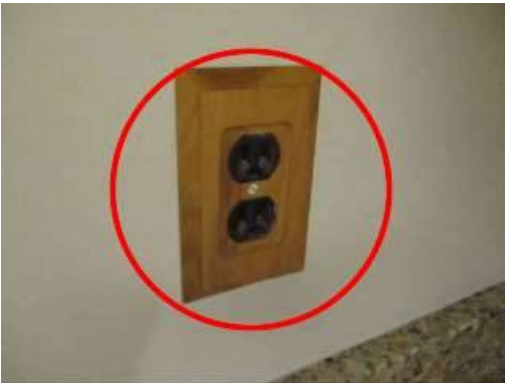
- One or more electric receptacles at the kitchen and/or exterior had no visible ground fault circuit interrupter (GFCI) protection, or the inspector was unable to determine if GFCI protection was present. If not GFCI-protected, receptacles in wet areas pose a shock hazard. Recommend that a qualified electrician evaluate and install GFCI protection if necessary and per standard building practices. General guidelines for GFCI-protected receptacles include the following locations:

One or more electric receptacles at the kitchen and/or exterior had no visible ground fault circuit interrupter (GFCI) protection, or the inspector was unable to determine if GFCI protection was present. If not GFCI-protected, receptacles in wet areas pose a shock hazard. Recommend that a qualified electrician evaluate and install GFCI protection if necessary and per standard building practices. General guidelines for GFCI-protected receptacles include the following locations:

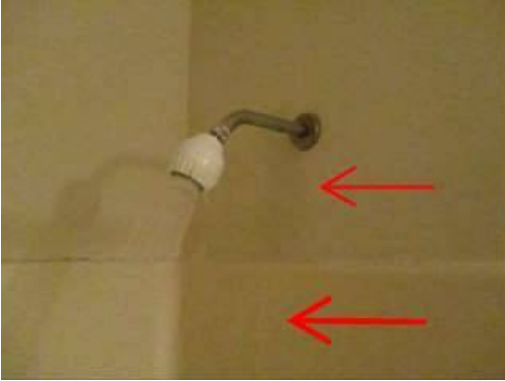
Photo 10-1

- The bathtub faucet at location(s) #A dripped when it was turned off. Recommend that a qualified plumber repair as necessary.

The bathtub faucet at location(s) #A dripped when it was turned off. Recommend that a qualified plumber repair as necessary.

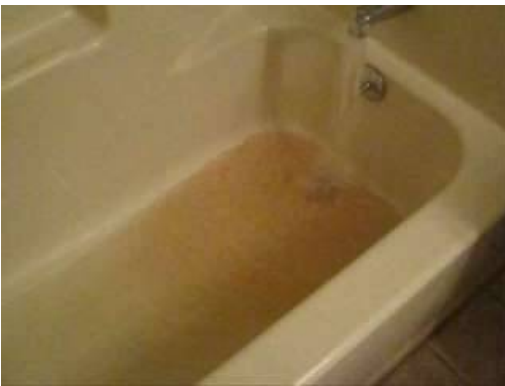
Photo 11-1

- The bathtub at location(s) #A drained slowly. Recommend clearing drain and/or that a qualified plumber repair if necessary.

The bathtub at location(s) #A drained slowly. Recommend clearing drain and/or that a qualified plumber repair if necessary.

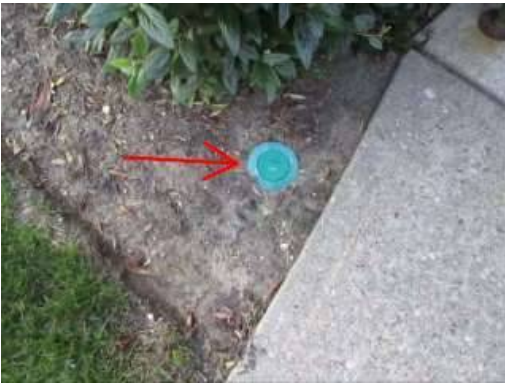
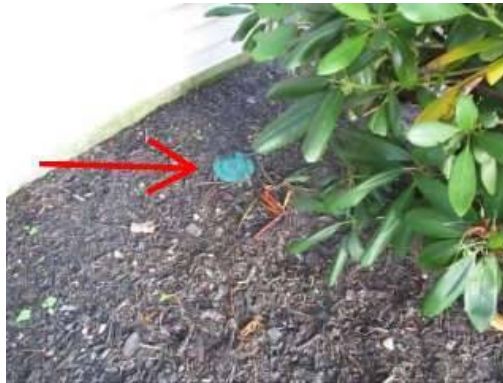
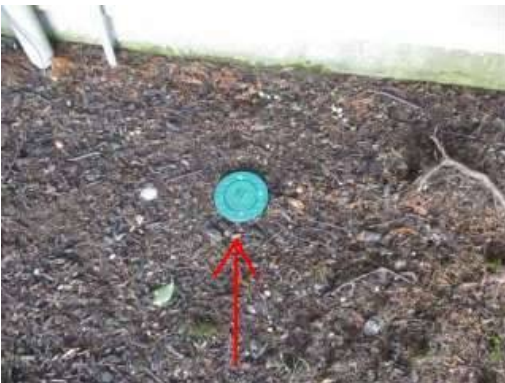
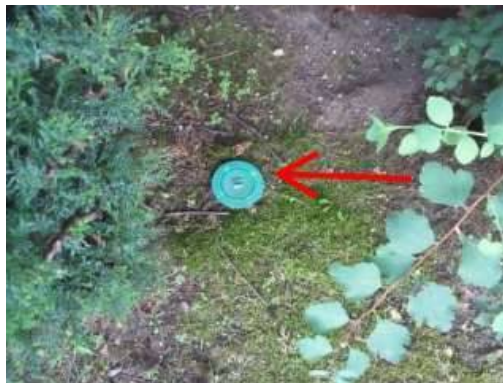
Evidence of prior treatment of wood-destroying insects: Many areas around the property exterior show bait stations installed.
