INSPECTION REPORT

# 99 Lyman Street, Asheville, North Carolina 28801

Prepared for  
Janis Loplom

Date Inspected  
Mar 11, 2024

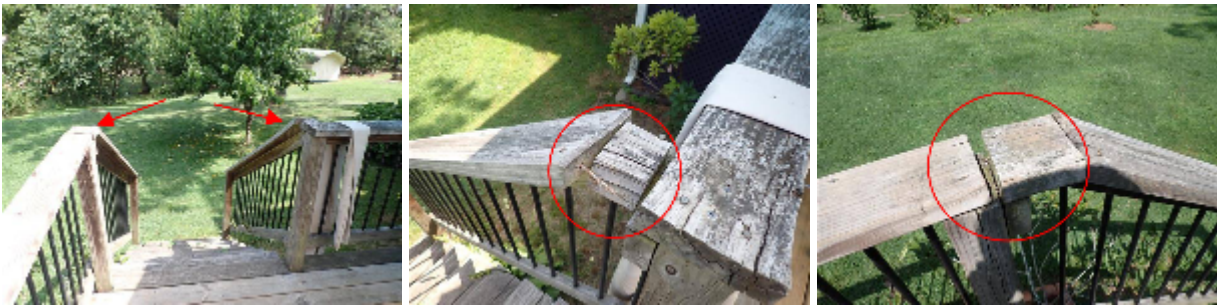
Handrail to the stairs of the rear deck is deteriorated and pulling away.

IMPACT	The deterioration reduces the stability of the railing
SUGGESTED ACTION	Advised to consult a carpenter to repair/replace as needed to prevent further movement or damage.

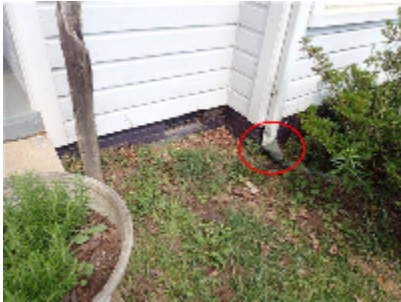
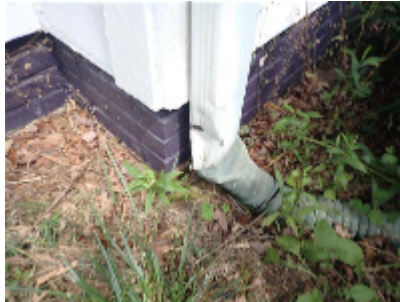
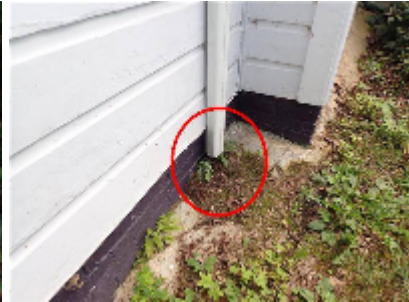
Several downspouts are damaged or missing kickouts.

A damaged or missing downspout weakens the structure of the downspout and alters the water flow.

Advised to consult a gutter professional for review of all areas and to repair/replace as needed for proper function.  
Recommend installing splashblocks or extension pipes at all downspouts where not currently installed to help move water further from the foundation.

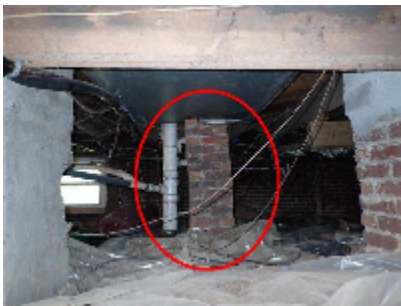
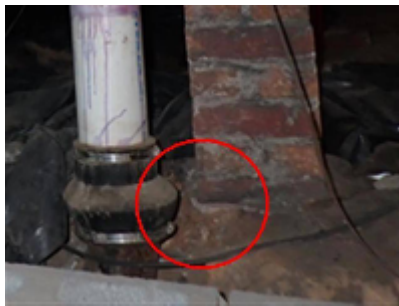
A brick column in the center of the crawlspace had a leaning appearance and was noted to be partially undermined at one corner where the dirt was dug out too closely.

Advised to consult a general contractor for further review and to make any repairs or corrections to prevent structural movement or damage.

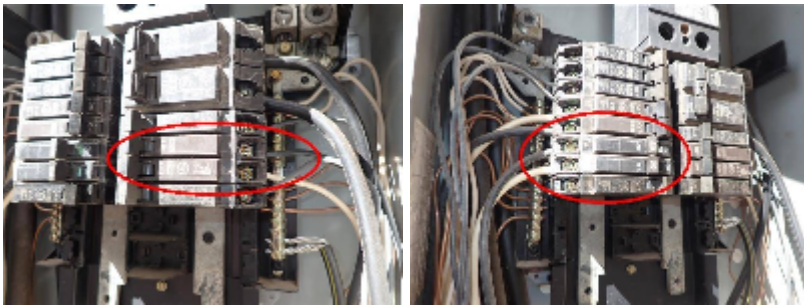
40 and 50 amp circuit breakers in the main electrical panel for the detached workshop appeared to be overfused.

Advised to consult an electrician for further evaluation and to correct as needed for safety and equipment protection.

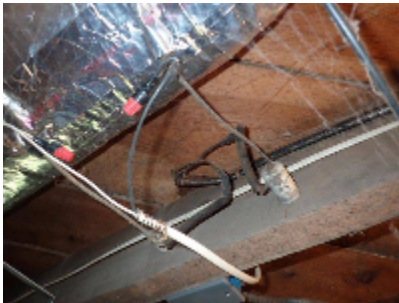
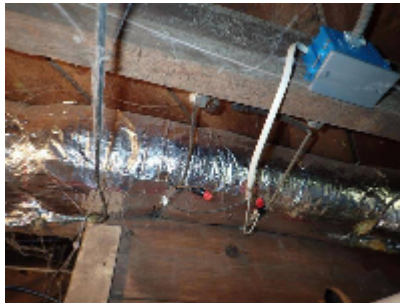
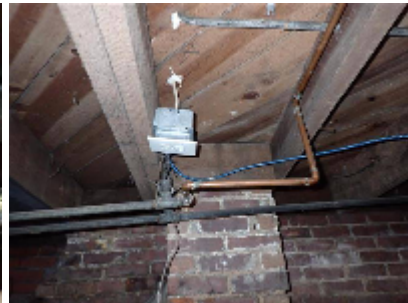
Several unenclosed electrical junctions were observed at the basement ceiling at the step down into the lower part of the basement, and in the laundry area, where newer wiring was connected to old knob and tube wiring. Old knob and tube wiring was also noted at other locations in the crawlspace.

Advised to consult an electrician for further review of all areas and to correct as needed for safety.

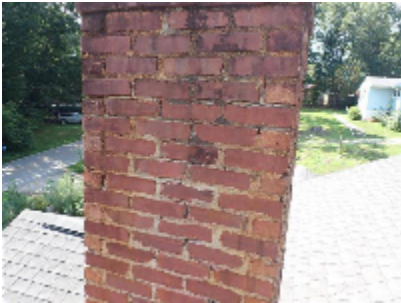
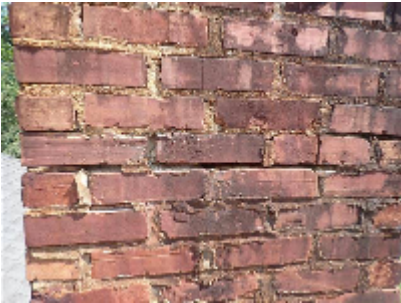
Chimney chase mortar is loose or deteriorating

The damage may worsen and would need more extensive repairs

Have spot-pointed by a qualified brick mason or tuckpointng technican to maintain optimal performance gong forward

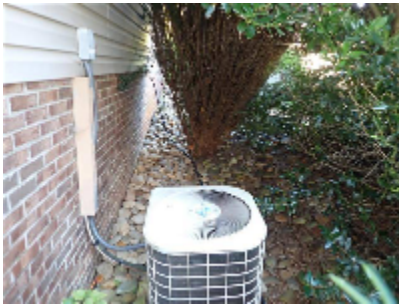
Condenser is nearing the end of its useful life.

Budget for a newer unit. In the interim, a higher level of maintenance can be expected

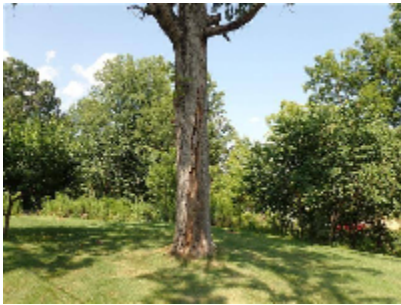
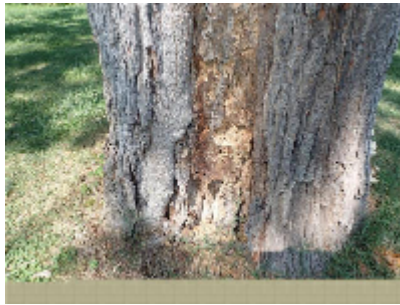
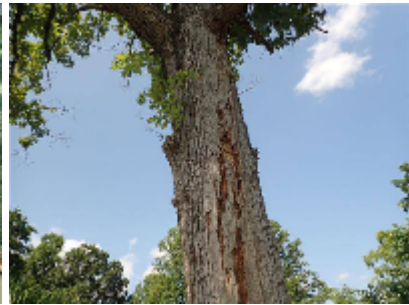
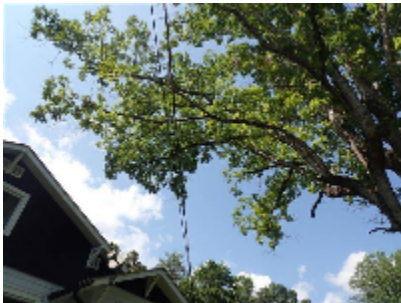
Large tree in close proximity to the home with a section that looked insect-ridden and possibly diseased.

Consider consulting an arborist for further review.

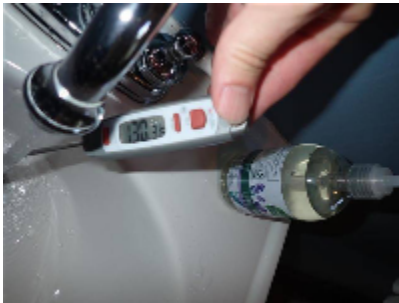
The temperature of the hot water in the home was high (130+ degs F, measured at the bathroom sink), presenting a possible scald hazard.

Advised to consult a repair professional to lower the temperature for safety. If higher temperatures are desired at the water heater, a cold water mixing valve or similar device could be installed to regulate temperatures at plumbing fixtures. Consult a plumber for more information and options.

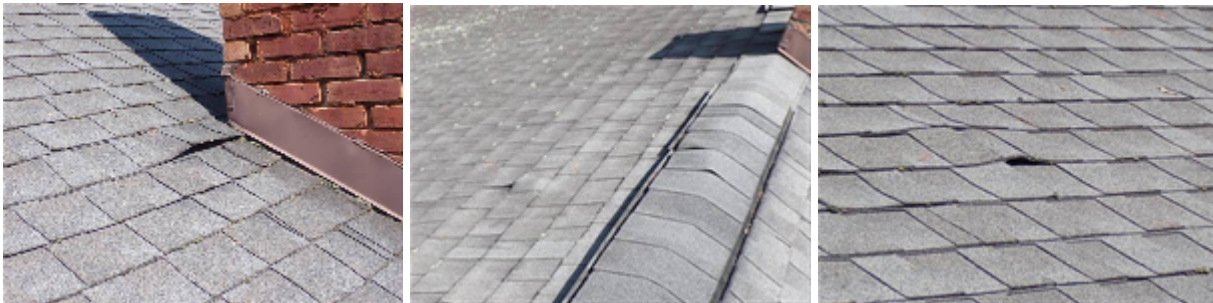
Several roof shingles were noted as pushing up or have an irregular appearance, which could be due to nail pops, loss of adhesion, or other factors, such as excessive heat in the attic. No damaged or missing shingles were observed.

Advised to consult a maintenance professional for review of all areas and to reset any nail pops or apply an appropriate adhesive to any loose shingles to prevent possible damage. Consider further review by a roofer.

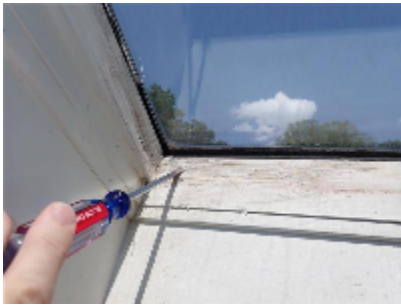
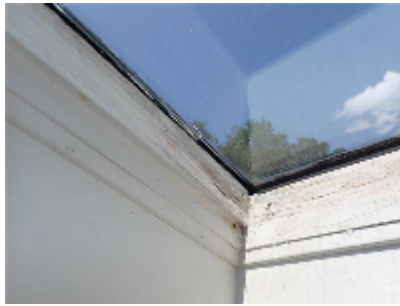
Decay/damage was observed the bottom inside corner of the skylight.

Advised to consult a carpenter for further review and to repair as needed to prevent further damage or water entry. Proper flashing of the skylight must be verified and corrected as needed to prevent water entry.

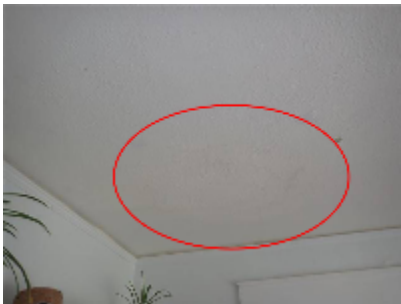
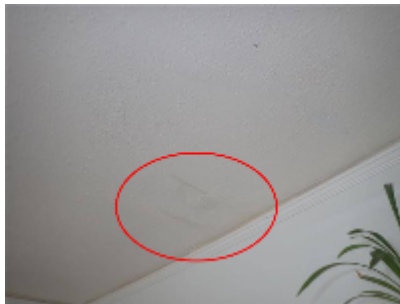
Several water stains were noted at the ceiling in the right main level bedroom. All areas were dry at the time and there were no obvious defects or source of leaking observed at the roof covering or flashings.

Recommend asking the seller for more information about any known history of leaking or repair at this location. Recommend painting the stained areas and periodically observing for changes.
