Incident #: 2021-2100718

Date: April 11, 2021, 1354 hours

Address: 1061 West Beaver Creek Blvd., Avon, Eagle County, CO 81632

A. Synopsis

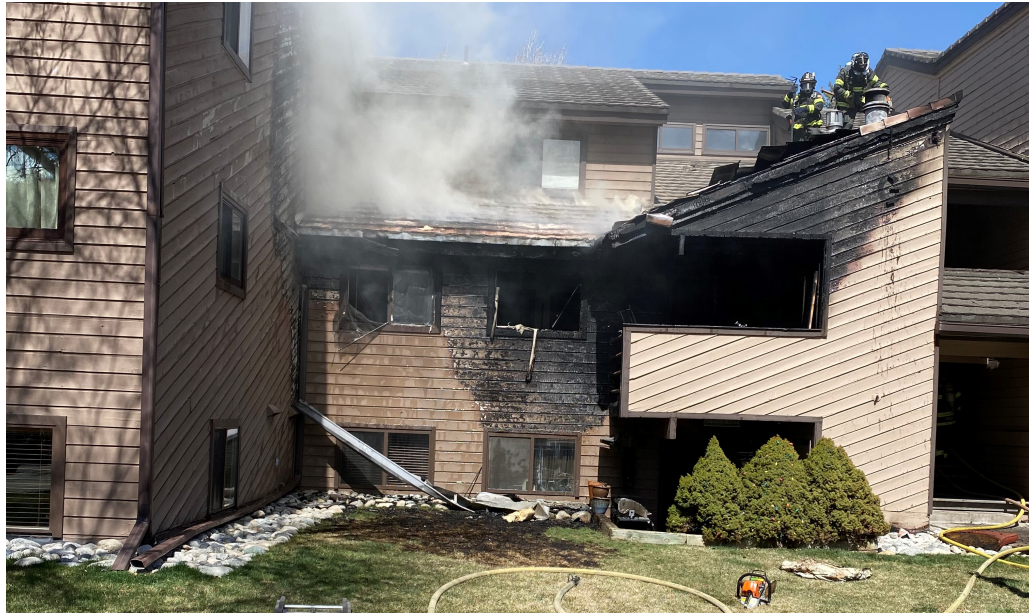
The fire location on the deck of unit G 201 is located on the south side of the building. The deck is about six feet above grade with wood siding around deck area. Approaching the fire area, the ground had been scorched. The siding near the deck shows a V pattern above a first (garden) level window. However, the pattern does not show the origin of the fire. The roof area above the fire area had a cold roof installed over the original roof. The fire spread through the open areas in the cold roof. The siding above and right of the deck shows a true V Pattern from the deck, this points toward the area of origin.

The stairway did have signs of fire. Areas of drywall was removed by fire department. This is a tactic used to find fire extension. The doorways in the stairwell did not have fire but several of the doors were damaged during search. Vents in the ceiling had smoke stains.
